Re: Contract No. 68-W6-0008, Technical Direction Document No. 96-03-0023
Madras Airport Preliminary Assessment

MADRAS AIRPORT

DRAFT
PRELIMINARY ASSESSMENT
MADRAS AIRPORT
MADRAS, OREGON

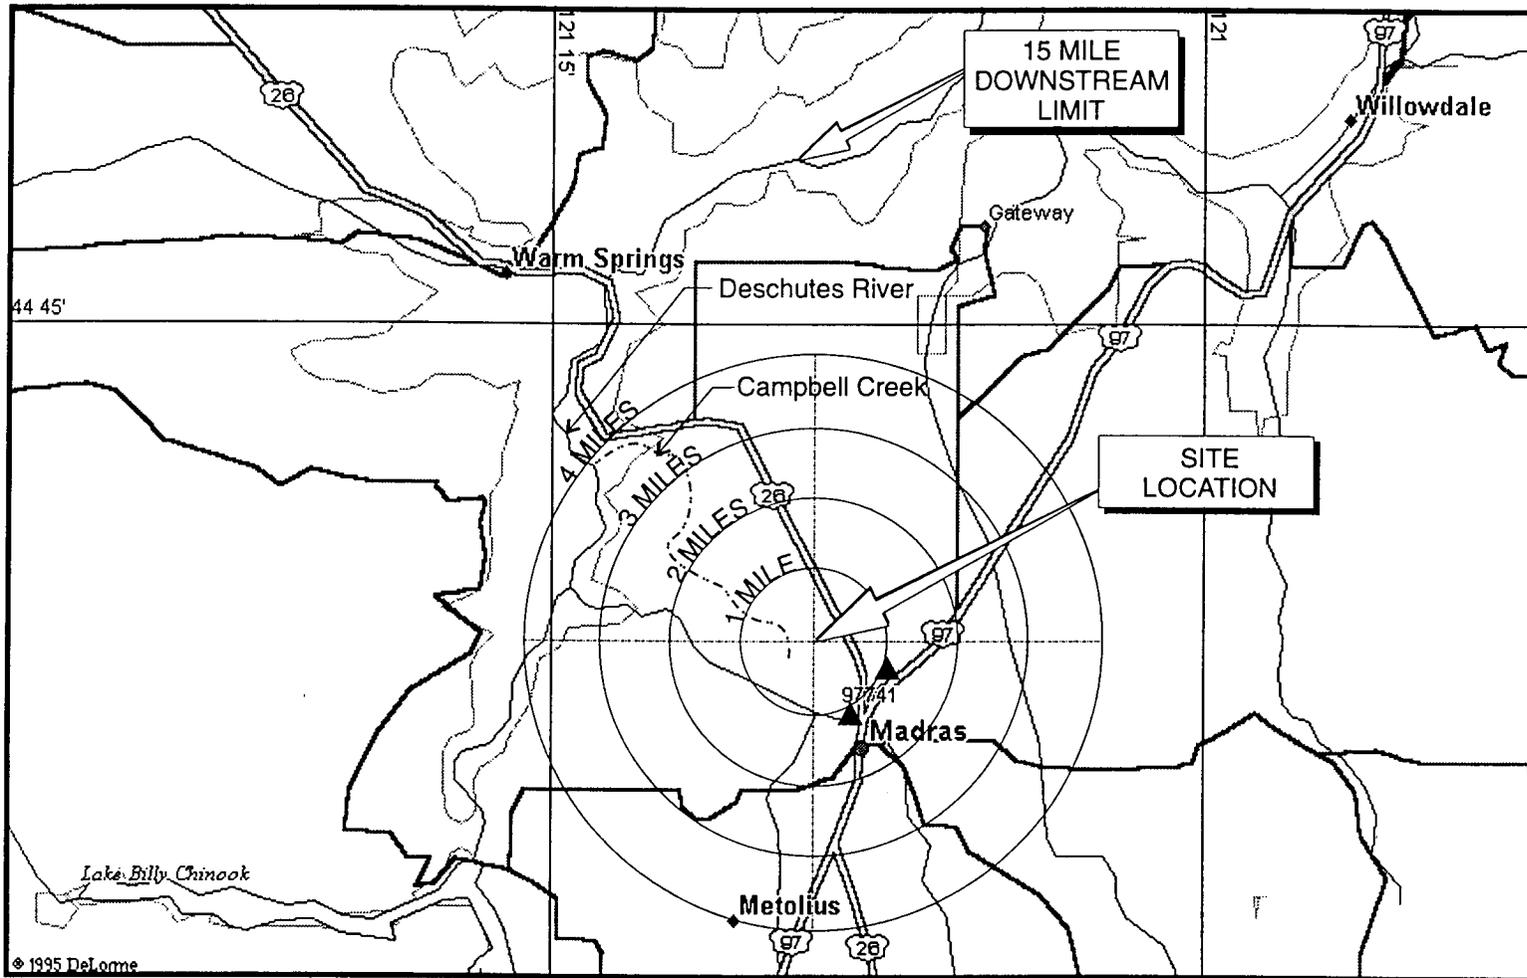
▲ = CITY OF MADRAS WELLS

Trenching on site, which took place as a result of the soil removal activity, revealed that only 2 to 3 feet of soil overlies bedrock. The top 3 feet of bedrock consisted of interbeds of basalt and sandstone averaging approximately 0.5 feet thick. The wells logs on record with the Oregon Department of Water Resources indicate that a pattern of volcanic and sedimentary rocks is consistent to a depth of greater than 800 feet. During installation of the 3 City of Madras wells, the depths at which groundwater was first encountered ranged from 361 feet to 404 feet, with depth to static water level averaging 294 feet. Production is listed as 200 to 300 gpm for the municipal wells. However, there may be areas where a shallower aquifer exists. A log for one well 3 miles east of the site is producing 60 gpm at 24 feet depth. No wells are located on airport property (Braezeale 1996). All water used on site is purchased from the Deschutes Valley Water District (DVWD). The source of the water for the DVWD is at Opal Springs approximately 11 miles southwest of the site (Office of Water Master, District 11). The City of Madras currently owns and operates 2 wells, both of which are between 1 and 2 miles from the site (Figure 3-1). Well #3 is a standby well, which augments the supply from the DVWD during times of high usage. Well #2 is used as an emergency backup supply. Another well, Well #1, has been abandoned (Braezeale 1996).
