# Indian Creek stream survey 12-30-14

Measurements and observations recorded using the “Protocol for collecting eroding streambank and channel attributes” (2014).

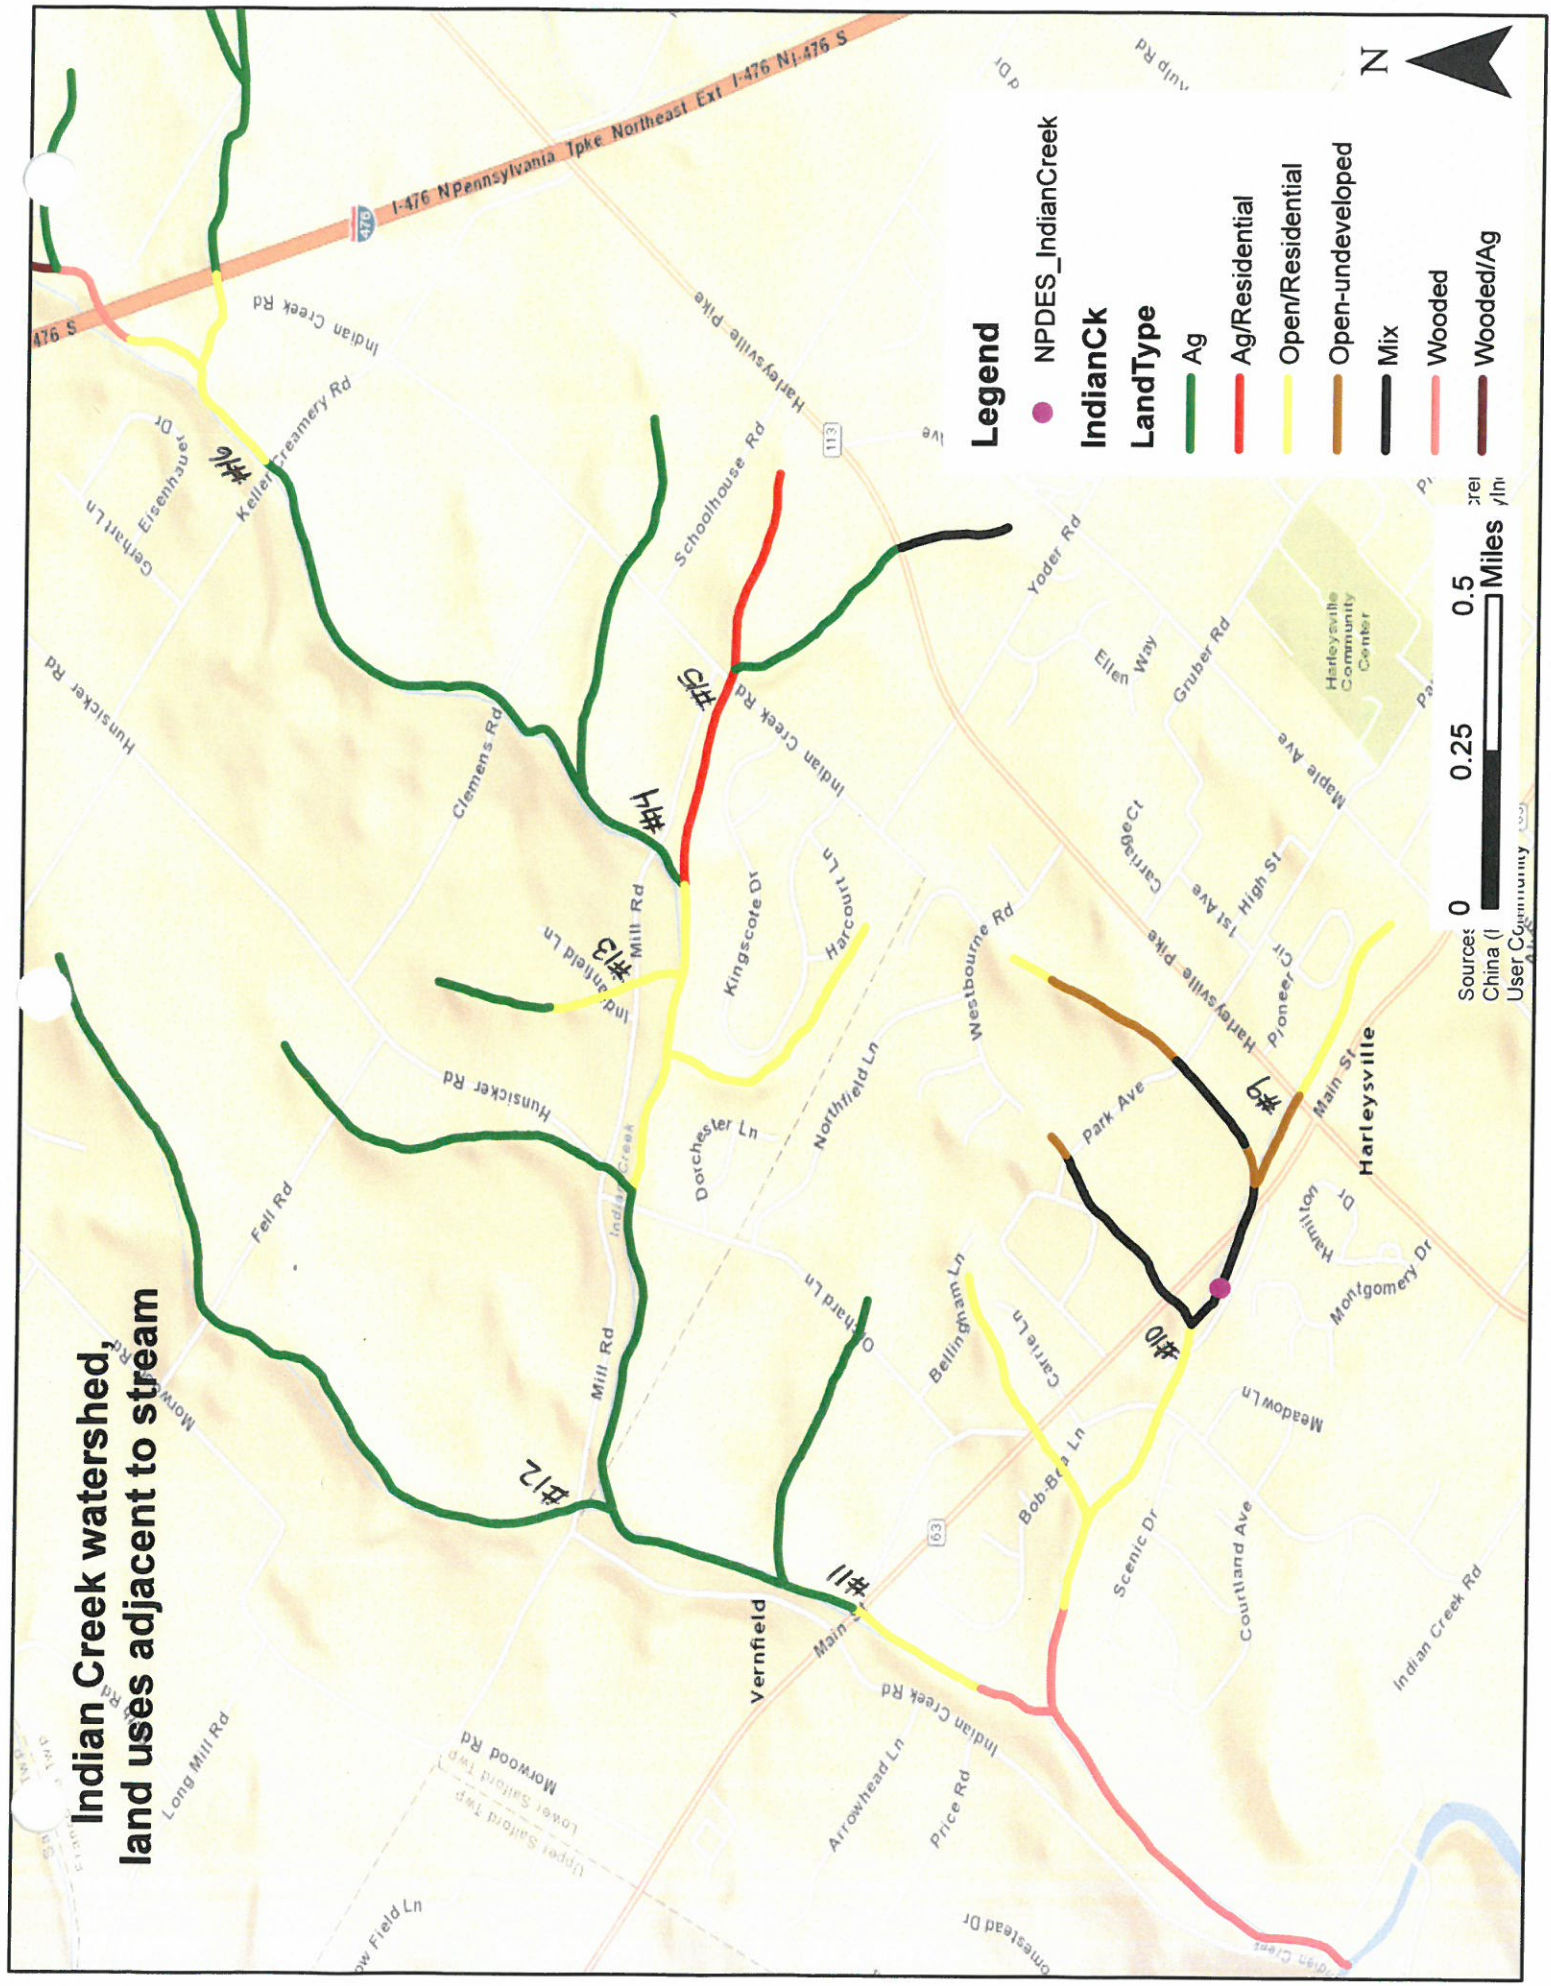
# Indian Creek watershed, land uses adjacent to stream

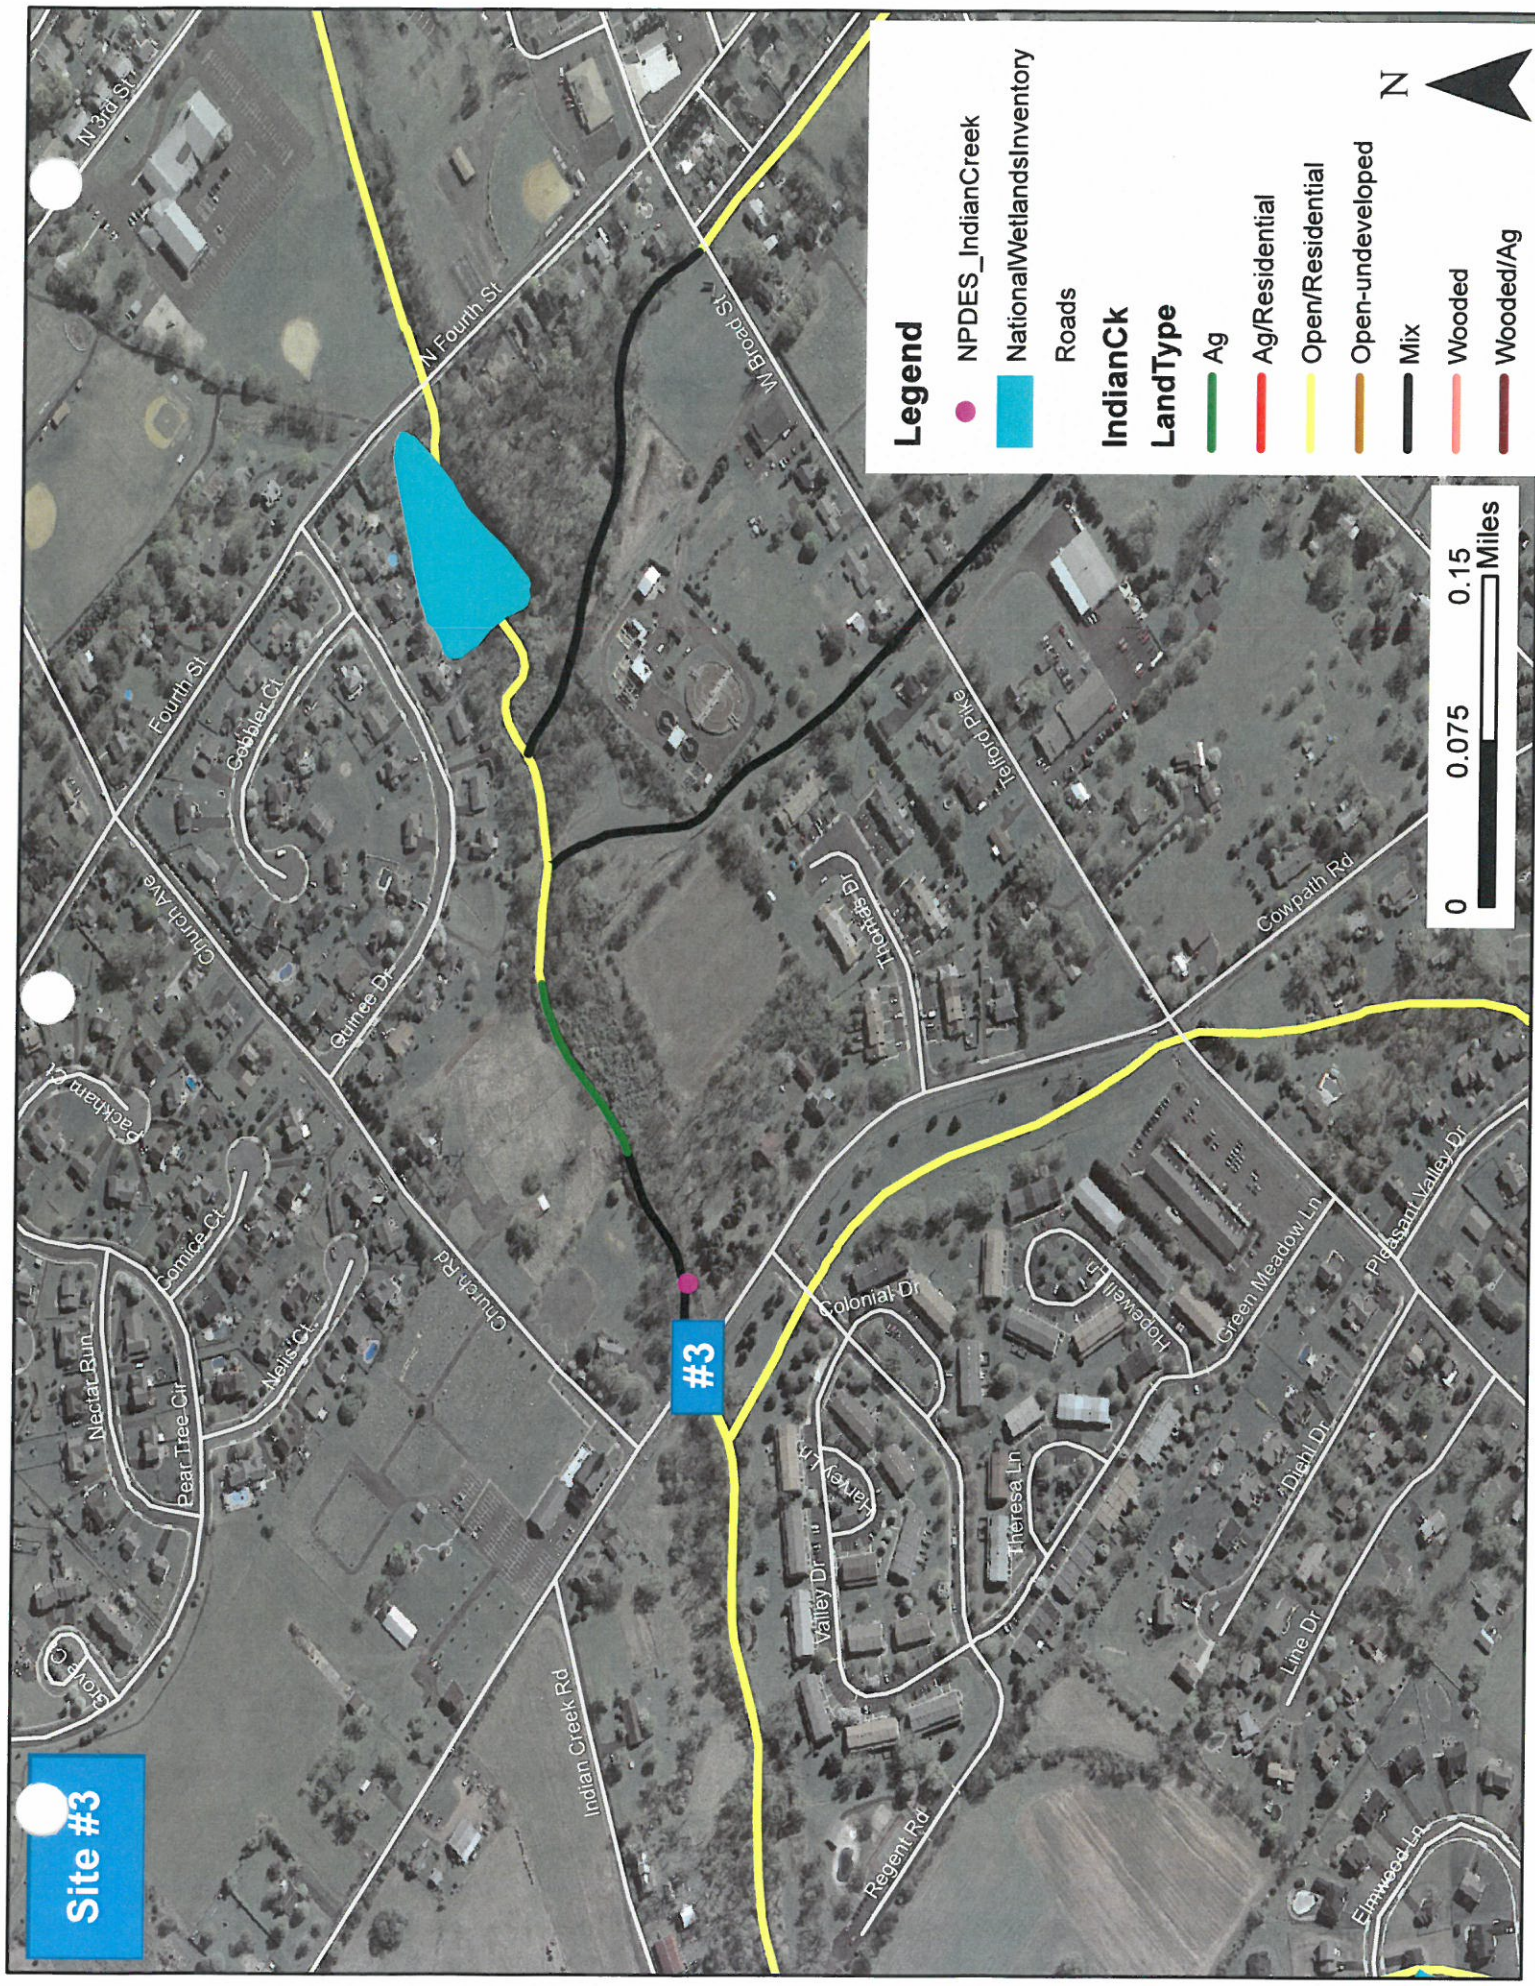
**Legend**

- NPDES\_IndianCreek
- NationalWetlandsInventory
- Roads
- IndianCk
- LandType
  - Ag
  - Ag/Residential
  - Open/Residential
  - Open-undeveloped
  - Mix
  - Wooded
  - Wooded/Ag
