Mountain State Mitigation Credits Company (MSMCC)

Buffalo Creek Bank Sites

Buffalo Creek Watershed Logan County, West Virginia

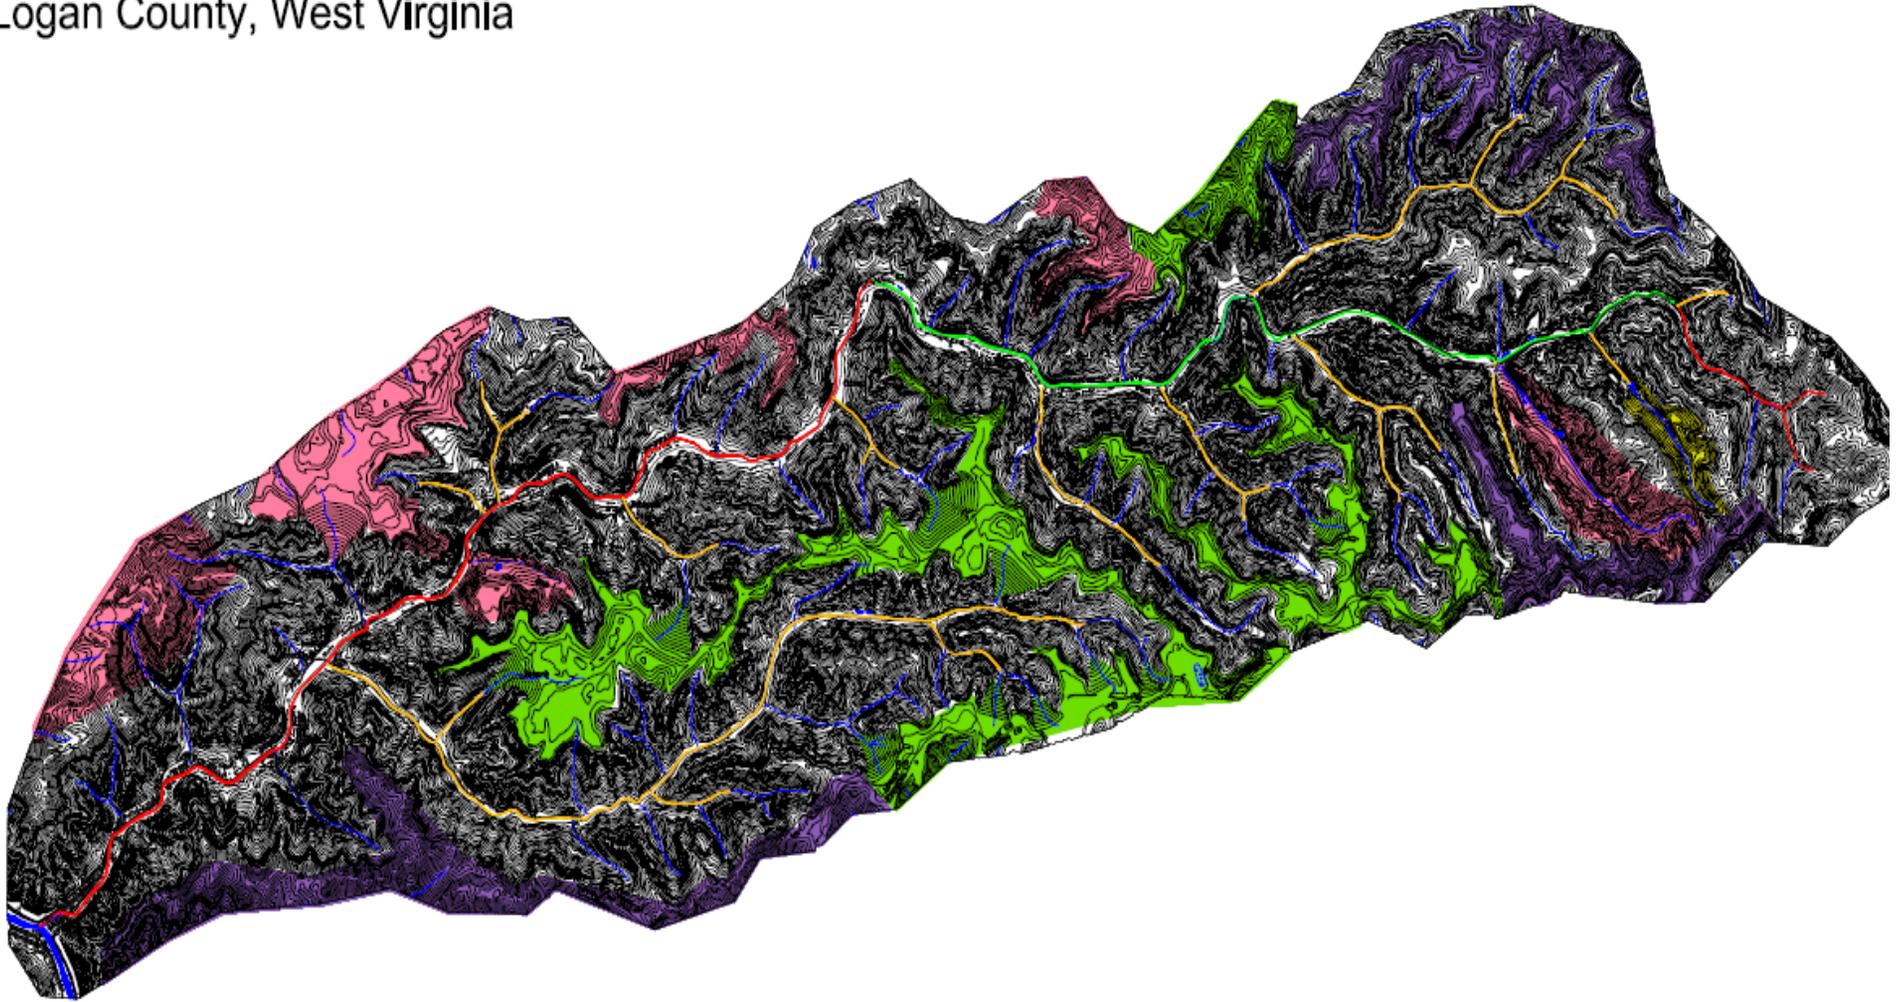
Completed Restoration Plan

Plans awaiting approval		
Site name	Location	Approx. Acre Feet
Lower	Man to Man	30,000
Upper 2B-1	Restoration and Buffer Strip	2,000
Upper 2B-2	Creek	3,000
Upper 2B-3	Below Forks	2,000

2009 Restoration Plans

Proposed Plans		
Site name	Location	Approx. Acre Feet
Upper 2B-1	Stone to Penick	30,000
Upper 2B-2	Below	71
Upper 2B-3	Penick to Cooper-Hague	30,000

Potential Restoration Plans

Potential Future Plans		
Site name	Location	Approx. Acre Feet
Right Fork	Right Fork Middle Creek	30,000
	Right Branch of Right Fork	2,000
	North Branch of Right Fork	2,000
Jordan Fork of Right Fork	Jordan Fork of Right Fork	3,000
	Proctor Fork of Buffalo Creek	7,000
Rocky Fork	Rocky Fork of Buffalo Creek	6,000
Condamint	Condamint Branch of Buffalo Creek	4,000
Eligible	Eligible Branch of Buffalo Creek	16,000
Gully	Gully Branch of Buffalo Creek	6,000
Young Fork	Young Fork of Buffalo Creek	20,000
Wolf	Wolf Branch of Buffalo Creek	11,000
Low and Middle Fork of Buffalo Creek	Low and Middle Fork of Buffalo Creek	16,000
North Fork	North Fork of Buffalo Creek	4,000
Cooper-Hague	Scrambled Fork of Buffalo Creek	1,000

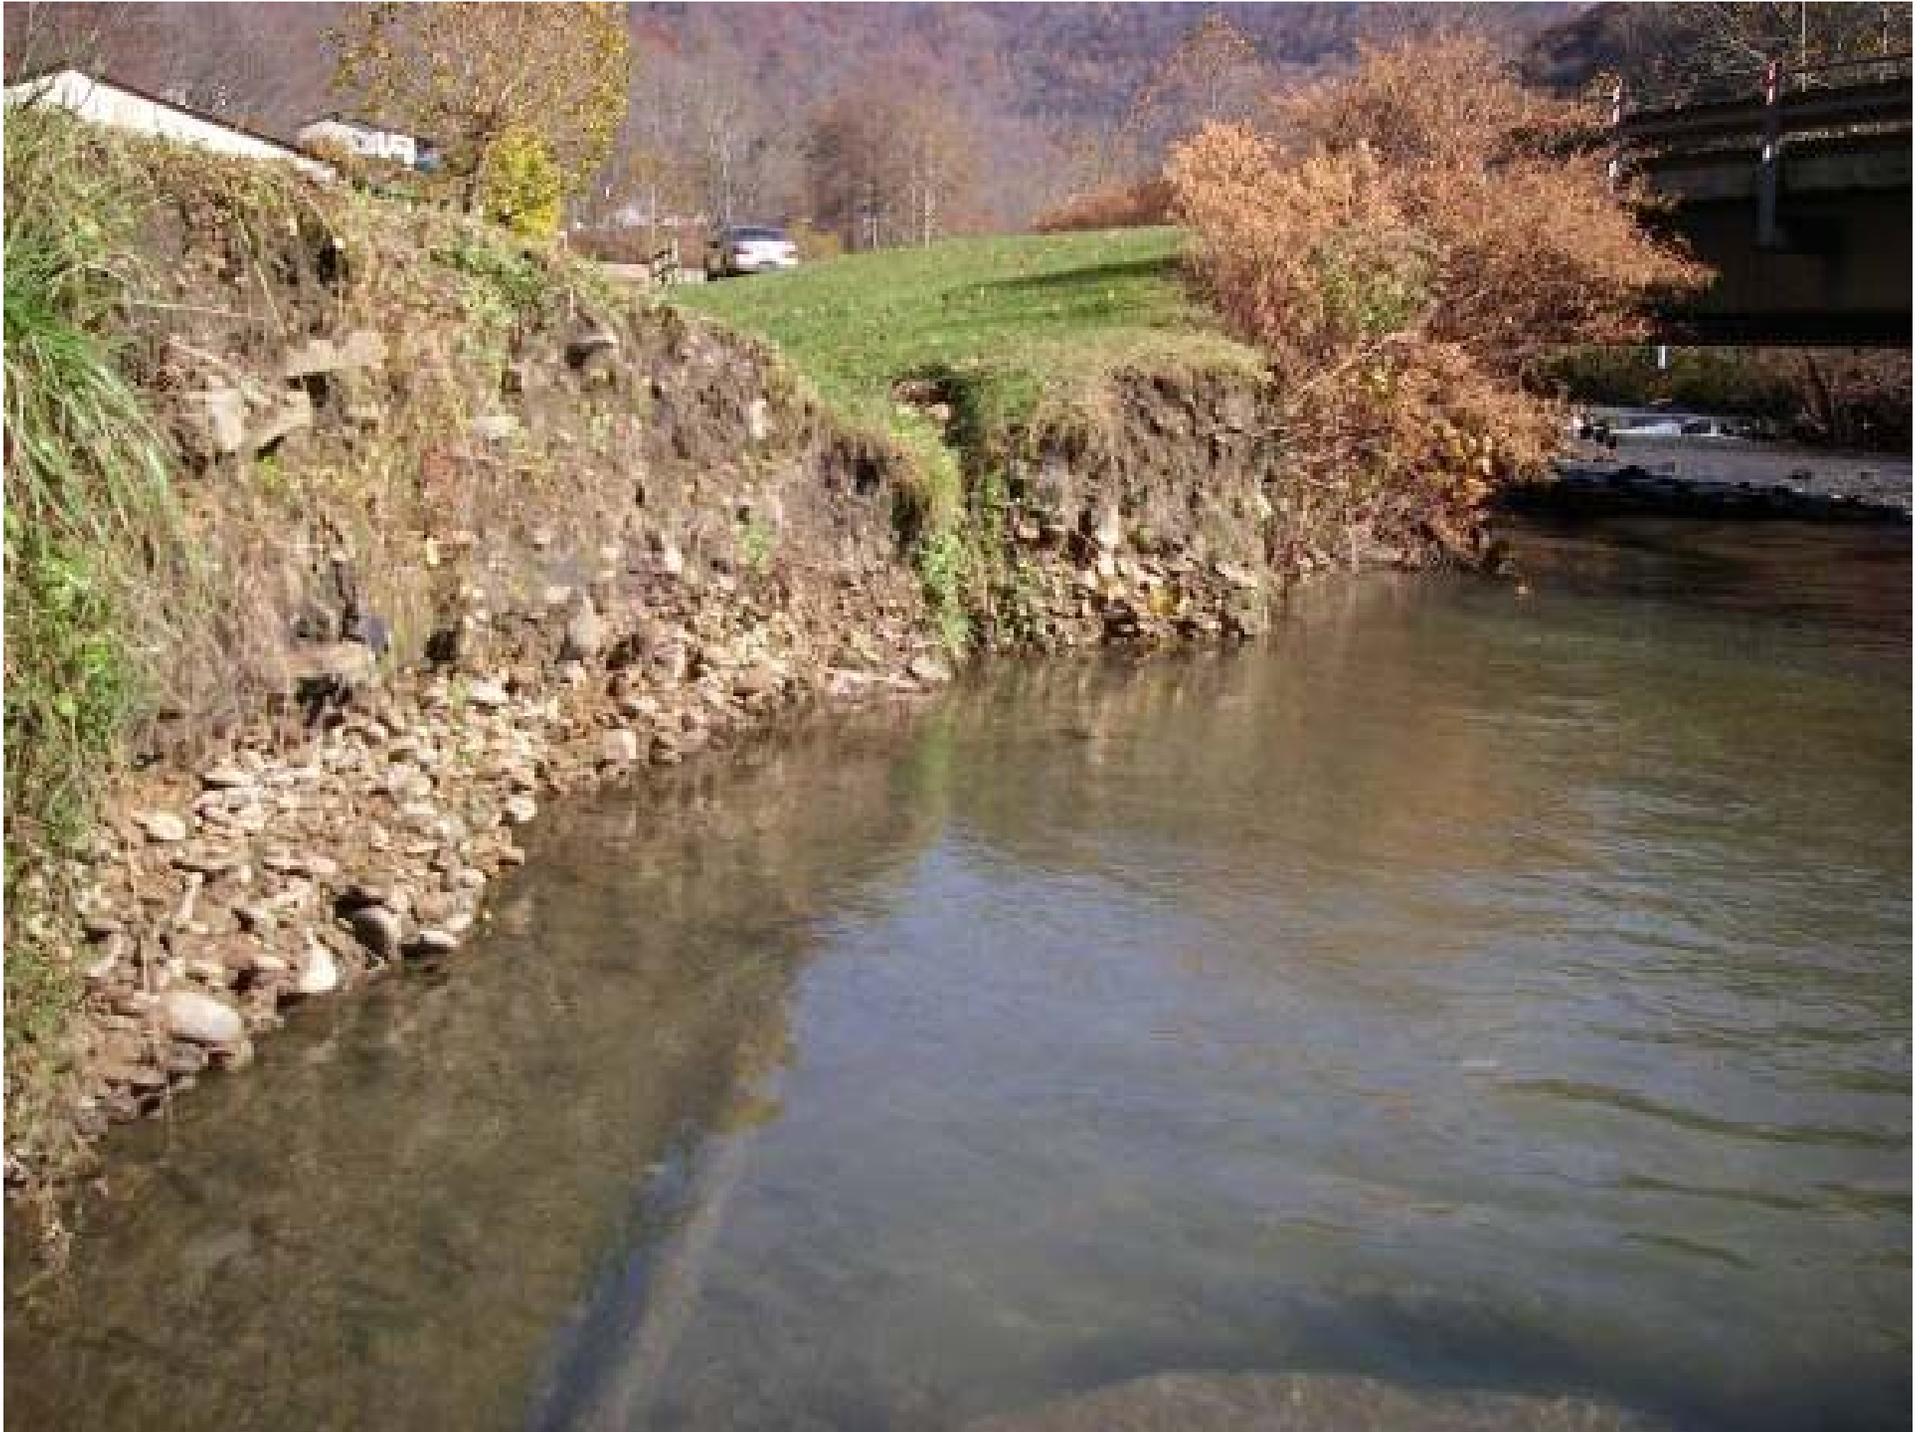
Much of the main reach is wide, flat, & shallow.

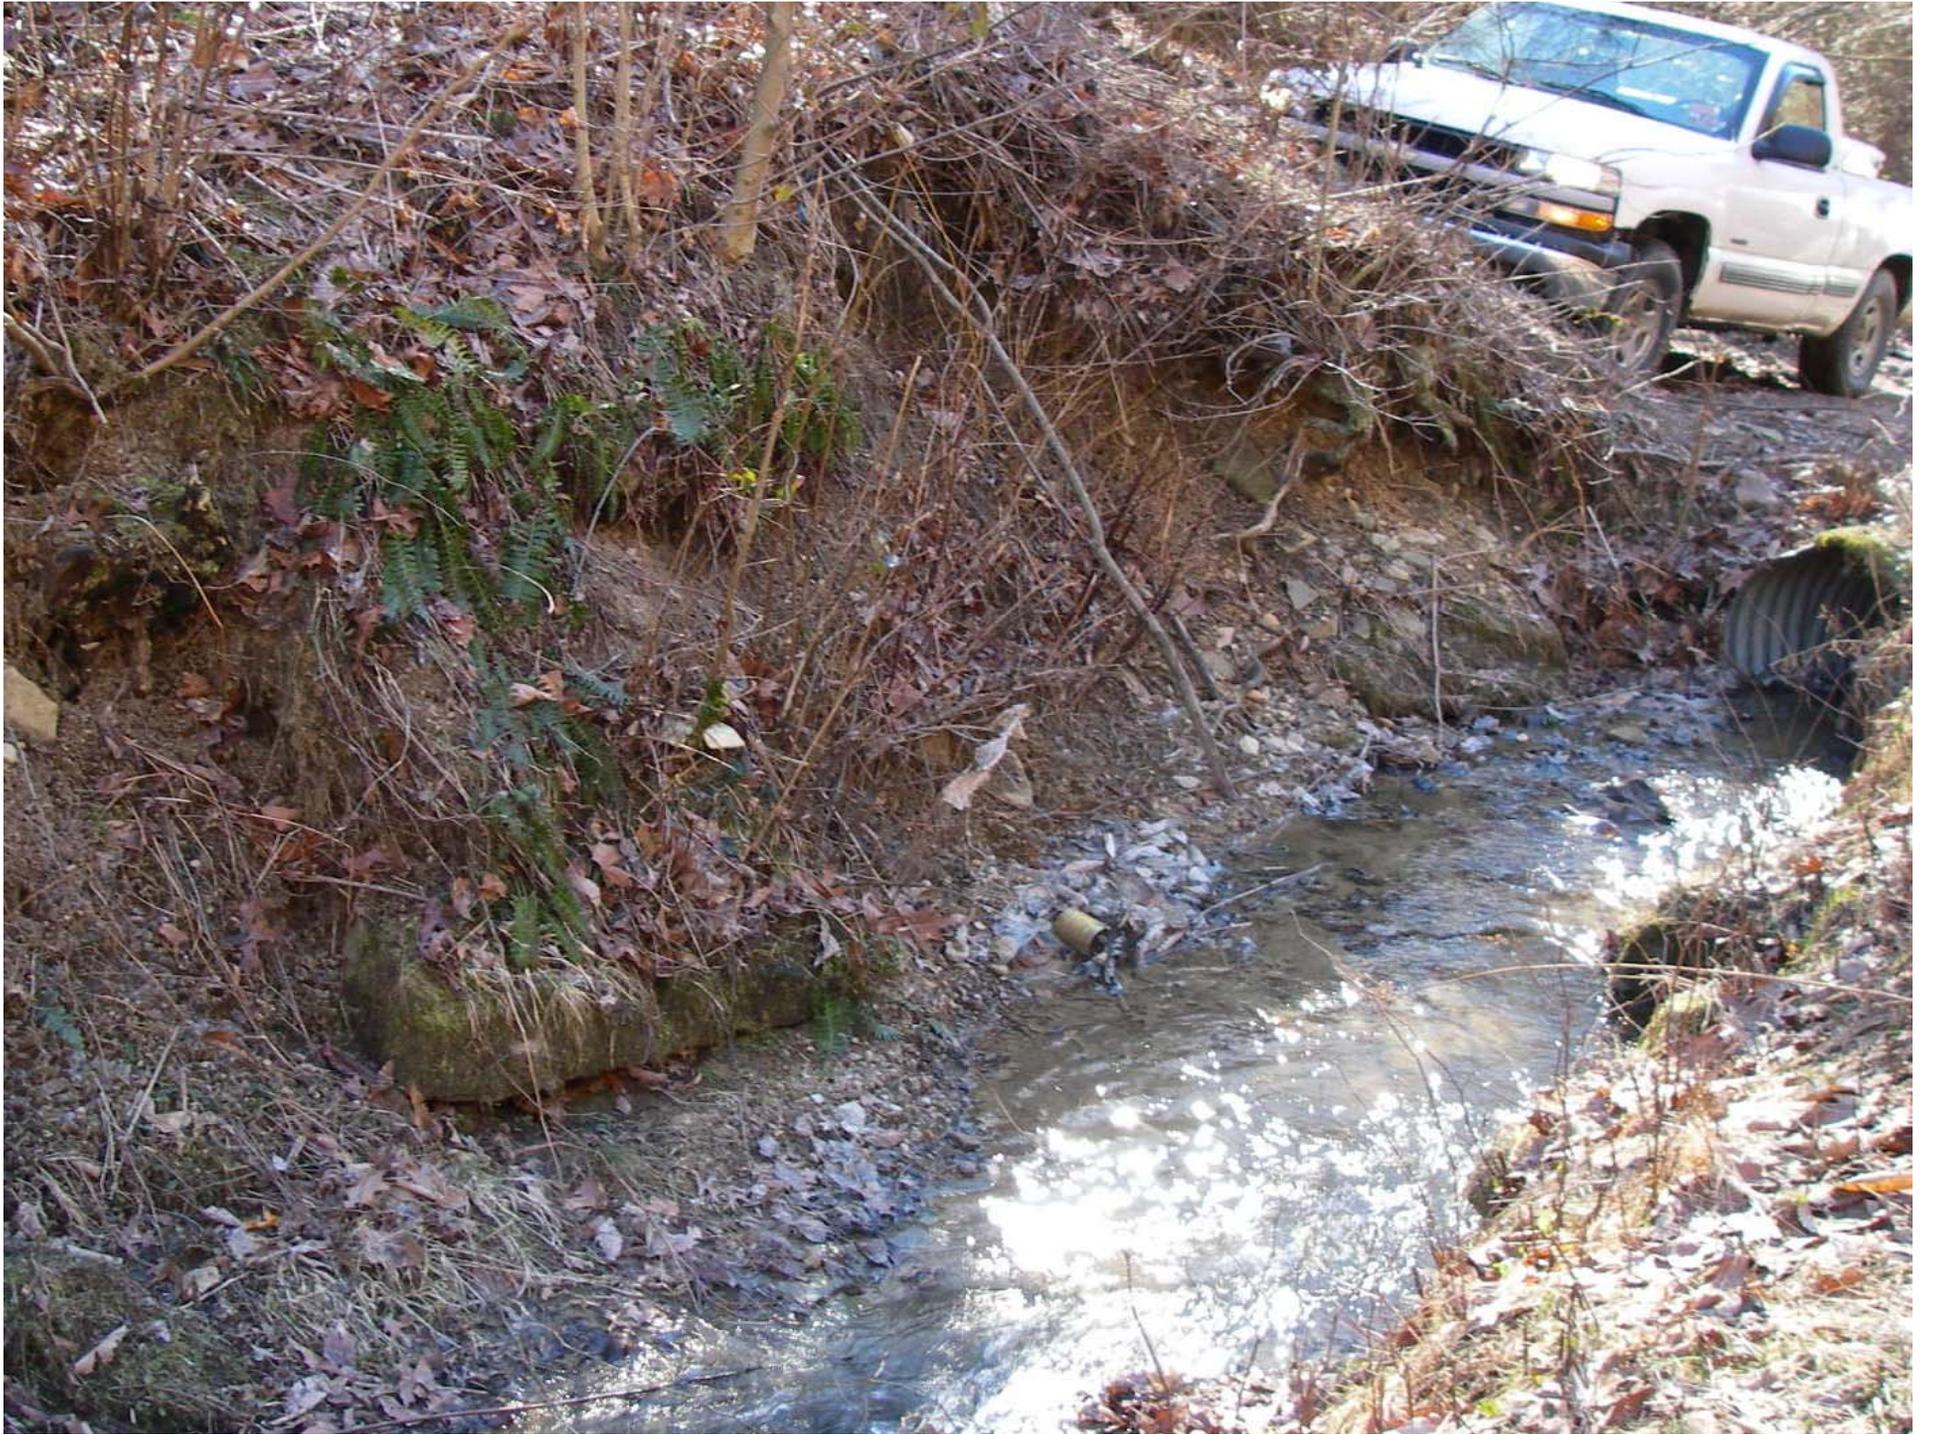
Upper Buffalo Creek - Plan #1, Sulphur Lick (Lower Section)

Sulphur Lick: 2,654 LF; Level III Restoration

Current	Post (5 Years)	Post (10 Years)	Maturity
HGM-FCI				
Hydrology	0.57	0.94	0.95	1.00
Biogeochemical	0.63	0.86	0.87	1.00
Habitat	0.31	0.76	0.77	1.00
RBP Habitat	54	135	157	172
Conductivity	345	300	250	199
WV-SCI	48.8	60.0	70.0	80.0
Mitigation Unit Yield				2,198

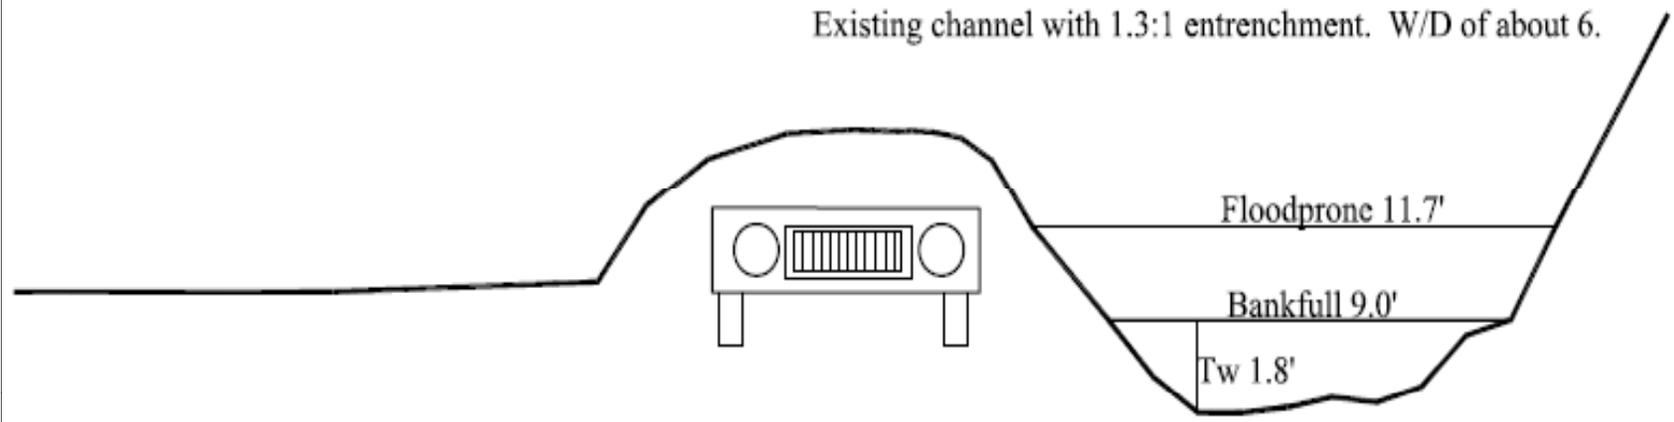
Existing channel with 1.3:1 entrenchment. W/D of about 6.

SSP#2; IP #1: 750 LF; Level III Restoration

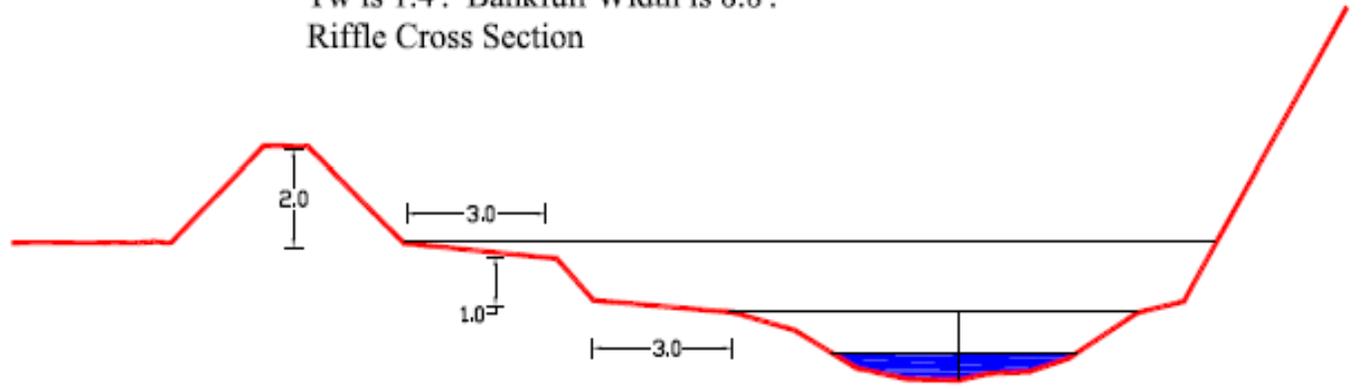
Restored 3 stage channel with 2:1 entrenchment. W/D of about 12.
Tw is 1.4'. Bankfull Width is 8.8'.
Riffle Cross Section
