Operation and Maintenance Plan

**Subsurface Gravel Wetland BMP Retrofit for Control of Nitrogen
in Stormwater: An EPA Green Infrastructure Demonstration and
Outreach Project for Hyannis Inner Harbor and the City of
Barnstable, MA**

**Intersection of South Street & Pleasant Street
Barnstable, MA**

BARNSTABLE, MA
NOVEMBER 2015 - CONSTRUCTION AS-BUILTS

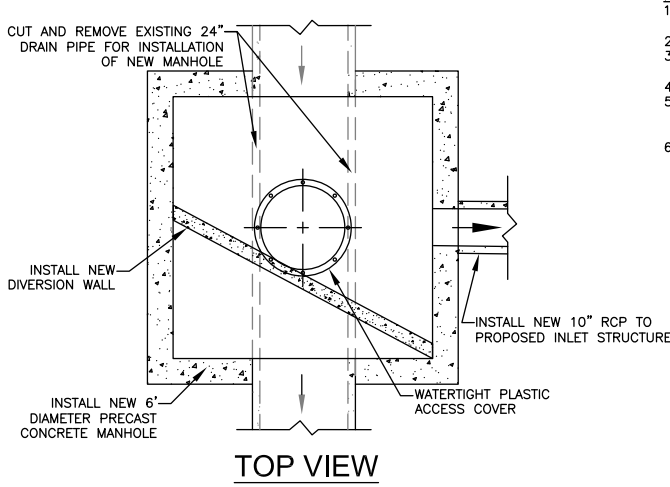
RCP INLET CONTROL STRUCTURE

TOP VIEW

ELEVATION VIEW

- NOTES**
- MANHOLE SHALL BE IN ACCORDANCE WITH SECTION 702 OF THE MA STANDARD SPECIFICATIONS
 - CIRCUMFERENTIAL STEEL REINFORCEMENT REQUIRED = 0.15 SQ. IN./LF. MINIMUM
 - STEEL REINFORCEMENT FOR BASE SECTION BOTTOM SHALL BE A MINIMUM OF 0.12 SQ. IN./LF. (BOTH WAYS)
 - ONE POUR MONOLITHIC BASE SECTION.
 - ANY NECESSARY ADJUSTMENTS DURING CONSTRUCTION WILL BE DONE BY SAW-CUTTING AND/OR CORING ONLY. NO JACKHAMMERS, HAMMERS AND CHISELS OR PNEUMATIC TOOLS WILL BE ALLOWED
 - STEPS SHALL CONFORM TO STD. 5.3.0 AND SHALL BE INSTALLED AT THE CASTING PLANT

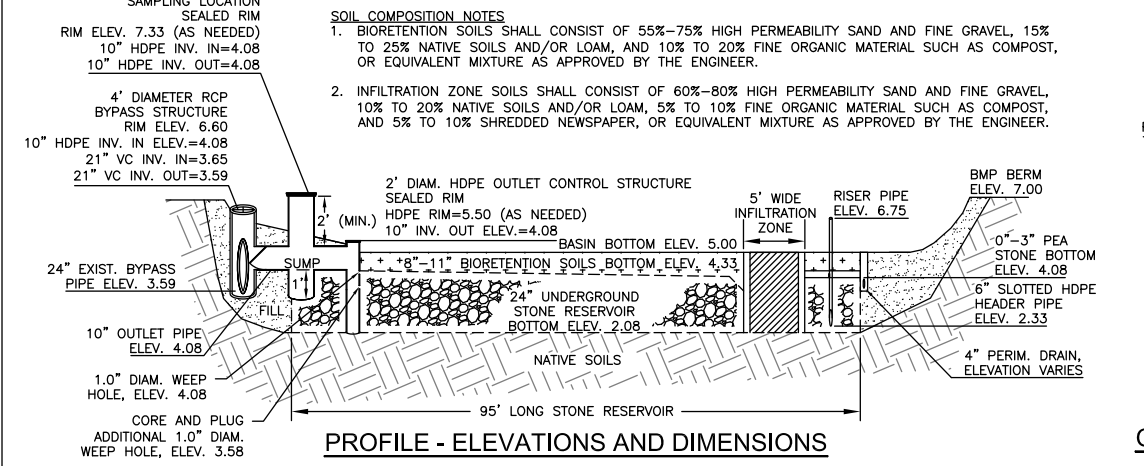
PROFILE - ELEVATIONS AND DIMENSIONS

- SOIL COMPOSITION NOTES**
- BIORETENTION SOILS SHALL CONSIST OF 55%-75% HIGH PERMEABILITY SAND AND FINE GRAVEL, 15% TO 25% NATIVE SOILS AND/OR LOAM, AND 10% TO 20% FINE ORGANIC MATERIAL SUCH AS COMPOST, OR EQUIVALENT MIXTURE AS APPROVED BY THE ENGINEER.
 - INFILTRATION ZONE SOILS SHALL CONSIST OF 60%-80% HIGH PERMEABILITY SAND AND FINE GRAVEL, 10% TO 20% NATIVE SOILS AND/OR LOAM, 5% TO 10% FINE ORGANIC MATERIAL SUCH AS COMPOST, AND 5% TO 10% SHREDDED NEWSPAPER, OR EQUIVALENT MIXTURE AS APPROVED BY THE ENGINEER.

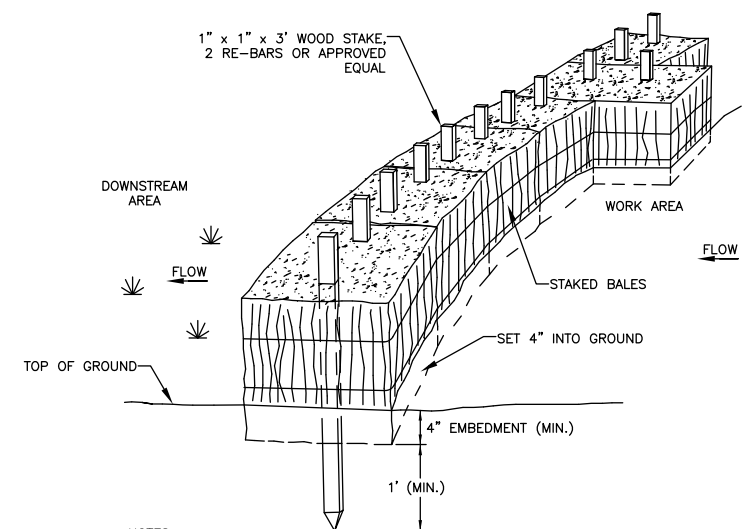
PERIMETER EROSION CONTROLS

NOTES
1. PUT ONE HAYBALE PERPENDICULAR ALONG HAYBALE BARRIER (100' O.C.)

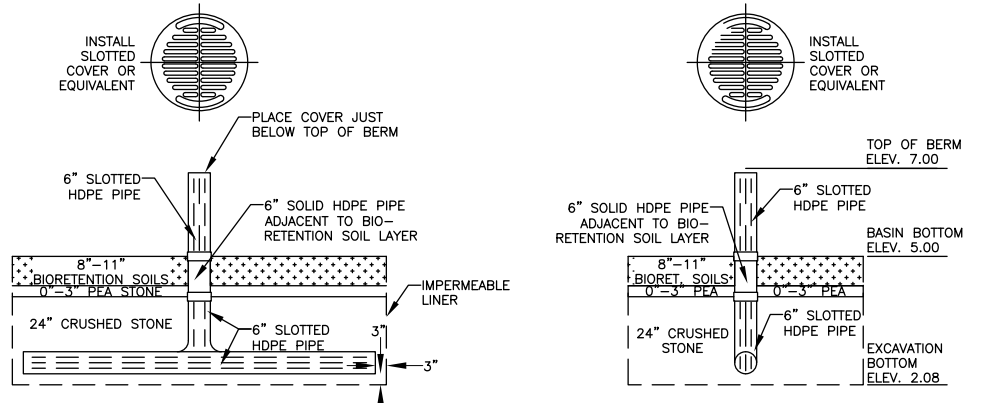
SLOTTED RISER PIPE DETAIL

CROSS-SECTION VIEW ELEVATION VIEW

SLOTTED PIPE SPECIFICATIONS
1. SLOTS SHALL BE A MINIMUM OF 0.040 INCHES WIDE SPACED EVERY 0.25\"/>

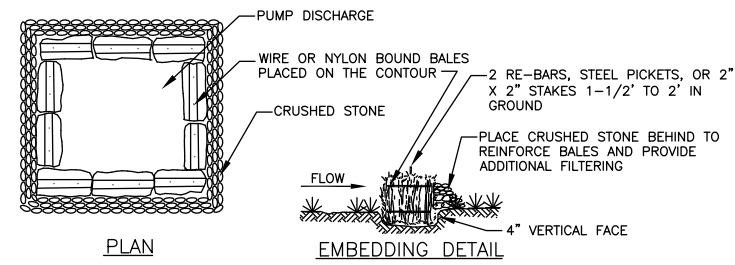
PUMPING DE-WATERING DISCHARGE AREA, HAY BALES

PLAN EMBEDDING DETAIL

STRAW BALE BARRIER CONSTRUCTION SPECIFICATIONS

1. BALES SHALL BE PLACED IN A ROW WITH ENDS TIGHTLY BUTTED.
2. EACH BALE SHALL BE EMBEDDED IN THE SOIL A MINIMUM OF 4\"/>

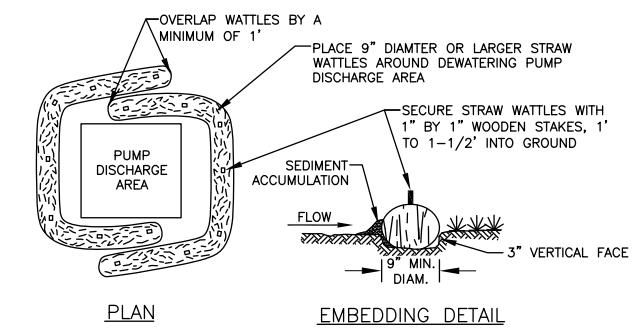
STRAW WATTLE DEWATERING AREA CONSTRUCTION SPECIFICATIONS

PLAN EMBEDDING DETAIL
