NONPOINT SOURCE SUCCESS STORY

Private Landowner Helps Control Mine Waste, Restoring Mule Gulch

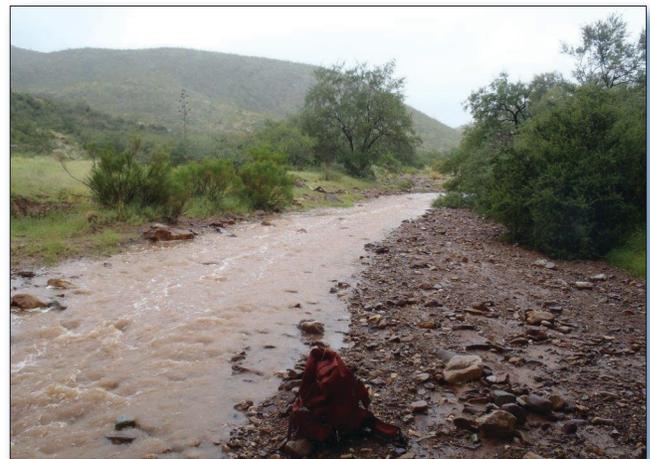
Photo by Jason Sutter, AZ DEQ (9/2016)

Figure 1. Mule Gulch is near Arizona's southern border.

Mule Gulch is in Bisbee, Arizona, in southeastern Arizona. Mule Gulch flows east from the Mule Mountains towards Whitewater Draw (Figure 1).

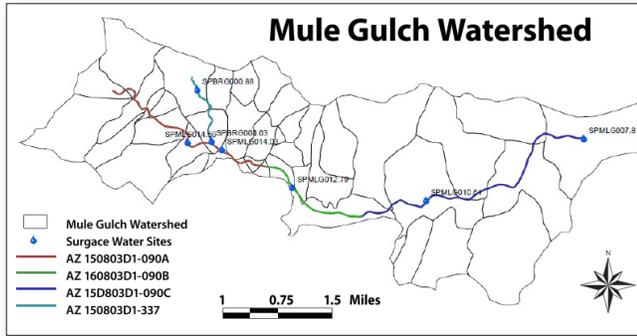
Figure 2. Seven water monitoring sites were established to assess water quality in Mule Gulch.

Because of rapid changes in water quality and flow observed during a July 1999 precipitation event, an intensive sampling and monitoring system (e.g., stream gages, data loggers, probes) was established in late 1999 and early 2000 (Figure 2).
