Airborne Lidar Pipeline Inspection Service (ALPIS™)

ALPIS (Airborne Lidar Pipeline Inspection Service) is a revolutionary new way to find leaks in natural gas transmission and gathering lines

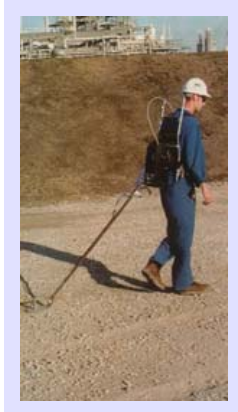
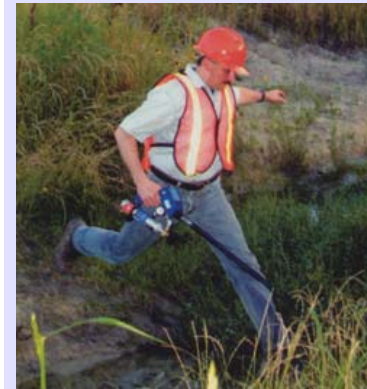
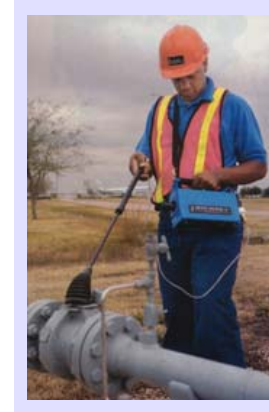
Conventional Inspection Methods

- **Hand-held or truck mounted "sniffers":**
 - Allow maximum coverage of only 8-10 miles a day
 - Scan the swath of one bumper width at best
 - Are ineffective over rough terrain and unwelcome over private land
- **Aerial patrols only look for secondary signs of leaks and right-of-way encroachments**

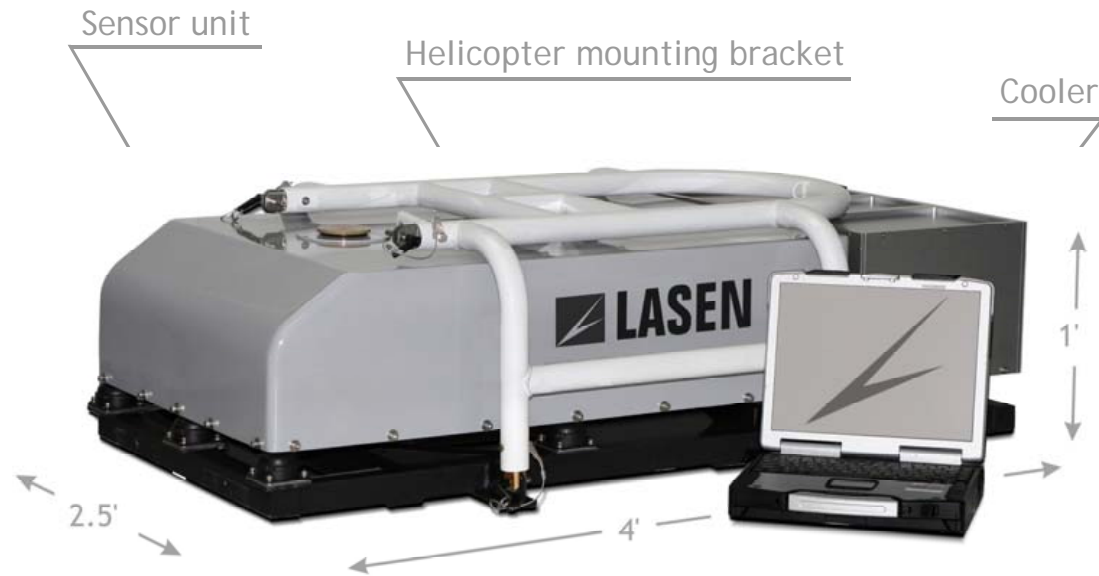
How It Looks

Package weight: 250 lbs.

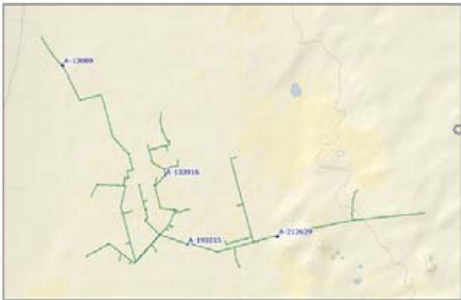
Inspection overview

Inspection results in a tabular format

Inspection results overlaid on a map
