Reductions of Perchlorate in Drinking Water May 2020

LEVELS OF PERCHLORATE IN DRINKING WATER HAVE DECLINED

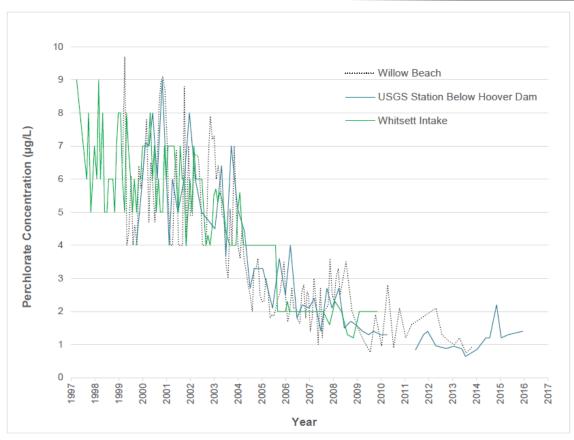
Exhibit A. Perchlorate Raw Water Sample Results from the Willow Beach, USGS Station, and Whitsett Sampling Sites, 1997 – 2016

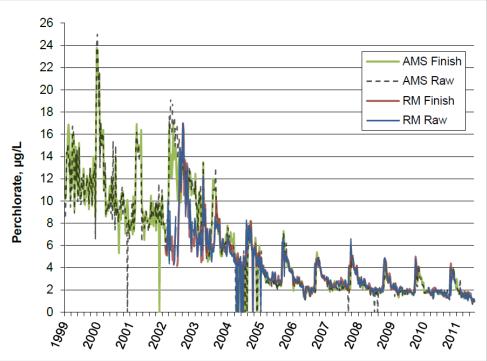
Perchlorate levels found in both raw and finished water decreased in a relatively consistent and an overall significant amount over the 13-year sampling period, as shown in Exhibit B (1999 – 2011).

Although the laboratory analytical methods changed over the period of sampling i.e., perchlorate could be measured at lower levels, the time period and range of decreases mirror those identified in the Lower Colorado River case study.
