# **CITY OF MANCHESTER, NEW HAMPSHIRE**

## ***Stormwater Management Program***

**Annual Report**

**May 1, 2011 through April 30, 2012**

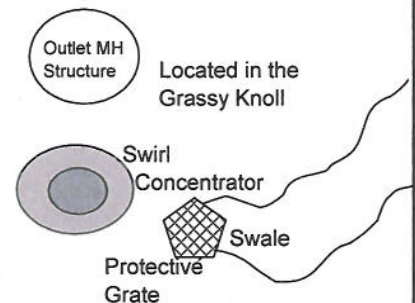
Tank Name **Dorrs Pond - KFC - 16' - Site 5** Date: 08/12/11  
 Inspector(s): Rob Robinson & Jean Paul Gilbert

Inspect Diversion Manhole Sand Depth ☒ <6" ☐ <12" ☐ Full  
 Structural Condition: ☒ Excellent ☐ Very Good ☐ Good ☐ Fair ☐ Poor ☐ Repair

Water Appearance in 1st Port: ☐ dry ☐ odor ☐ oily ☒ H2O depth/in. 2 - 3 ft.  
 Depth of sand: ☐ 1"-3" ☐ 4"-6" ☒ 7"-9" ☐ 10"-12" ☐ 1-2 feet ☐ > 2ft.  
 Does the sand seem to be evenly distributed throughout the tank bottom? ☒ YES ☐ NO  
 Structural Condition: ☒ Excellent ☐ Very Good ☐ Good ☐ Fair ☐ Poor ☐ Repair  
 Weed/brush growth around tank: ☐ None ☐ Little ☐ Moderate ☒ Heavy  
 Recommendations: Cleaned all three chambers.

If cleaned, how much sand/grit was removed? 3.0 Cubic Yards

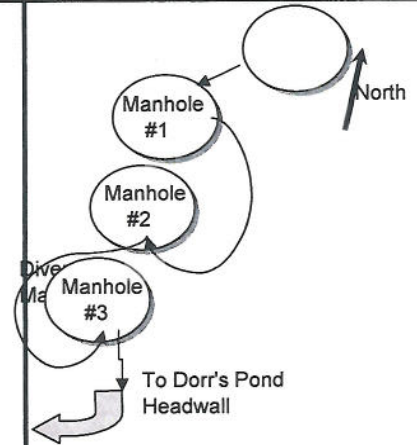
Tank Name **Dorrs Pond - Headwall - 12' - Site 6** Date: 08/12/11  
 Inspector(s): Rob Robinson & Jean Paul Gilbert

Recommendations: Cleaned all three chambers.

If cleaned, how much sand/grit was removed? 3.0 Cubic Yards

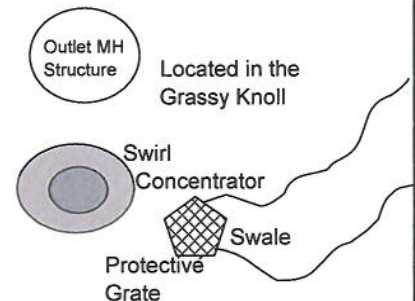
Tank Name Dorrs Pond - KFC - 16' - Site 5 Date: 11/28/11  
 Inspector(s): Rob Robinson & Jean Paul Gilbert

Water Appearance in 1st Port: ☐ dry ☐ odor ☐ oily ☒ H2O depth/in. 2 - 3 ft.  
 Depth of sand: ☒ 1"- 3" ☐ 4"- 6" ☐ 7"- 9" ☐ 10"- 12" ☐ 1 - 2 feet ☐ > 2ft.  
 Does the sand seem to be evenly distributed throughout the tank bottom? ☒ YES ☐ NO  
 Structural Condition: ☒ Excellent ☐ Very Good ☐ Good ☐ Fair ☐ Poor ☐ Repair  
 Weed/brush growth around tank: ☐ None ☐ Little ☐ Moderate ☒ Heavy  
 Recommendations: Clean all three chambers. One chamber was cleaned, will clean the other chambers in the spring.

If cleaned, how much sand/grit was removed? 1.0 Cubic Yards

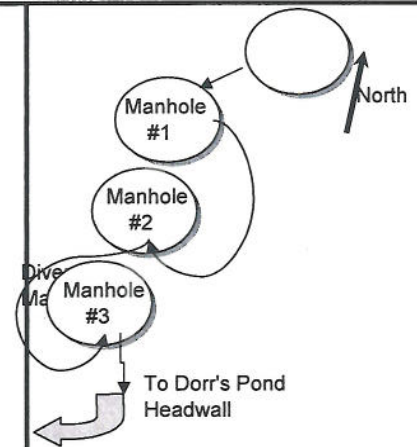
Tank Name Dorrs Pond - Headwall - 12' - Site 6 Date: 11/28/11  
 Inspector(s): Rob Robinson & Jean Paul Gilbert

Recommendations: Okay till spring.
