SUBJECT: Long-term Stewardship Assessment (*desktop*) Bettis Atomic Power Laboratory EPA ID: PA0 89 009 0004 West Mifflin, Pennsylvania, 15122-0079

DATE: September 23, 2023

Remedy Assessment Summary:

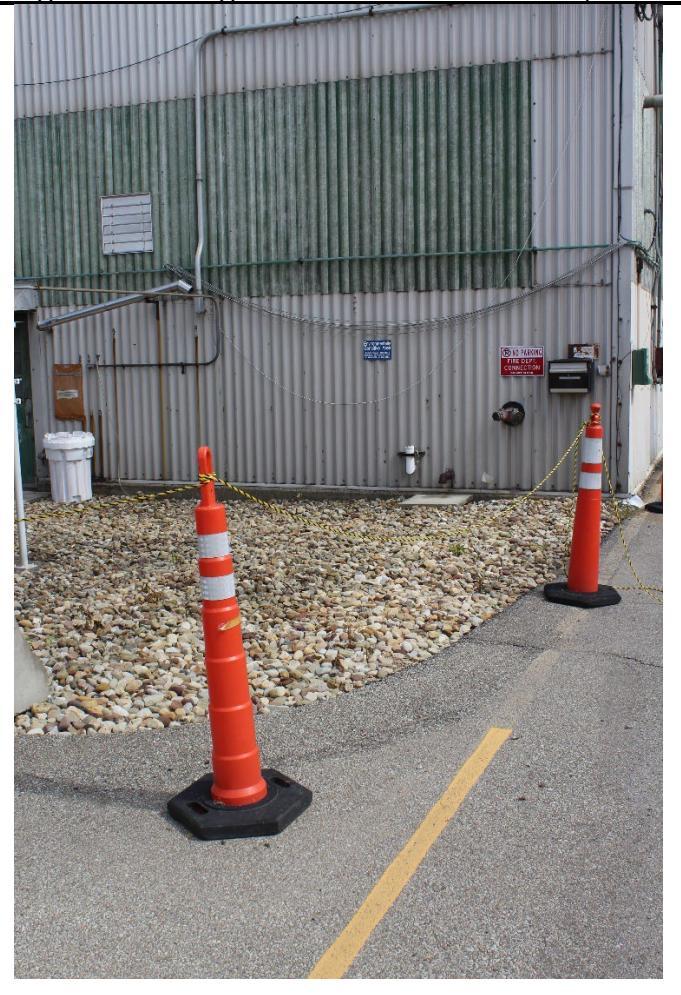
Picture 1 J Building Underground Storage Tank / Waste Oil Tank (UST/WOT) Location

Picture 1: J Building Underground Storage Tank / Waste Oil Tank (UST/WOT) Location

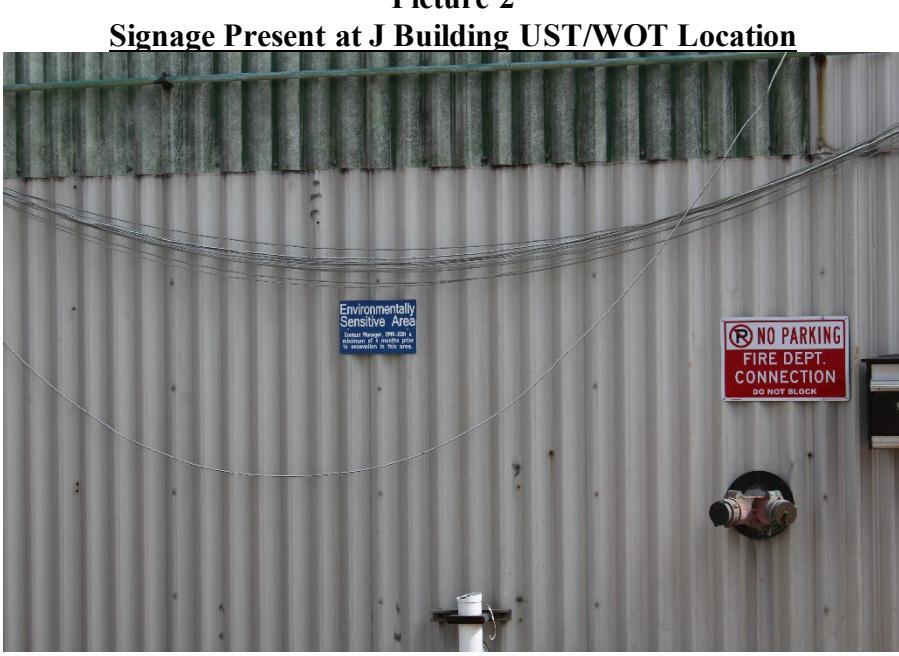
Picture 2

- Picture 2: Signage Present at J Building UST/WOT Location
- Picture 3: Bettis Landfill
- Picture 4: Bettis Landfill Vegetative Cover
- Picture 5: Groundwater Monitoring Well # 75 (protective bollard post)
- Picture 6: Groundwater Monitoring Well # 75 (secured)
- Picture 7: Perimeter Fencing with Signage

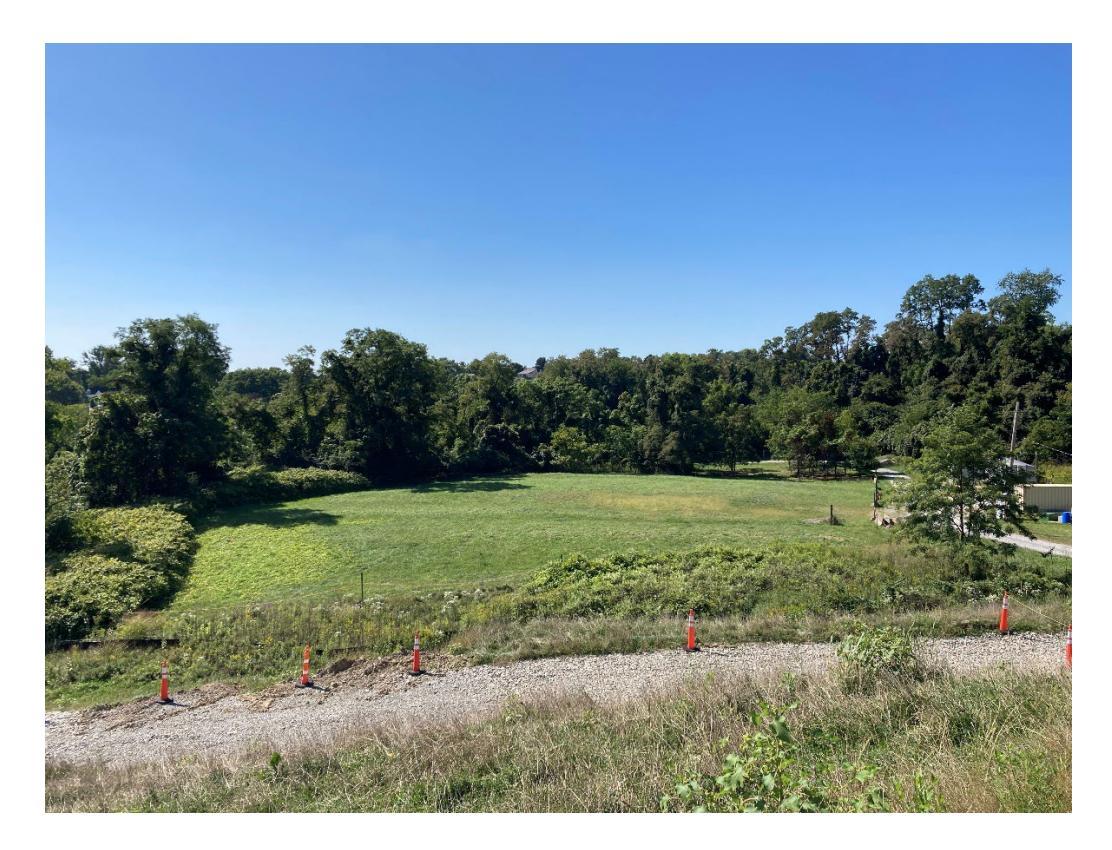
Picture 4 <u>Bettis Landfill Vegetative Cover</u>

Vegetative covers on the IWS, former Underground Storage Tank/Waste Oil Storage, and Trash Chute area continue to be maintained, and are in good condition, with mowing occuring annually.

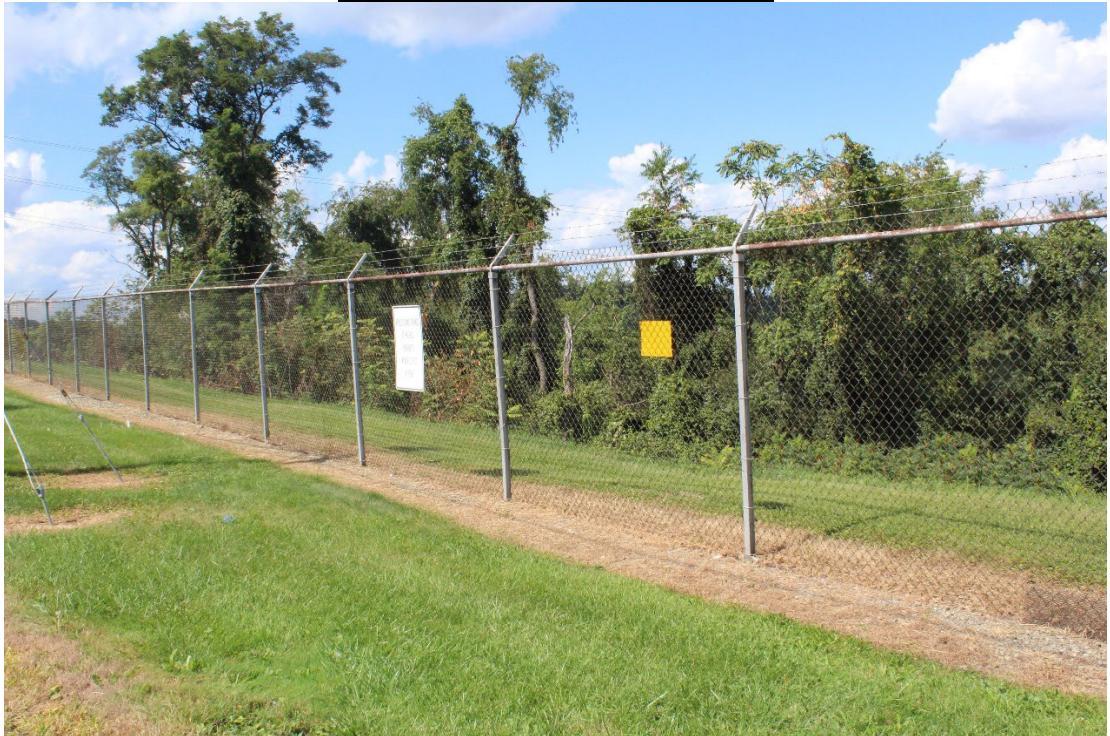
Picture 7

Miscellaneous Review and Assessment Questions:	<u>Yes</u>	<u>No</u>	Notes
• Is the security fence intact?	X		Security fence is intact around the developed portion of the site which includes the UST/WOT areas and most of the length of the Coke Gas Lines on the property. Access to the Inactive Waste Site, Bettis Landfill, and Trash Chute Area is restricted and controlled through secure access points and a 24/7 onsite security force.
• Is the appropriate signage posted?	Х		Signage is present at the Inactive Waste Site, Bettis Landfill, and Trash Chute Area, as required. Verified by routine monitoring.

Perimeter Fencing with Signage
