## **National Guidance: Best Management Practices for Preparing Vessels Intended to Create Artificial Reefs**

**Asbestos**

May 2006

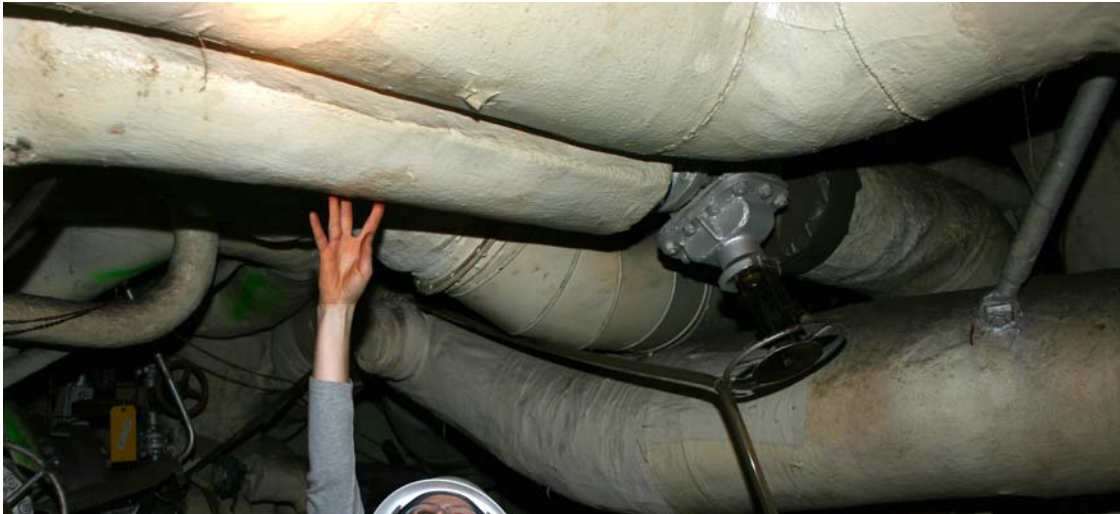
Asbestos pipe wrapping on the ex-USS Oriskany.

The primary source of friable asbestos is pipe wrappings around the main boilers and steam fittings. On most vessels the asbestos coating, which is 1 to 3 inches thick, is covered with canvas and is usually painted. If work needs to be done around the piping and the covering, causing the asbestos to be disturbed, the disturbed material should be removed. If the covering is deteriorated and it is likely that the asbestos will break free during sinking, then removal or encapsulation with an epoxy or other non-water soluble and non-toxic sealer should be considered. Certain boilers and piping are covered with a very friable asbestos paste. If such friable asbestos is not covered with canvas and/or paint, the friable asbestos should be sealed or encapsulated with an epoxy or other non-water soluble and non-toxic sealer.

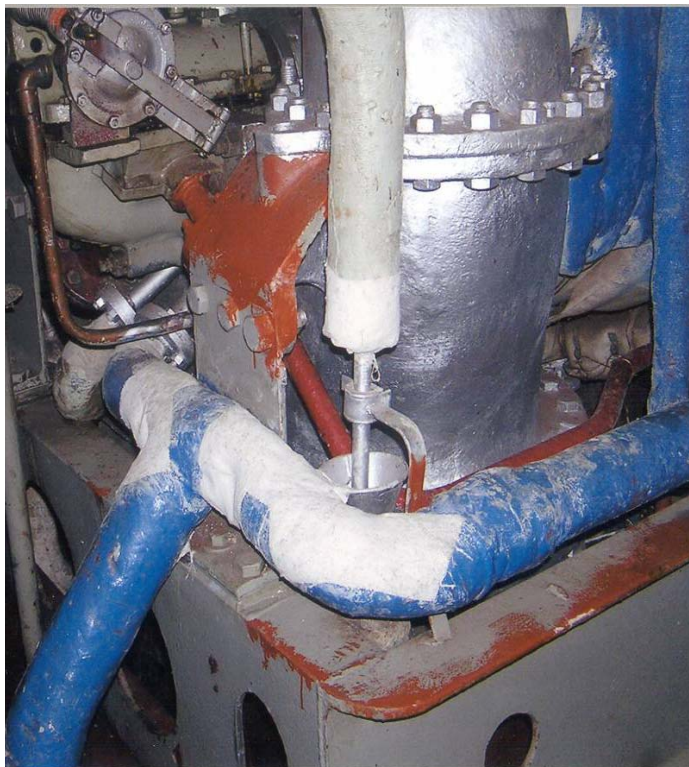
Photo courtesy of Laura S. Johnson  
Patched asbestos pipe wrapping on the ex-USS Oriskany.
