National Guidance: Best Management Practices for Preparing Vessels Intended to Create Artificial Reefs

Paint

May 2006

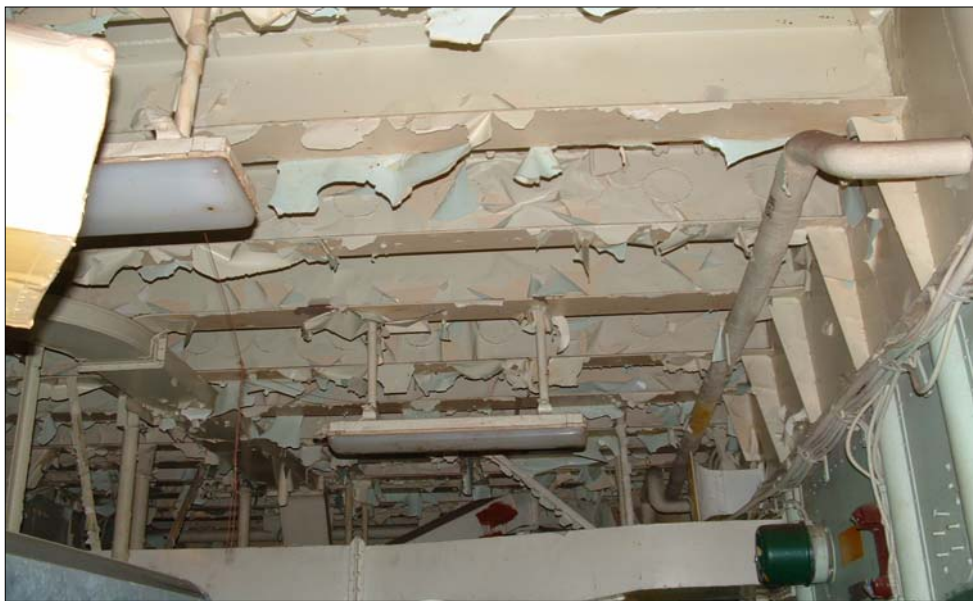
Exfoliating ceiling paint on the ex-USS Oriskany before being cleaned.

Removal of intact paints generally is not necessary. Topside paint may contain other constituents, such as trace metals or biocides. Unlike underwater hull paint containing high concentrations of biocides designed to leach rapidly, topside paints are designed for long life. They also may contain significantly lower levels of these substances than hull coatings. However, exfoliating paint (paint that is blistering, peeling, and pitting) and exfoliated paint (paint chips and flakes) should be removed.
