Milltown Reservoir Sediments Operable Unit

of the Milltown Reservoir/Clark Fork River Superfund Site

Record of Decision

Part 2: Decision Summary

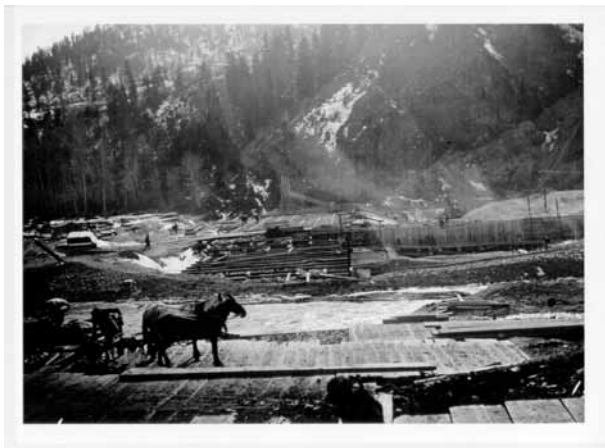
Milltown Dam Construction, 1906

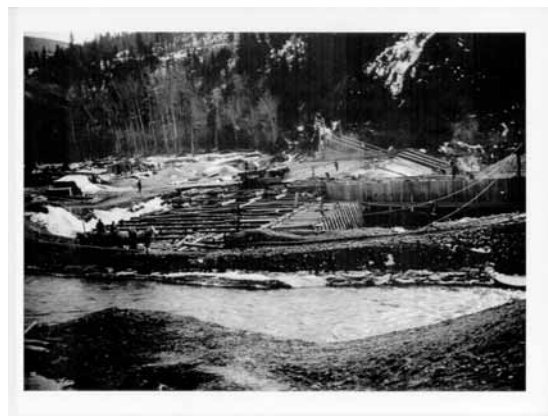
Milltown Dam Construction, 1906

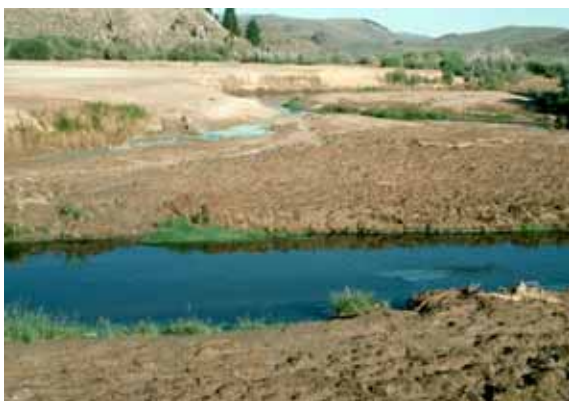
Silver Bow Creek Showing Slickens Deposits

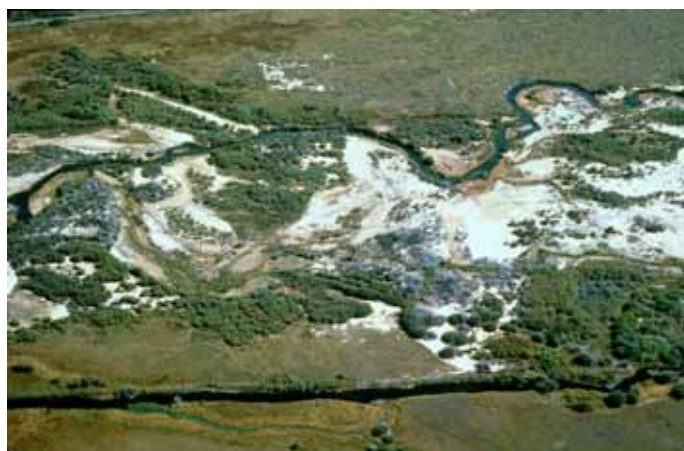
Tailings deposits along the Upper Clark Fork River
