Final 2016 Delisting Document

Waterbody Impairments Removed from the Impaired Waters Lists

**State of Rhode Island
Department of Environmental Management
Office of Water Resources**

March 2018

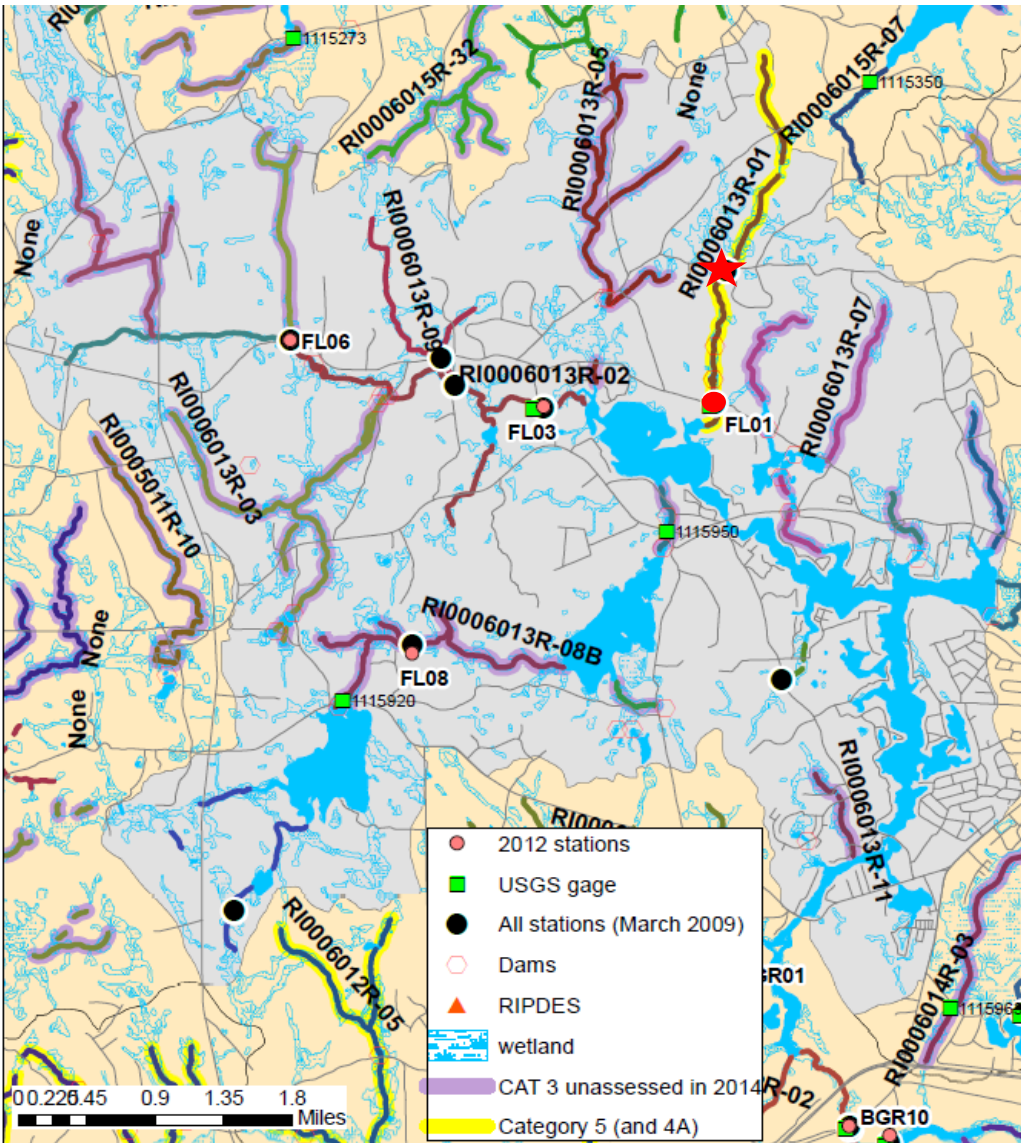
Boyd Brook at FL02 8/22/2006

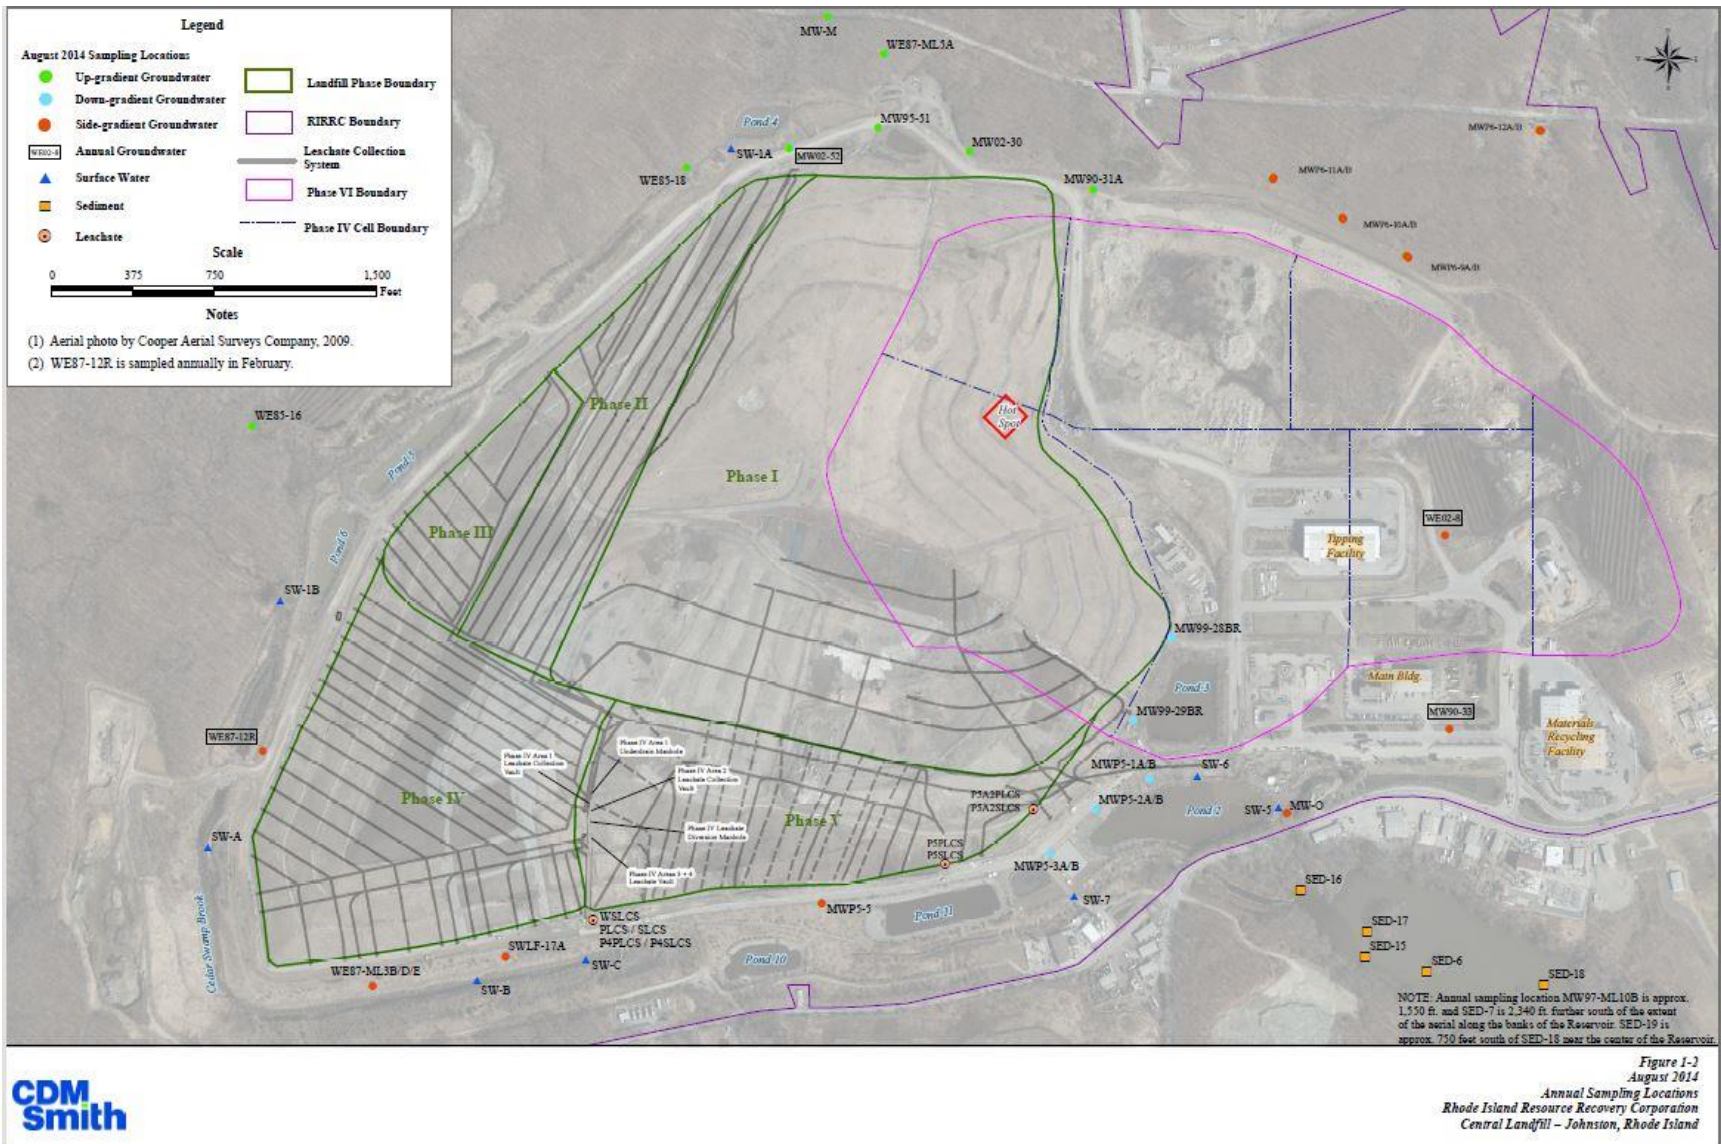
Site map of Central Landfill including relocated Cedar Swamp Brook and sampling stations.

Swamp Brook. Data collected from various locations along the re-routed stream path are found to be in compliance with the State’s water quality standard for iron, as shown in the table below. The current stream path location and sampling sites are shown in the figure below. Site SW-1B is located on Cedar Swamp Brook at the outlet from a waterbody known as the “swimming hole”, and the other four sampling locations are downstream locations along the new route of Cedar Swamp Brook (SW-A, SW-B, SW-C, and SW-7). All sampling locations are shown as blue triangles.

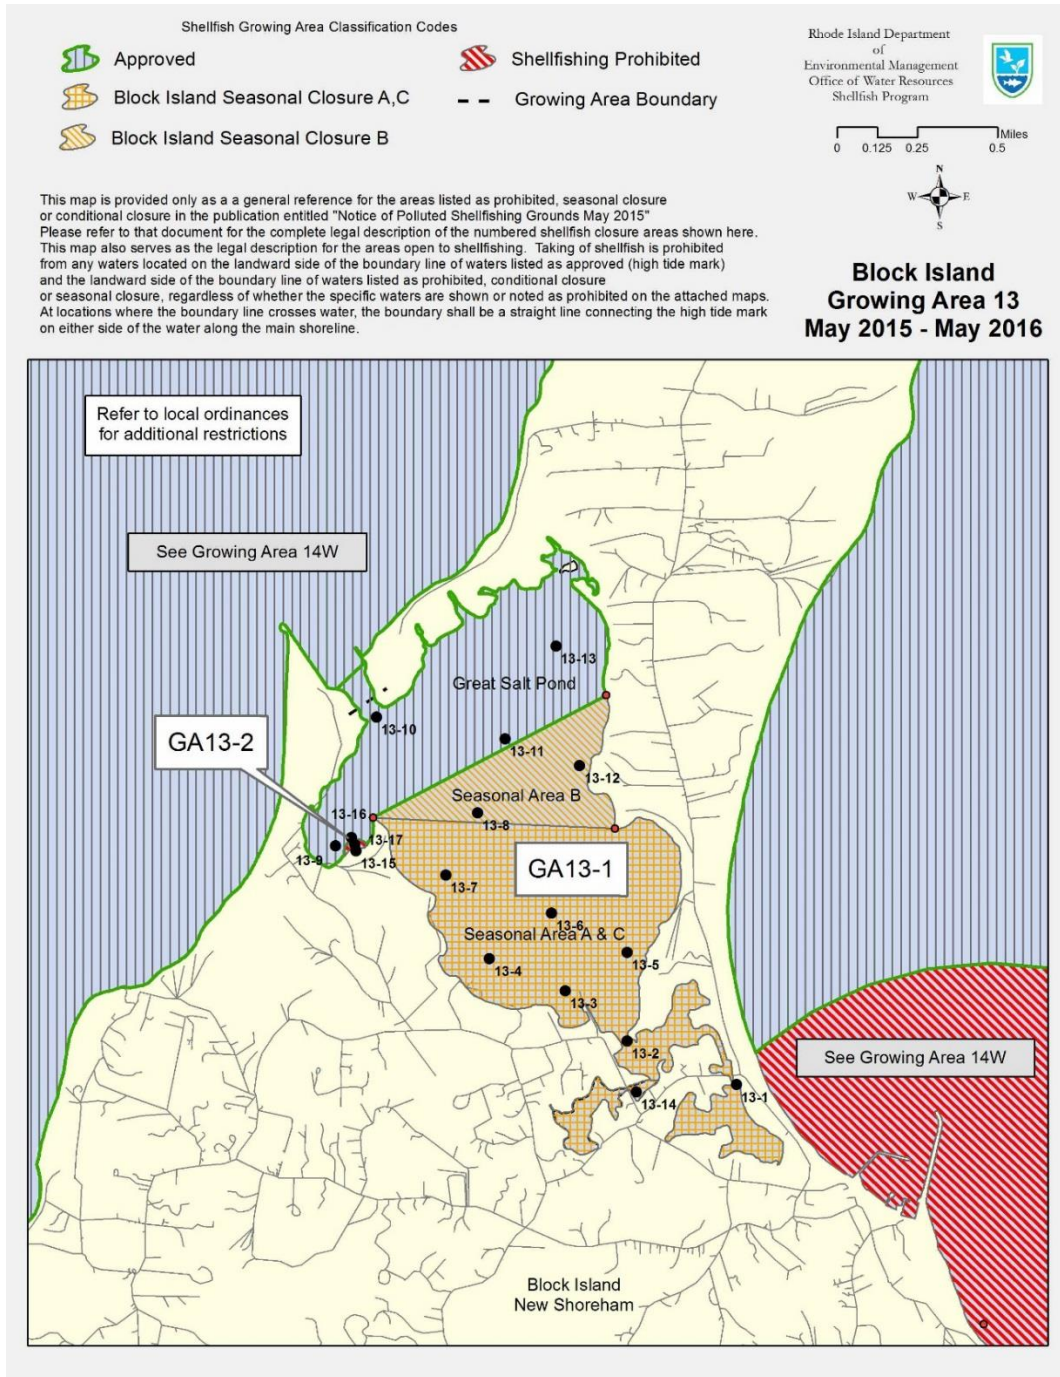
Fecal coliform – The majority of Great Salt Pond including Trim’s Pond and Harbor Pond are conditionally approved for shellfishing on a seasonal basis (see Shellfish Growing Area Classification Map below). They are closed to shellfishing from sunrise on the last Saturday in June through sunrise on the Tuesday immediately following Columbus Day, due to concerns that marina activities may adversely impact the sanitary quality of the waters. Though shellfishing use is prohibited seasonally, water quality must meet the applicable fecal coliform criteria for SA-classified waters year-round for the most recent 30 samples (geomean of 14; 90th percentile of < 49 to 31, dependent on number of samples analyzed using Mtec or MPN method) to be considered in support of the shellfishing use. Samples are collected monthly at all stations (shown on map below) by the Block Island Harbor Master.

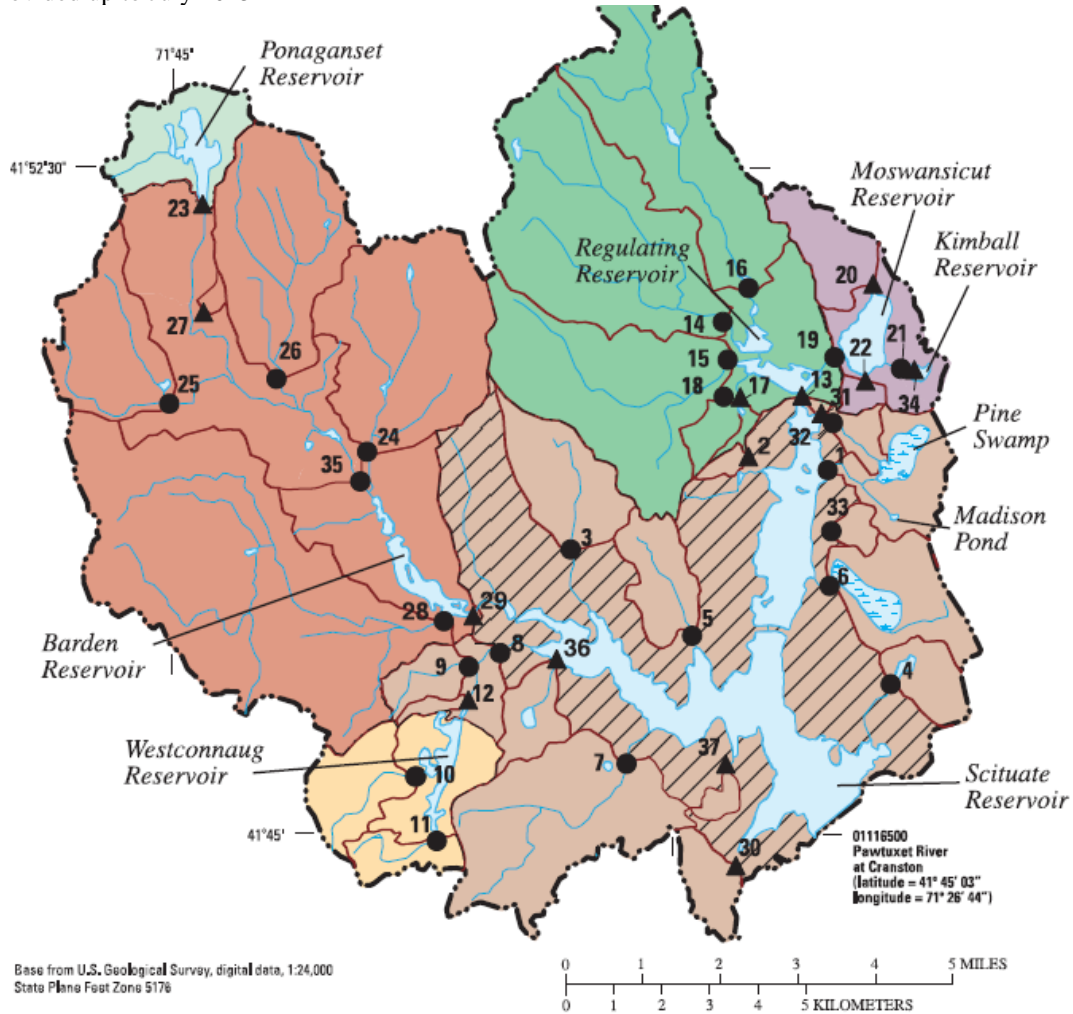
E. coli data collected monthly in Moswansicut Stream from 2010 – 2015 (at Station 22 on the map below) under both wet and dry weather conditions by the Providence Water Supply Board indicate that the primary and secondary contact uses are being met with the attainment of the USEPA *E. coli* geometric mean criteria of 124 col/100 mL. In the last few years, the Providence Water Supply Board has worked to discourage geese from this sub-watershed. They have a contract with USDA regarding goose management and have stopped mowing grass near the top of the dam upstream of the sampling location. RIDEM is not aware of other management actions that may have been taken that may have also contributed to the observed water quality improvements.

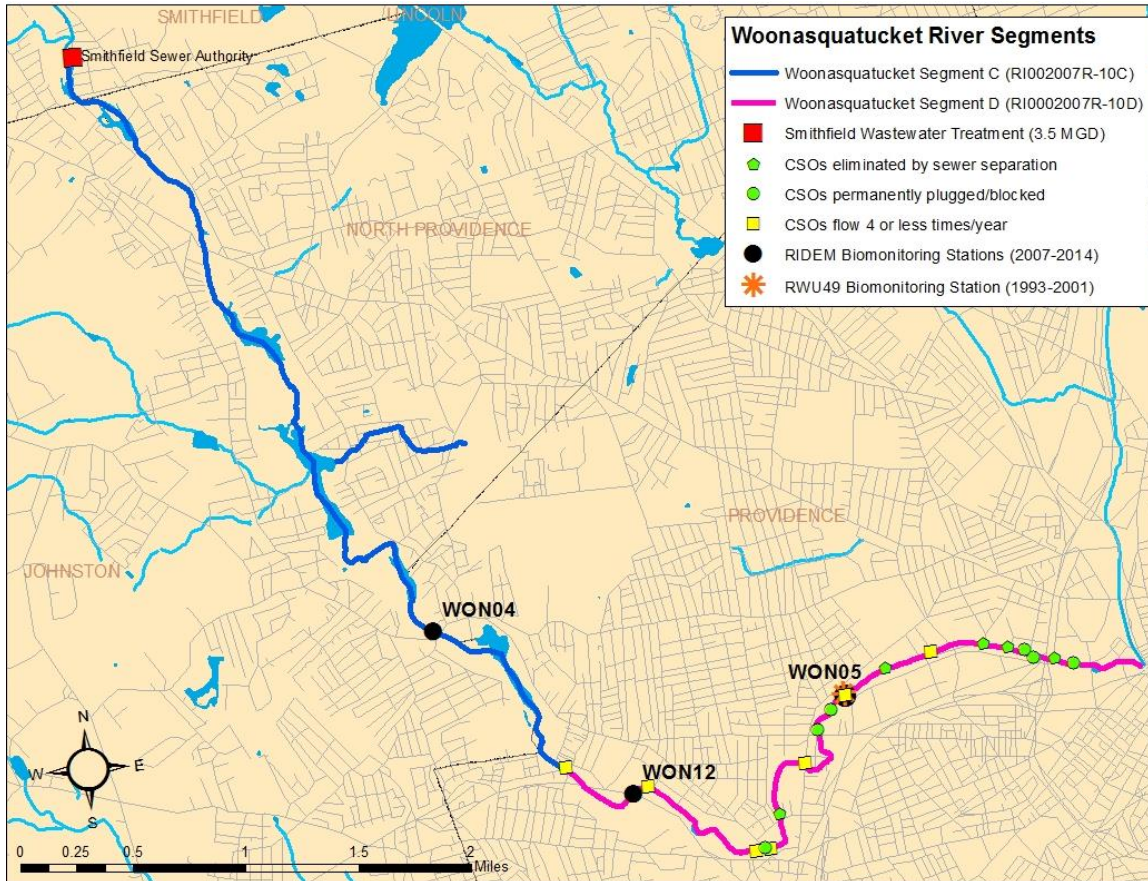
Benthic-Macroinvertebrate Bioassessments – This segment of the Woonasquatucket River is listed on RI’s 2014 303(d) List of Impaired Waters as not supporting aquatic life use due to benthic-macroinvertebrate bioassessments. This impairment was first listed on RI’s 2010 303(d) list based on macroinvertebrate data, summarized below, collected in 2007 & 2008 in accordance with a [Quality Assurance Program Plan](#), under the Rhode Island Department of Environmental Management’s Wadeable Stream Biomonitoring Program. Sampling was conducted at a station (WON04) by the Greenville/Manton Street Bridge in Providence. This waterbody segment runs from Esmond Mill Drive, Smithfield to the CSO outfall at Glenbridge Avenue in Providence, and the station is in the downstream region of the segment (see map below).

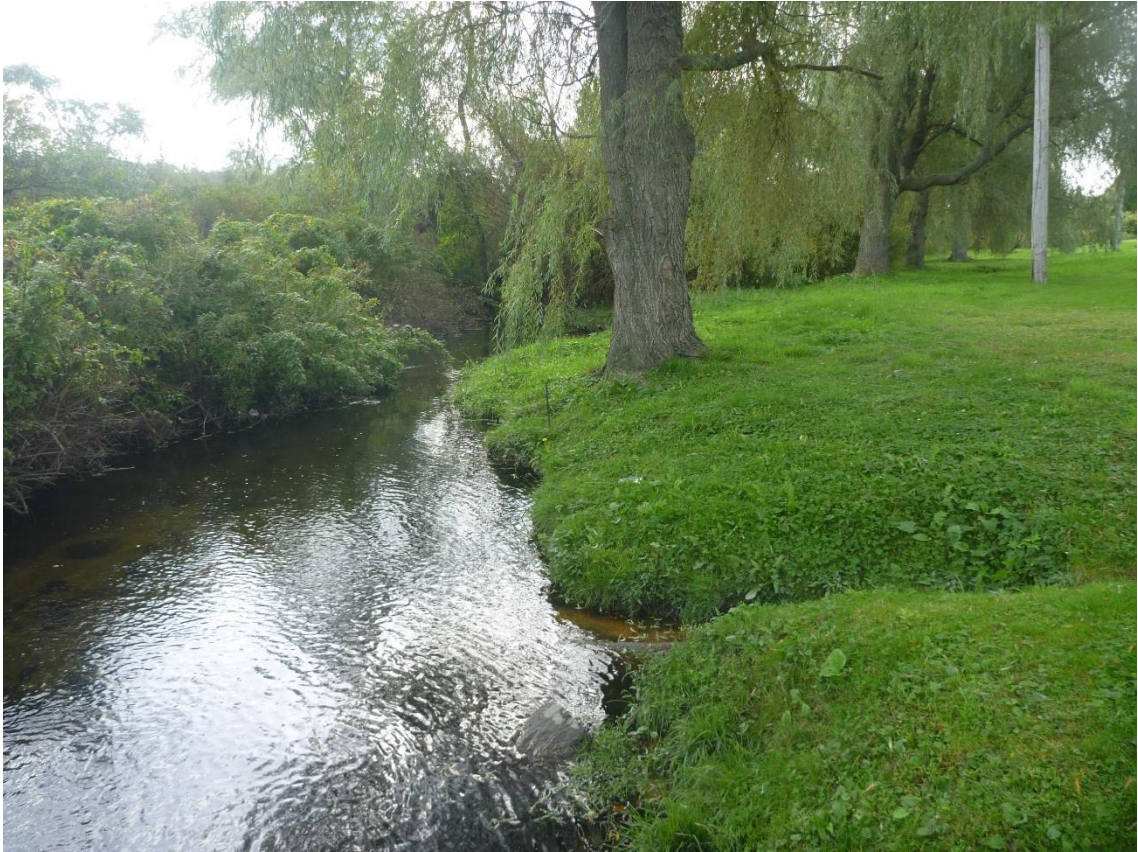
Bailey's Brook at Kempenaar's Clam Bake

Current RBP protocols for benthic macroinvertebrate biomonitoring require sampling in freshwater environments with riffle habitat. Reconnaissance of RWU05 indicates riffle habitat does not exist in this reach (see Figure below), and therefore no recent macroinvertebrate samples have been taken in this waterbody segment. The benthic macroinvertebrate bioassessment cause is not appropriate in this waterbody type and will be delisted. Rhode Island has not yet developed a biological indicator for low gradient, non-riffle streams. However, RIDEM is aware there are nutrient impacts in this waterbody. Therefore, RIDEM is adding aquatic life use impairment causes for phosphorus (total) to more accurately reflect available information.

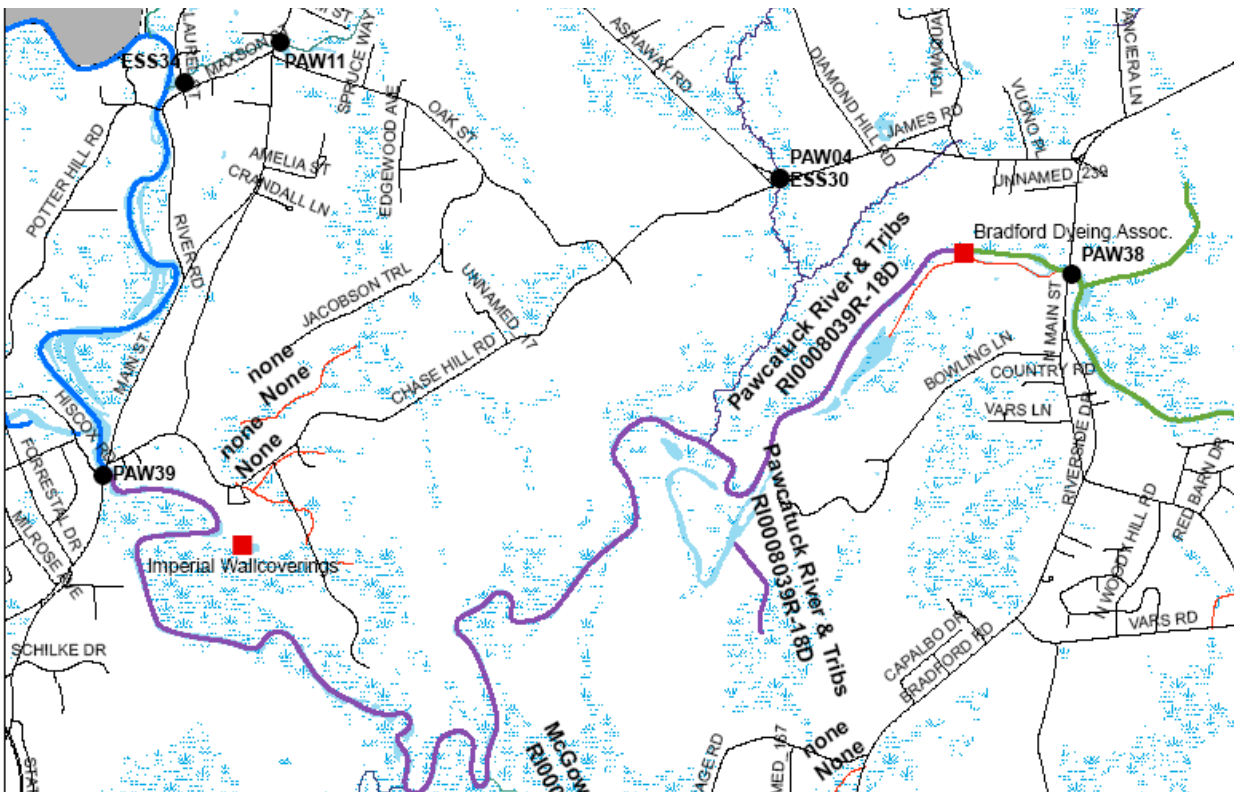
Benthic-Macroinvertebrate Bioassessments – This segment of the Pawcatuck River & Tribs is listed on RI’s 2014 303(d) List of Impaired Waters as not supporting aquatic life designated use due to benthic-macroinvertebrate bioassessments. This waterbody segment stretches 5.23 miles from Bradford Dyeing Associates (BDA) WWTF discharge point to the Route 3 bridge crossing – the purple segment on the map below.

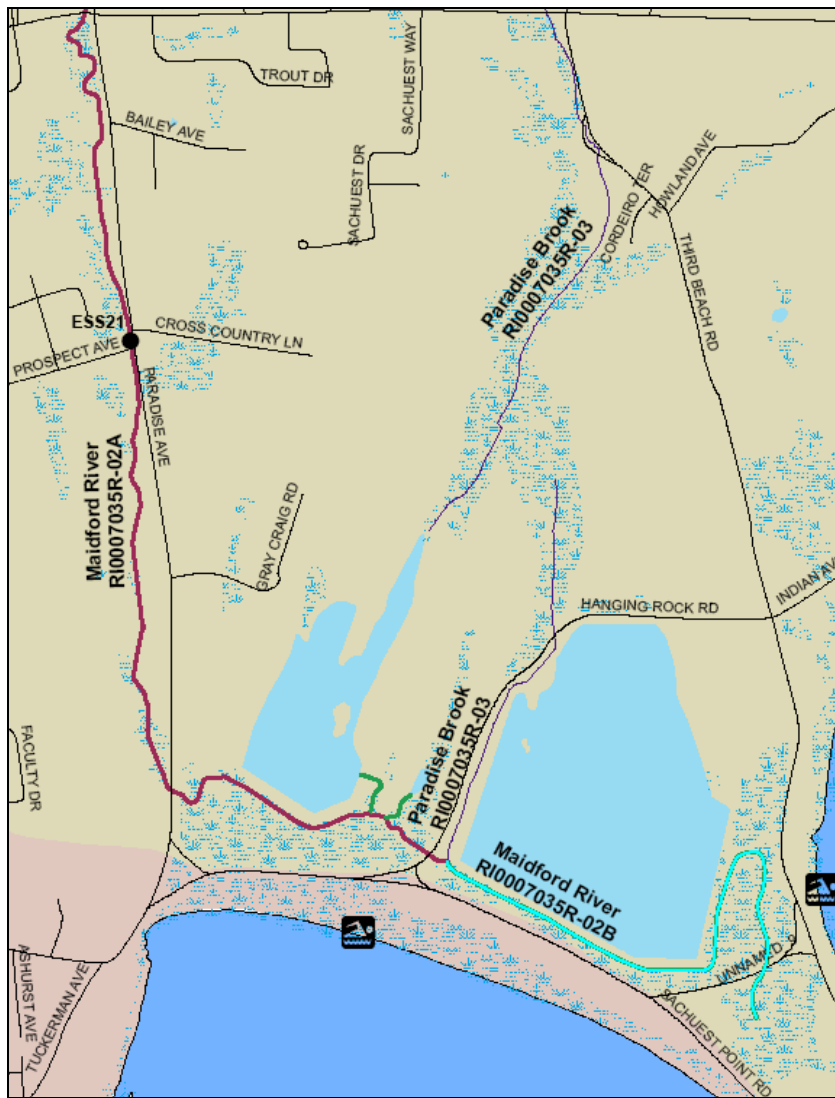
Maidford River and Paradise Brook segmentation 2000 - 2014 IR Assessment Cycles

**Segmentation of the Maidford River has changed several times over the past two decades in response to available information. With this 2016 Integrated Reporting assessment cycle, the Maidford River segments have been updated to more accurately reflect salinity and other conditions on Maidford River. Segment 2A is now defined as extending from the headwaters to the diversion structure of the Newport Water Division (NWD) on Paradise Avenue, and Segment 2B is defined as extending from the NWD diversion structure to Hanging Rock Road. A new waterbody ID, classified as salt water based on salinity readings has been added for the lower reach from Hanging Rock Road to Third Beach (RI0007035E-01).*

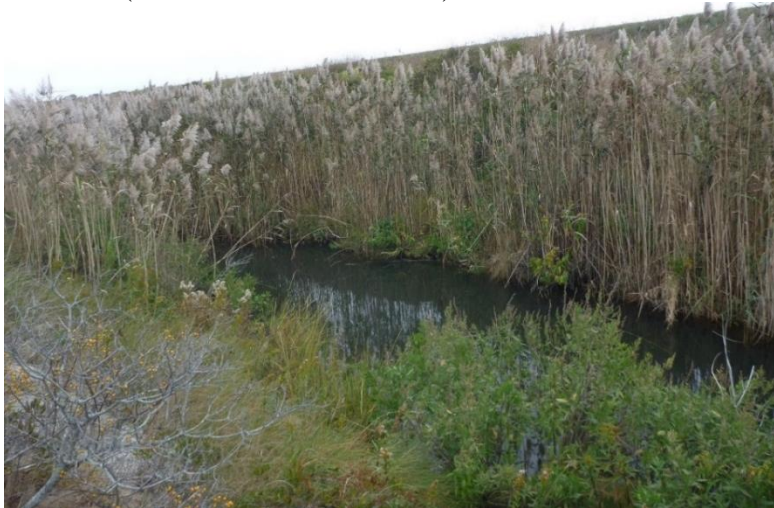
Photo: The lower Maidford River (RI0007035E-01) is located in Estuarine Emergent Wetlands along Sachuest Point Road (Photo taken 10-23-2013).

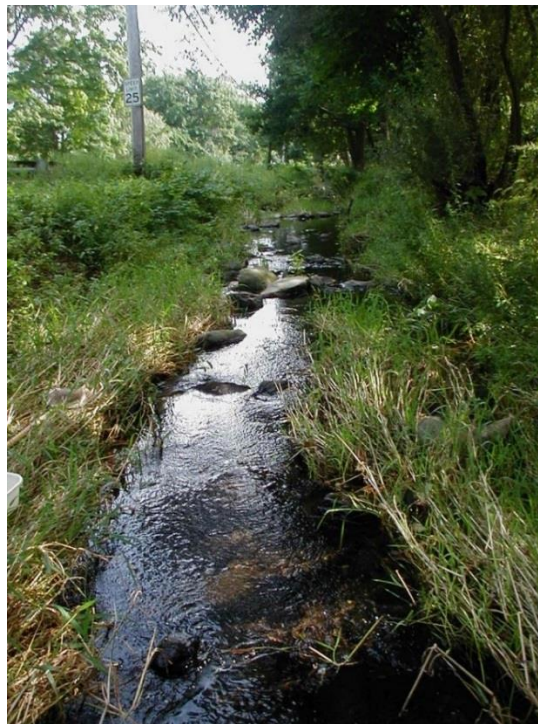
Maidford River Segment 2A at RWU27/ESS21 (Maidford River at Prospect Ave) is a wadeable freshwater stream (photo taken 8/27/2004).

Maidford River Segment 2A is still considered Not Supporting (Impaired) for aquatic life use with benthic-macroinvertebrate bioassessments as one cause (also listed for turbidity,

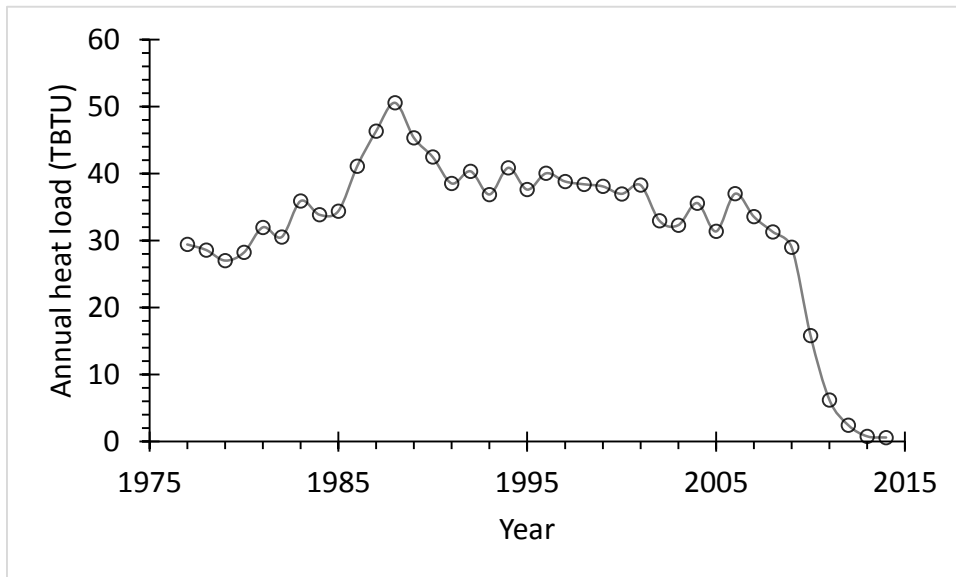
Figure 1: Annual heat load (units are trillions BTU per year) from Brayton Point cooling water 1977 to 2014. (Data source: Table 1-5 of 2014 Brayton Point Annual Report).

The current NPDES permit went into effect on May 13, 2012, coincident with the conversion of the plant to closed-cycle cooling *via* two 500 ft. tall natural draft cooling towers. The current permit allows 1.7 TBTU (trillion BTU) per year heat load to Mt. Hope Bay and a 70 MGD intake flow limit. The increased intake flow limit of 70 MGD in the 2012 permit corrects an inadvertent omission of including “blow-down” and “make up” water for one of the cooling towers in the intake flow limit established in the earlier permit. (US EPA, 2012) The conversion to closed cycle cooling dramatically reduced the heat load discharged into Mt. Hope Bay (Fig. 1), with the annual heat loading falling from 30-50 TBTU annually prior to closed-cycle cooling to 2.4 TBTU annually during 2012 (conversion year) to 0.8 TBTU in 2013 and 0.6 TBTU in 2014 after conversion. The post-closed cycle cooling heat load was less than 5% of that experienced prior to the 2012 conversion (Fig. 1).

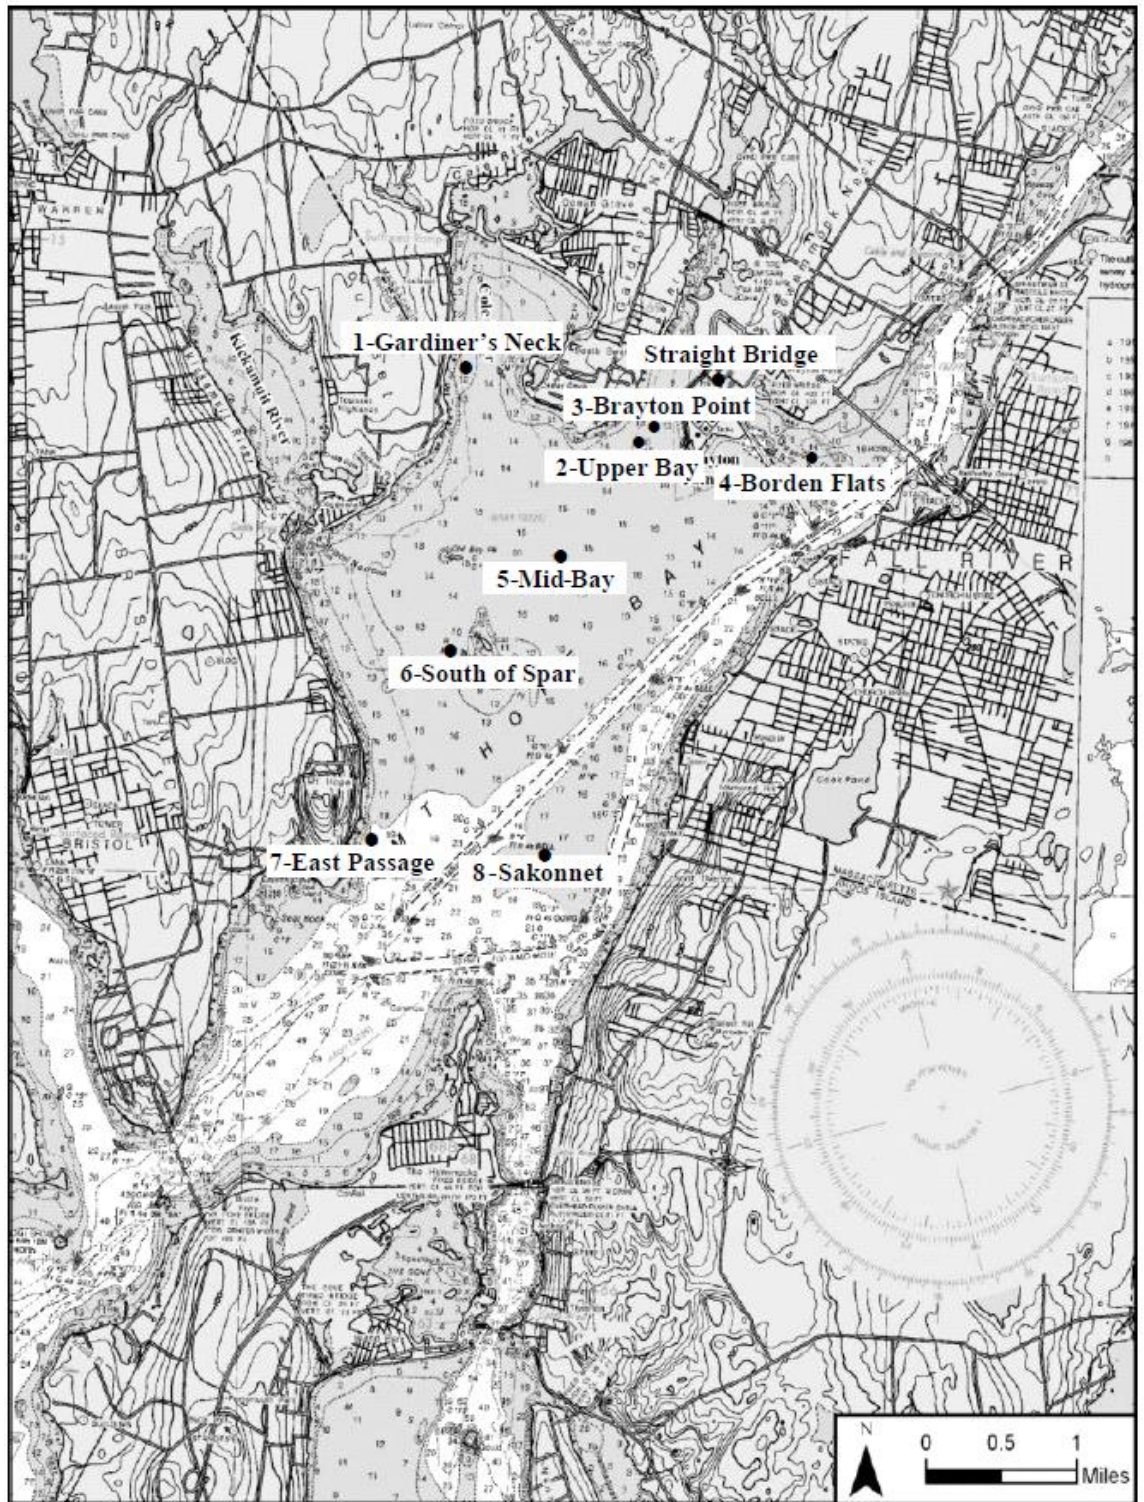
Figure 2: Location of thermistor buoys in Mt. Hope Bay. Thermistor temperature data were collected at near surface and near bottom depths at eight locations in the Bay and at the ‘Straight Bridge’ in the discharge canal. (Figure 3-2 copied from 2012 Brayton Point Annual Report).

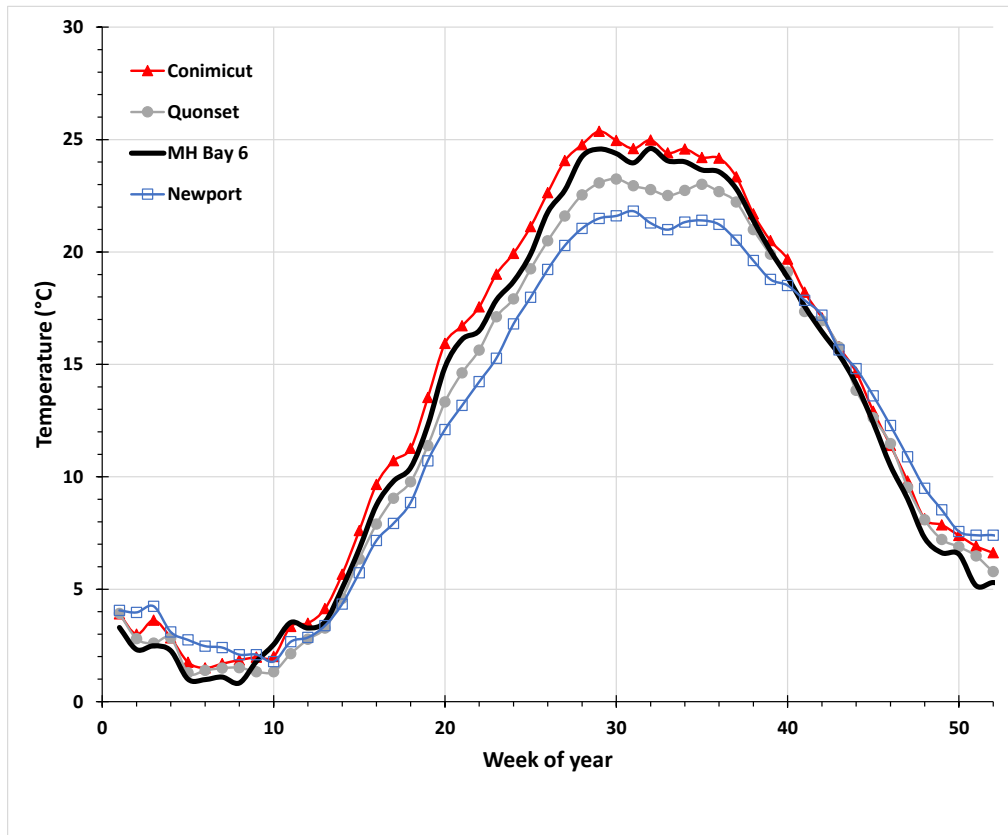
Figure 3: Comparison of water temperature mean annual cycle at Mount Hope Bay Buoy 6 (south of Spar Island) to those at Conimicut Point, Quonset Point and Newport Harbor. Means are based on NOAA observations during 2012-2015.

use as a reference to which the Mt. Hope Bay water temperatures may be compared. Water temperature observations collected every 6 minutes at Borden Flats Light (Fall River, MA, NOAA station # 8447387), Conimicut Point Light (Warwick, RI, NOAA station # 8452944), Quonset Point (North Kingstown, RI, NOAA station # 8454049) and at Newport, RI (NOAA station # 8452660) during the 2008-2015 period of interest are available for evaluation.

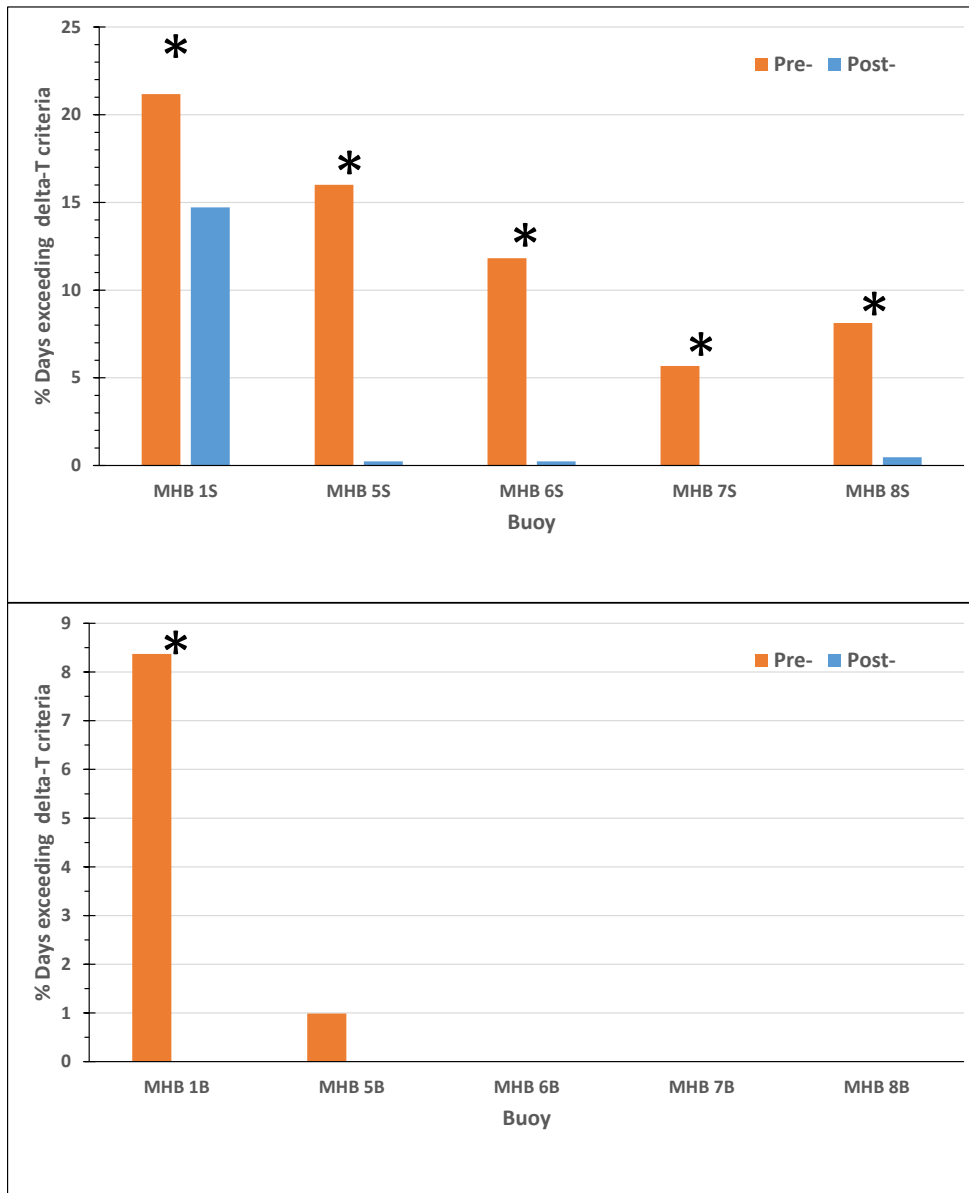
Figure 4: Comparison of frequency of days exceeding *summer* (7-day rolling average temperature + 0.9°C) seasonal delta-T temperature criteria using Conimicut Pt. as a reference prior to ('Pre') and following ('Post') conversion to closed cycle cooling at five buoy locations in Mt. Hope Bay. Pre- and post- frequencies compared with Fisher's exact test; statistically significant differences in frequencies designated with asterisk. Top panel is surface temperature and bottom panel is bottom temperature summer threshold exceedance frequency. Buoys 1 and 5 are in MA waters, buoys 6, 7 and 8 are located in RI waters of Mt. Hope Bay.

The frequency of bottom water summer season delta-T exceedance was lower than that observed at the surface, as one might expect. In RI waters of Mt. Hope Bay (stations 6B, 7B, 8B), no summer seasonal delta-T exceedances were noted prior to or after the conversion to closed cycle cooling (Fig. 4, bottom). For buoy locations in MA waters (stations 1B and 5B), the frequency of summer delta-T temperature exceedances declined significantly, with no bottom water summer delta-T exceedances occurring after the conversion to closed cycle cooling (Fig. 4, bottom).

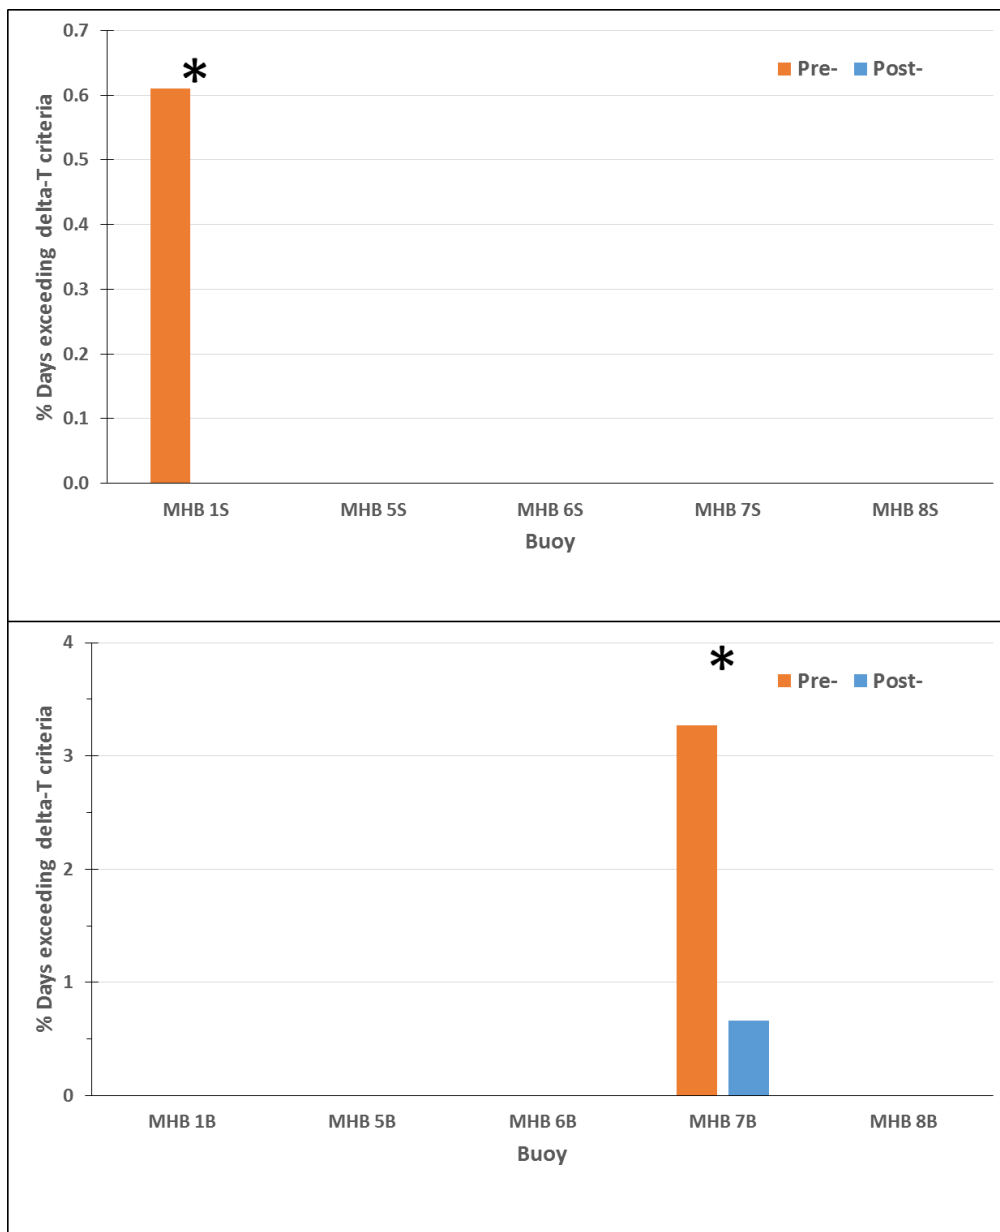
Figure 5: Comparison of frequency of days exceeding *winter* (mean temperature + 2.2°C) seasonal delta-T temperature criteria using Conimicut Pt. as a reference prior to (‘Pre’) and following (‘Post’) conversion to closed cycle cooling at five buoy locations in Mt. Hope Bay. Pre- and post- frequencies compared with Fisher’s exact test; statistically significant differences in frequencies designated with asterisk. Top panel is surface temperature and bottom panel is bottom winter temperature exceedance frequency. Buoys 1 and 5 are in MA waters, buoys 6, 7 and 8 are located in RI waters of Mt. Hope Bay.

Frequency of exceeding the winter seasonal temperature delta-T criteria (mean temperature + 4°F (2.2°C) above normal; in effect from October 1st until June 16th) was generally lower than the frequency of summer delta-T threshold exceedance, both before and after the conversion to closed cycle cooling. At most locations (5S, 6S, 7S, 8S, 1B, 5B, 6B, 8B) no (frequency = 0%) winter delta-T exceedances were noted prior to- and after- the conversion to closed cycle cooling (Fig. 5). However, declines in frequency of winter delta-T criteria after conversion to closed cycle cooling were noted at two locations (Buoy 1S in MA waters and buoy 7B in RI waters). Frequency of winter delta-T exceedance post-closed cycle cooling declined from 0.6% to 0% of days at the surface of the Gardiner's Neck station (1S) and declined from 3.3% of days to 0.7% (5 of 757 days) of days at the bottom water of the Mt. Hope station (7B; Fig. 5). The five days on which the winter delta-T criteria was exceeded at Buoy 7B (Mt. Hope) were on January 14-18, 2015. At this time a cold front moved into the area and ice was forming on Mt. Hope Bay. The extent of ice during the cold snap and subsequent record-cold winter of 2015 resulted in Buoy 7 being moved off its mooring. Buoy 7 was pushed ashore by the ice and was later recovered and deployed at its long-term location on 3/27/2015 (Brayton Point Station 2015 Annual Report, Table 3-9). The five January 2015 temperature exceedances at Buoy 7B (Fig. 5) likely reflect a change in the buoys position (ice pushed it ashore) rather than bottom water temperatures during January 14-18, 2015.
