**United States Steel Corporation  
Midwest Plant  
Portage, Indiana**

**Enhanced Wastewater Process Monitoring Design**

**06-29-2018  
Revised 12/21/2018**

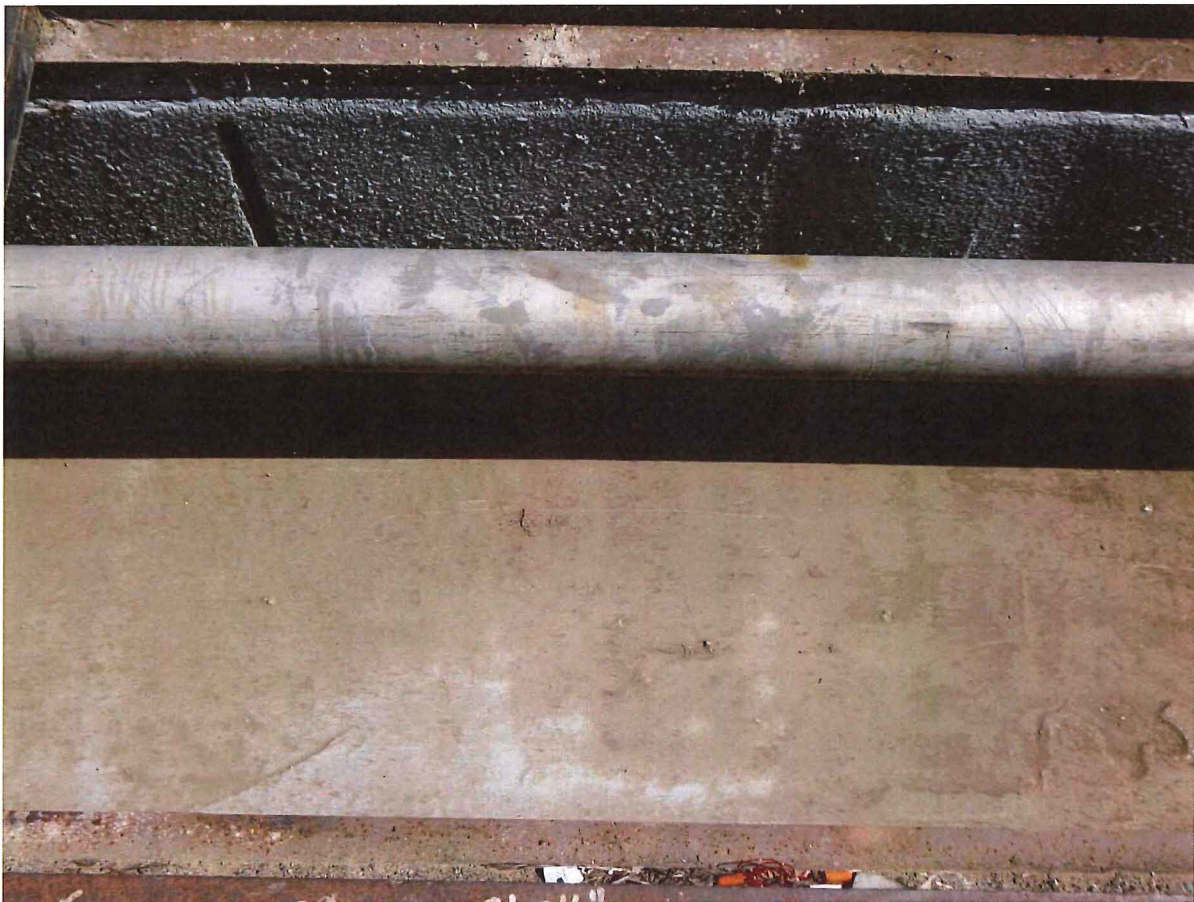
**Picture 1:** This picture shows the work performed pursuant to Consent Decree Paragraph 9.a.i., 9.a.ii., 9.a.iii., and 9.a.iv.

To address the integrity of the containment trench for the chrome process wastewater piping, the trench was cleaned, and new concrete bottom poured. The trench slope was reestablished to direct any flow in the trench to the chrome trench sump. Please see Figure 1 and Figure 2 in Appendix 1 for the location of the trench.

A protective epoxy coating was installed over all of the concrete in the trench. A total of three layers were installed. The inner-most primer layer is for proper bonding, then a coating of a chemical resistance epoxy applied in 2 layers to establish a thickness for better service wear. The epoxy coating is chemically compatible with the process water and will prevent deterioration of the concrete.

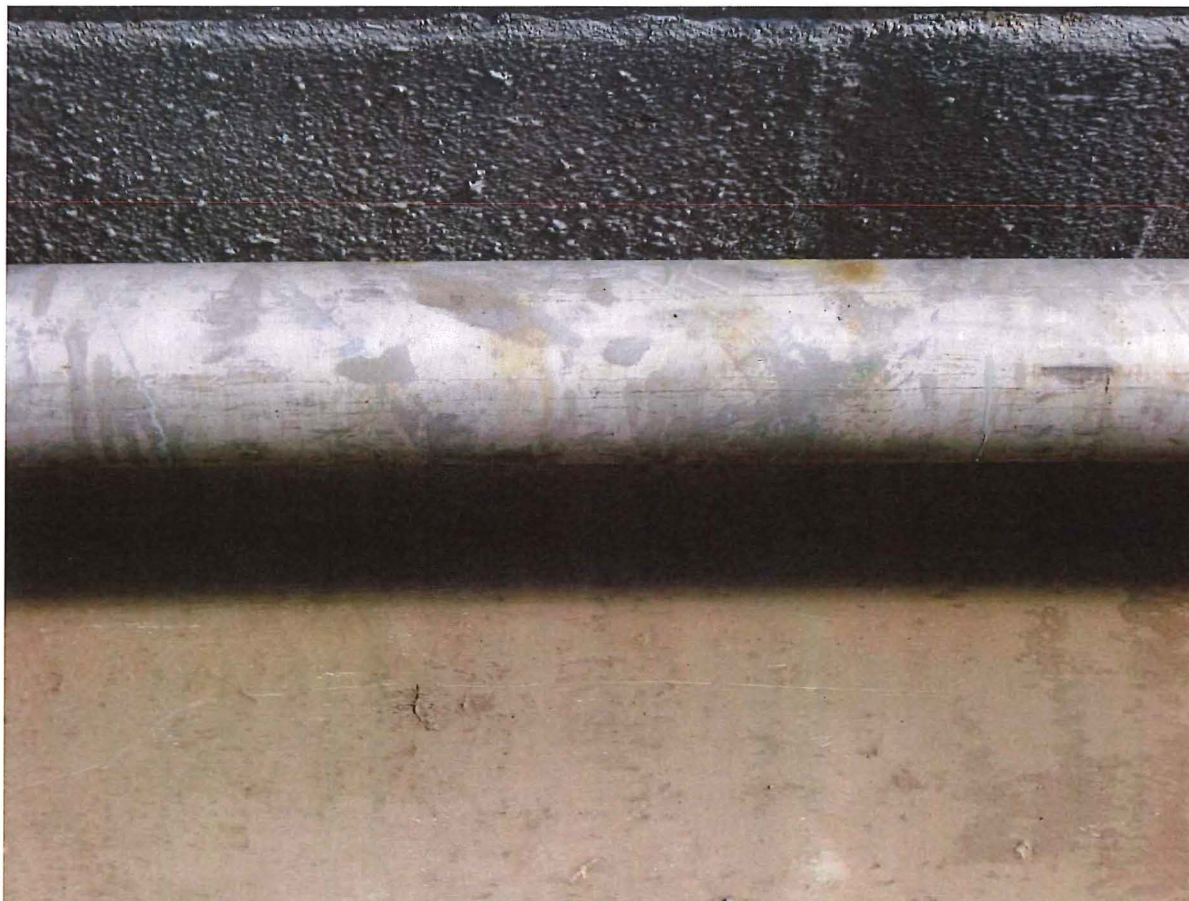
**Picture 2:** This picture shows the work performed pursuant to Consent Decree Paragraph 9.a.i., 9.a.ii., 9.a.iii., and 9.a.iv.

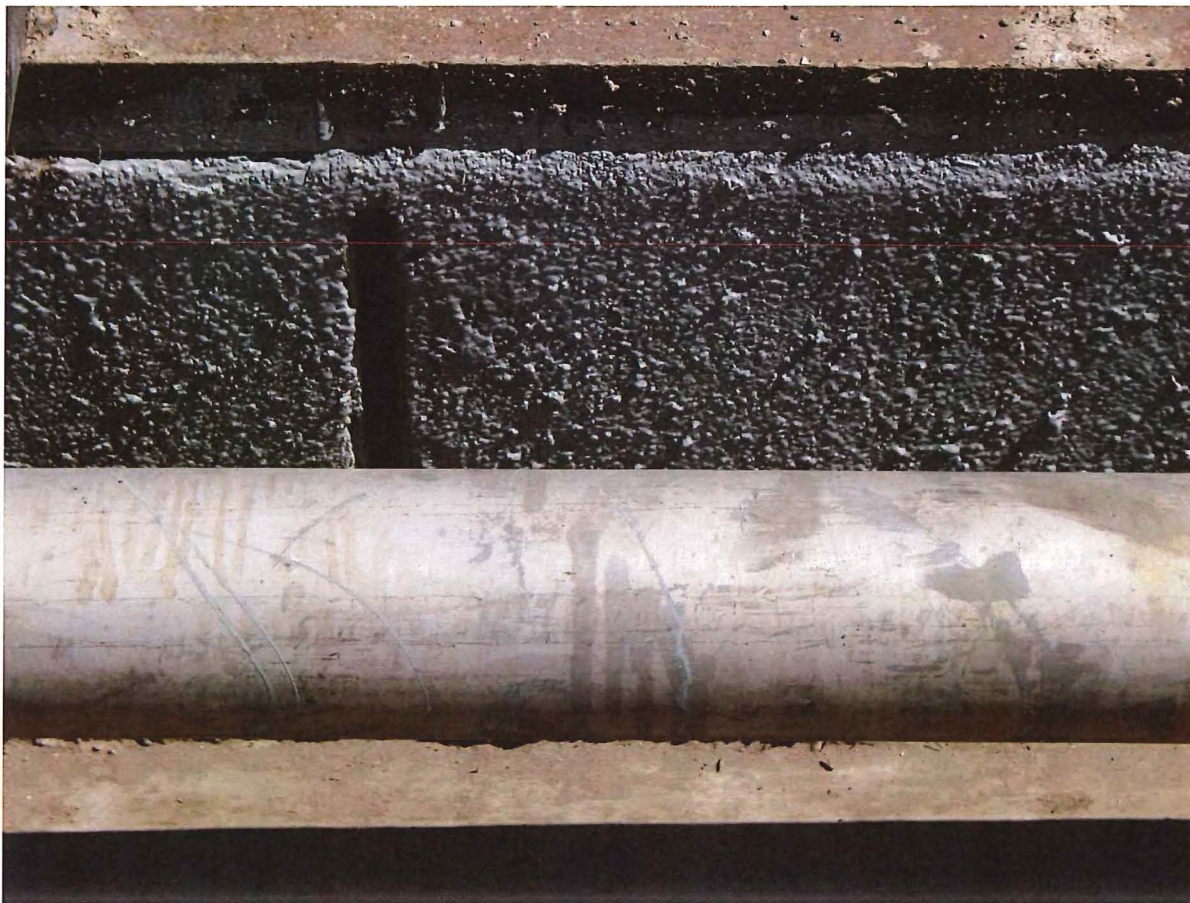
**Picture 3:** This picture shows the work performed pursuant to Consent Decree Paragraph 9.a.iv.

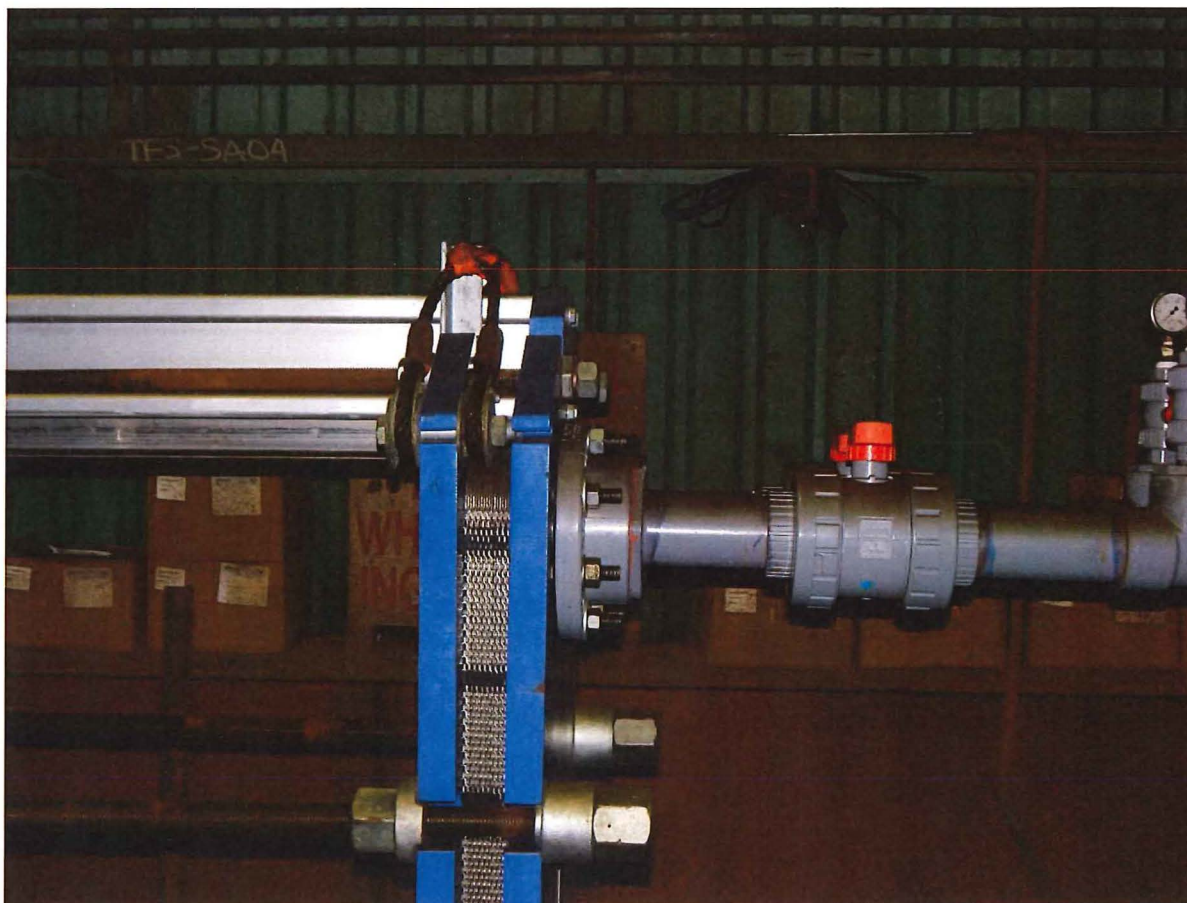
**Picture 4:** This picture shows newly installed double walled heat exchanger on January 15, 2018 pursuant to Consent Decree Paragraph 9.v.

A single wall plate and frame heat exchanger on the Chrome Line Plater section, and two spiral heat exchangers on the Chrome Line ChemTreat section were replaced with double wall plate and frame heat exchangers. The double wall heat exchangers significantly reduce the likelihood of process water leaking into the non-contact cooling water.

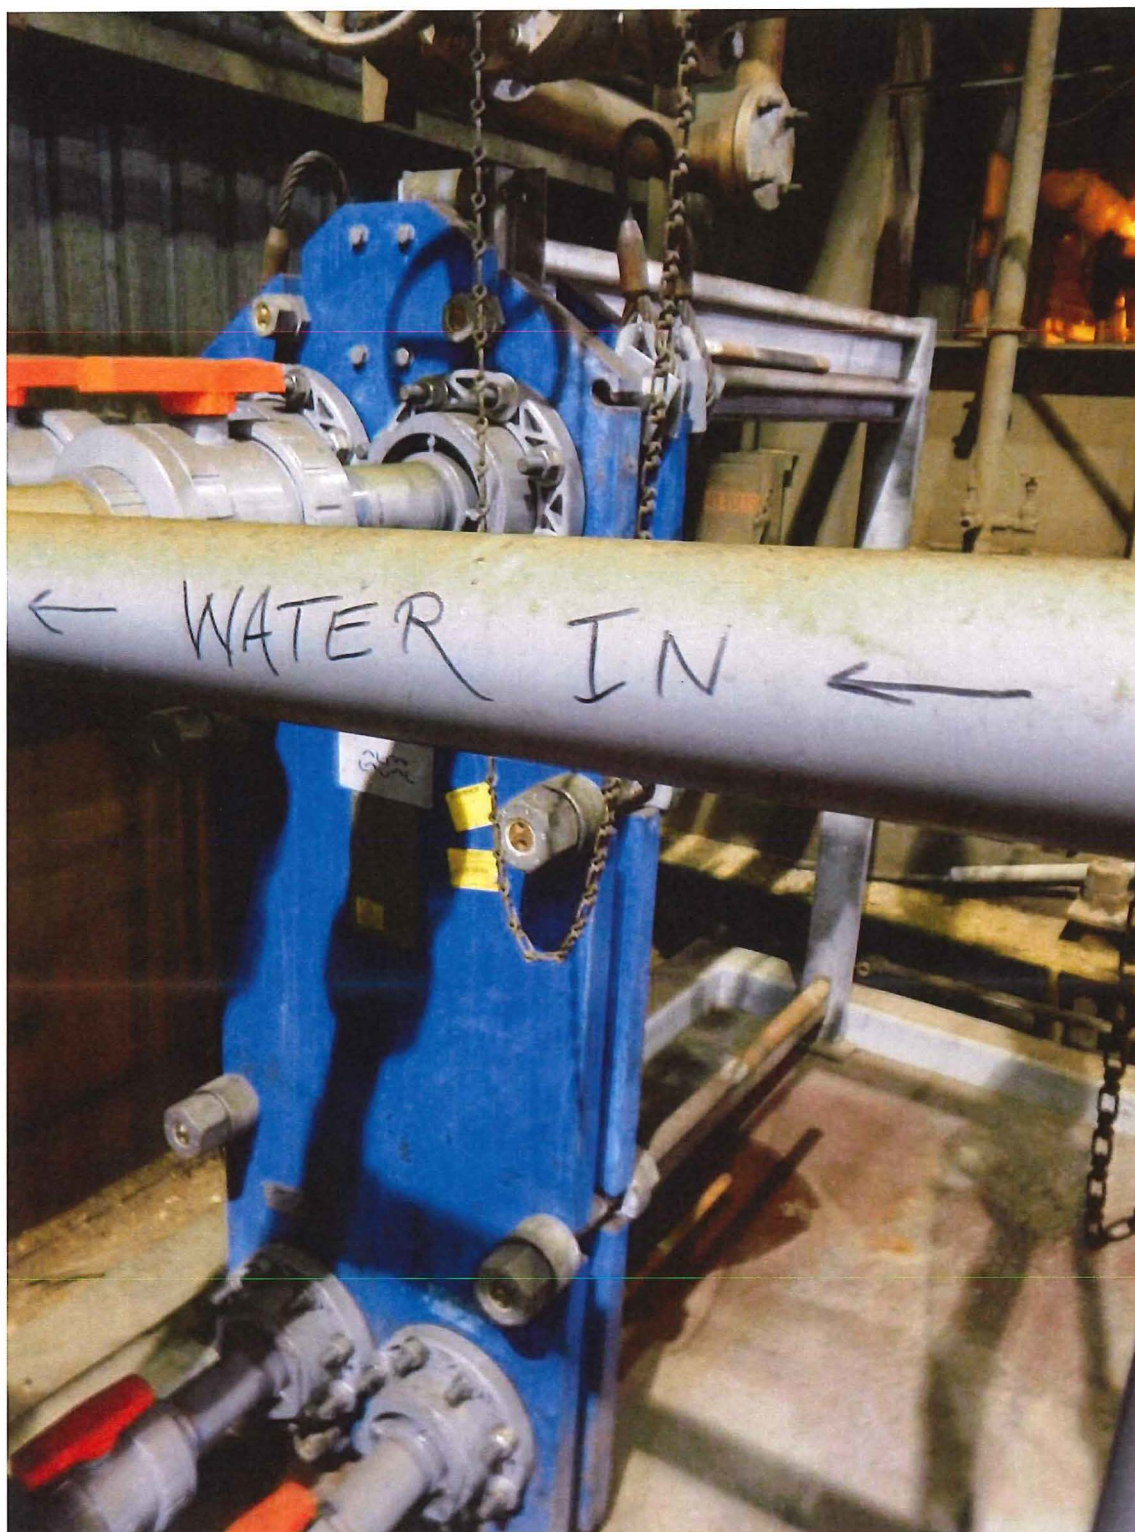
**Picture 5:** This picture shows the newly installed back up double walled heat exchanger pursuant to the Enhancend Wastewater Process Monitoring Design

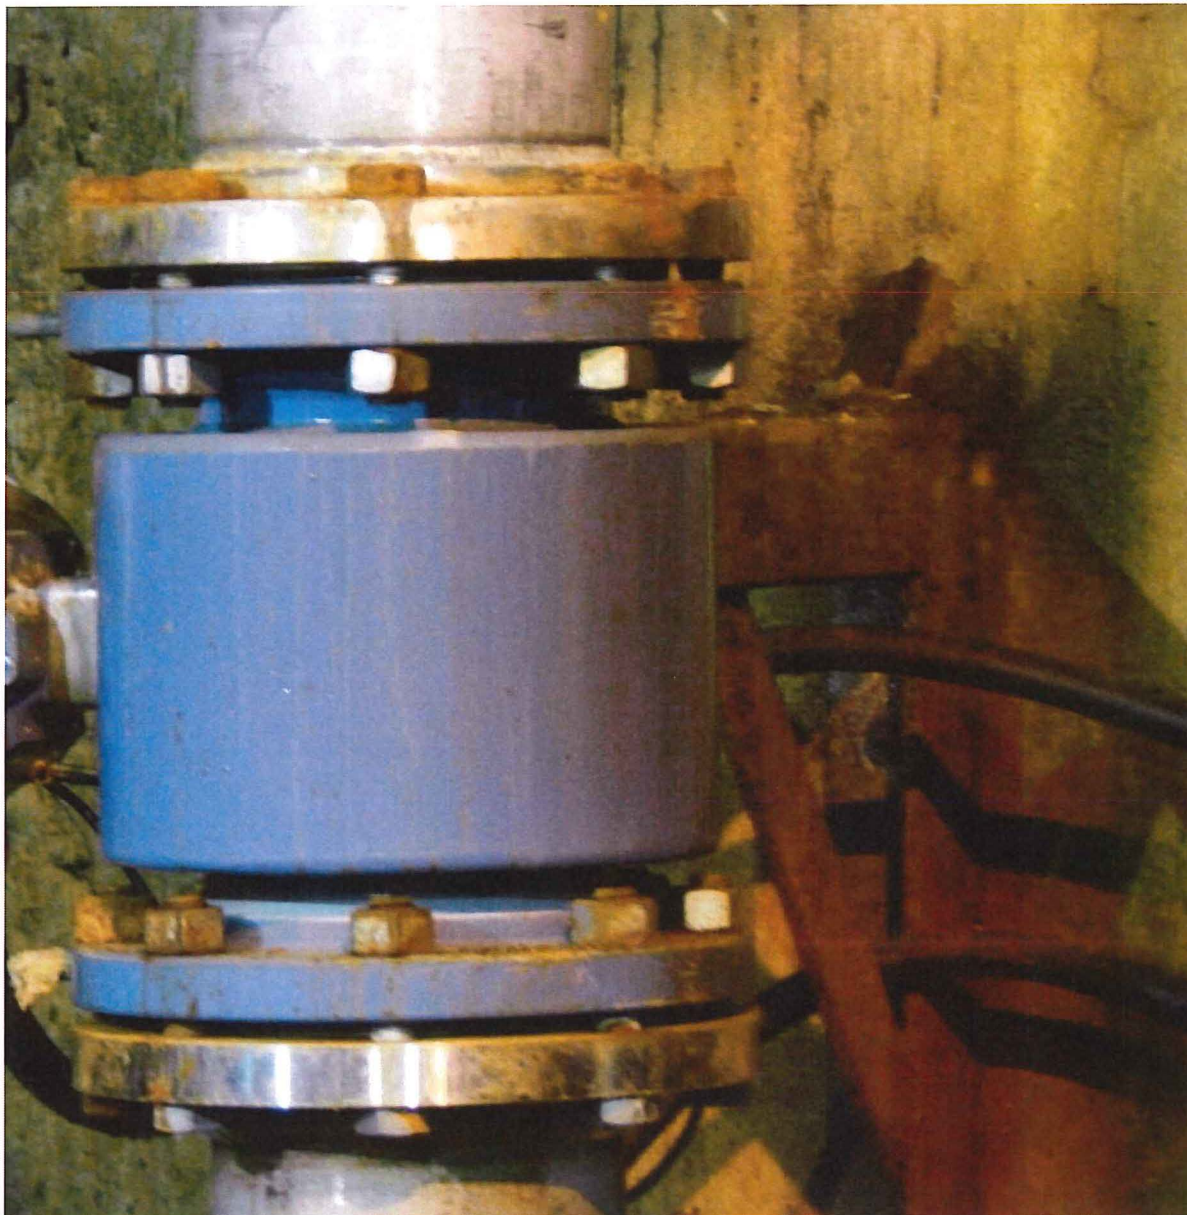
**Picture 6:** Chrome containment trench: pictures of inlet flow meter on chrome transfer pipeline

Two flow meters were installed at the inlet and outlet areas of the chrome plant influent wastewater piping. The pipe entry flow meter is located just after the combining of chrome wastewater flows from the Tin and Chrome Lines basement sumps and the pipe delivery flow meter is located just prior to discharge into the chrome plant equalization tank. Both installation locations were selected to minimize any hydraulic effects that may contribute towards accuracy errors. The pipeline is continuous and does not have any tie-ins along the length between the flow meters. Please see Figure 1 and Figure 2 in Appendix 1 for the location of the pipe entry and pipe delivery flow meters.

Rosemount flow meters are installed at the entry and exit of the chrome plant influent wastewater piping. Due to the line and pump configuration, the flow at each meter location varies, but the meters trend together. These meters would detect a line failure. Other methods are employed to detect leaks including conductivity metering in key locations, periodic sampling and inspection.

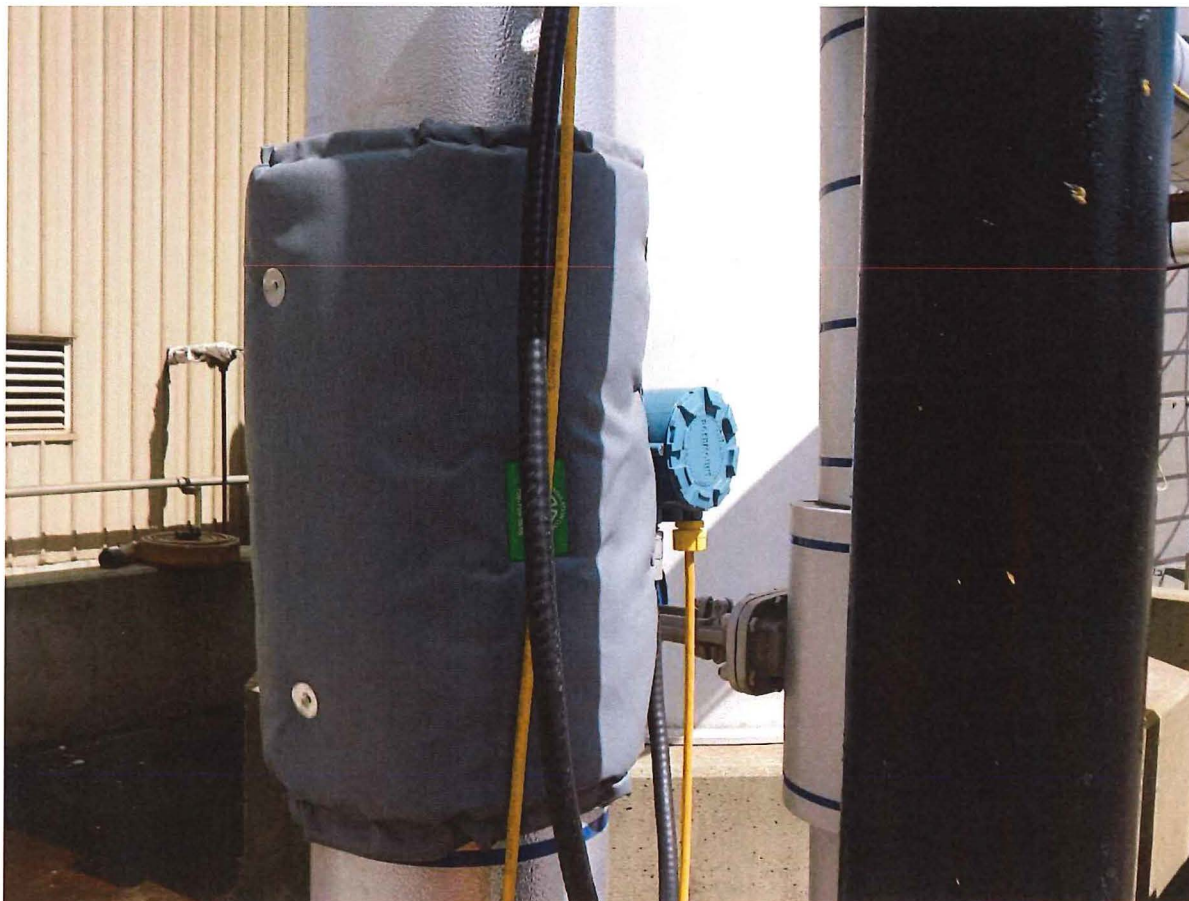
**Picture 7:** Chrome containment trench: pictures of outlet flow meter on chrome transfer pipeline

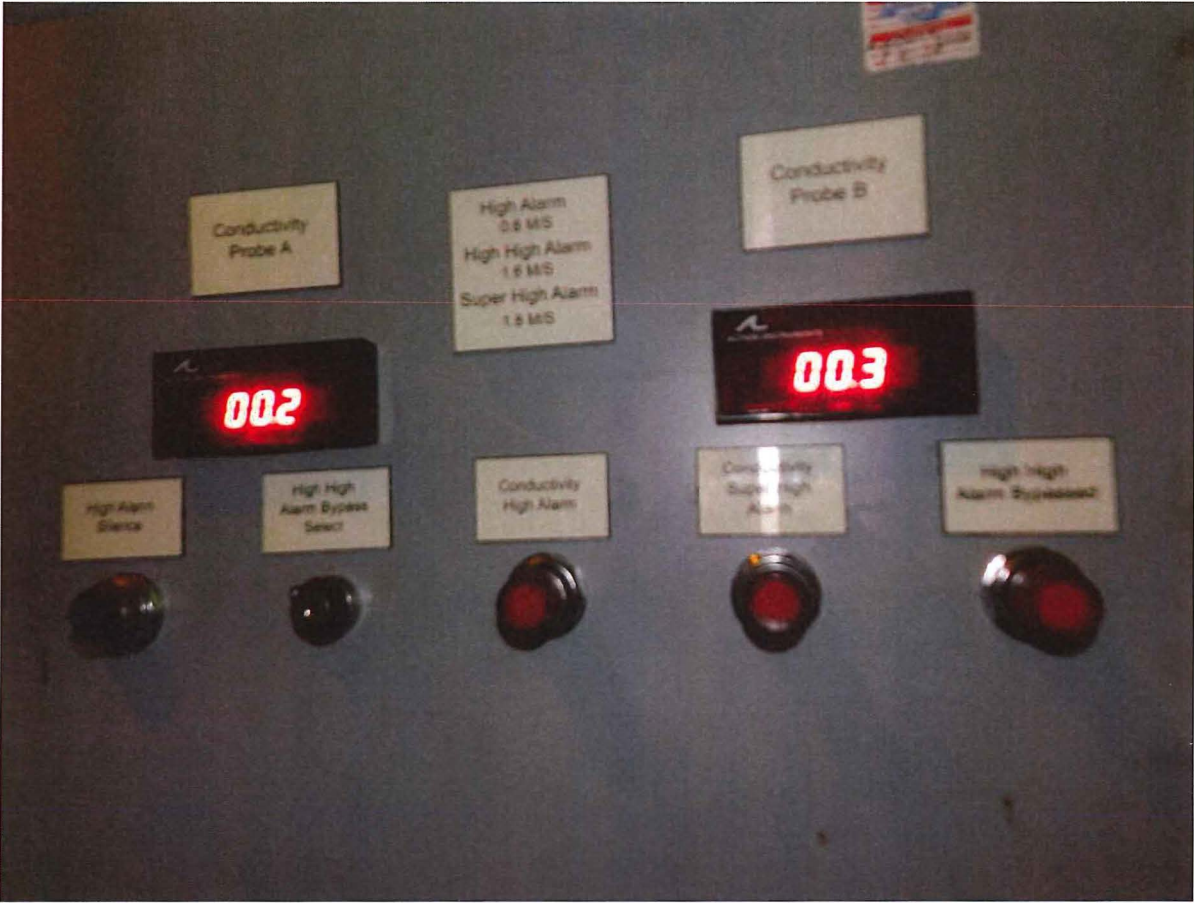
Picture 8: Chrome Line Plater: picture of conductivity probes installed

Chrome Line Plater sump	If the existing conductivity probe should experience drift from calibration the sump shutdown controls may not function properly.	Install an additional conductivity probe in the sump.	Install an additional conductivity probe which will act independently of the existing probe to alert for high chrome concentrations and shutdown sump pumps.	Probe was installed.
Chrome Line Plater sump	Chrome wastewater enters the sump from 2 separate areas. The existing conductivity probe may not detect high chrome concentrations quickly.	Install an additional conductivity probe in the sump.	Install an additional conductivity probe so that each influent source can be monitored rapidly. This will allow a detection of high chrome concentration from either influent source and shutdown the sump pumps. Each probe will act independently to alert for high chrome concentrations and shutdown sump pumps.	Probes were installed.

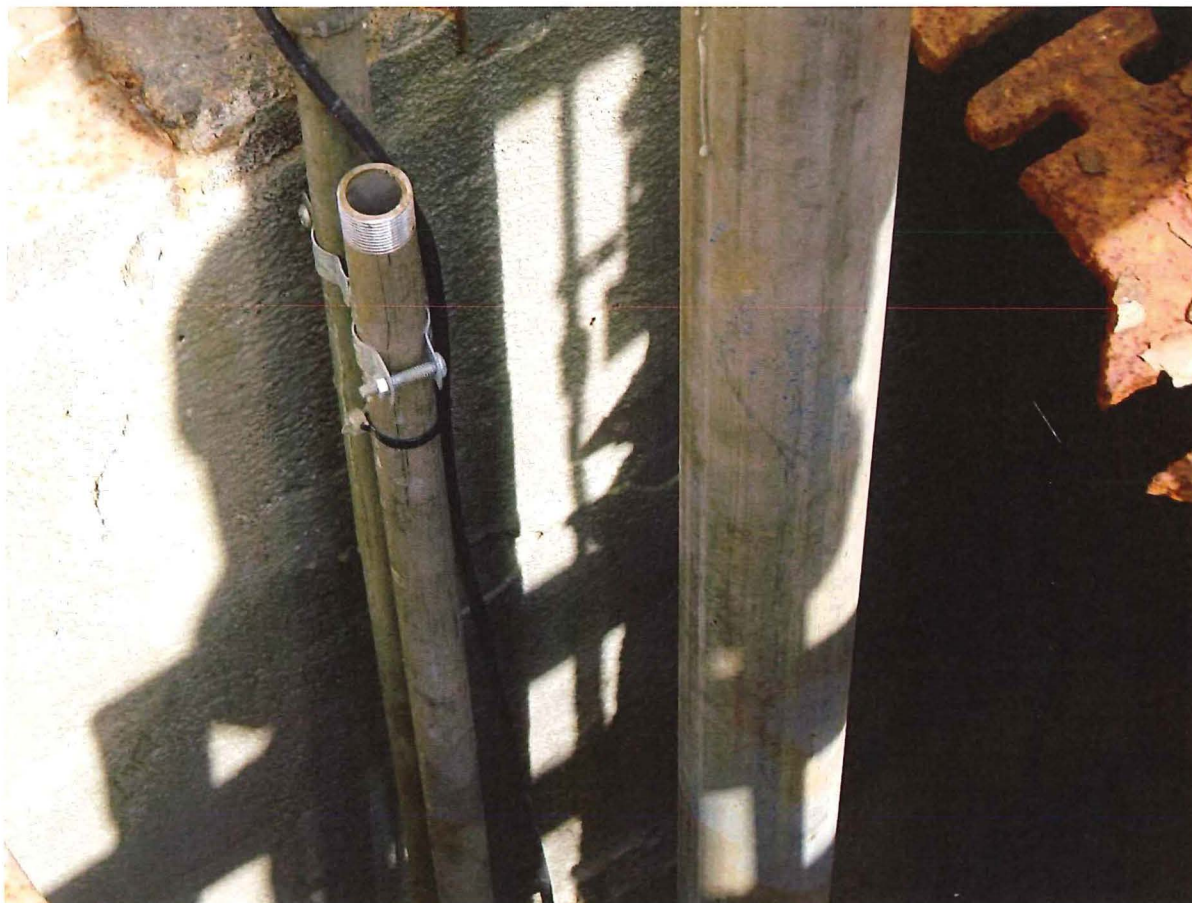
**Picture 9:** Chrome containment trench sump: Picture of high level float

A new high-level alarm will be installed in the chrome trench sump and will be tied into the plant alert/alarm system. The operator will then take the appropriate action in response to an alarm, which may include the shutdown of any process lines if they are contributing to the high level. Maintenance will investigate the cause of the high volumetric level in the trench sump and initiate repairs.

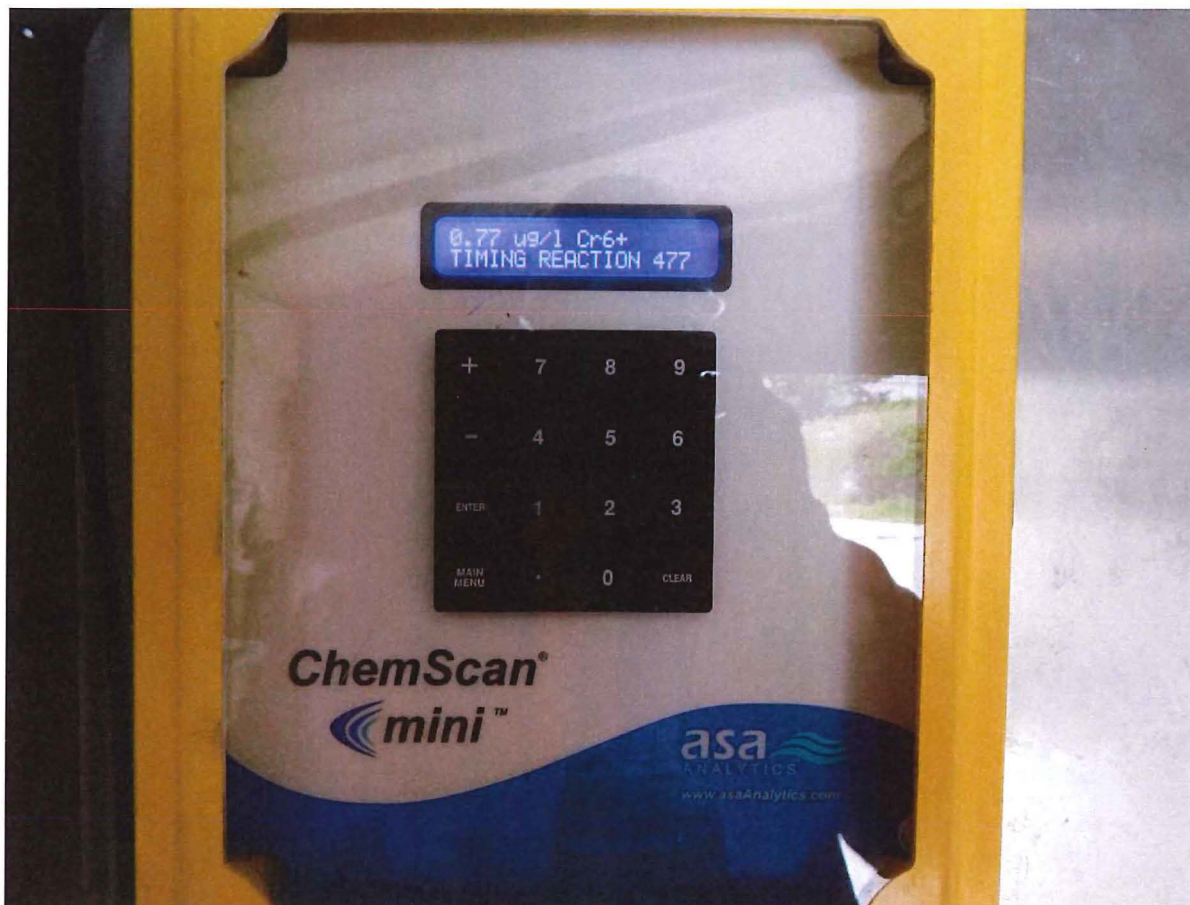
Picture 10: Final treatment plant discharge: Picture of ChemScan unit currently being trialed

The discharge of the Final Treatment Plant will undergo a trial of the ChemScan unit to determine the accuracy in measuring hexavalent chromium presence. The Chemscan unit will be placed at the discharge rather than an upstream location to minimize interferences and perform the measurement on the less contaminated wastewater. The trial will determine the optimal location for the unit.

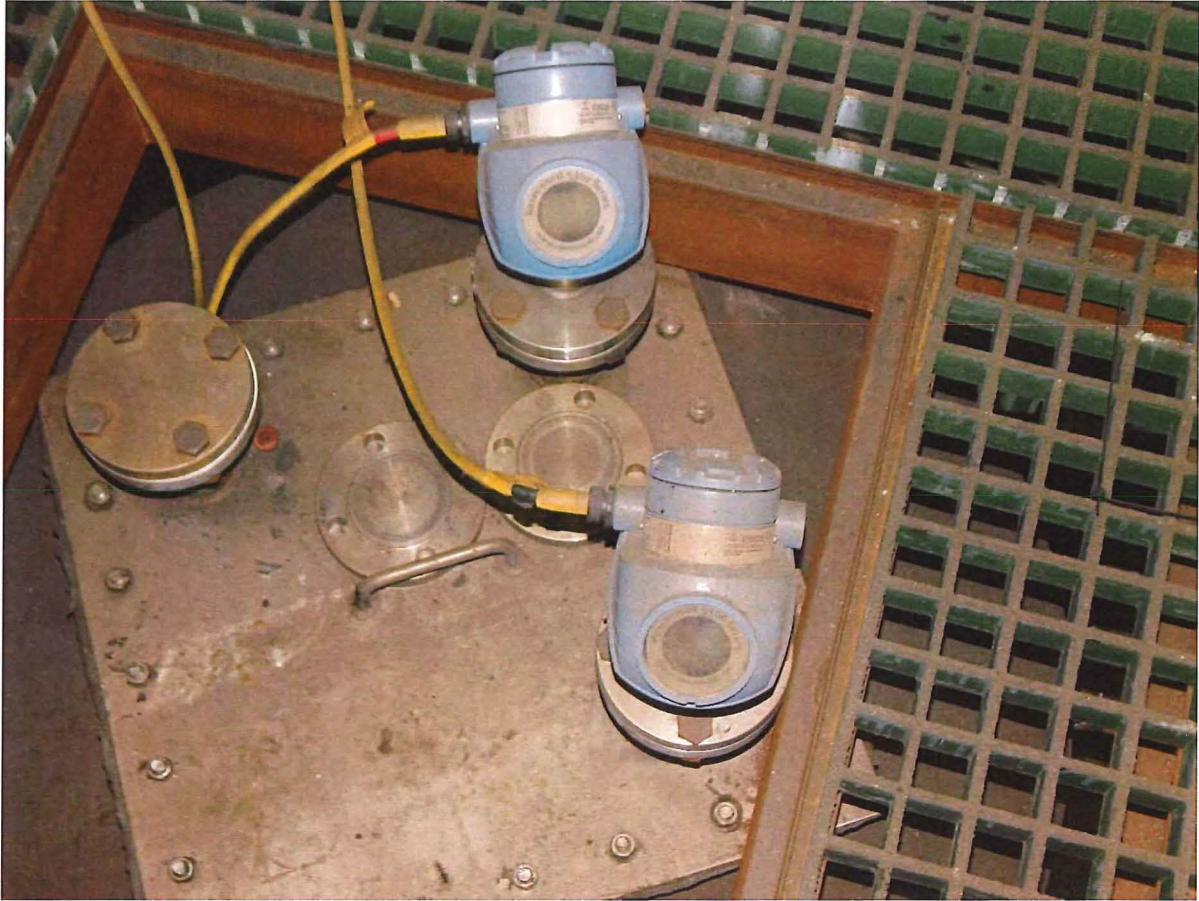
**Picture 11:** Chrome Line Evaporator: Picture of redundant level sensors installed on top of Evaporator

An evaporator for the chrome line will have two new guided wave level sensors installed to replace the current level pressure sensor. Solids buildup on the current level pressure sensor could cause improper level detection and potentially prevent the drain valve from opening and overflow the evaporator to subsequent tanks and on to the chrome basement sump. The new high-level sensors will detect if the volume of process water in the evaporator approaches an overflow condition. The following will automatically occur in response to an alarm:

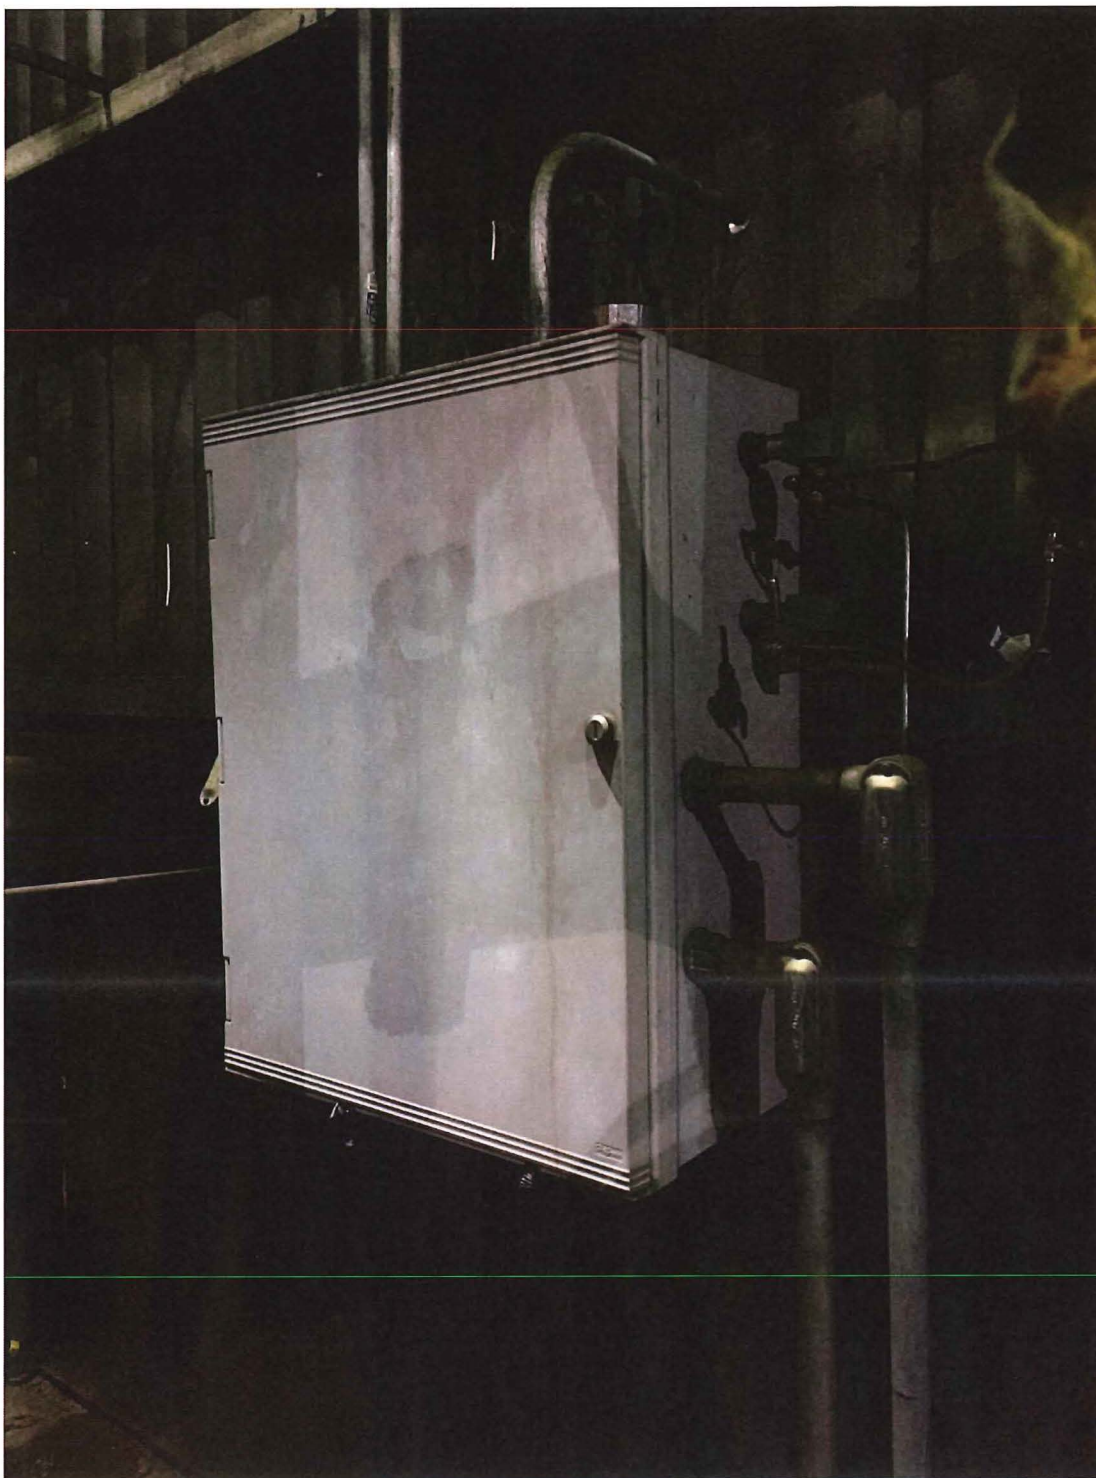
**Picture 12:** Chrome Line Evaporator: Picture of box housing relay installed to open vacuum breaker valve

1. Open the level-control return valve to discharge the solution back to the evaporator feed tank
2. Break the vacuum of suction drawing solution through the evaporator
3. Shut down the feed pumps at the inlet to the evaporator
4. Alert Operations to the problem

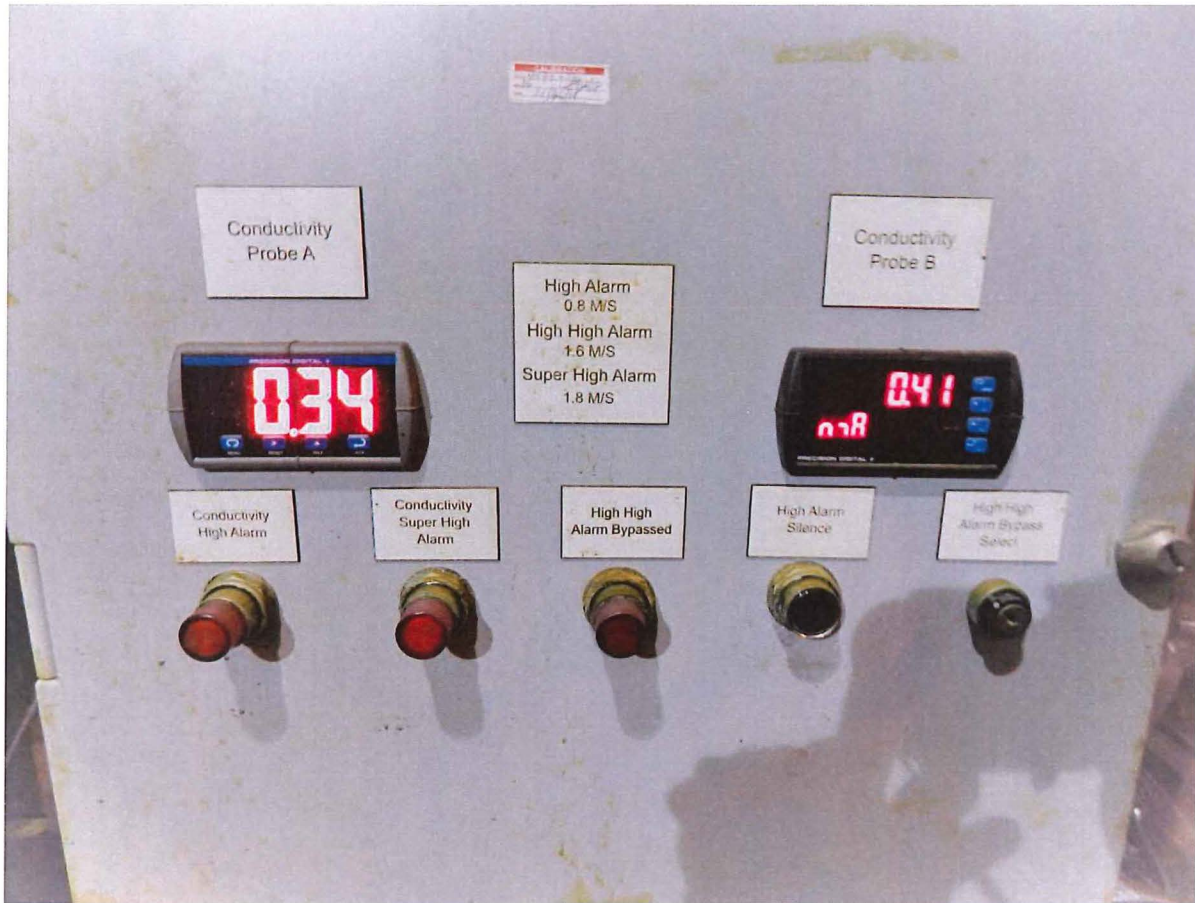
Picture 13: Tin Line Chem Treat Sump: Picture of Conductivity Meter Installed

An inline spare probe will be installed near the sump pumps to provide additional monitoring. The two conductivity probes will be tied to the plant alert/alarm system. The probes will be installed to alarm in the event a process water release is detected. A high concentration will automatically initiate a shutdown of the sump pumps. The appropriate alarm levels will be determined from concentrations above the normal process discharge range. Please see Figure 1 and Figure 2 in Appendix 1 for the location of the Tin Line basement sump.

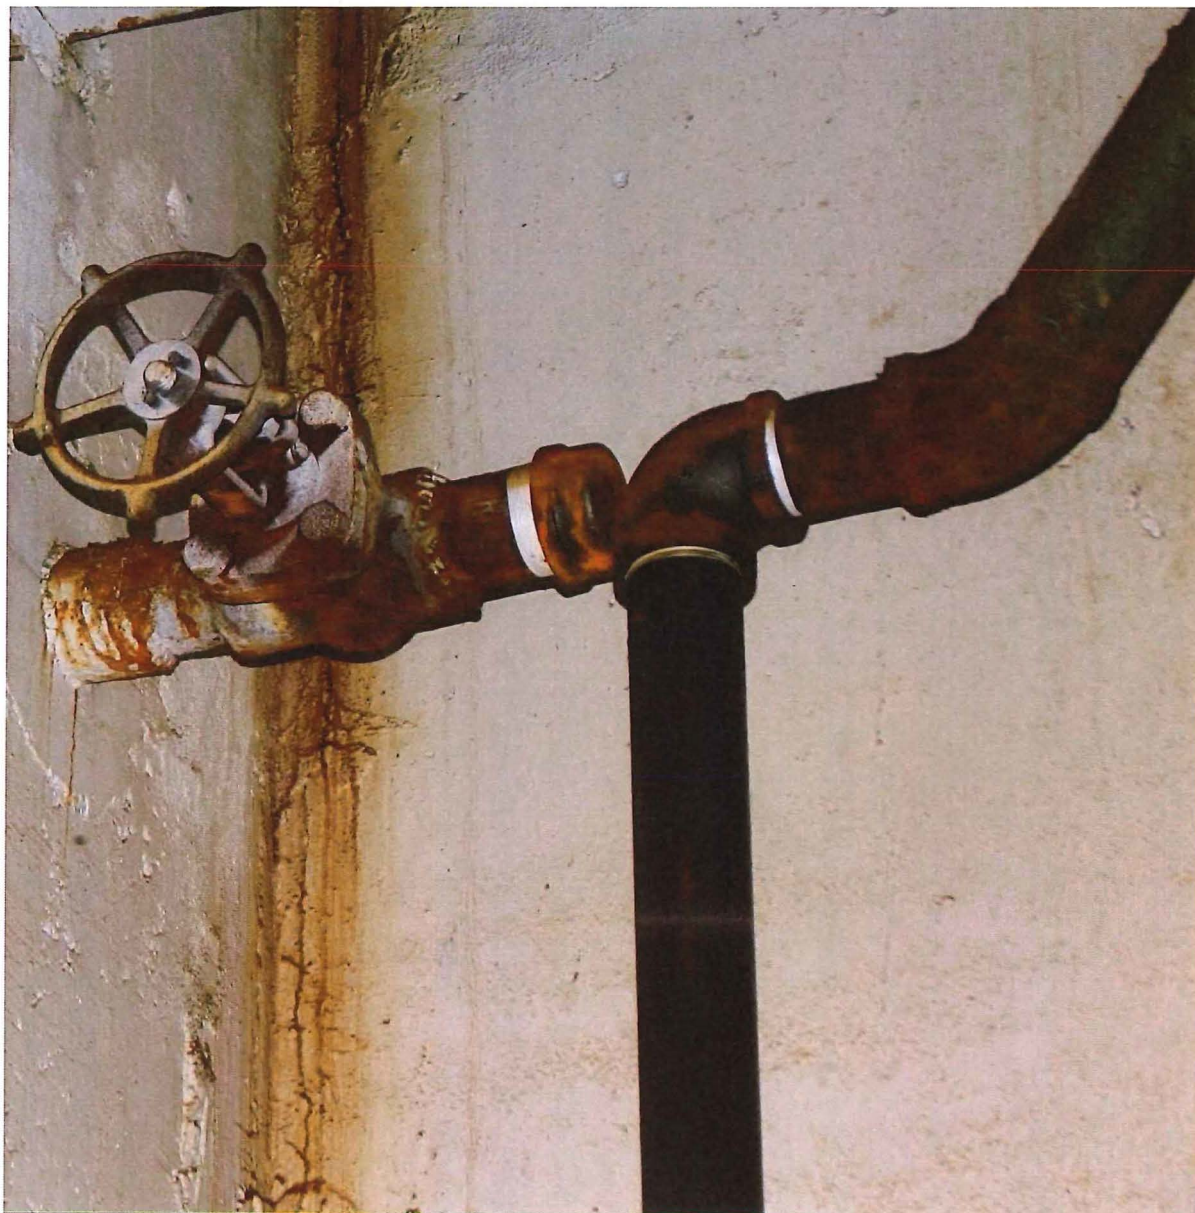
**Picture 14:** Tin Line Looper Pit Sump: Picture of modifications to piping system to eliminate access to DIW

A drain was identified in the delivery looper pit of the Tin Line that discharged to the Final Treatment Plant. Rerouting this drain will ensure that all material collected in the looper pit will be pumped to the chrome treatment plant. Please see Figure 1 and Figure 2 in Appendix 1 for the location of the modified piping from the looper pit.

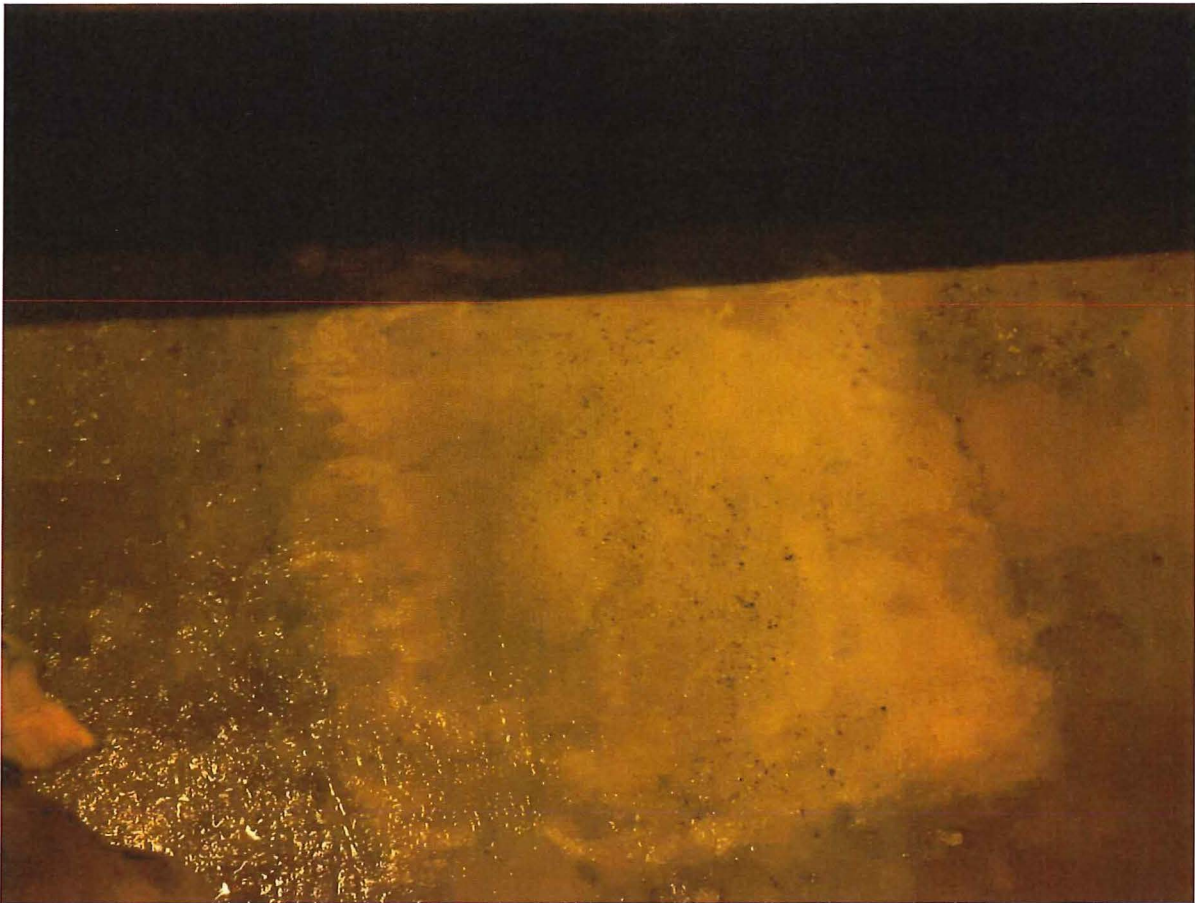
**Picture 15:** Tin Line Annex: Picture of repairs and sealing of DIW vault

The Tin Annex contains an offline pickle cleaning solution (sulfuric acid) and a neat hydrochloric acid tank. Concrete around the top of manhole DIW 19 that discharges to the DIW process sewer has eroded and could allow migration of these acids to the Final Treatment Plant. This manhole in the Tin Annex will be permanently sealed. This will allow any tank leak to be fully contained. A vacuum truck will remove any accumulated material. Please see Figure 1 and Figure 2 in Appendix 1 for the location of manhole DIW 19.

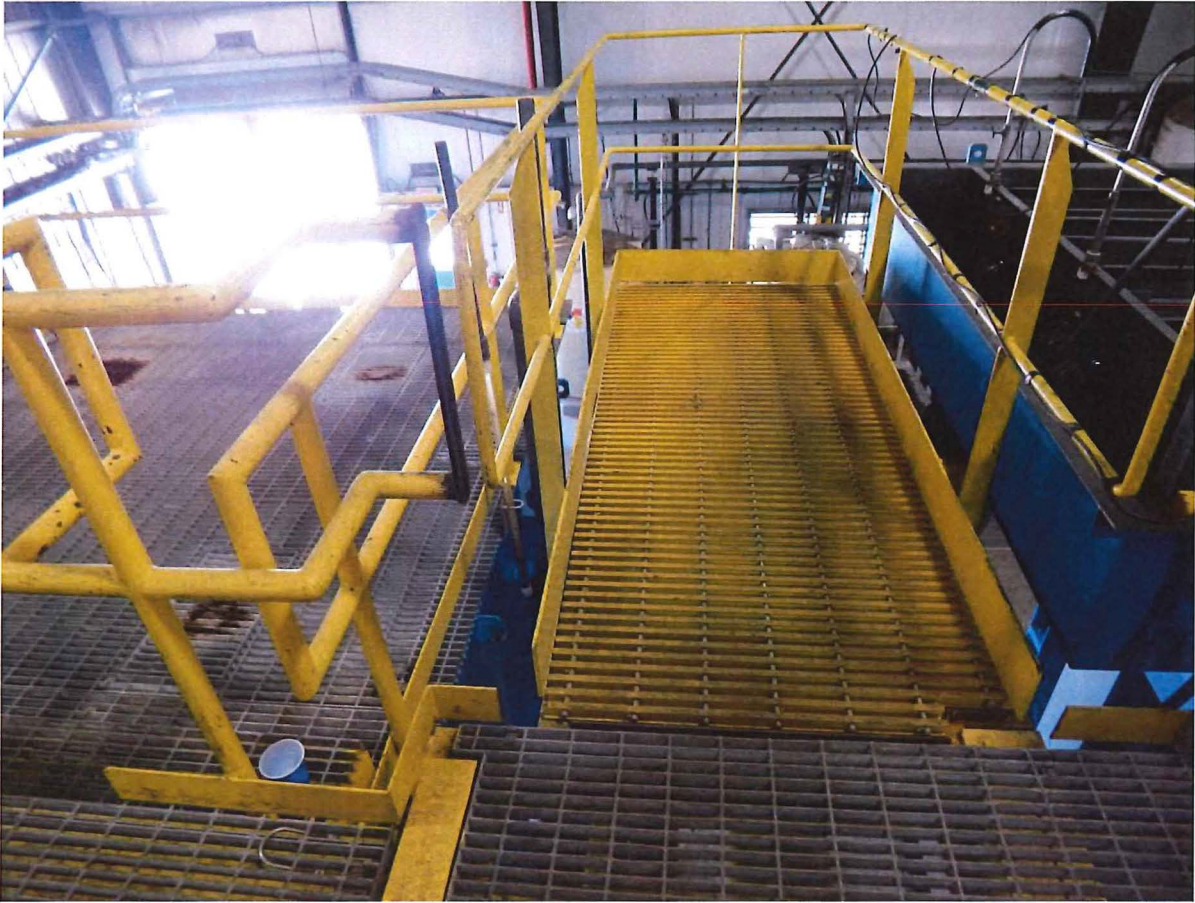
Picture 17: Chrome plant lamellas: Pictures of access platforms installed

The original access points to clean and inspect the lamella plates did not provide a safe access the entire width of the equipment. By adding additional access platforms at the effluent troughs, the operator can now safely perform maintenance and cleaning activities.

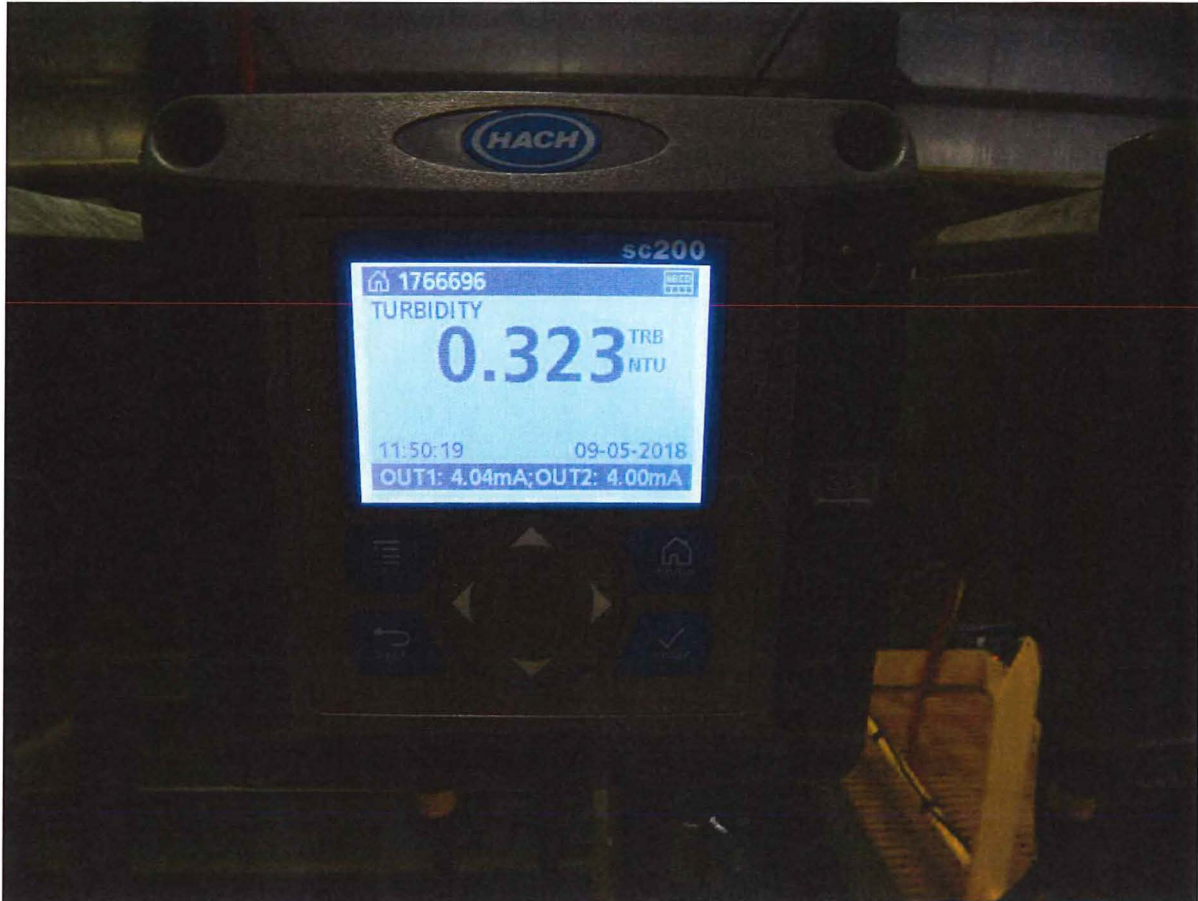
Picture 18: Chrome Plant Lamellas: Picture of Turbidimeter Reading

The lamella plates in the Chrome Plant remove chrome bearing solids from the treatment stream. There are three discharge channels from the separation plates of the lamellas. There was a turbidity probe in only one of the three discharge channels of each train. This prevented detection of solids discharging from the other two channels. Additional inline turbidity meters

were recently installed in the other two channels of each train to measure the solids carryover across all three channels. Each of the six turbidimeters are tied into the plant alert/alarm system and can initiate an alarm independently.
