**United States Steel Corporation  
Midwest Plant  
Portage, Indiana**

**Enhanced Wastewater Process Monitoring Design**

**06-29-2018  
Revised 12/21/2018**

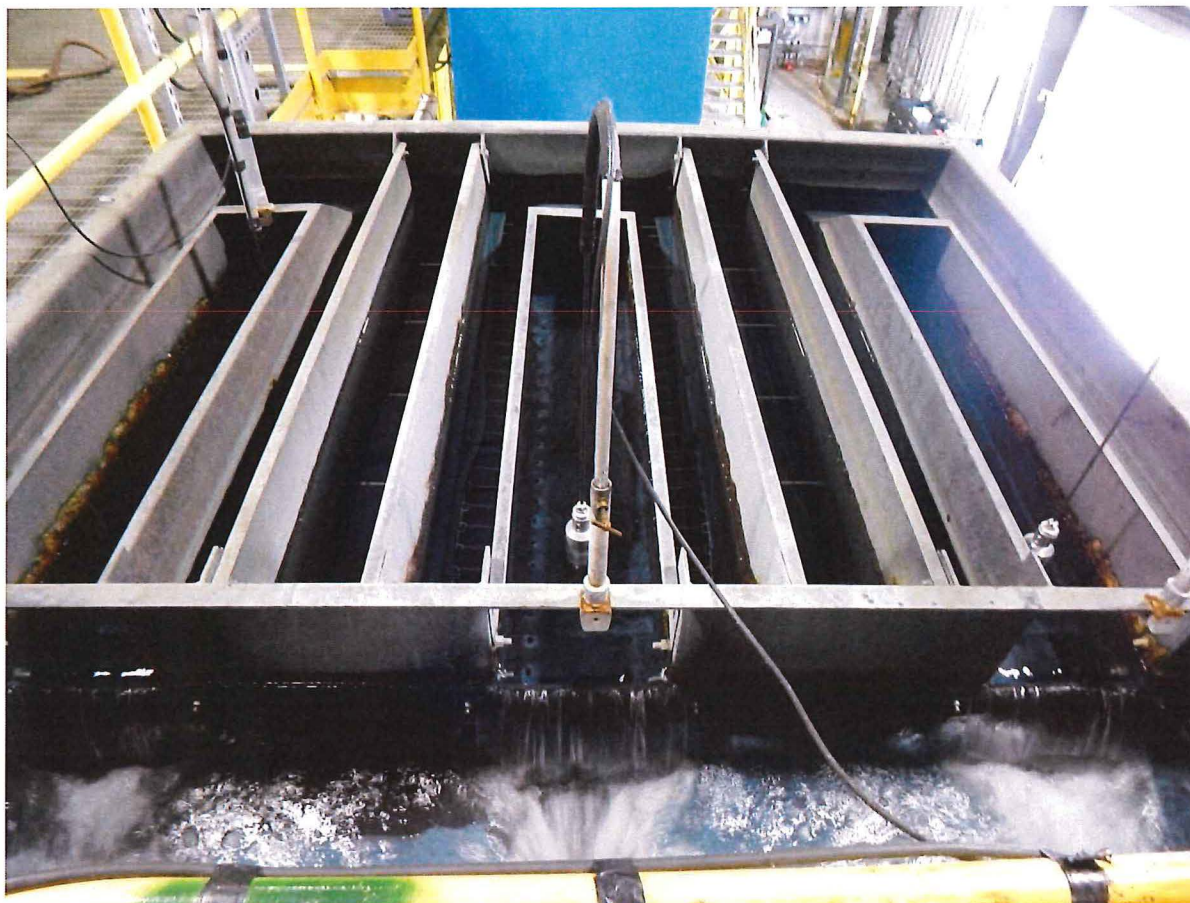
**Picture 19:** Chrome plant lamellas: Pictures of additional turbidimeters

The lamella plates in the Chrome Plant remove chrome bearing solids from the treatment stream. There are three discharge channels from the separation plates of the lamellas. There was a turbidity probe in only one of the three discharge channels of each train. This prevented detection of solids discharging from the other two channels. Additional inline turbidity meters

were recently installed in the other two channels of each train to measure the solids carryover across all three channels. Each of the six turbidimeters are tied into the plant alert/alarm system and can initiate an alarm independently.
