**United States Steel Corporation  
Midwest Plant  
Portage, Indiana**

**Enhanced Wastewater Process Monitoring Design**

**06-29-2018  
Revised 12/21/2018**

## Photographic Summary of Actions Taken by U. S. Steel Pursuant to the Midwest Consent Decree

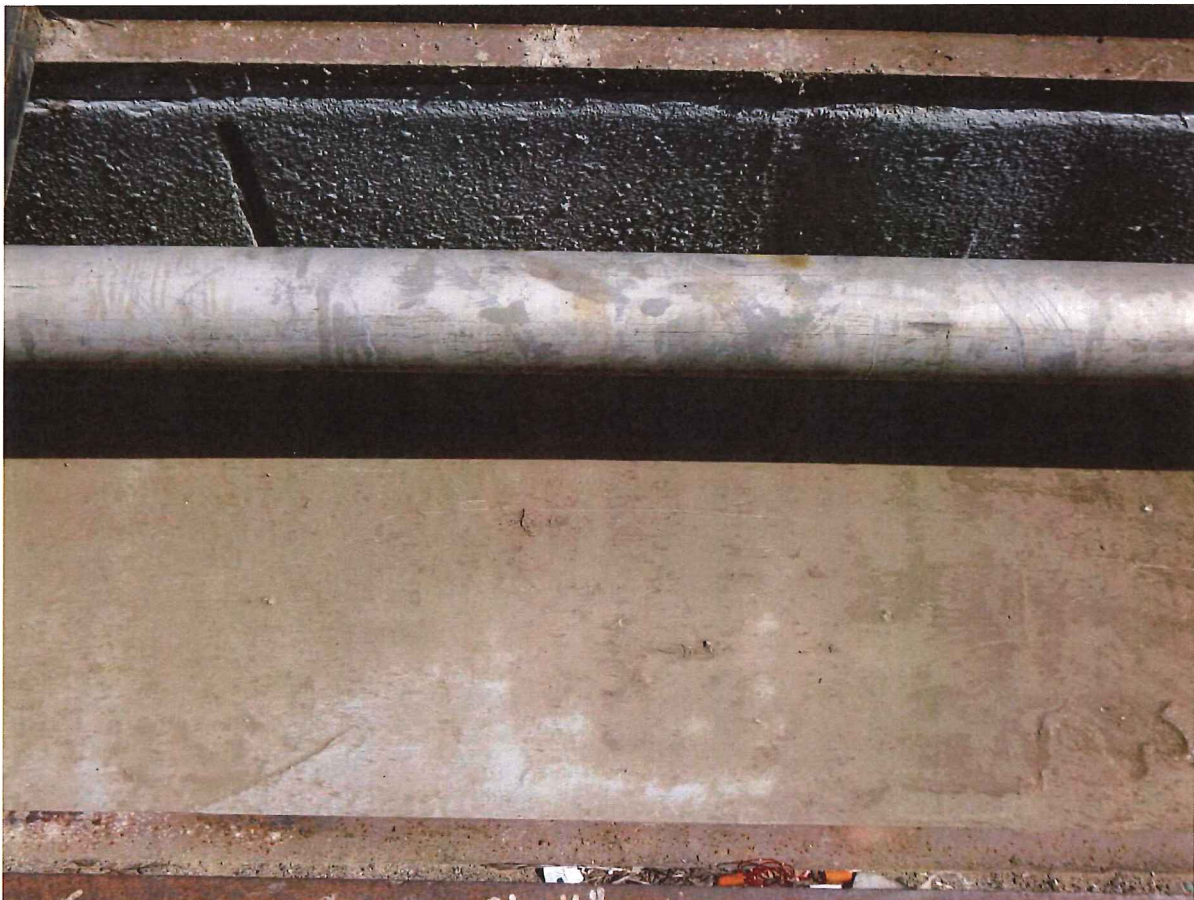
**Picture 1:** This picture shows the work performed pursuant to Consent Decree Paragraph 9.a.i., 9.a.ii., 9.a.iii., and 9.a.iv.

To address the integrity of the containment trench for the chrome process wastewater piping, the trench was cleaned, and new concrete bottom poured. The trench slope was reestablished to direct any flow in the trench to the chrome trench sump. Please see Figure 1 and Figure 2 in Appendix 1 for the location of the trench.

A protective epoxy coating was installed over all of the concrete in the trench. A total of three layers were installed. The inner-most primer layer is for proper bonding, then a coating of a chemical resistance epoxy applied in 2 layers to establish a thickness for better service wear. The epoxy coating is chemically compatible with the process water and will prevent deterioration of the concrete.

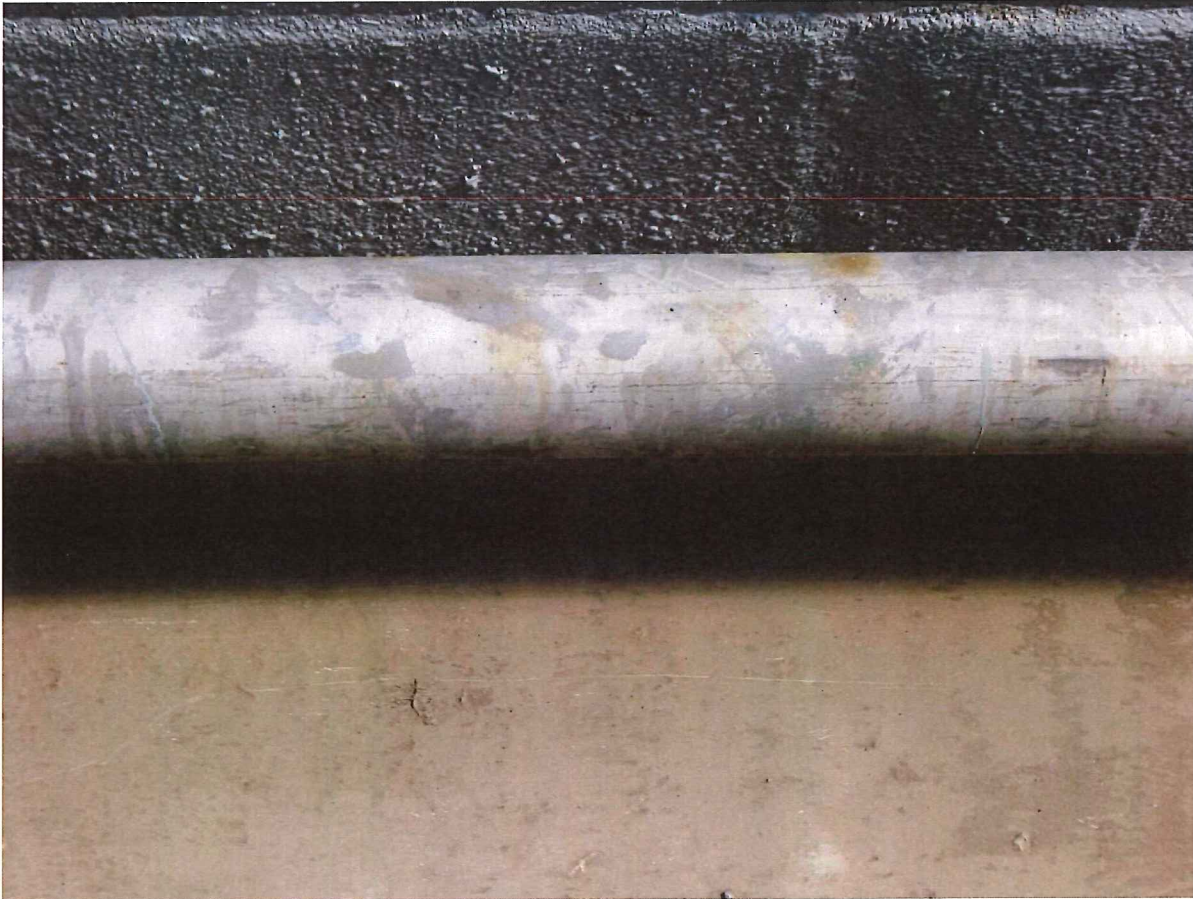
**Picture 2:** This picture shows the work performed pursuant to Consent Decree Paragraph 9.a.i., 9.a.ii., 9.a.iii., and 9.a.iv.

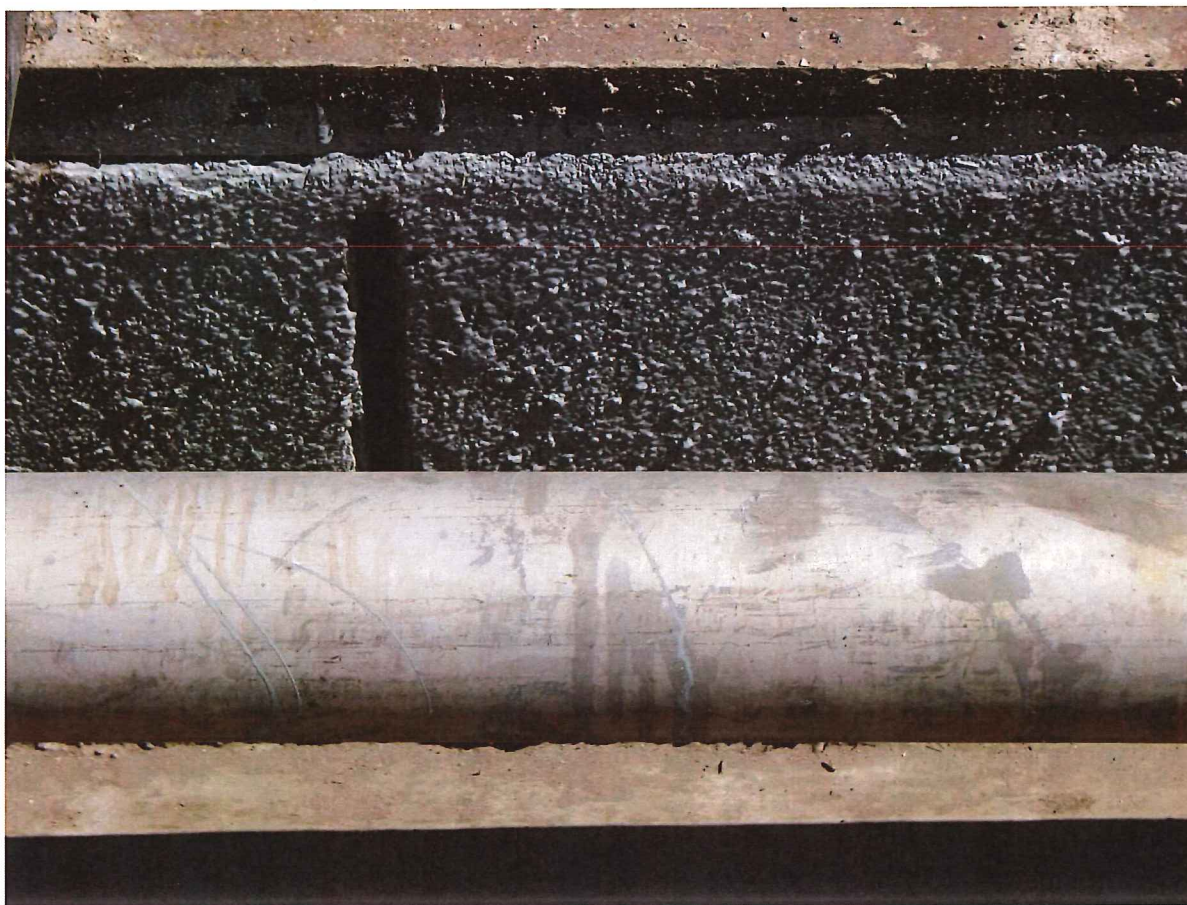
**Picture 3:** This picture shows the work performed pursuant to Consent Decree Paragraph 9.a.iv.

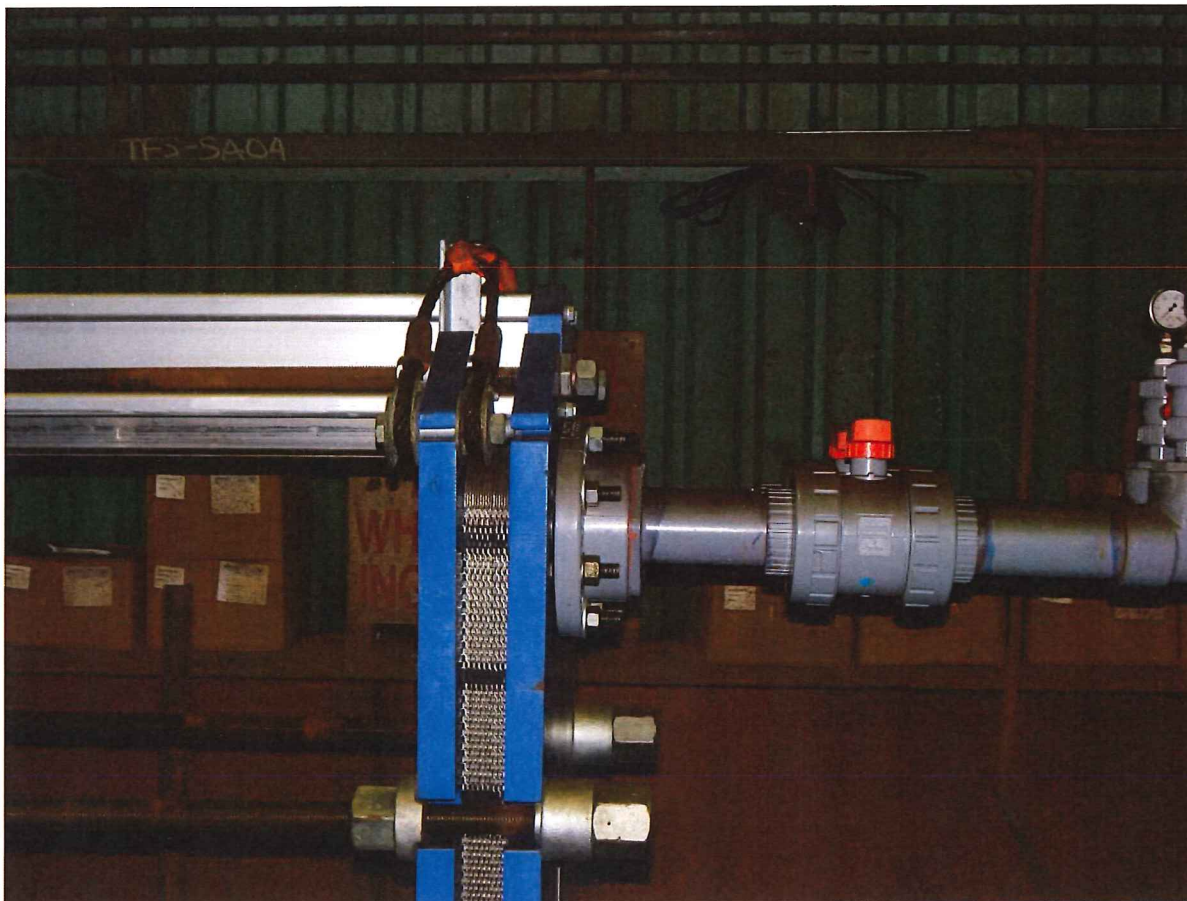
**Picture 4:** This picture shows newly installed double walled heat exchanger on January 15, 2018 pursuant to Consent Decree Paragraph 9.v.

A single wall plate and frame heat exchanger on the Chrome Line Plater section, and two spiral heat exchangers on the Chrome Line ChemTreat section were replaced with double wall plate and frame heat exchangers. The double wall heat exchangers significantly reduce the likelihood of process water leaking into the non-contact cooling water.

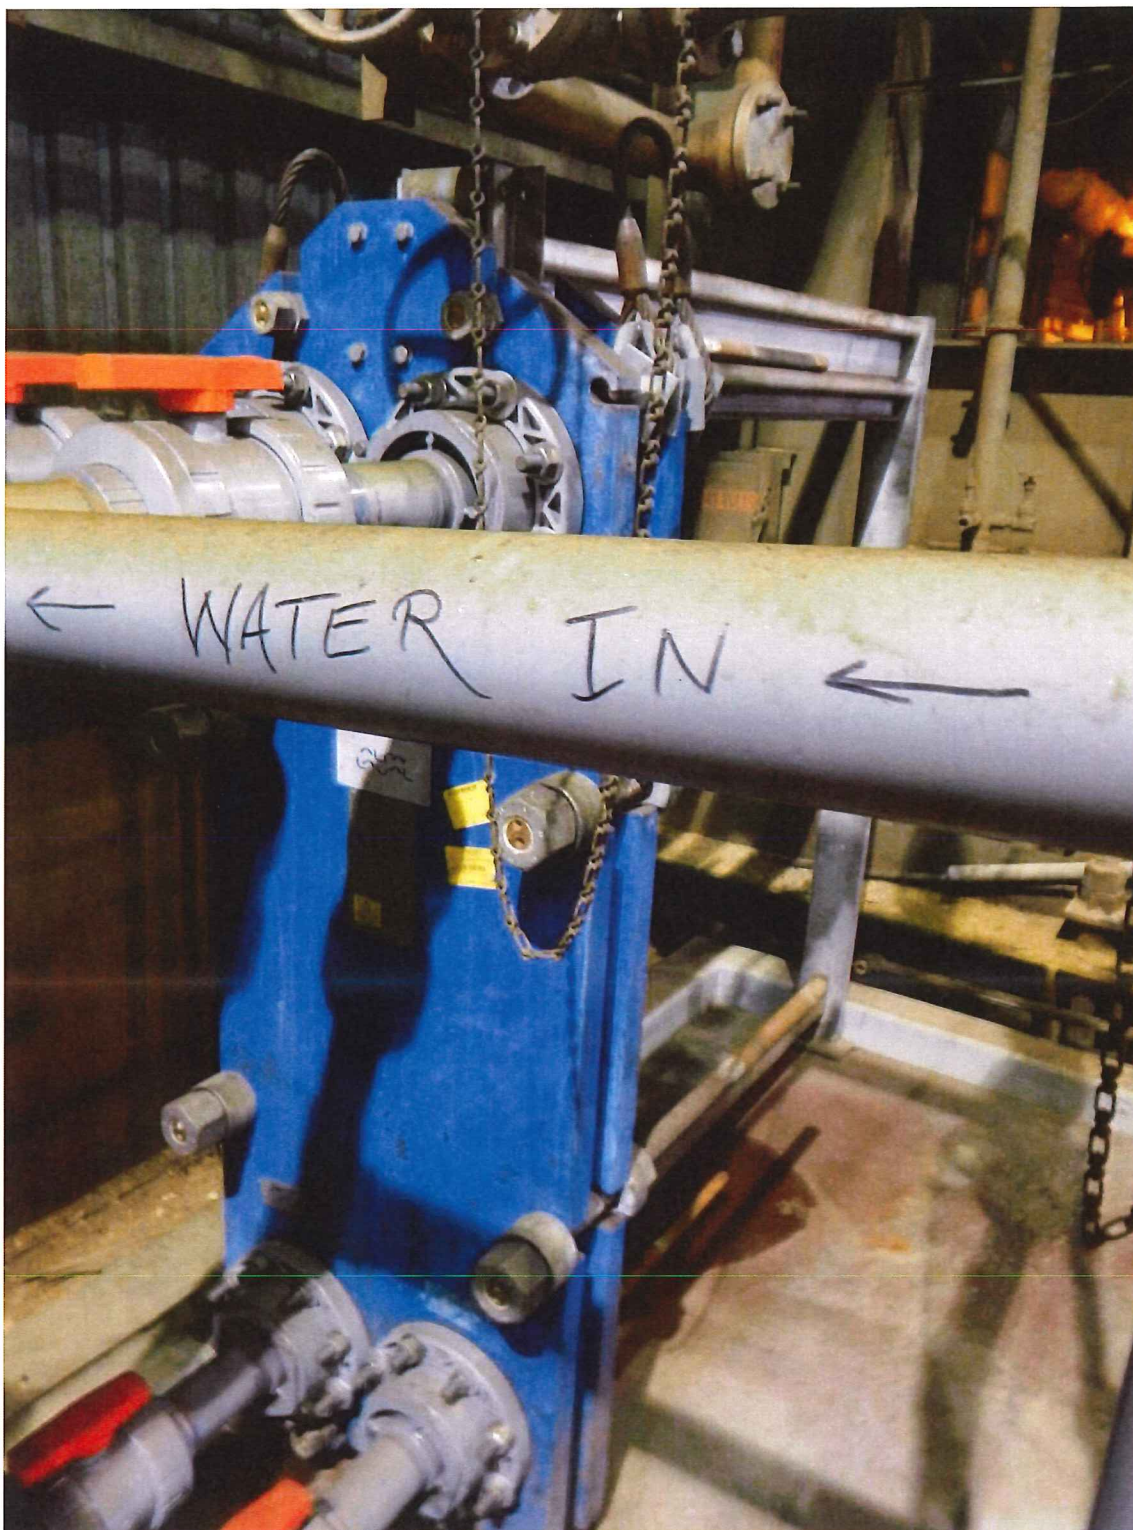
**Picture 5:** This picture shows the newly installed back up double walled heat exchanger pursuant to the Enhancend Wastewater Process Monitoring Design

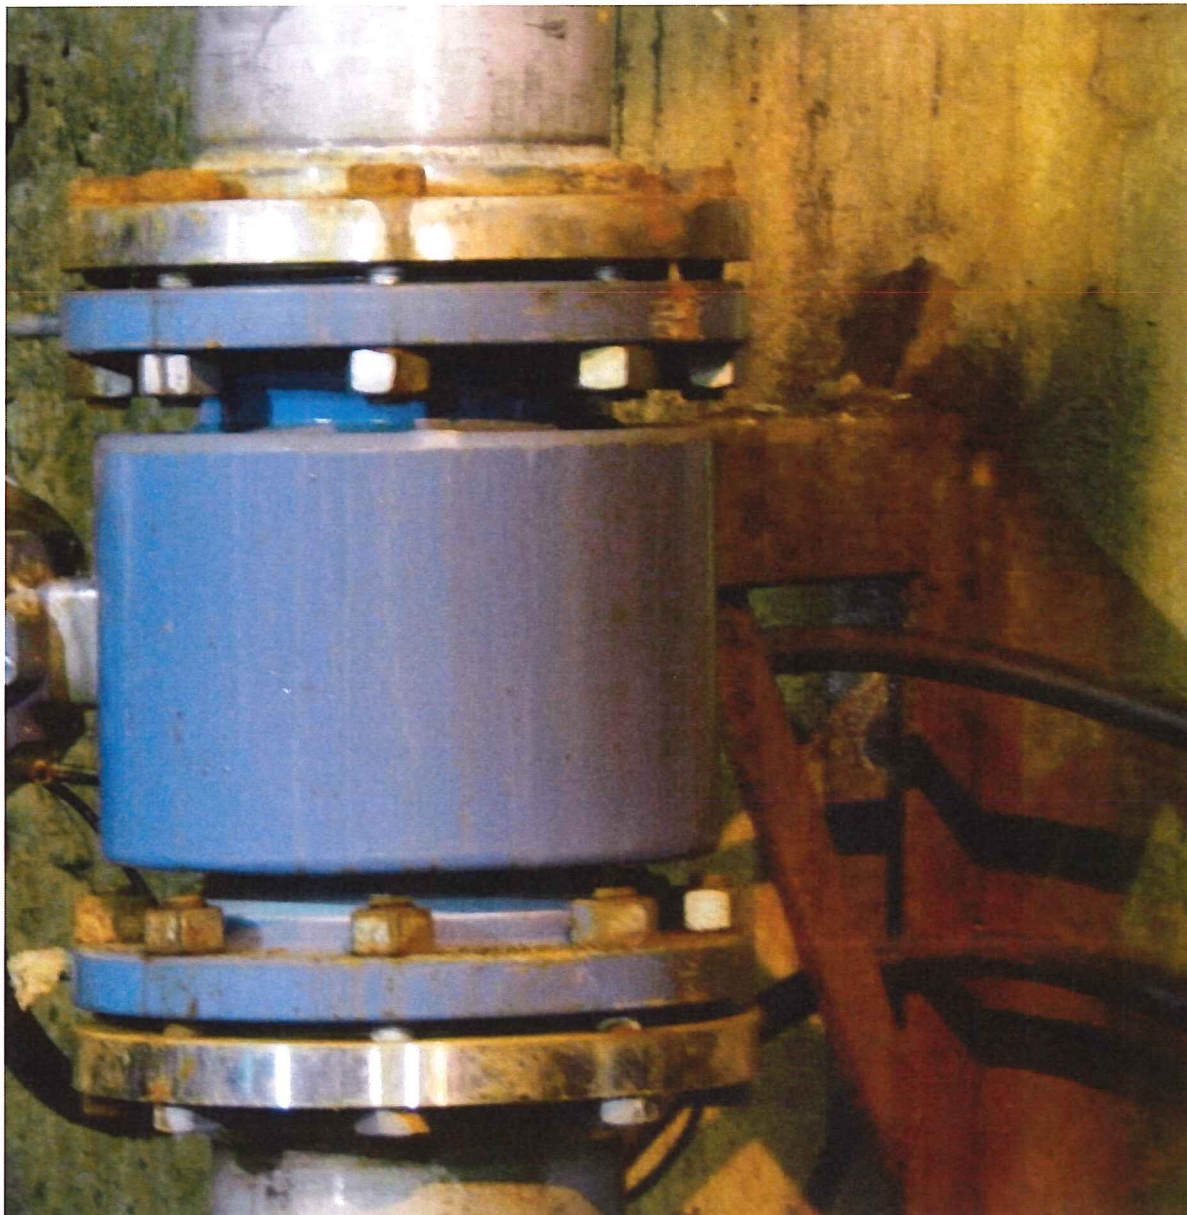
**Picture 6:** Chrome containment trench: pictures of inlet flow meter on chrome transfer pipeline

Two flow meters were installed at the inlet and outlet areas of the chrome plant influent wastewater piping. The pipe entry flow meter is located just after the combining of chrome wastewater flows from the Tin and Chrome Lines basement sumps and the pipe delivery flow meter is located just prior to discharge into the chrome plant equalization tank. Both installation locations were selected to minimize any hydraulic effects that may contribute towards accuracy errors. The pipeline is continuous and does not have any tie-ins along the length between the flow meters. Please see Figure 1 and Figure 2 in Appendix 1 for the location of the pipe entry and pipe delivery flow meters.

Rosemount flow meters are installed at the entry and exit of the chrome plant influent wastewater piping. Due to the line and pump configuration, the flow at each meter location varies, but the meters trend together. These meters would detect a line failure. Other methods are employed to detect leaks including conductivity metering in key locations, periodic sampling and inspection.

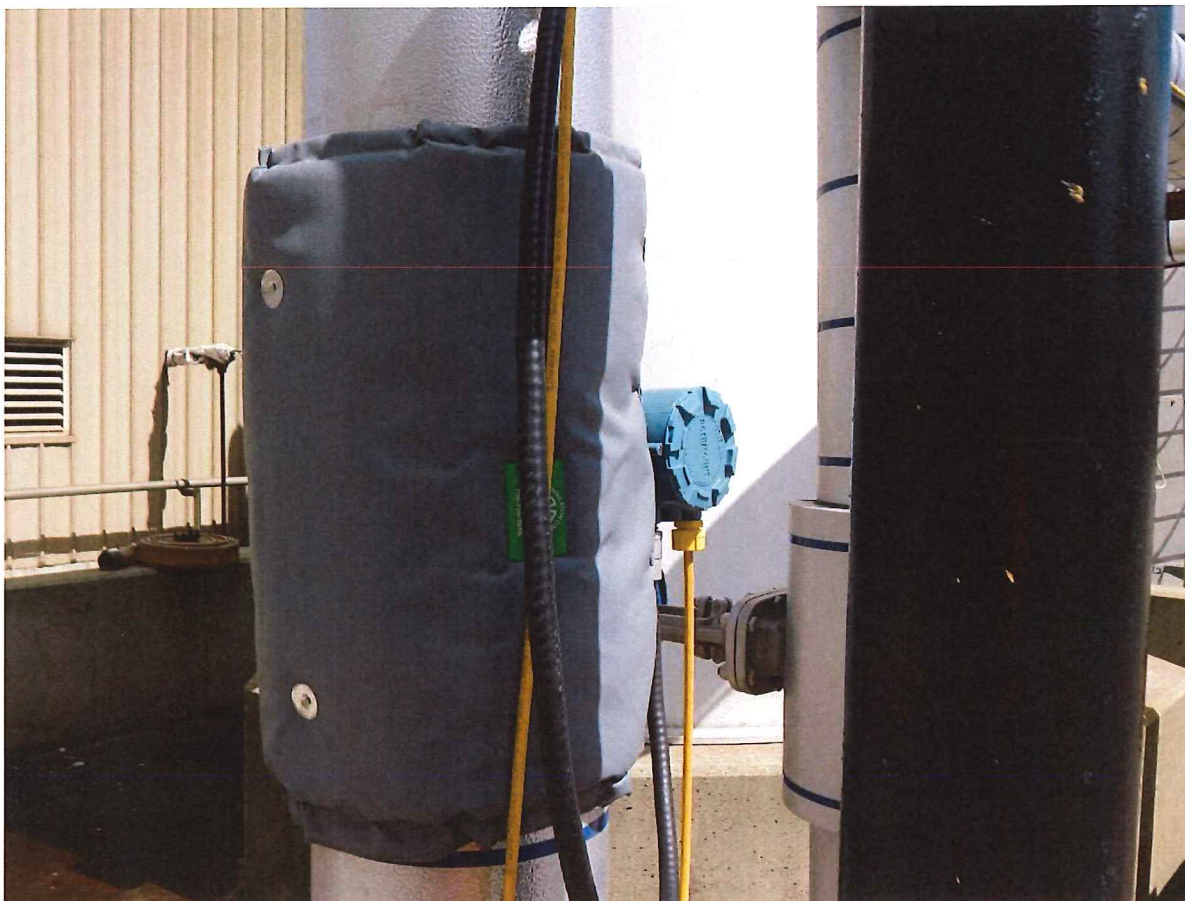
**Picture 7:** Chrome containment trench: pictures of outlet flow meter on chrome transfer pipeline

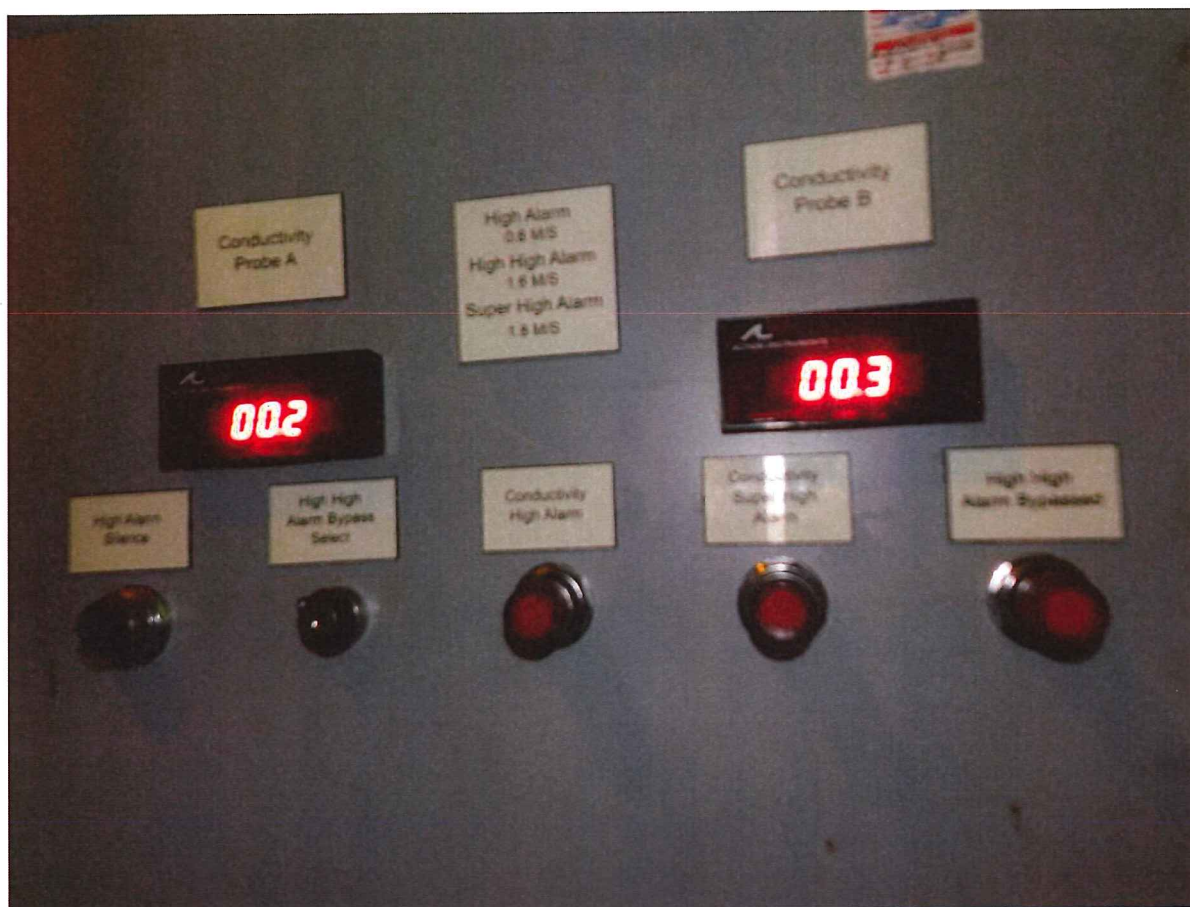
**Picture 8:** Chrome Line Plater: picture of conductivity probes installed

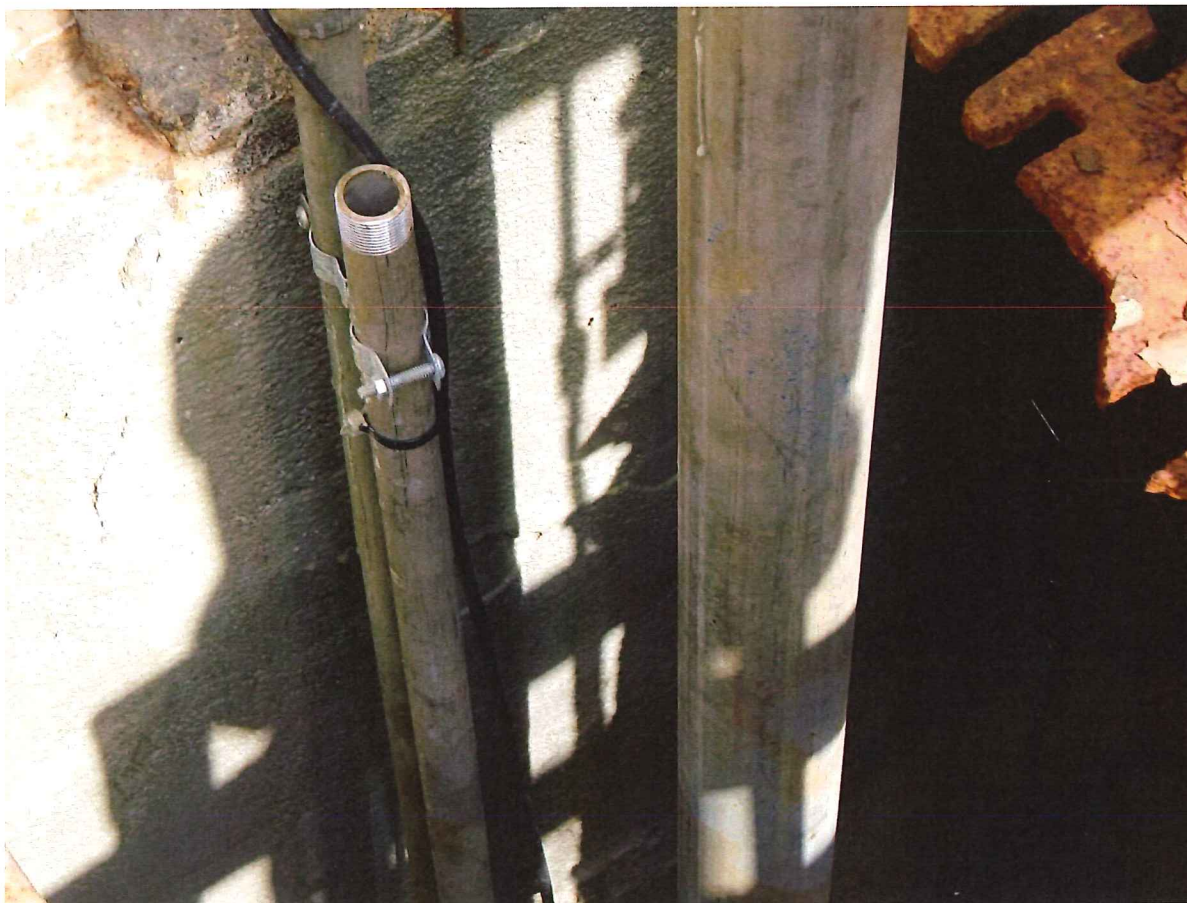
**Picture 9:** Chrome containment trench sump: Picture of high level float

A new high-level alarm will be installed in the chrome trench sump and will be tied into the plant alert/alarm system. The operator will then take the appropriate action in response to an alarm, which may include the shutdown of any process lines if they are contributing to the high level. Maintenance will investigate the cause of the high volumetric level in the trench sump and initiate repairs.

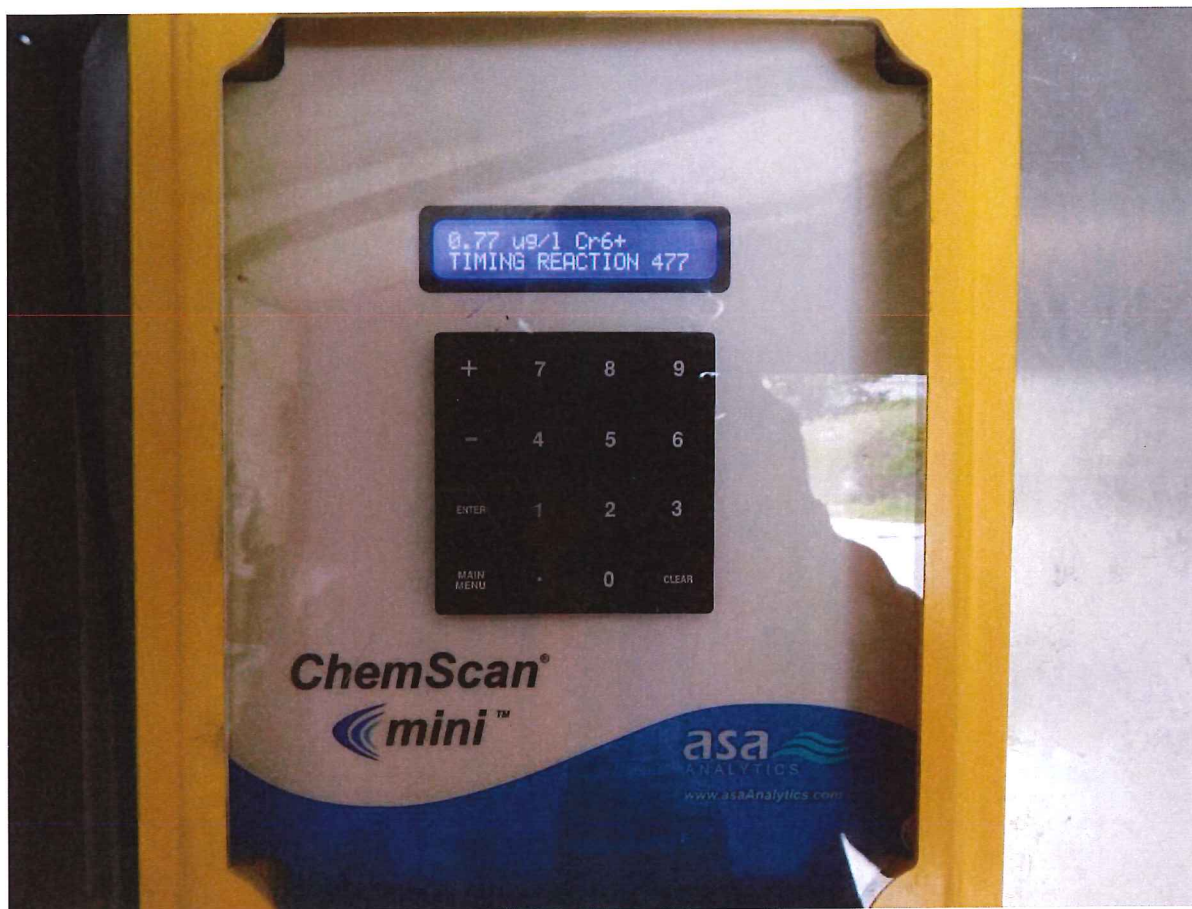
Picture 10: Final treatment plant discharge: Picture of ChemScan unit currently being trialed

U. S. Steel then contacted ASA Analytics (ASA) to begin a trial of a ChemScan® mini process analyzer (ChemScan). The trial began with bench scale testing in the ASA laboratory using samples from the Midwest Plant Chrome Treatment Plant discharge, Final Treatment discharge, and non-contact cooling water from the Chemtreat and Plater section heat exchangers of the Chrome Process Line. The ChemScan unit's larger sample ports did not experience plugging, and the concentration in the samples other than the Chrome Plant discharge well-matched third party analytical concentration tests. The Chrome Plant may be experiencing interferences that continue to be investigated.

The discharge of the Final Treatment Plant will undergo a trial of the ChemScan unit to determine the accuracy in measuring hexavalent chromium presence. The Chemscan unit will be placed at the discharge rather than an upstream location to minimize interferences and perform the measurement on the less contaminated wastewater. The trial will determine the optimal location for the unit.

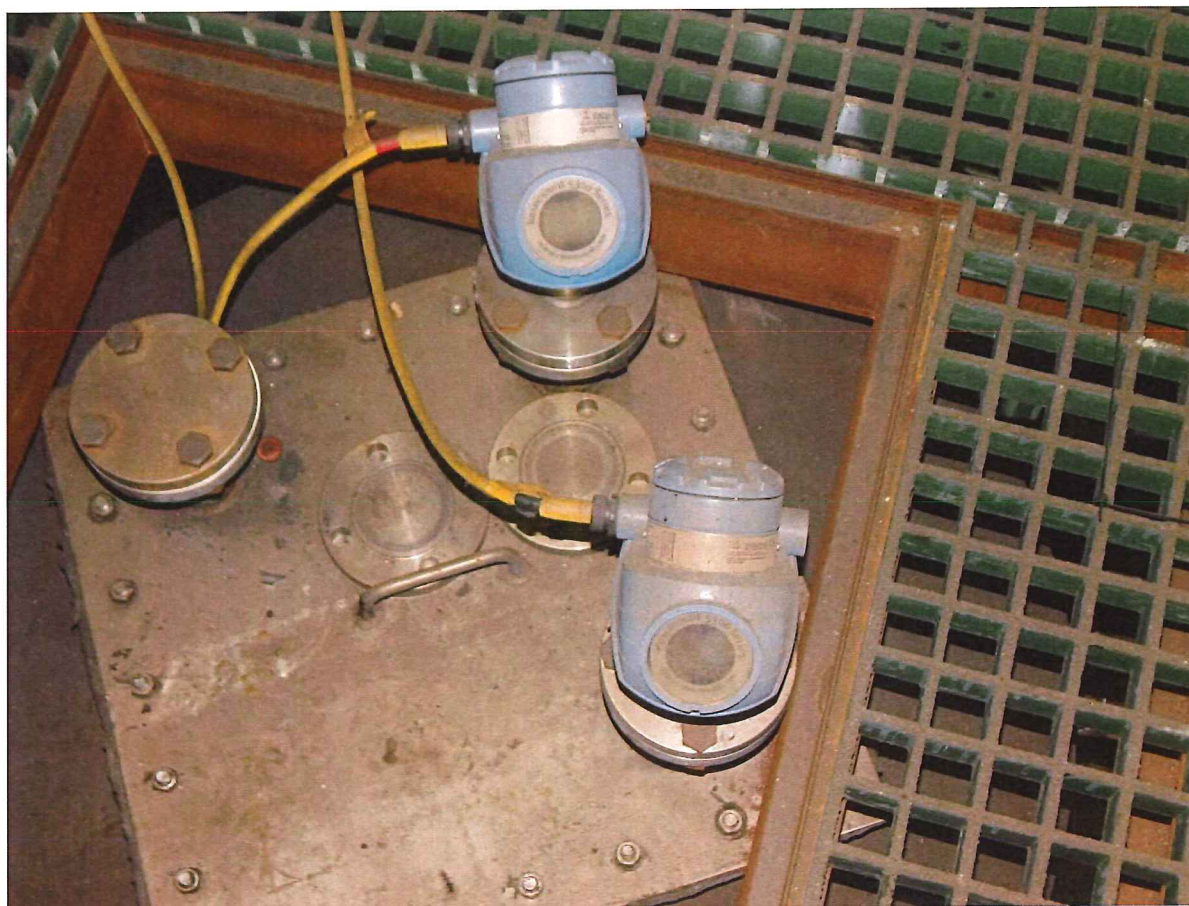
**Picture 11:** Chrome Line Evaporator: Picture of redundant level sensors installed on top of Evaporator

An evaporator for the chrome line will have two new guided wave level sensors installed to replace the current level pressure sensor. Solids buildup on the current level pressure sensor could cause improper level detection and potentially prevent the drain valve from opening and overflow the evaporator to subsequent tanks and on to the chrome basement sump. The new high-level sensors will detect if the volume of process water in the evaporator approaches an overflow condition. The following will automatically occur in response to an alarm:

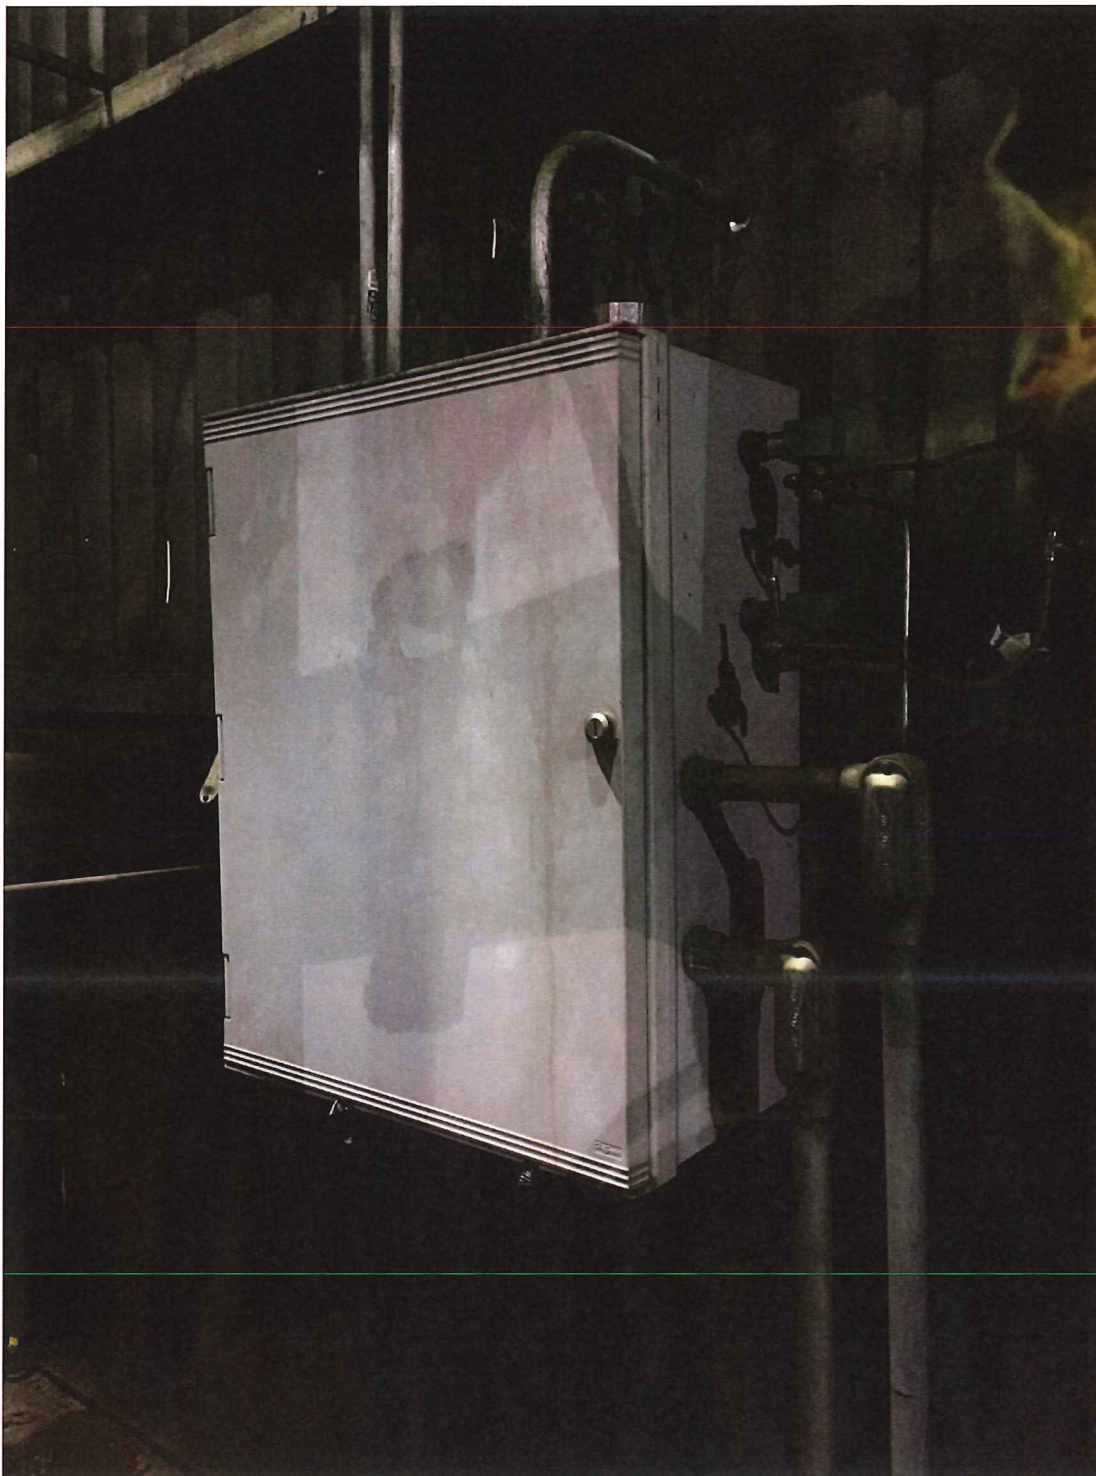
**Picture 12:** Chrome Line Evaporator: Picture of box housing relay installed to open vacuum breaker valve

1. Open the level-control return valve to discharge the solution back to the evaporator feed tank
2. Break the vacuum of suction drawing solution through the evaporator
3. Shut down the feed pumps at the inlet to the evaporator
4. Alert Operations to the problem

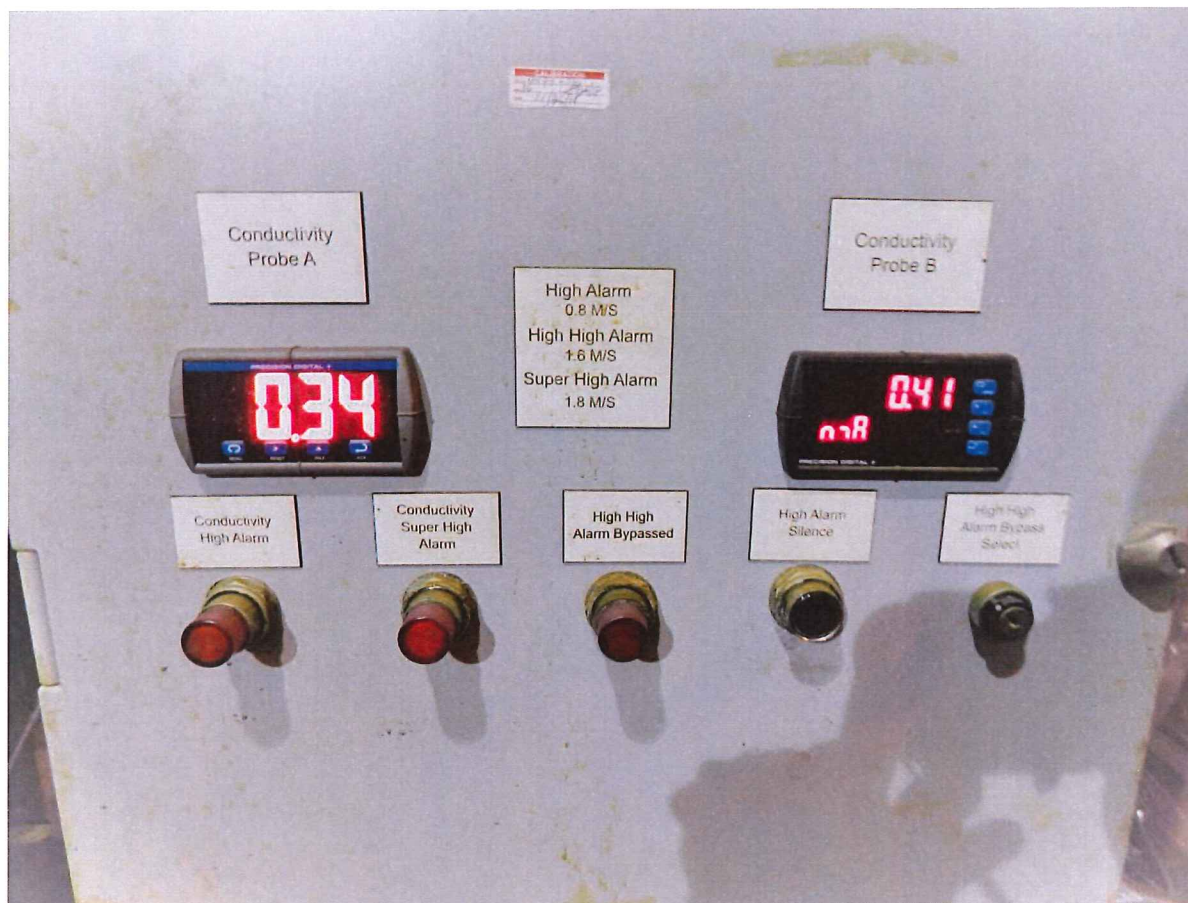
Picture 13: Tin Line Chem Treat Sump: Picture of Conductivity Meter Installed

An inline spare probe will be installed near the sump pumps to provide additional monitoring. The two conductivity probes will be tied to the plant alert/alarm system. The probes will be installed to alarm in the event a process water release is detected. A high concentration will automatically initiate a shutdown of the sump pumps. The appropriate alarm levels will be determined from concentrations above the normal process discharge range. Please see Figure 1 and Figure 2 in Appendix 1 for the location of the Tin Line basement sump.

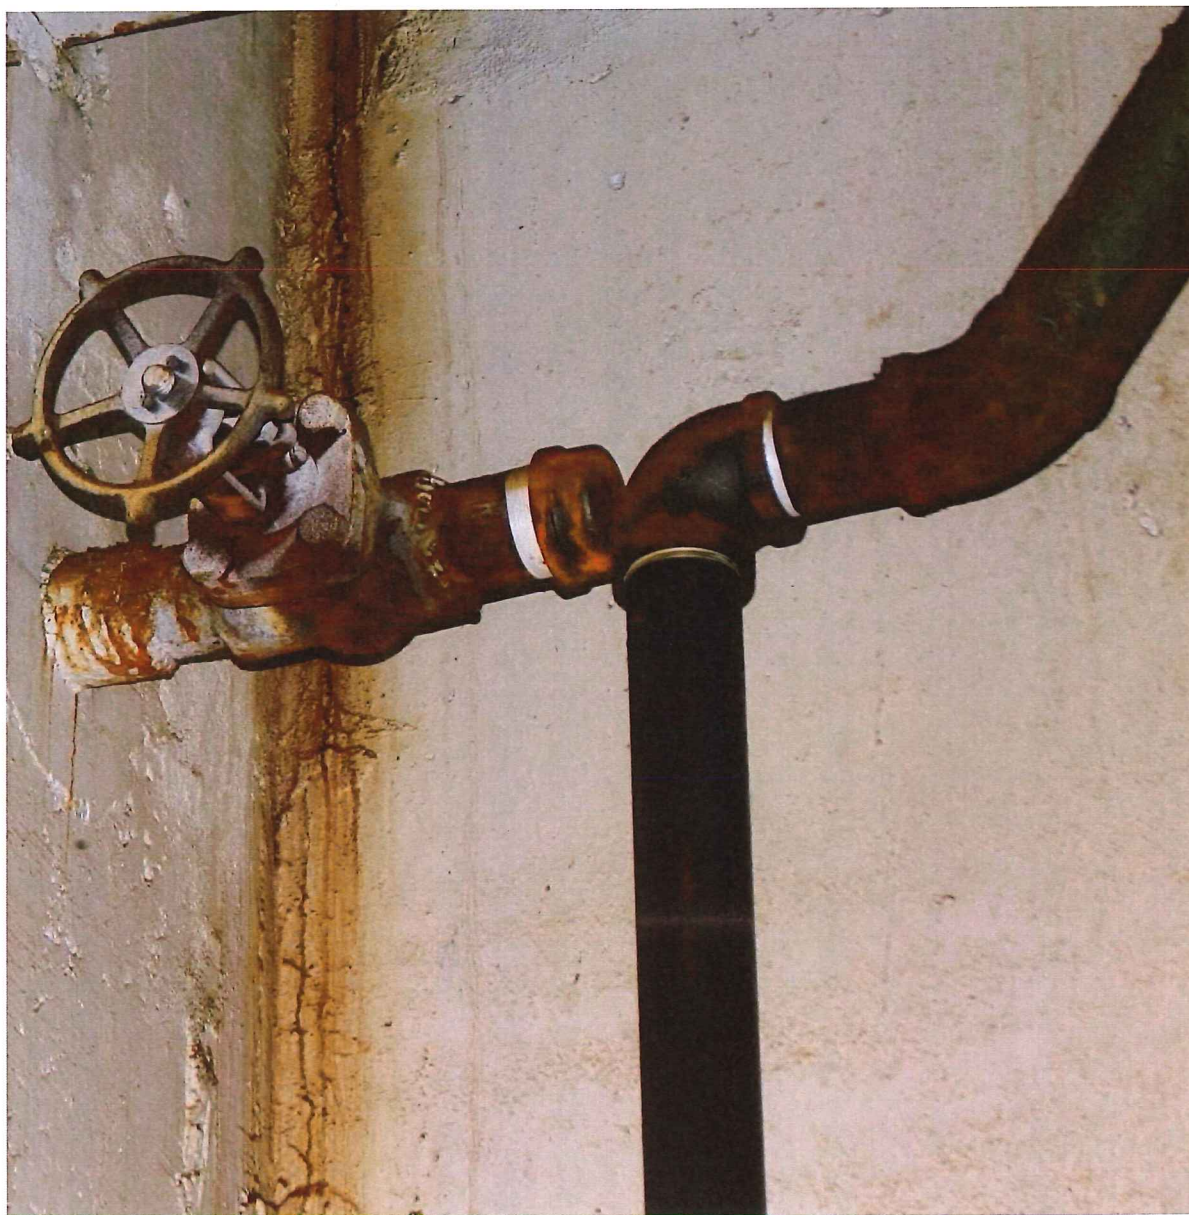
**Picture 14:** Tin Line Looper Pit Sump: Picture of modifications to piping system to eliminate access to DIW

A drain was identified in the delivery looper pit of the Tin Line that discharged to the Final Treatment Plant. Rerouting this drain will ensure that all material collected in the looper pit will be pumped to the chrome treatment plant. Please see Figure 1 and Figure 2 in Appendix 1 for the location of the modified piping from the looper pit.

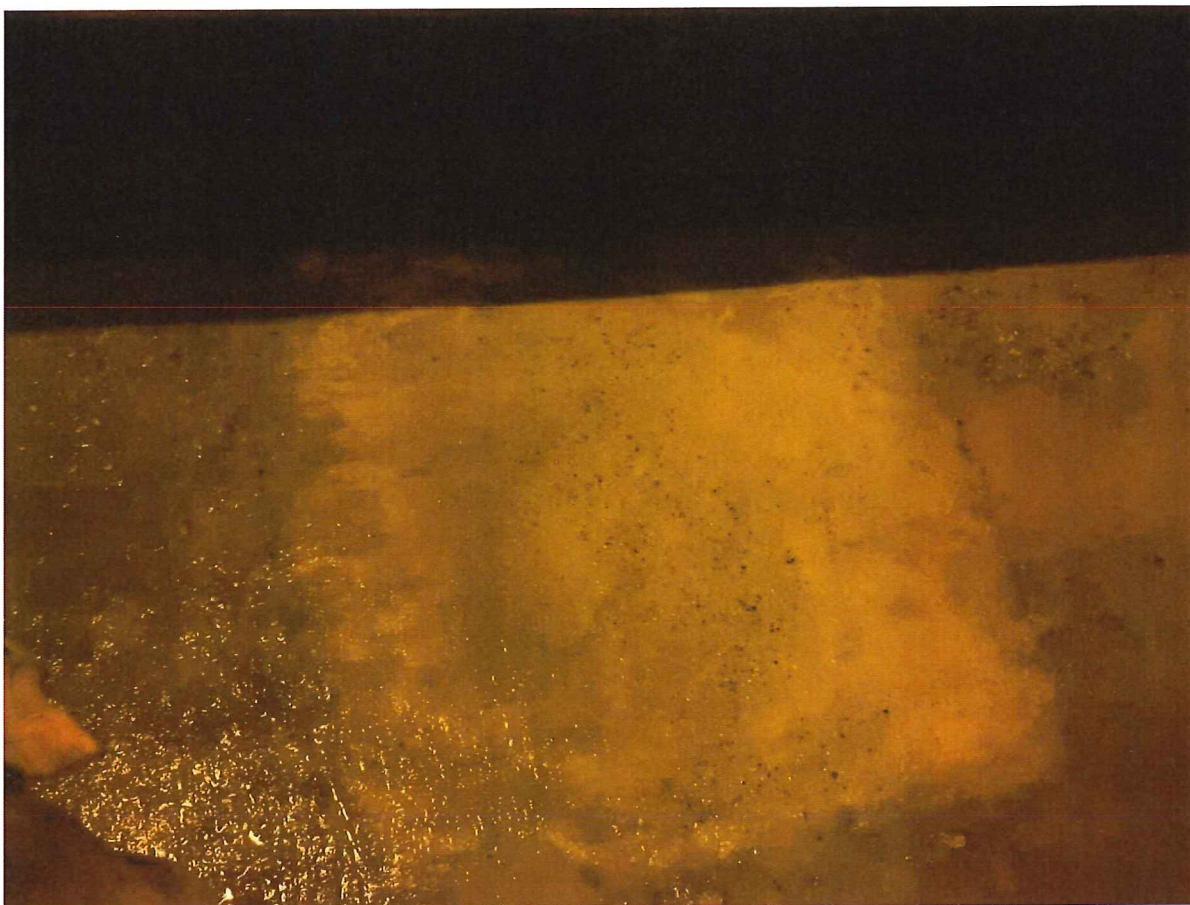
**Picture 15:** Tin Line Annex: Picture of repairs and sealing of DIW vault

The Tin Annex contains an offline pickle cleaning solution (sulfuric acid) and a neat hydrochloric acid tank. Concrete around the top of manhole DIW 19 that discharges to the DIW process sewer has eroded and could allow migration of these acids to the Final Treatment Plant. This manhole in the Tin Annex will be permanently sealed. This will allow any tank leak to be fully contained. A vacuum truck will remove any accumulated material. Please see Figure 1 and Figure 2 in Appendix 1 for the location of manhole DIW 19.

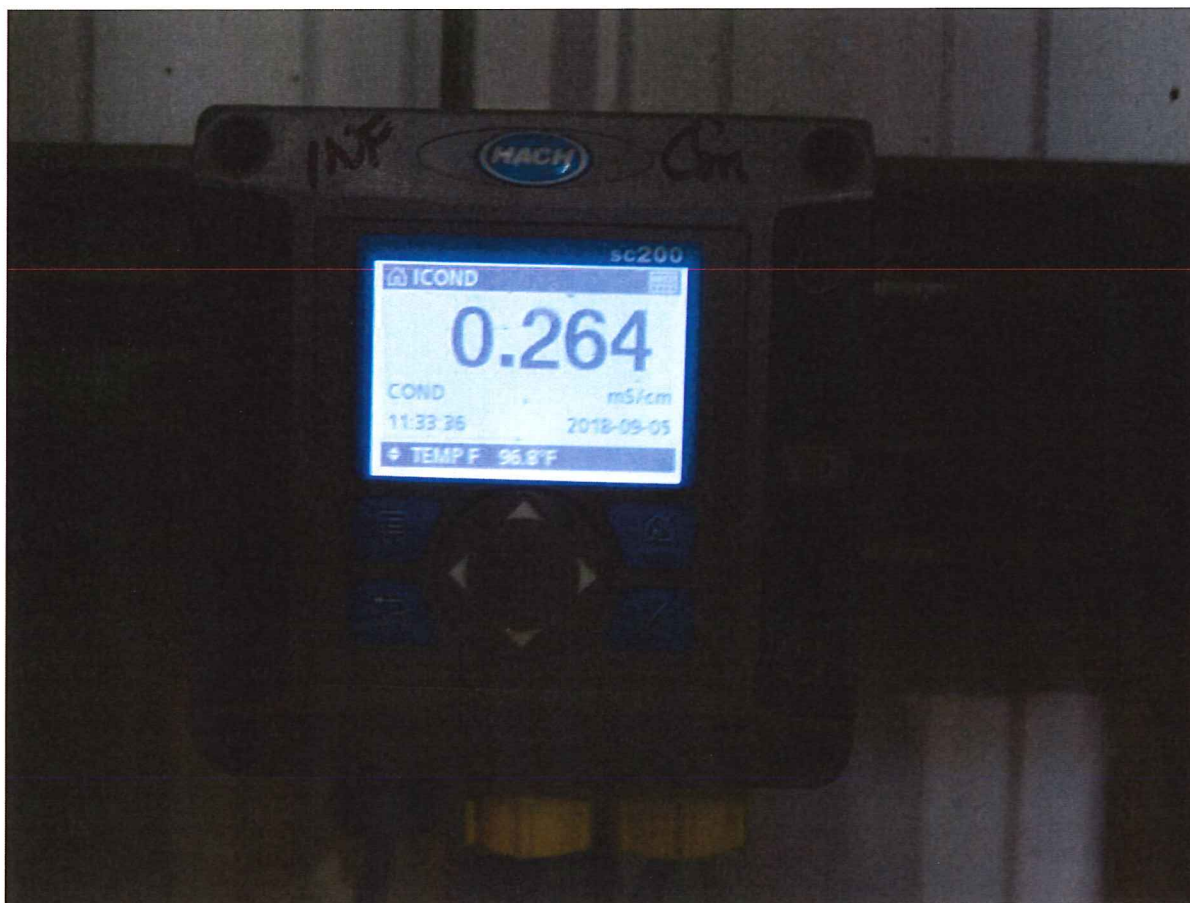
**Picture 16:** Chrome Containment Trench: Conductivity probe installed to help detect small leaks of chrome wastewater from pipeline

A conductivity probe will be installed in the chrome trench sump to identify potential process water leaks into the trench. A higher ionic concentration, and therefore conductivity, is expected in a process wastewater as opposed to a stormwater source. Currently, there is no visual method to differentiate between storm water and process water presence in the trench. Once installed, the probe will be tied to the plant alert/alarm system. An acceptable conductivity action level will be determined based on an ongoing analysis of the normal readings. The conductivity monitoring will be in addition to the operators' visual check of the sump.

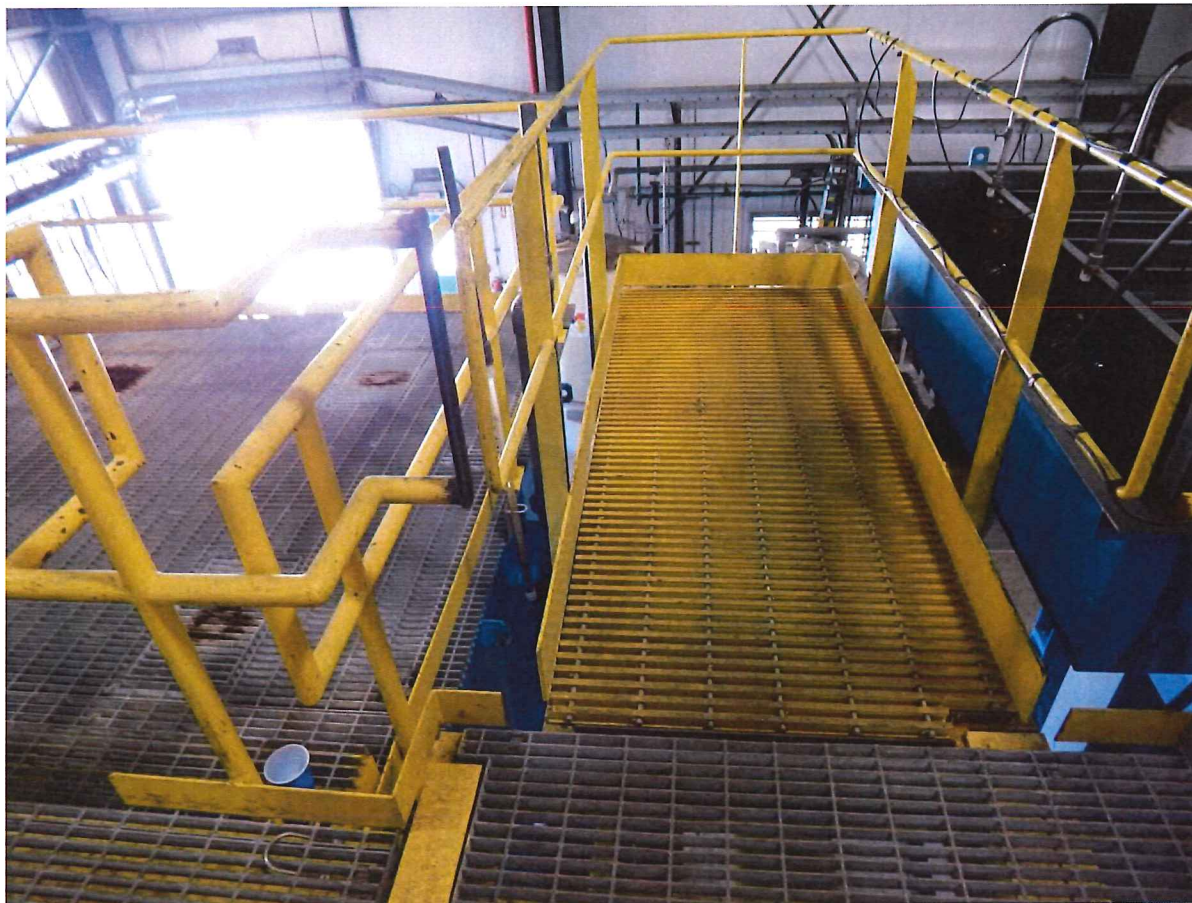
**Picture 17:** Chrome plant lamellas: Pictures of access platforms installed

The original access points to clean and inspect the lamella plates did not provide a safe access the entire width of the equipment. By adding additional access platforms at the effluent troughs, the operator can now safely perform maintenance and cleaning activities.
