**United States Steel Corporation  
Midwest Plant  
Portage, Indiana**

**Enhanced Wastewater Process Monitoring Design**

**06-29-2018  
Revised 12/21/2018**

## Photographic Summary of Actions Taken by U. S. Steel Pursuant to the Midwest Consent Decree

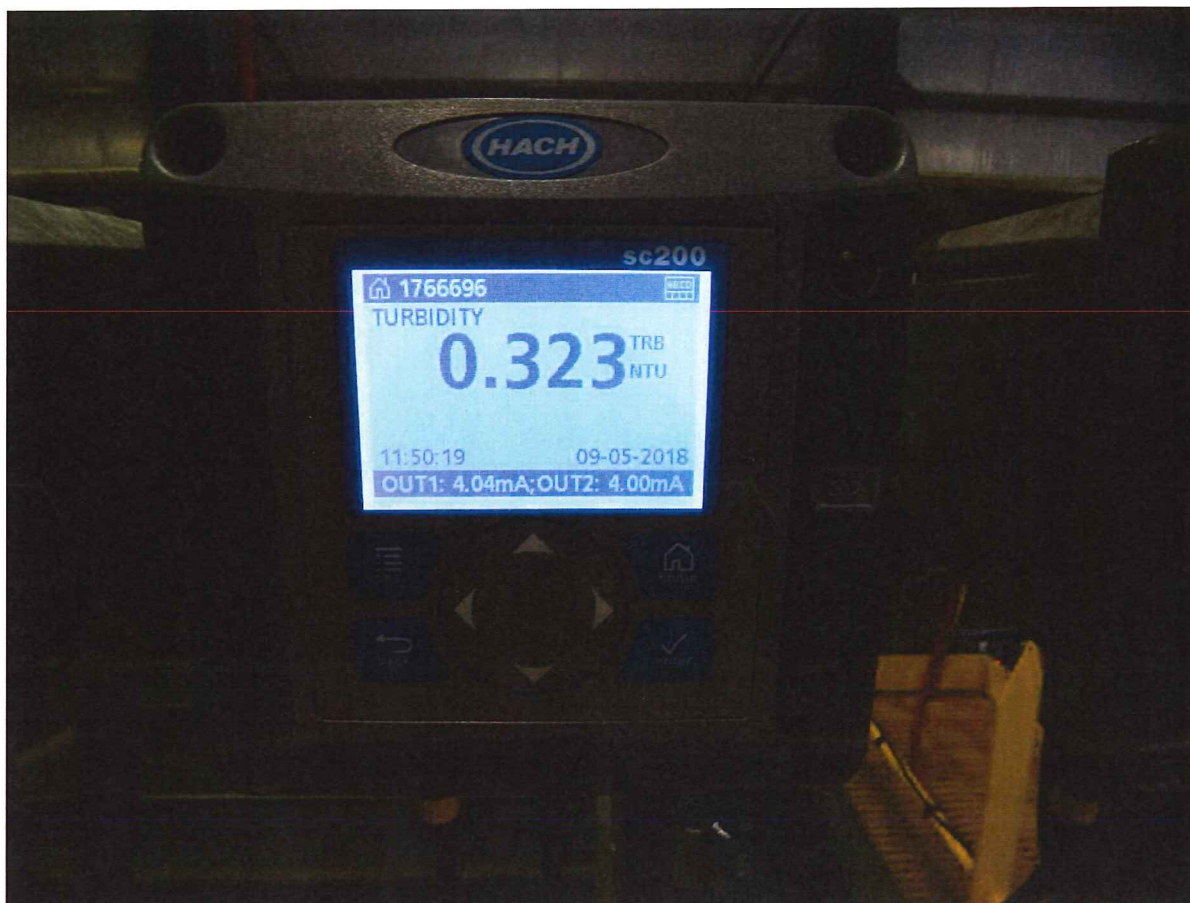
Picture 18: Chrome Plant Lamellas: Picture of Turbidimeter Reading

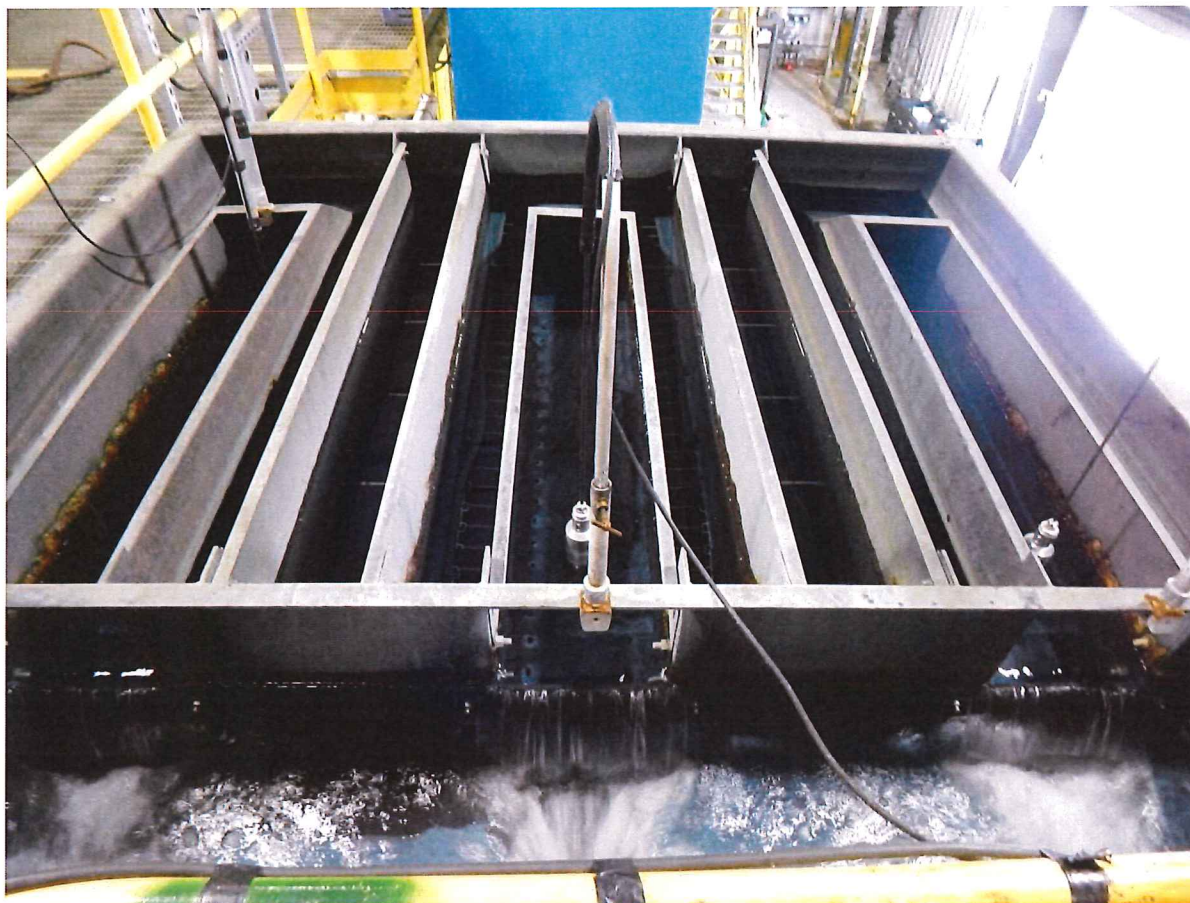
**Picture 19:** Chrome plant lamellas: Pictures of additional turbidimeters

The lamella plates in the Chrome Plant remove chrome bearing solids from the treatment stream. There are three discharge channels from the separation plates of the lamellas. There was a turbidity probe in only one of the three discharge channels of each train. This prevented detection of solids discharging from the other two channels. Additional inline turbidity meters

were recently installed in the other two channels of each train to measure the solids carryover across all three channels. Each of the six turbidimeters are tied into the plant alert/alarm system and can initiate an alarm independently.
