FIGURE 1-1. SITE LOCATION MAP
 REMEDIAL INVESTIGATION REPORT
 NORTH BELMONT PCE SUPERFUND SITE
 NORTH BELMONT, GASTON COUNTY, NORTH CAROLINA
 SEDS PROJECT No. 96S-058, JUNE 1997

FIGURE 1-2
 RI/FS STUDY AREA
 REMEDIAL INVESTIGATION REPORT
 NORTH BELMONT PCE SUPERFUND SITE
 NORTH BELMONT, GASTON COUNTY, NC
 SEDS PROJECT No. 96S-058, JUNE 1997

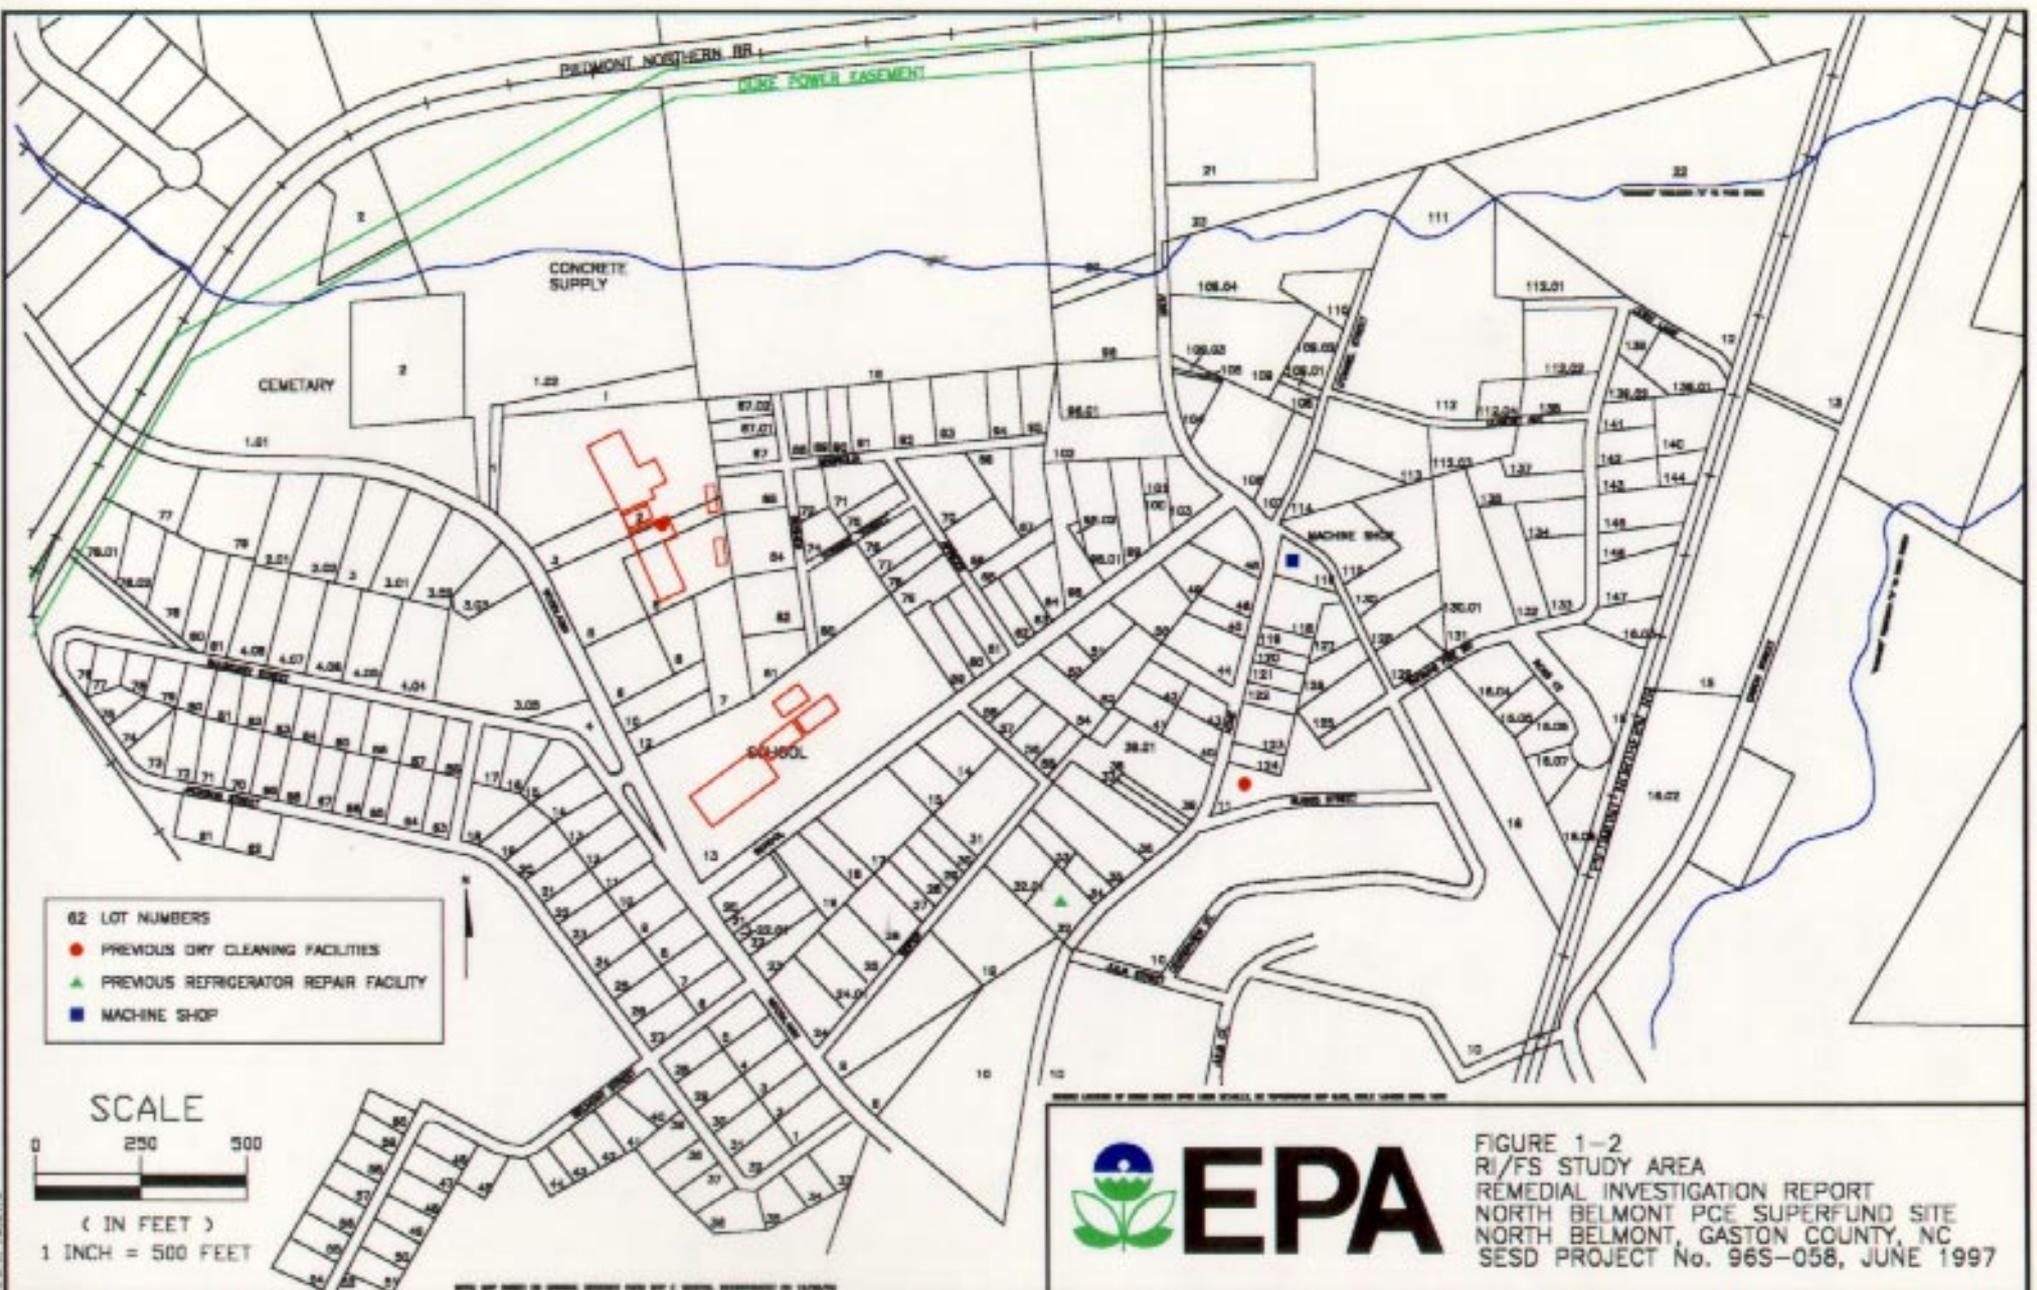
- 62 LOT NUMBERS
- PREVIOUS DRY CLEANING FACILITIES
- ▲ PREVIOUS REFRIGERATOR REPAIR FACILITY
- MACHINE SHOP

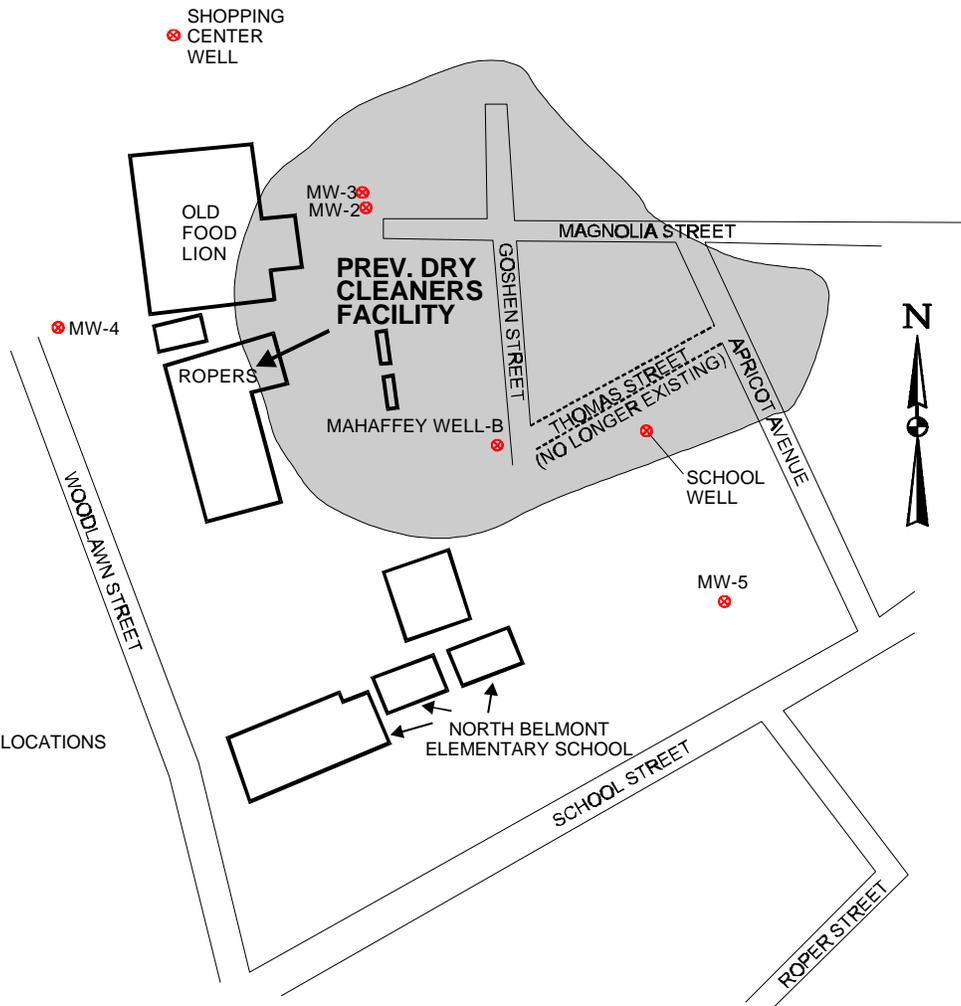
FIGURE 1-3. APPROXIMATE PCE/TCE GROUND WATER PLUME, 1991
 REMEDIAL INVESTIGATION REPORT
 NORTH BELMONT PCE SUPERFUND SITE
 NORTH BELMONT, GASTON COUNTY, NORTH CAROLINA
 SESD PROJECT No. 96S-058, JUNE 1997

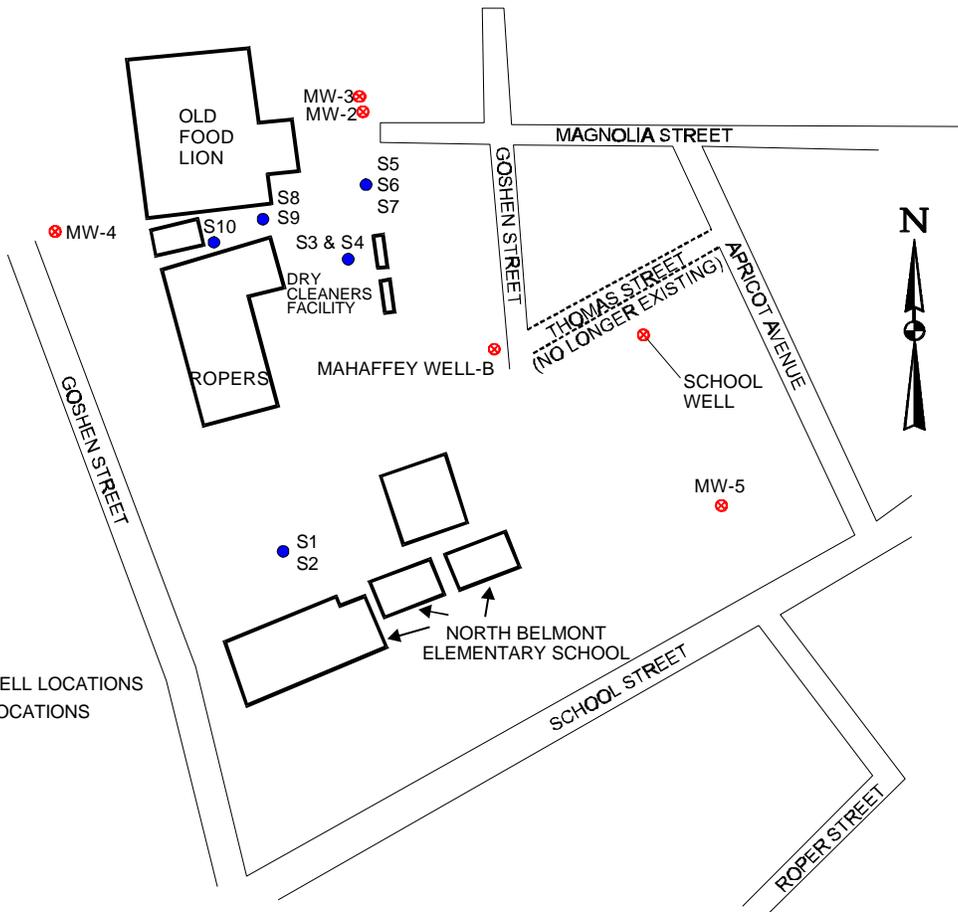
⊗ MONITORING WELL LOCATIONS
● SOIL SAMPLE LOCATIONS

FIGURE 1-4. NCDEHNR, SOIL SAMPLE LOCATIONS, JULY 1993
REMEDIAL INVESTIGATION REPORT
NORTH BELMONT PCE SUPERFUND SITE
NORTH BELMONT, GASTON COUNTY, NORTH CAROLINA
SESD PROJECT No. 96S-058, JUNE 1997

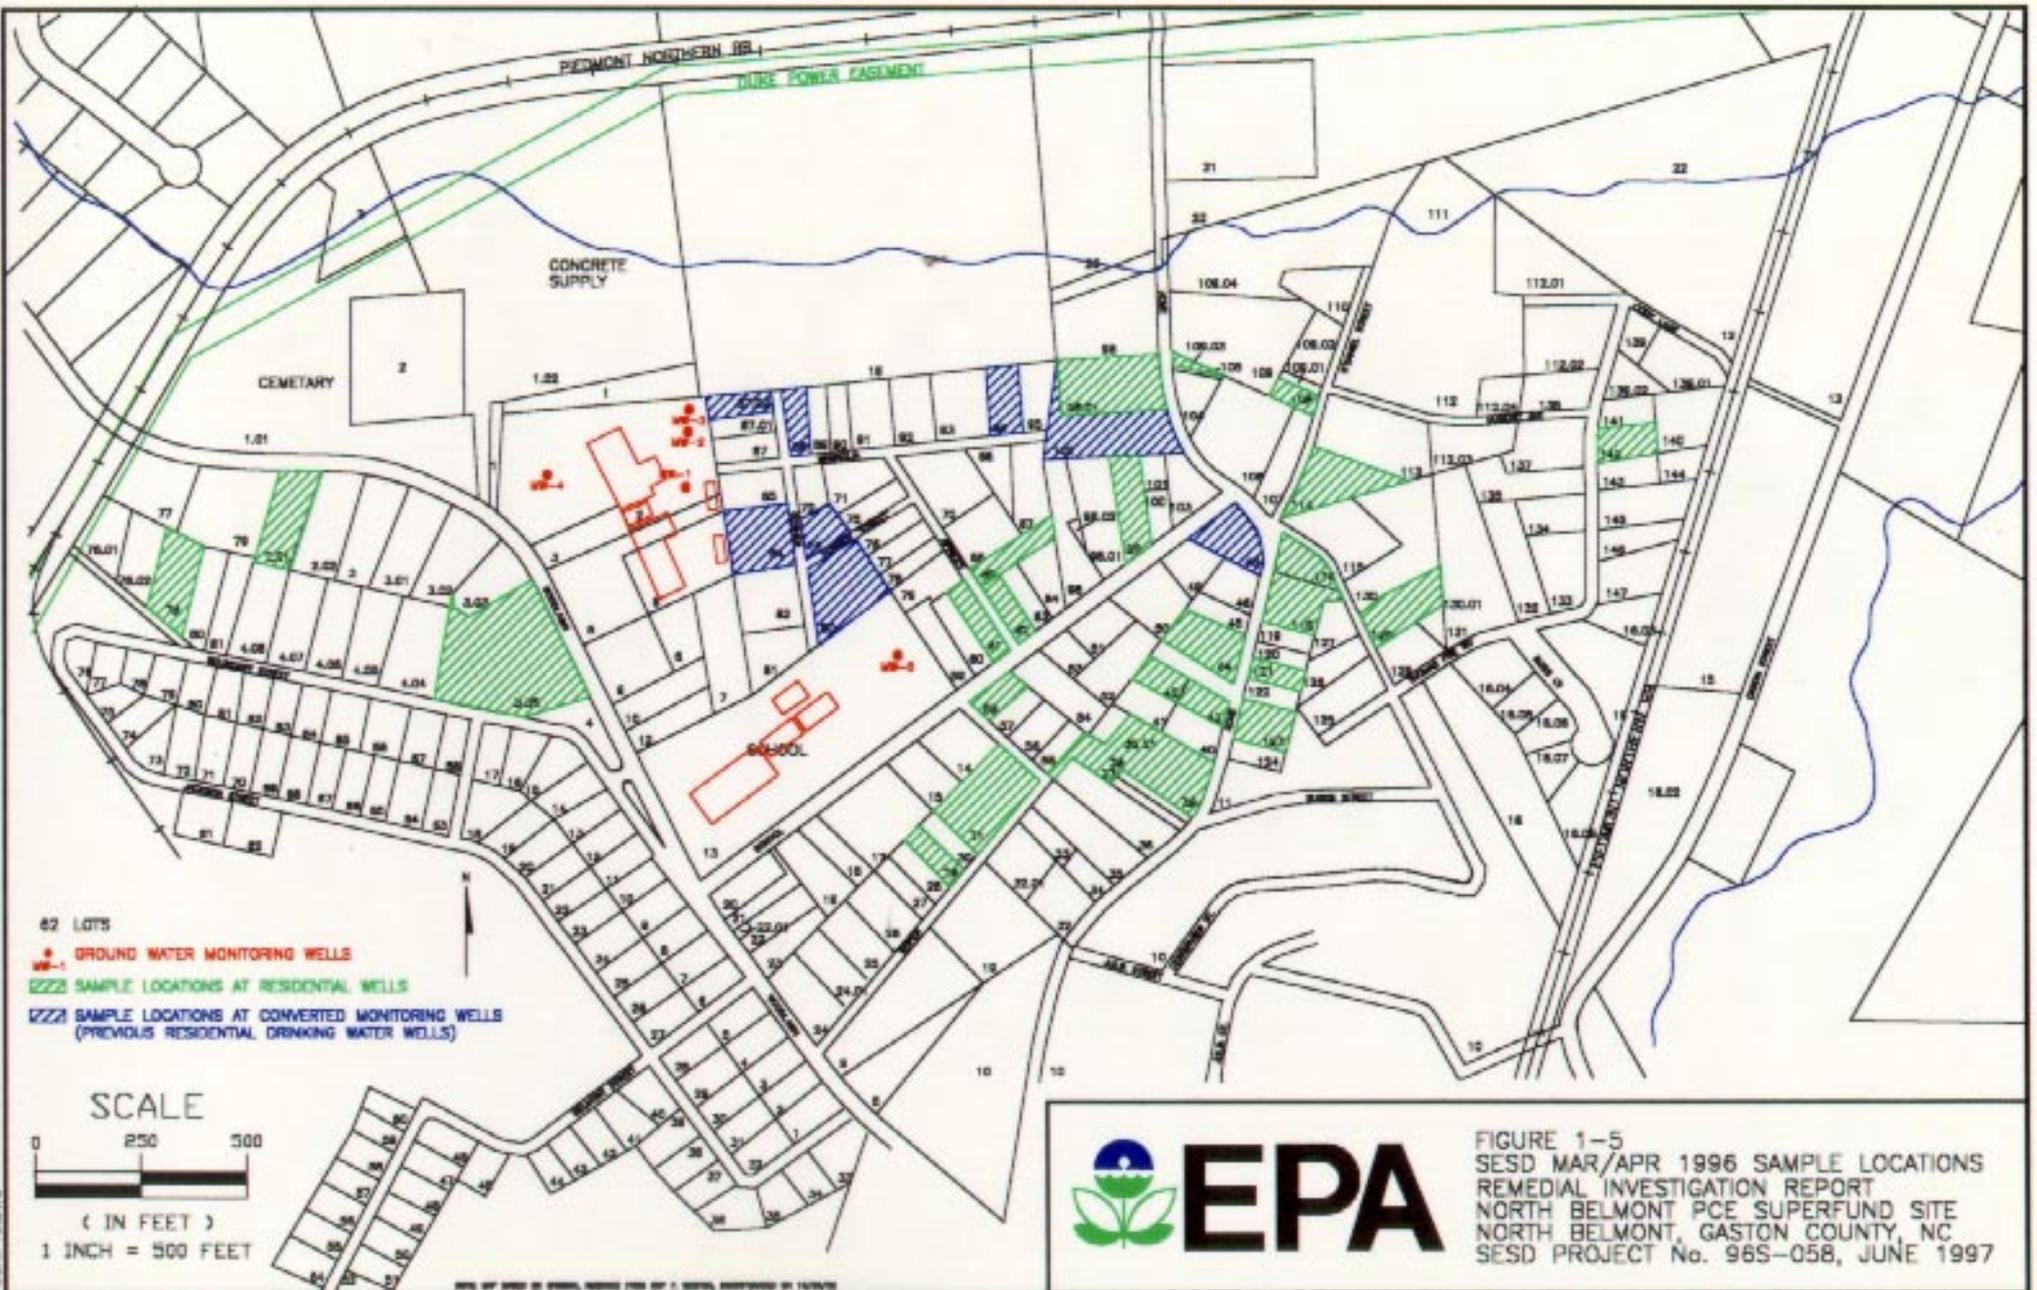
FIGURE 1-5
 SESD MAR/APR 1996 SAMPLE LOCATIONS
 REMEDIAL INVESTIGATION REPORT
 NORTH BELMONT PCE SUPERFUND SITE
 NORTH BELMONT, GASTON COUNTY, NC
 SESD PROJECT No. 96S-058, JUNE 1997
