International Boundary and Water Commission
United States Section

Transboundary Flows Pump Station CIJA

June 18, 2015

Tijuana River Valley Recovery Team

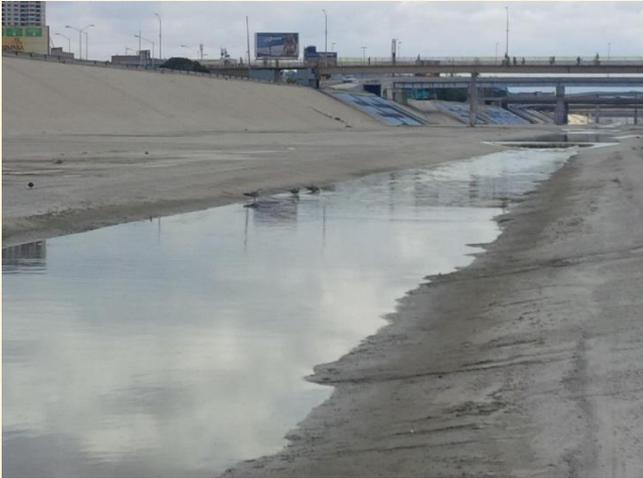
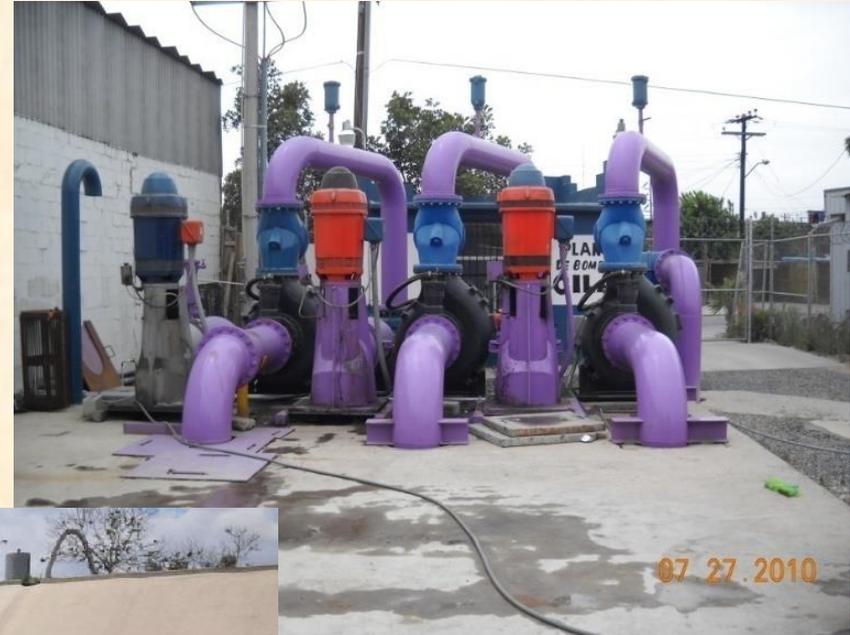
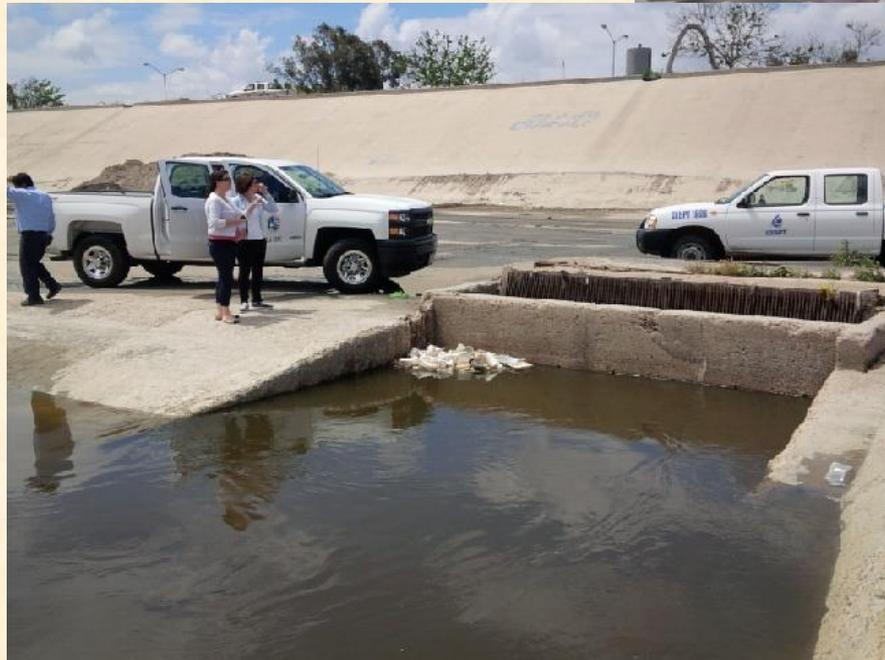
Pump Station CILA

- Diversion of dry weather low flows from Tijuana River pilot channel
- Small concrete weir in pilot channel
- Screen, 30 inch diameter pipe
- Conveyed to wet well outside of concrete channel.
- These flows are NOT delivered to SBIWTP

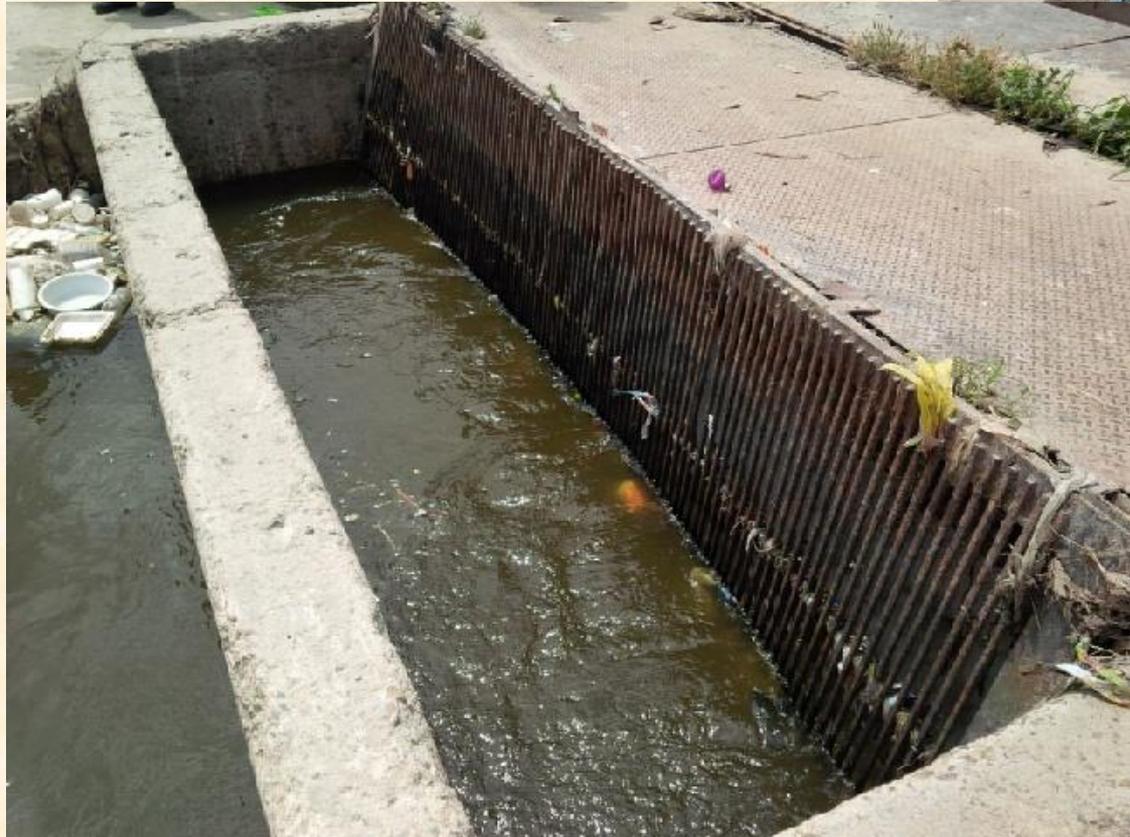
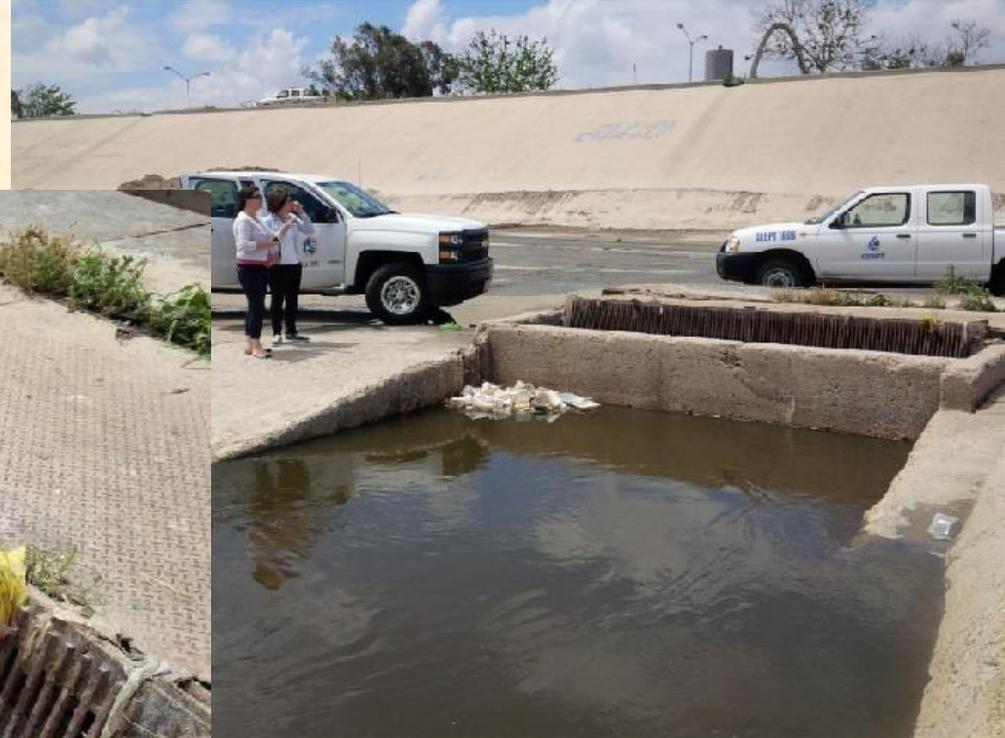
Pump Station CILA

- Wet weather sediment and debris accumulation
- Screen and weir submergence at high flow – difficult/unsafe to access.
- CESPT wet weather operation:
 - When river flows are below 1000 Ips, flow is diverted into CILA Pump Station.
 - When flows exceed 1000 Ips, CILA Pump Station is shut down

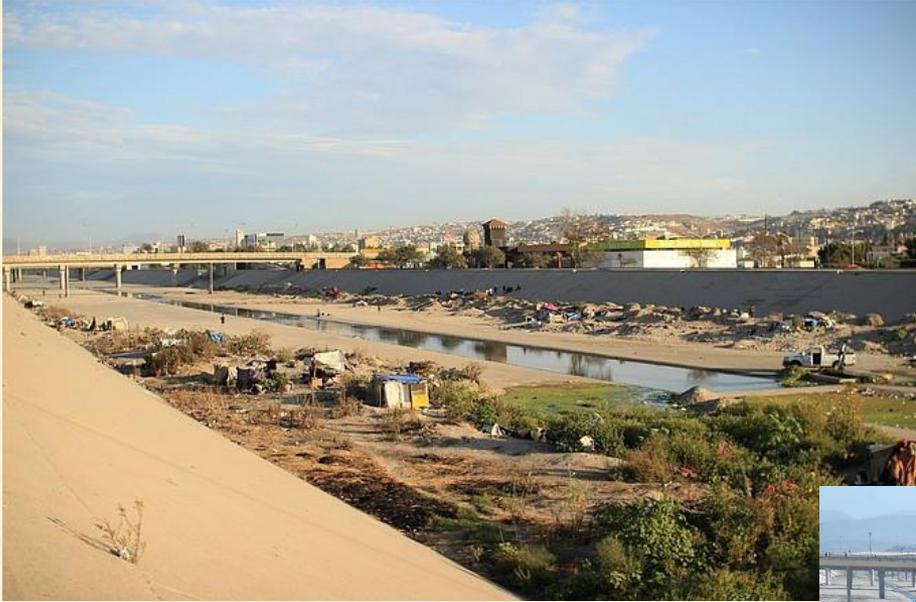
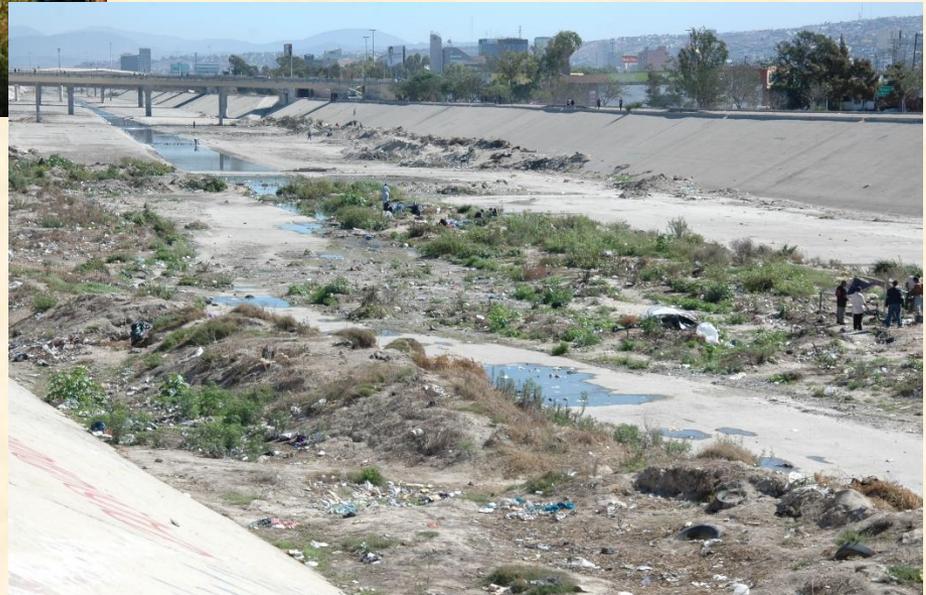
Tijuana River - CILA Pump Station to Boundary - 2013

- During January and February 2015, it became increasingly difficult and unsafe for CESPT to maintain the CILA intake screens due to the large number of homeless people living in the channel and depositing excessive amounts of trash and debris in the pilot channel and screens.
- Even though Pump Station CILA was continuously in operation, overflows occurred (especially at night) due to clogged screens and lack of continuous cleaning.

- In late January 2015, Mexico was advised to correct the problem of overflows at the diversion and the two IBWC Sections met with CESPT to discuss how that could be achieved.
- In late February 2015, in preparation for a moderate flow event in the river, the City of Tijuana took the opportunity to remove all debris and sediment from the concrete channel between the CILA Pump Station and the international border.
- The City of Tijuana is patrolling the levee so that the homeless do not return to the area.
