List of key personnel interviewed EPA Internal Review Team of the Gold King Mine Spill, Colorado

Gold King Mine

Gold King Mine Flow Data and Chart

Photos and Google Earth Images

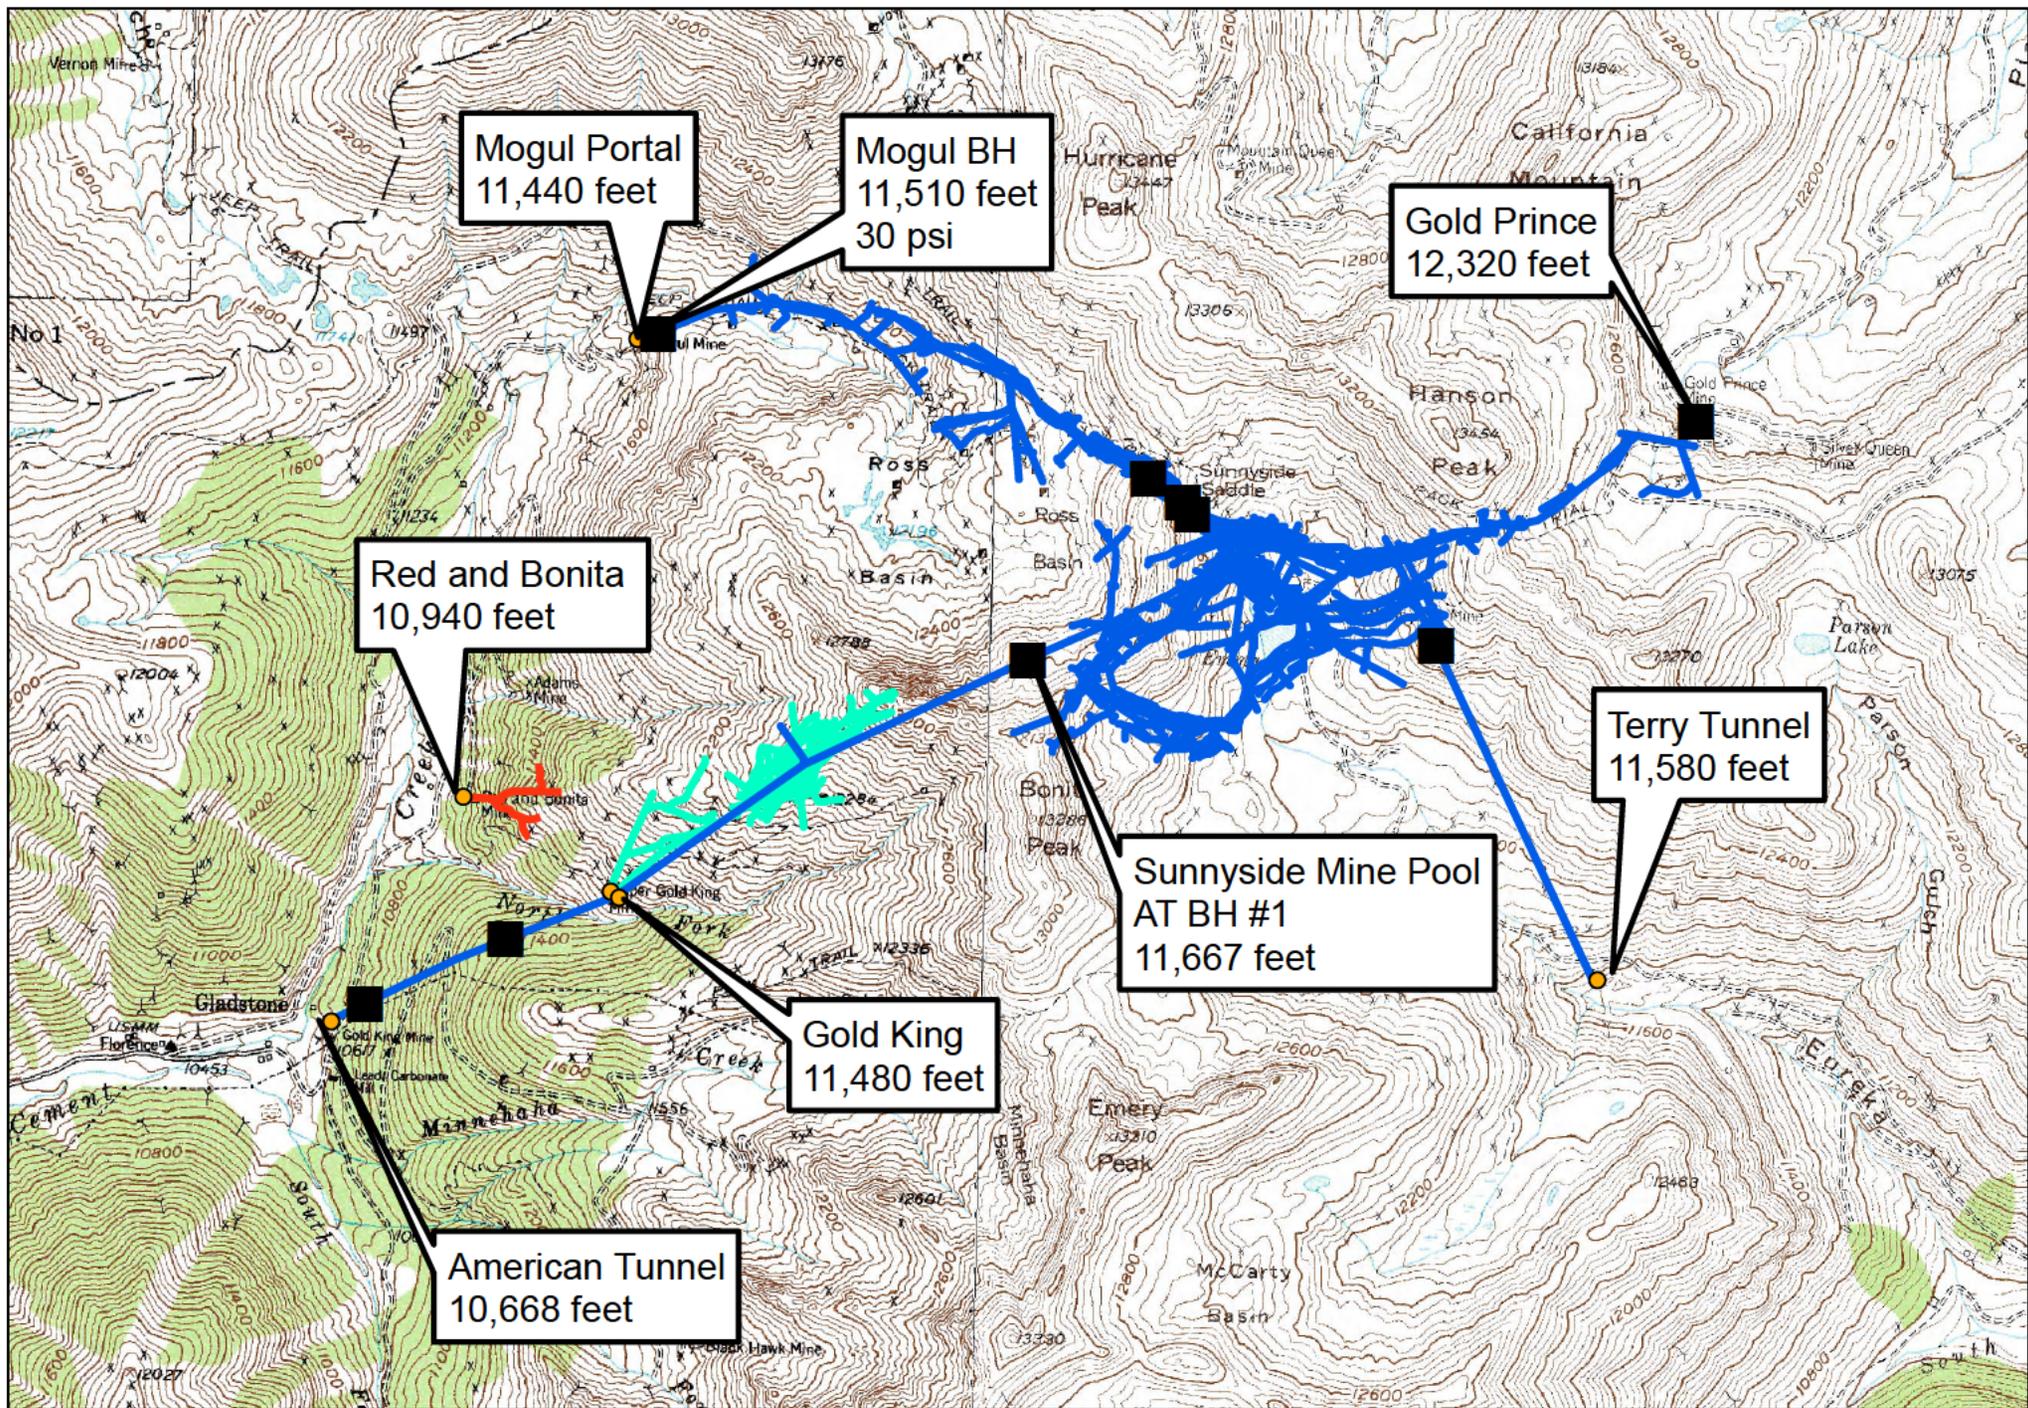
Mine and Pool Elevations

Approximation of Mine Portal Elevations
and Mine Pool Elevations
Created for ARSG
(b) (6)
4/17/2014

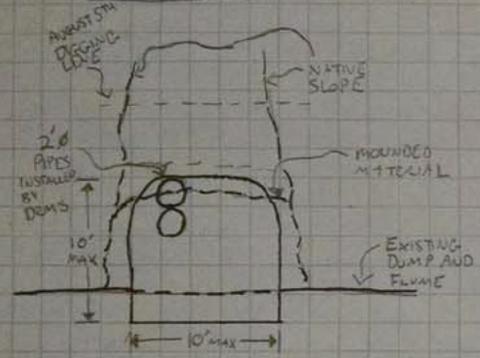
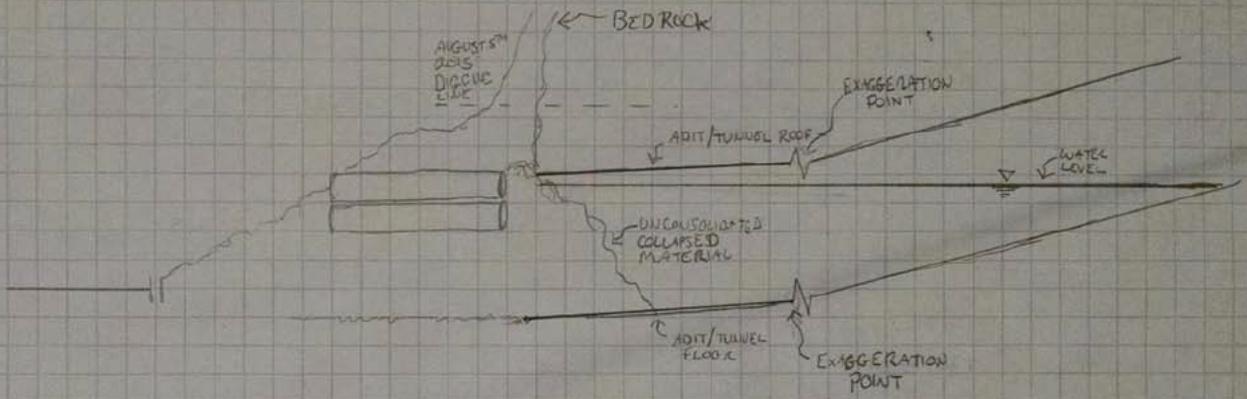
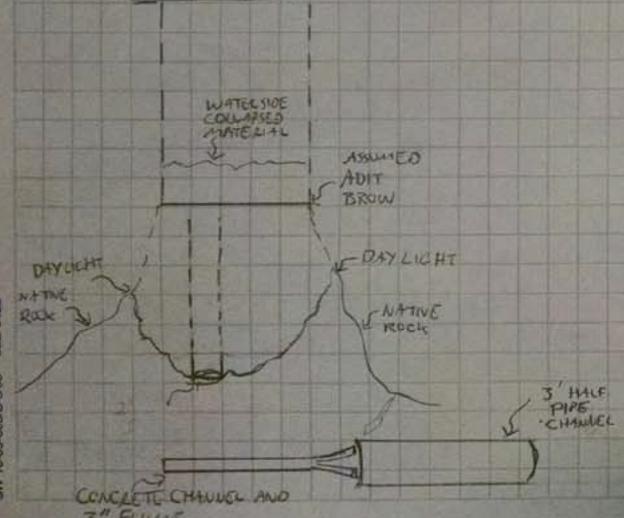
EPA Working Assumptions

FRONT VIEW N.T.S.

SIDE VIEW N.T.S.

TOP VIEW N.T.S.

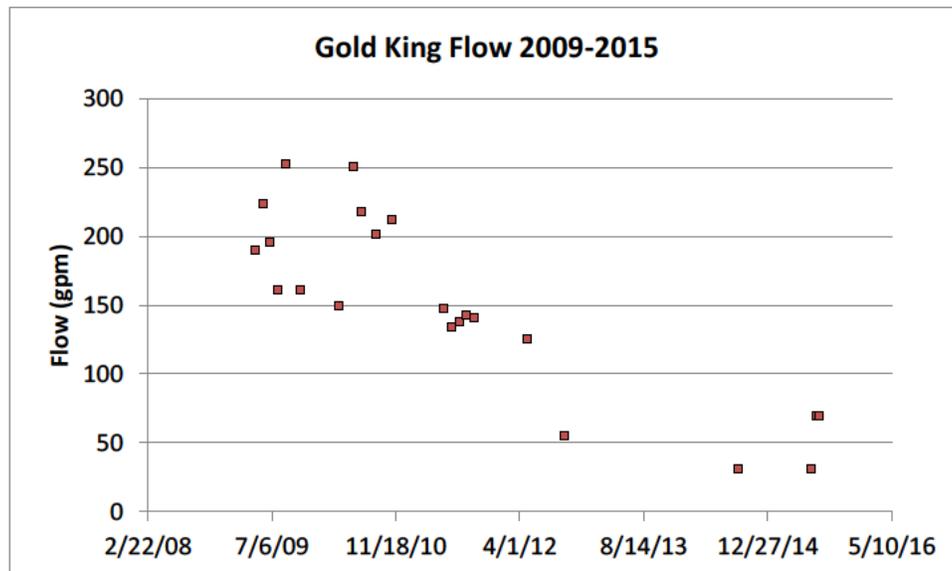
Gold King Mine flow data is available from 2009 through 2014, with multiple sampling events from 2009-2011 and fall sampling from 2012-2014. Gold King Mine spring flow was not measured from 2012 to the present due to high snow and potential avalanche conditions, and flow was not measured during fall 2013 due to the government shutdown. Flow was also measured by START during 2014 and 2015 site visits.

For years with multiple flow measurements (2009, 2010, 2011), the Gold King Mine discharge varied by up to 45 percent within 1 year (2009), when the November flow was 45 percent greater than the August flow.

The Gold King Mine discharge annual average runoff flow varied from the annual average non-runoff flow by up to 22 percent (2010).

Older historic data from START showed flow was 42 gpm in July 2005, 135 gpm in September 2005, and 314 gpm in October 2006. This widely variable flow may have been due to backup of water behind the American Tunnel reaching the elevation of the Gold King rather than an indication of the variability of flow from the Gold King Mine.

Measurements in 2015 included 31 gallons per minute (gpm) on June 24 (similar to Fall 2014), and 69 gpm on both July 15 and July 23.

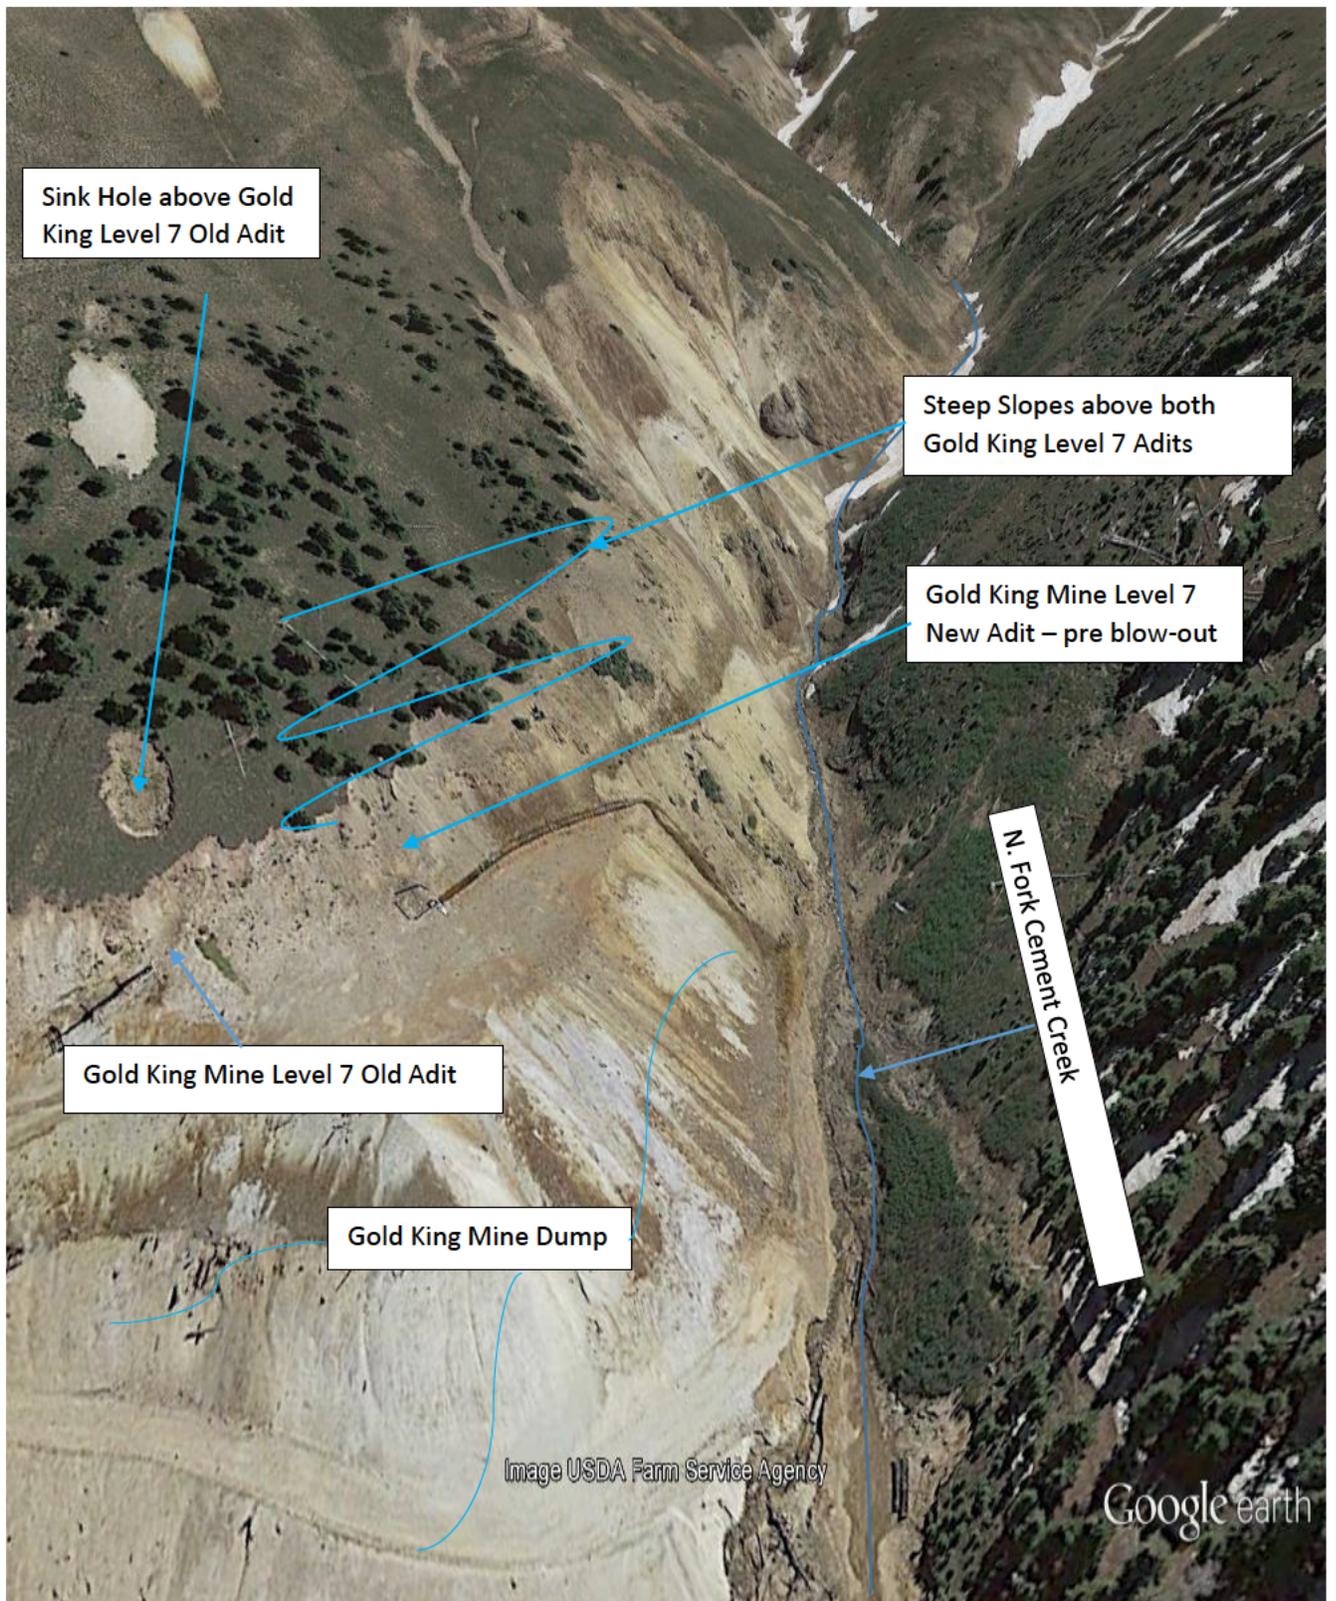
Photo 1 Google Earth June 2015 Image - Gold King Level 7 Adits and Mine Dump

Sink Hole above Gold King Level 7 Old Adit

Steep Slopes above both Gold King Level 7 Adits

Gold King Mine Level 7 New Adit – pre blow-out

N. Fork Cement Creek

Gold King Mine Level 7 Old Adit

Gold King Mine Dump
