NONPOINT SOURCE PROGRAM SUCCESS STORY

South Carolina

Implementing a Total Maximum Daily Load Reduces Bacteria

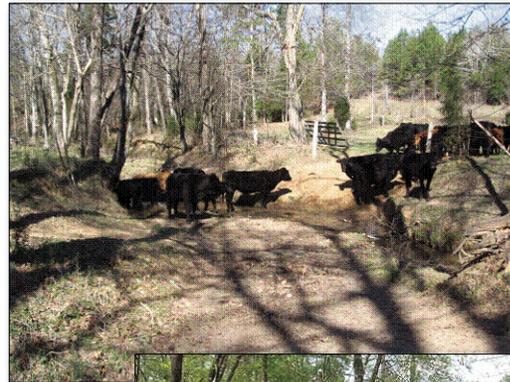
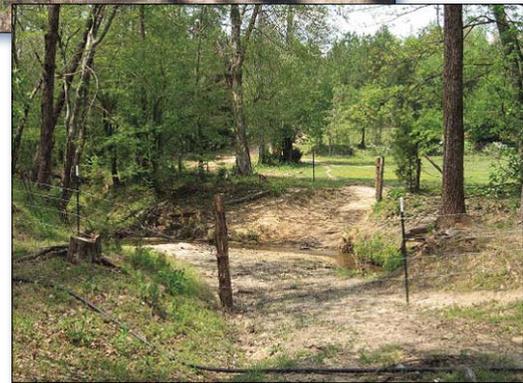
Figure 1. A site in the Rocky Creek watershed before (top) and after (bottom) the landowner installed livestock exclusion fencing.

Although the watershed is primarily forested, a significant amount of land is in agricultural use, particularly cattle pasture (Figure 1). Other fecal coliform sources include runoff from wildlife in forested areas, land application of manure, failing septic systems, urban runoff, and leaking or overflowing sewer systems. To address these sources, the SCDHEC used water quality data collected at the monitoring sites to develop a total maximum daily load (TMDL) for the watershed and begin the restoration process. As the TMDL was developed, preliminary studies identified sources of fecal

both water quality and farm operations. The project targeted seven farms for participation on the basis of affordability and the greatest potential for benefit to the SCDHEC's water quality program. The BMPs implemented included building fences along streams and creeks to exclude livestock; installing cross-fencing to reduce pasture size and better control grazing; using no-till planting to reduce erosion; adding vegetation buffers and filter strips; installing water well/watering systems (Figure 2); establishing stream crossings; and building manure sheds and covered composters. Each participating landowner implemented at least four and as many as six BMPs.

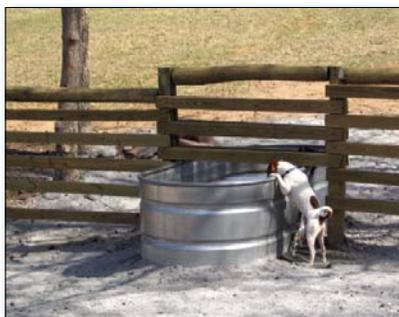
Figure 2. This alternative watering source, underlain by geotextile pad and crushed gravel to prevent erosion, serves two cattle pastures.
