NONPOINT SOURCE PROGRAM SUCCESS STORY

District of Columbia Daylighting a Tributary to Broad Branch and Installing Treatment Practices Improve Stream Health

EPA 841-F-15-001M
February 2015

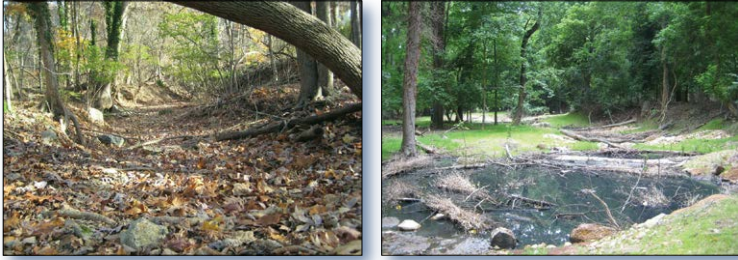
Figure 2. The Broad Branch tributary was previously confined to a pipe buried under the original stream valley (left). The daylighting project restored the stream to the surface (right).

DDOE, in partnership with the National Park Service, the DDOT, the District of Columbia Water and Sewer Authority (DC Water), and the Embassy of Peru daylighted the piped stream in the spring of 2014 (Figure 2). Three regenerative stormwater conveyance systems were installed in the daylighted stream. Partners installed 10 low impact development systems throughout the project area to treat stormwater runoff from a nearby road and alley.

The stream daylighting and regenerative stormwater conveyance systems used open-channel, sand seepage filtering systems that employ a series of shallow aquatic pools, riffle-weir grade controls, native vegetation and an underlying sand channel to slow stormwater velocities, infiltrate stormwater, recharge ground water, and treat pollutants through chemical and biological processes. The restoration techniques applied also reduce erosive forces on the banks of the streams where they are installed and positively affect the ecology of the restoration area by creating conditions favorable to aquatic macroinvertebrates and other wildlife. The stream restoration is expected to result in the removal of 67 pounds (lb) of total nitrogen per year, 11.8 lb of total phosphorus per year, and 8,570 lb of total suspended sediment per year.
