# Section 319

# NONPOINT SOURCE PROGRAM SUCCESS STORY

## Implementing Best Management Practices Reduces Total Dissolved Solids in Turkey Creek

EPA 841-F-15-001CC  
May 2015

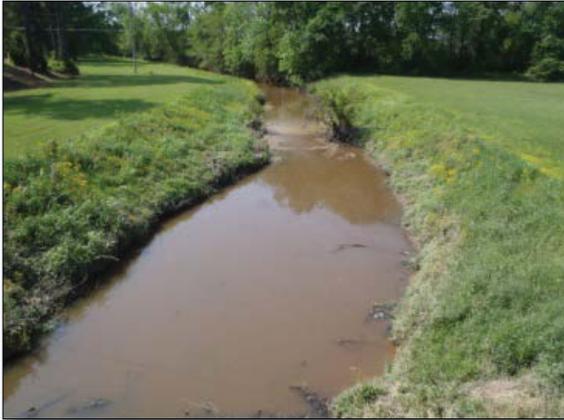
Figure 2. Before partners implemented BMPs, Turkey Creek carried high sediment loads during summer months.

Ambient water quality data collected in 1999 indicated Turkey Creek did not support its designated use of FWP due to high concentrations of TDS (Figure 2). The criterion for TDS is 500 milligrams per liter; furthermore, no more than 30 percent of the TDS samples collected on a monthly or near monthly basis may exceed this criterion. TDS concentrations in Turkey Creek exceeded this maximum allowable concentration 65 percent of the time in 1999. As a result, the segment was added to the state’s CWA section 303(d) list of impaired waters in 2000. No TDS total maximum daily loads were developed for this watershed.
