# NONPOINT SOURCE PROGRAM SUCCESS STORY

# Michigan

## Stream Stabilization Projects Put Carrier Creek on the Path to Recovery

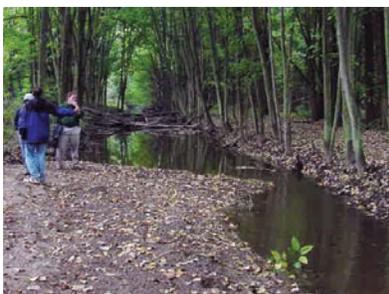
Figure 1. Before: Note the shallow, linear stream channel and the lack of in-stream habitat features.

MIDEQ determined that the quality of the biota in this segment of the creek was reduced by urban runoff, poor in-stream habitat, and excessive sediment deposition (Figures 1 and 2). MIDEQ completed a Total Maximum Daily Load (TMDL) for Carrier Creek biota in 2002. As noted in the TMDL, achievement of the WQS for designated uses for Carrier Creek will be demonstrated by assessing the macroinvertebrate community and the in-stream habitat as it relates to sediment.

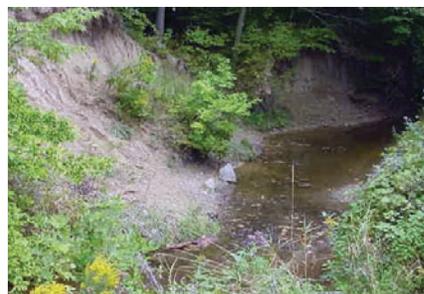
Figure 2. Before: Note the erosion of historic dredge spoils and poor in-stream habitat.

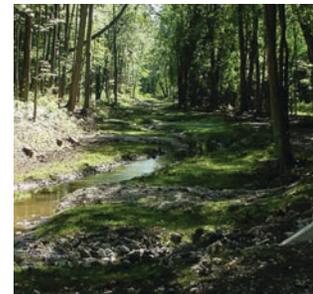
Figure 3. After: Restored stream meanders.

In 2000 a team of contractors, local agencies, and volunteers stabilized and restored 5 miles (3,771 linear feet) of channel using funding from MIDEQ. These projects increased channel stability, improved in-stream habitat, and reconnected the channel to its floodplain. The upstream end of the channel was narrowed, and the stream pattern was reestablished with structures that promote meandering. Throughout the rest of the restored reach, various structures were installed to stabilize the channel, including cross-vanes, J-hooks, lunkers, log revetments and riprap (Figures 3, 4, and 5). In some locations, the project team removed dredge spoils that were separating the stream from its natural floodplain.

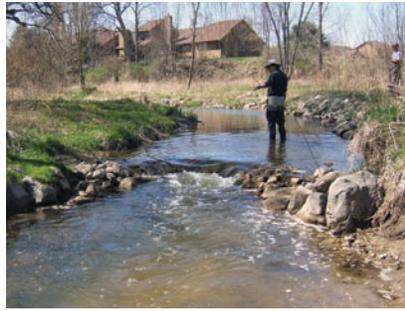
Figure 4. After: A crossvane.

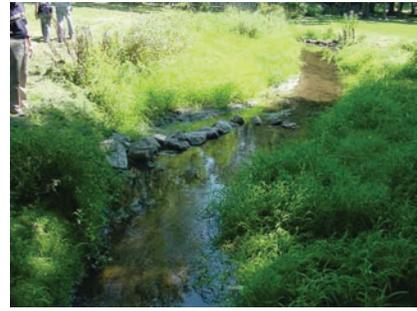
Figure 5. After: A J-Hook.
