# NONPOINT SOURCE PROGRAM SUCCESS STORY

# WISCONSIN

## Stream Restoration Efforts Result in Rebound of Brown Trout Population

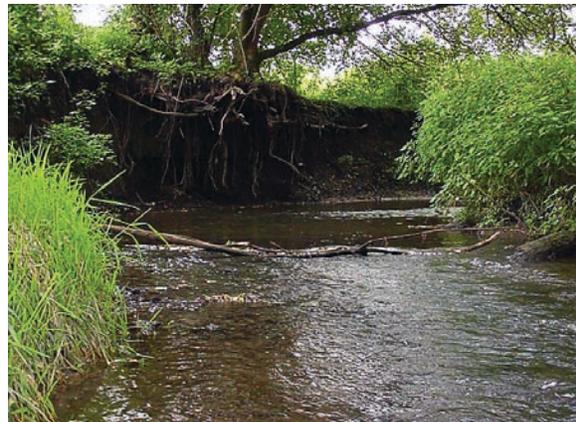
Figure 1. West Branch Sugar River: Pre-rehabilitation conditions.

of eurythermal minnows, which are adaptable to a wide range of temperatures. In addition, the available habitat was insufficient to sustain a number of top-level carnivores, such as brown trout, and was rated poor. In particular, the in-stream surveys indicated that the habitat upstream of State Highway 92 suffered from environmental degradation and had habitat scores ranging from poor to fair. The main problems included steep, highly eroded streambanks, shallow water depth and heavy silt deposits in the stream (Figure 1).

Building on 13 years of local watershed restoration activities, more work began in 1999 to improve the riparian corridor and habitat upstream of State

Highway 92. Project participants placed more than 20,000 feet of riprap to stabilize the toe of the stream; reshaped 58,000 feet of streambank; seeded 17 acres; and placed more than 1,000 fish habitat structures in the stream. Participants placed riprap on the banks and seeded them, establishing grasses with good root structure to preserve bank integrity. Reestablishing vegetation along the streambanks also provided a buffer to mitigate runoff from the surrounding agricultural fields.

Other project elements included narrowing the river in appropriate places to increase flow velocity, flushing the soft sediment out of the channel and uncovering the gravel bottom, which is essential to trout reproduction.

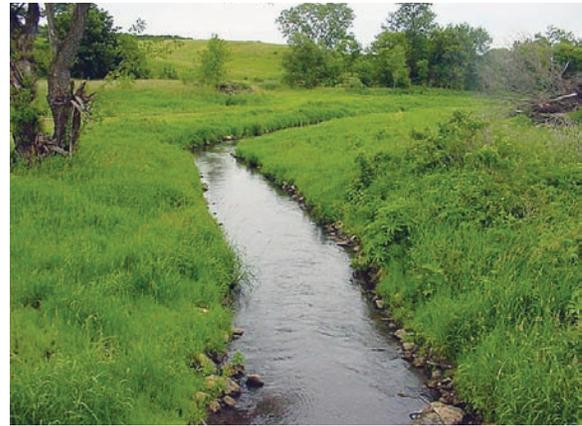
In 2002 habitat evaluations at three sites found that the habitat had improved, and scores ranged from good to excellent (Figure 2).

Figure 2. West Branch Sugar River: Post-rehabilitation conditions.

ridor and adding stream habitat enabled the river to meet its potential as cold water Class II trout water. These changes, including improvements in habitat, increased numbers of indicator species and evidence of natural reproduction of trout, resulted in Wisconsin delisting all three segments in 2004 from its 303(d) list.
