USEPA Addressing Erosion at the Former Cove Transfer Station #1

In September 2016, the U.S. Environmental Protection Agency (USEPA) Region 9 is planning to begin construction activities to mitigate surface erosion at the former transfer area located in the Cove/Red Valley Chapter of the Navajo Nation, in eastern Arizona.

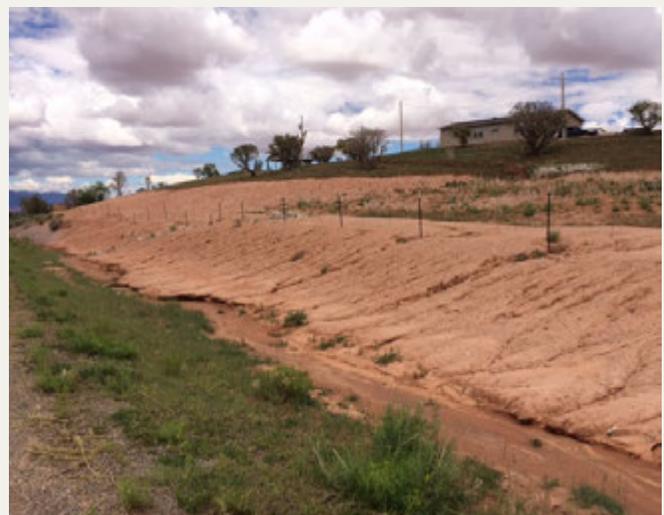
Eroded soil at the base of the slope.

The erosion repair at the former Cove Transfer Station site will include: stabilizing the affected slopes and constructing slope diversion channels; restoring the roadside ditch with rock material; removing dead or dying vegetation and excavating and consolidating any contaminated soils on site as appropriate; vegetating the affected slope with seeds and young plants; and providing irrigation with an onsite water tank to feed a drip irrigation system, until plants are established. The erosion repair work is anticipated to continue through mid October 2016.

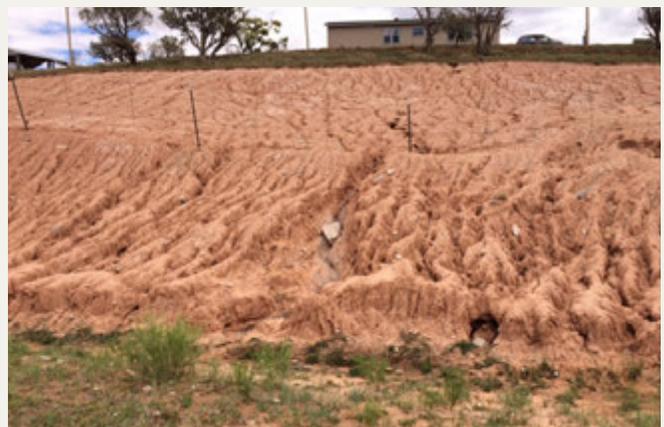
Since the completion of a site removal action in November 2012, sections of the site slope and other adjoining areas have become highly eroded due to intense rain storms that occur seasonally, creating small channels and gullies (up to two feet in depth) throughout much of the site.

Small channels and gullies along the side of the slope.
