NONPOINT SOURCE SUCCESS STORY

Watershed Restoration Decreases Sediment Levels and Improves Fish Habitat in Jordan Creek

EPA 841-F-17-001F
July 2017

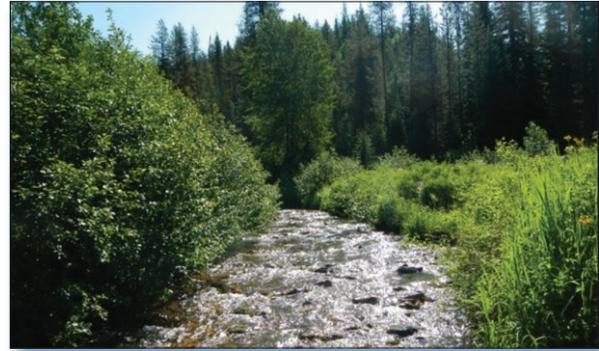
Figure 2. Jordan Creek during the 2012 assessment (after restoration).

Other 2012 data also indicate beneficial use support. A fish survey detected sculpin and westslope cutthroat trout, native species associated with good water quality. Stream habitat data showed high bank stability (85 percent) and cover (100 percent), and low percent fines less than or equal to 2.5 millimeters (mm) in size (7 percent). According to DEQ's *Guide to Selection of Sediment Targets for Use in Idaho TMDLs*, most impairment is found when percent fines of 2.5 mm in size are greater than 30 percent. Because data show Jordan Creek now fully supports its cold-water aquatic life designated use, DEQ removed this AU from Idaho's impaired waters list in the 2014 Integrated Report (Figure 2).
