## GreenChill Best Practices Guideline

### Commercial Refrigeration Leak Prevention & Repairs

U.S. Environmental Protection Agency  
Stratospheric Protection Division

May 2011

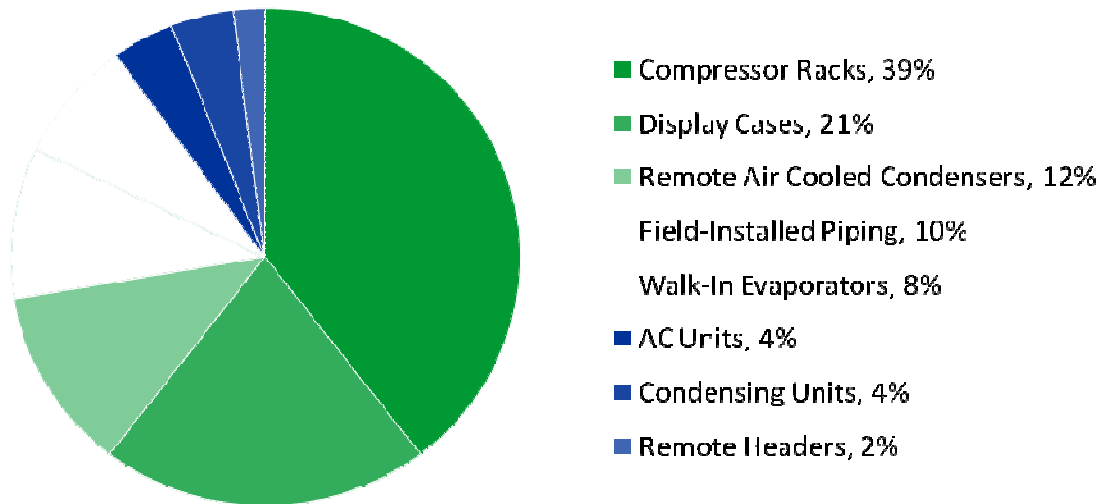
**Figure 1: Leak Sources for a Regional Supermarket Chain**

Leaks can occur in a variety of locations throughout a supermarket. Figure 1 provides estimates from one regional supermarket chain of the portion of refrigerant leaks coming from specific sources. Each leak source is explained further below.

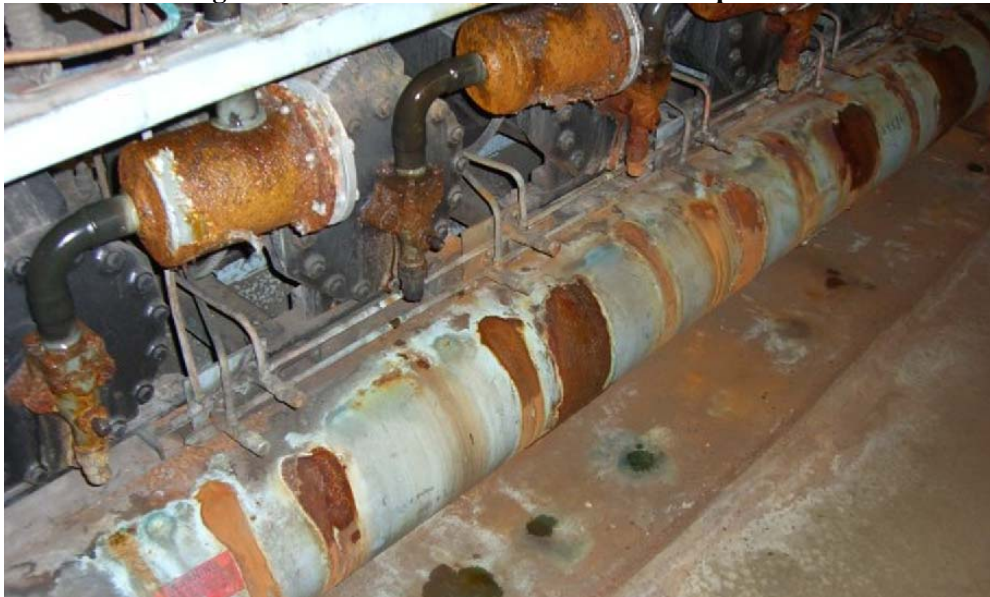
**Figure 2: Excessive corrosion on rack components**

- Steel components such as suction accumulators, suction filter shells, steel suction valves mounted on the suction line, and even receivers mounted below a suction manifold due to corrosion, as seen in Figure 2.

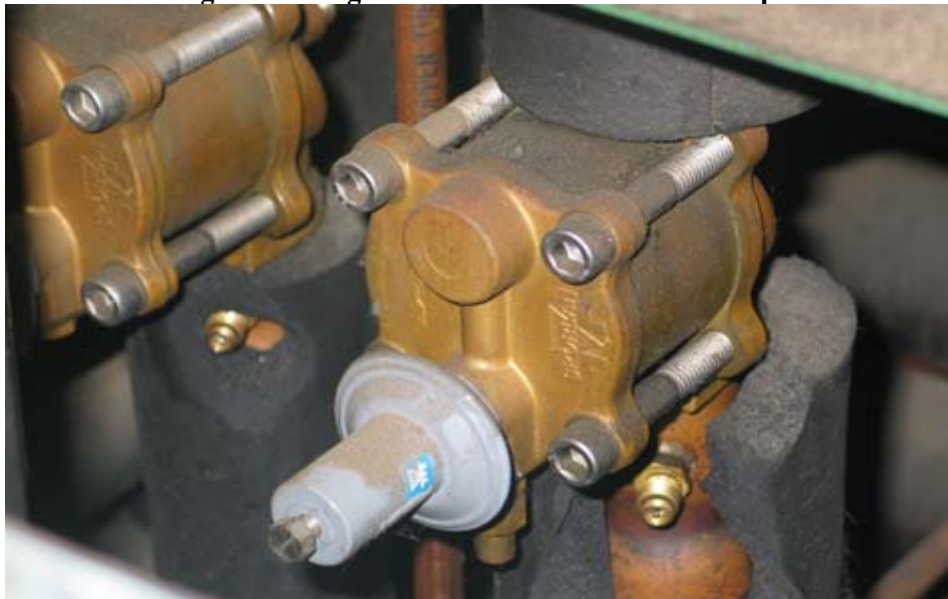
**Figure 3: Image of a Schrader valve with no caps**

- **Poor brazing techniques.** Leaks can result from improper brazing techniques such as improper cleaning of the joint prior to brazing, using the wrong brazing alloy, and failure to heat the joint uniformly or to the proper temperature before filling the joint with brazing alloy.
- **Improperly tightened fittings.** Leaks occur from threaded and flared fittings either when they are not tightened sufficiently or when they are over-tightened and crack.
- **Valve caps and seals missing.** To reduce leaks through valve stems and Schrader cores, all valve stems that are designed to be capped, and all access Schrader valves, must have the proper caps in place. Figure 3 provides an example of a Schrader valve without any caps. The caps must also have the proper seal or o-ring in place to ensure leak tightness.

- ✓ *Ensure the proper cap is in place on all valve stems designed to be capped, as well as access Schrader valves. The caps should also have the proper seal or o-ring in place to ensure leak tightness.*

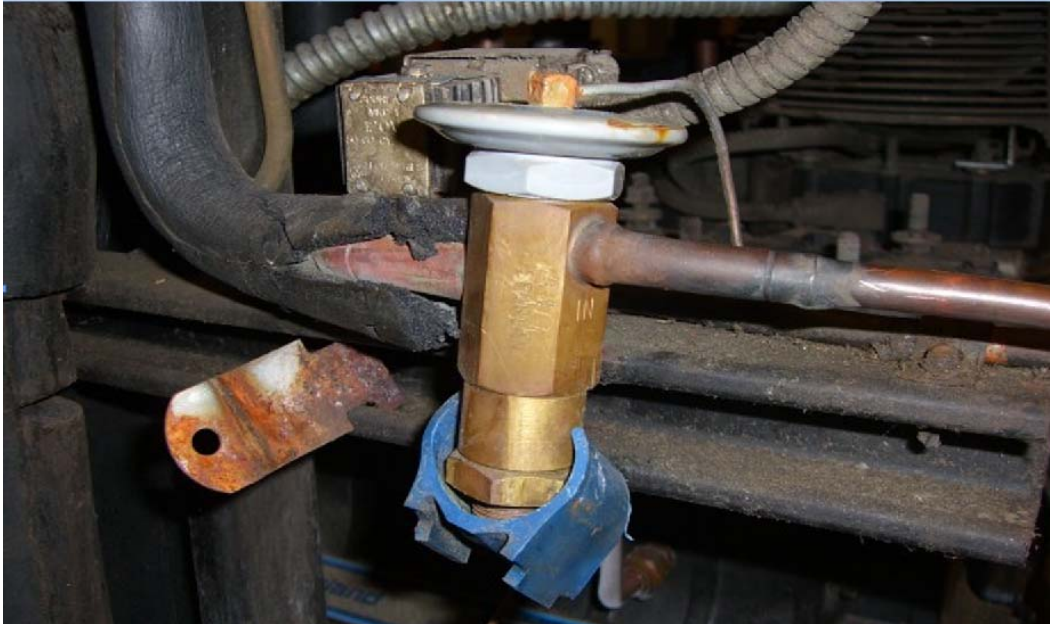
**Figure 4: Image of broken clamp caused by vibrations**

- **Vibration.** Most vibrations in refrigeration systems occur on or near the compressor discharge lines and are caused by gas pulsations. If severe, discharge line vibrations can result in broken lines or fittings, as seen in Figure 4.

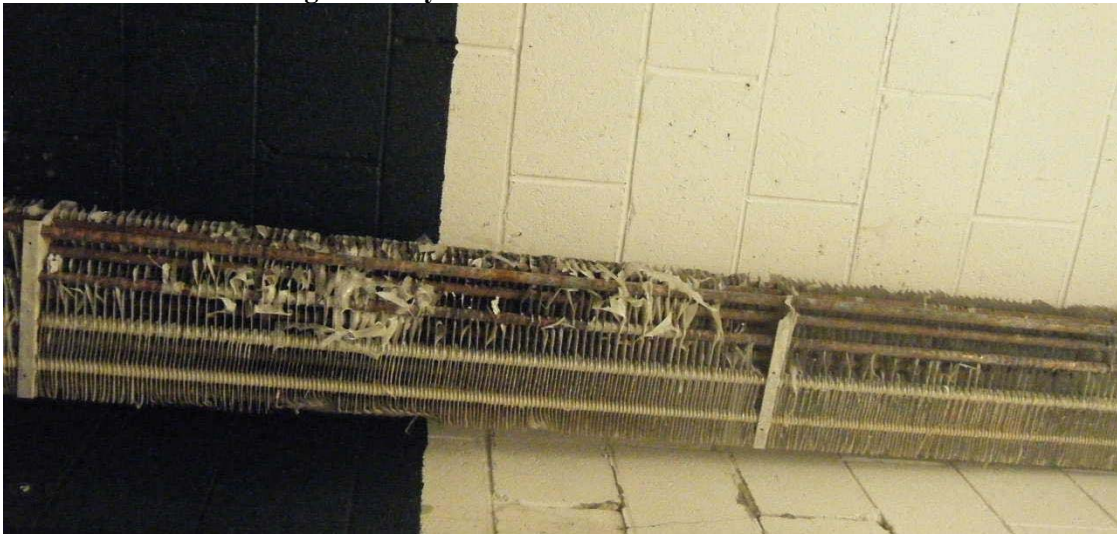
**Figure 5: 3-year old uncoated service deli coil**

- **Corrosion.** Copper evaporator coils in contact with food acids such as vinegar may corrode over time and develop pinhole leaks, as seen in Figure 5. Corrosion leaks can also occur on compressor rack components from condensation forming or dripping on steel rack components. Incompatible or improperly used cleaning materials also cause corrosion. Technicians should only use cleaning agents that are compatible with the refrigeration components—especially the evaporators and associated piping.

- ✓ *Ensure equipment located in vulnerable environments has epoxy or phenolic coatings on fin-tube surfaces, refrigerant piping, or other components that are subject to corrosion. Vulnerable equipment may include service deli cases that are in contact with vinegar-containing products and rooftop condensers that are located near the coastline or a chemical plant.*

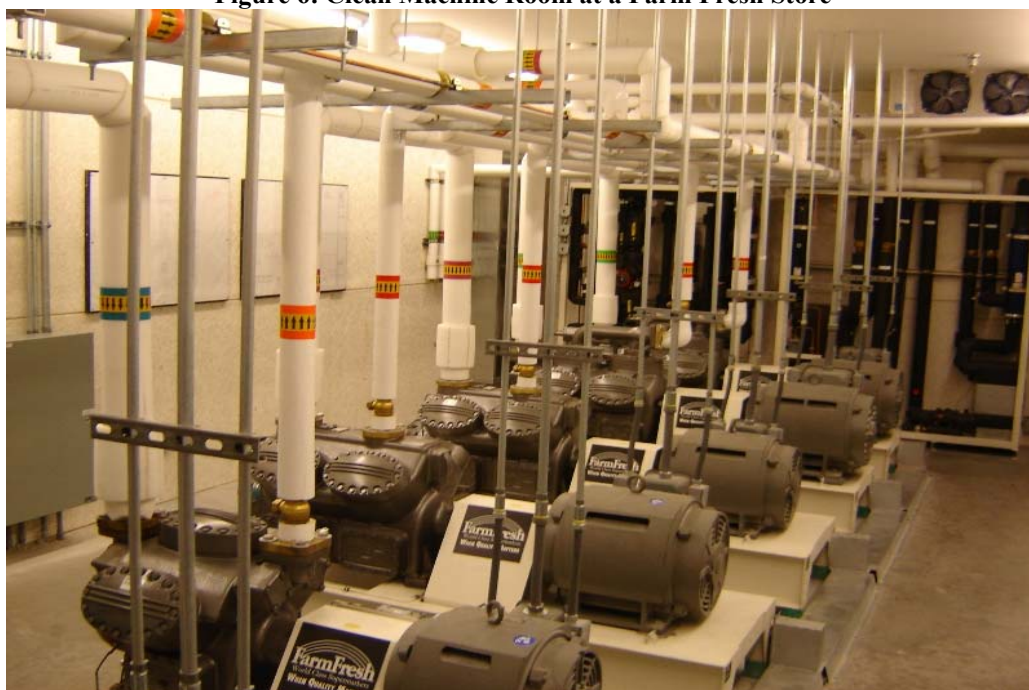
**Figure 6: Clean Machine Room at a Farm Fresh Store**

A clean and uncluttered mechanical room provides a safe and accessible environment for service technicians and sends a strong signal about a store's commitment to equipment maintenance and leak reduction. Dirty refrigeration compressor racks, air-cooled condensers, remote headers, and walk-in evaporator coils make it difficult for technicians to spot leaks and create the impression that a store is not concerned with the maintenance of equipment. Motivation of service technicians is key to the success of a leak reduction program. To instill a sense of pride in your service technicians, refrigeration racks as well as the entire mechanical room should be kept as clean as possible. Compressor racks and their components should be free of oil and dirt. Corrosion on steel components should be removed and components painted with a rust-inhibiting paint to help prevent future corrosion. Mechanical rooms should not be permitted to be used as storage areas by the store personnel - besides the obvious safety concerns, the clutter reduces a technician's productivity, adds to his or her frustration, and increases maintenance costs. As a result, equipment and mechanical rooms should be cleaned at least annually. Oil spills and other substantial messes should also be cleaned as they occur.
