Identification, Management, and Proper Disposal of PCB-Containing Electrical Equipment used in Mines

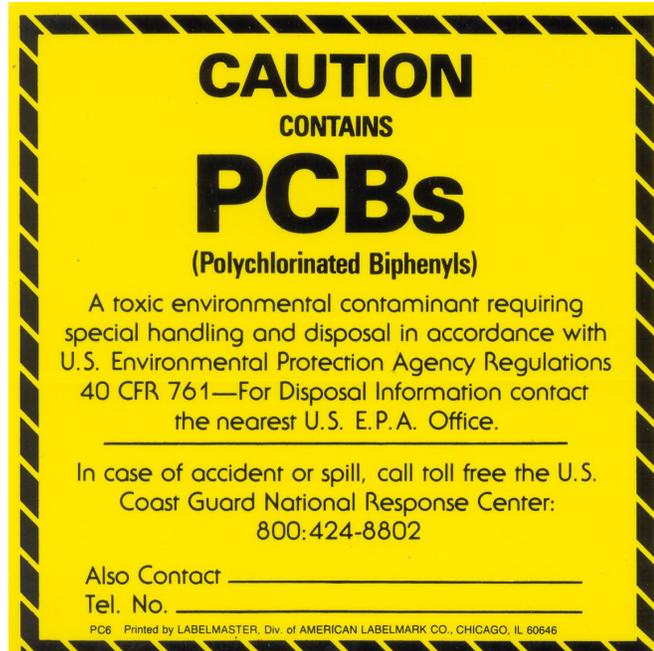
Fig. 1

This is a PCB Mark. Marks may also have a white background.

The regulations require transformers and capacitors containing three pounds or more of dielectric be identified by PCB Marks (Fig.1), placed on the equipment by the owner or user if they contain ≥ 500 ppm (0.05%) PCBs. They are designated PCB transformers or PCB capacitors. Mineral oil transformers containing ≥ 50 ppm (0.005%) PCBs are designated PCB contaminated transformers. All of the above are regulated for use and disposal. This does not necessarily mean that PCBs of lower concentrations or PCBs in small capacitors are not hazardous to human health and the environment. For purposes of this paper “PCB-containing” means dielectrics containing any detectable quantity of PCBs.

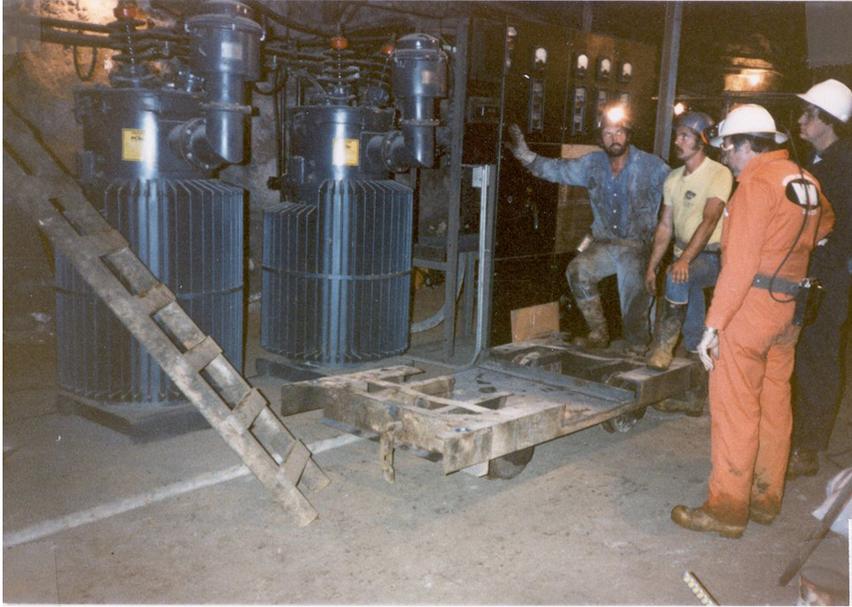
Fig. 2

76-gallon PCB (Pyranol) Transformers in the Eagle Mine at Gilman, Colorado, 1984

PCB transformers (Fig. 2) may carry a PCB trade name on the manufacturer nameplate. The regulations require the assumption "...that a transformer manufactured prior to July 2, 1979, that contains...fluid other than mineral oil and whose concentration is not established, is a PCB Transformer..." and contains ≥ 500 ppm PCBs. If the date of manufacture or the type of dielectric fluid is unknown, the transformer must be assumed to be a PCB transformer. PCB concentrations must be established by chemical analysis or testing using SW 846-Method 8082 and other methods¹² (see ASTM D-4059) to document compliance with the regulations. Rebuilt transformers may carry replacement nameplates that do not correctly identify the dielectrics.

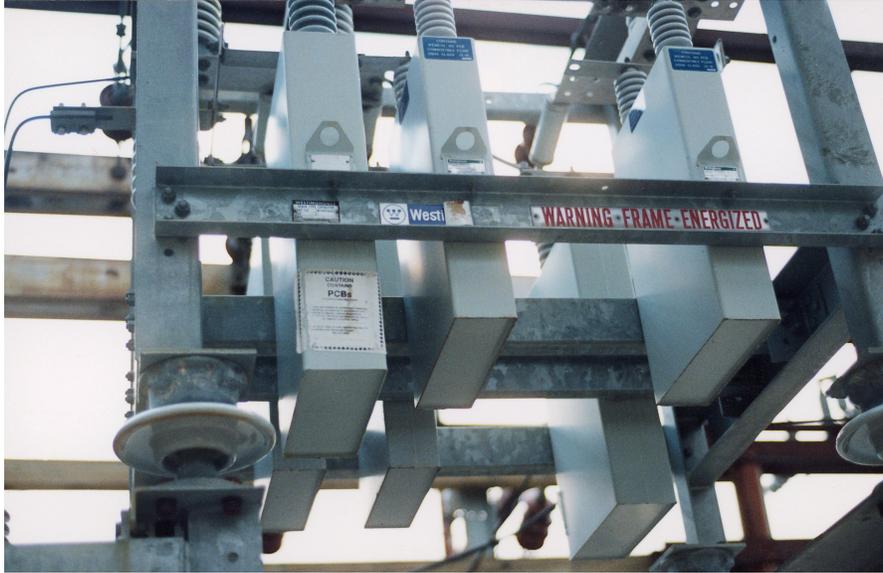
Fig. 3
PCB Marked Capacitor on the left

By 1976, 95 % of the capacitors produced in the United States were filled with PCBs¹³ (Fig.3). PCB capacitors contain the pure aroclors, 1242 or 1016. Manufacture before July 2, 1979, or a PCB trade name on the nameplate is a good indicator of high concentration PCBs. The regulations require the assumption “that a capacitor manufactured prior to July 2, 1979, and whose PCB concentration is not established, contains ≥ 500 ppm PCBs” and is a PCB capacitor. If the date of manufacture is unknown the capacitor must be assumed to be a PCB capacitor and assumed to contain ≥ 500 ppm PCBs. Because most capacitors are sealed units, that testing will require penetration of the casing that may destroy their usefulness and result in leaks which must be eliminated or contained. A helpful aid in identifying capacitors that do not contain PCBs is that the regulations require capacitors manufactured between 1978 and 1998 be marked “No PCBs” by the manufacturer.

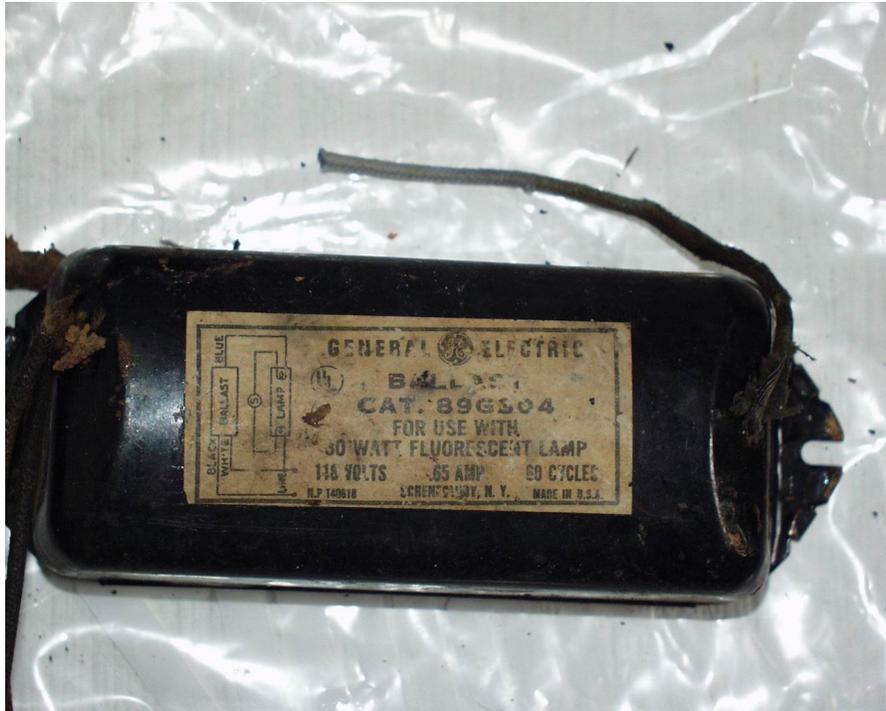
Fig. 4
Fluorescent Light Ballast

Typical fluorescent light ballasts (Fig. 4) manufactured before May 31, 1979, contain a small capacitor buried in the tar or asphalt potting material filling the ballast that functions as an insulator. These capacitors hold about an ounce of aroclor. Asphalt material in fluorescent light ballasts manufactured before 1978 has been found to have a better than 50% chance of containing regulated levels of PCBs.¹⁴ A helpful aid in identifying light ballasts is that the regulations require that ballasts manufactured between July 1978 and July 1998 be marked "No PCBs" by the manufacturer.

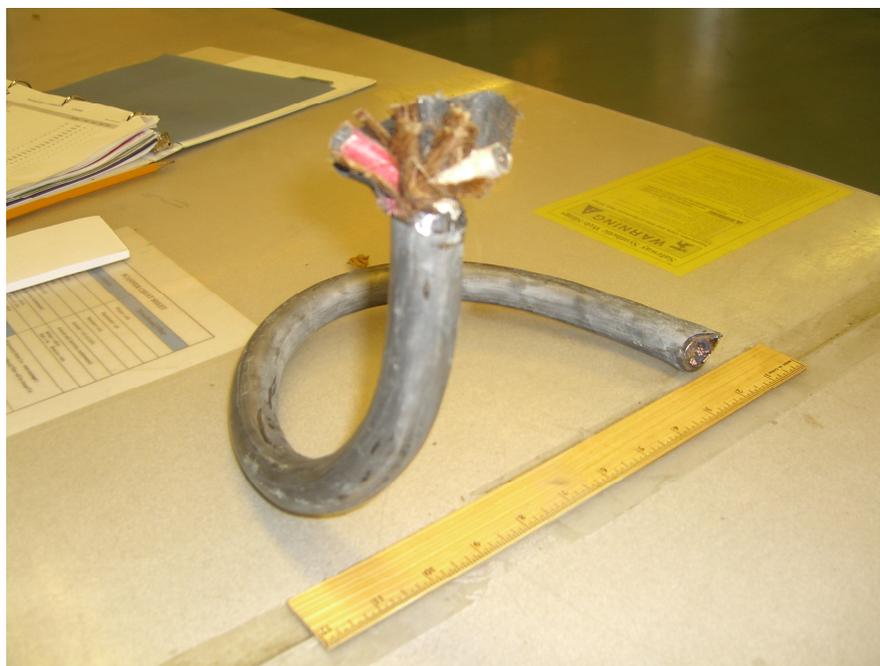
Fig. 5
Lead Jacket Electrical Cable

Electrical cable (Fig. 5) can contain PCBs. In some cases, the cable is enclosed in a lead jacket which makes it difficult to handle. If electrical cable contains liquids or damp insulation, PCBs should be suspected.

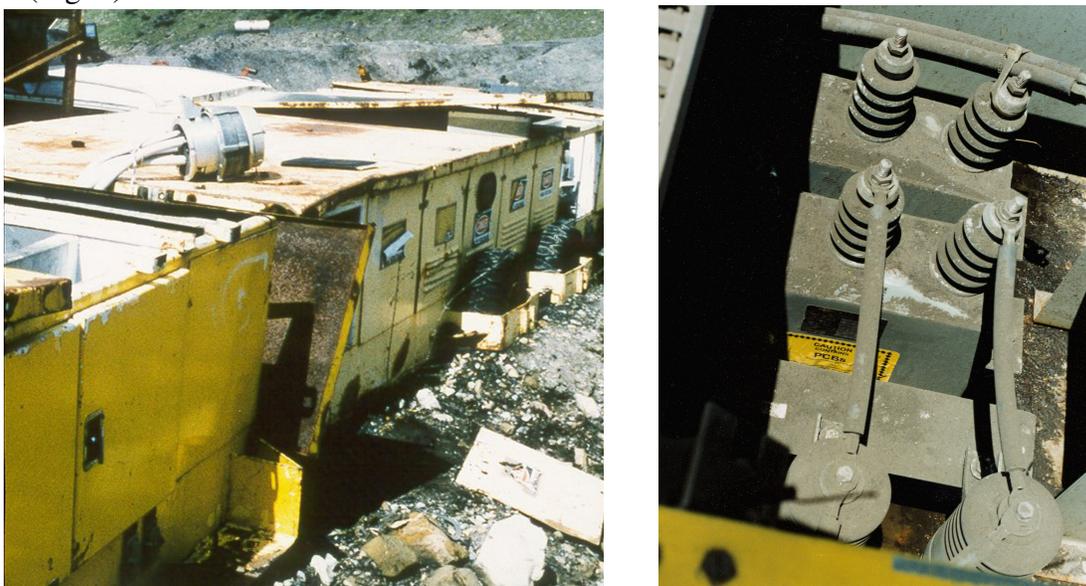
Fig. 6

Coal Mine Power Center containing PCB Capacitors

Underground and surface mines and the attendant crushing, milling, and smelting facilities may use PCB-containing electrical equipment. PCBs are most likely to be in transformers, capacitors, fluorescent light ballasts, cable, and drums of unidentified oils. Underground inspections have revealed transformers grouped in permanent substations, located singly, or mounted on mine cars that can be transported throughout the mine. Capacitors are found in locations similar to those of transformers. PCB capacitors have been found in electric locomotives. In coal mines, PCB capacitors have been found in wheel or skid-mounted power centers (Fig. 6).
