December 18, 2018

Project No. 30401358

**RE: DNAPL RECOVERY ACTIVITIES QUARTERLY REPORT – 3RD QUARTER 2018
UNION PACIFIC RAILROAD HOUSTON WOOD PRESERVING WORKS FACILITY
4910 LIBERTY ROAD FACILITY, HOUSTON, TEXAS
POST-CLOSURE CARE PERMIT NO. HW-50343; INDUSTRIAL SWR NO. 31547**

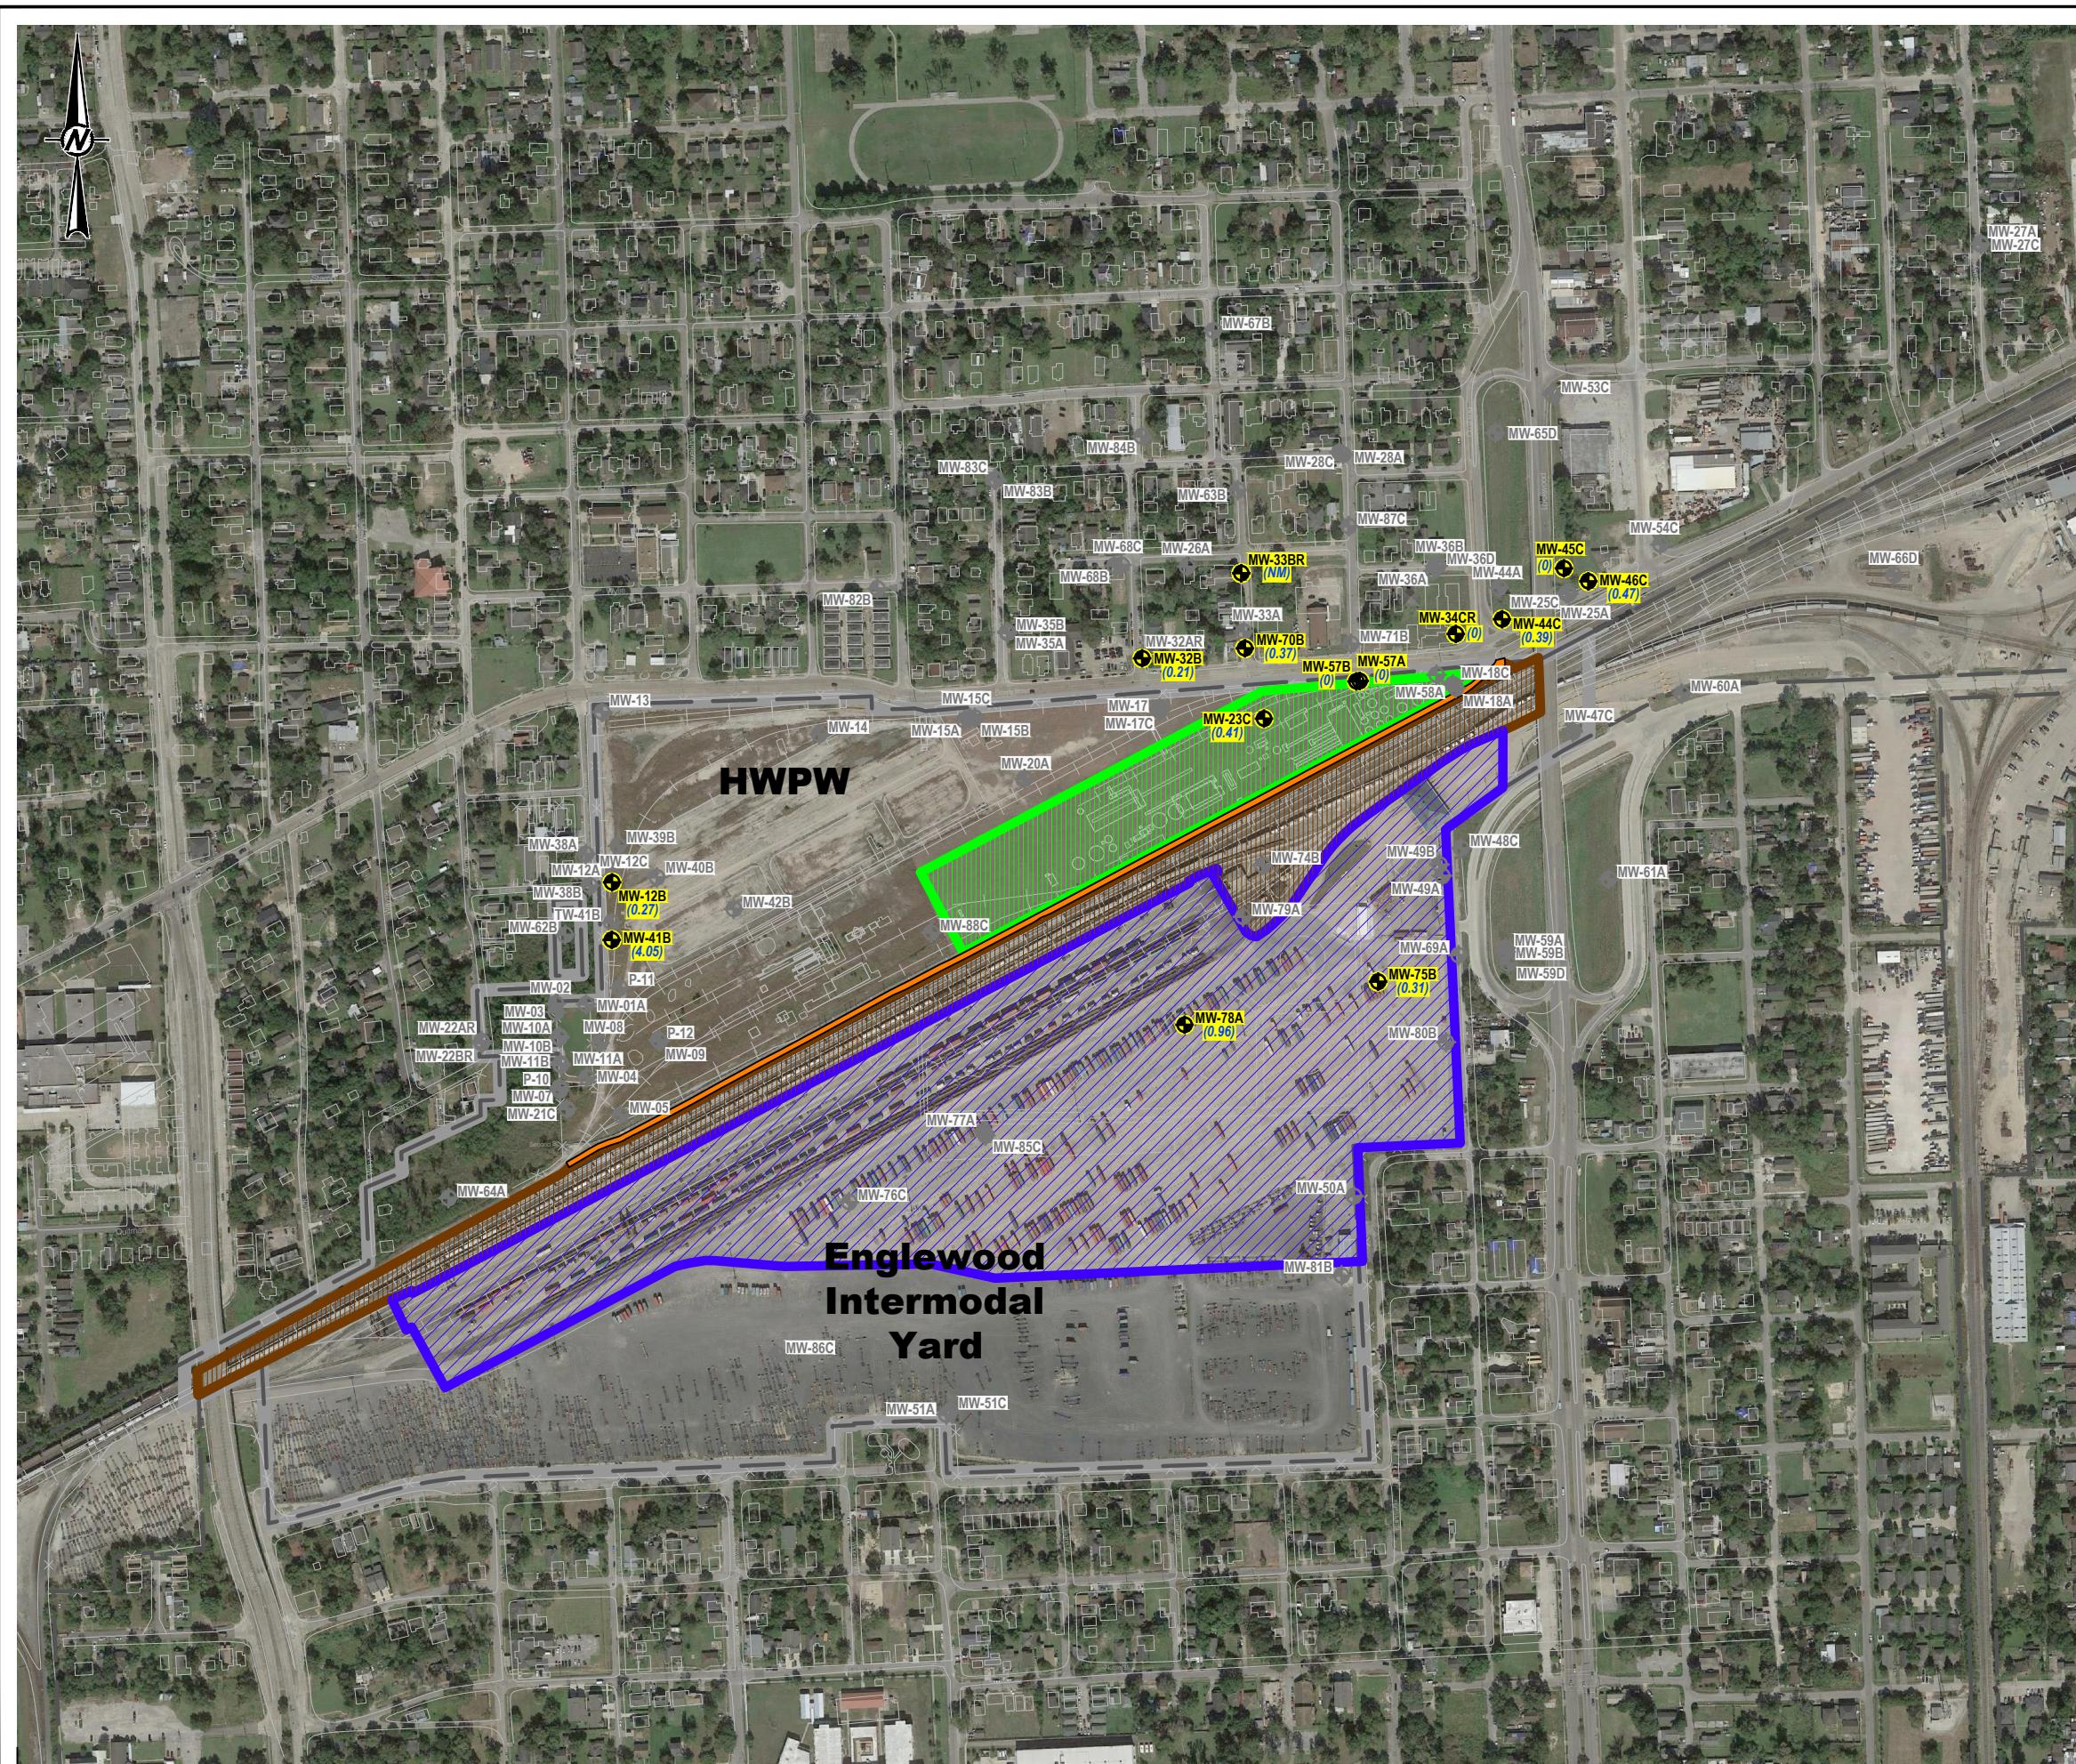
PROJECT NO. 30401358 REV. 0 FIGURE 1

Figure 1 shows the location of the DNAPL recovery wells.

TITLE
IN-WELL DNAPL THICKNESS
SEPTEMBER 2018

- B-TZ/B-CZ Wells: At the beginning of the recovery activities, monitoring wells with the thickest DNAPL measurements included MW-12B and MW-41B on the west side of the Site (Figure 1). DNAPL thicknesses increased following the February 2013 recovery event in MW-12B (May 2013) and in MW-41B (June 2013). However, DNAPL thicknesses in well MW-12B gradually decreased from 8.18 feet in May 2013 to 0.11 feet thick in August 2015, with a slight increase to 0.65 feet from August 2015 to February 2016. Since February 2016, the DNAPL thickness in MW-12B has fluctuated between 0.19 feet (August 2018) to 0.6 feet (September 2017).

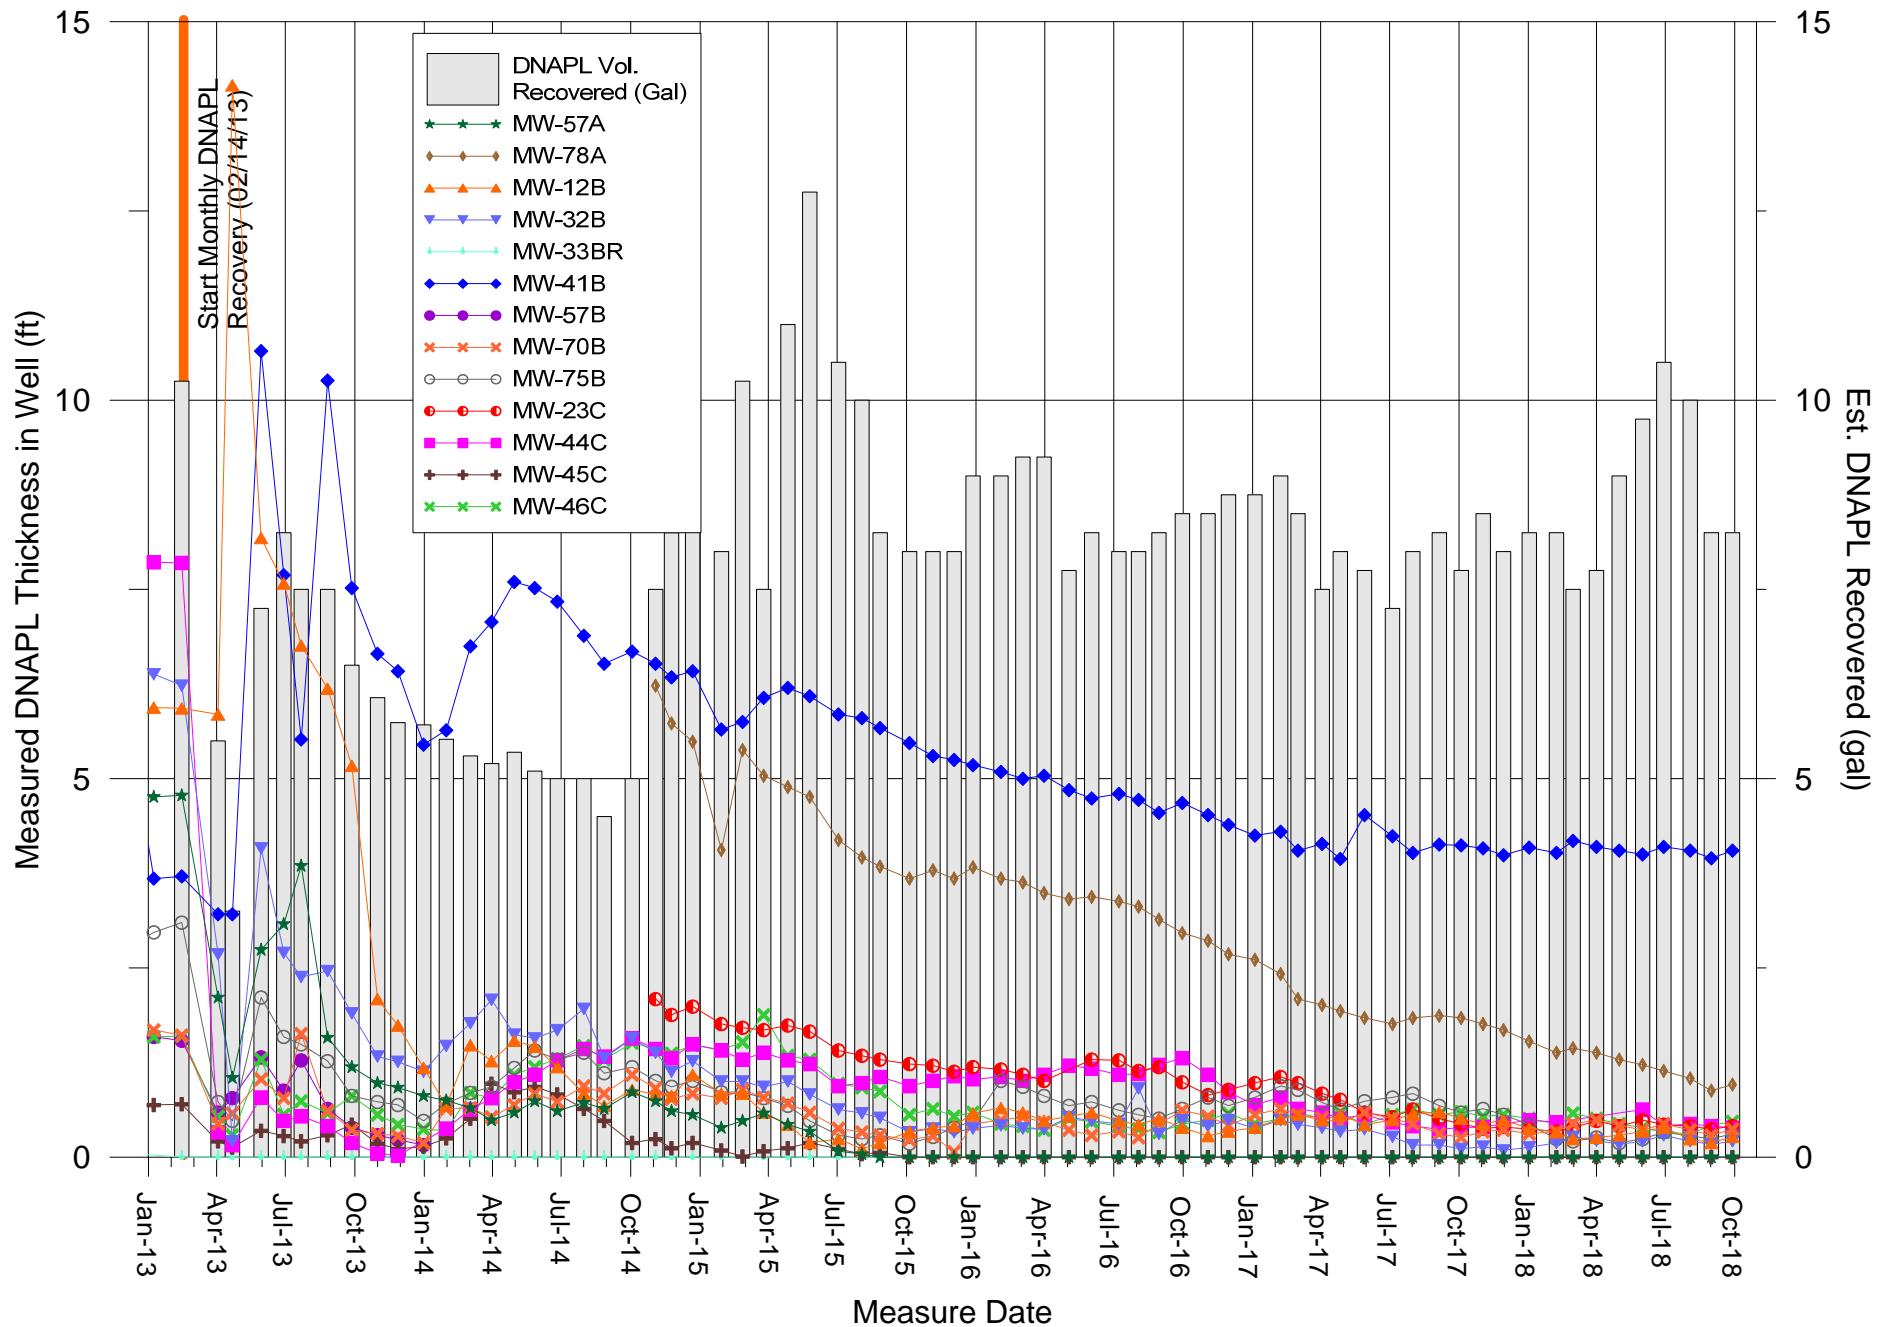
Figure 2
DNAPL Recovery Activities February 2013 - September 2018
UPRR Houston Wood Preserving Works

A summary of the DNAPL recovery measurements for the DNAPL activities from February 2013 through September 2018 is provided in Table 1. A graph of DNAPL thicknesses prior to each monthly recovery efforts over time is presented on Figure 2. Observations from the recovery activities are provided below:

- A-TZ Wells: Initially, MW-57A was the only well completed in the A-TZ Unit that contained DNAPL. DNAPL thickness decreased from 4.78 feet in February 2013 to less than 1 foot thick from October 2013 through January 2015 in MW-57A. DNAPL thickness decreased in MW-57A in January 2015 from 0.39 feet to not detected in August 2015. No DNAPL has been detected in MW-57A since August 2015 (approximately 37 months). Following installation of MW-78A in May 2014 in the Englewood Industrial Yard and detection of DNAPL in the well, MW-78A was incorporated in the recovery program starting in early November 2014. DNAPL thickness in MW-78A was measured at 4.06 feet (late January 2015), increased to 5.38 feet (late February 2015), and has steadily decreased to 0.96 feet (September 2018).

DNAPL thicknesses in MW-41B during the first months of the recovery activities increased to 10.26 feet (August 2013). Measured thicknesses through May 2014 fluctuated, then began a steady decrease over time, with a slight increase from January to May 2015, and from April to May 2017. Since August 2017, DNAPL thickness in MW-41B has been relatively stable over that period fluctuating only about 0.23 feet in the monthly measurements (3.95 feet to 4.18 feet) (Figure 2).

- C-TZ Wells: Similar to the wells measured in the other units, DNAPL thicknesses in the C-TZ wells MW-44C, MW-45C, and MW-46C significantly decreased over the first two months of recovery activities, with some sporadic increases from May through August 2013 (Figure 2). From December 2013 through early October 2014, C-TZ wells MW-44C, MW-45C, and MW-46C showed increasing DNAPL thicknesses with the largest increase at MW-44C increasing about 1.57 feet. Since August 2015, no DNAPL has been detected in MW-45C. MW-44C was unable to be measured during March, April, and May 2018 due to road construction activities that had covered the well. Before this interruption, the DNAPL thickness in MW-44C had remained relatively stable from July 2017 to February 2018, ranging from 0.37 feet (September 2017) to 0.46 feet (February 2018). The DNAPL thickness measurement in late September 2018 was similar to measurements from earlier in the year. DNAPL thickness in well MW-46C has fluctuated between 0.58 feet (March 2018) to 0.31 feet (August 2018) over the past six months. Well MW-34C was gauged in October 2013, and no DNAPL was measured in the well (the well historically had DNAPL sporadically present). In May 2014, replacement well MW-34CR was installed and is now gauged as part of the recovery program. However, no DNAPL has been detected in the well.

With the on-going monthly DNAPL recovery activities, the overall trend in DNAPL thicknesses over the past six months has been either 1) a stable or decreasing trend in the wells with a significant DNAPL thickness (MW-41B and MW-78A) or 2) a relatively stable trend for the wells with less than a foot of measurable DNAPL thickness. Based on the overall observations, the current recovery procedures are achieving the response action objective of removing the readily recoverable DNAPL from the wells as well as reducing the overall thicknesses. Therefore, there are no proposed changes to the recovery activities at this time.
