Subject: May 20-21, 2024, SSO Inspection Trip Report for the City of East St. Louis

Enclosed, please find a copy of the U.S. Environmental Protection Agency Inspection Trip Report that describes and documents the observations made by EPA inspectors in the City of East St. Louis on May 20-21, 2024. The purpose of the reconnaissance inspection was to observe portions of the city's sanitary sewer collection system.

Enclosure - NPDES SSO Inspection Trip Report

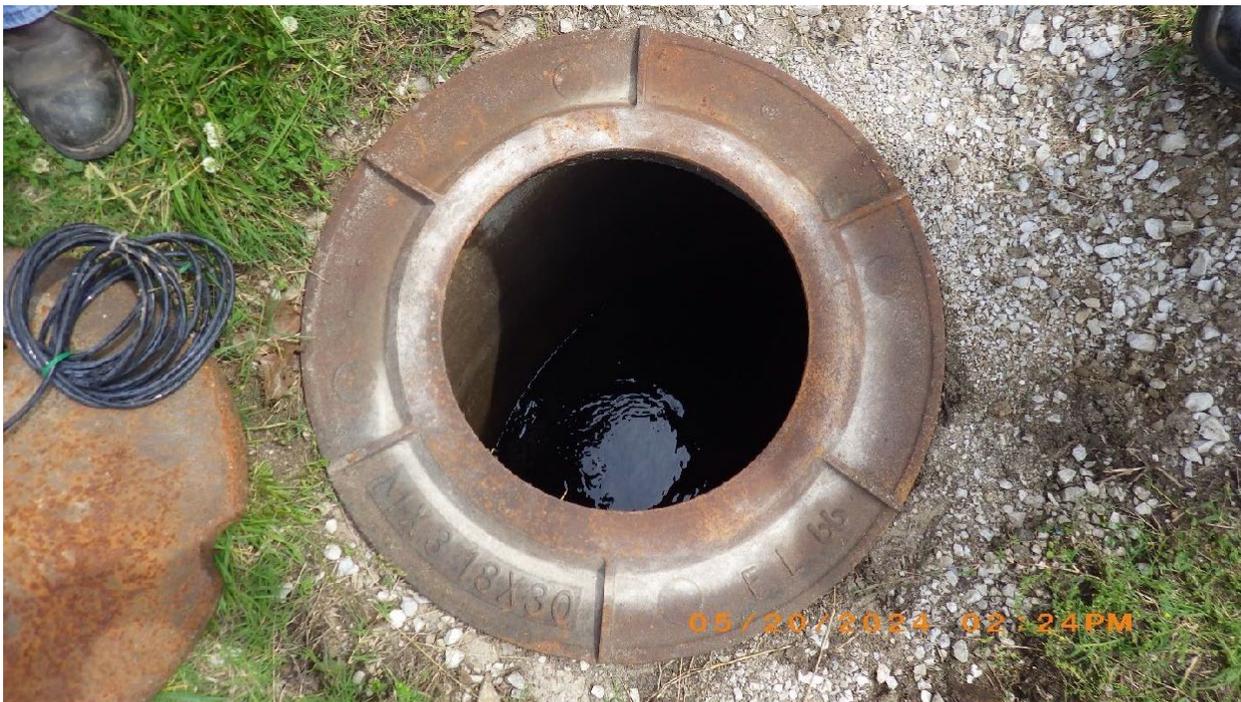
Photo 1: CCHS0412

On May 20, Inspectors Dean Maraldo and Eric Small met Mathew Missey and other CESL and City of Cahokia Heights representatives at the last manhole in the Cahokia Heights collection system before entering the Dayline Track sewer. The Cahokia Heights sewer staff removed the manhole cover and we observed high flow in the manhole indicating surcharged conditions (see Photo 1 below). After observing this manhole, Inspectors Dean Maraldo and Eric Small met with CESL representatives to observe a manhole along the Dayline Track sewer.

Description: Last manhole in the Cahokia Heights collection system before entering the City of East St. Louis Dayline Track sewer that runs along Ridge St. in this portion of the city. We observed high flow in the manhole indicating surcharged conditions.

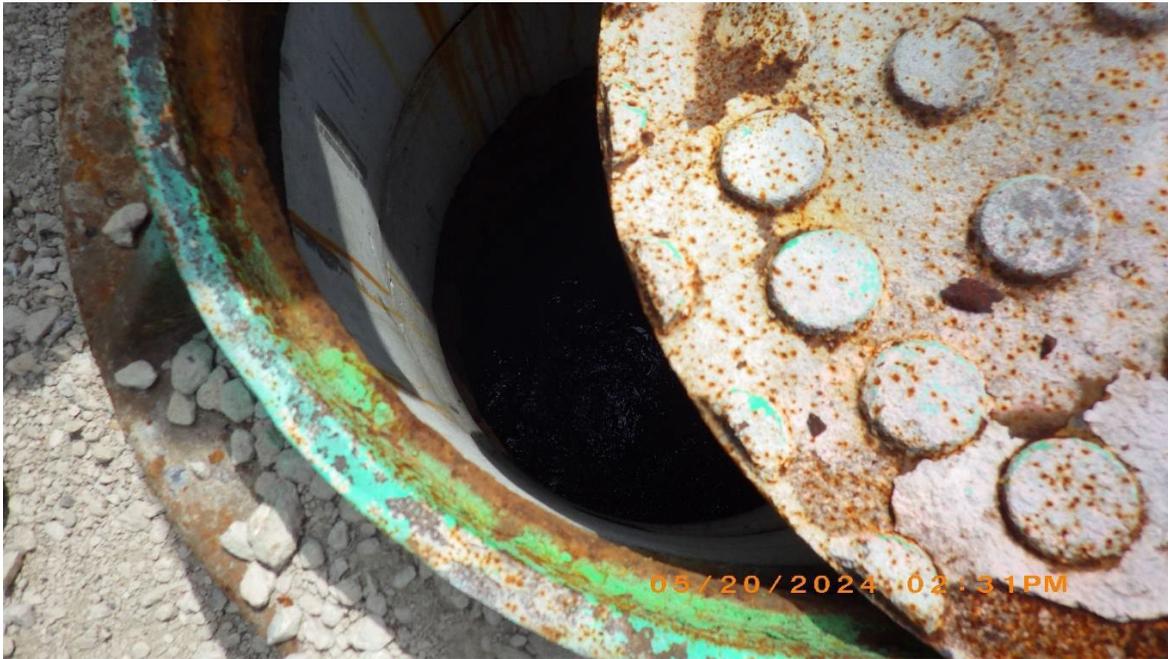
Photo 2: CCHS0413

Inspectors Dean Maraldo and Eric Small joined Mathew Missey and other CESL representatives at manhole #42 on the Dayline Track sewer (see Photo 2, below). EPA observed a high level of sewage in the manhole, indicating surcharged conditions downstream of the manhole. Mat Missey said there is an 8" sewer line that brings sewage from the Cahokia Heights sewer system into this manhole, then a 12" sewer line out of this manhole. EPA inspectors observed that the 12" outlet sewer line was nearly filled with sewage flow. We concluded the inspection at this point and agreed to continue the inspection and meet at CESL's 63<sup>rd</sup> St. Pump Station at 8:30 A.M. the next day (May 21).

Description: View inside CESL Manhole #42 on the Dayline Track Sewer.

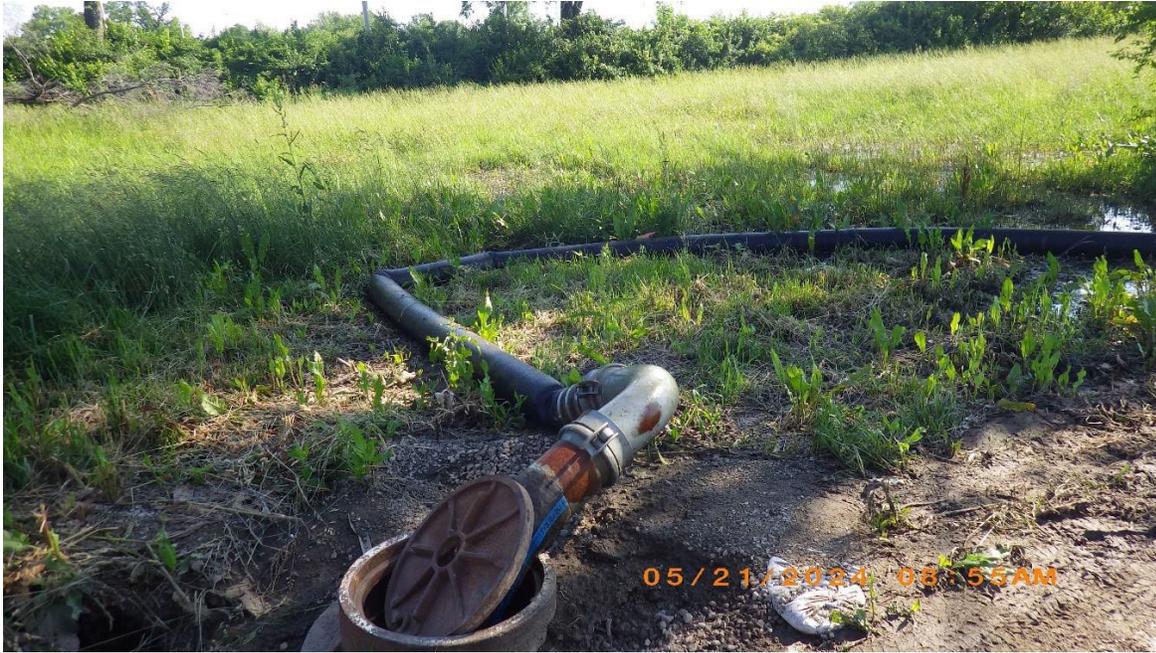
Photo 3: CCHS0424

Inspectors Dean Maraldo and Eric Small arrived at CESL's 63<sup>rd</sup> St. Pump Station at 8:30 A.M. on May 21, 2024. We met Mathew Missey and other CESL utility workers. The 63<sup>rd</sup> St. Pump Station represents the end of CESL's Dayline Track sewer. According to Mat Missey, the pump station normally operates a triplex system, with two pumps running and one pump serving as a backup. Due to pump failures, the pump station has been operating with one pump since October 2023. Two new pumps have been ordered. CESL applied for a grant (\$1.8 million) in pump station upgrades, including replacement of pumps. At the time of inspection, the pump station was running on one station pump and one portable 8" bypass pump (see Photos 3-5 below). Mathew Missey said he expected two portable bypass pumps to be in operation, including the 8" bypass pump and an additional 6" bypass pump. However, upon arrival on the morning of the inspection, he noticed only the 8" portable bypass pump was on site and operating. He later learned that the city removed the 6" portable bypass pump. After touring the pump station, we concluded the inspection at 9:15 A.M. on May 21, 2024.

Description: Portable 8" bypass pump hose from the Dayline Track sewer to CESL sewer main.

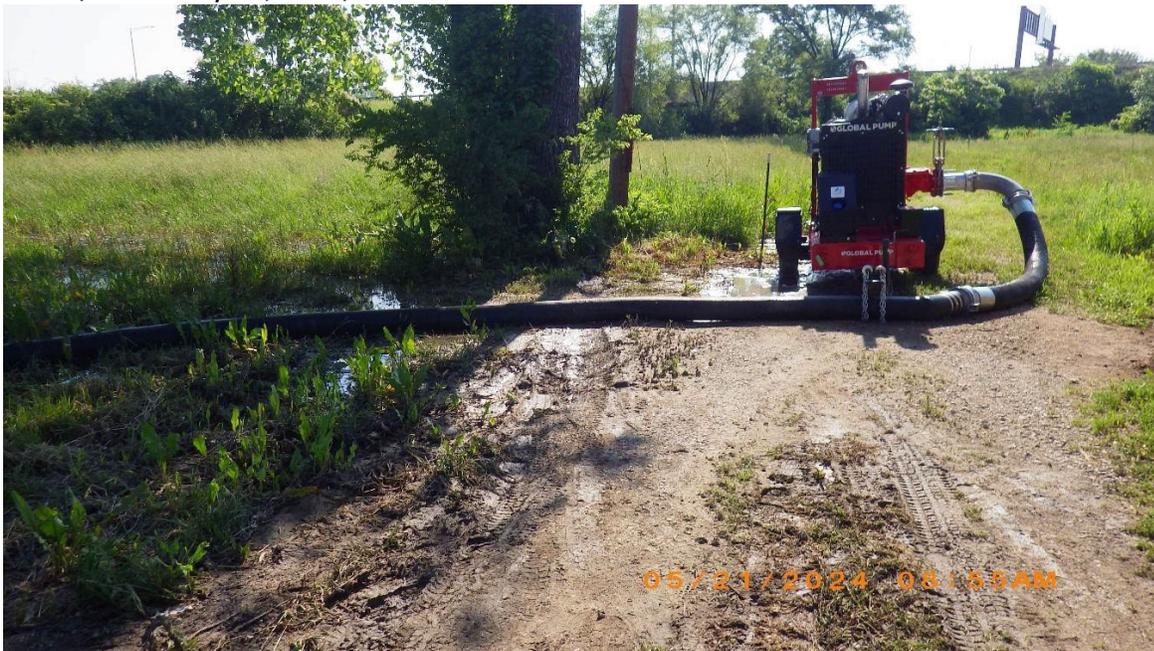
Photo 4: CCHS0425

Description: Portable 8" bypass pump.

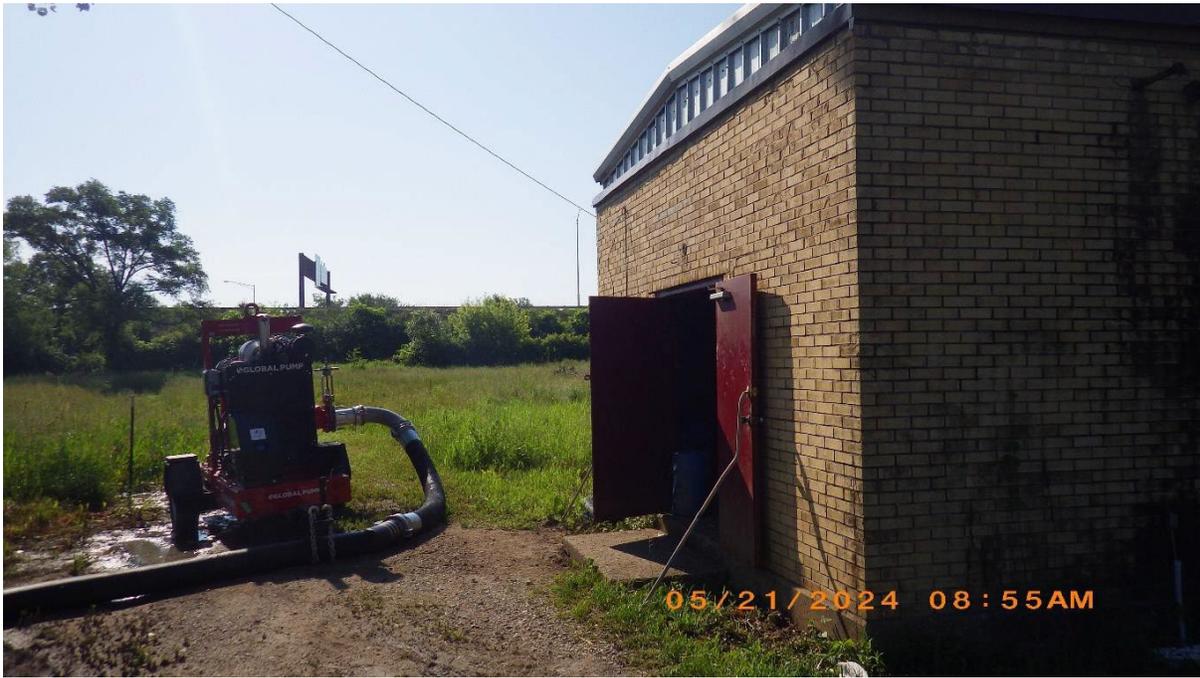
Photo 5: CCHS0426

Description: Portable 8" bypass pump and 63<sup>rd</sup> St. Pump Station building.
