**Municipality/Organization:** Town of Boxborough

**& Reporting Period:** No. 2: May 04 – May 05

## **NPDES PII Small MS4 General Permit Annual Report**

Re: Boxborough Transfer Station  
Semi-annual Groundwater Monitoring

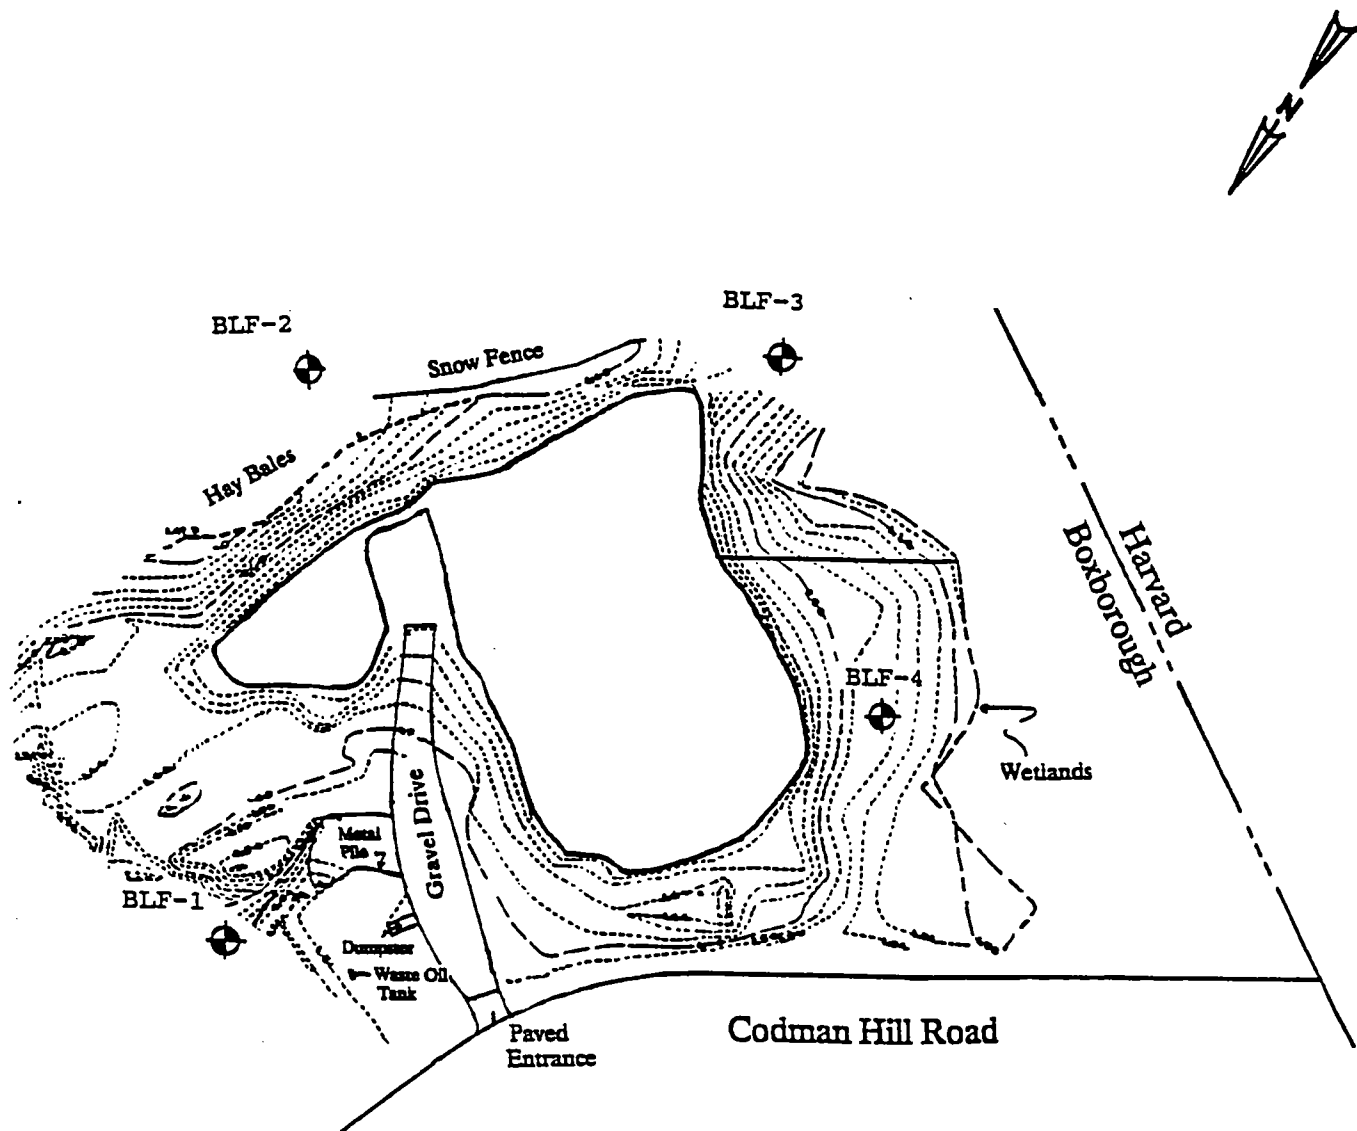
Monitoring Well Network  
Boxborough Landfill/Transfer Station

The Littleton Water Department sampled the monitoring well network at the Boxborough Transfer Station on December 11, 2003. Four monitoring wells (BLF-1 through BLF-4) were sampled and analyzed for volatile organic compounds (VOCs) via EPA method 524.2, Safe Drinking Water Act (SDWA) heavy metals and general water quality parameters. A surface water sample (SW-1) was collected from the wetland located on the southern side of the landfill and sampled for VOCs. A copy of the laboratory report is provided in Appendix A and field measurements with groundwater elevations are included in Appendix B.

Arsenic was detected in wells BLF-3 and BLF-4 at concentrations of 0.078 milligrams per liter (mg/L) and 0.078 mg/L, respectively. These concentrations exceed the US EPA standard of 0.05 mg/L. MTBE was detected in the groundwater sample from BLF-3 at a concentration of 0.94 micrograms per liter (ug/L). All other tested parameters were found to be within acceptable levels for both groundwater and surface water samples at the site.

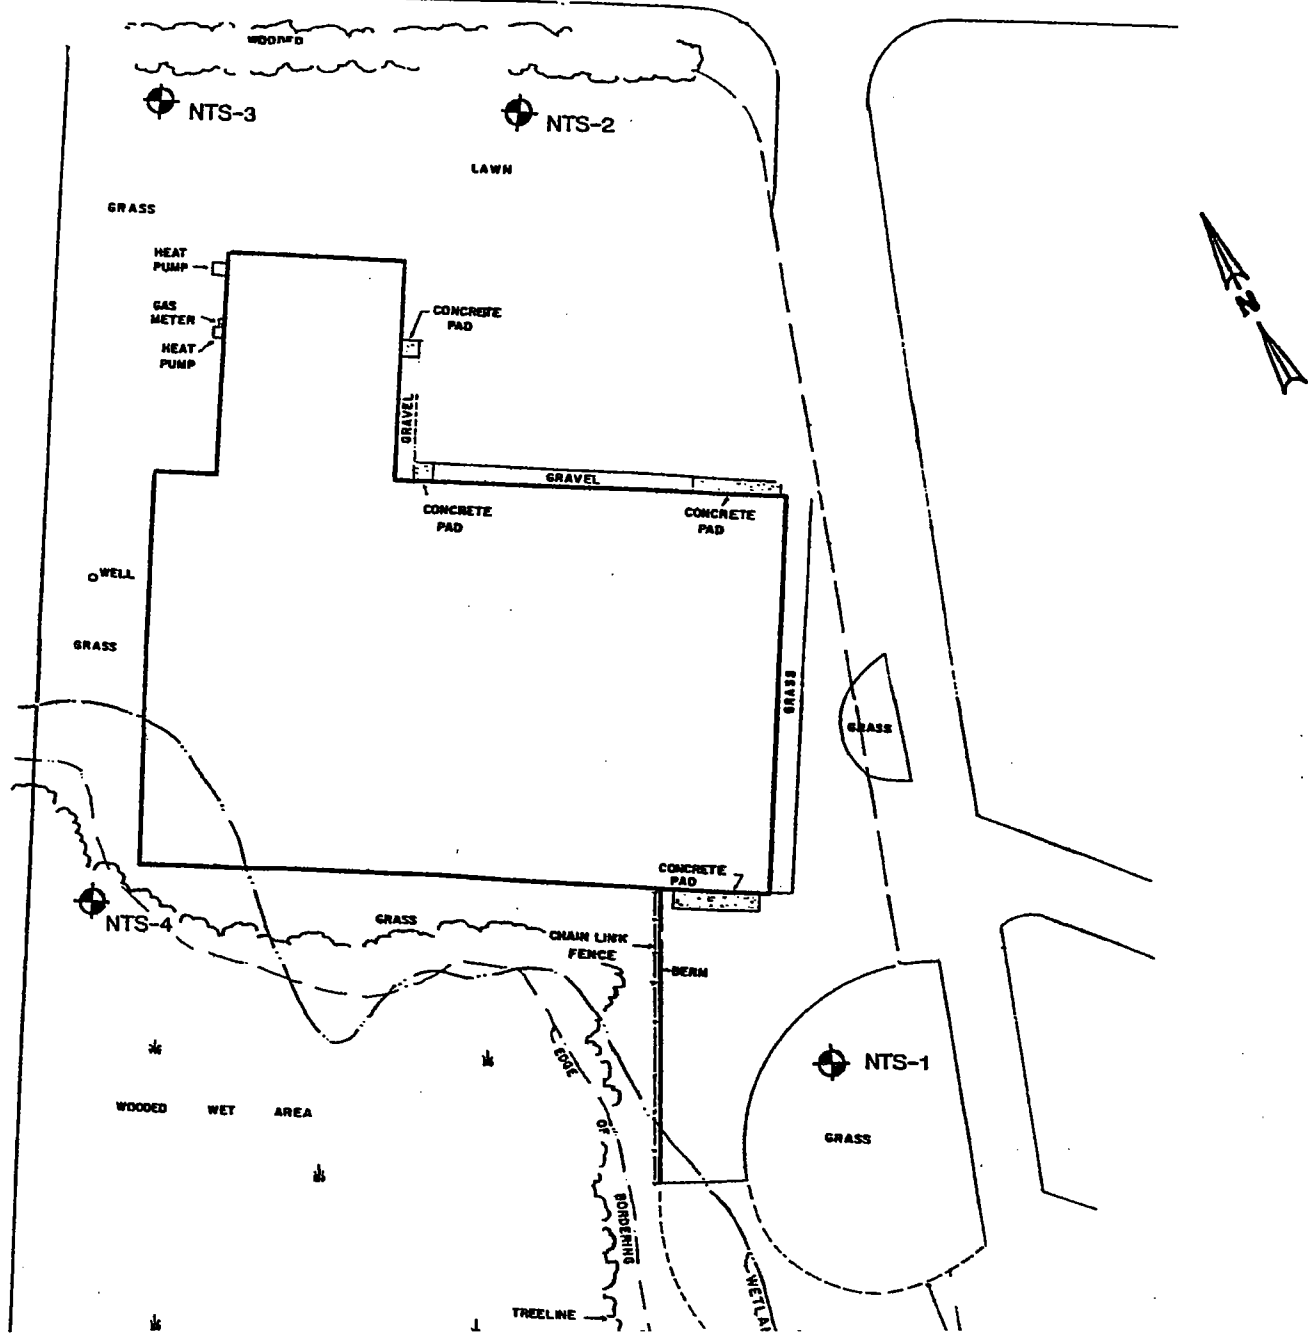
11.8?  
Nitrate levels were low across the site and no VOC's were detected. Groundwater samples from monitoring well NTS-2 exhibited elevated concentrations of sodium and chloride, which is likely the result of road salt on the driveway and along Massachusetts Avenue. All other groundwater quality parameters measured remain at acceptable levels. No SDWA metals were detected in the cooling tower effluent.

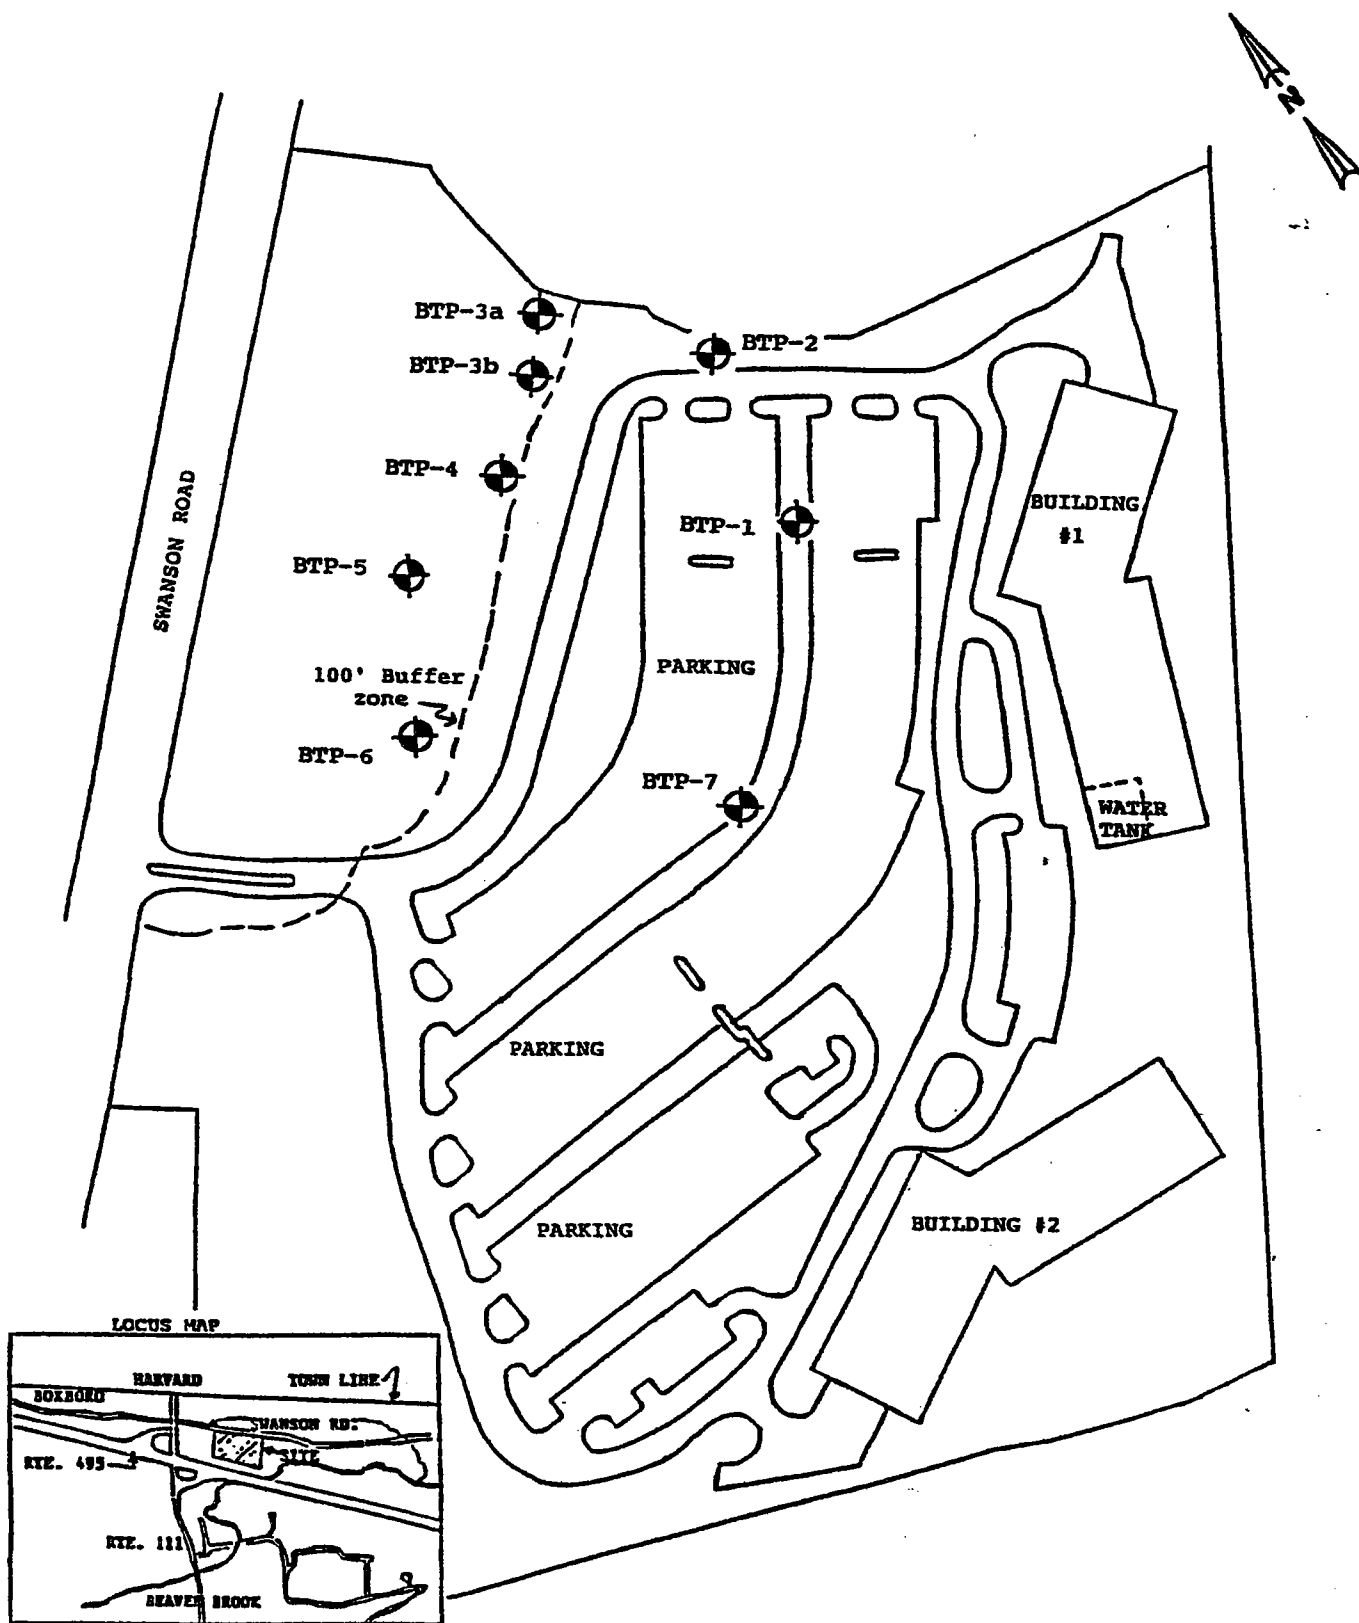
Monitoring Well Network  
Boxborough Technical Park  
Swanson Road

Elevated sodium was detected in wells BTP-1 and BTP-4 and most likely attributed to nearby road salting activities. No VOCs were identified in any wells and all other water quality parameters measured remain at acceptable levels.
