Year 4 Annual Report

New Hampshire Small MS4 General Permit

Reporting Period: July 1, 2021 - June 30, 2022

Town of Exeter

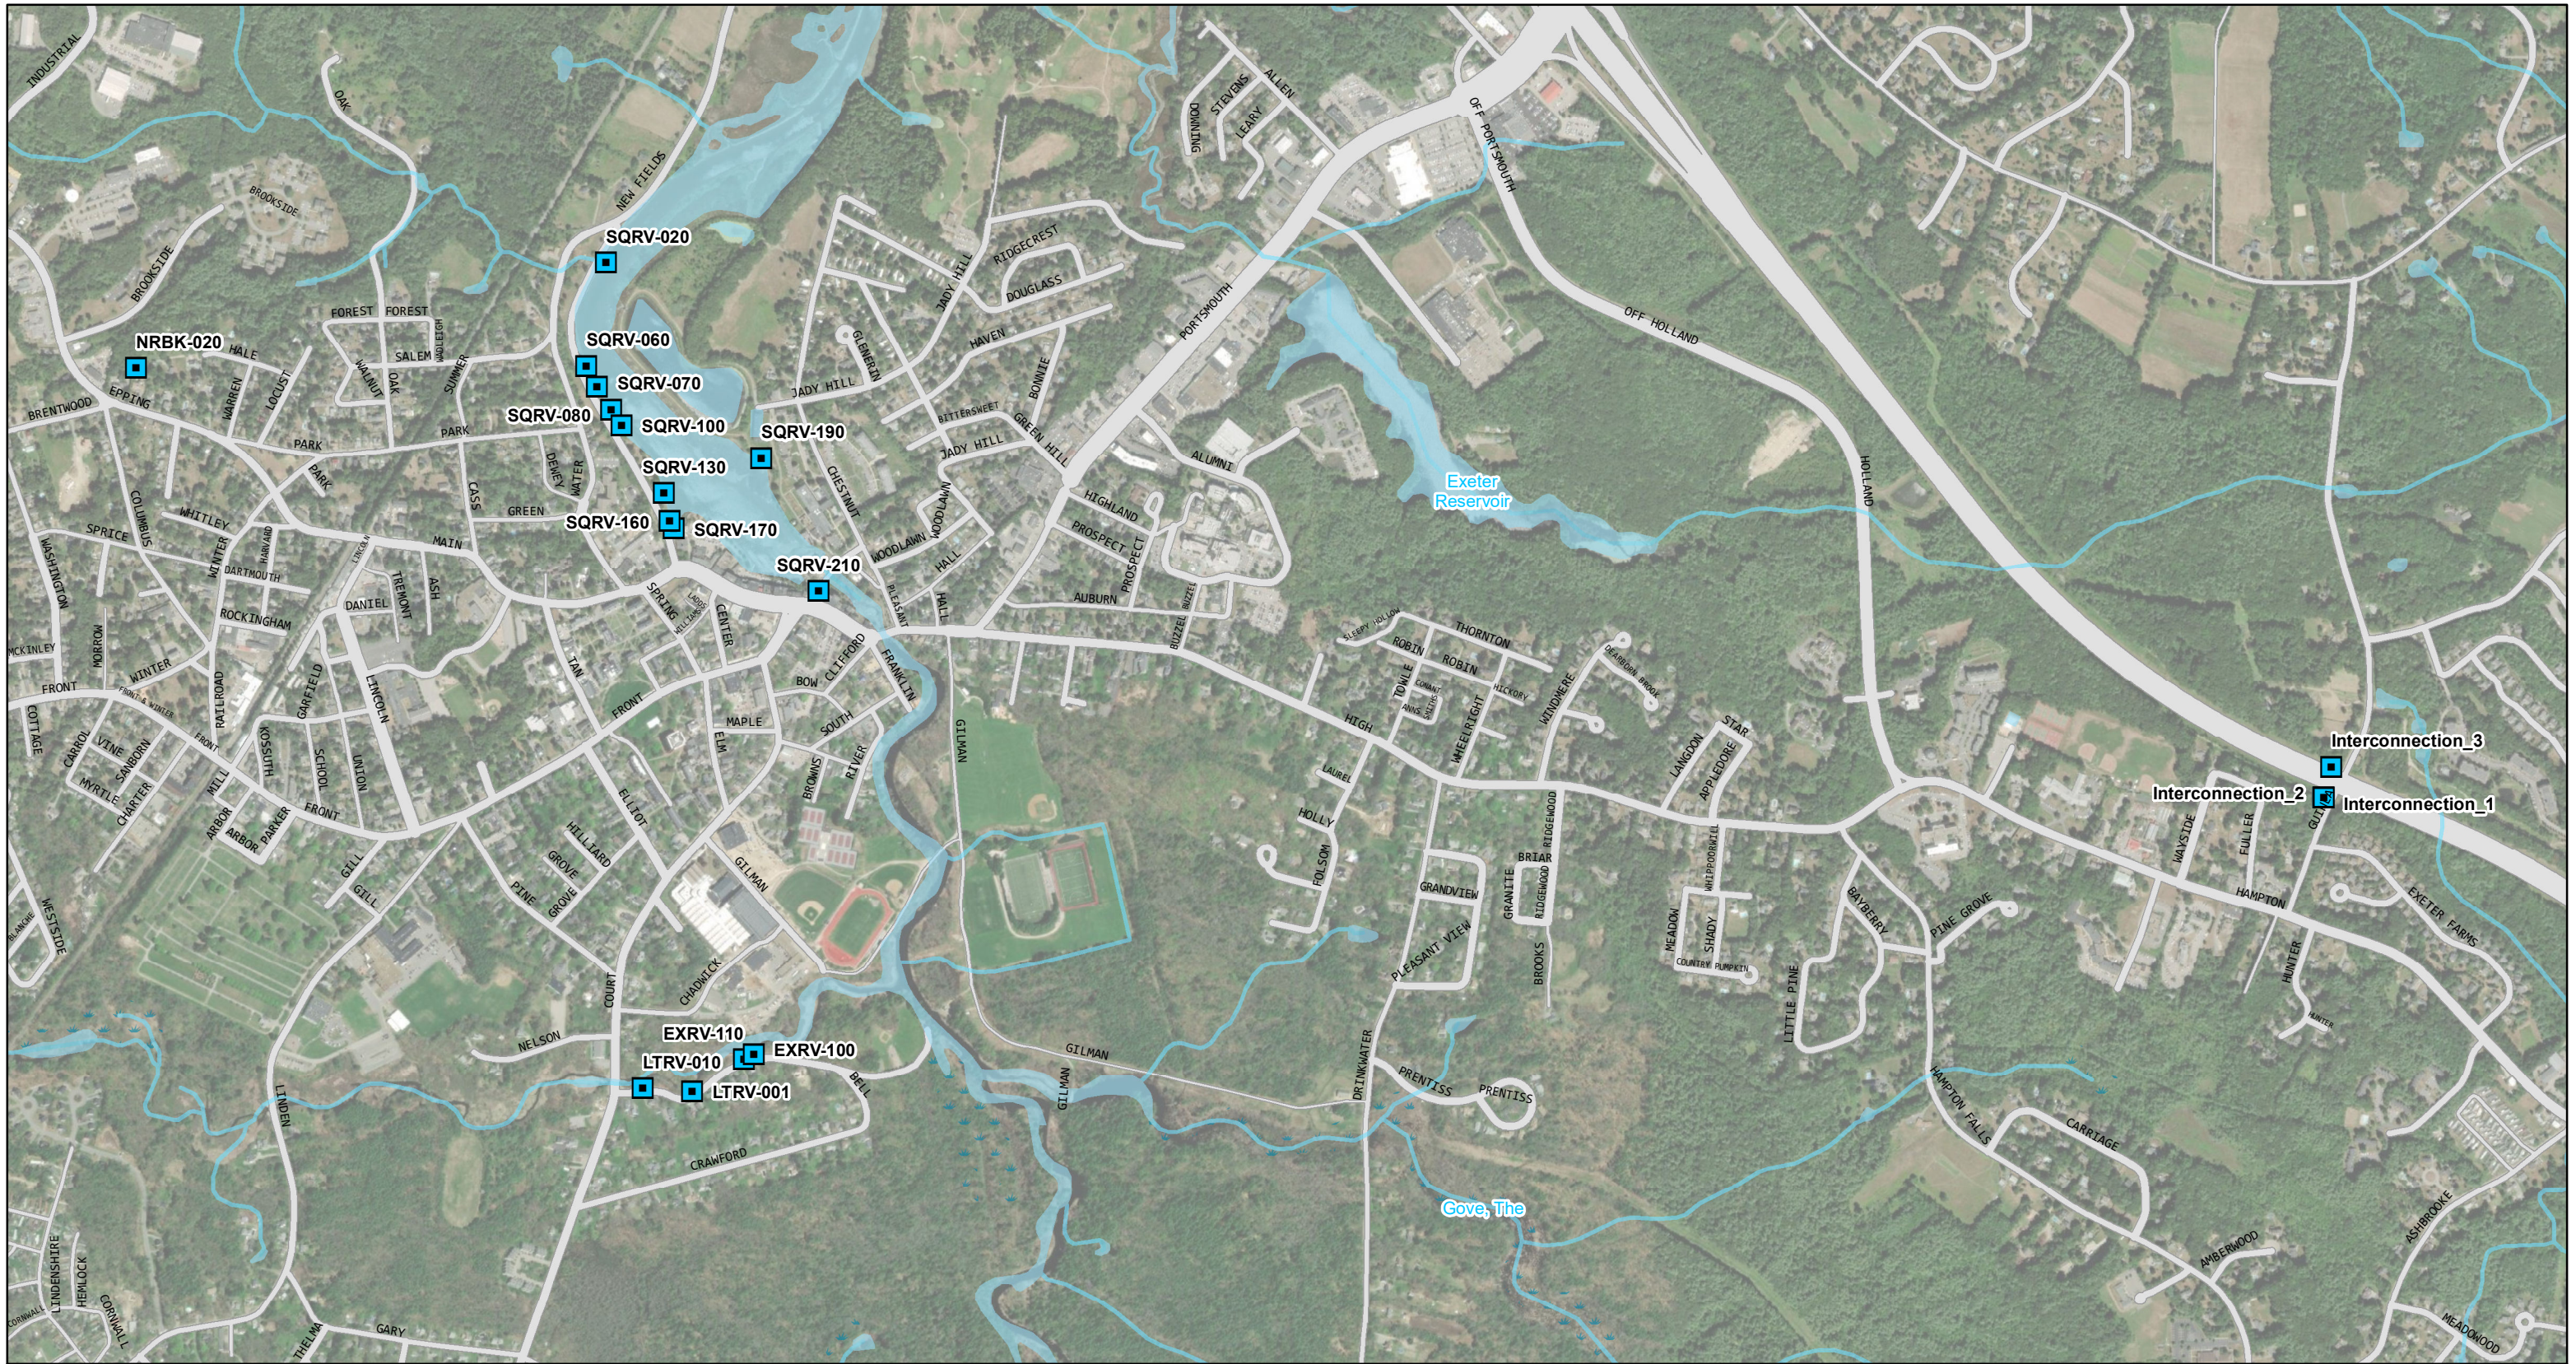
Dry Weather Outfall Sampling Locations	
Exeter	
Acton, MA	November 2021
Figure 1

The 18 outfalls (Figure 1) were evaluated and sampled (if dry weather flow was observed) on October 7, 2021 and October 8, 2021 following a period of at least 48 hours with less than 0.1-inch of rainfall¹. During the sampling event the 3 locations had dry weather flow and samples were collected. At the remaining 15 outfalls no flow was observed with 12 being dry and 3 with stagnant water. Per the IDDE Plan, these were not sampled. Additionally, at the Town's request outfall SQRV-090 was sampled. At the time of inspection, the outfall was submerged; however, flow was observed at the next upstream manhole and samples were collected. The status of each outfall is summarized in **Table 1**.

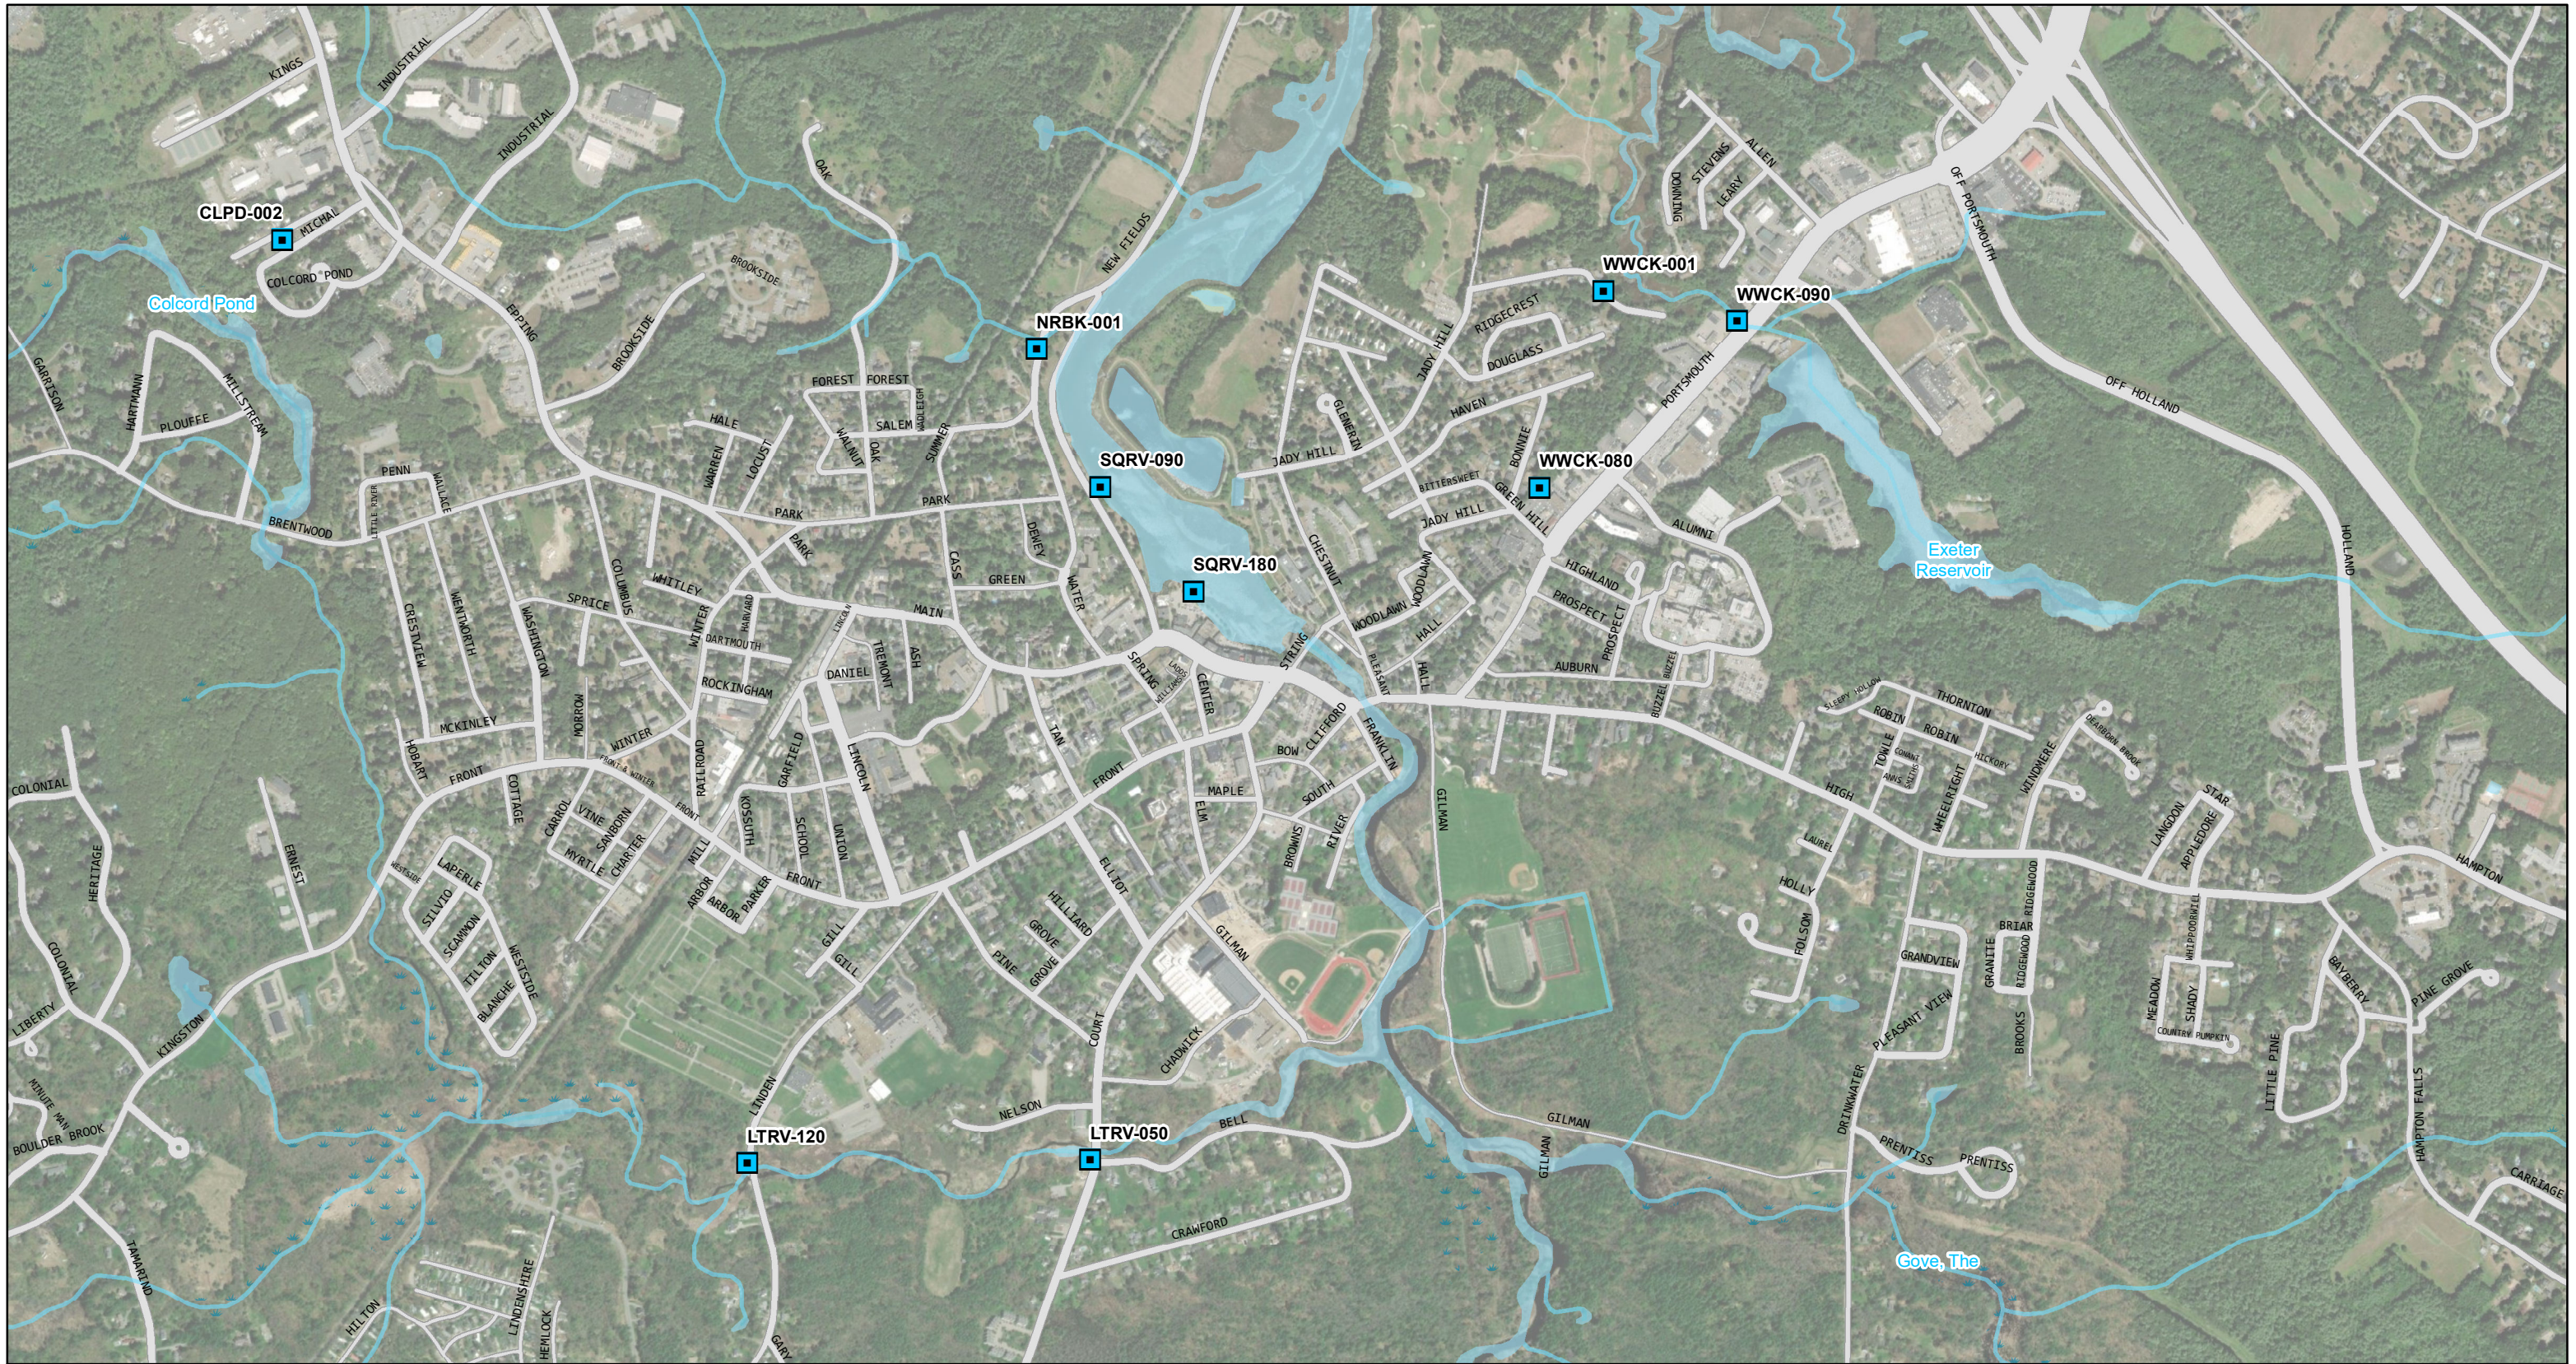
Additionally, 9 outfalls in the May 4, 2021 memo prepared by Wright-Pierce, were identified as requiring reinspection (Figure 2). The 9 outfalls were evaluated and sampled (if necessary) on October 22, 2021 following a period of at least 48 hours with less than 0.1-inch of rainfall. Of the 9 outfalls inspected, 2 had dry weather flow and were sampled. One outfall (SQRV-180) was unable to be located and therefore, the next upgradient catch basin was inspected, and flow was observed entering the catch basin during the initial inspection. However, prior to sampling the catch basin a vehicle had parked over the catch basin making it inaccessible and samples could not be collected. The 6 remaining outfalls did not have dry weather flow. The status of each outfall is summarized in Table 2.
