**RE: NPDES Phase II Small MS4 General Permit  
EPA Permit Number MA043025  
MassHighway Permit Year 10 Annual Report**

**& Reporting Period: No. 10: April 2012-March 2013**

## **NPDES Phase II Small MS4 General Permit Annual Report**

# Impaired Waters Program – Summary of NPDES Permit Year 10

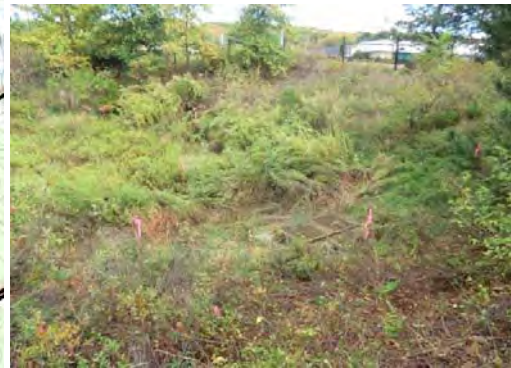
Existing extended detention basin was modified to increase capacity

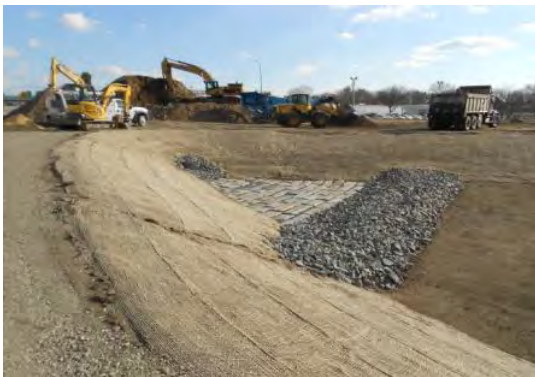
Construction of Infiltration Basin

MassDOT designed, permitted, and constructed **10 infiltration basins and 3 infiltration swales** to treat stormwater runoff from 9.38 acres of impervious cover of MassDOT roadways prior to discharge to Aberjona River as part of the Retrofit Project Initiative. These stormwater BMPs will achieve an estimated effective impervious cover reduction of **8.79 acres**. Additional BMPs have not been proposed due to site constraints. However, the possibility of additional reductions in effective impervious cover may be reviewed during future programmed project work and as standalone projects through the Retrofit Initiative.

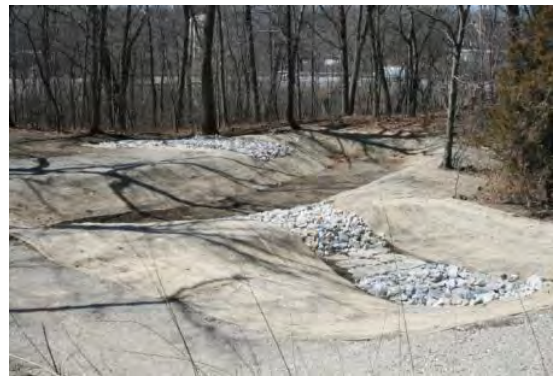
Construction of Infiltration Basin

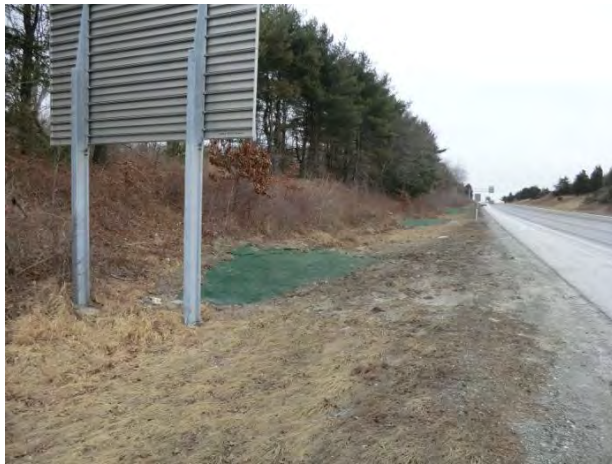
Construction of Infiltration Swale

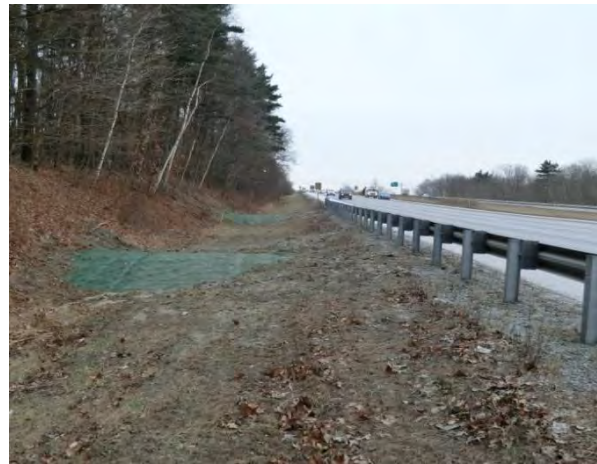
Construction of Infiltration Swale

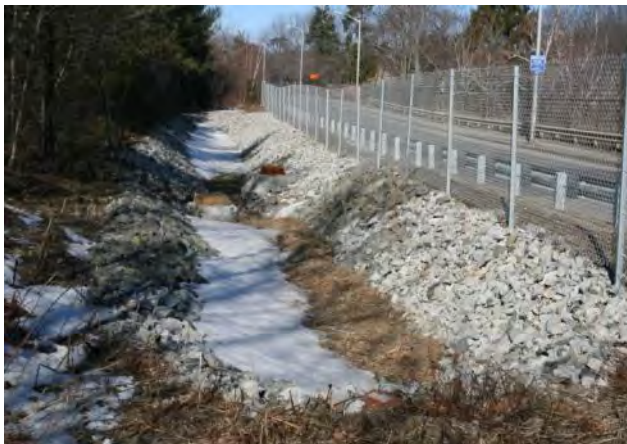
Construction of Infiltration Basin

MassDOT designed, permitted and constructed **1 infiltration basin and 1 dry detention basin** to treat stormwater runoff from 0.96 acres of impervious cover of MassDOT roadways prior to discharge to Burncoat Park Pond as part of the Retrofit Project Initiative. These stormwater BMPs will achieve an estimated effective impervious cover reduction of **0.82 acres** thus meeting the 9% impervious cover target.

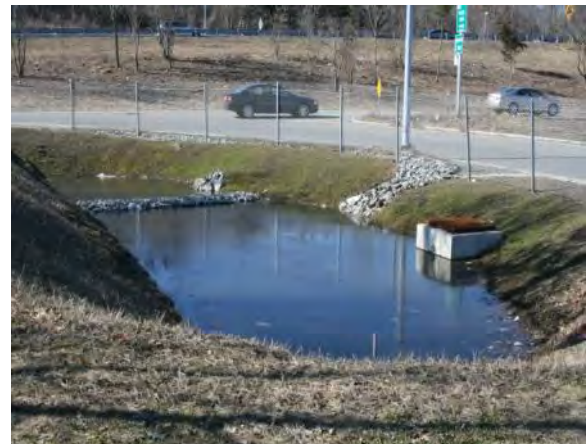
Construction of Dry Detention Basin

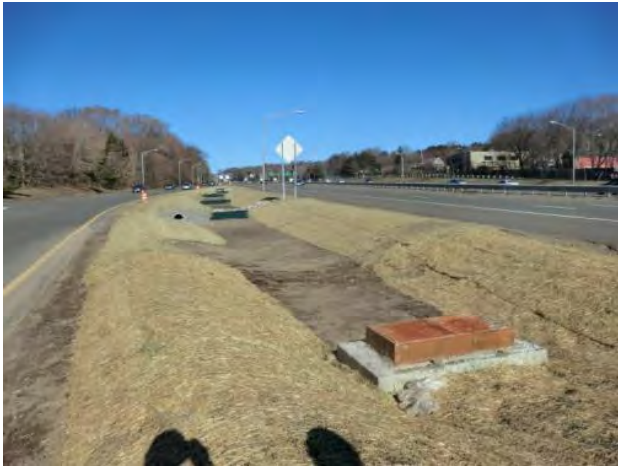
Construction of Infiltration Basin

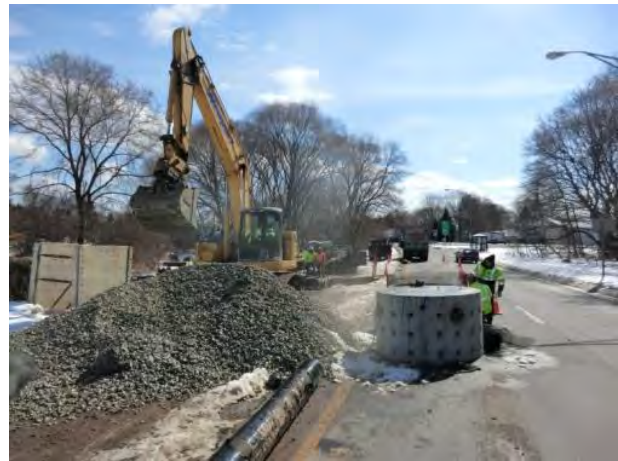
Construction of Leaching Catch Basin

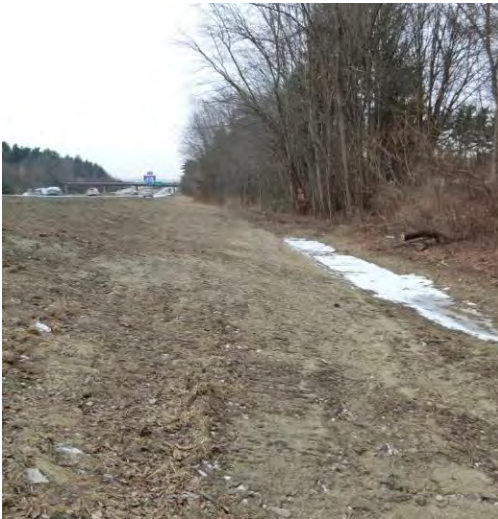
Construction of Infiltration Basin

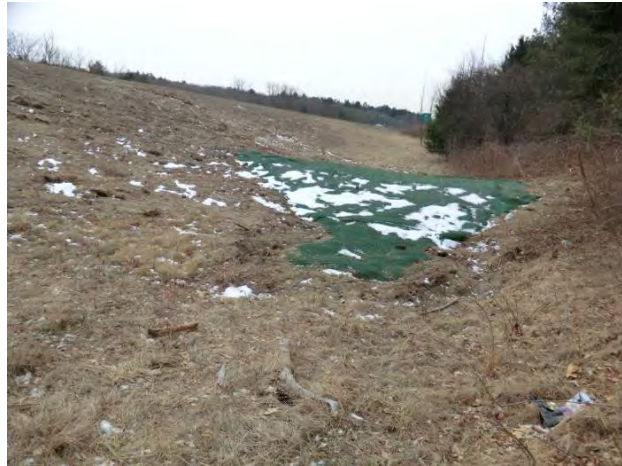
Construction of Infiltration Swale

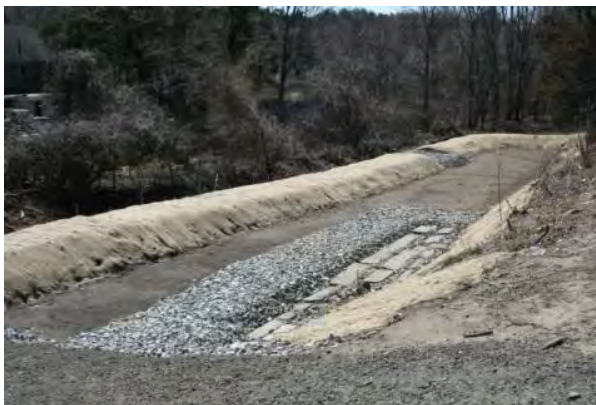
Construction of Infiltration Basin

MassDOT designed, permitted and constructed **8 infiltration basins** to treat stormwater runoff from 5.27 acres of impervious cover of MassDOT roadways prior to discharge to Hawkes Pond as part of the Retrofit Project Initiative. These stormwater BMPs will achieve an estimated effective impervious cover reduction of **4.68 acres**. Additional BMPs have not been proposed due to site constraints. However, the possibility of additional reductions in effective impervious cover may be reviewed during future programmed project work and as standalone projects through the Retrofit Initiative.

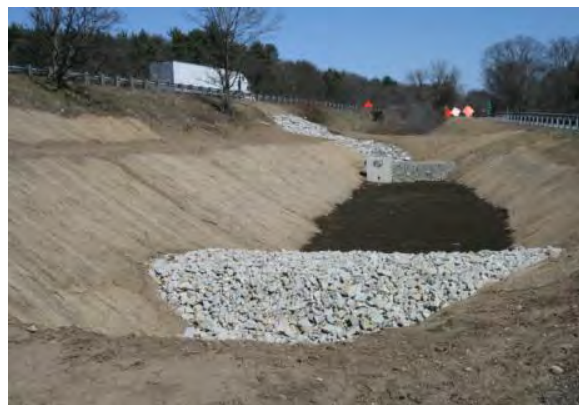
Construction of Infiltration Basin

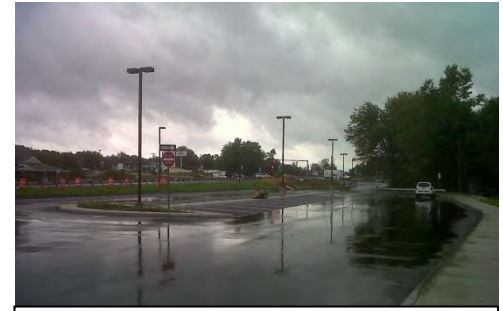
Permeable Pavement Parking Lot

Within Permit Year 10, MassDOT completed construction of the Park and Ride Lot and associated stormwater management improvements. The construction cost of the entire project was \$1 million. **Approximately \$100,000 of the total construction cost is related to stormwater management improvements.**

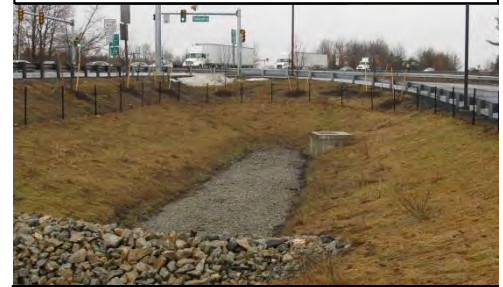
Infiltration Basin

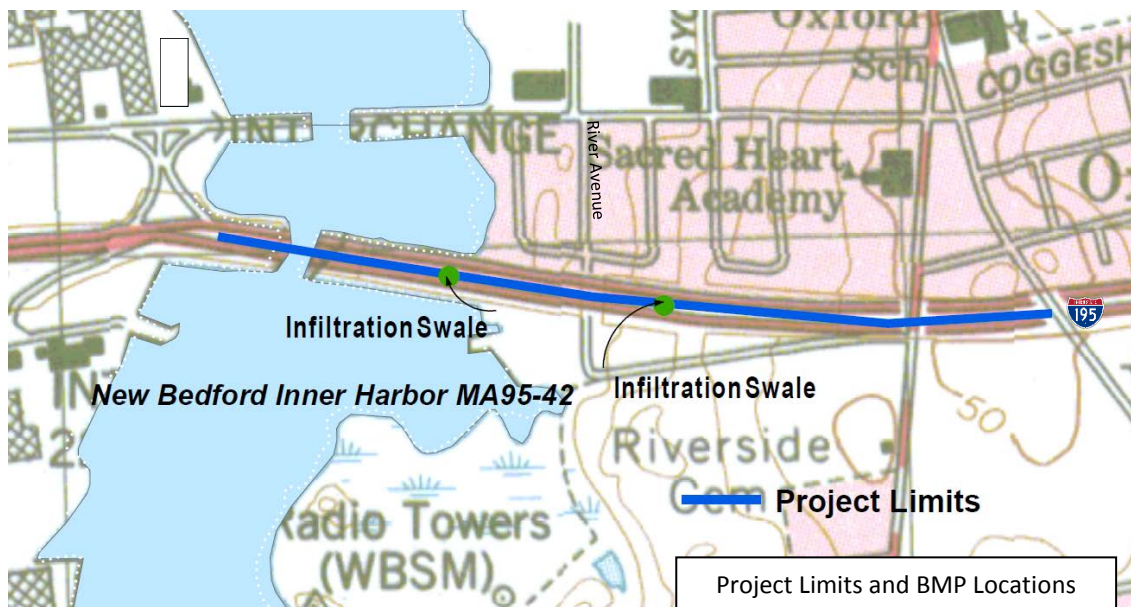
Project Limits and BMP Locations

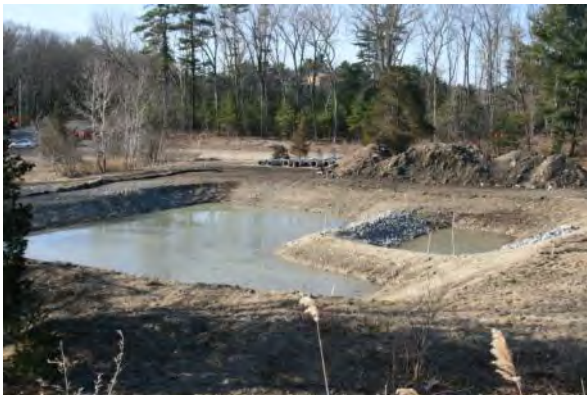
Construction of Infiltration Basin

MassDOT designed, permitted and constructed **5 infiltration basins and 1 infiltration swale** to treat 12.0 acres of impervious cover and 11.0 acres of pervious cover of MassDOT roads as part of the resurfacing project. These stormwater BMPs will achieve an estimated pollutant loading reduction of **16.8 lb/yr**.

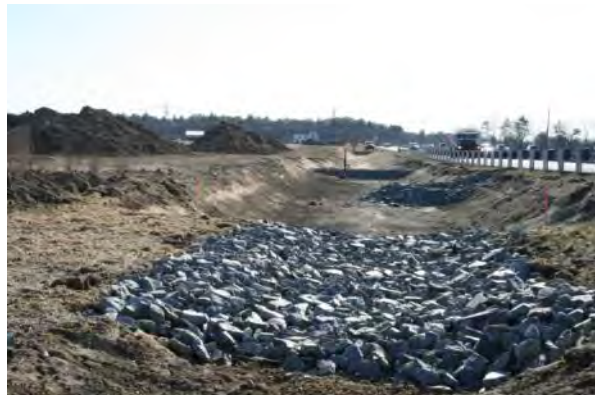
Construction of Infiltration Basin

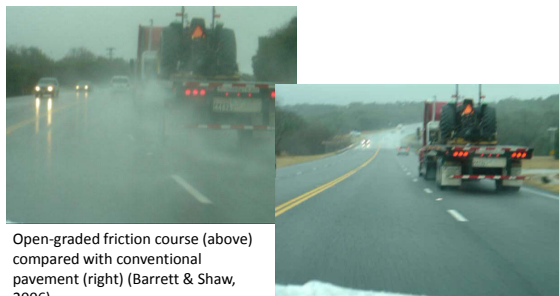
OGFC (a.k.a. permeable friction course – PFC) is a permeable surface of hot mix asphalt pavement. It is typically used on limited access roadways to reduce spray, hydroplaning, and road noise. Runoff flows into the voids in the OGFC, and then laterally over the underlying conventional asphalt base pavement. Reduced spray means less particulate wash-off from vehicles, resulting in a reduction in pollutants entrained in runoff.

Open-graded friction course (above) compared with conventional pavement (right) (Barrett & Shaw, 2006)

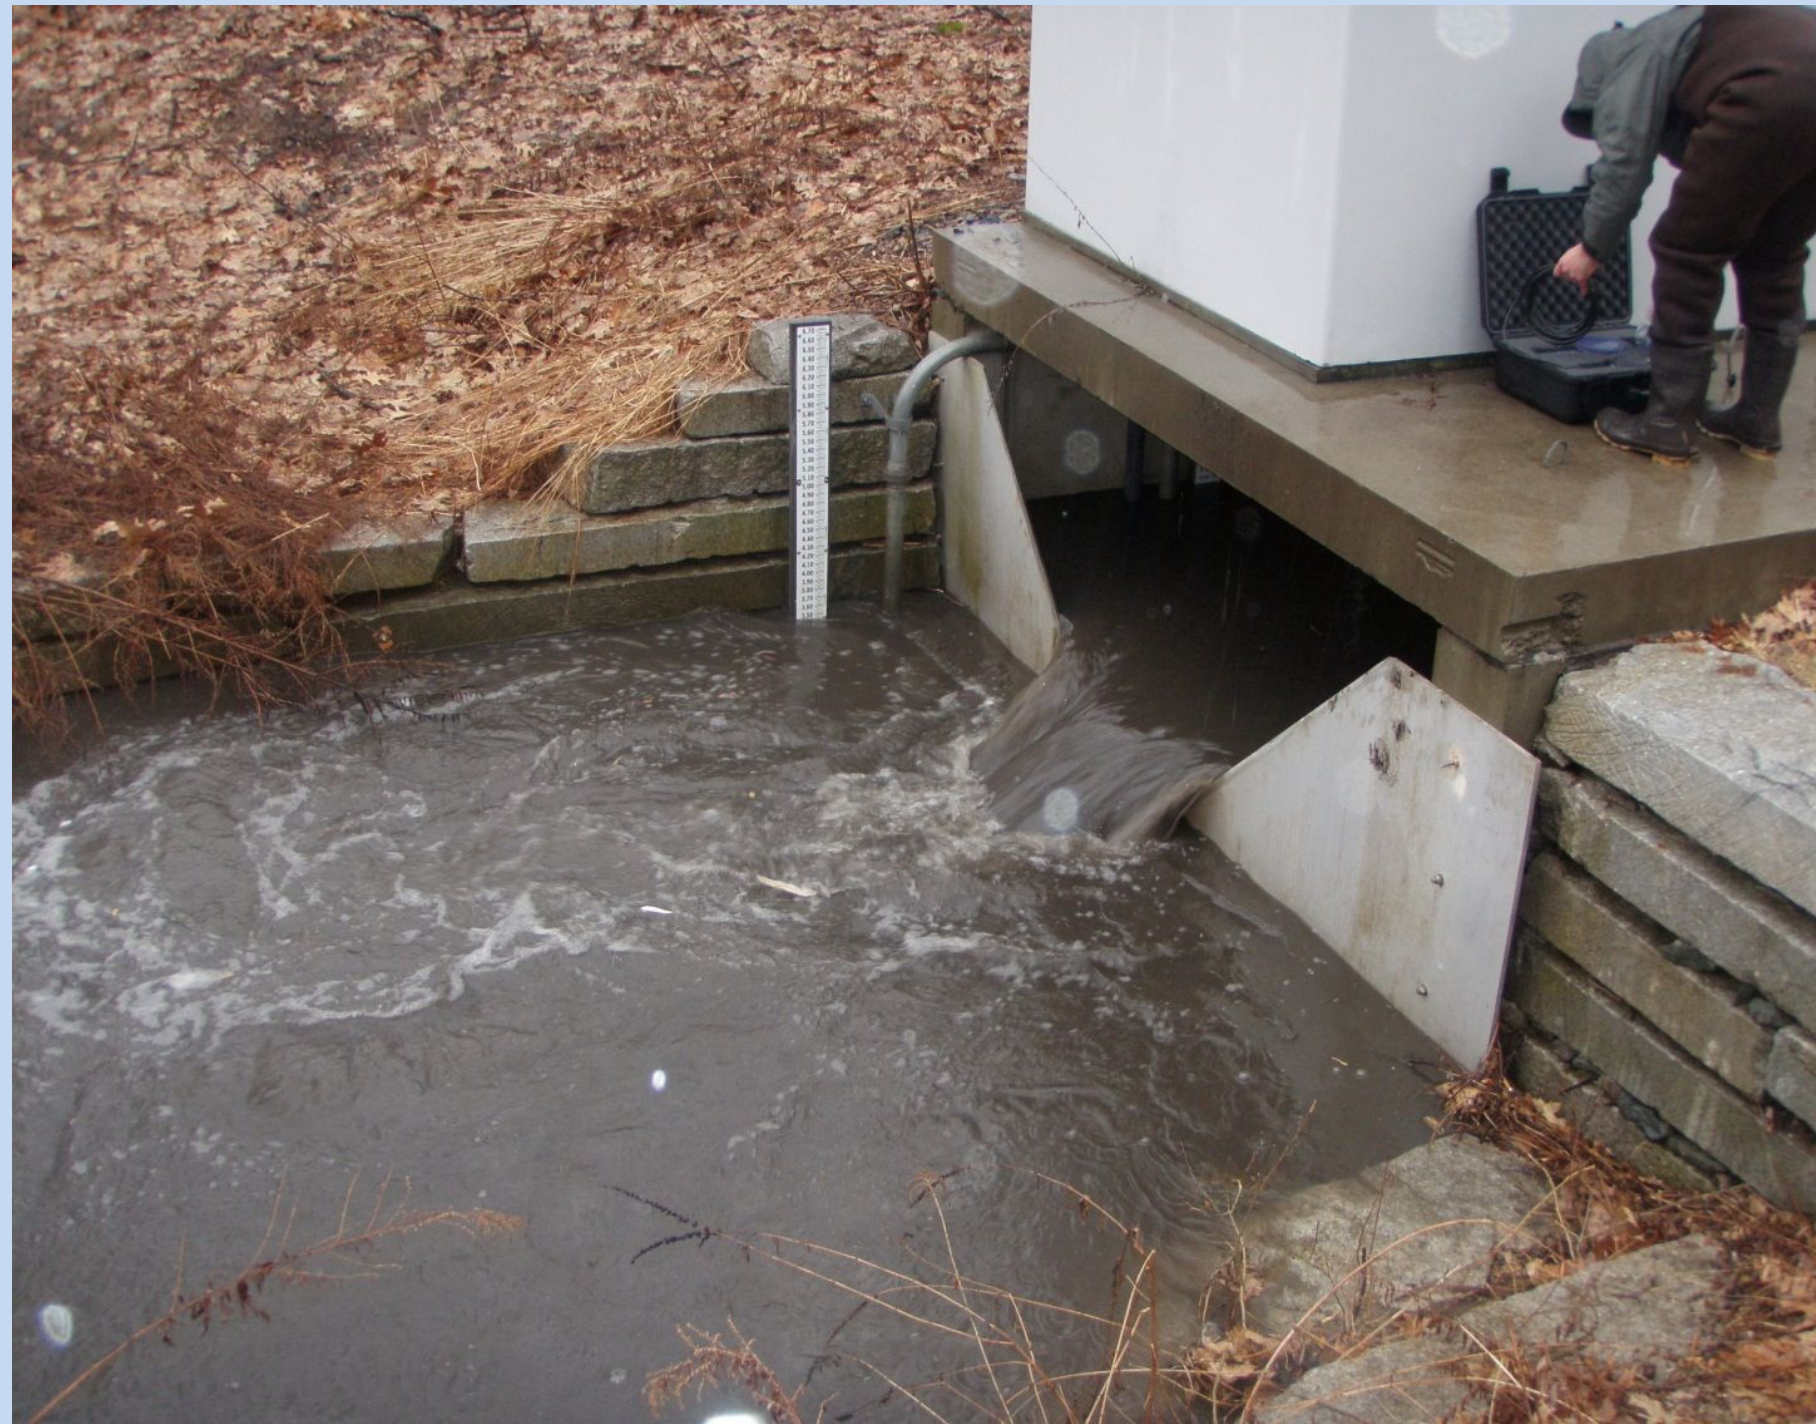
Stormwater run-off at outfall WA-17. Rte 128 contributes a significant amount of pollution to the reservoir.  
CWD/USGS maintained monitoring station.

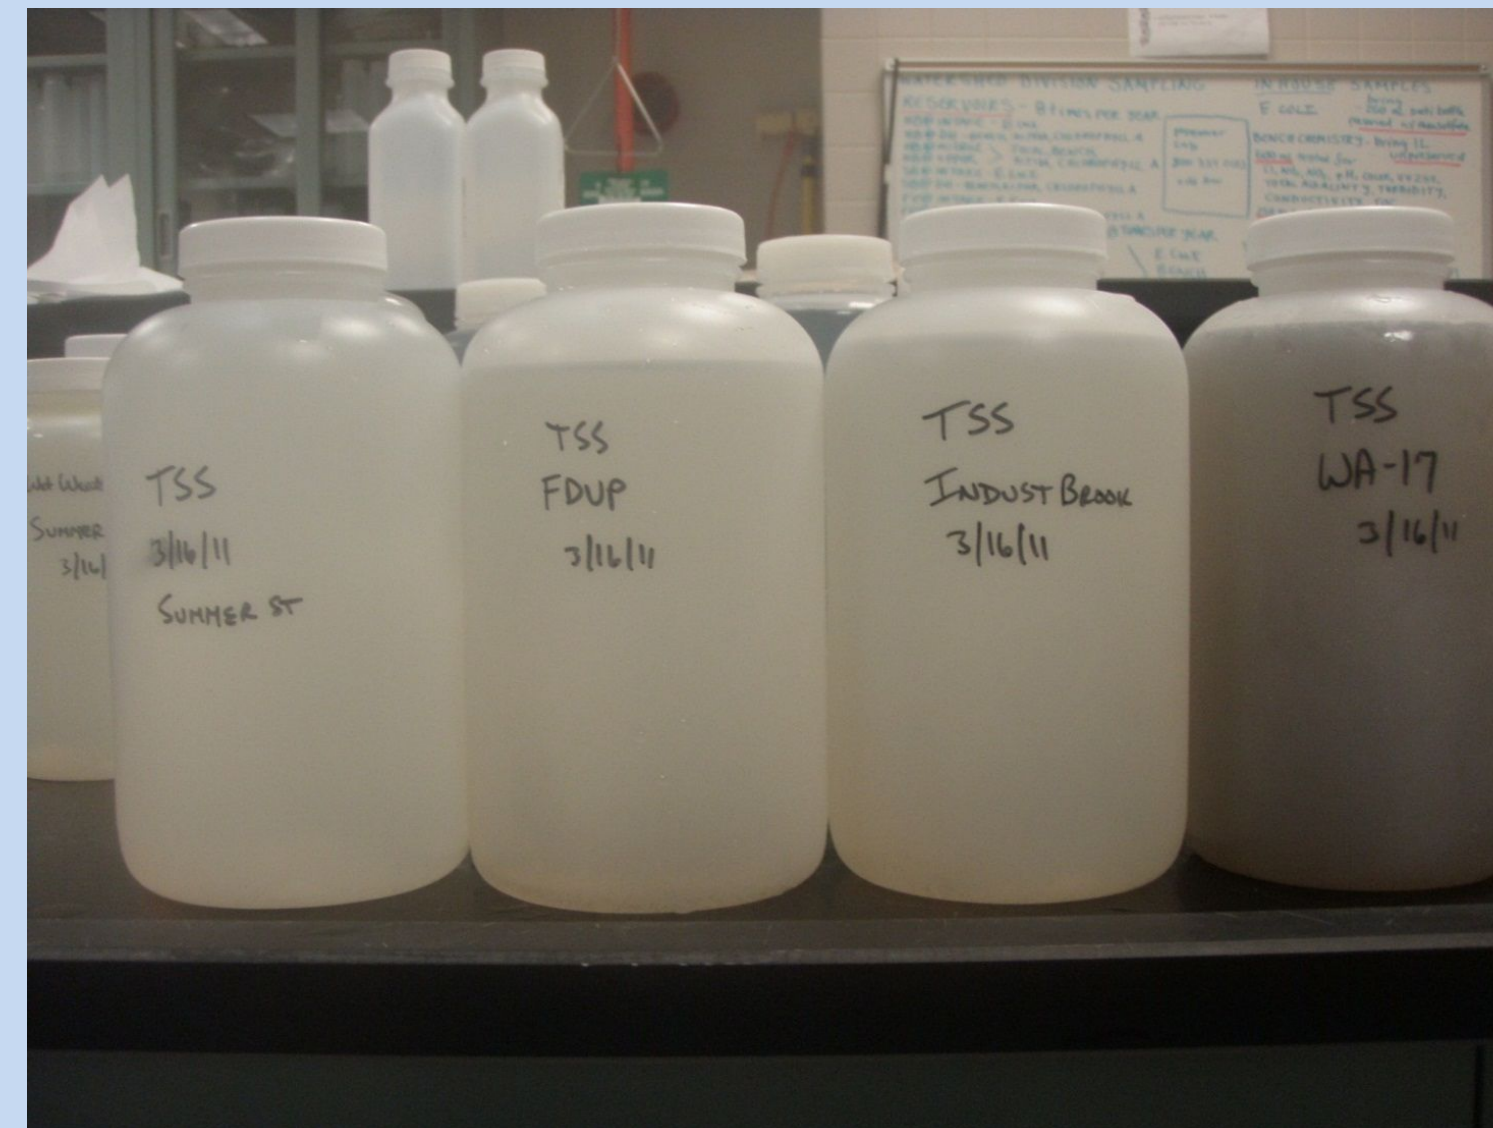
Watershed stormwater samples. WA-17 sample pictured on right, before stormwater improvements were implemented

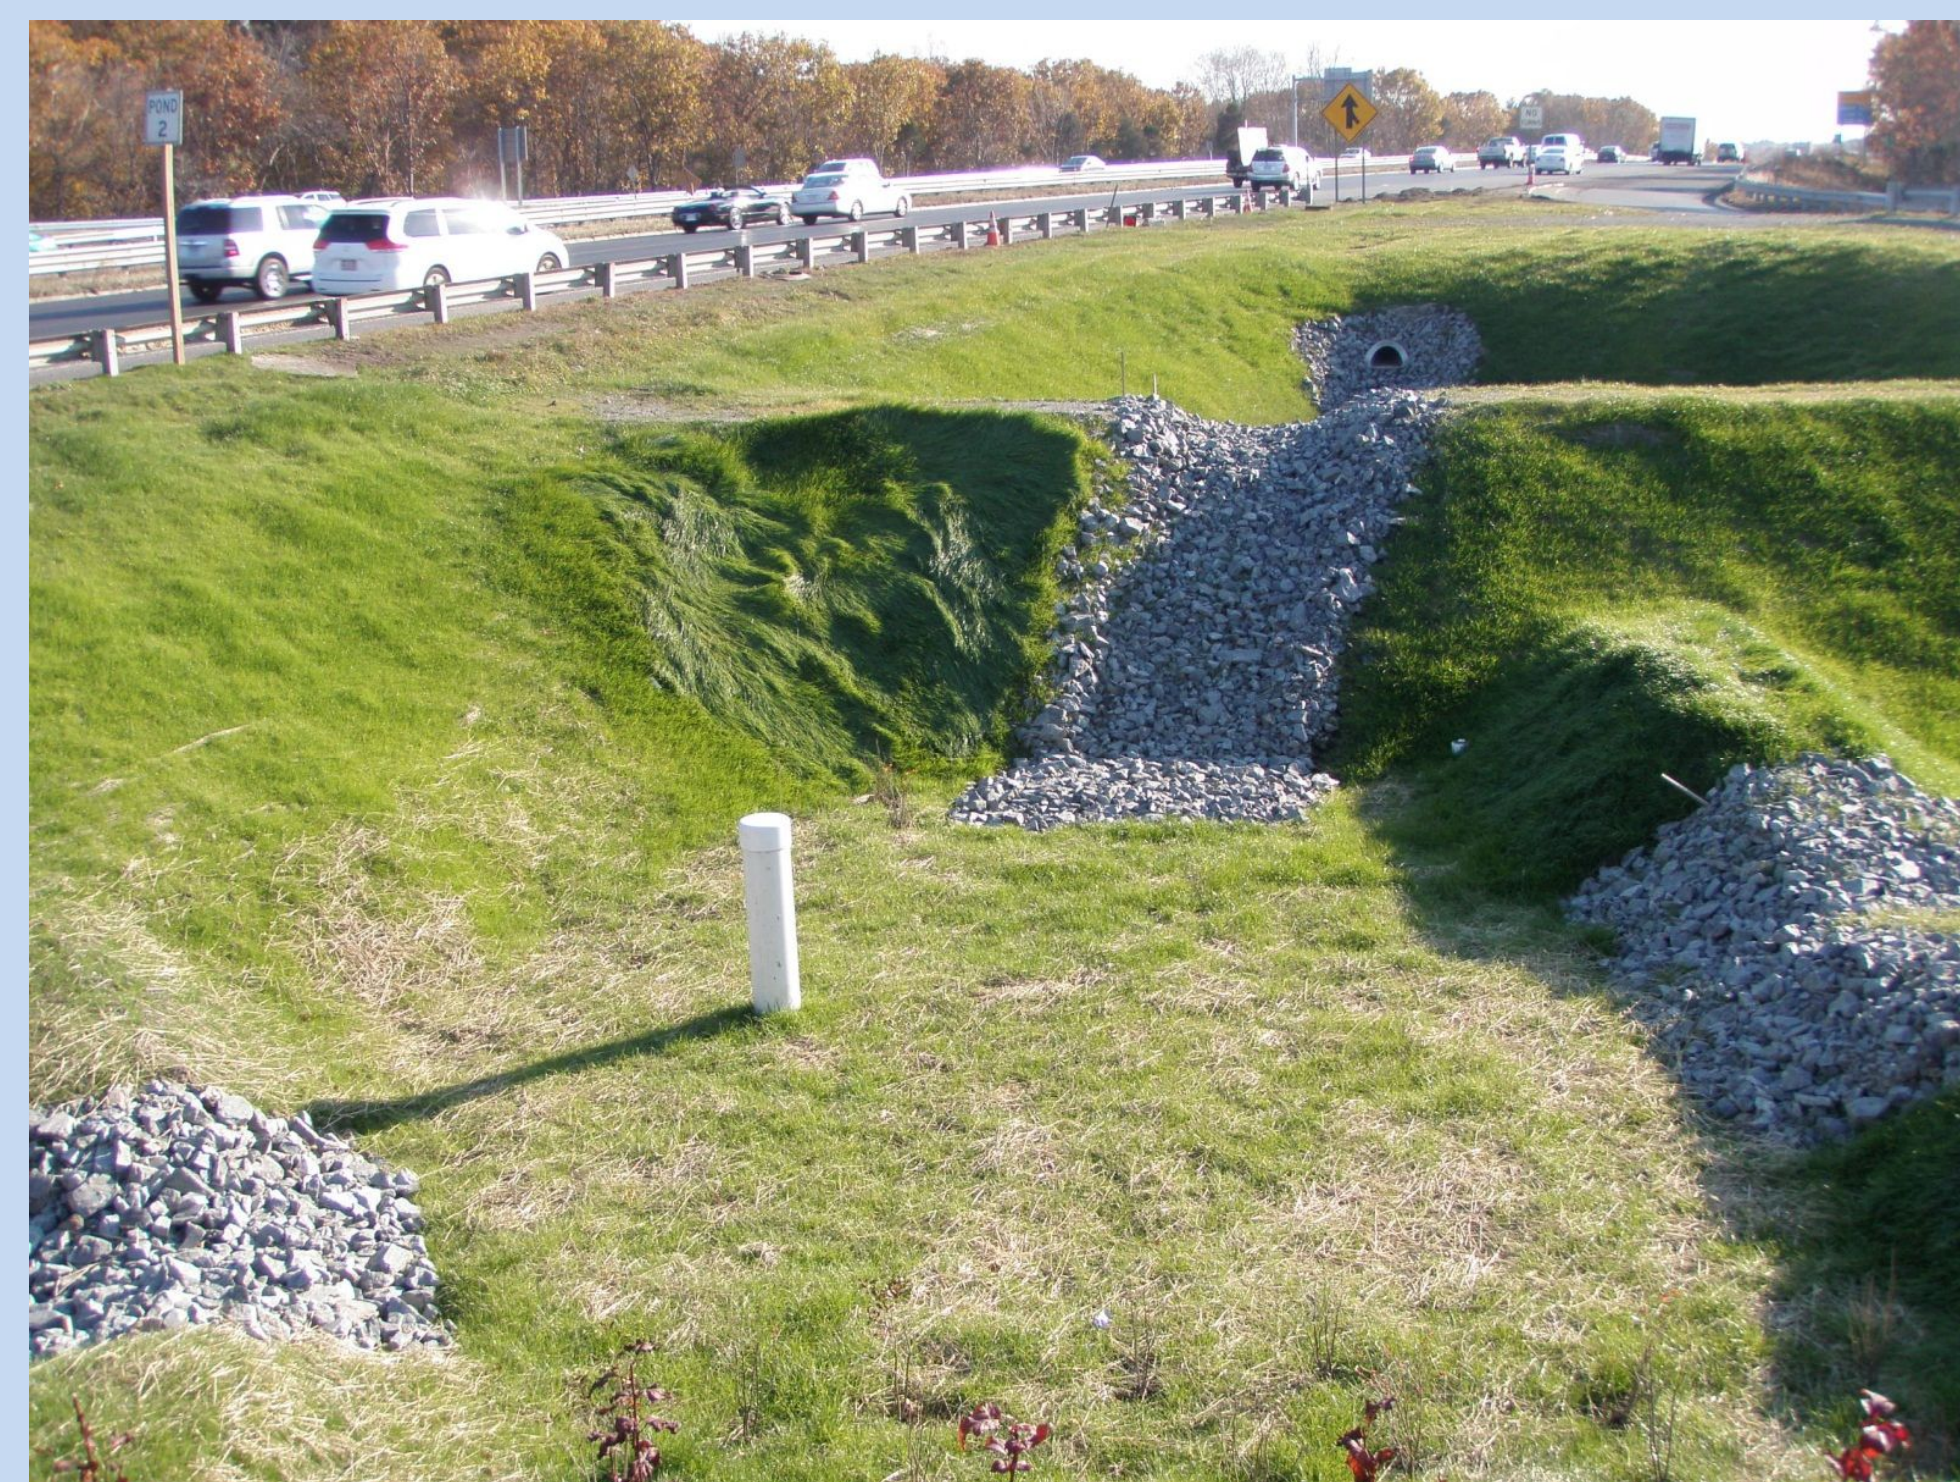
Gravel wetland for stormwater run-off along Rt. 128

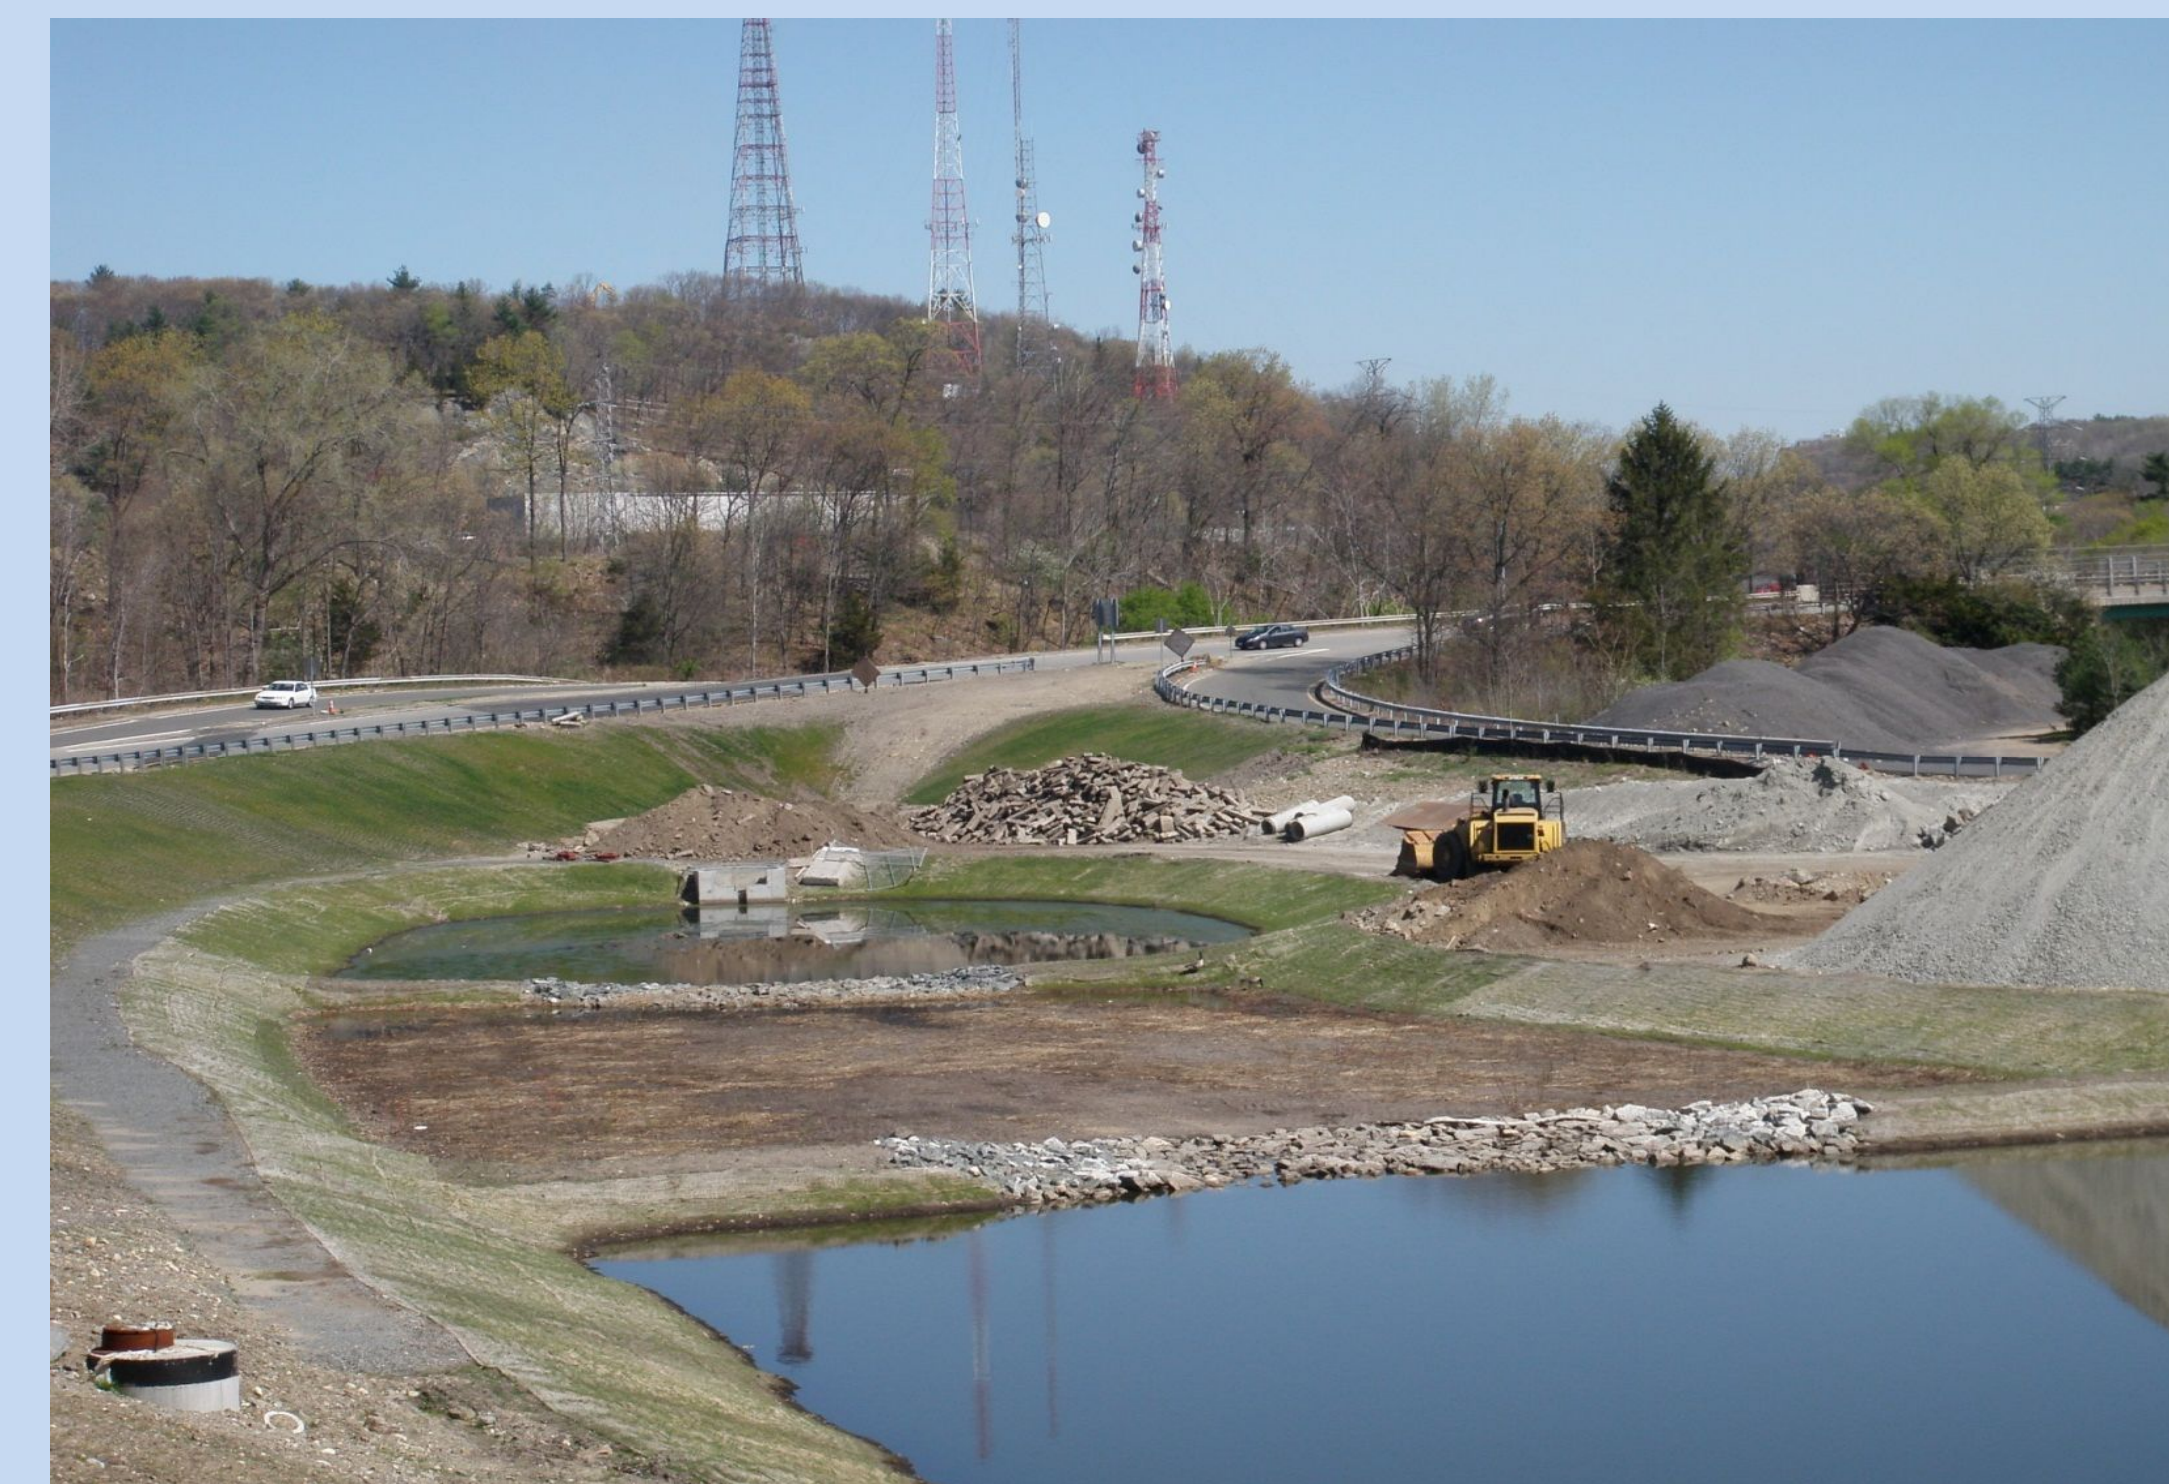
Gravel wetland with wet ponds under construction along Rt. 128 at outfall WA-17
