Report of Dam Safety Assessment of Coal
Combustion Surface Impoundments
American Electric Power (AEP) and Southwest
Electric Power Company (SWEPCO)
H.W. Pirkey Power Plant, Hallsville, TX

AMEC Project No. 3-2106-0183.0003

November 2010

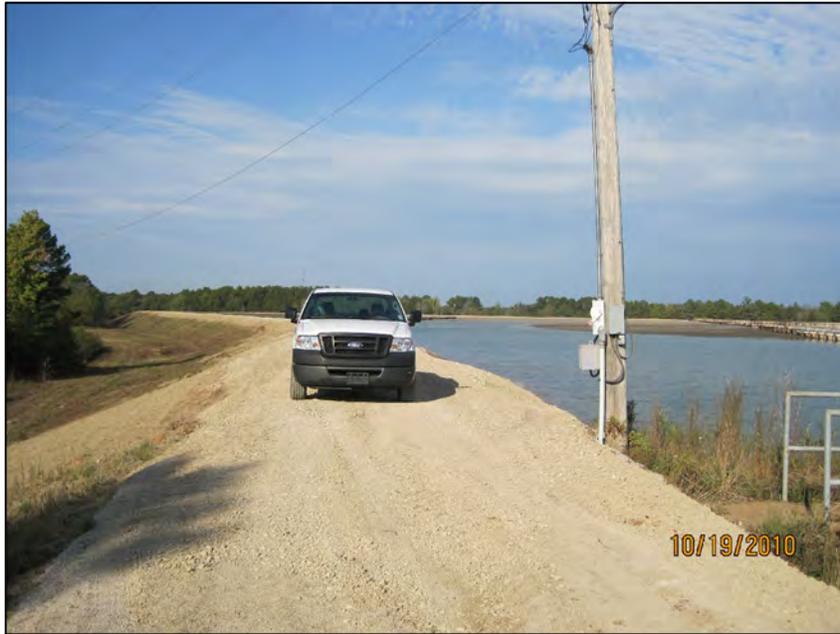
WAP-1
CREST AT SOUTHEAST CORNER CREST LOOKING WEST

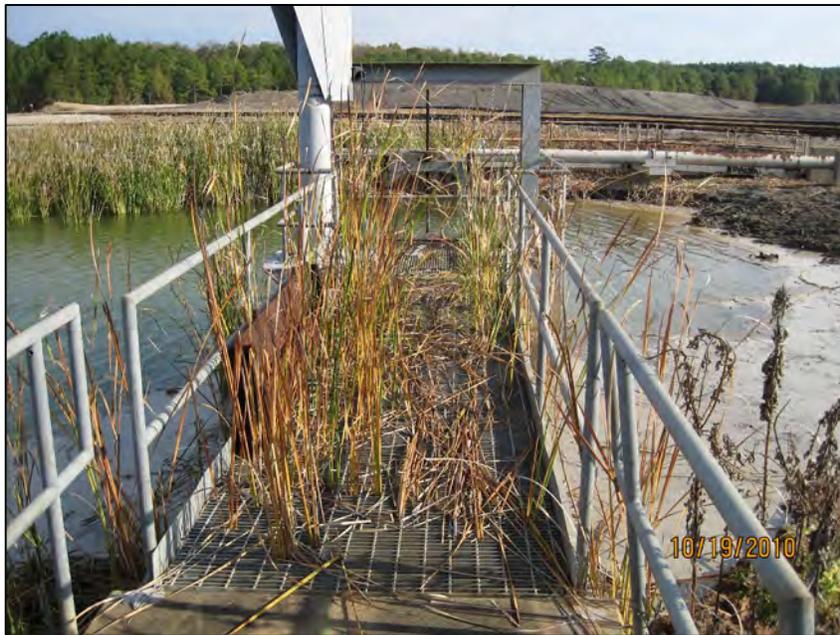
WAP-2
TOP OF DISCHARGE STRUCTURE

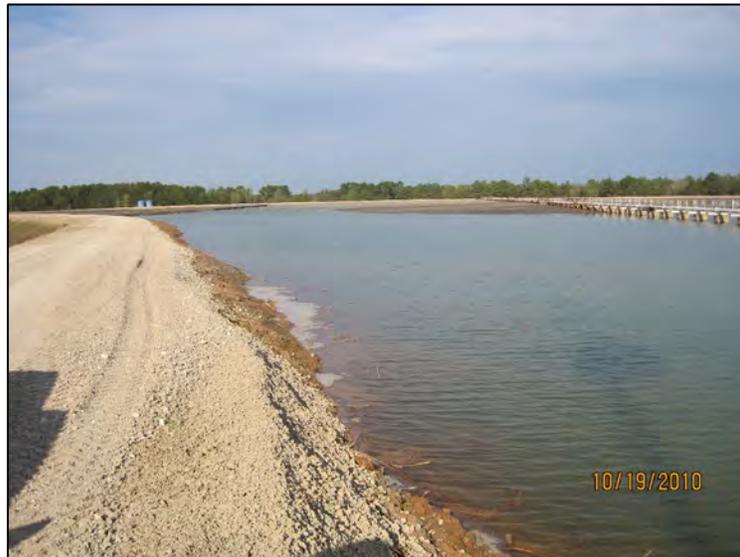
**WAP-4
UPSTREAM SLOPE AT SOUTHEAST CORNER LOOKING WEST**

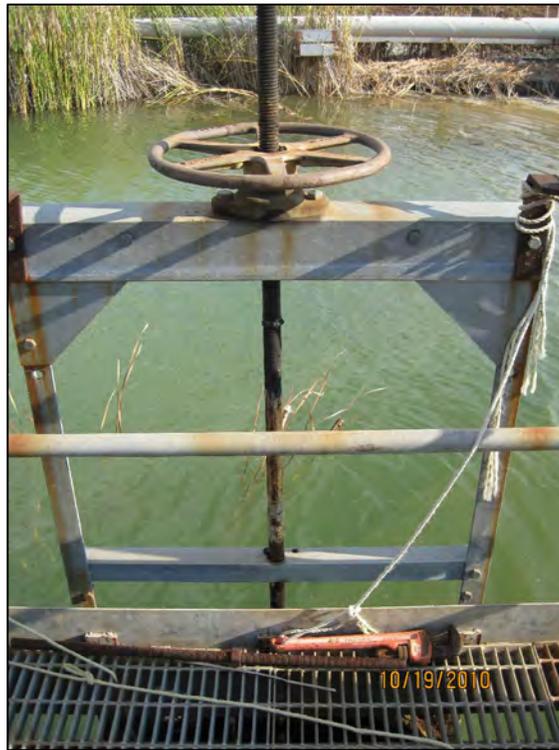
**WAP-3
DISCHARGE PIPE VALVE OPERATOR**

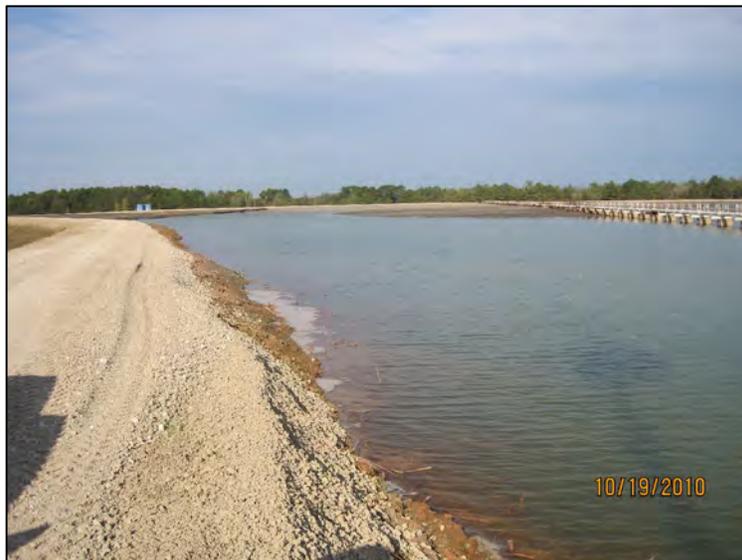
**WAP-4
UPSTREAM SLOPE AT SOUTHEAST CORNER LOOKING WEST**

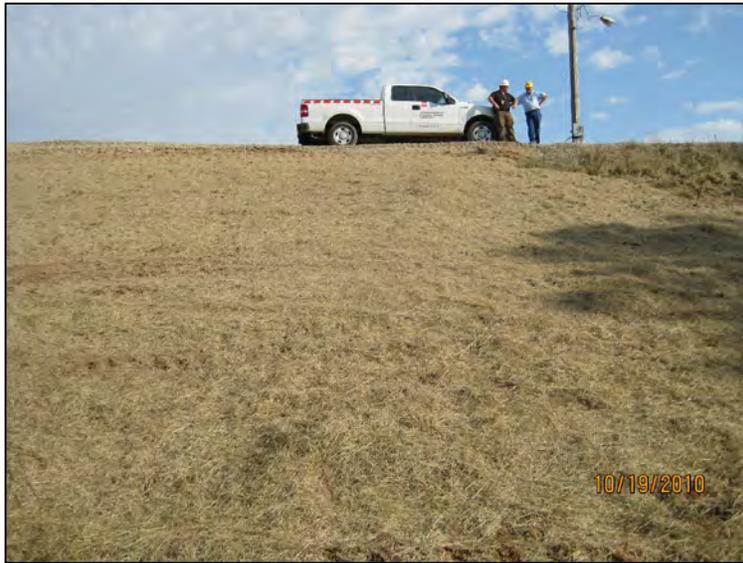
WAP-5
LOOKING NORTH UP DOWNSTREAM SLOPE AT SOUTHEAST CORNER

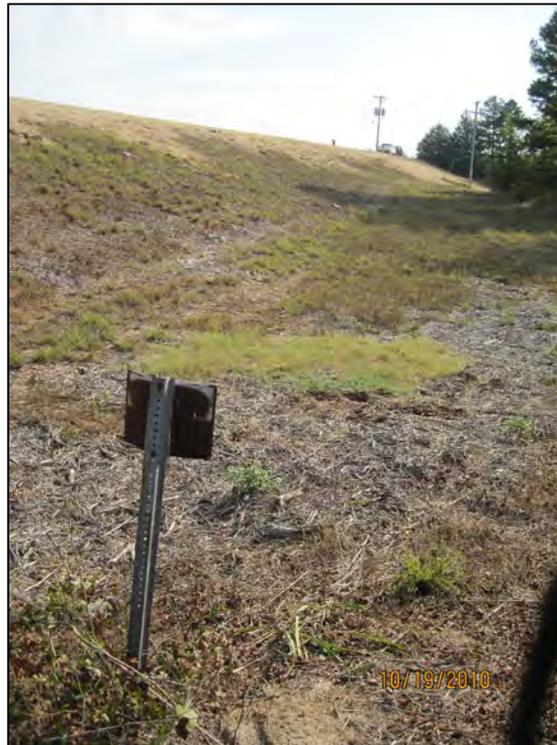
WAP-6
LOOKING EAST ON SOUTH DOWNSTREAM EMBANKMENT

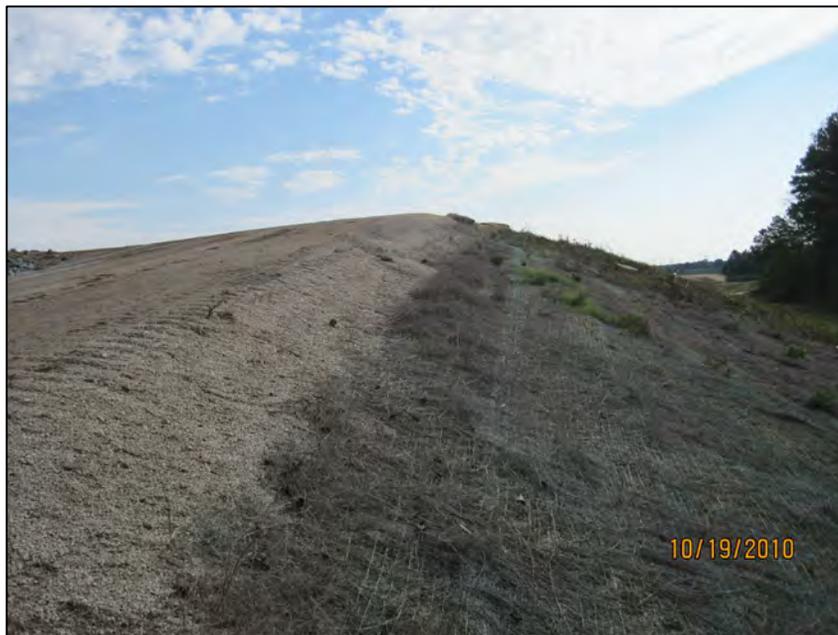
WAP-10

SURFACE EROSION AT SOUTHWEST EMBANKMENT CORNER

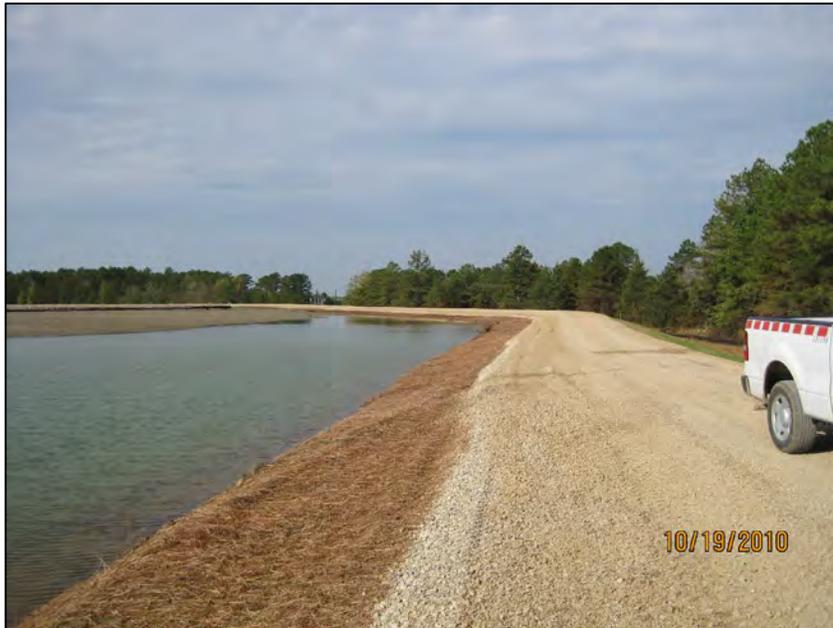
WAP-13
LOOKING WEST FROM CREST OF NORTHERN EMBANKMENT

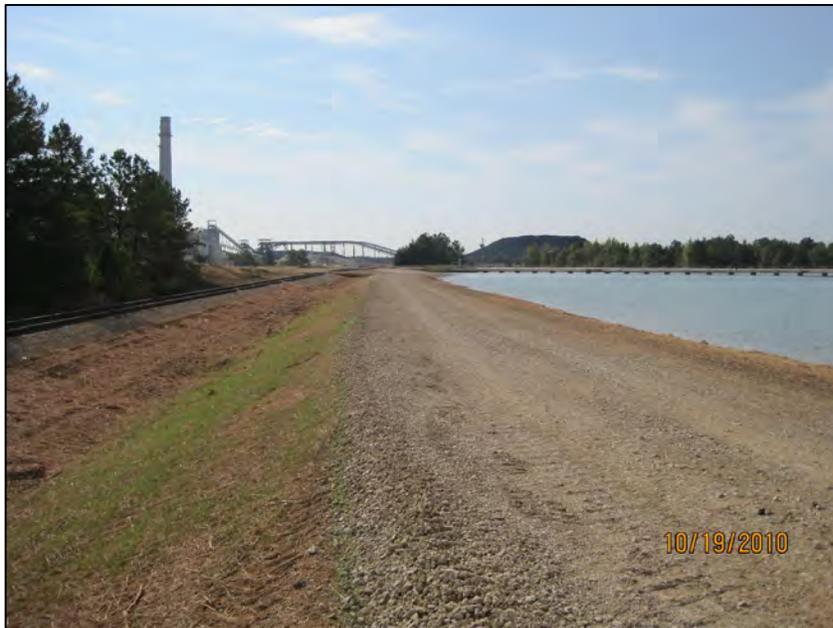
WAP-14
LOOKING SOUTH FROM CREST OF EASTERN EMBANKMENT

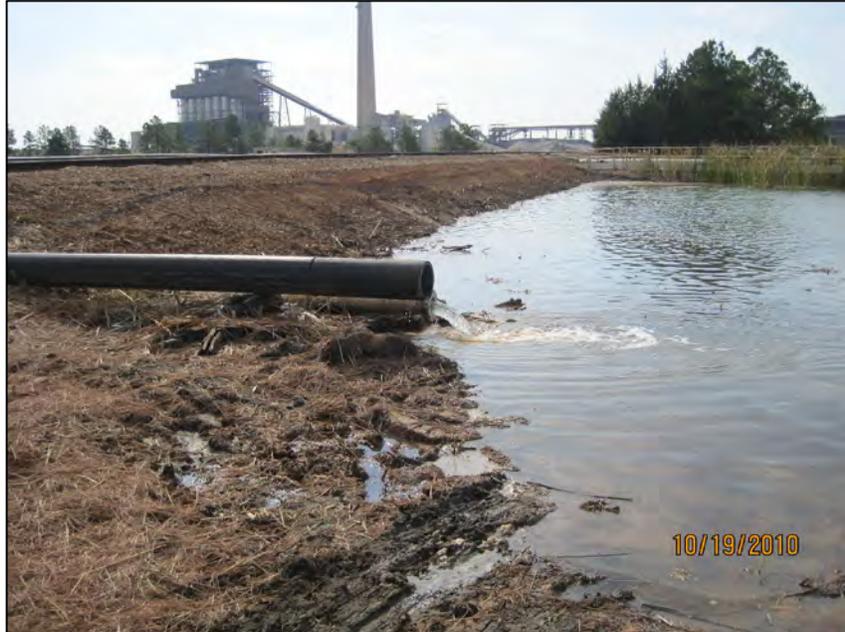
**WAP-15
LOOKING SOUTH AT INFLUENT PIPE-NEUTRALIZED
WASTE FROM DEMINERALIZER**

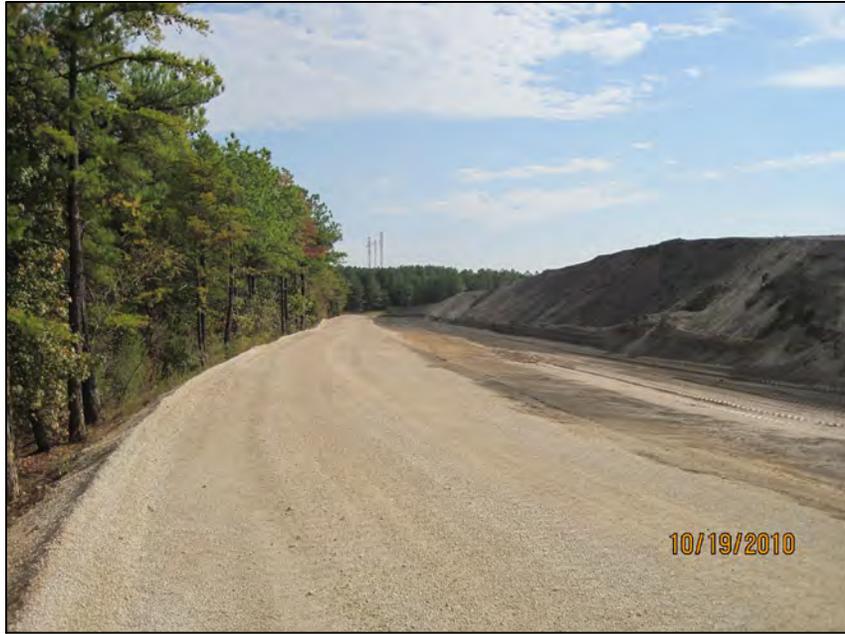
EAP-2
LOOKING NORTHEAST FROM
CREST OF NORTHERN EMBANKMENT

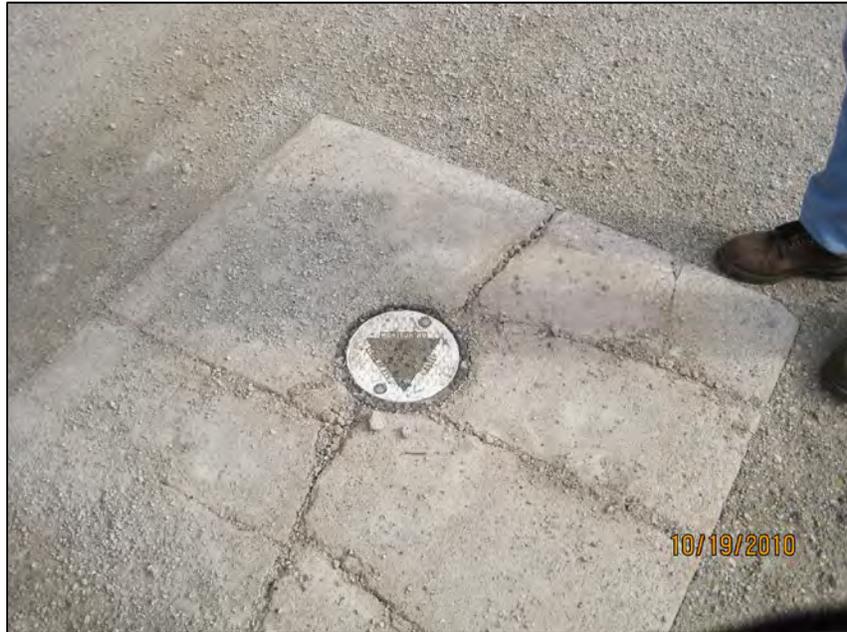
**EAP-3
PIEZOMETER ON CREST OF NORTHERN EMBANKMENT**

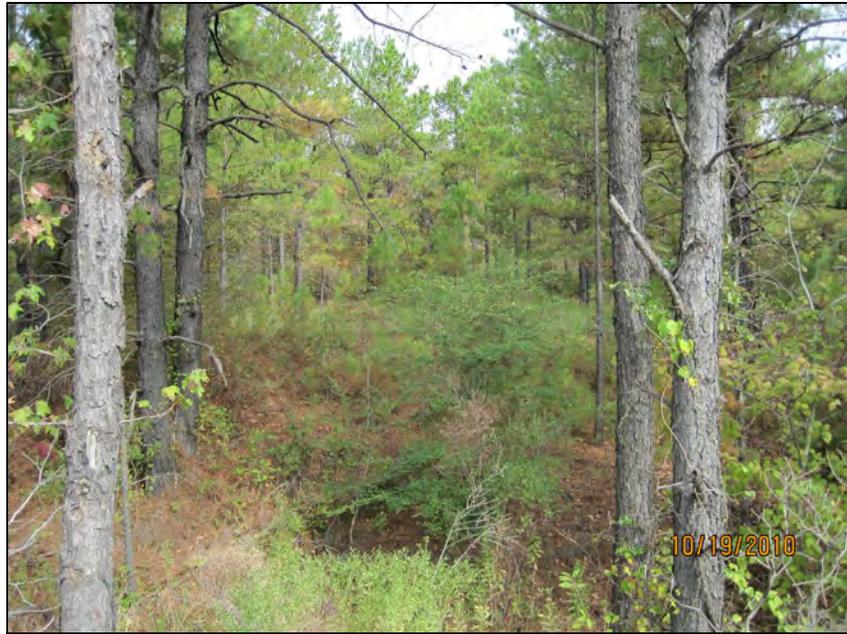
**EAP-4
LOOKING NORTH FROM NORTHERN
EMBANKMENT AT HIGHER GROUND**

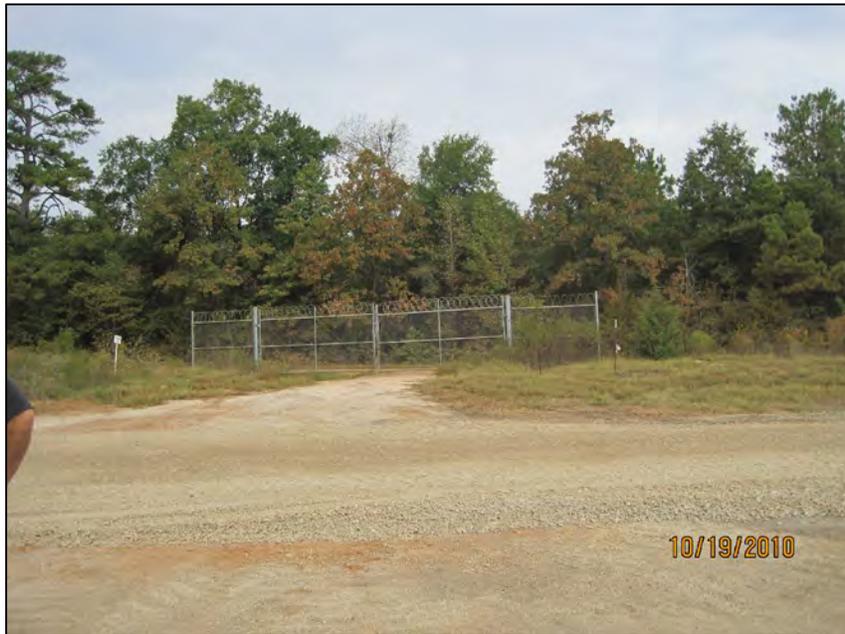
EAP-7
GATE TO ROAD NORTH OF NORTHERN EMBANKMENT

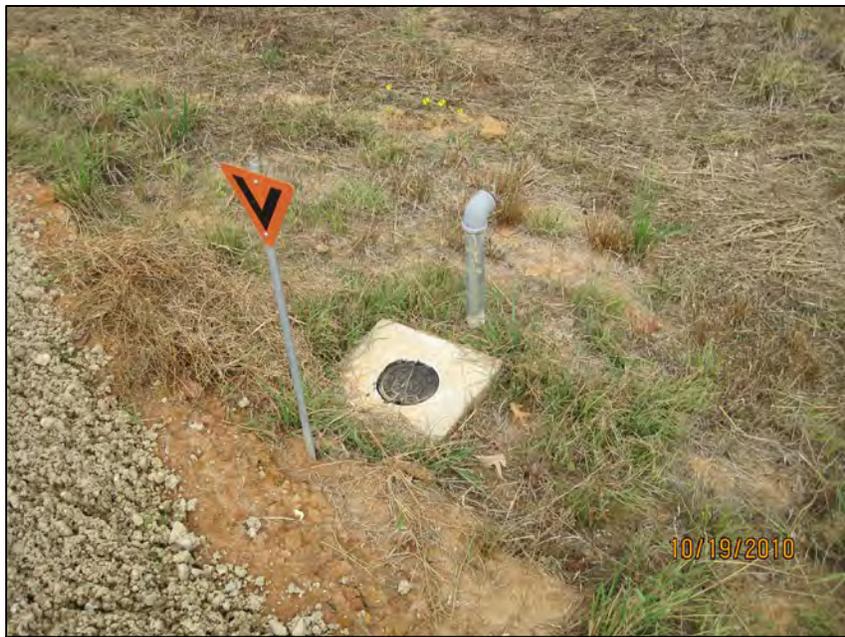
EAP-8
GAS PIPELINE ON NORTHEAST CORNER ?????? ASK DON

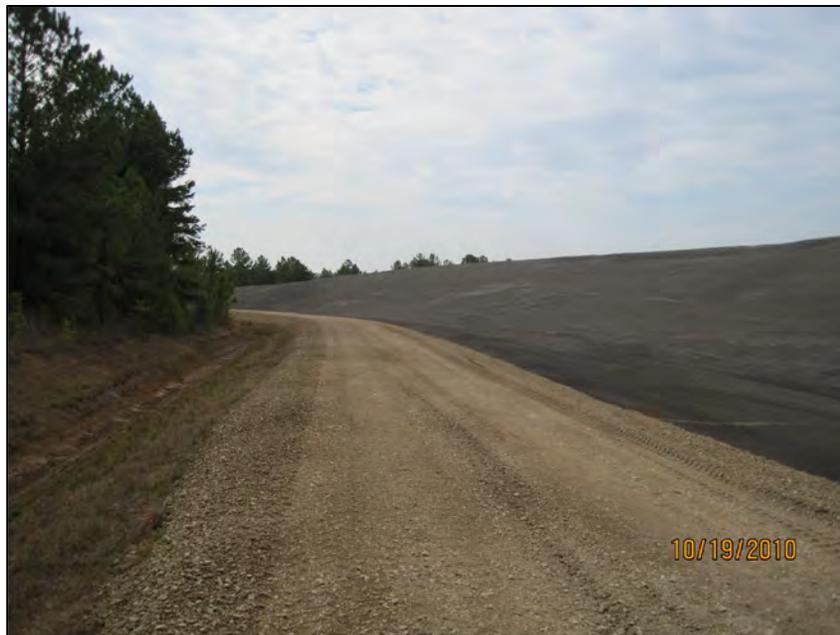
EAP-10

**LOOKING SOUTH FROM EASTERN CREST AT
ASH STACK AND HIGHER GROUND TO EAST**

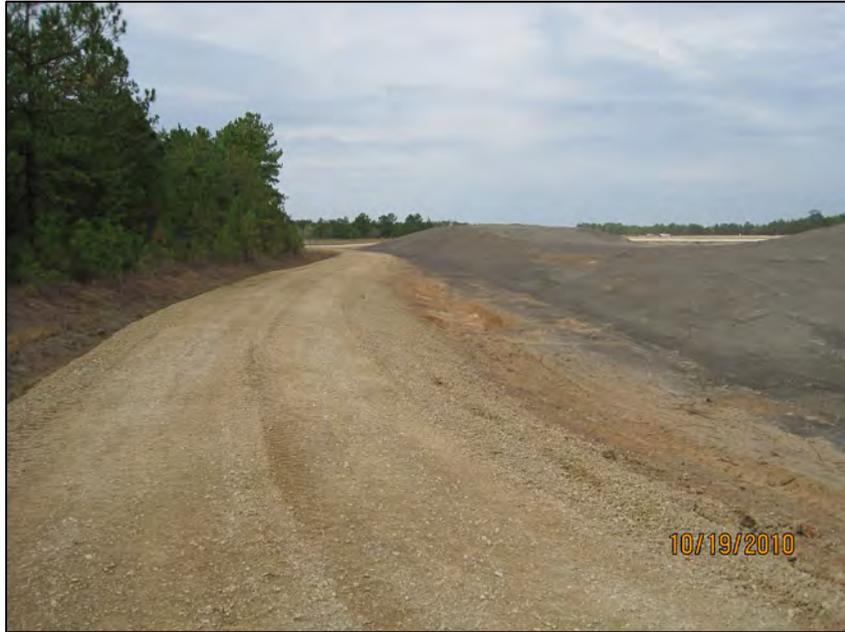
EAP-11
LOOKING WEST FROM SOUTHEAST CORNER CREST

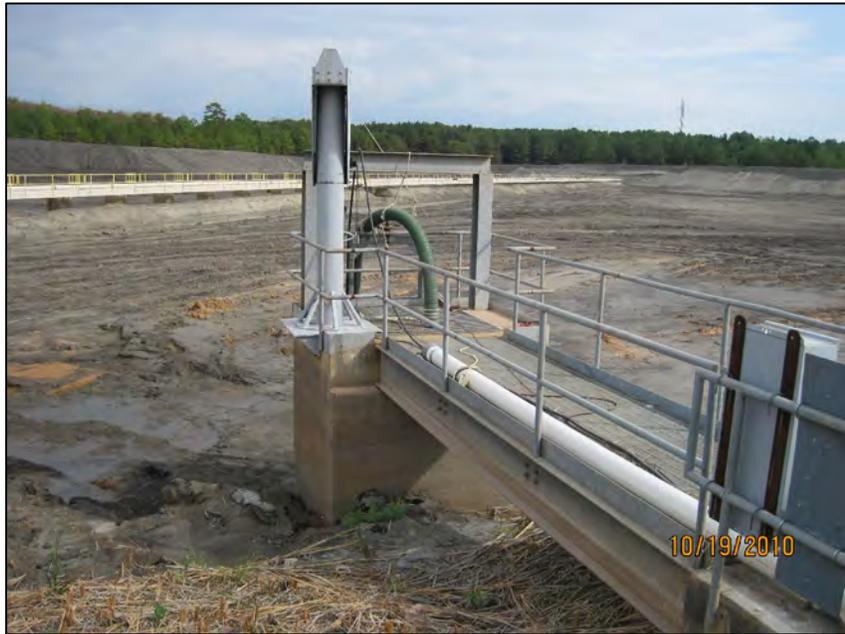
EAP-12
LOOKING NORTHEAST FROM SOUTHWEST CORNER ACROSS DISCHARGE STRUCTURE

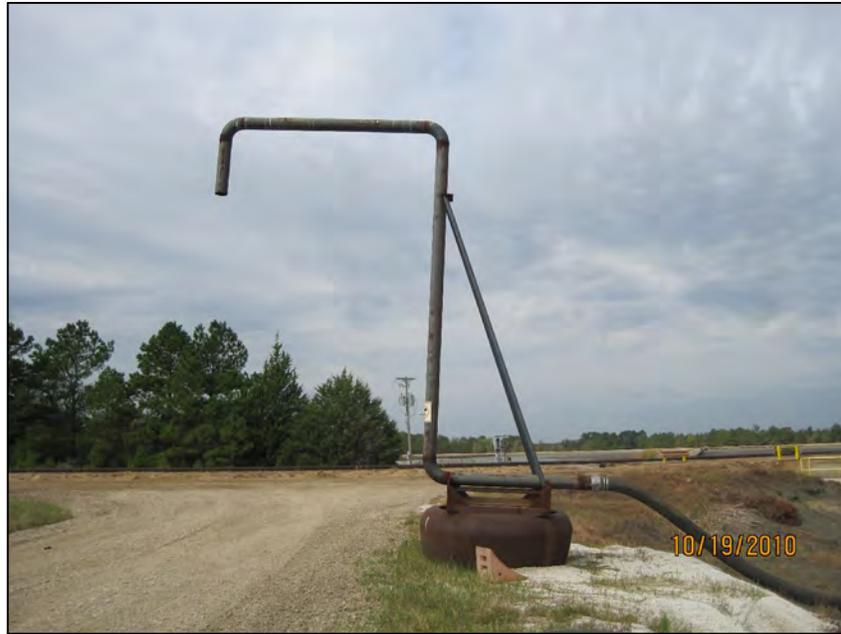
**EAP-13
SOUTHWEST CREST LOOKING NORTHWEST
PAST DUST CONTROL LOAD OUT PIPE**

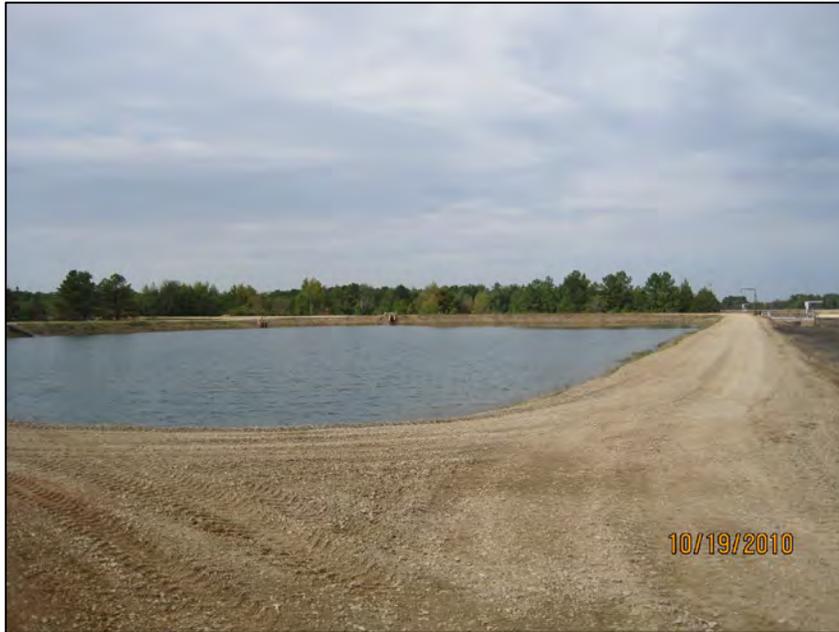
SAP-1
LOOKING WEST ACROSS POND FROM NORTHEAST CORNER

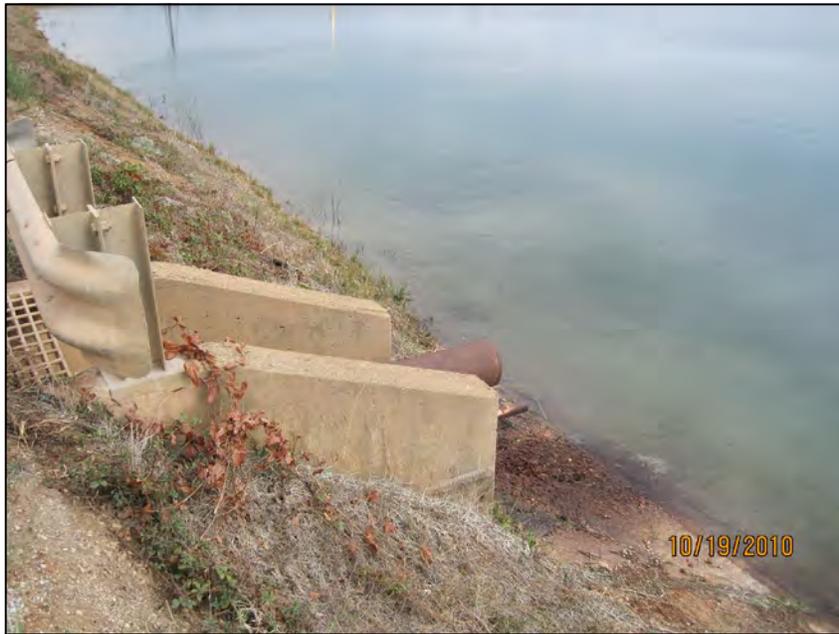
SAP-2
INFLUENT OF BOILER BLOWDOWN
DISCHARGE PIPE AT SOUTHWEST CORNER

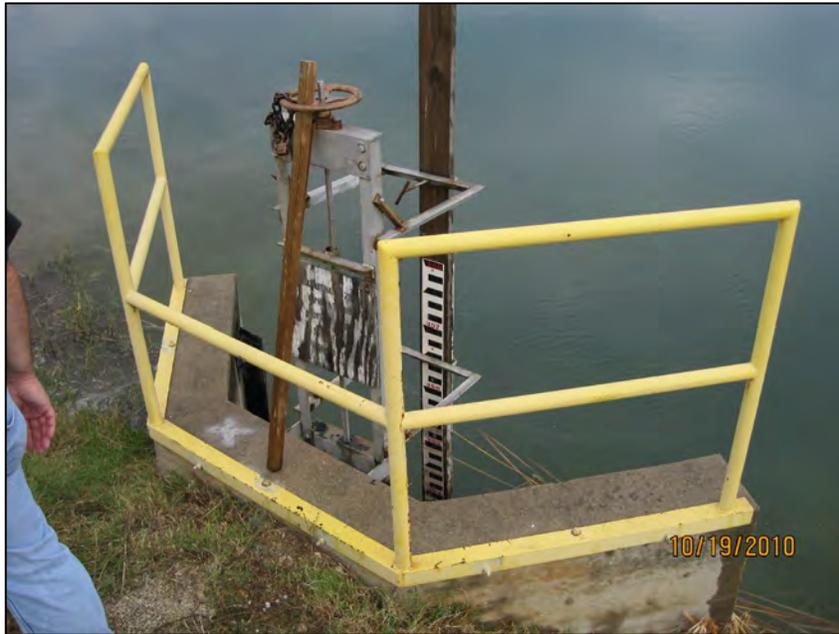
SAP-3
NPDES DISCHARGE OUTFALL 006 AT SOUTHWEST CORNER

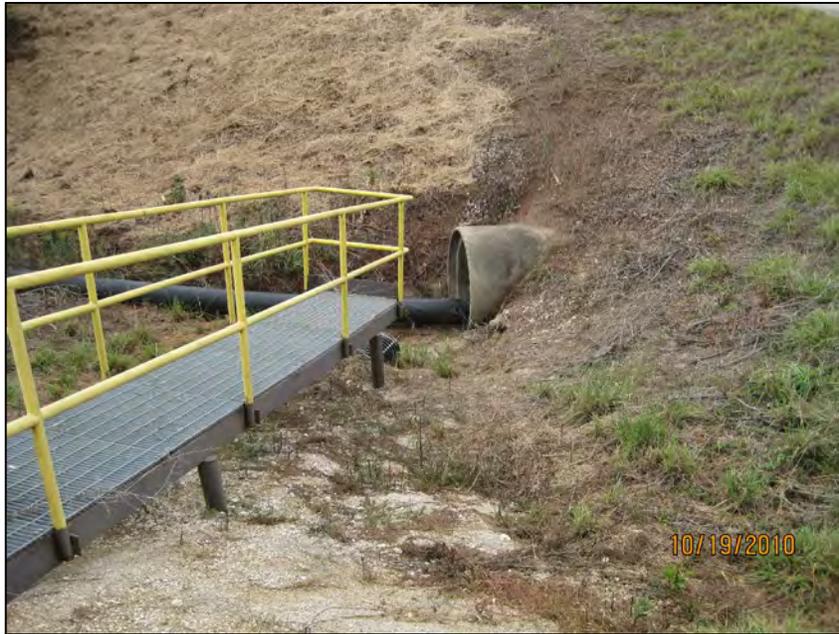
SAP-4
TRANSFER PIPE CARRYING REUSE
FLOW TO ADJADENT LIGNITE MINE

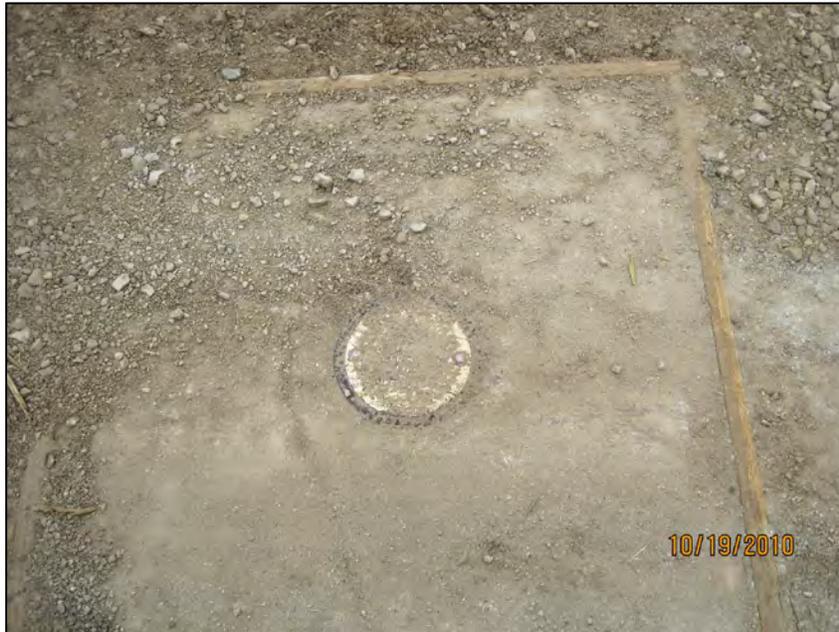
**SAP-5
PIEZOMETER AT SOUTHWEST CORNER**

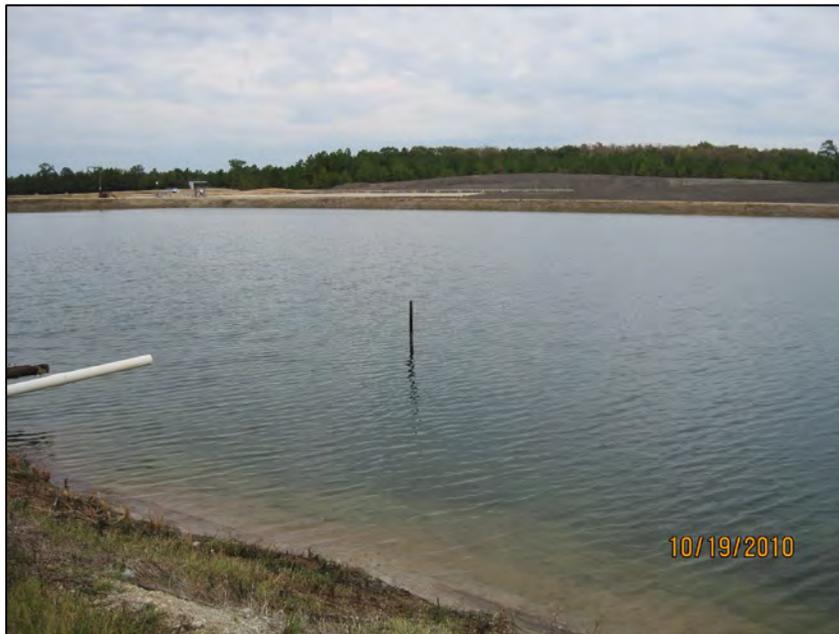
**SAP-6
FROM SOUTHEAST CORNER LOOKING NORTHWEST AT
MARKER INDICATING LOCATION OF PLANT REUSE PIPE**

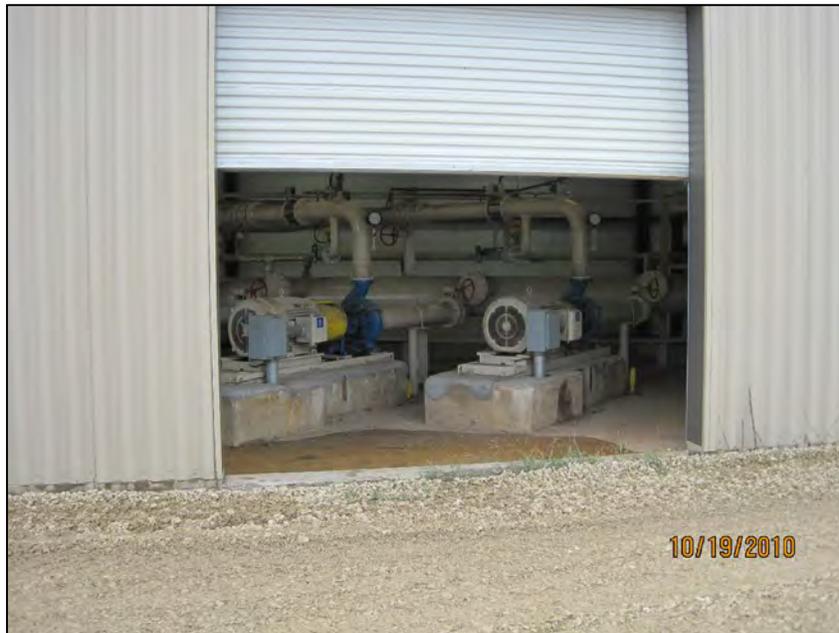
SAP-7
REUSE PUMP HOUSE ON SOUTH SHORE OF POND

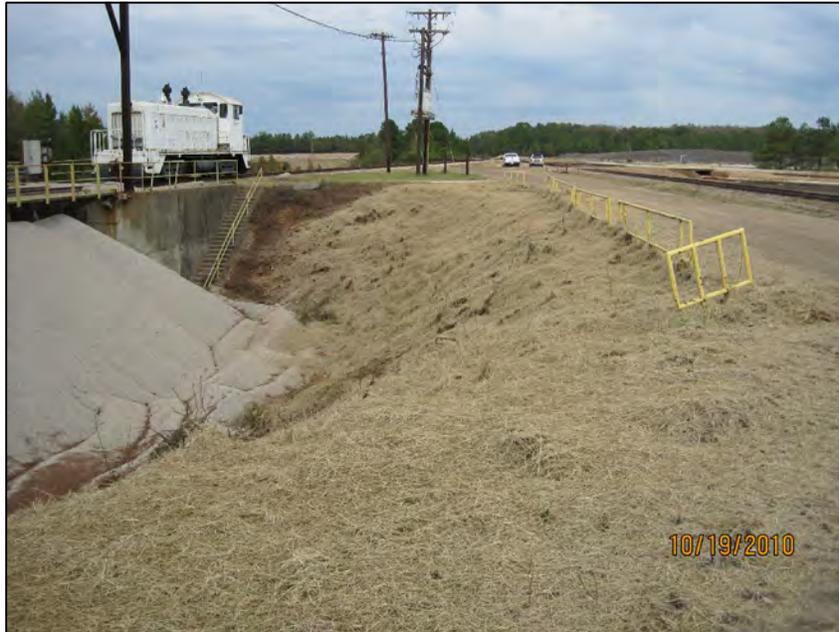
SP-3
WEST OF SURGE POND LOOKING NORTHWEST
AT LIMESTONE UNLOADING AREA

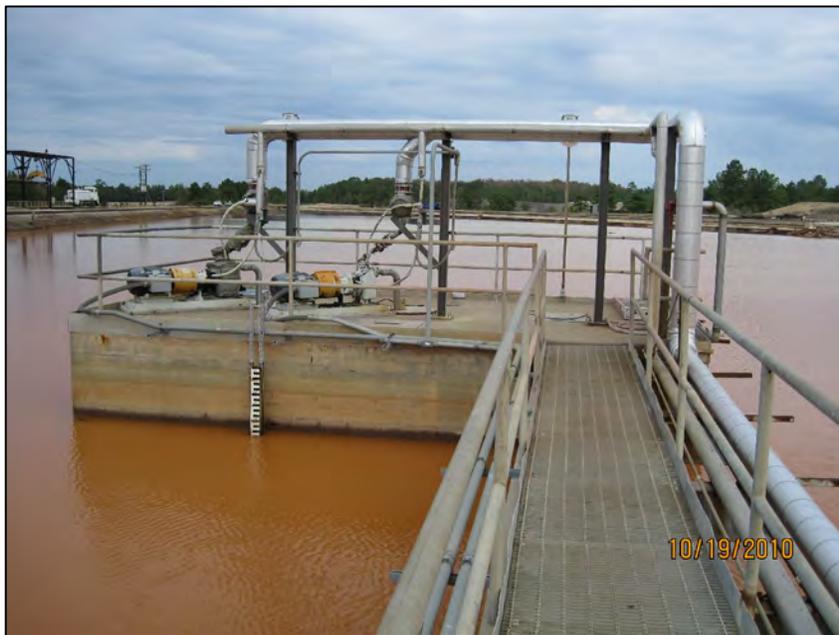
**SP-6
LOOKING NORTH SOUTH EDGE OF POND
AT FACILITY REUSE PUMP STATION**

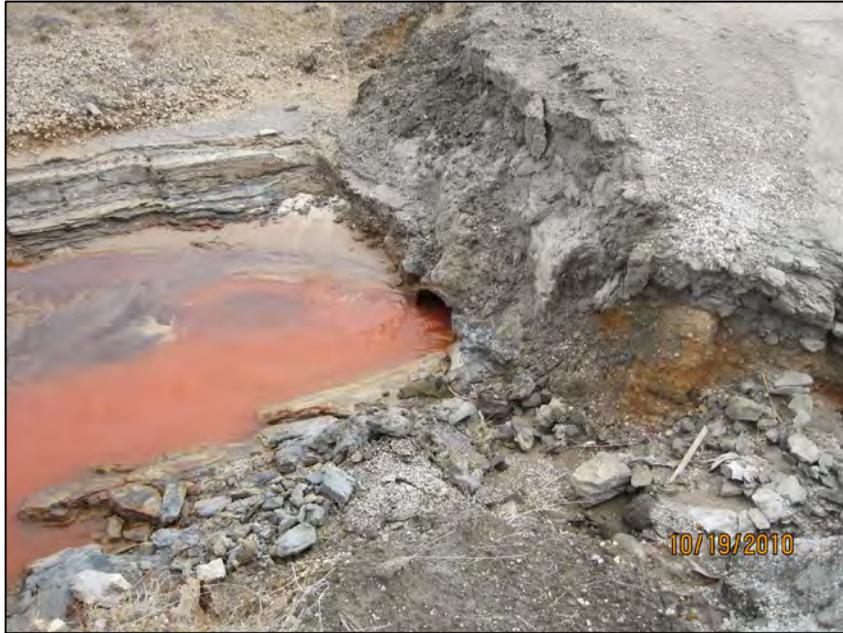
SP-7

SOUTHEAST CORNER OF POND LOOKING AT FLOWING FLUE GAS DESULFURIZATION PROCESS INFLUENT PIPE (18-INCH)

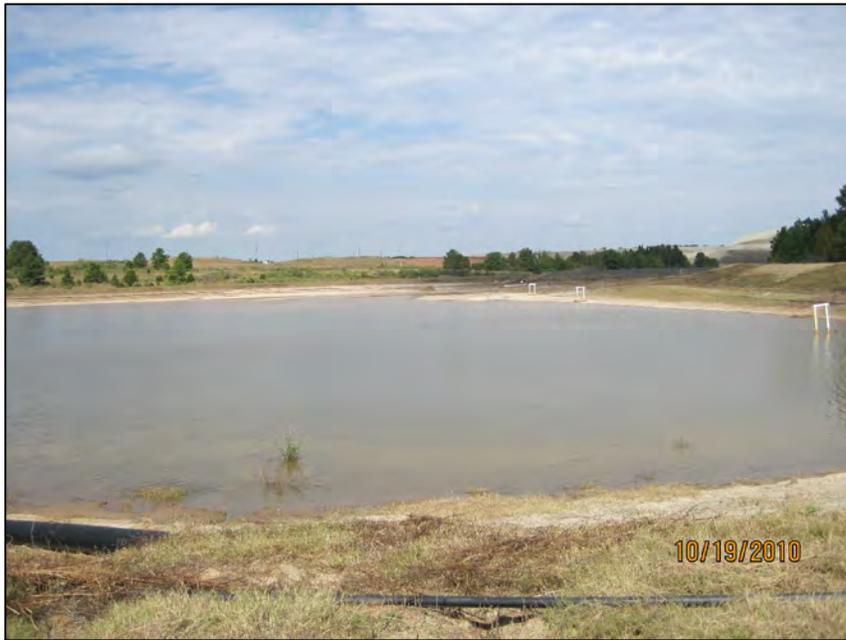
LRP-1
LOOKING NORTH ACROSS POND FROM
SOUTHEASTERN EMBANKMENT CREST

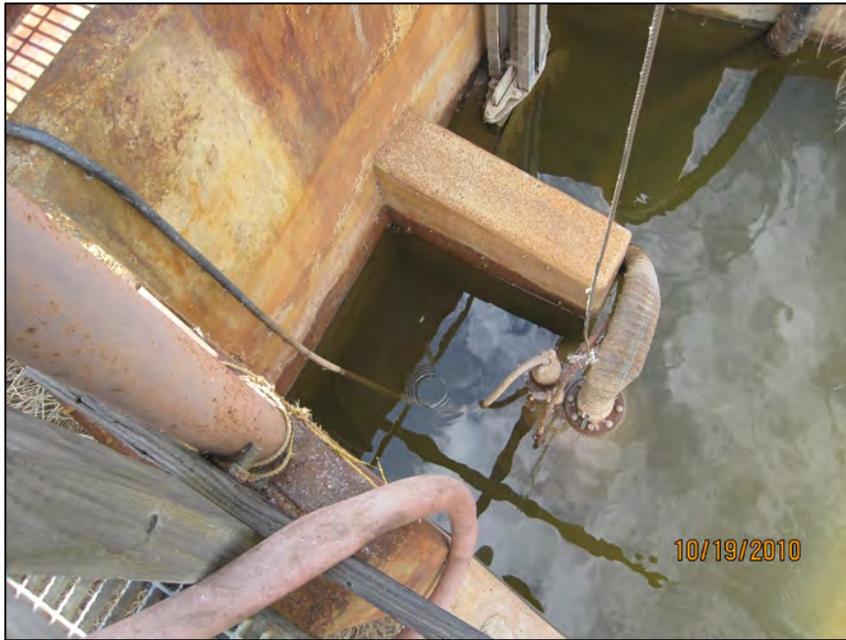
LRP-2
POND DISCHARGE STRUCTURE-NPDES OUTFALL 004

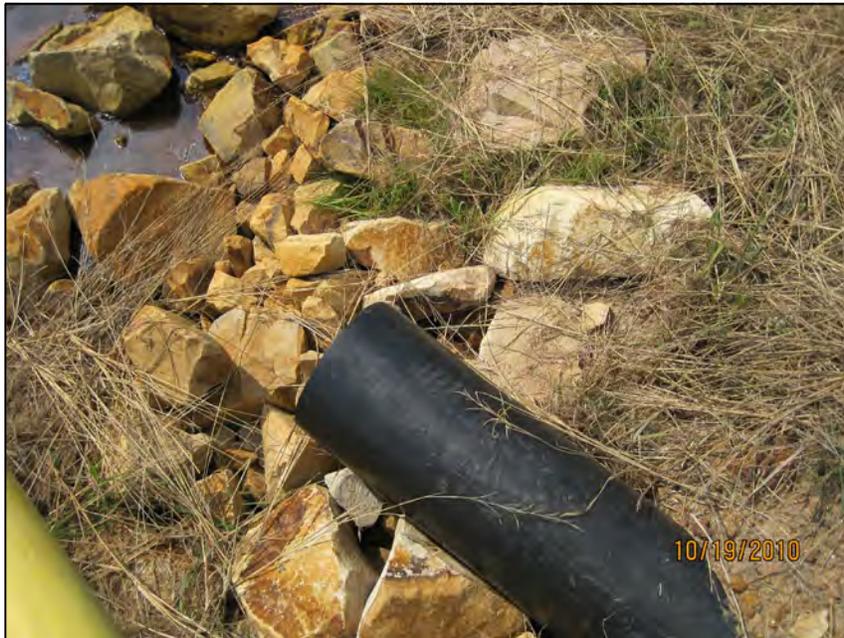
**LRP-3
DOWNSTREAM DISCHARGE-NPDES OUTFALL 004**

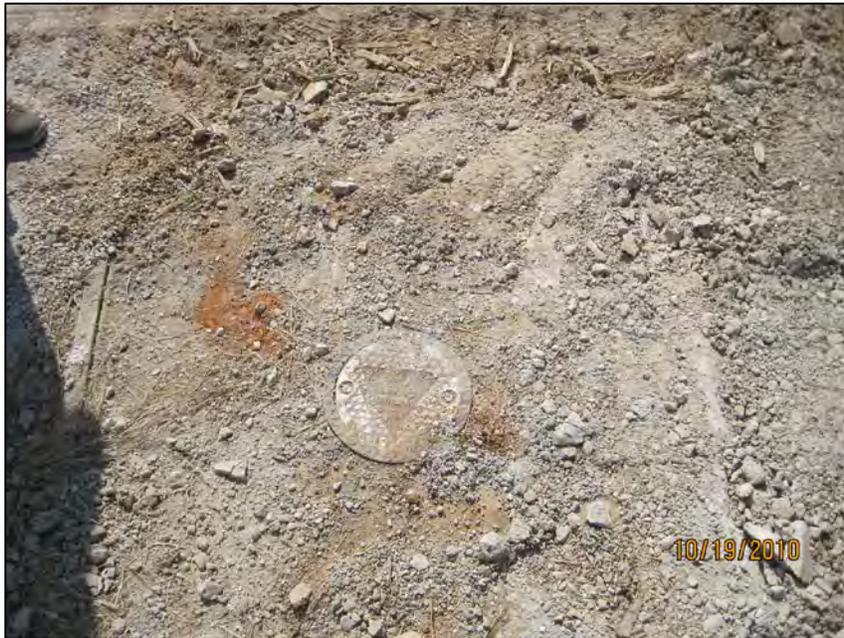
**LRP-5
PIEZOMETER ON EMBANKMENT CREST**

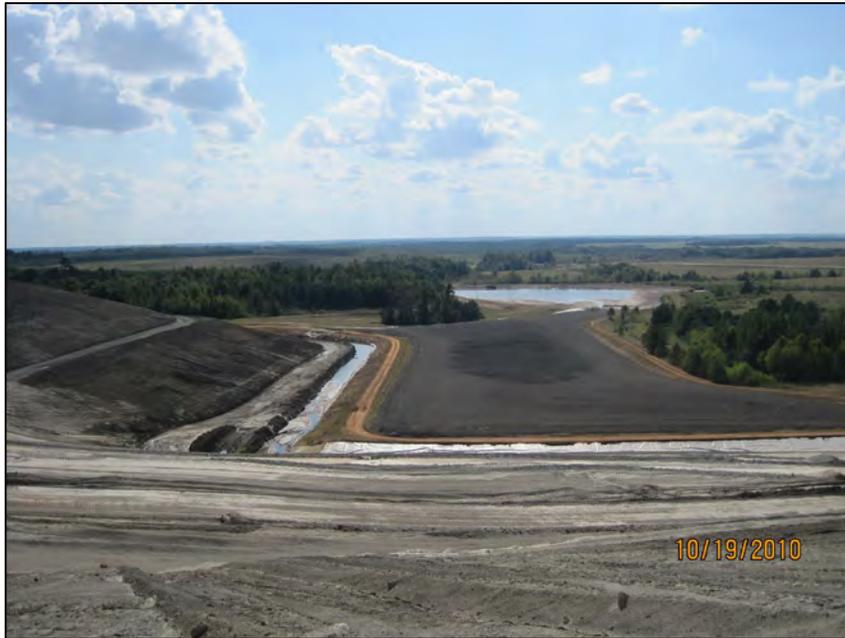
LRP-9
ATOP LANDFILL LOOKING SOUTHWEST AT LANDFILL PERIMETER CHANNEL AND LANDFILL RUNOFF POND
