**DRAFT REPORT
ROUND 7 DAM ASSESSMENT - WISCONSIN POWER & LIGHT
COLUMBIA GENERATING STATION
PRIMARY ASH, SECONDARY ASH, POLISHING & LANDFILL
STORMWATER PONDS
PARDEEVILLE, WISCONSIN**

January 17, 2011

Re: Round 7 Dam Assessment - Draft Report
EPA Contract No. EP10W001313
Wisconsin Power & Light – Columbia Generating Station
Primary Ash, Secondary Ash, Polishing & Landfill Storm Water Ponds
Pardeeville, Wisconsin

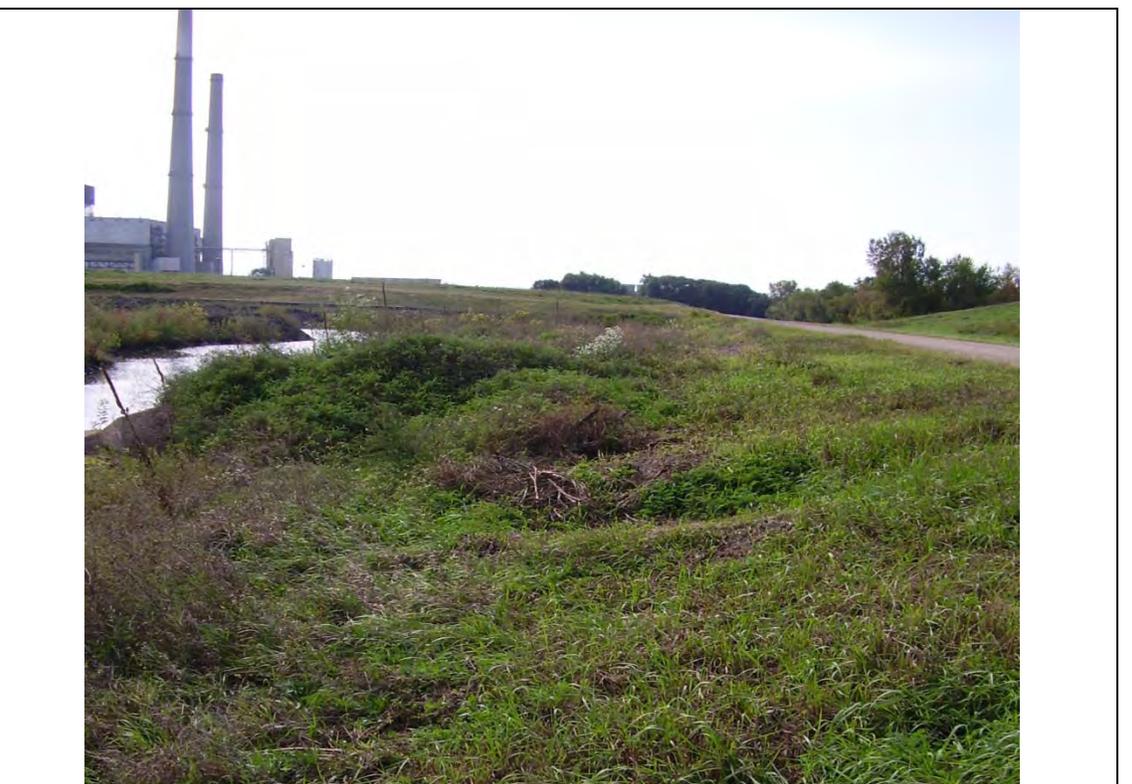
Photo No. 2	Date: 9/28/10
Direction Photo Taken: South	
Description: Upstream slope of PAP.

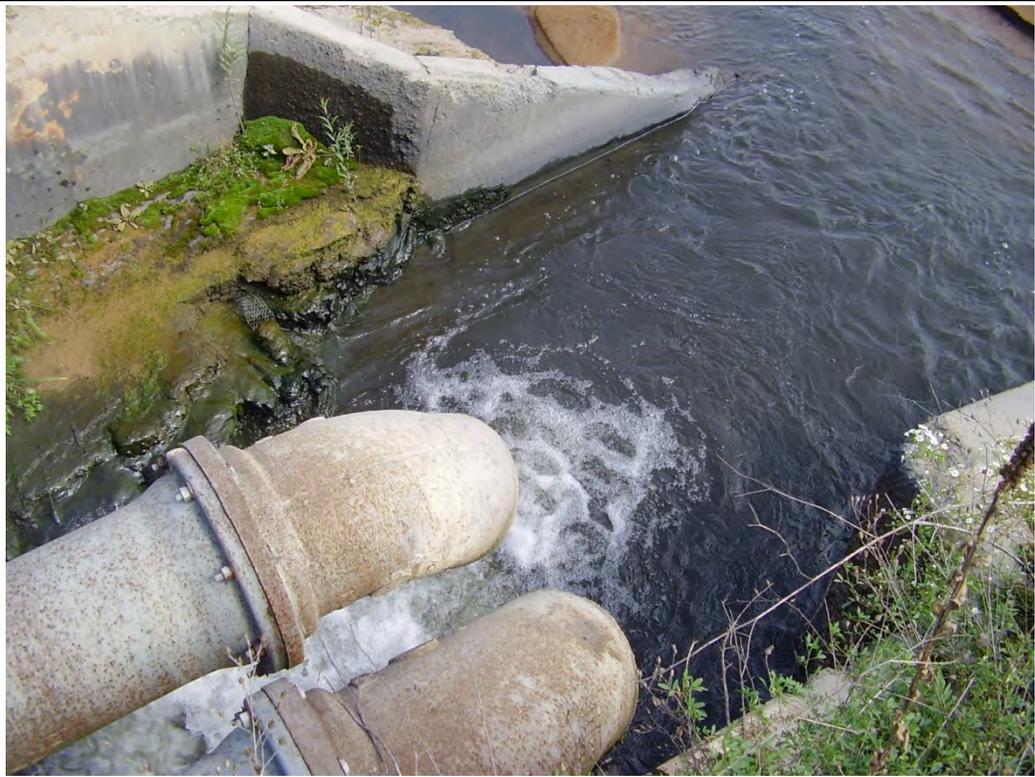
Photo No. 3	Date: 9/28/10
Direction Photo Taken: Northeast

Description:
PAP Discharge Pipelines:
(2) 12" Diameter

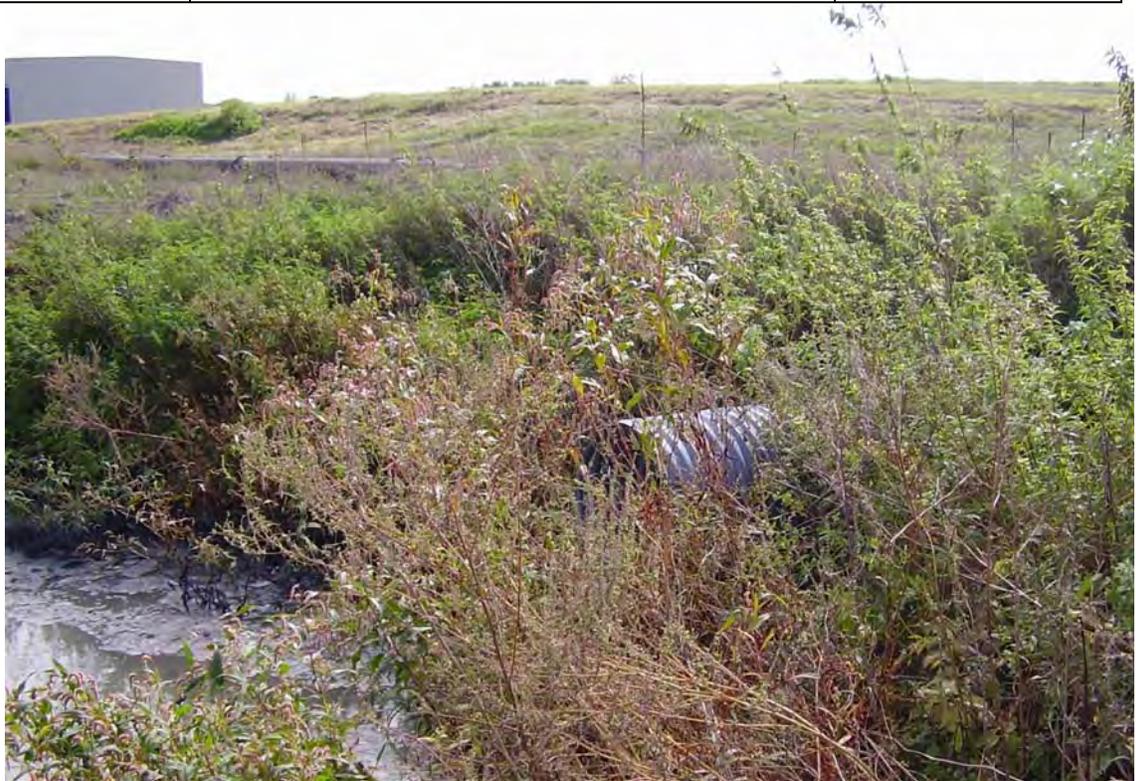
Description:
Upstream slope of PAP and water treatment sump discharge pipeline:
(1) 24" Diameter.

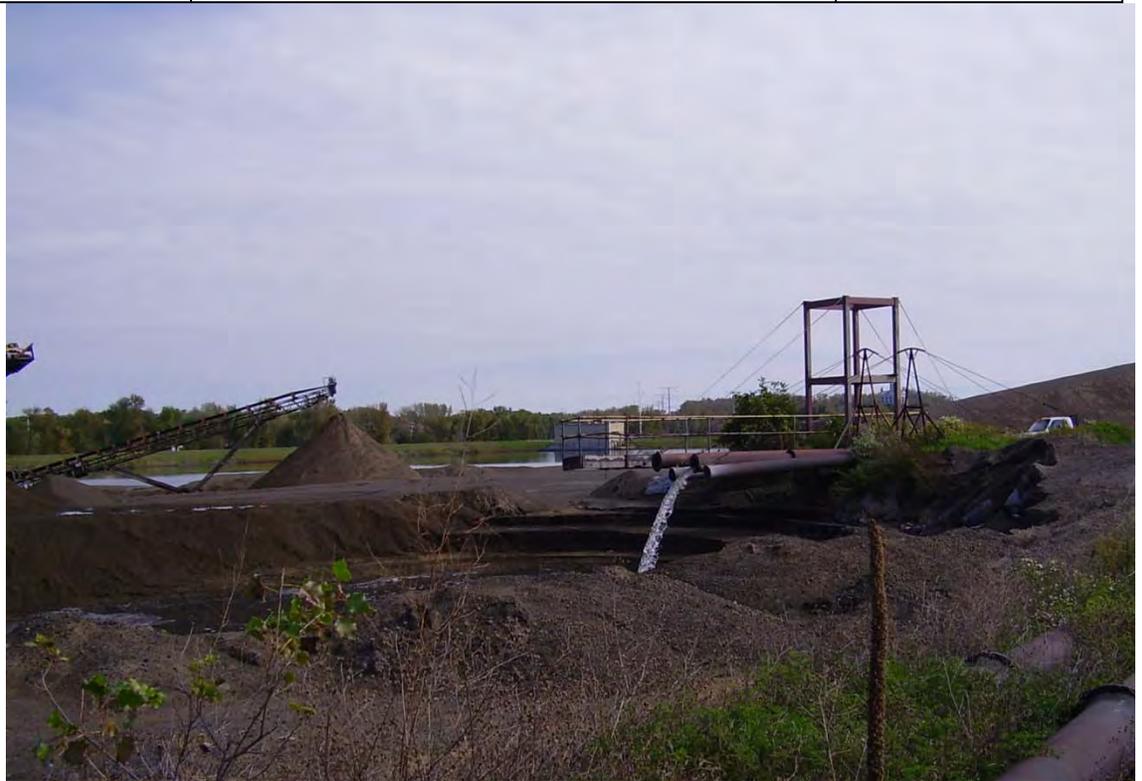
Description:
Discharge Pipelines in
southeast portion of PAP:
(2) 12" Diameter,
(2) 8" Diameter.

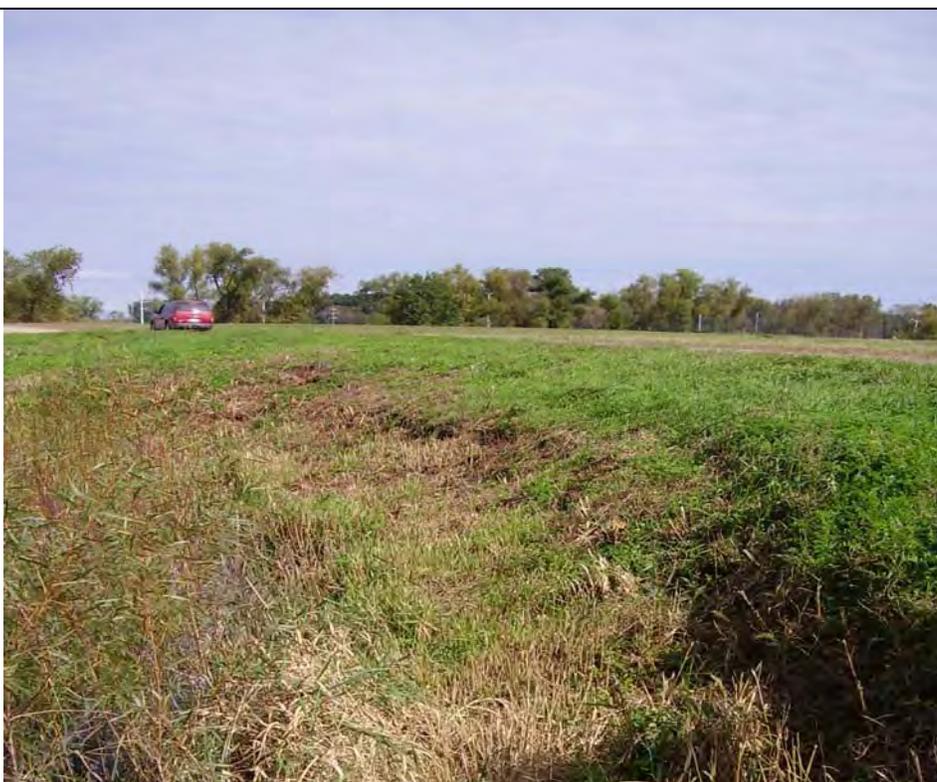
Photo No. 16	Date: 9/28/10

The PAP water surface elevation at the time of inspection was at an elevation of 796 feet MSL. Therefore, the lower portion of the upstream slope was underwater or covered by ash deltas and not visible. No rip rap was present on the upstream slope and there was wave action erosion of the upstream slope at the pond water elevation throughout much of the impoundment. An example of the observed erosion is shown in Photo 16. The upstream slope was generally vegetated with grass that appeared to be regularly mowed.

Direction Photo Taken: North		
Description: Upstream slope of PAP and downstream slope of SAP.

1. Evaluate the extent of wave action erosion on the upstream slopes of the PAP;
2. Perform a hydrologic/hydraulic analysis of the PAP, SAP and PP to determine the adequacy of the current operating conditions and design to accommodate the appropriate precipitation event;
3. Evaluate the slope and seepage stability of the PAP, SAP and LSP based on current operating conditions and methodologies. The effects of high water events from the Wisconsin River should be considered in the analysis for the PAP and SAP; and,
4. Develop an EAP for the impoundments.

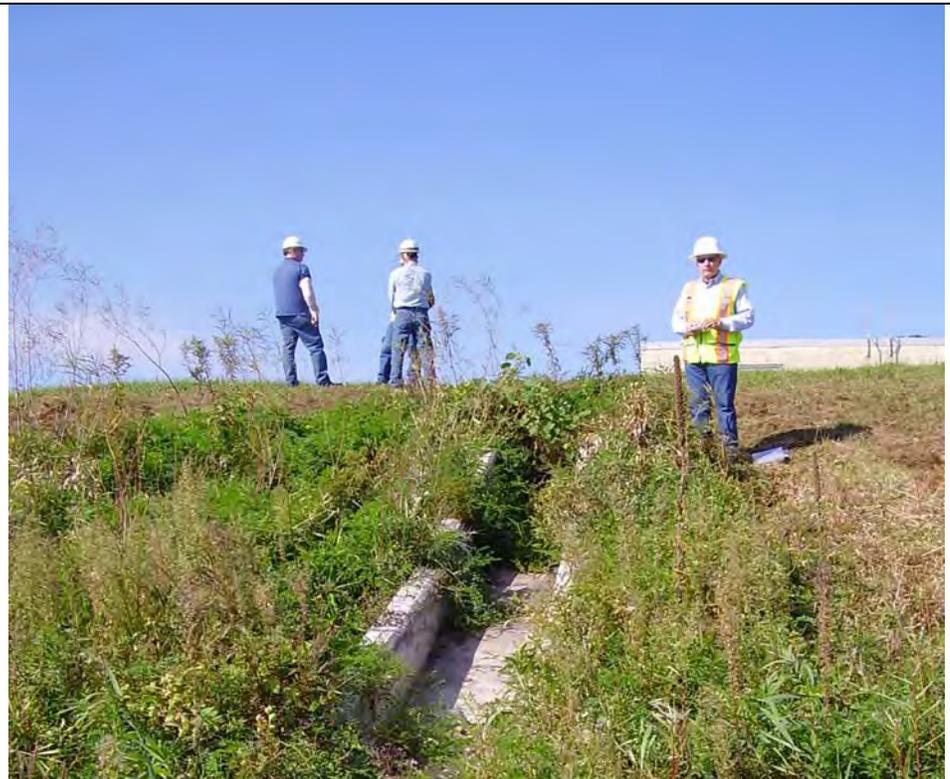
Description:
Upstream slope of SAP, downstream slope of PAP, and 8" discharge pipeline and concrete spillway.

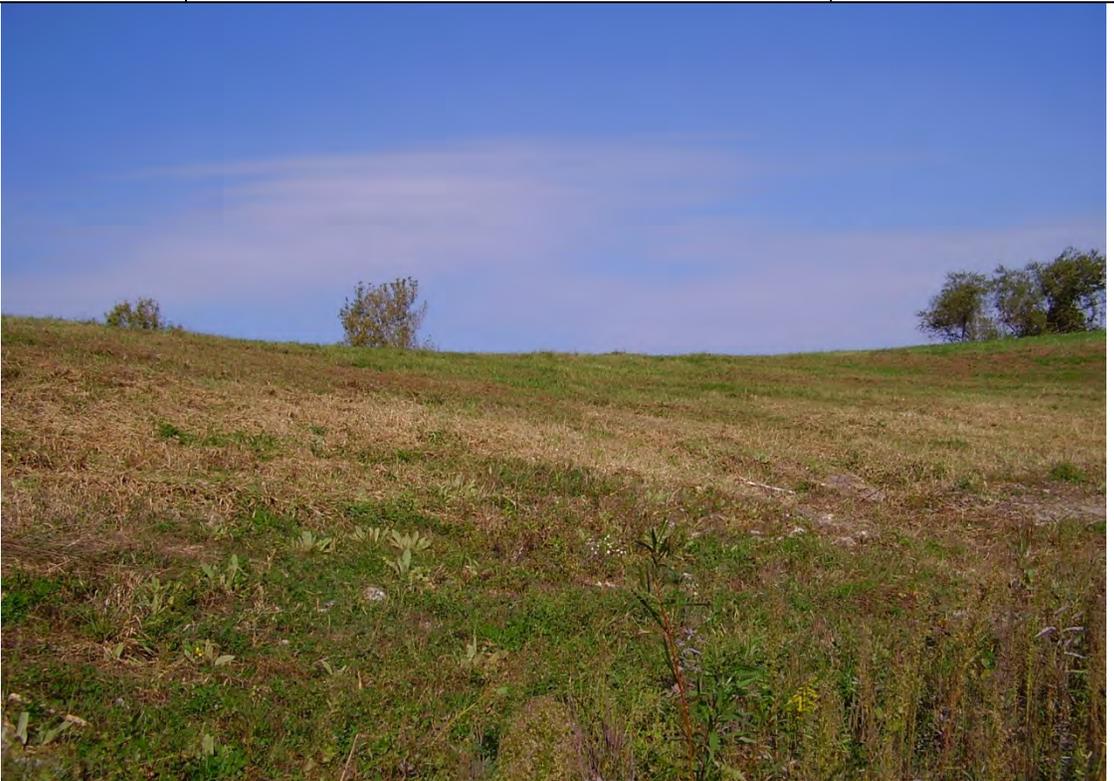
The SAP water elevation at the time of inspection was approximately at an elevation of 790 feet MSL¹⁵. Therefore, the lower portion of the upstream slope was underwater or covered by ash deltas and not visible. No rip rap was present on the upstream slope and there was minor wave action erosion of the upstream slope at the historic pond water elevation (approximately 796 feet MSL) throughout much of the impoundment. An example of the observed erosion is shown in Photo 31. The upstream slope was generally vegetated with grass that appeared to be regularly mowed.

Photo No. 31	Date: 9/28/10
Direction Photo Taken: North	
Description: Upstream slope of SAP and downstream slope of PAP.

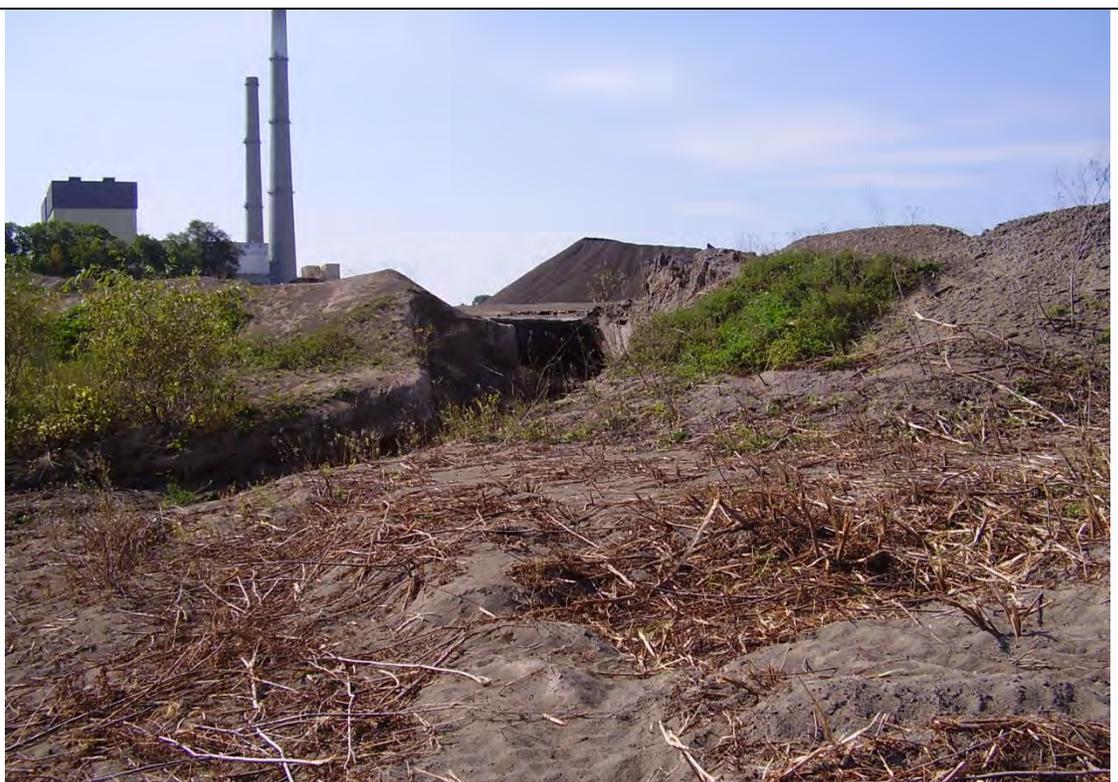
The impoundment is incised along the western and southern embankments. An embankment separates the PAP from the SAP such that the eastern embankment downstream slope of the PAP is the same as the western embankment upstream slope of the SAP. The backwaters of the Wisconsin River are generally near the downstream slope of the northern embankment of the PAP. During high water events, such as occurred during our Site visit, the backwaters of the Wisconsin River cover the downstream toe and part of the northern embankment as shown in Photos 24 through 26. The downstream slope of the northern embankment of the impoundment was generally in good condition. The northern embankment was vegetated with grass that appeared to be regularly mowed and trees had recently been removed from the northern embankment as shown in Photo 27. There was minor wave action erosion over much of the eastern embankment downstream slope as shown in Photos 31 and 32. A large ditch that appeared to be formed by stormwater erosion was noted on the downstream slope near the southeast corner of the PAP. The eroded ditch was approximately 10 feet wide, 6 feet to 8 feet deep, and 50 feet long and is shown in Photos 34 and 35.

Description:
Upstream slope of SAP, downstream slope of PAP, and large erosional feature.

1. Repair erosion ditches present in the PAP, SAP and LSP.

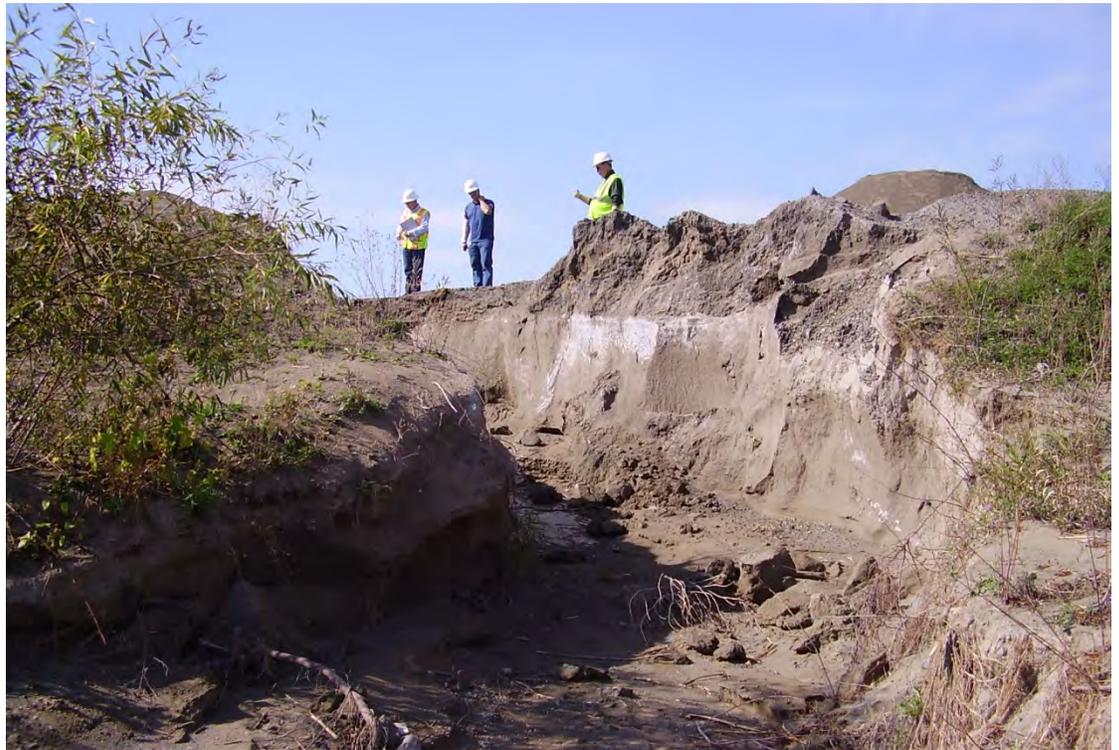
Description:
Erosional feature in SAP.

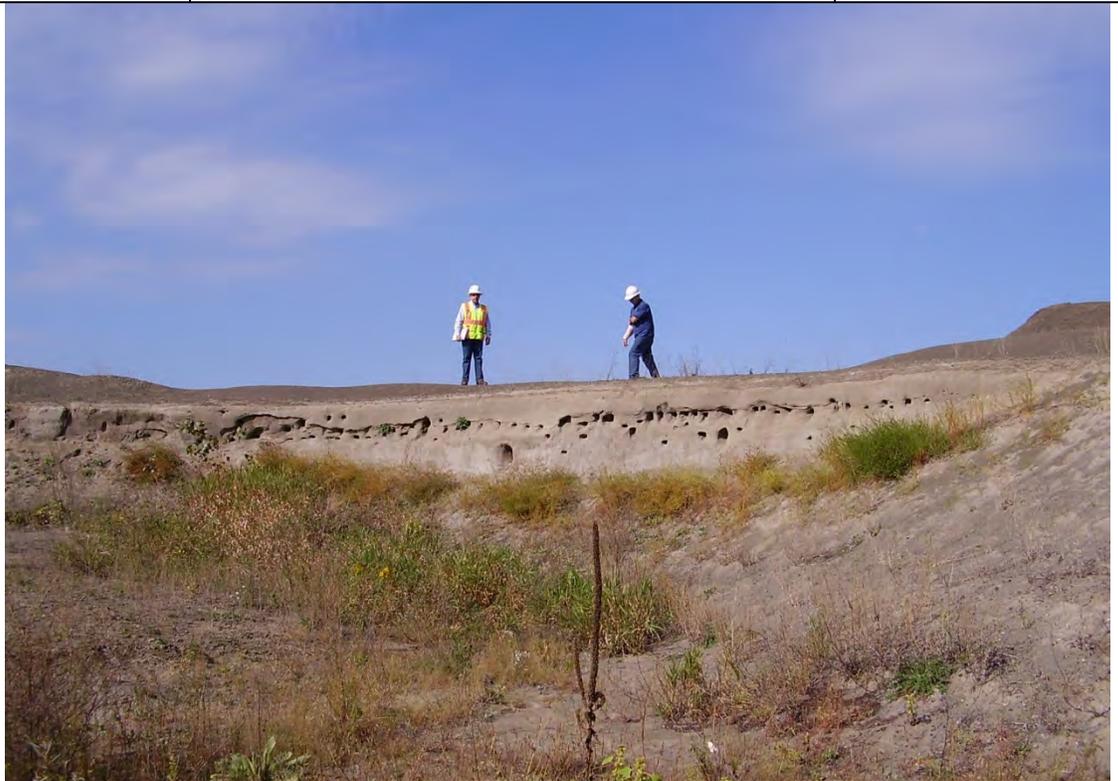
Description:
Downstream slope of PAP and animals/bird burrows.

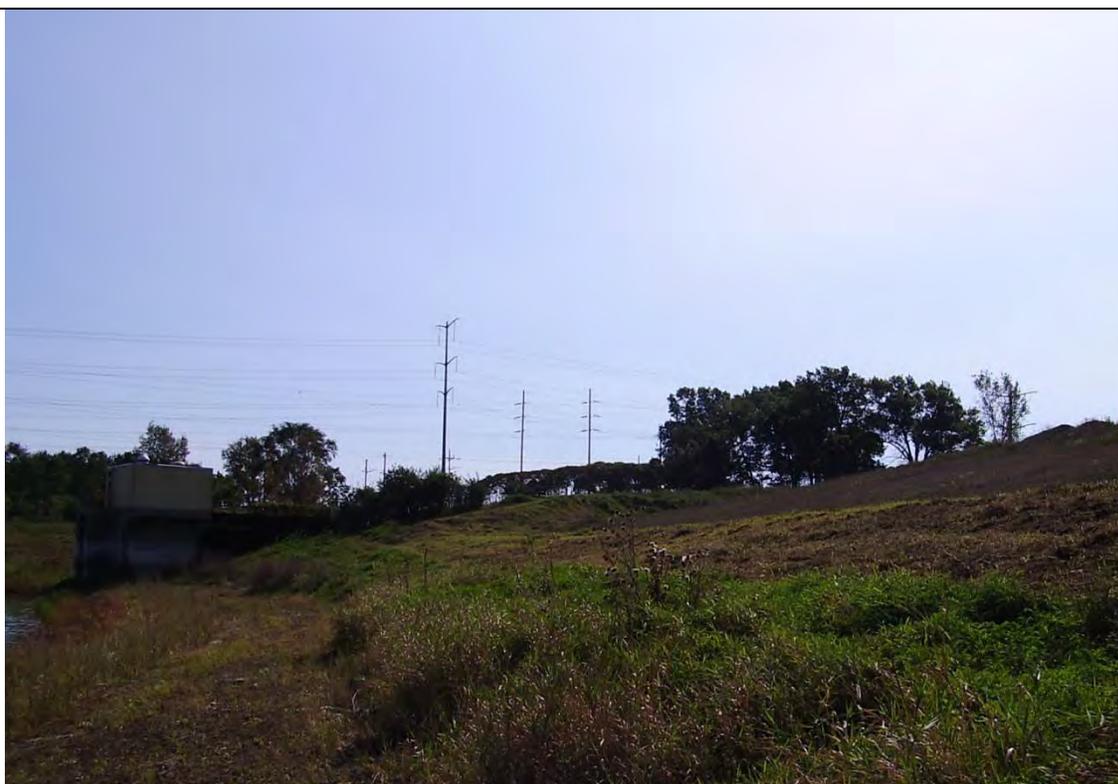
Photo No. 38	Date: 9/28/10
Direction Photo Taken: Southeast

Description:
Upstream slope of SAP and SAP pump house.

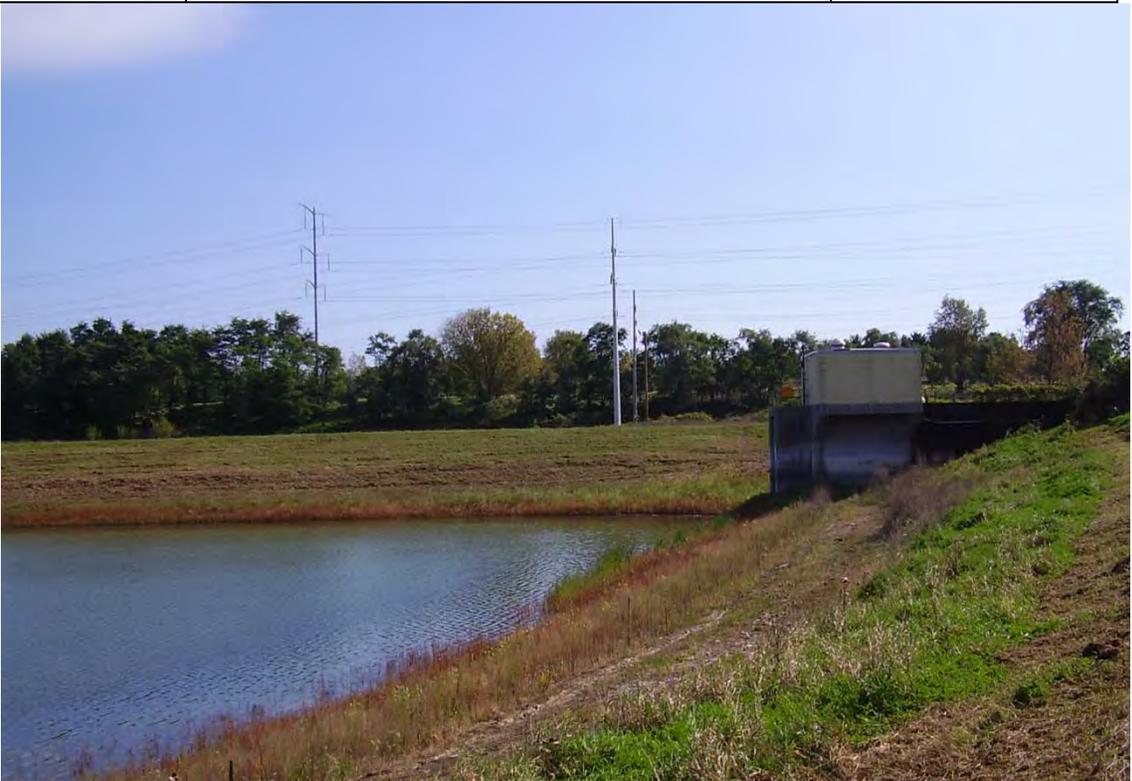
Photo No. 39	Date: 9/28/10
Direction Photo Taken: East	
Description: Upstream slope of SAP and SAP pump house.

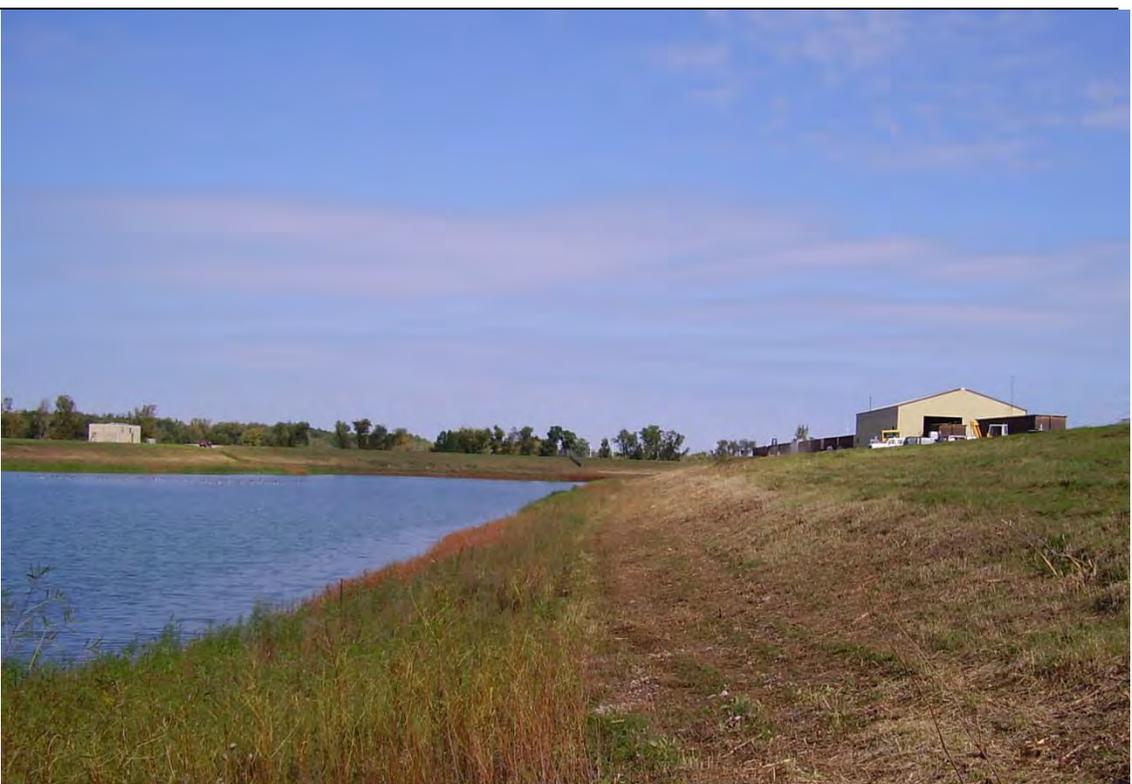
Photo No. 40	Date: 9/28/10
Direction Photo Taken: North	
Description: Upstream slope of SAP.

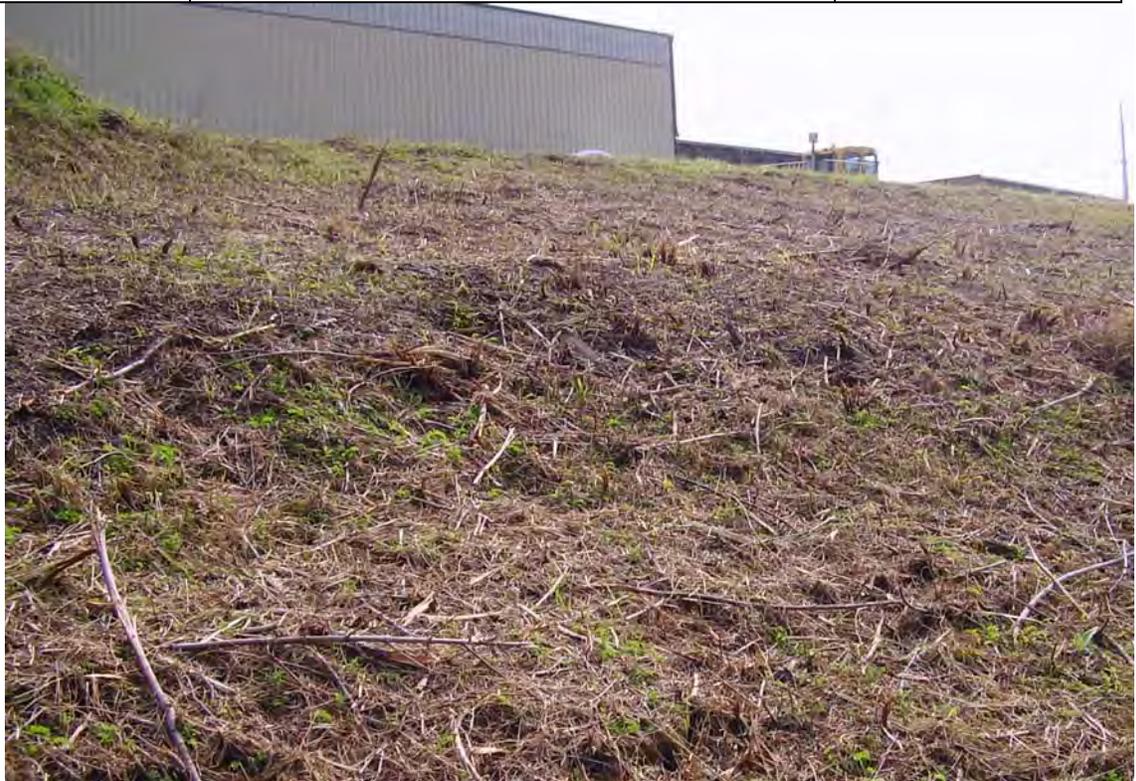
Photo No. 41	Date: 9/28/10
Direction Photo Taken: Southeast	
Description: Upstream slope of SAP and equipment shed.

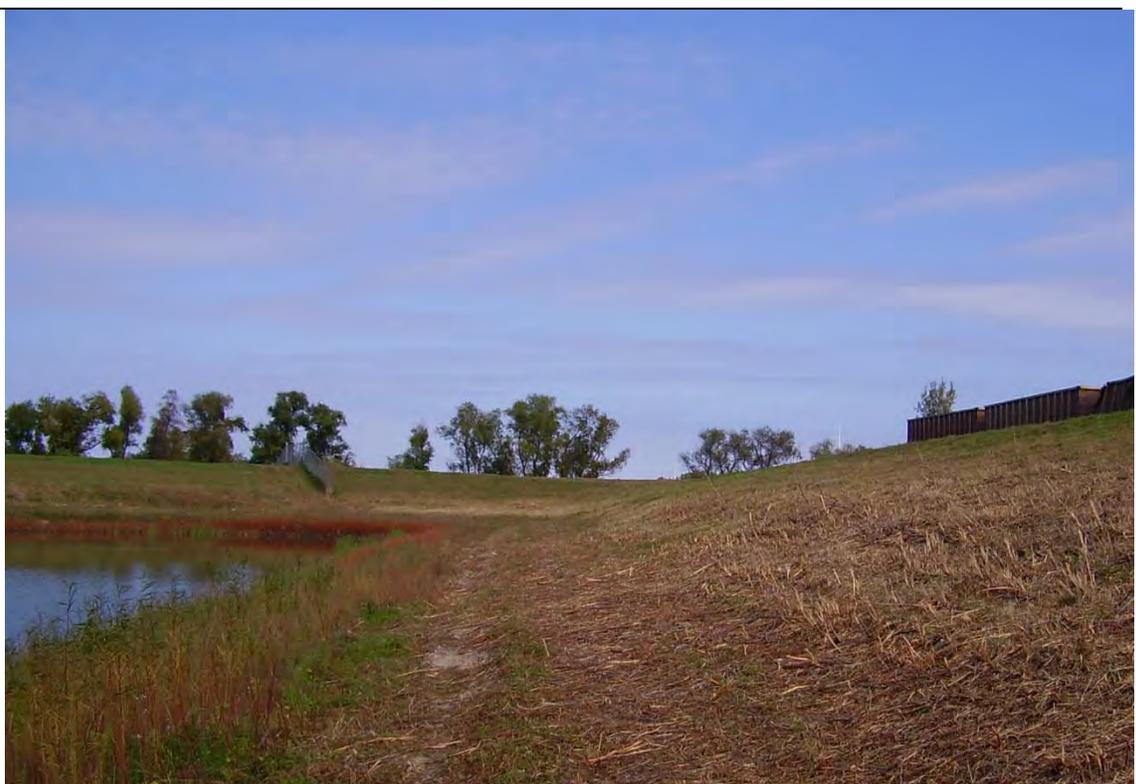
Photo No. 42	Date: 9/28/10
Direction Photo Taken: North	
Description: Upstream slope of SAP.

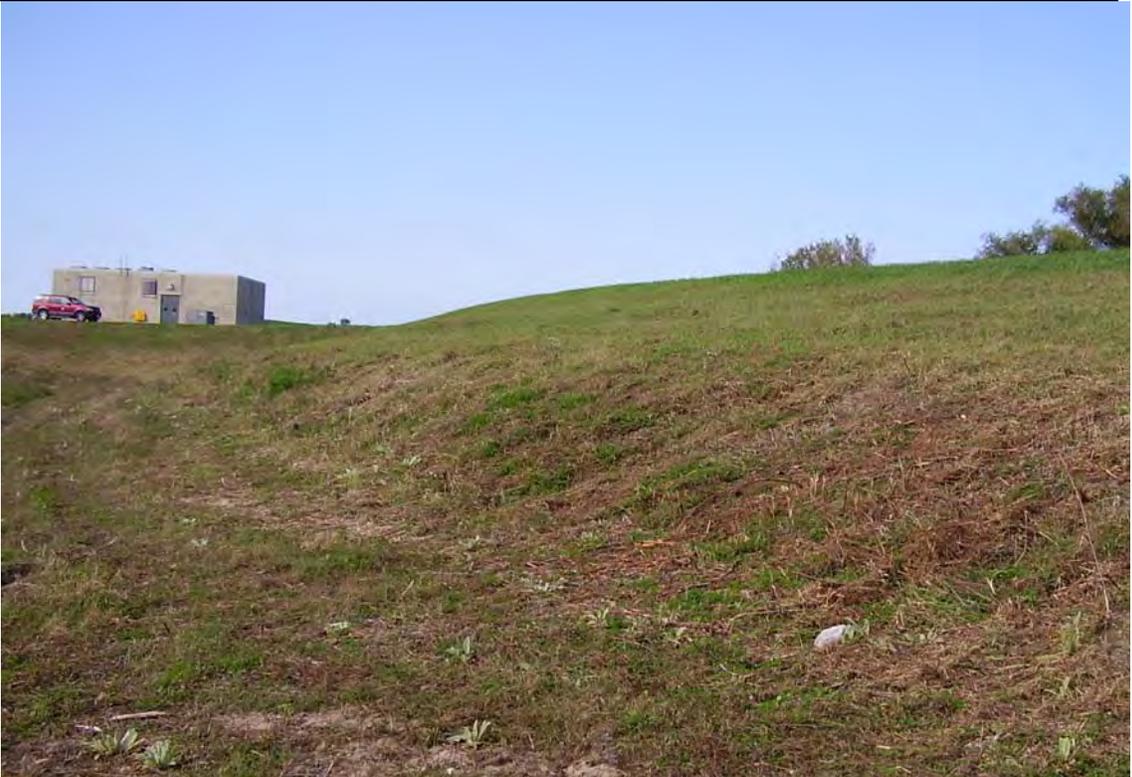
Photo No. 43	Date: 9/28/10
Direction Photo Taken: Southwest	
Description: Upstream slope of SAP.

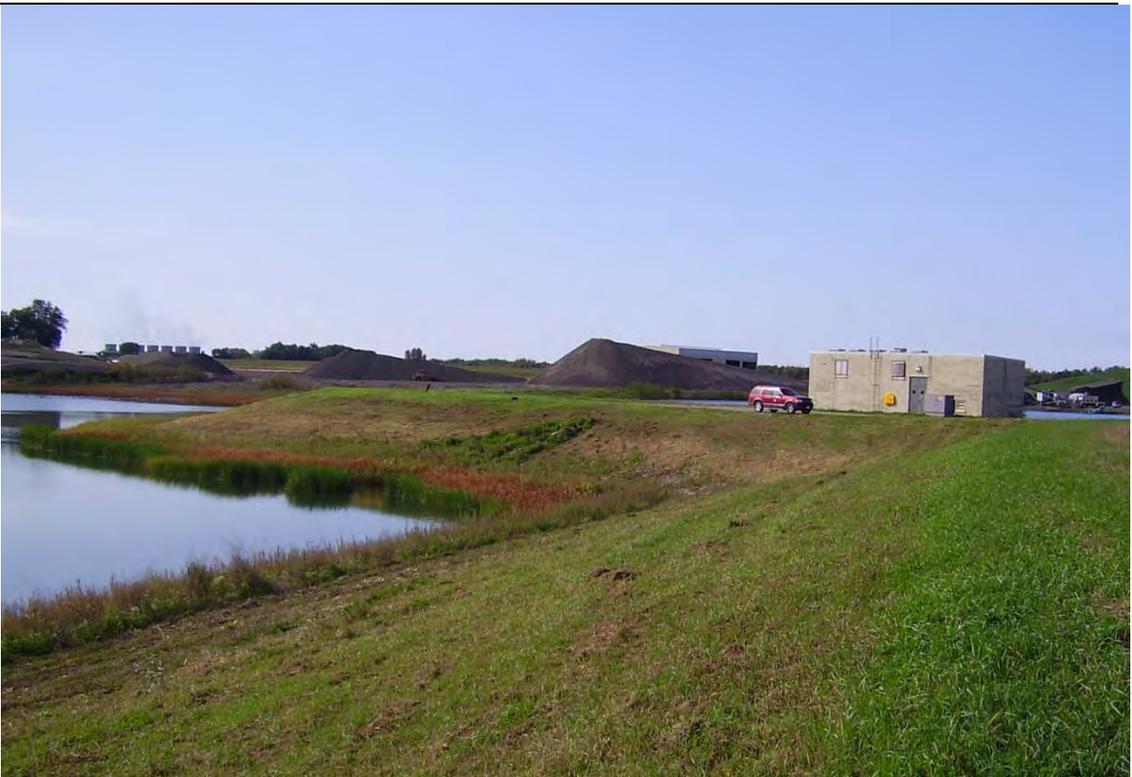
Photo No. 44	Date: 9/28/10
Direction Photo Taken: Southwest	
Description: Upstream slope of SAP and PAP pump house.

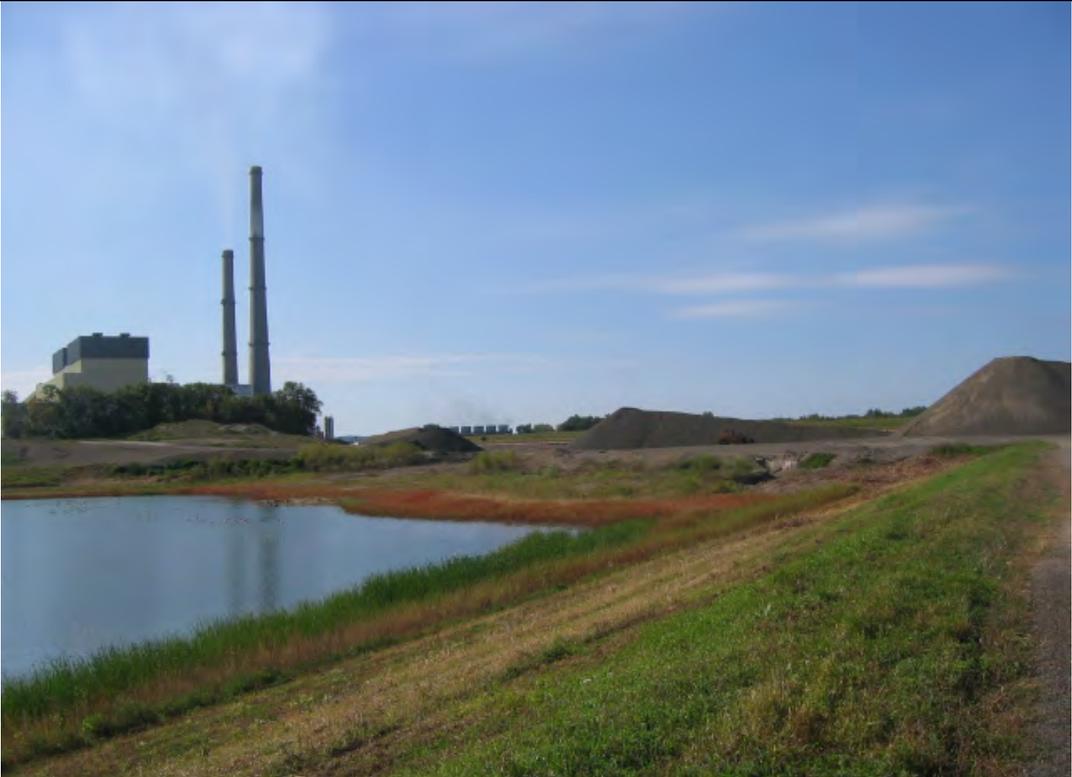
Photo No. 45	Date: 9/28/10
Direction Photo Taken: Southwest	
Description: Upstream slope of SAP and downstream slope of PAP and crest.

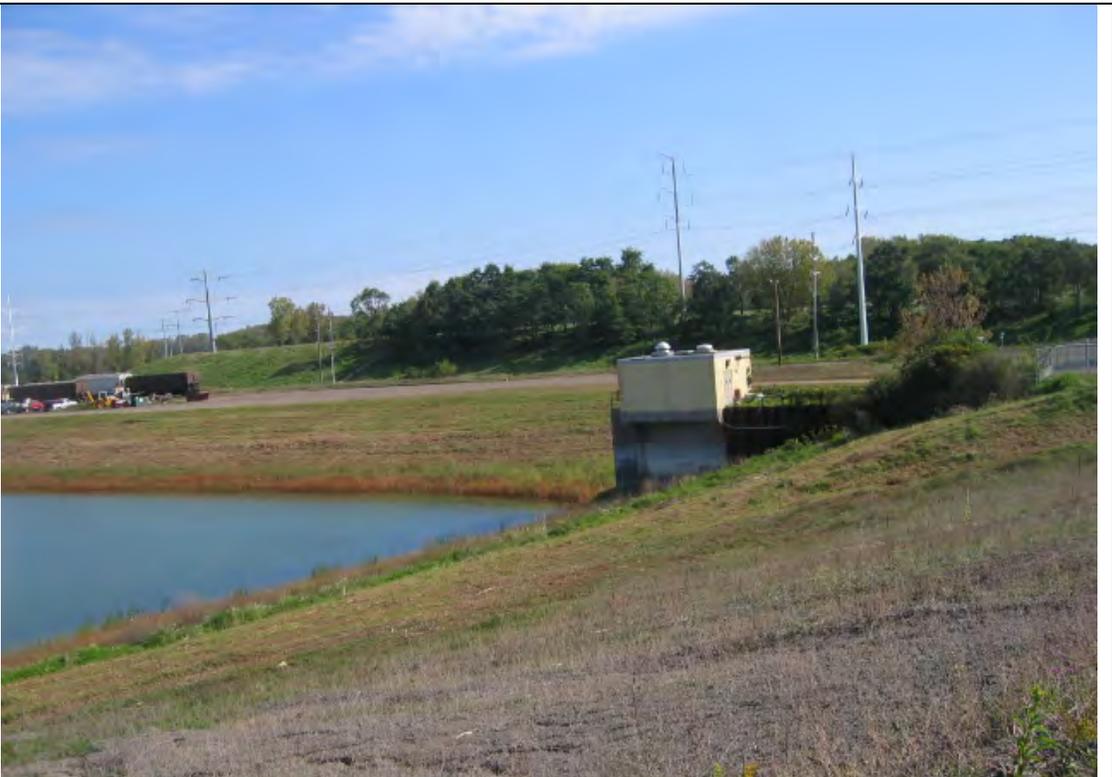
Photo No. 46	Date: 9/28/10
Direction Photo Taken: East	
Description: Crest of SAP and SAP pump house.

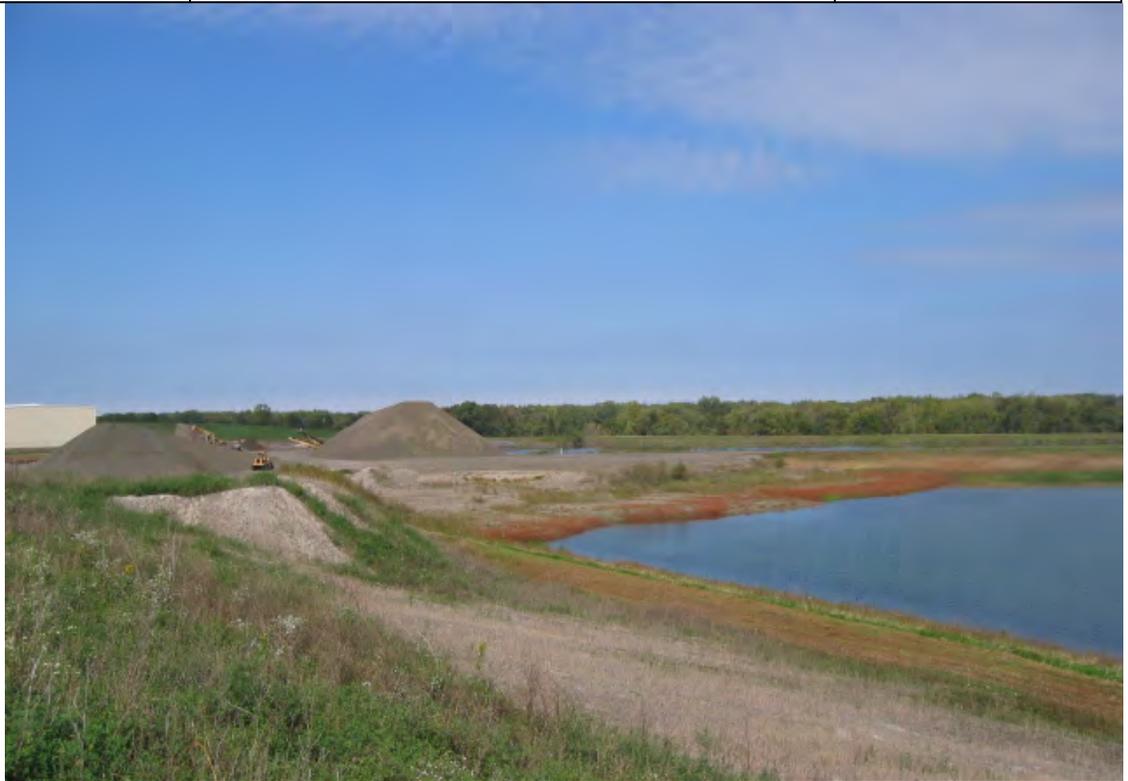
Photo No. 47	Date: 9/28/10
Direction Photo Taken: Northwest	
Description: Crest of SAP.

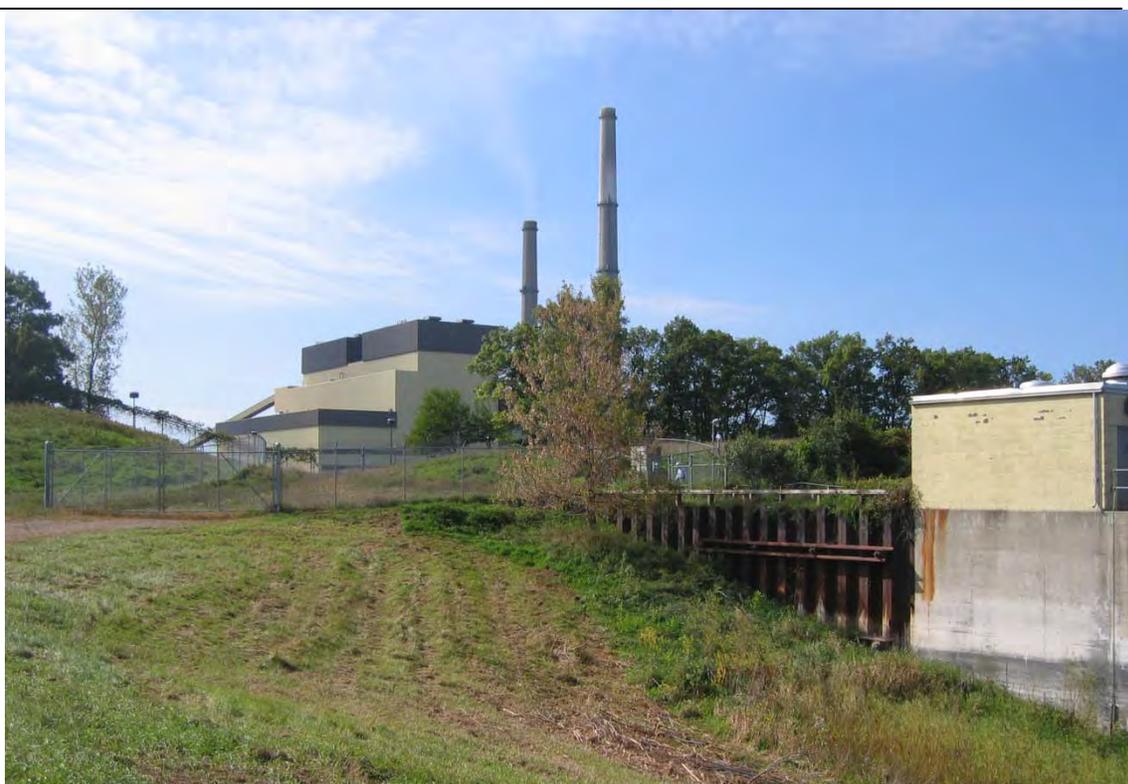
Photo No. 48	Date: 9/28/10
Direction Photo Taken: Southwest	
Description: Crest of SAP and SAP pump house.

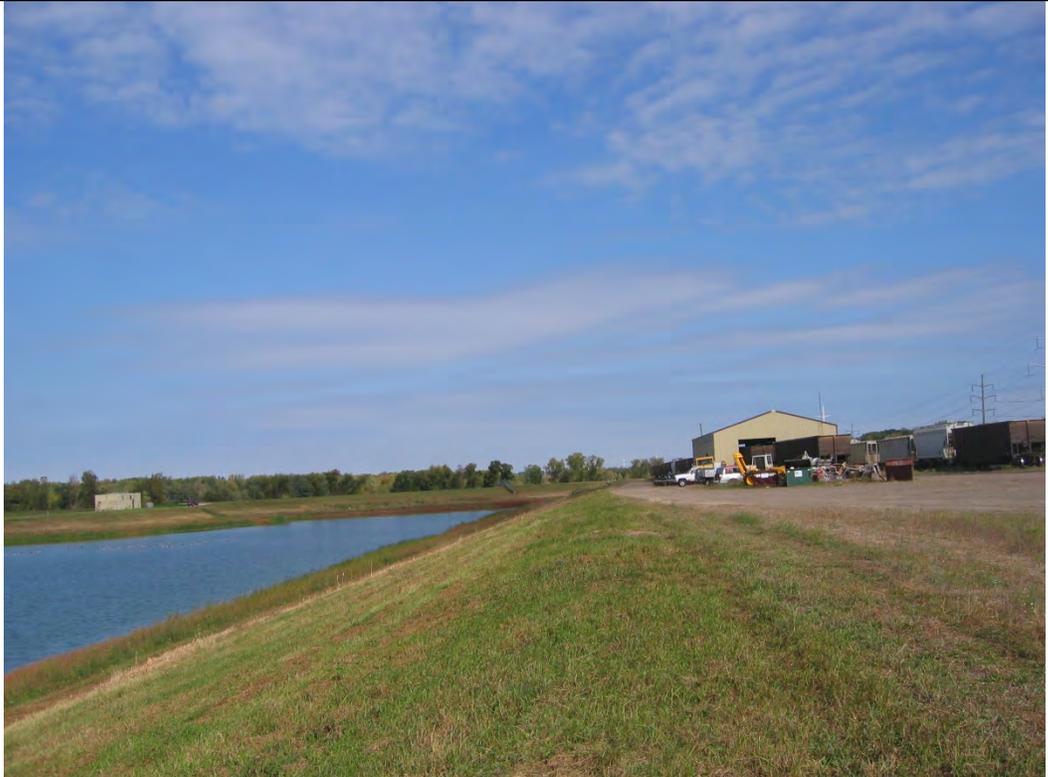
Photo No. 49	Date: 9/28/10
Direction Photo Taken: North	
Description: Crest of SAP

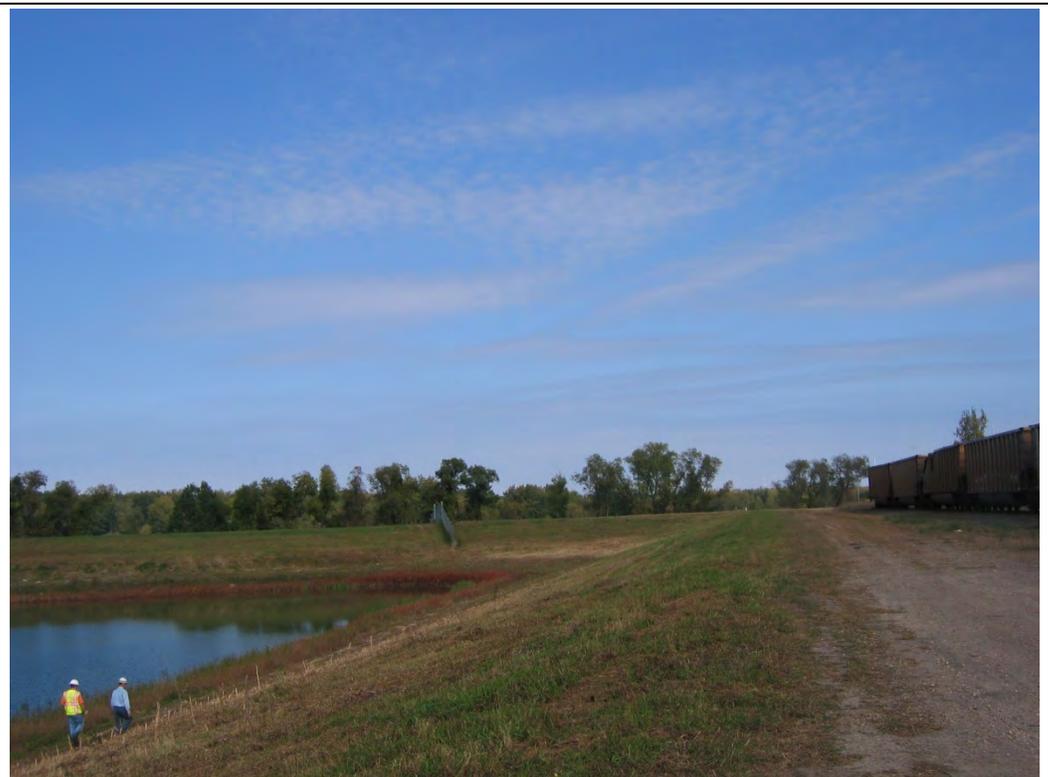
Photo No. 50	Date: 9/28/10
Direction Photo Taken: North	
Description: Crest of SAP.

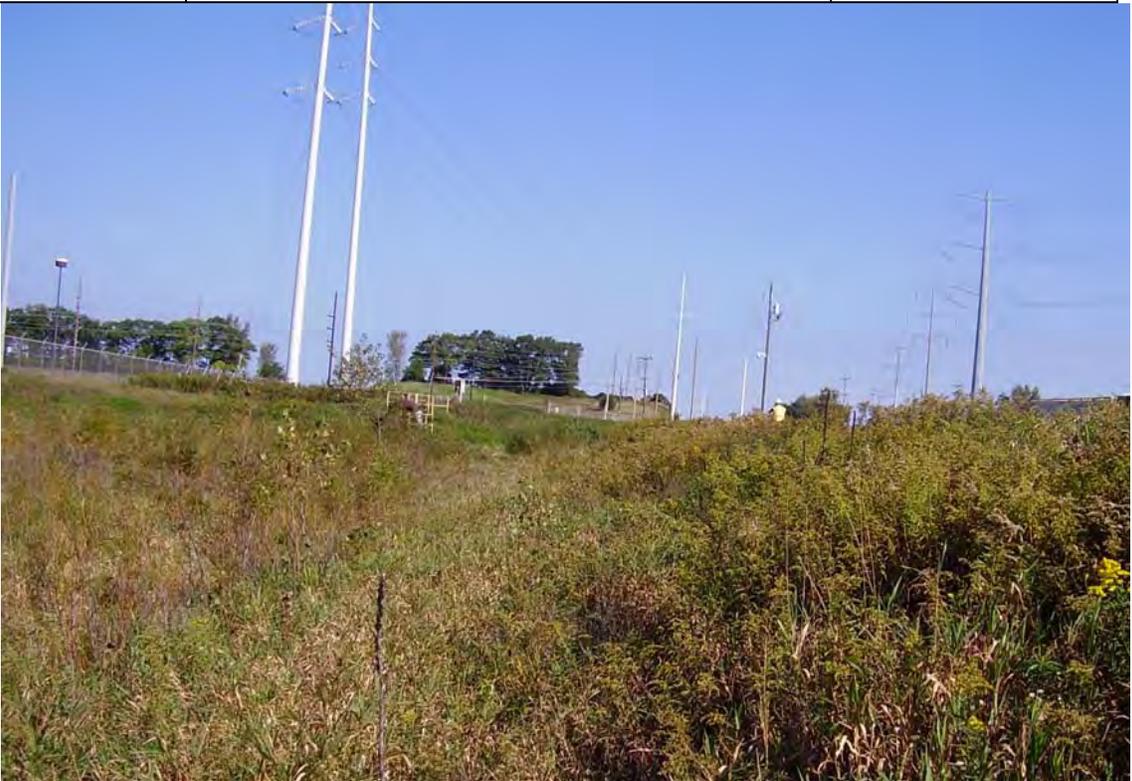
Photo No. 51	Date: 9/28/10
Direction Photo Taken: North	
Description: Upstream slope of Polishing Pond Impoundment (PP).

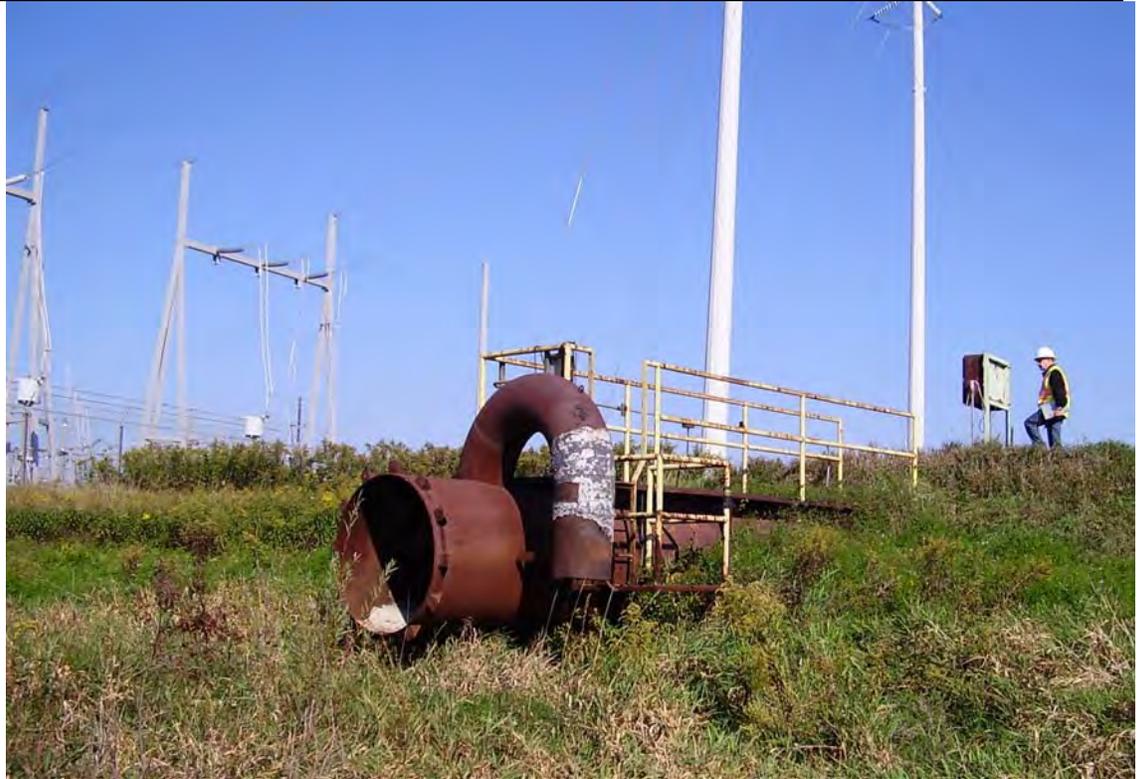
Photo No. 53	Date: 9/28/10
Direction Photo Taken: North West

Description:
Upstream slope of PP and (1) 4' inlet pipe.
