**DRAFT REPORT
ROUND 7 DAM ASSESSMENT - WISCONSIN POWER & LIGHT
COLUMBIA GENERATING STATION
PRIMARY ASH, SECONDARY ASH, POLISHING & LANDFILL
STORMWATER PONDS
PARDEEVILLE, WISCONSIN**

January 17, 2011

Re: Round 7 Dam Assessment - Draft Report
EPA Contract No. EP10W001313
Wisconsin Power & Light – Columbia Generating Station
Primary Ash, Secondary Ash, Polishing & Landfill Storm Water Ponds
Pardeeville, Wisconsin

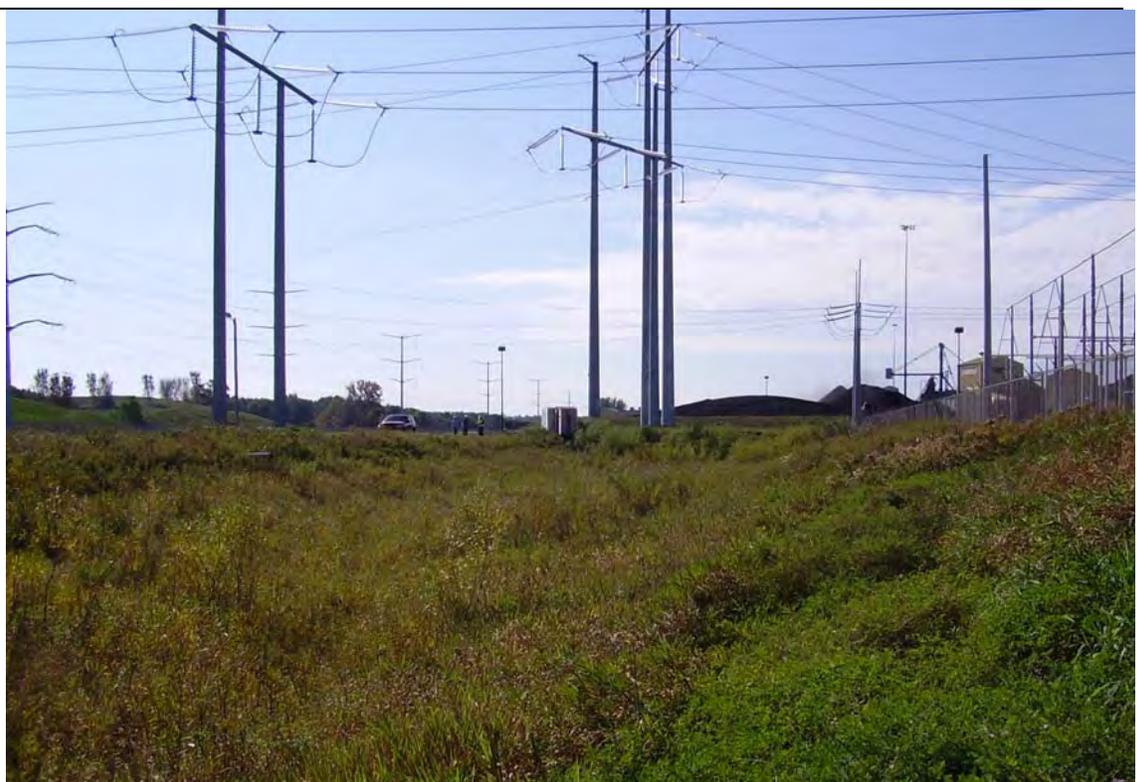
Photo No. 54	Date: 9/28/10
Direction Photo Taken: South

Description:
Upstream slope of PP.

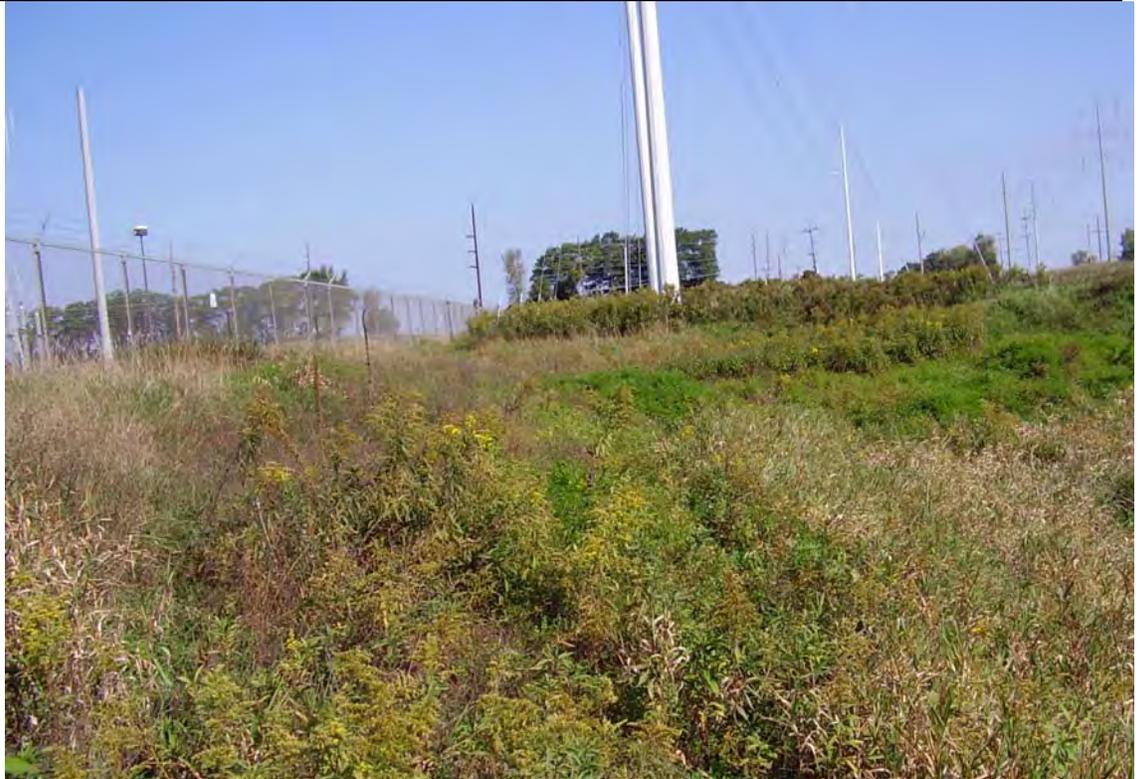
Description:
Upstream slope of PP.

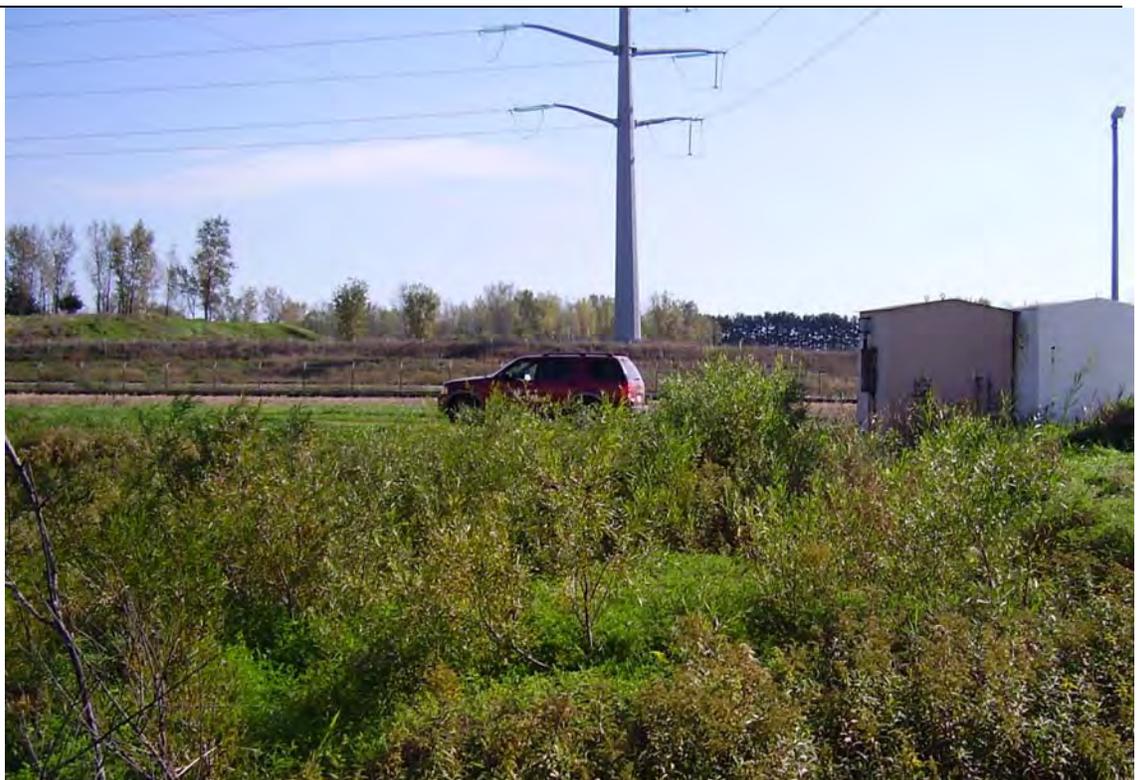
Photo No.
56

Description:
Crest of PP.

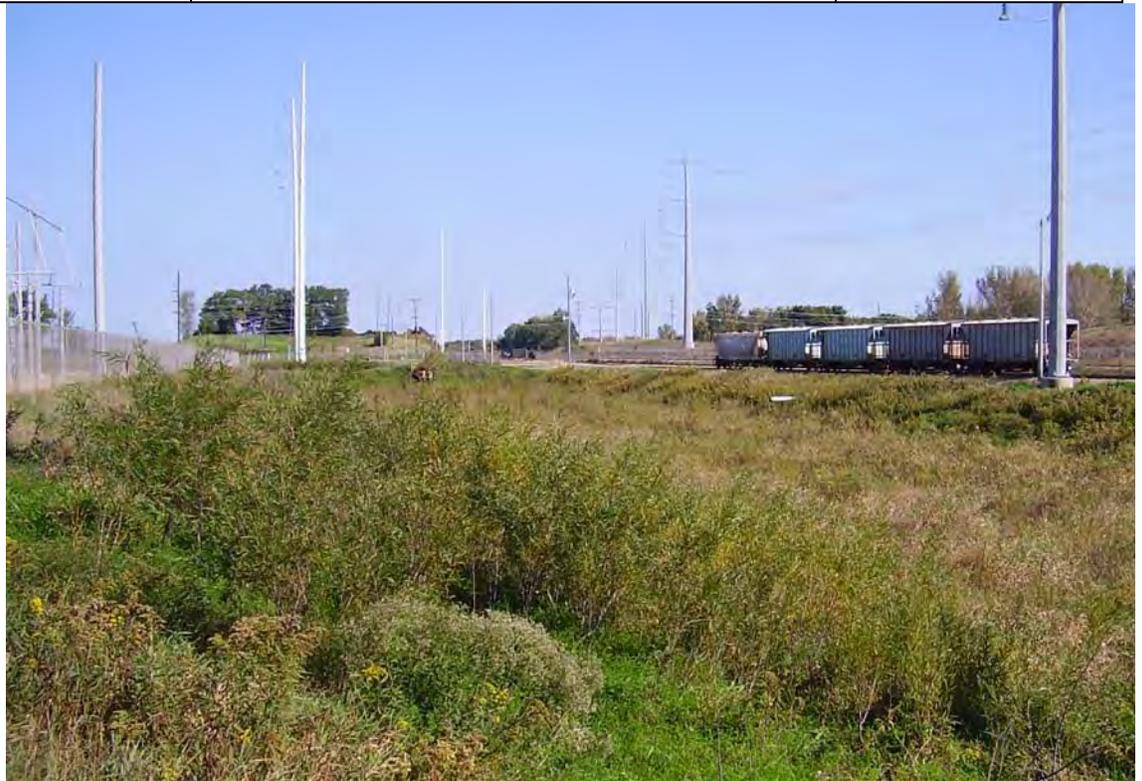
Upstream slope and crest of
PP.

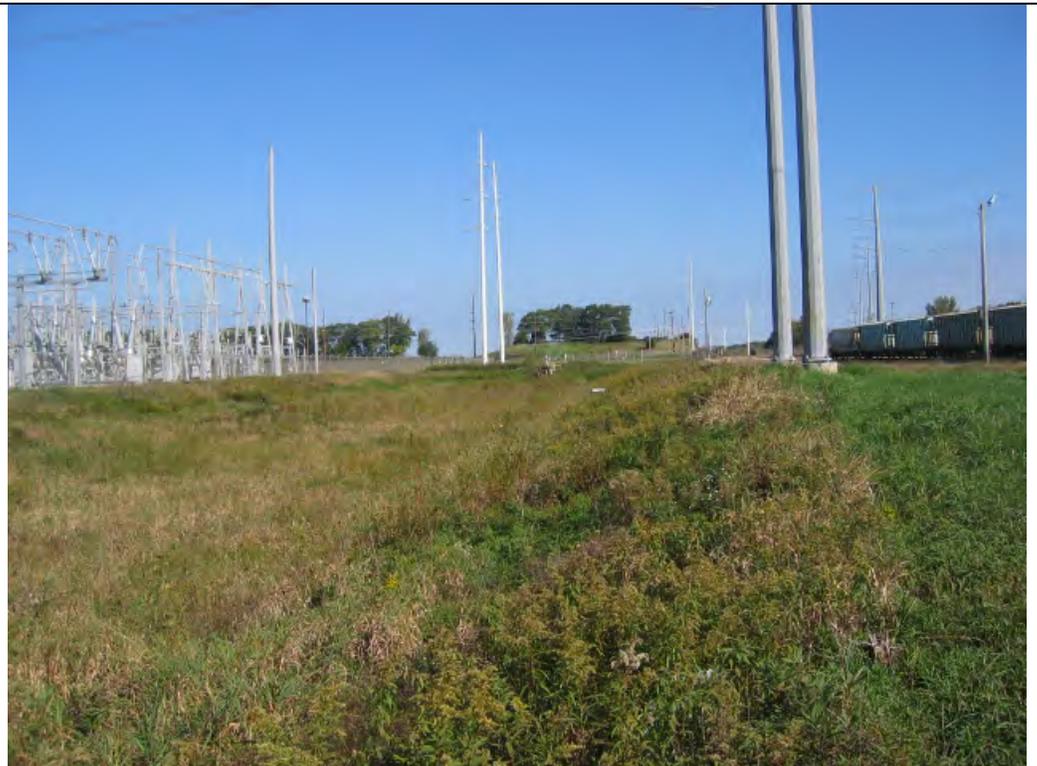
Photo No.
58

Upstream slope and crest of
PP.

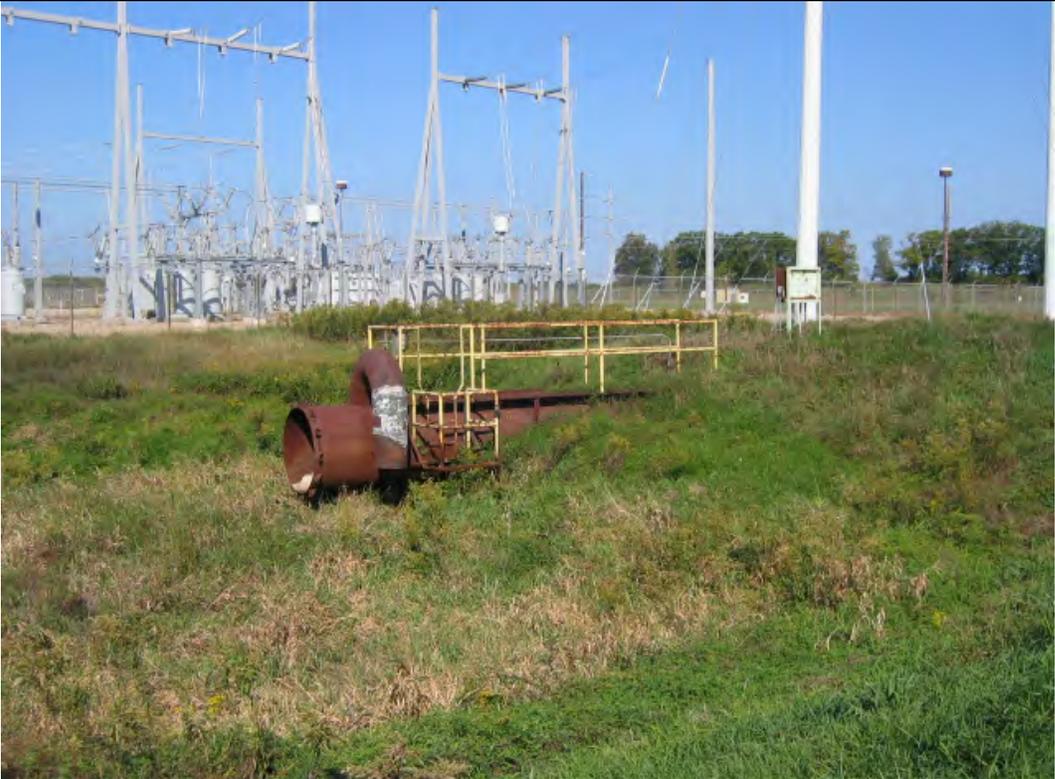
Photo No. 59	Date: 9/28/10
Direction Photo Taken: Northwest

Description:
Crest of PP.

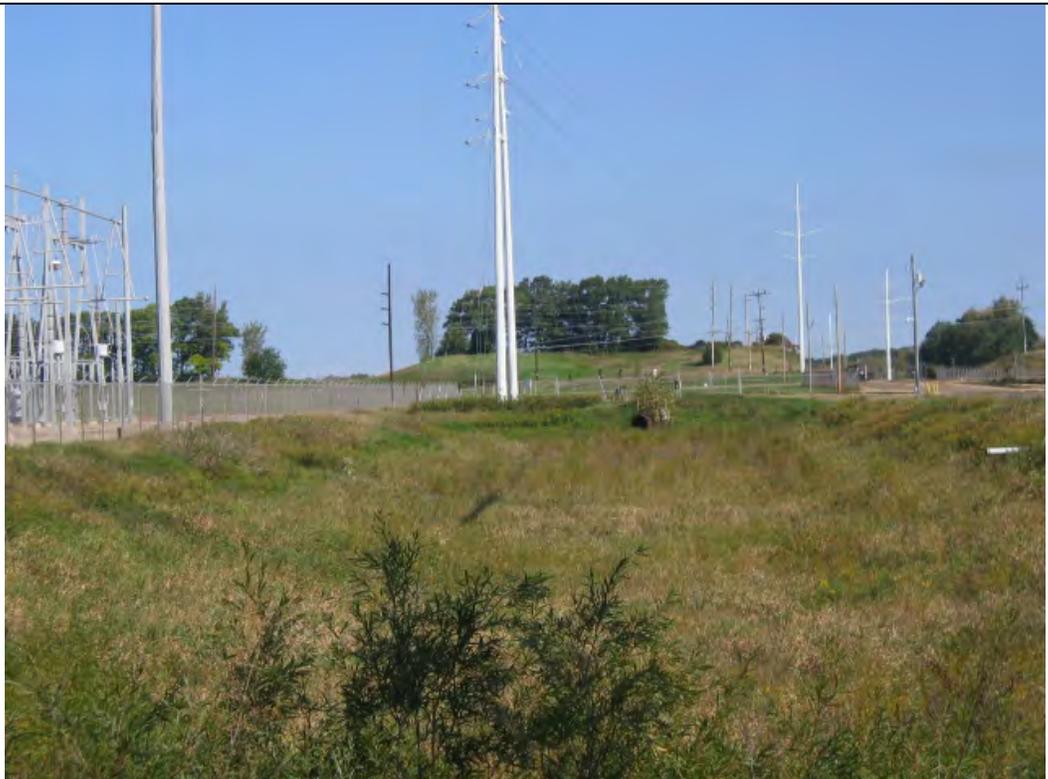
Photo No. 60	Date: 9/28/10
Direction Photo Taken: North

Description:
Upstream slope and crest of PP.

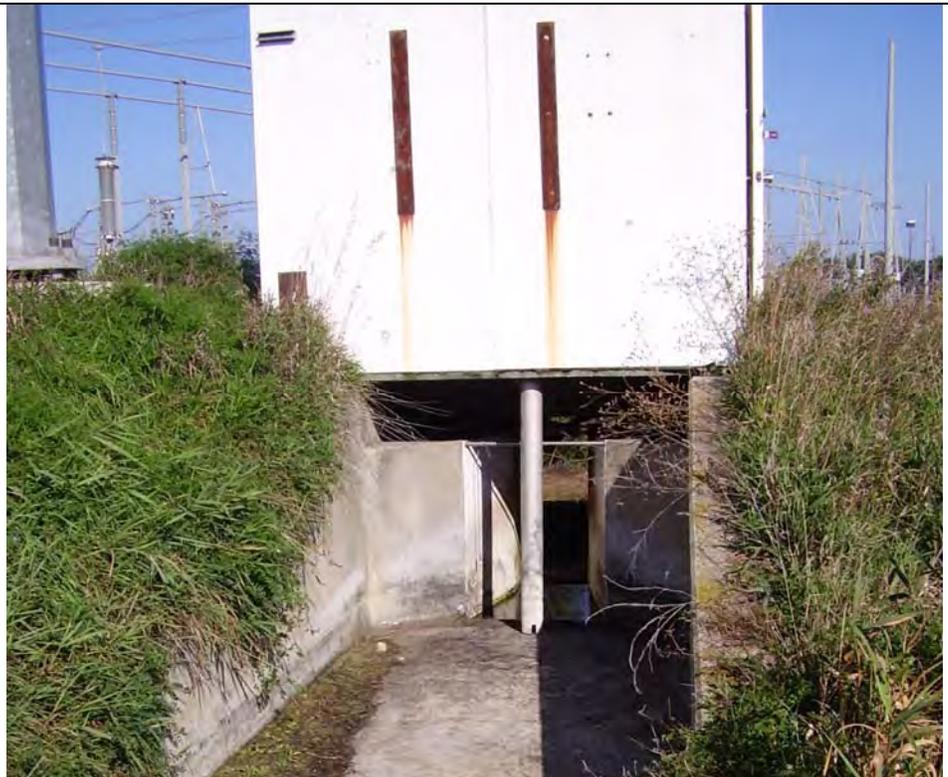
The primary spillway is a concrete structure that is 12 inches wide and 36 inches tall at the narrowest point beneath the equipment shed. The invert elevation of the primary spillway is approximately 802 feet MSL¹⁶. The approach apron for the primary spillway is approximately 68 inches wide and 17 feet long and tapers to 12 inches wide beneath the equipment building. The discharge apron (shown in Photo 62) expands to approximately 66 inches wide and extends 20.5 feet before emptying into the drainage ditch (shown in Photo 63) that extends south from the spillway. The primary spillway appeared to be in good condition with no major cracks or structural defects at the time of our inspection.

Description:
PP primary Spillway.

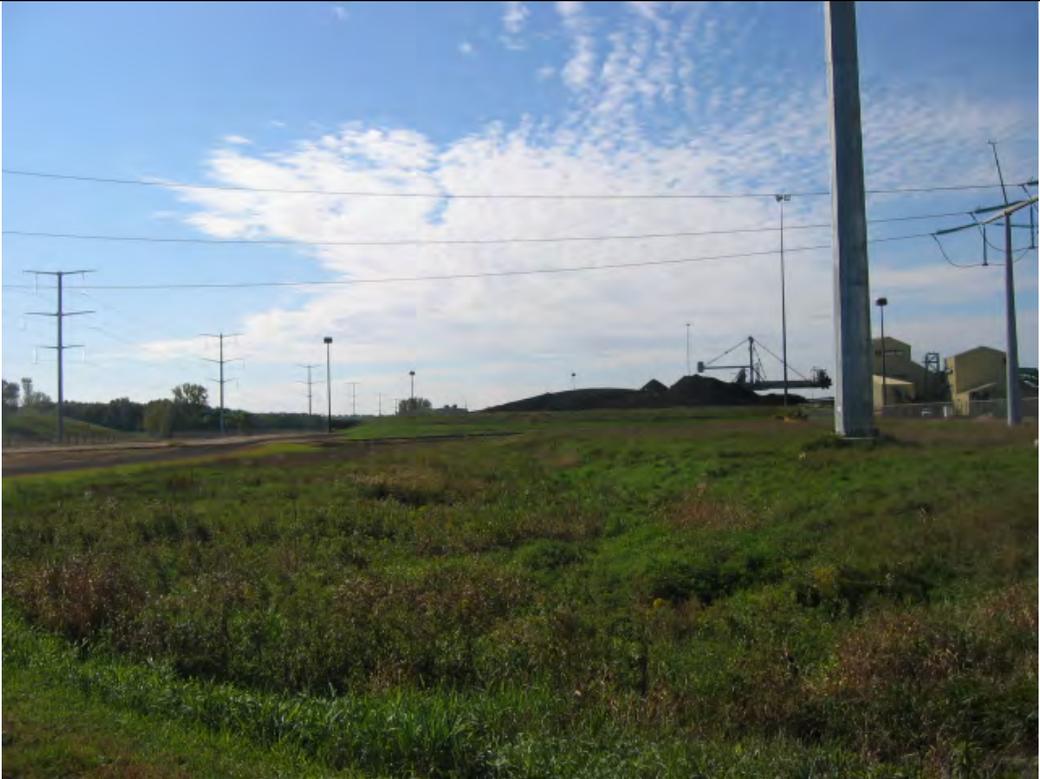
Photo No. 63	Date: 9/28/10
Direction Photo Taken: South

Description:
Drainage ditch south of PP.

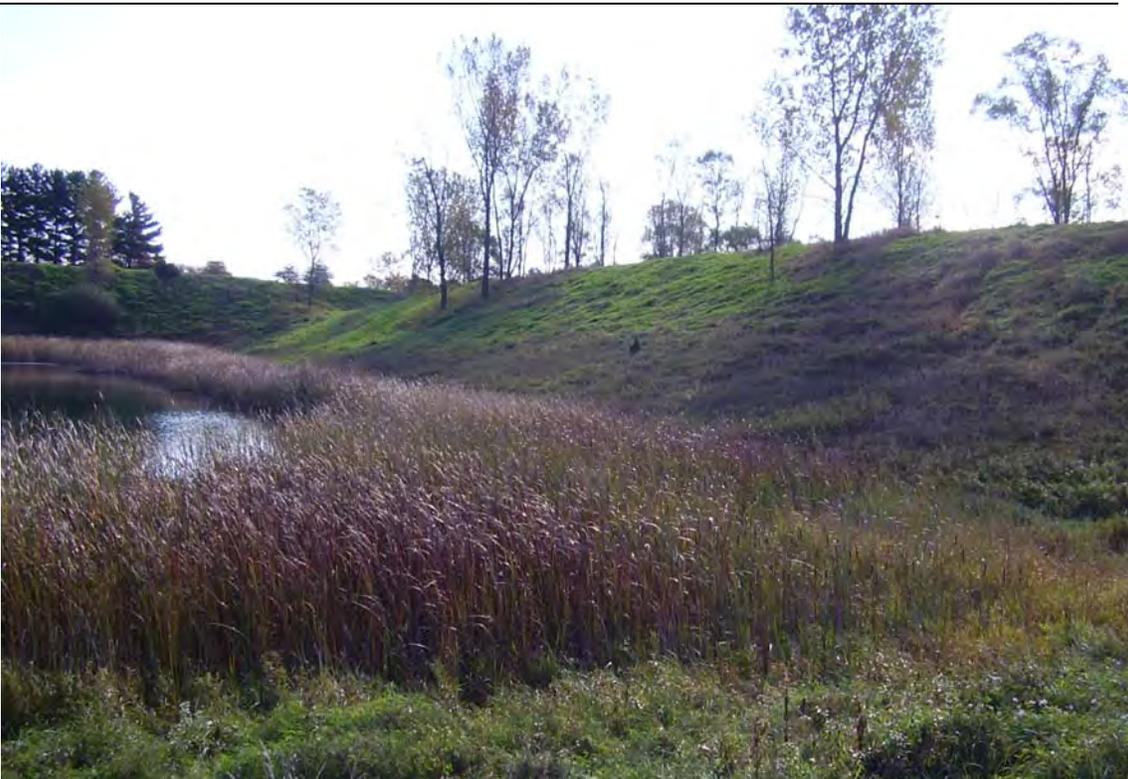
Photo No. 64	Date: 9/28/10
Direction Photo Taken: Southeast

Description:
Upstream slope of the Landfill Stormwater Pond Impoundment (LSP).

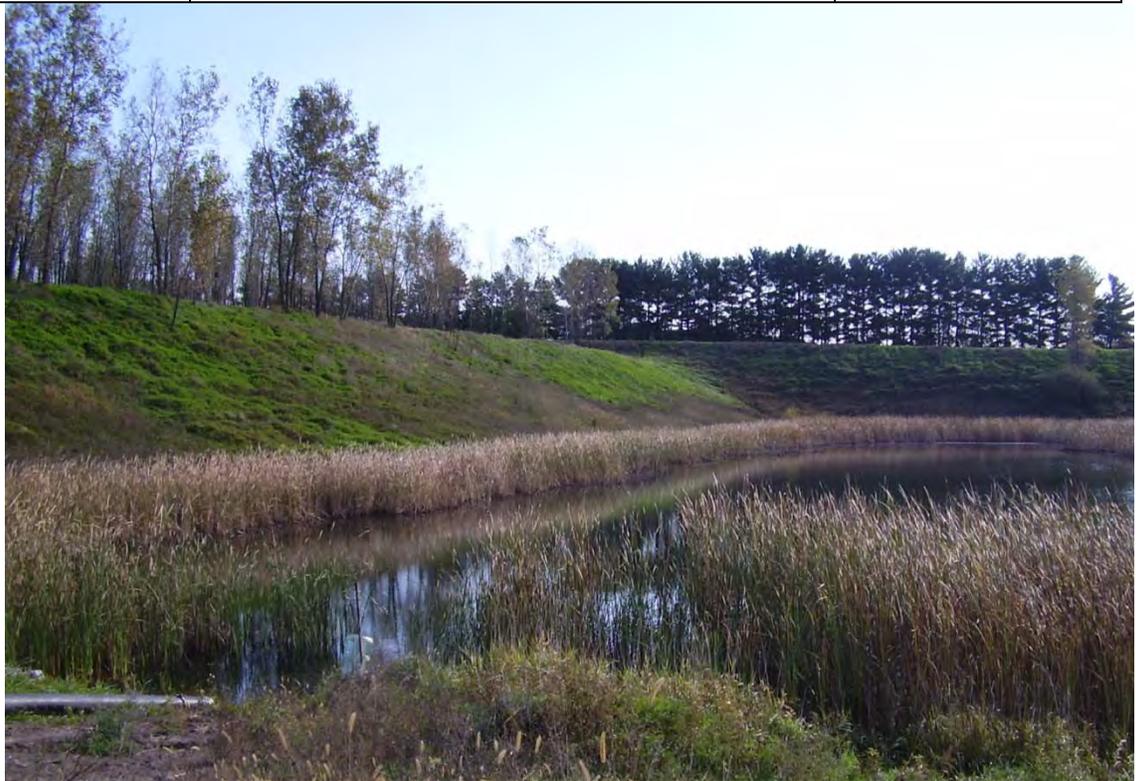
Photo No. 65	Date: 9/28/10
Direction Photo Taken: Northeast	
Description: Upstream slope of LSP.

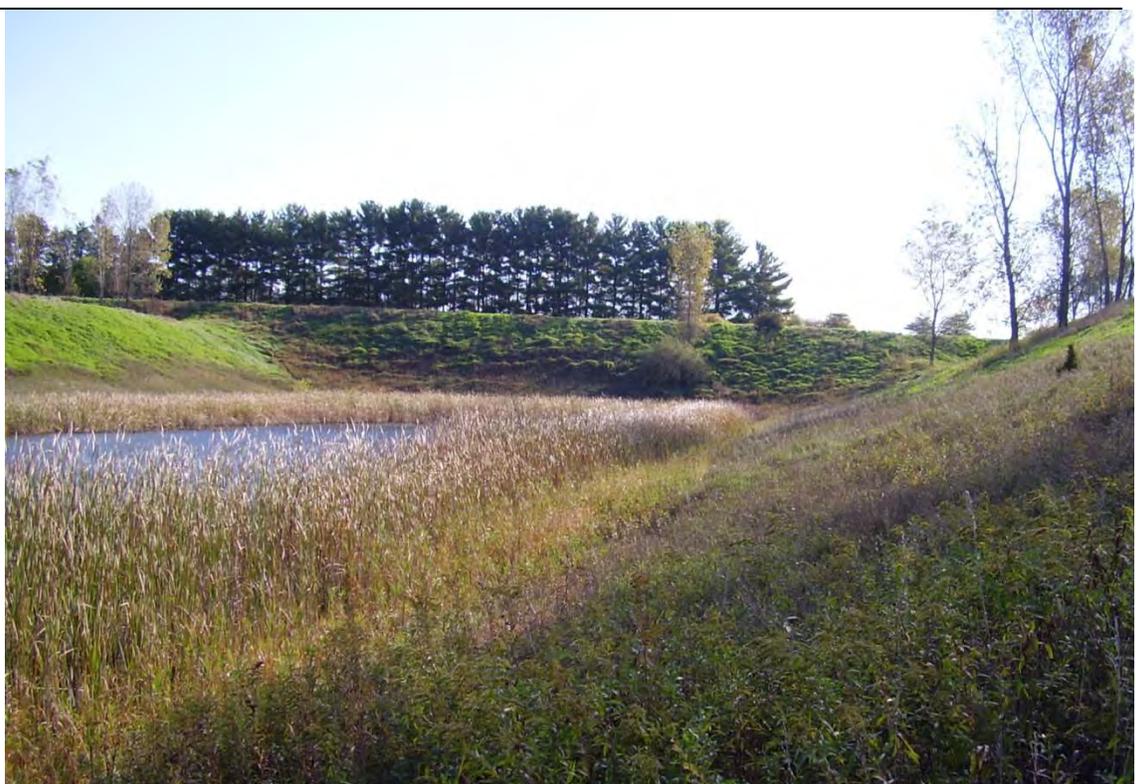
Photo No. 66	Date: 9/28/10
Direction Photo Taken: East	
Description: Upstream slope of LSP.

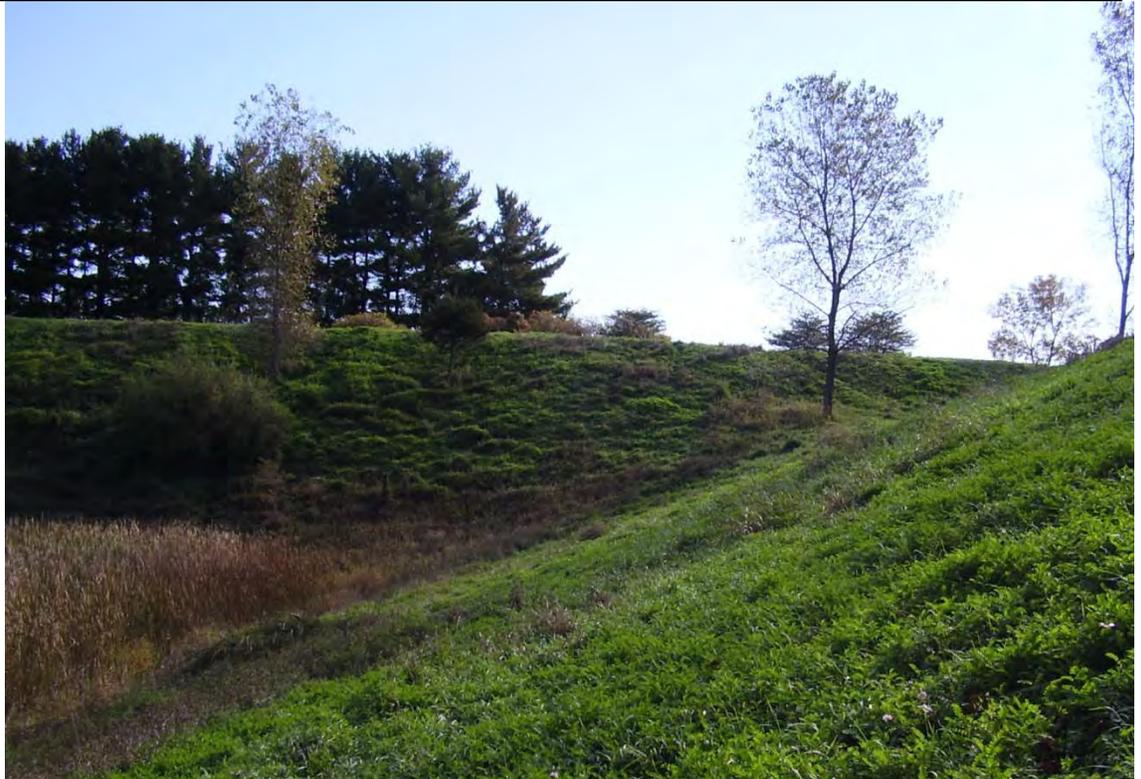
Description:
Upstream slope of LSP.

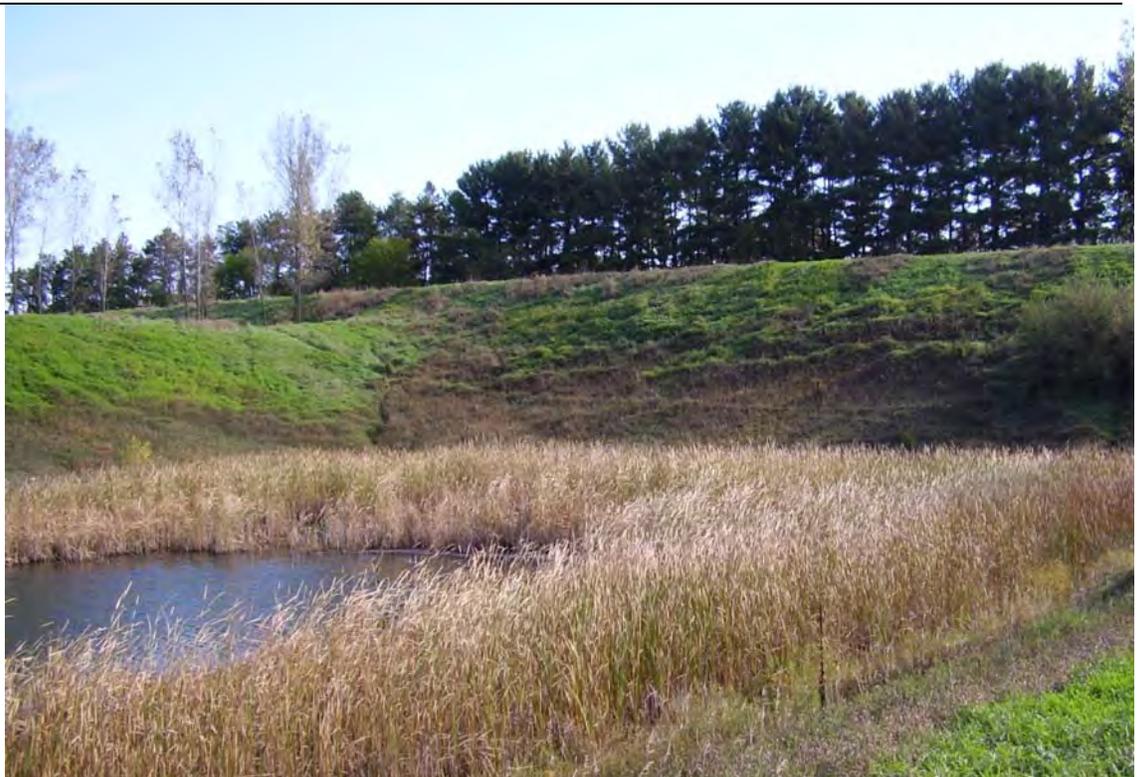
Photo No.
68

Description:
Upstream slope of LSP.

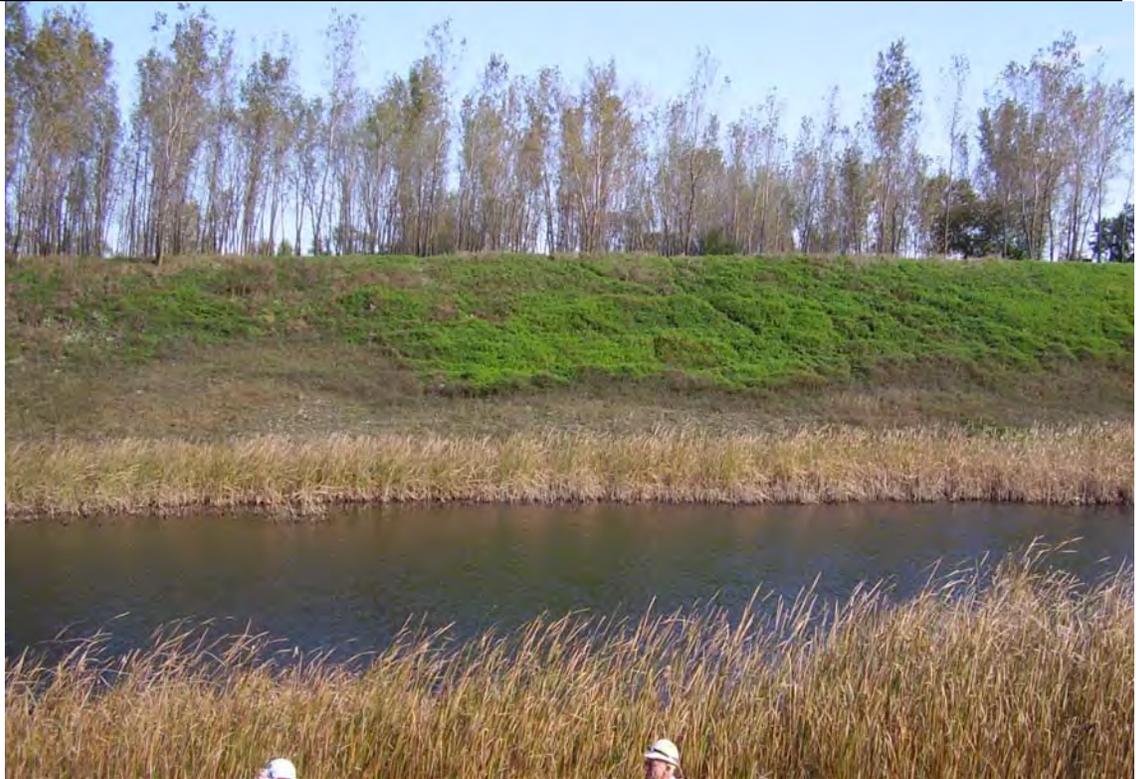
Photo No. 69	Date: 9/28/10
Direction Photo Taken: North

Description:
Upstream slope of LSP.

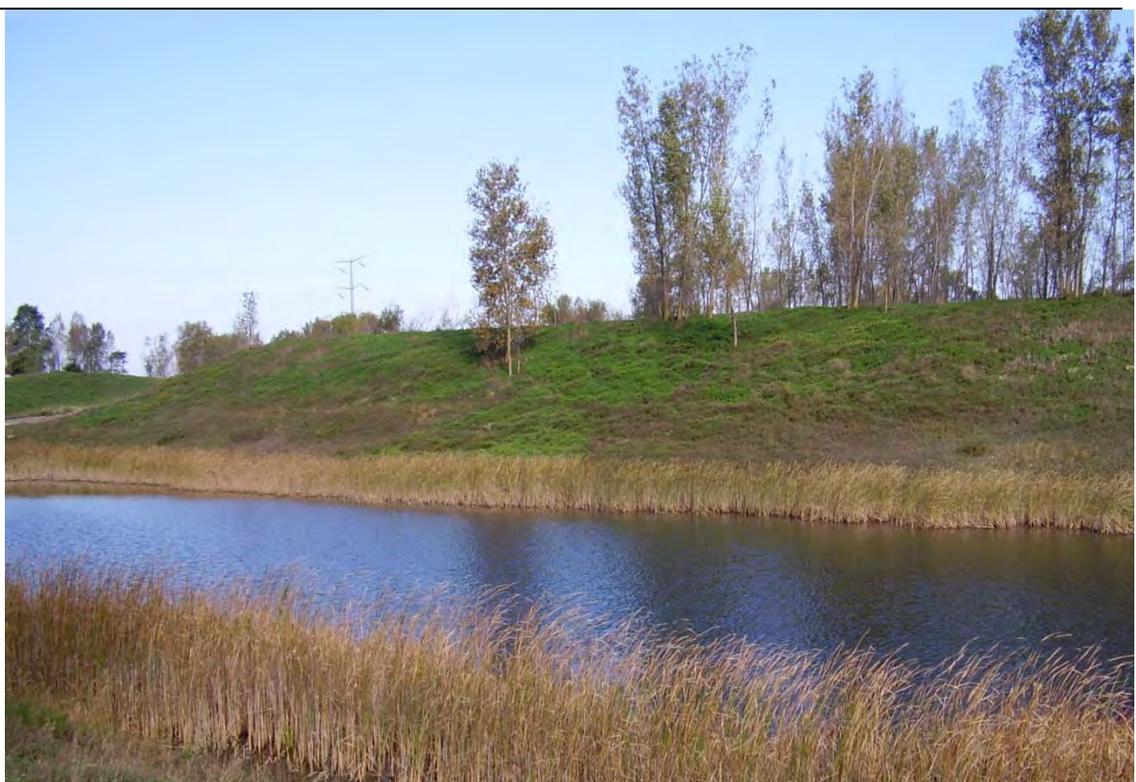
Photo No. 70	Date: 9/28/10
Direction Photo Taken: Northwest

Description:
Upstream slope of LSP.

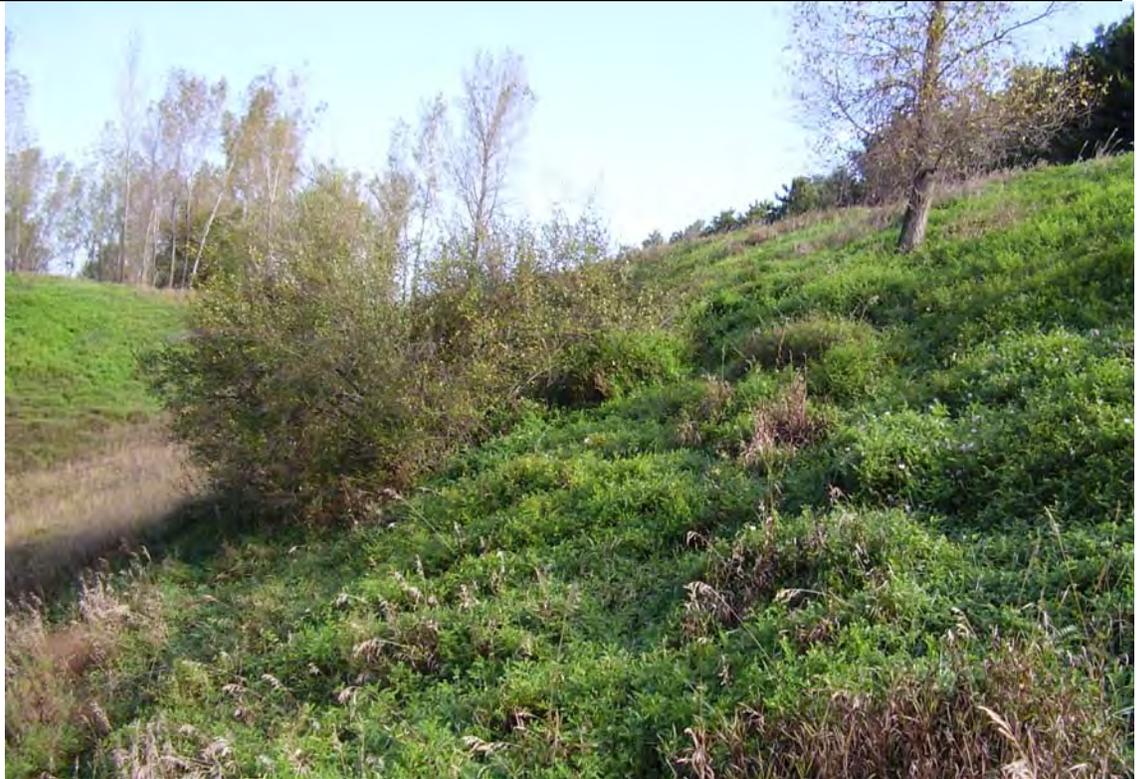
Photo No. 71	Date: 9/28/10
Direction Photo Taken: North

Description:
Upstream slope of LSP.

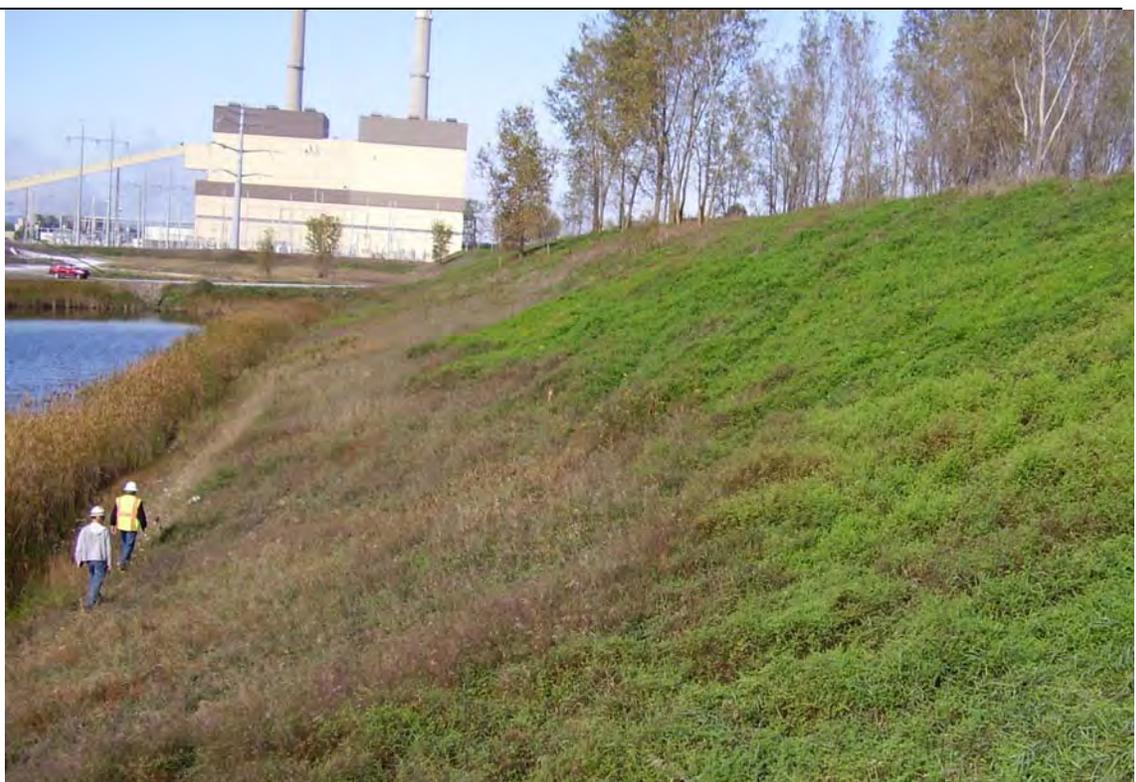
Photo No. 72	Date: 9/28/10
Direction Photo Taken: West

Description:
Upstream slope of LSP.

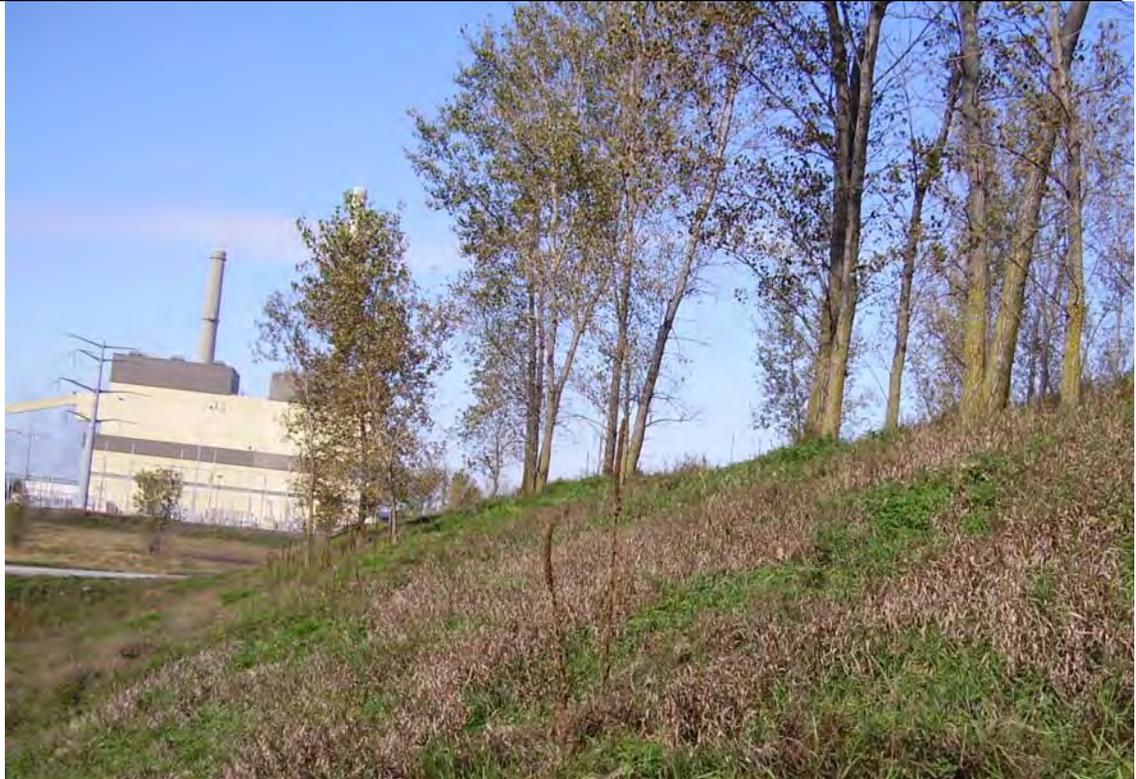
Description:
Upstream slope of LSP.

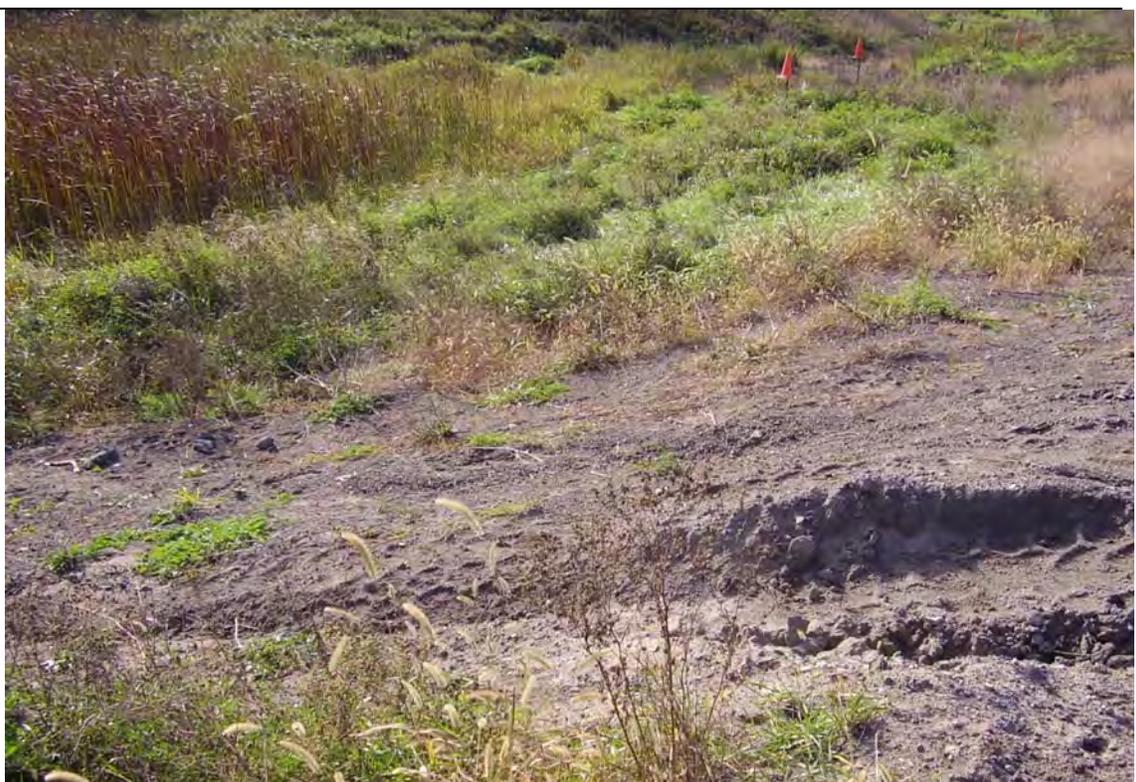
Photo No. 74	Date: 9/28/10
-------------------------------	-------------------------

Description:
Upstream slope of LSP.

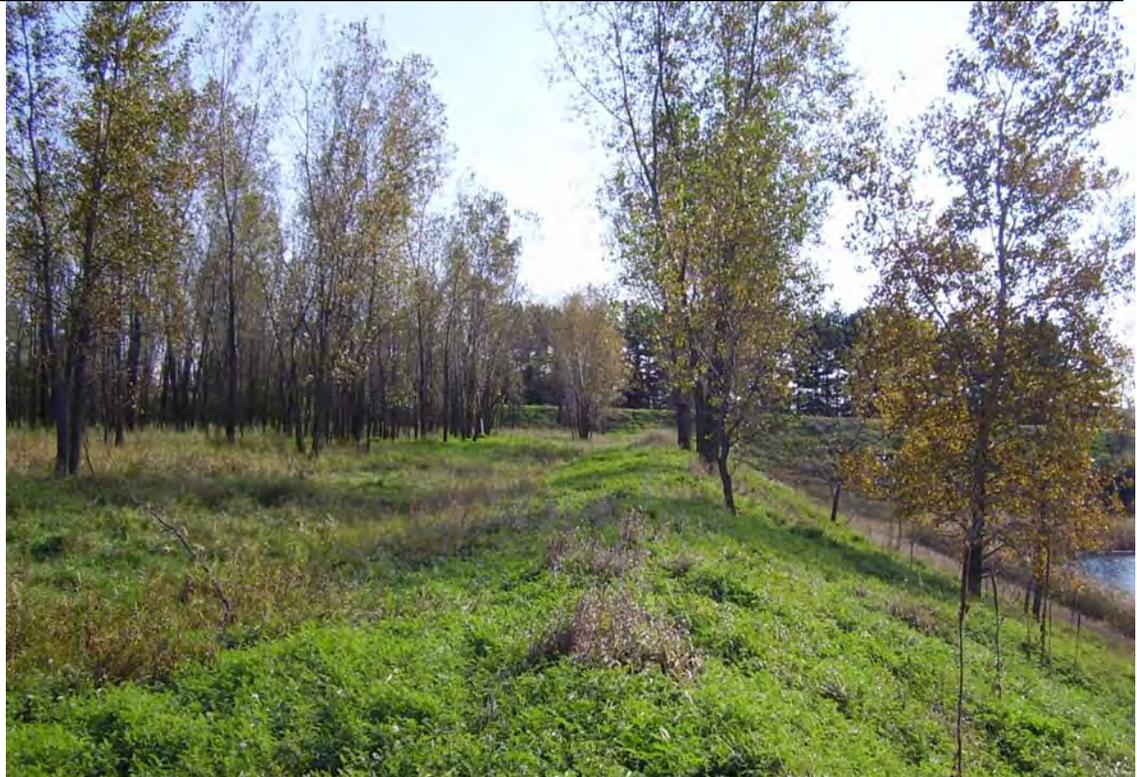
Photo No. 75	Date: 9/28/10
Direction Photo Taken: East	
Description: Crest of LSP.

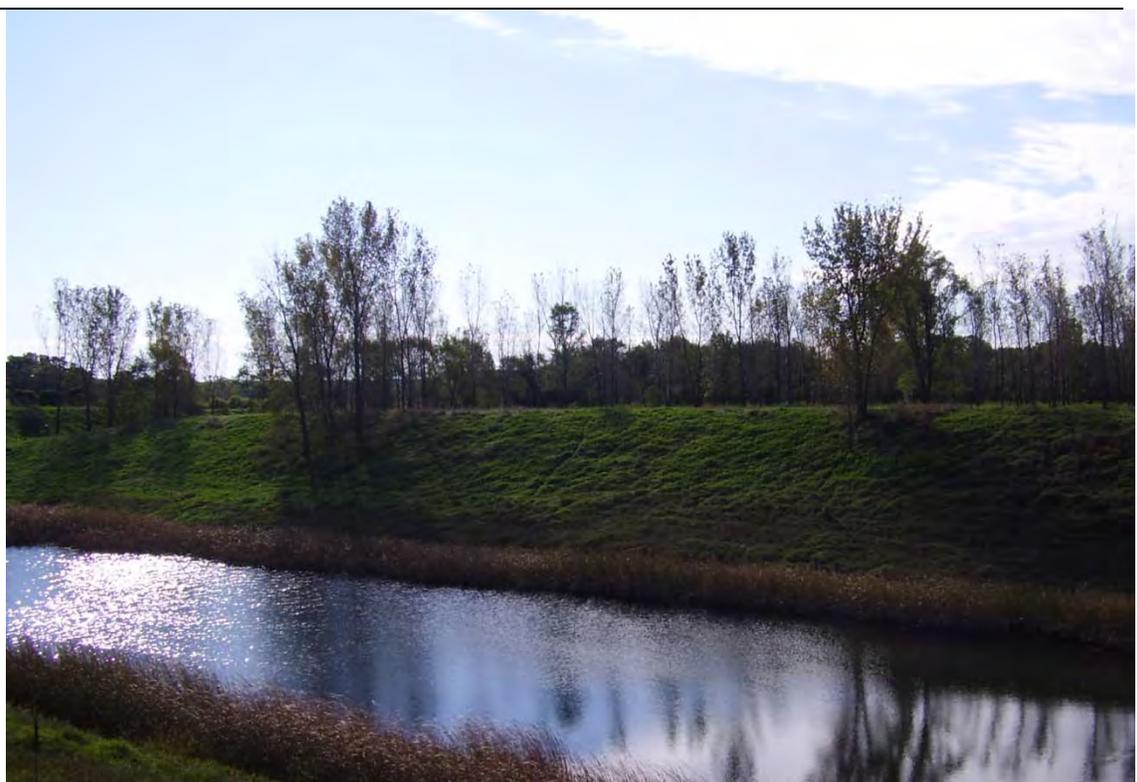
Photo No. 76	Date: 9/28/10
Direction Photo Taken: Southeast	
Description: Crest of LSP.

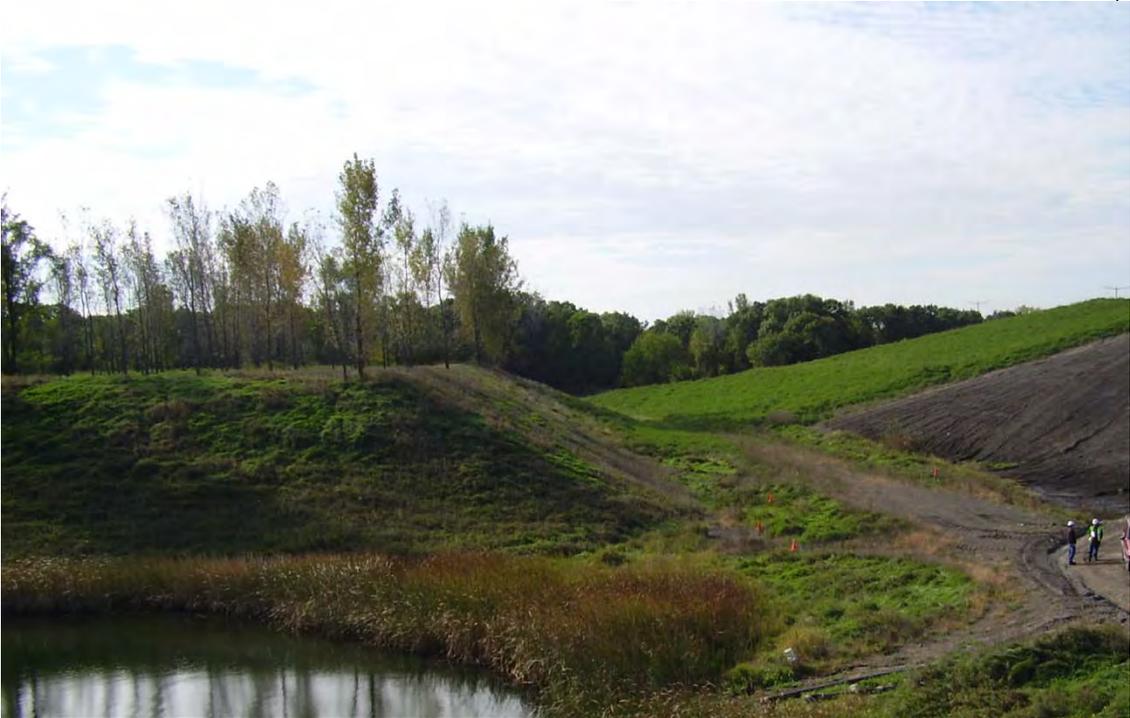
Description:
Upstream slope and crest of LSP.

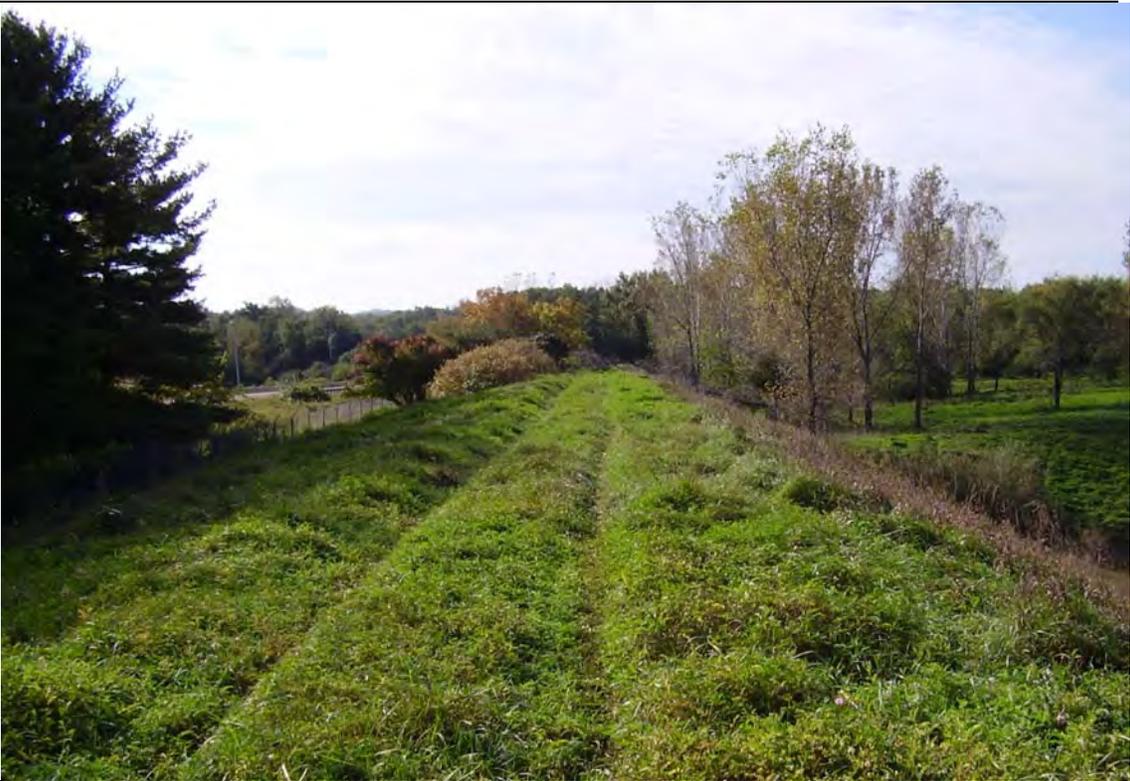
Photo No. 78	Date: 9/28/10
-------------------------------	-------------------------

Description:
Crest of LSP.

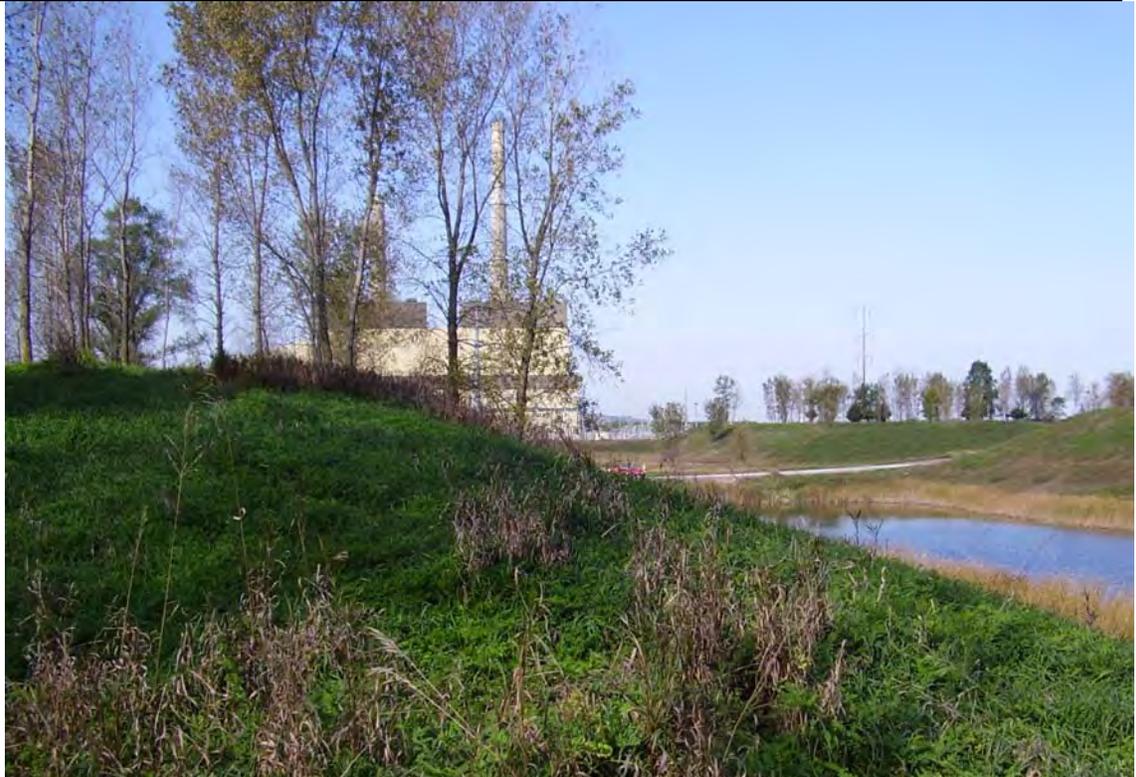
Description:
Crest of LSP.

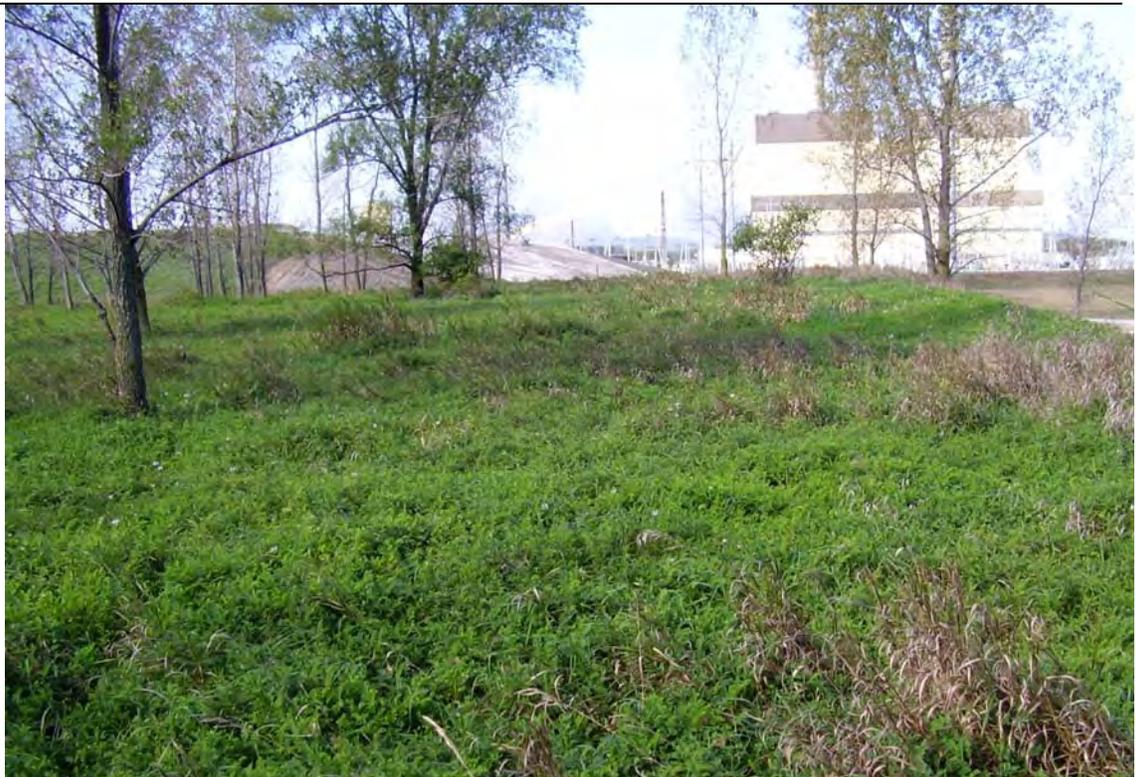
Description:
Crest of LSP.
