**DRAFT REPORT
ROUND 7 DAM ASSESSMENT - WISCONSIN POWER & LIGHT
COLUMBIA GENERATING STATION
PRIMARY ASH, SECONDARY ASH, POLISHING & LANDFILL
STORMWATER PONDS
PARDEEVILLE, WISCONSIN**

January 17, 2011

Re: Round 7 Dam Assessment - Draft Report
EPA Contract No. EP10W001313
Wisconsin Power & Light – Columbia Generating Station
Primary Ash, Secondary Ash, Polishing & Landfill Storm Water Ponds
Pardeeville, Wisconsin

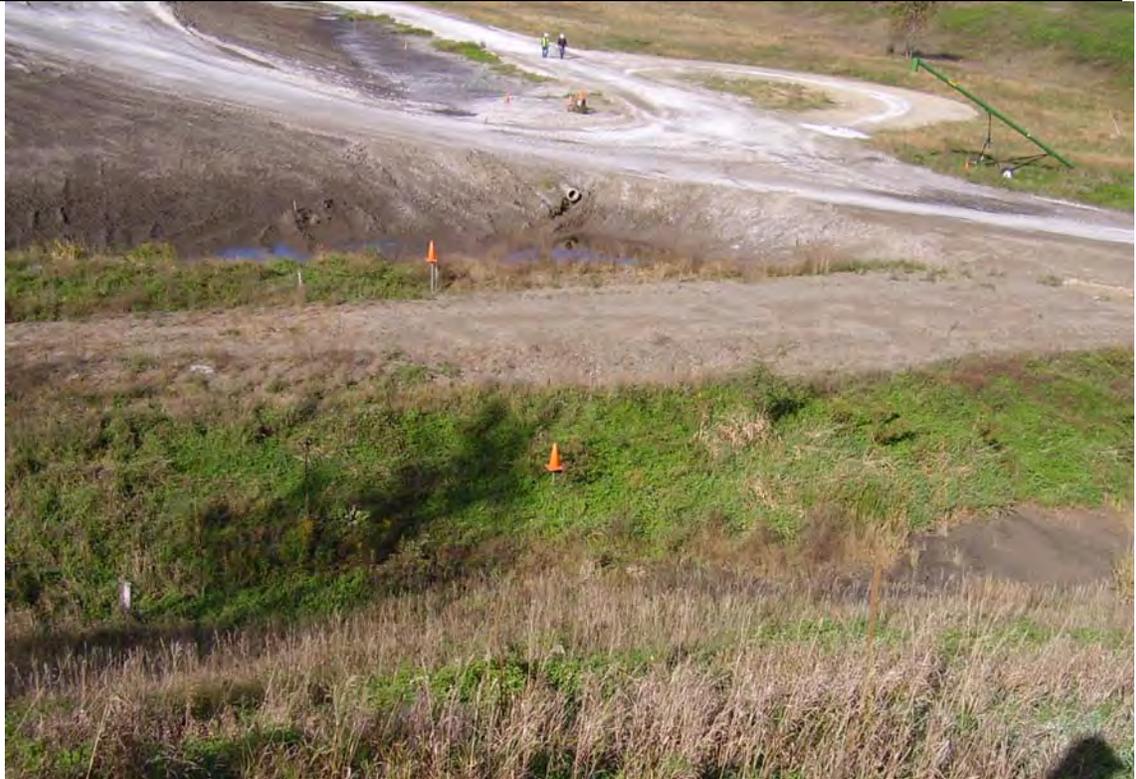
Photo No. 81	Date: 9/28/10
Direction Photo Taken: West

Description:
Crest of LSP.

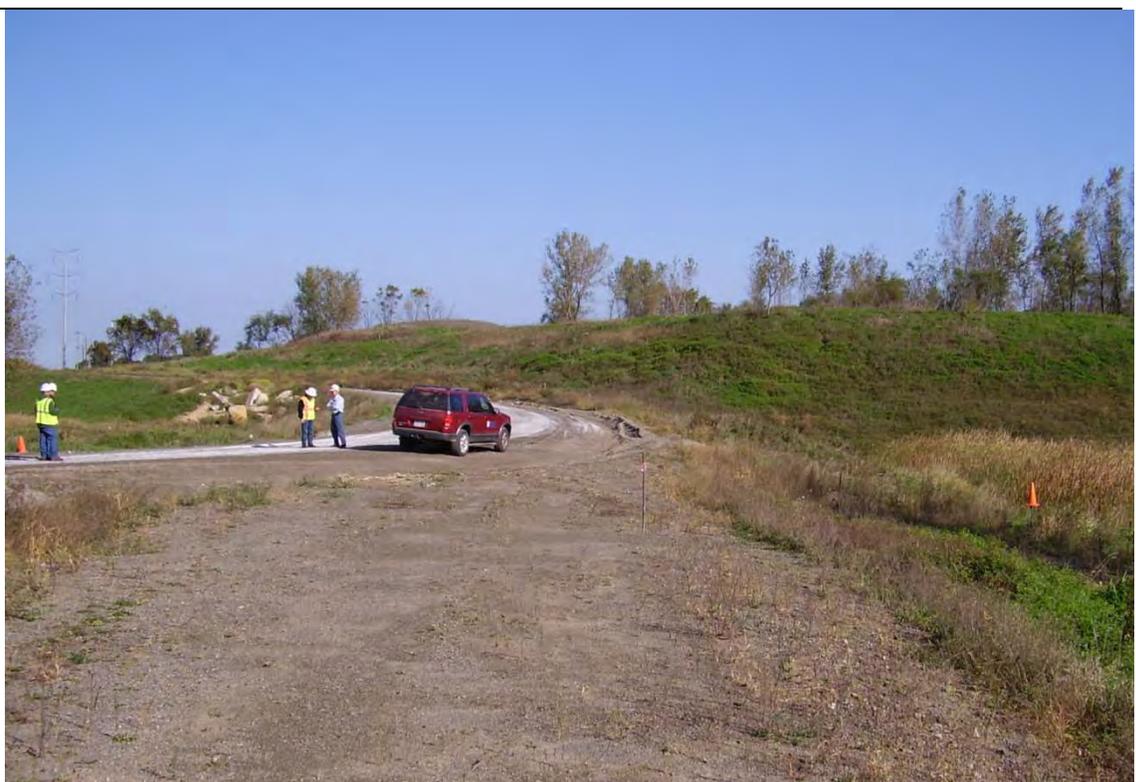
Photo No. 82	Date: 9/28/10
Direction Photo Taken: North

Description:
Crest of LSP.

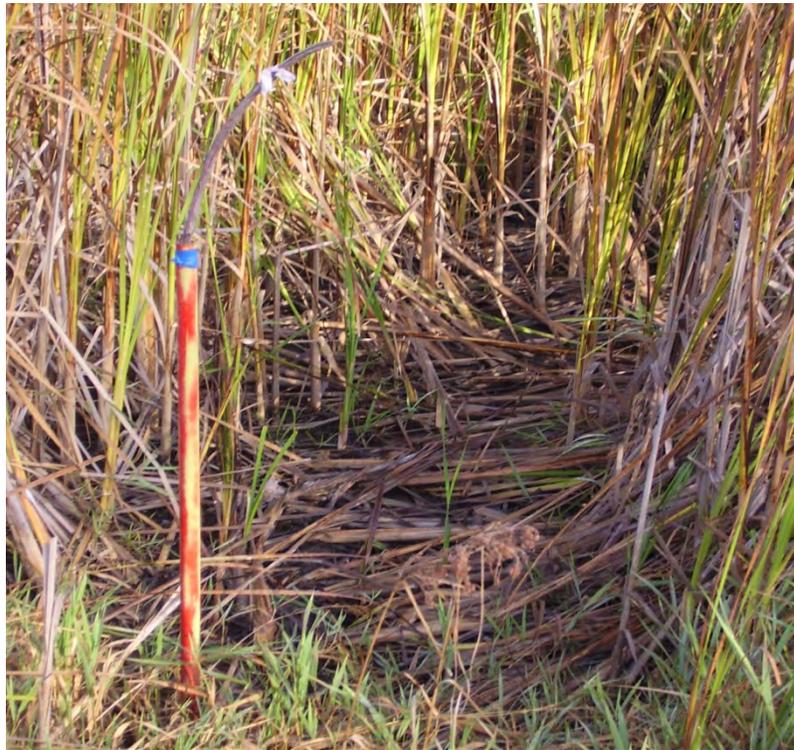
Photo No. 83	Date: 9/28/10
Direction Photo Taken: Northeast

The LSP pond water surface at the time of inspection was at an elevation of 796 feet MSL based on information provided by CGS. Therefore, the lower portion of the upstream slope was underwater and not visible. No rip rap was present on the upstream slope. A 24-inch diameter corrugated metal pipe discharges storm water into the impoundment along the western embankment. The metal stake that is used to mark the water levels in the impoundment is located in the southwest corner and is shown in Photo 83.

Description:
Metal Stake Water level marker in LSP.

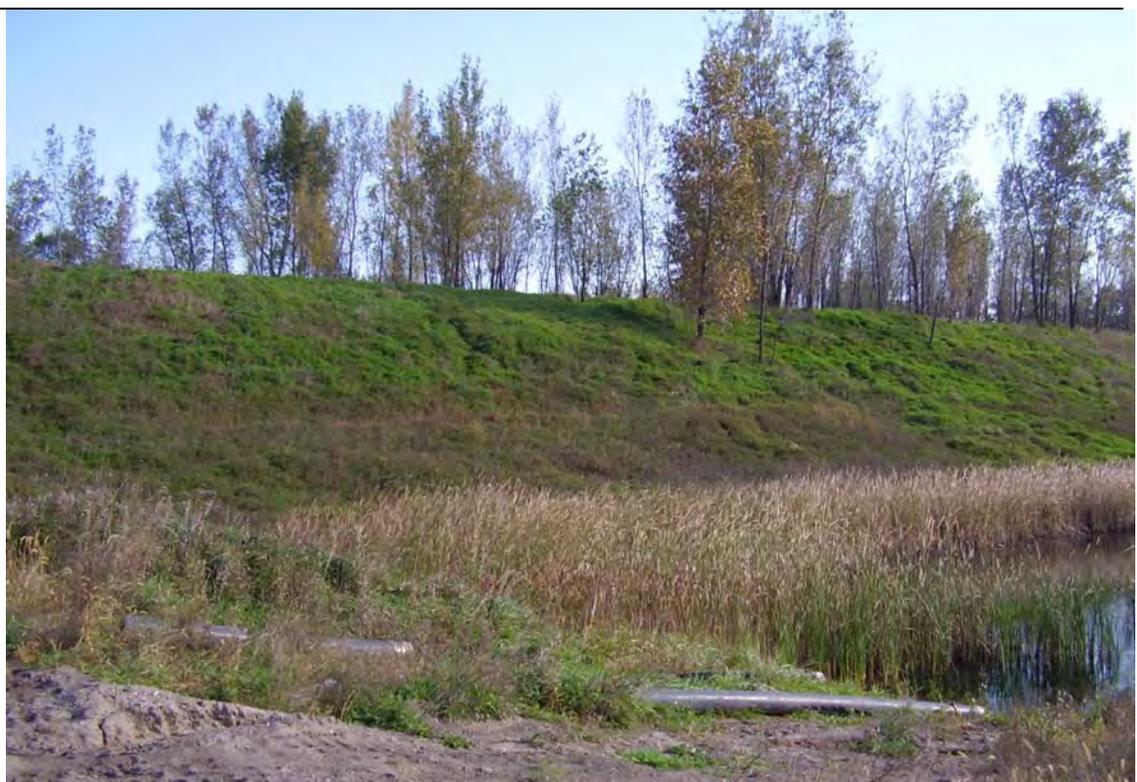
Photo No. 84	Date: 9/28/10
Direction Photo Taken: Northeast

Description:
Upstream slope and crest of PP.

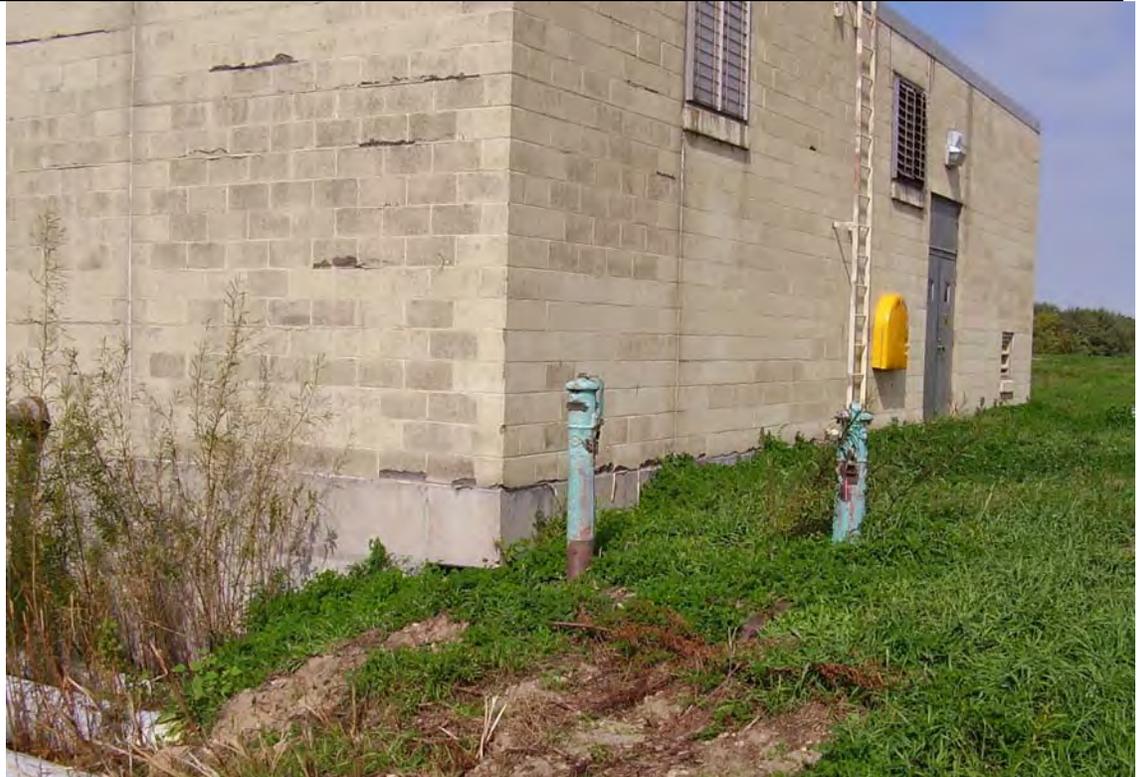
Photo No. 85	Date: 9/28/10
Direction Photo Taken: Northwest	
Description: PAP pump house.

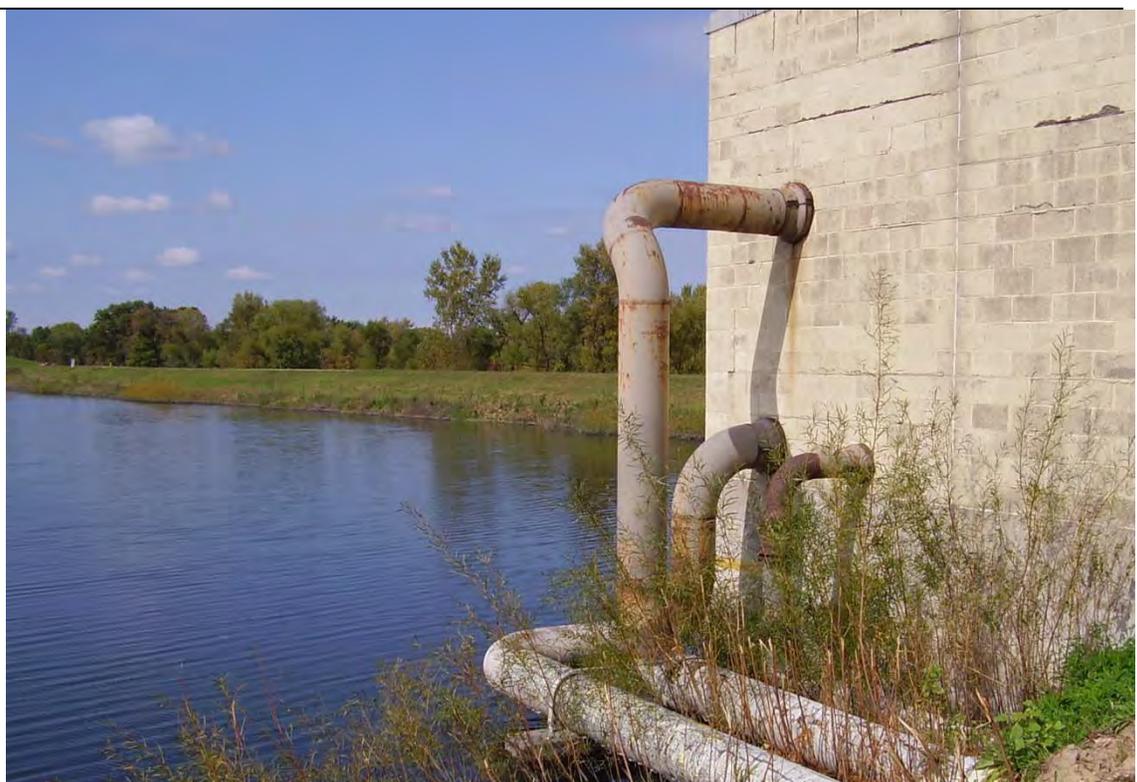
Photo No. 86	Date: 9/28/10
Direction Photo Taken: Northwest	
Description: PAP pump house.

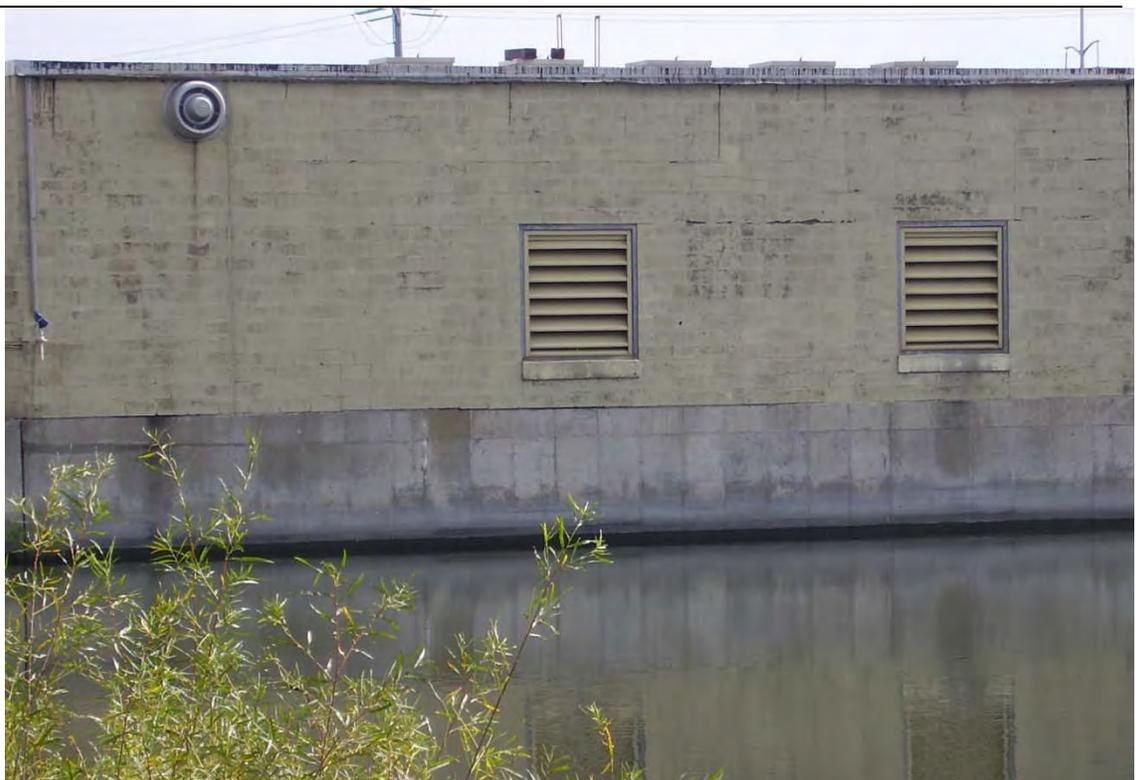
PAP pump house.

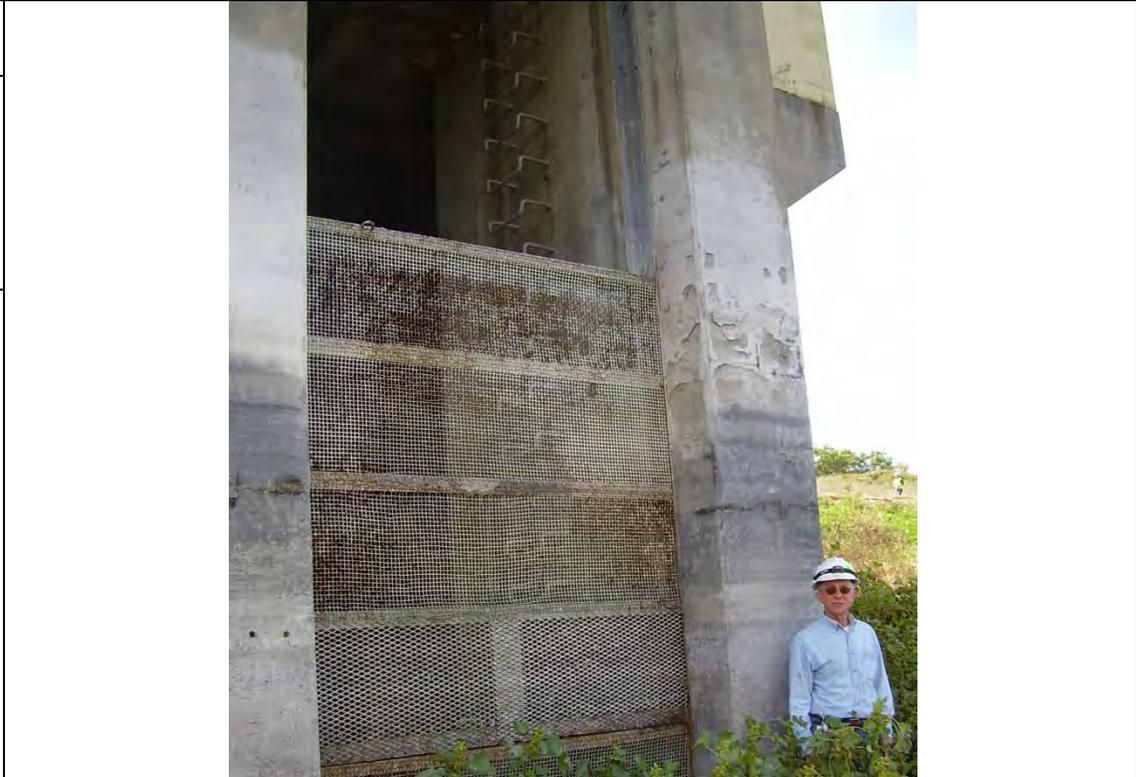
Description:
SAP pump house intake.

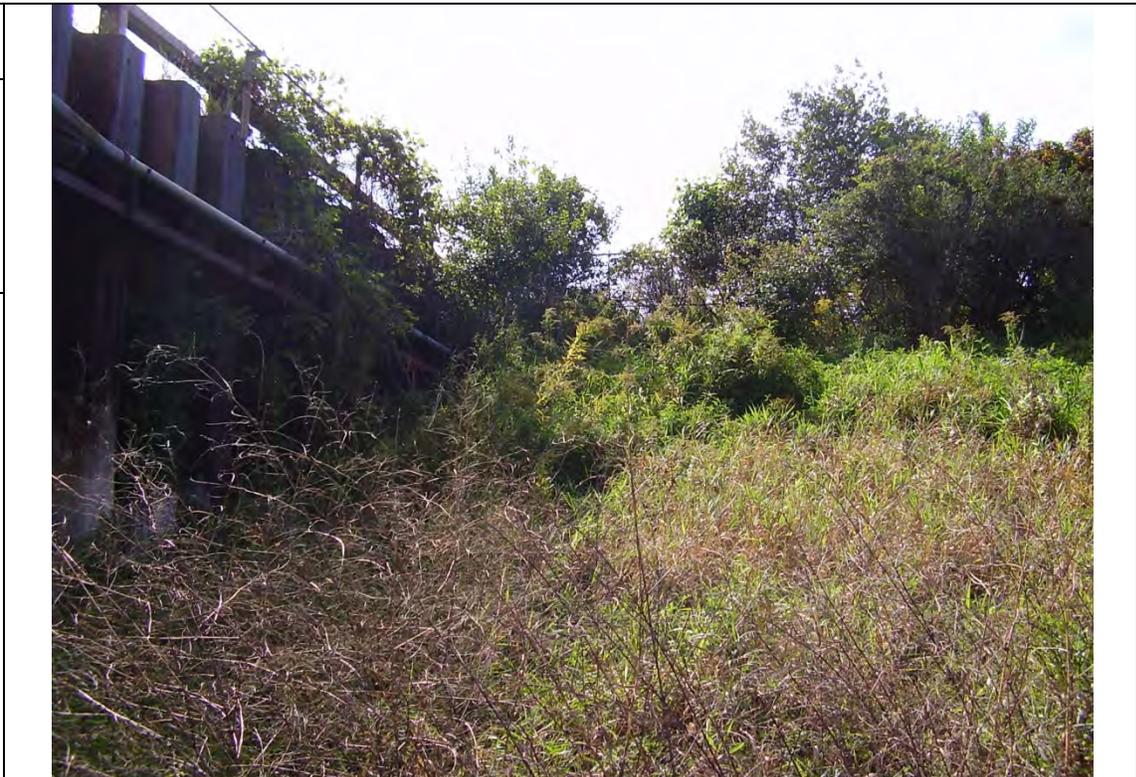
Photo No. 90	Date: 9/28/10
-------------------------------	-------------------------

Description:
SAP pump house.

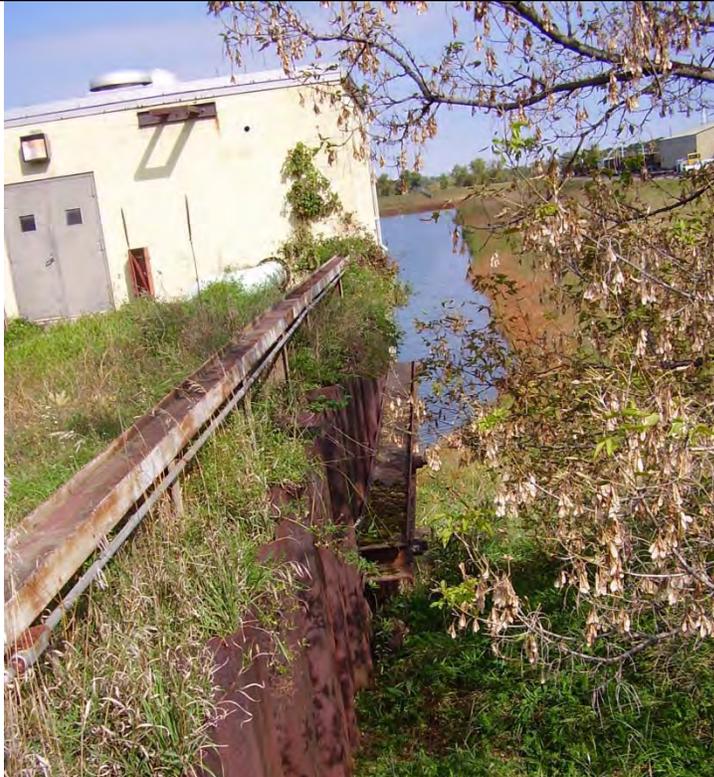
Photo No. 91	Date: 9/28/10
Direction Photo Taken: North

Description:
SAP pump house.

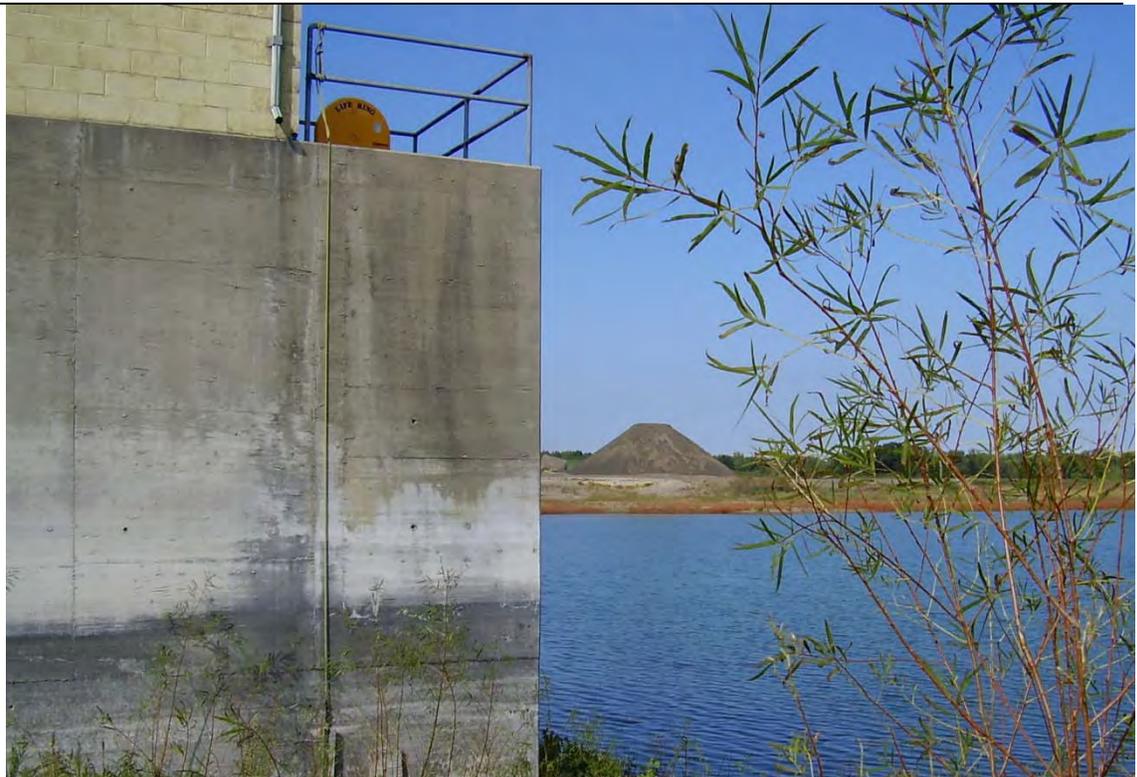
Photo No. 92	Date: 9/28/10
Direction Photo Taken: Northwest

Description:
SAP pump house.

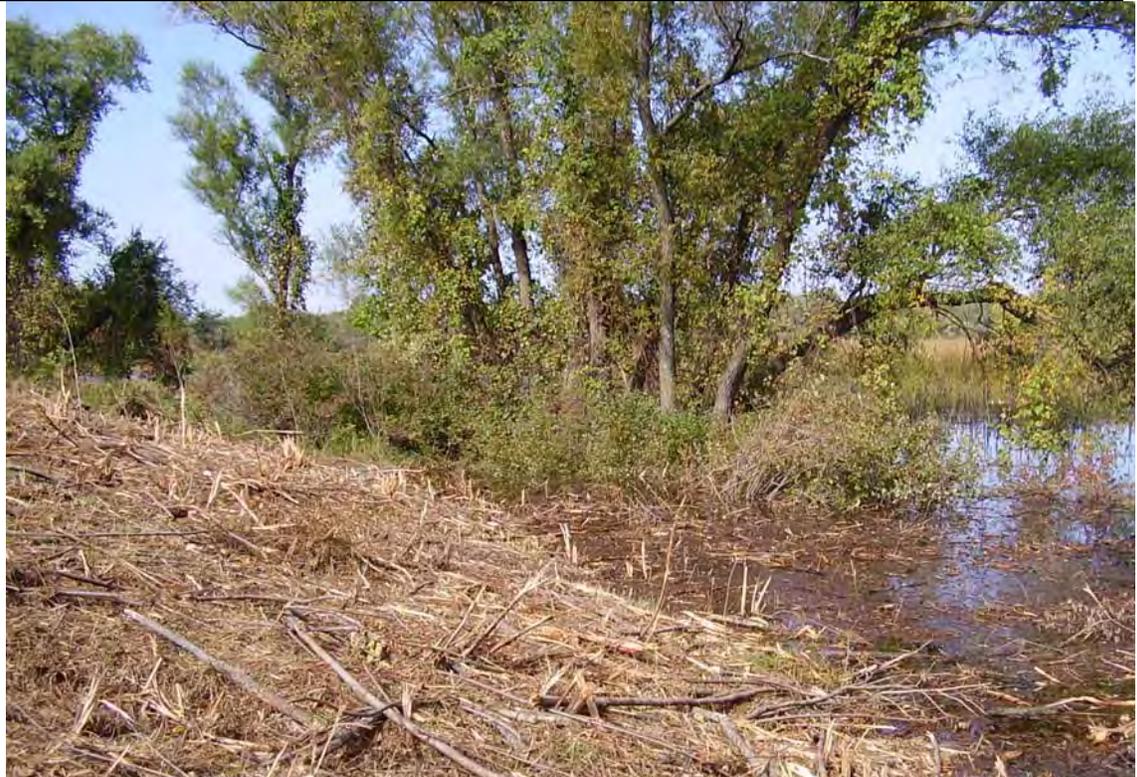
Photo No. 93	Date: 9/28/10
Direction Photo Taken: Northwest	
Description: SAP downstream slope.

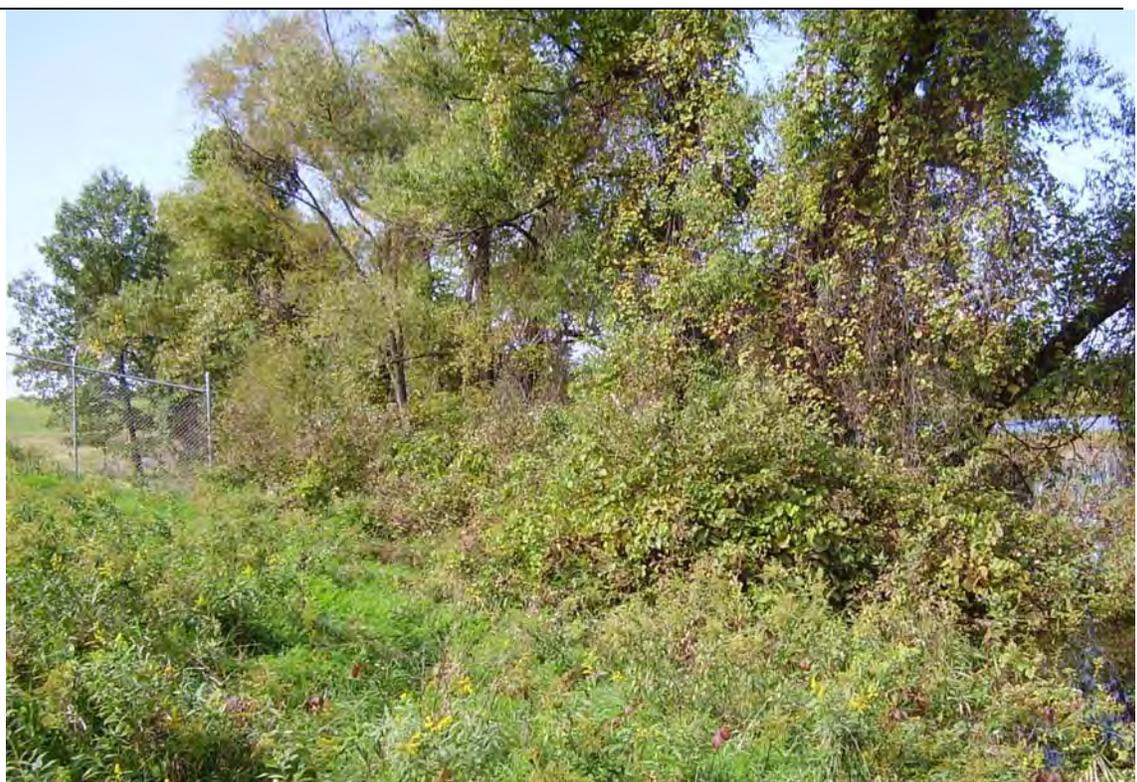
Photo No. 94	Date: 9/28/10
Direction Photo Taken: Southwest	
Description: SAP downstream slope.

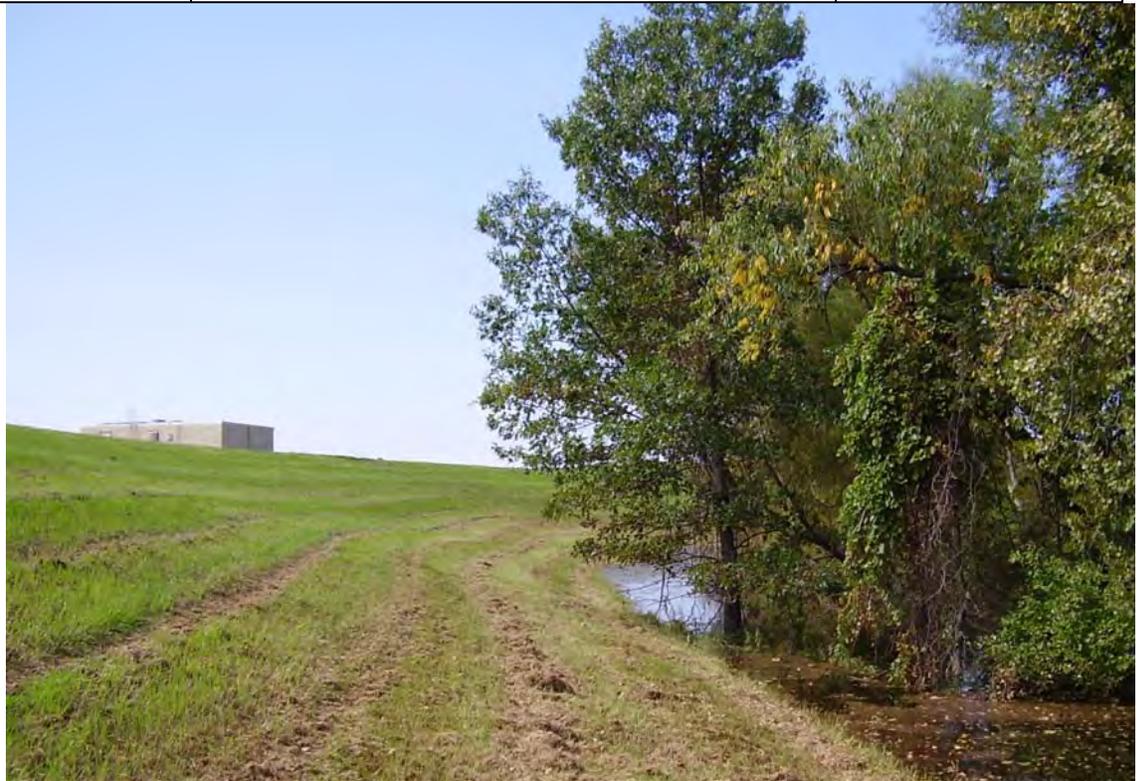
Description:
SAP downstream slope.
