Site Name: Progress Energy Asheville Date: 29 MAY 2009
 Unit Name: 1964 POND Operator's Name: Progress ENERGY
 Unit I.D.: Hazard Potential Classification: High Significant Low

Site Name: Progress Energy Asheville Date: 29 May 2009
 Unit Name: 1982 PdND Operator's Name: Progress ENERGY
 Unit I.D.: Hazard Potential Classification High Significant Low

1982 Ash Pond - Photo Log

May 29, 2009

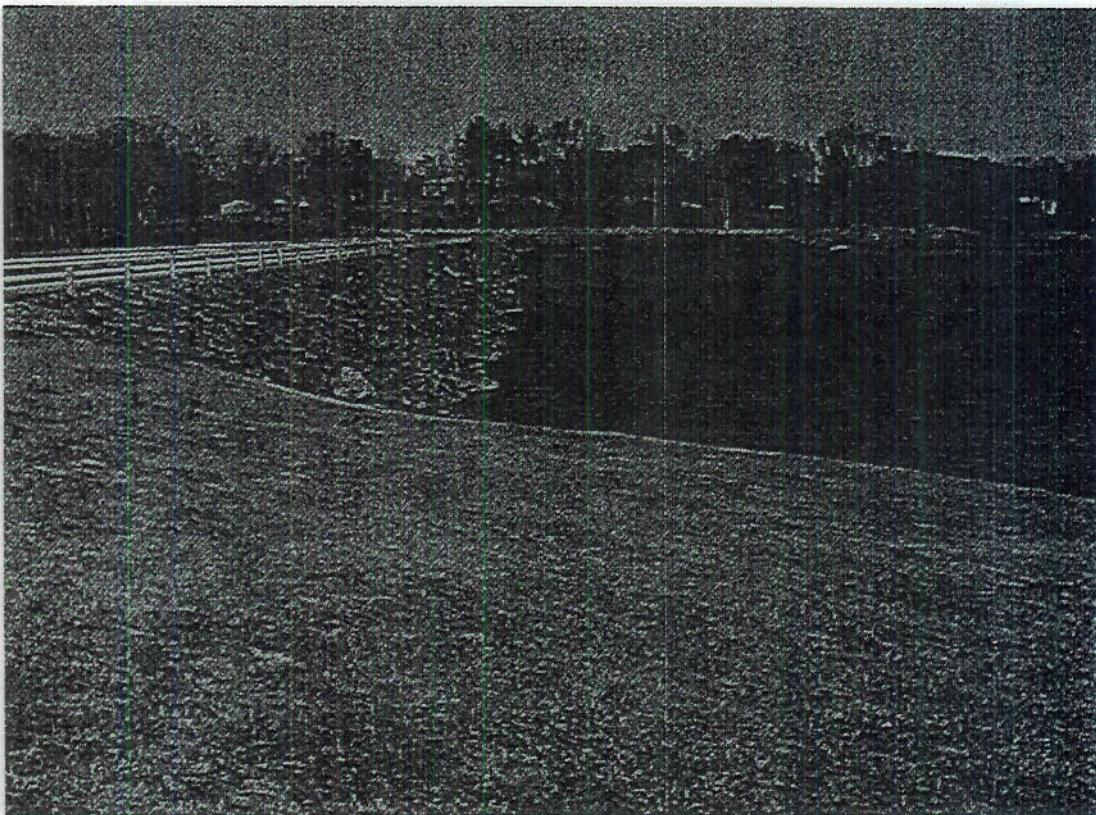
The upstream slope of the dam is well rip-rapped with sound, angular rocks (local mica gneiss) up to 2 feet in size. The slope is approximately 2(H):1(V), with some minor undulations. The rip-rap is free of vegetation and in good condition (photograph 1).

Photograph 1: Cooling Lake Dam – upstream slope looking north.

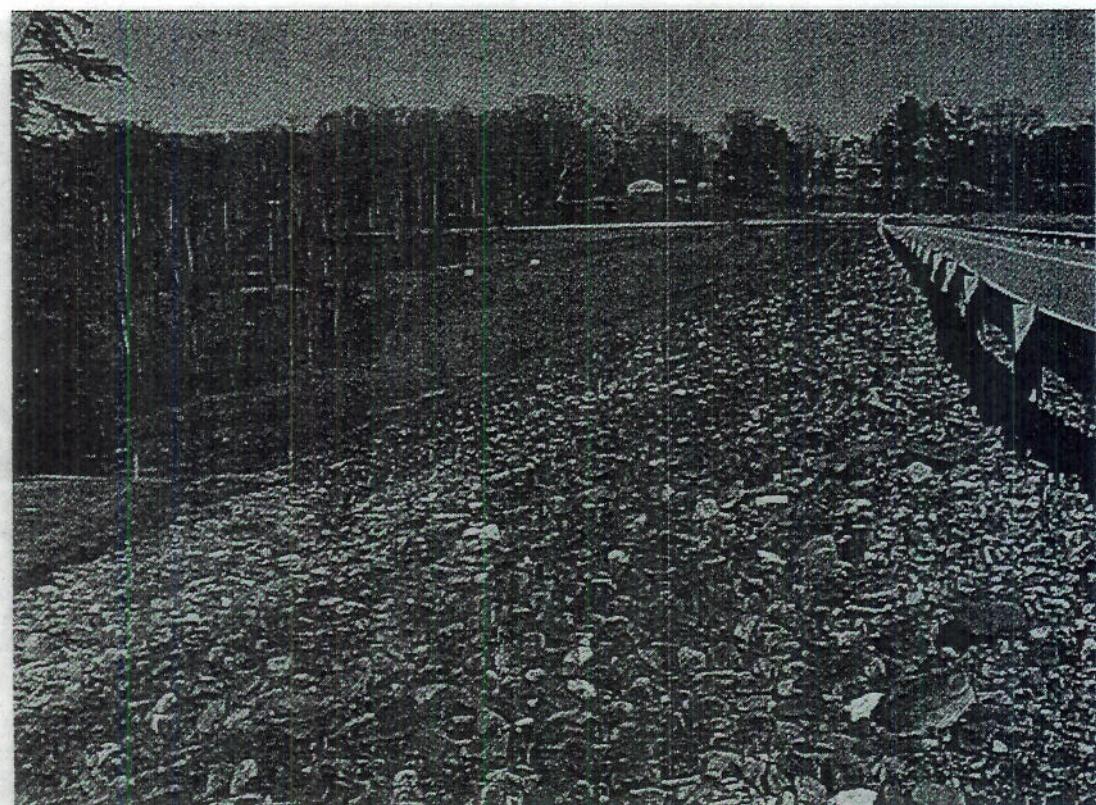
No cracks were noted in the asphalt pavement along the crest of the dam. The downstream slope is in good condition with no vegetation and no evidence of slumping or surface movement (photographs 2, 3). No seepage from beneath the rip-rap at the toe of the dam along the contact with the south abutment was noted, as has been seen before. Woody vegetation had been cut back in the wet area downstream of the Cooling Lake Dam prior to our inspection (photograph 4). Localized seeps were noted within the cleared downstream area, south of the main seepage collection ditch, as in previous inspections. The seepage from this area and the main seepage collection ditch is measured at the weir (photograph 5) and was noted to be clear. Erosion/leaking around the north side of the measurement weir, noted in past inspections, has been repaired. No excessive accumulation of sediment behind the weir was noted.

Photograph 2: Cooling Lake Dam – downstream slope looking north.

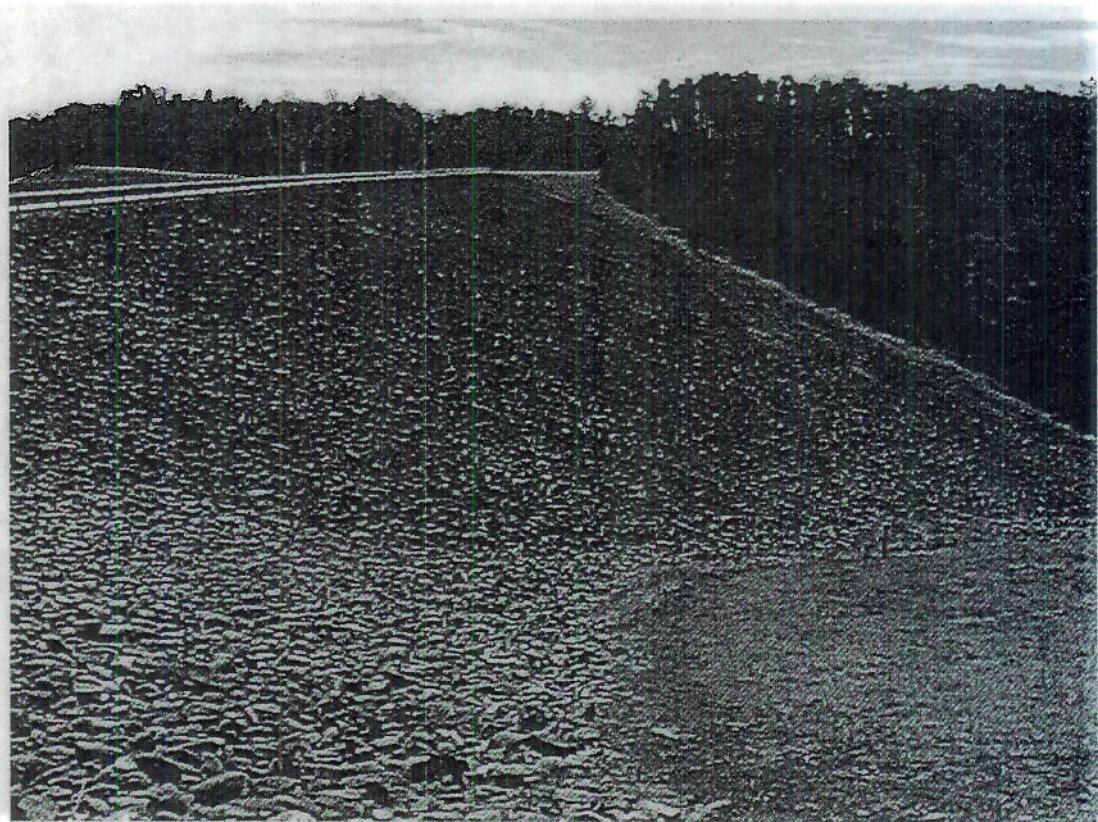
Photograph 3: Cooling Lake Dam – downstream slope looking south.

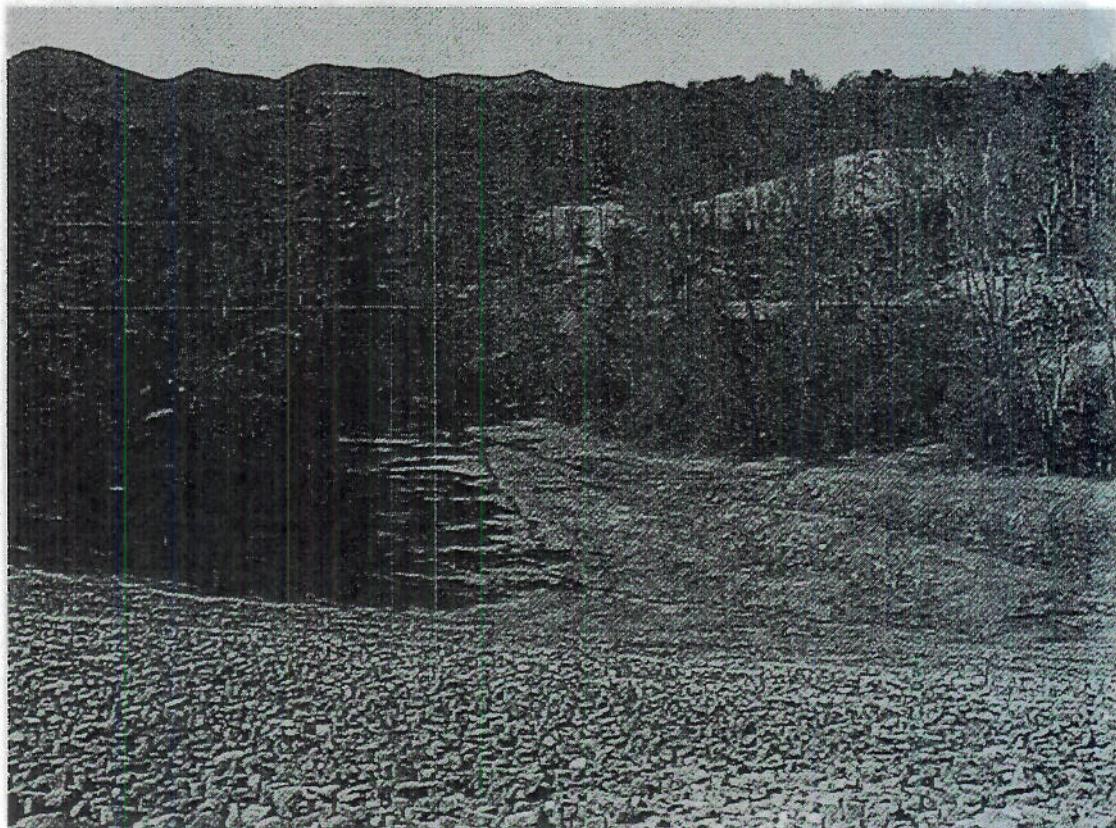
Photograph 4: Cooling Lake Dam – looking west, downstream of dam.

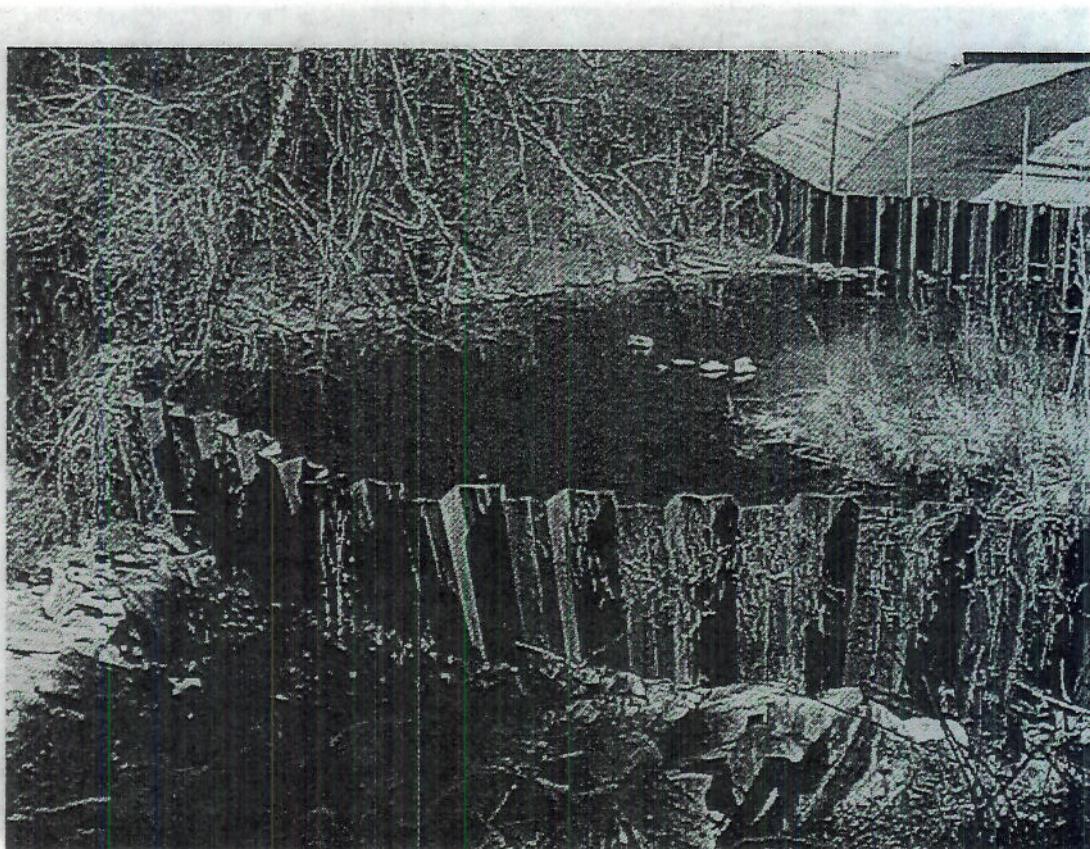
The stilling pools are also in good condition. The first stilling pool has scattered rip-rap along the bottom and is in about the same condition as reported in the 2002 inspection report. The displaced sheet piles creating this pool appear not to have changed, judging from previous reports (photographs 11 and 12). The second pool located downstream from the first also appears to be in generally good condition.

Photograph 12: Cooling Lake Dam – spillway drop walls and energy dissipation pool.

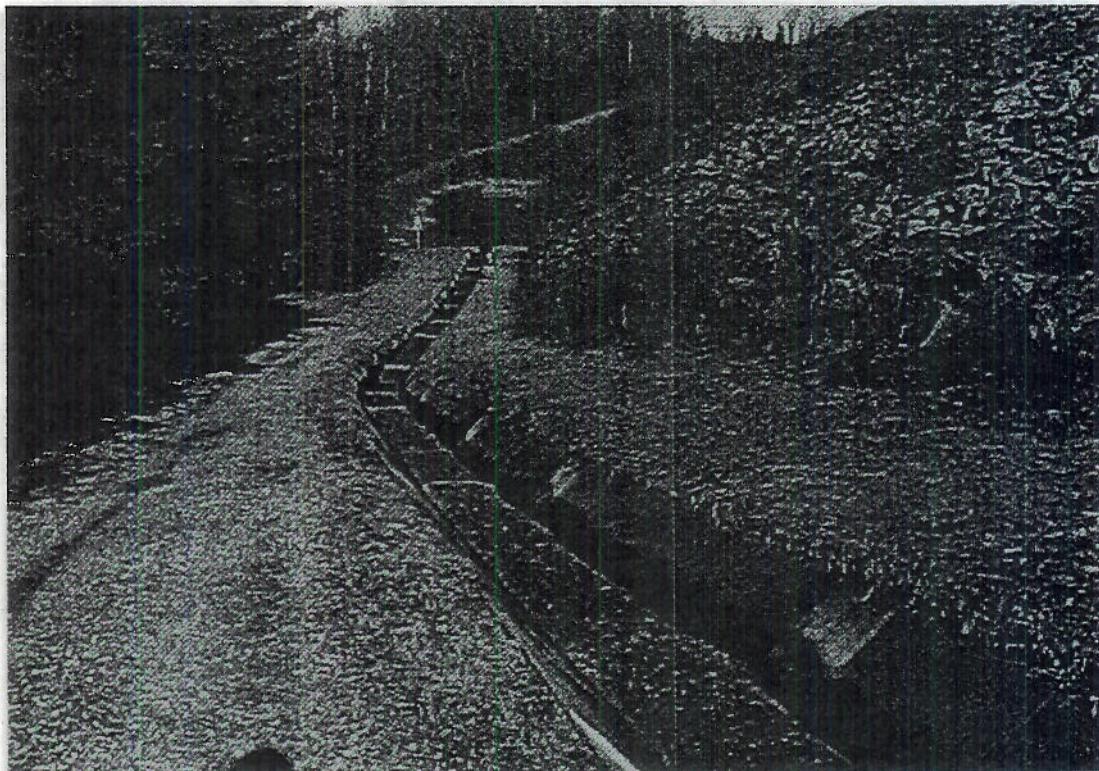
The caulked expansion joints in the concrete flume carrying discharge from the 1982 pond to the NPDES monitoring point at the toe of the 1964 pond dam were observed to be in good condition (photograph 22). No significant erosion or scaling of concrete was noted. Voids adjacent to the flume noted during the 1997 inspection at several locations along approximately the downstream half of the flume were filled with concrete shortly after the 2002 inspection (photograph 23). Discharge from the drainpipe installed below the downstream end of the concrete flume was observed to be clear (photograph 24).

Photograph 22: 1964 Ash Pond – downstream slope looking north along concrete flume carrying discharge from the 1982 Ash Pond.

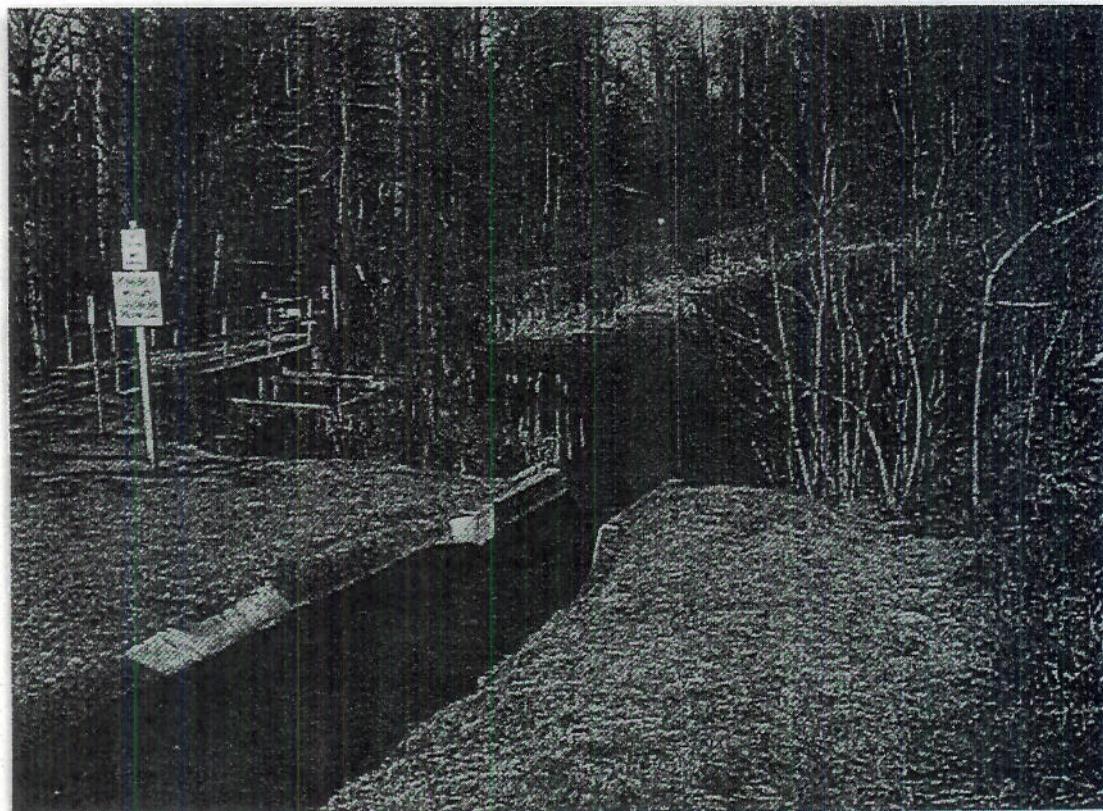
The skimmer, stilling basin and outlet structure are in good condition (photographs 25 and 26). No evidence of deteriorating concrete was observed at the outlet structure.

Photograph 26: 1964 Ash Pond – concrete flume discharge into stilling pond.

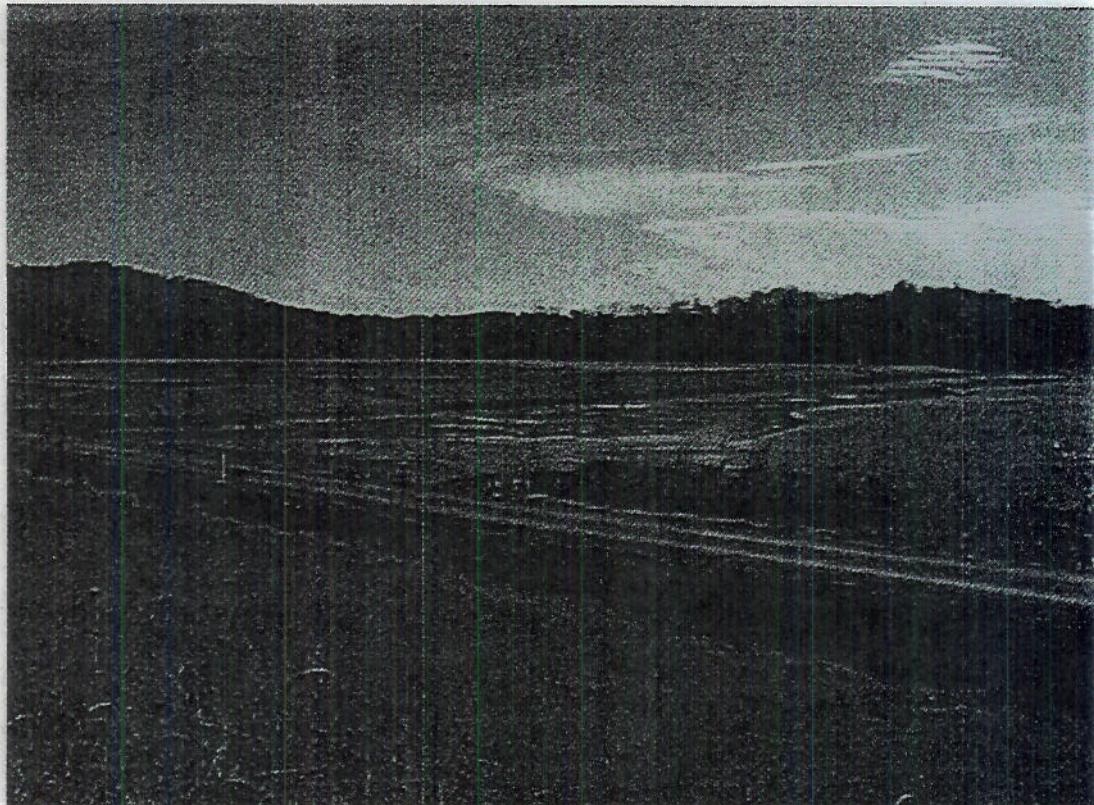
The internal ash dike, located within the northern half of the 1982 Ash Pond (photograph 28), was constructed in 2006 with ash excavated from the 1982 Ash Pond. The internal ash dike was observed to be in overall good condition. Grass cover was observed on the upstream and downstream slopes of the internal ash dike (photograph 29). The outlet pipe located at the southeast corner of the internal dike appears to be in good condition (photograph 30).

Photograph 28: 1982 Ash Pond and internal ash dike within 1982 Ash Pond, looking northeast.

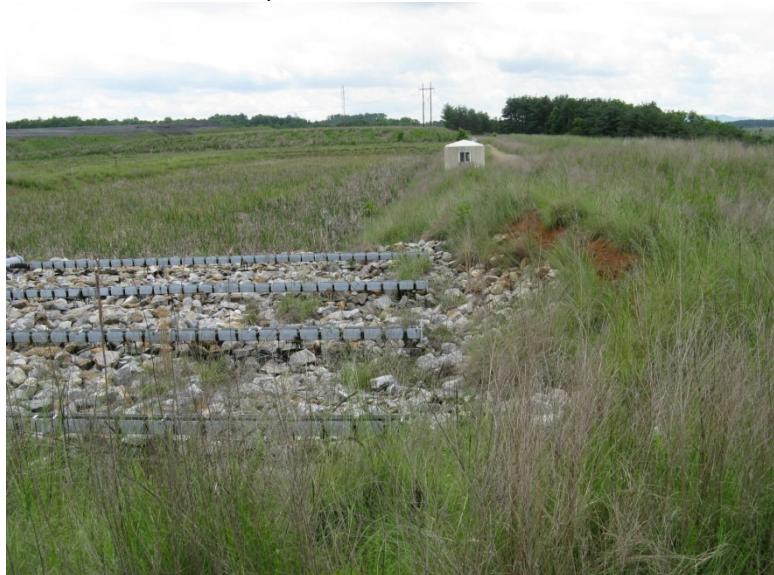
Photo 3: 1964 Dam - Stilling Pond Outlet, Toe, Photo: 070, 5/29/09

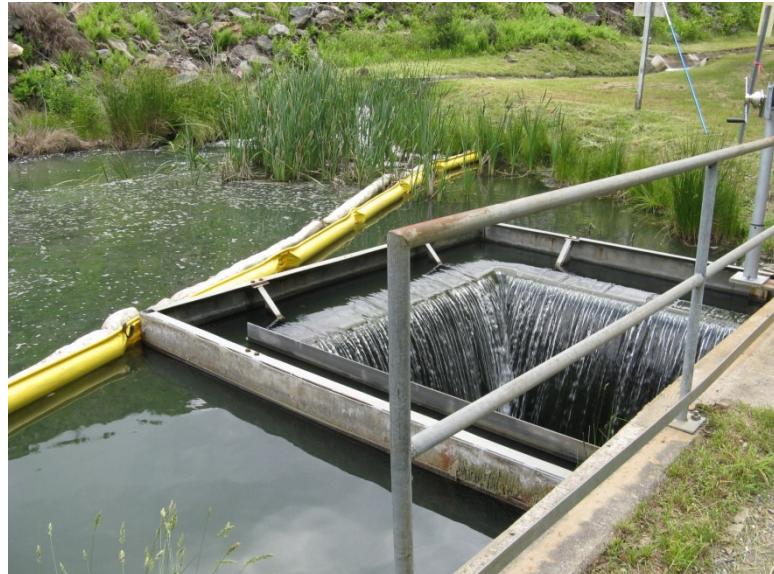
Photo 4: 1964 Dam - Concrete Flume, Right Groin, Photo: 083, 5/29/09
(note: right and left are based on the observer facing downstream)

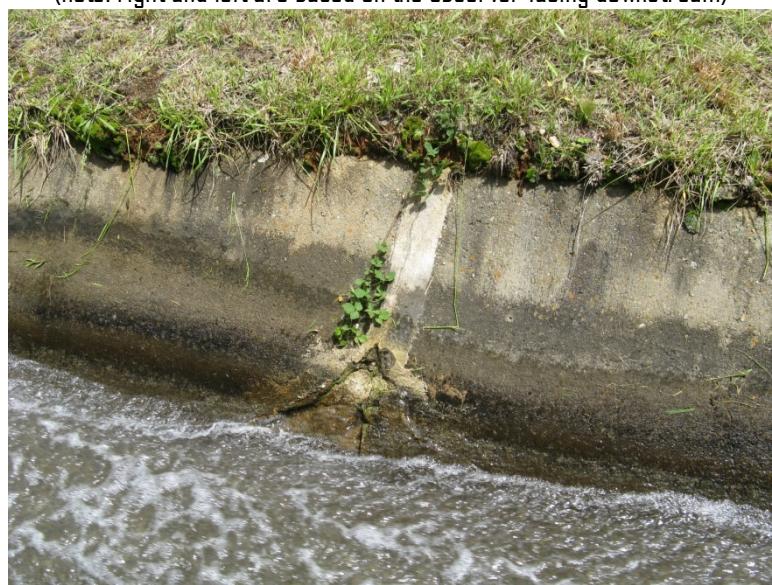
Photo 7: 1964 Dam - Stilling Pond Outfall, Toe, Photo: 086, 5/29/09

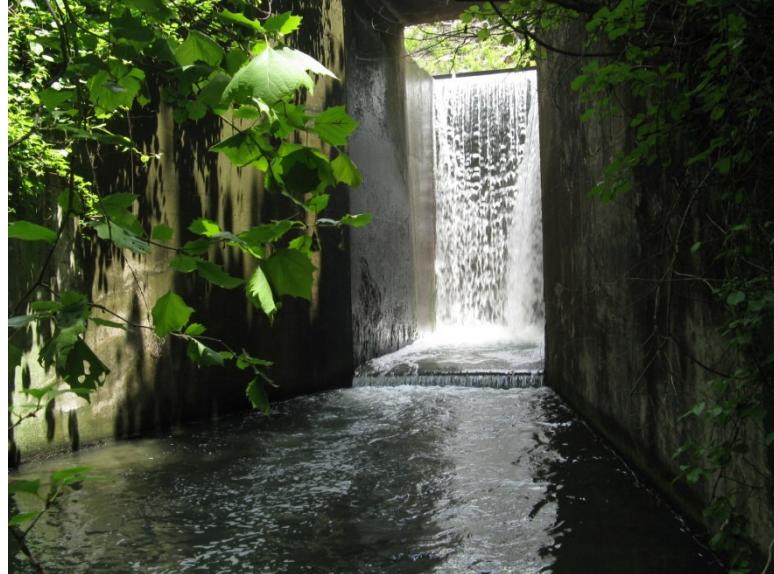
Photo 8: 1964 Dam - 60" CMP Underneath I-26, Toe, Photo: 087, 5/29/09

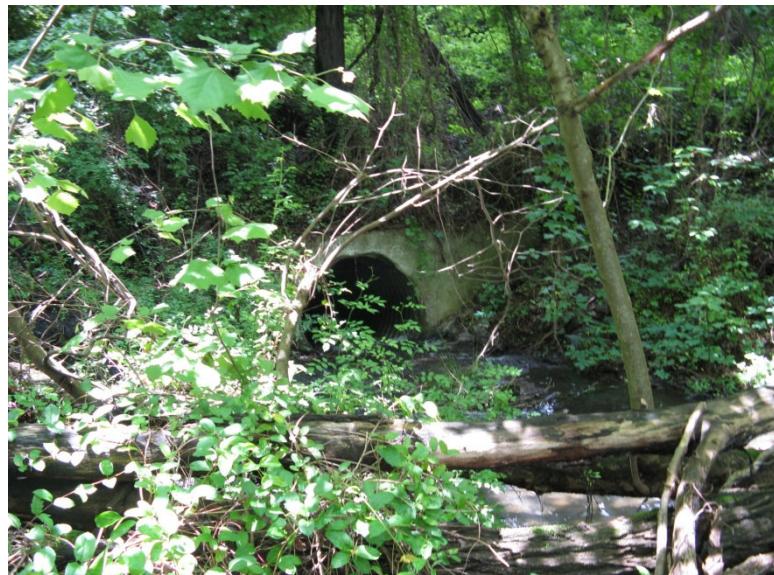
Photo 9: 1964 Dam - Internal Drain, Toe, Photo: 081, 5/29/09

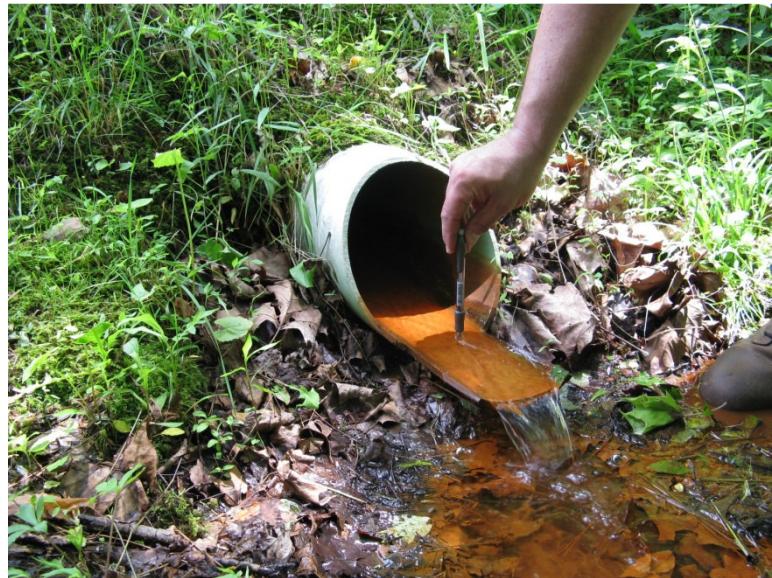
Photo 10: 1982 Dam - Weir Outlet for Internal Drain, Toe, Photo: 006, 5/29/09

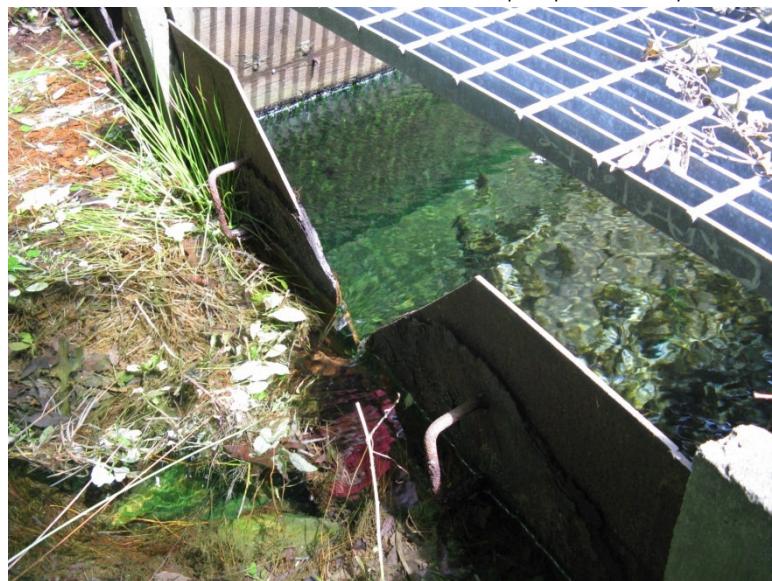
Photo II: 1982 Dam - Crest and Downstream Embankment, Crest (Right Side), Photo: 021, 5/29/09
(note: right and left are based on the observer facing downstream)

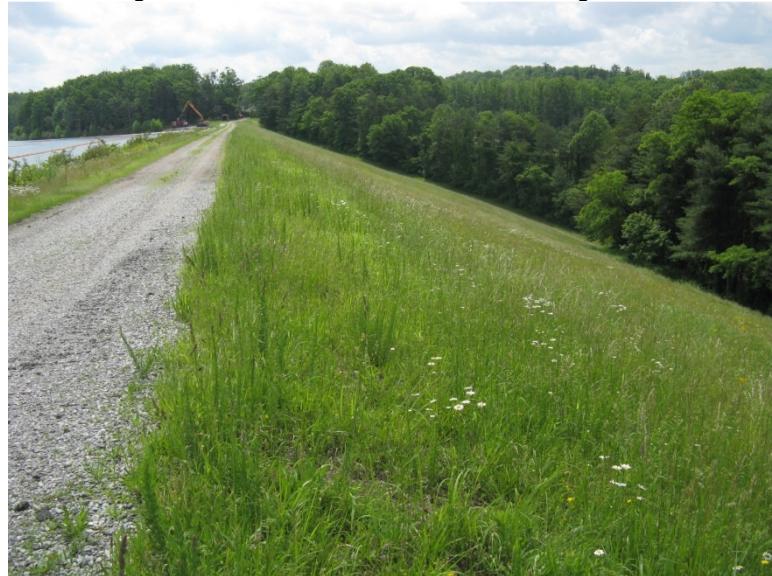
Photo I2: 1982 Dam - Upstream Embankment, Crest(Right Side), Photo: 024, 5/29/09
(note: right and left are based on the observer facing downstream)

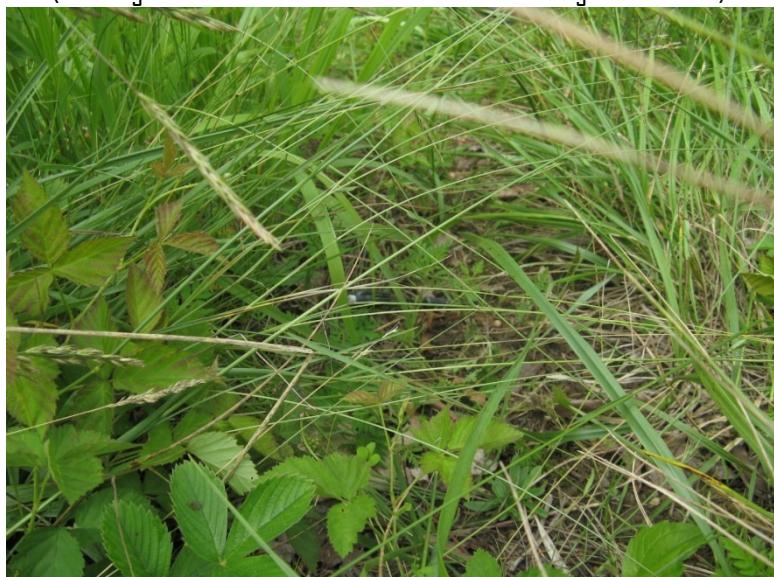
Photo 15: 1982 Dam - Midsection of Downstream Slope, Downstream Embankment, Photo: D30, 5/29/09

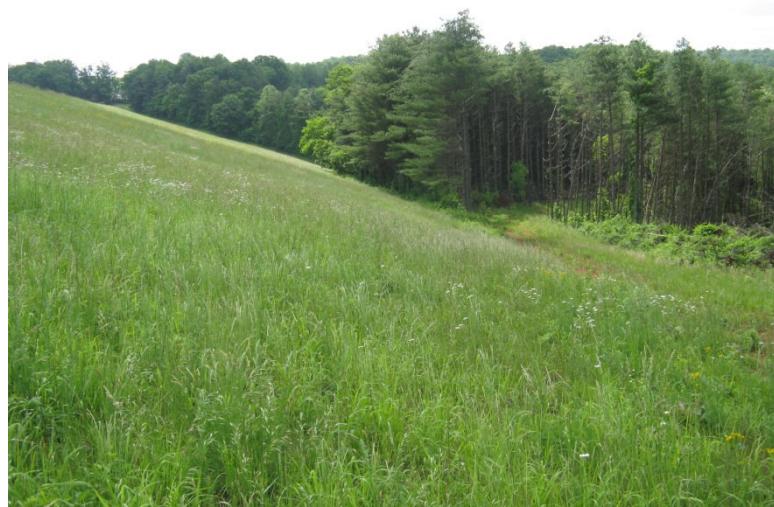
Photo 17: 1982 Dam – Tall Vegetation, Left Groin, Photo: 037, 5/29/09
(note: right and left are based on the observer facing downstream)

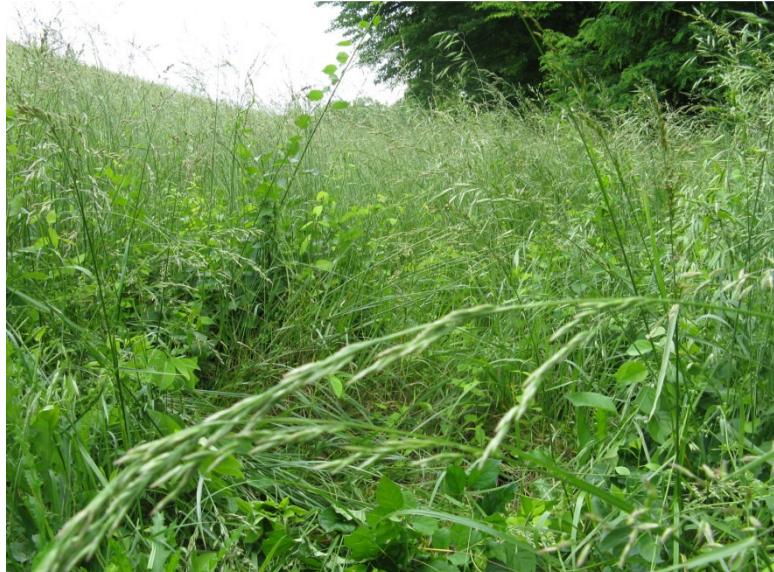
Photo 18: 1982 Dam – Minor Rill Erosion, Downstream Embankment, Photo: 033, 5/29/09
