Assessment of Dam Safety Coal Combustion Surface Impoundments (Task 3) Final Report

Duke Energy

W.C. Beckjord Station
New Richmond, Ohio

March 22, 2010

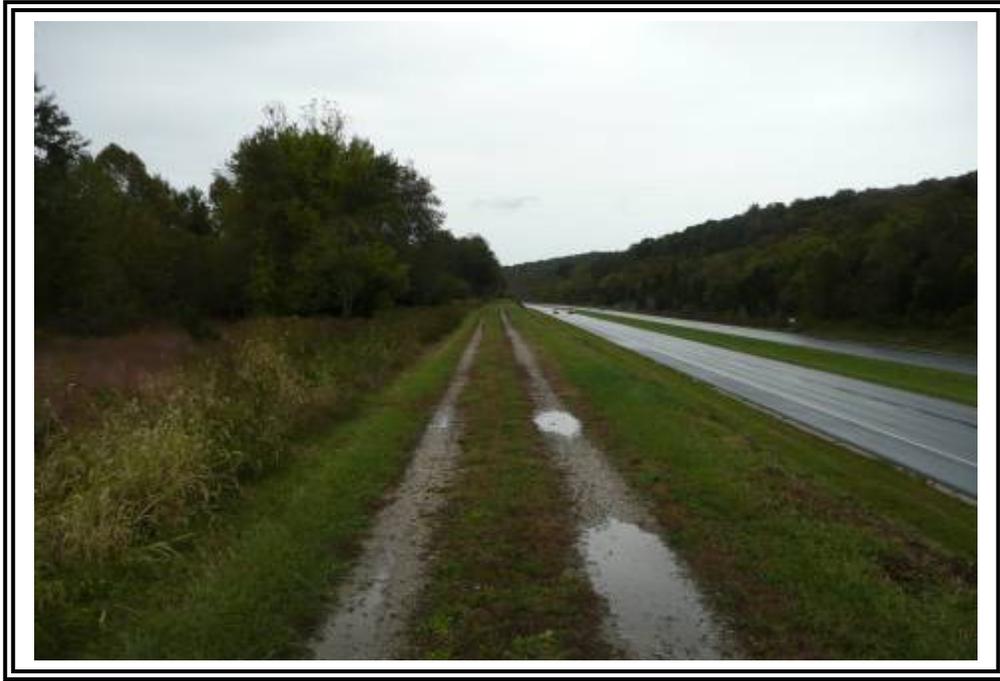
1

East dike crest and interior slope face, looking north.
Note small isolated “birdbaths” in access drive as a result of recent rainfall.

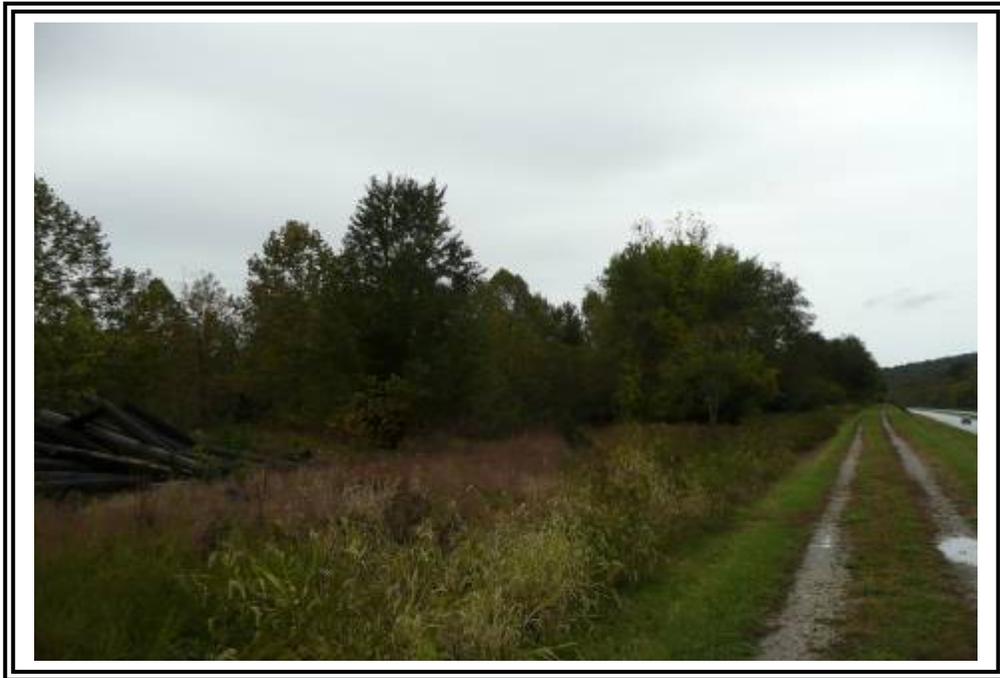
2

There was no visible liquid in the pond at the time of our site visit and the average height observed from the embankment crest to the top of ash in the pond (the freeboard) was approximately 8 to 10 feet. A majority of the ash in the pond is covered with heavy brush and large trees (Photo 2). Ash Pond A reportedly contains an interior dike which could not be located during the site visit. In general, the dikes do not show signs of changes in their horizontal alignments.

Looking across Ash Pond A from east dike, facing north. Note vegetation and large trees in ash/slag surface.

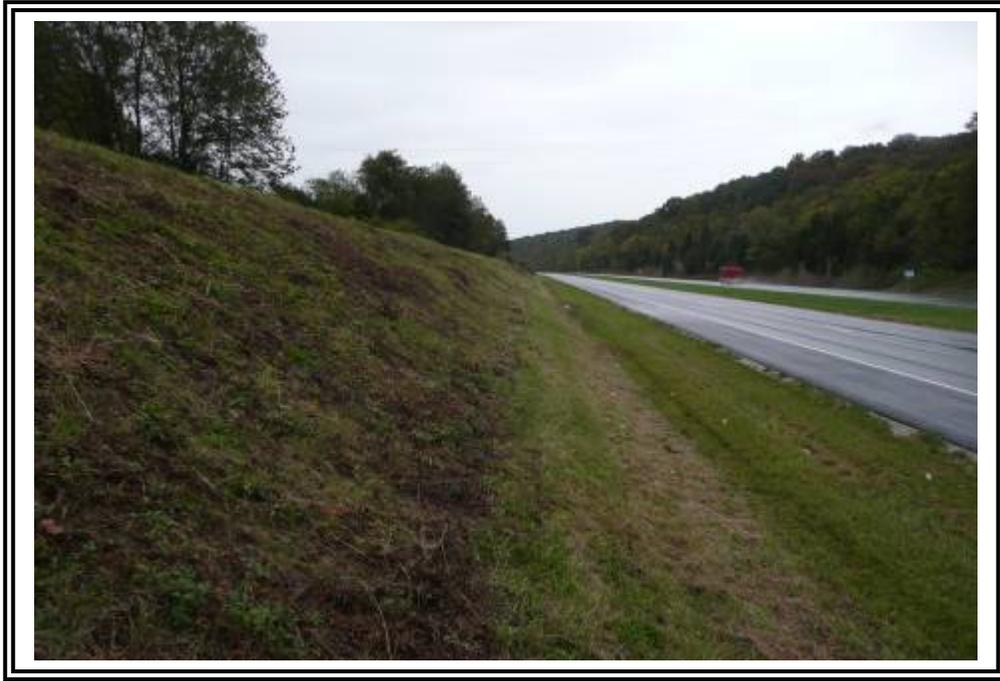
3

The crest width of the north (Photo 10), east (Photo 1), and south (Photo 24) dikes of the Ash Pond A embankment were measured to be approximately 14, 17 and 14 feet, respectively. In general, the east dike (Photo 3), south dike adjacent to Pond B, and the exterior slope of the north dike from the corner at the east end to the cell tower site access ramp appeared to be maintained and mowed.

Exterior slope of east dike, looking north. Note proximity of U.S. Route 52 southbound lanes and ditch at toe.

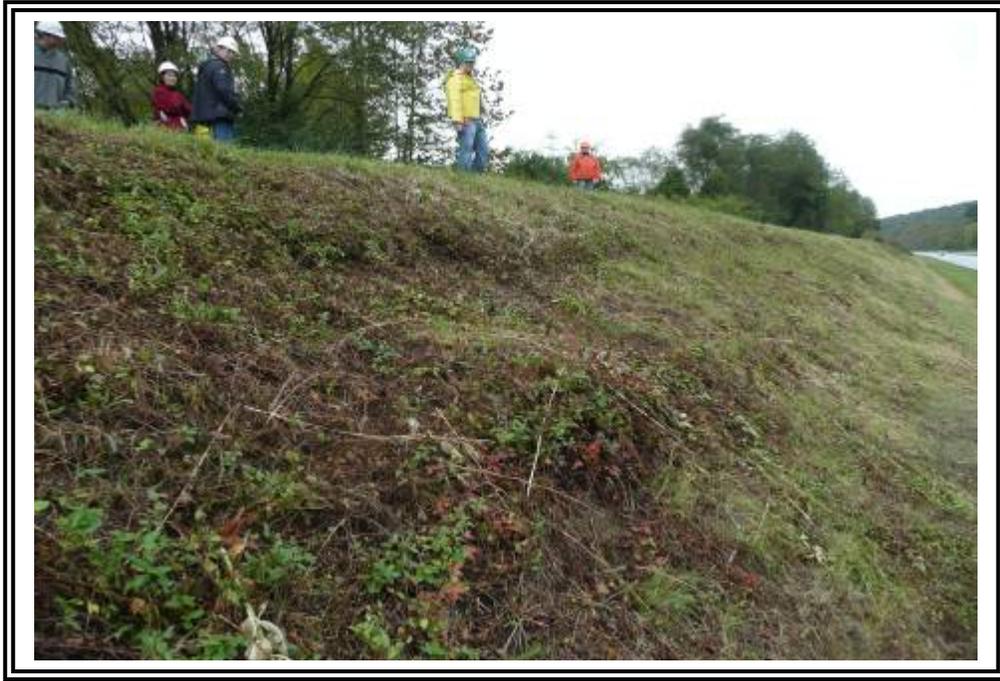
5

Surficial scarps/sloughs were observed on the exterior slope of the east dike. One scarp/slough was measured to be approximately 15 to 20 feet long. The scarps/sloughs appeared to be the result of an over steepened slope. The areas were generally covered with grass (Photo 5). Water was observed in the US Route 52 drainage swale at the toe of the east dike (Photo 6). Near the

Faint vegetated creep in east dike exterior slope, looking north.

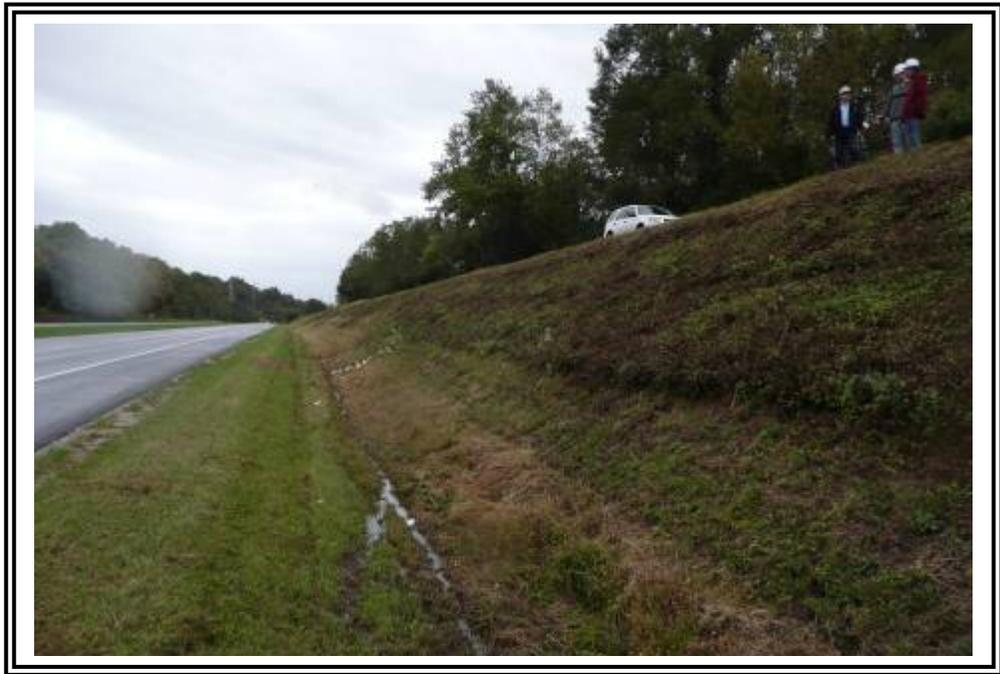
6

East dike exterior slope, looking south. Runoff is collected in the highway ditch line.

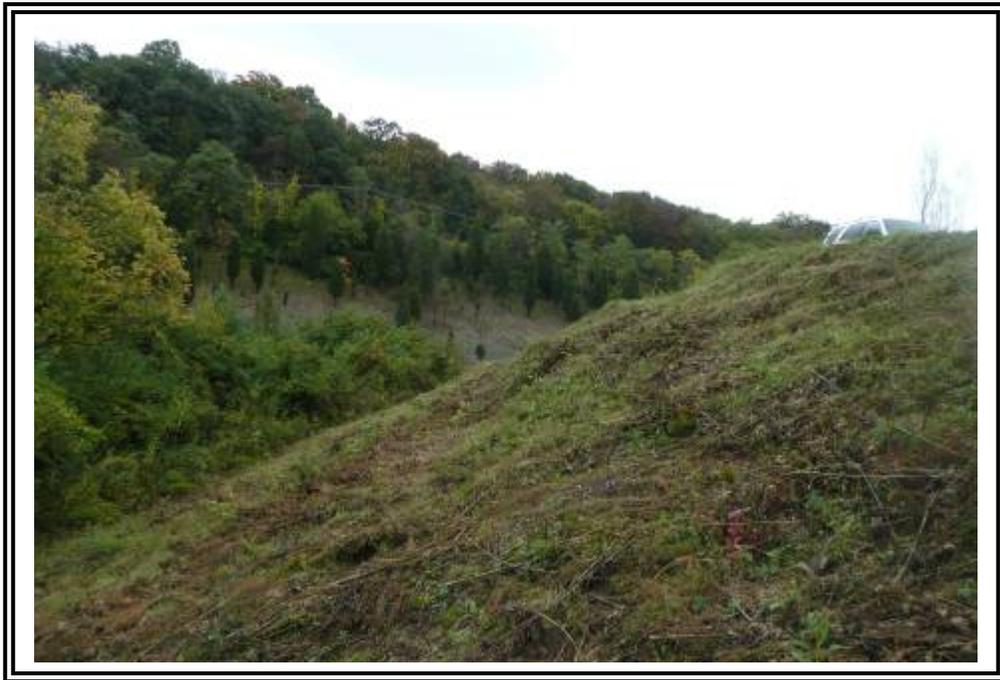
7

At the east end of the north dike on the exterior slope an erosion rill was noted. The rill was grassed over. Undulations in the slope surface were observed in this location due to grading activity (Photo 7).

Surface undulations on exterior slope at corner of east and north dikes, looking east.

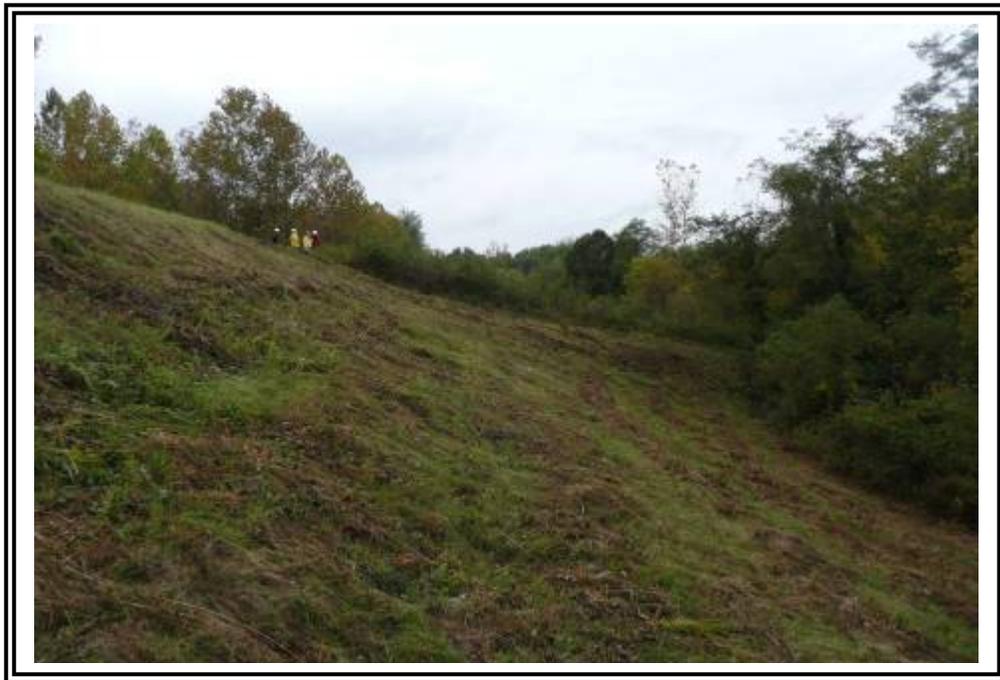
8

North dike, exterior slope, looking west. Note that slope gets flatter here and vegetation is not maintained where cell tower access road crosses drainage swale/creek at toe of dike.

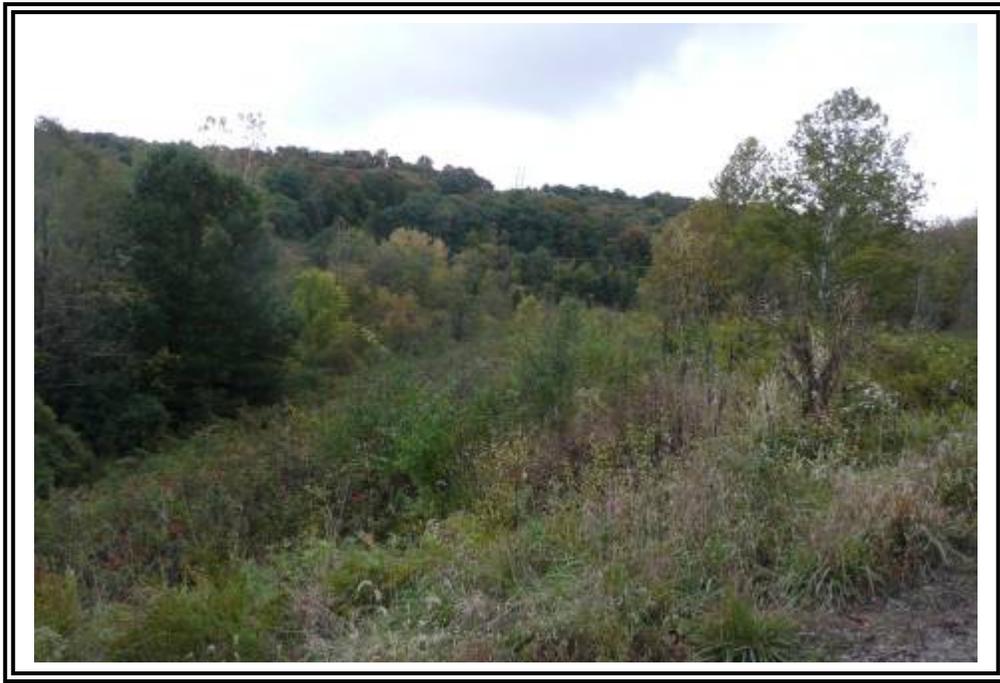
11

Exterior slope of north dike showing heavy vegetation, looking east.

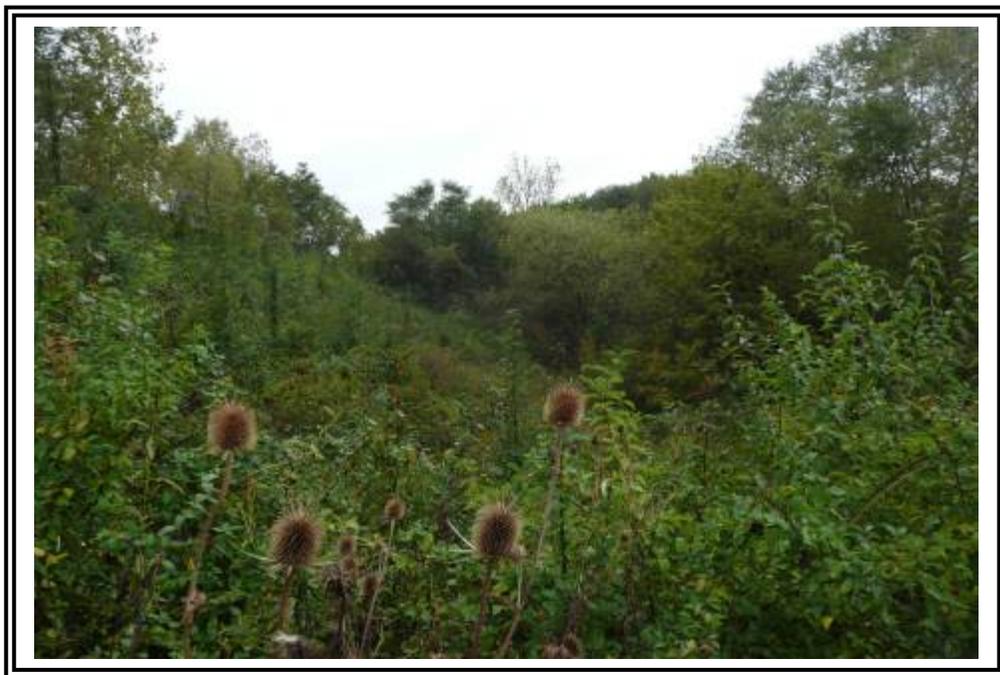
12

Heavy vegetation on the north dike exterior slope, looking west.

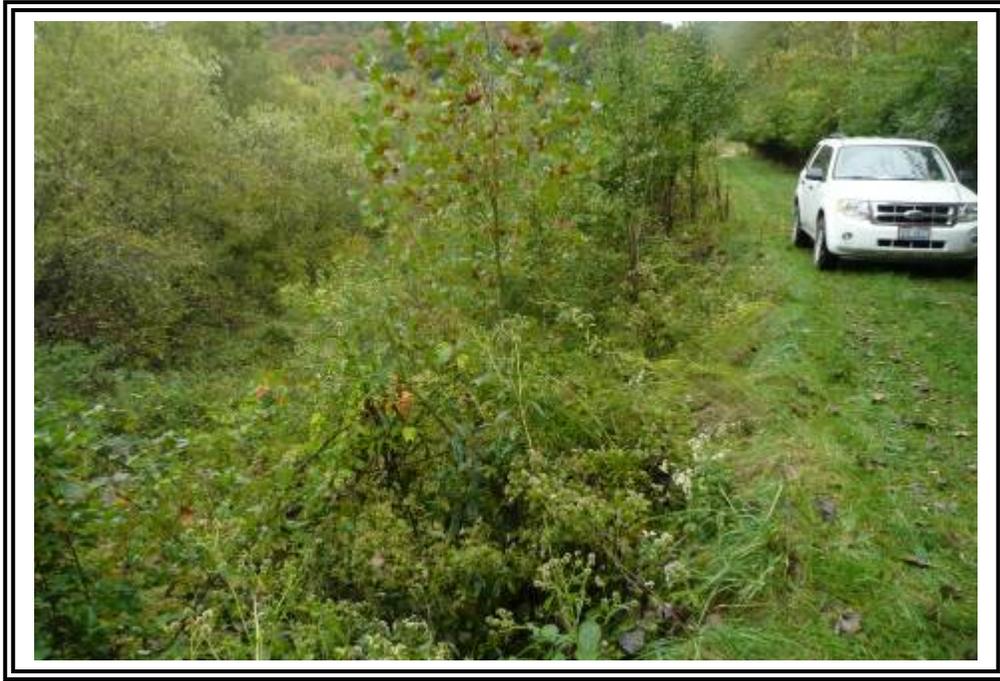
15

Heavy vegetation on the exterior slope of the north dike, looking east from the north dike crest.

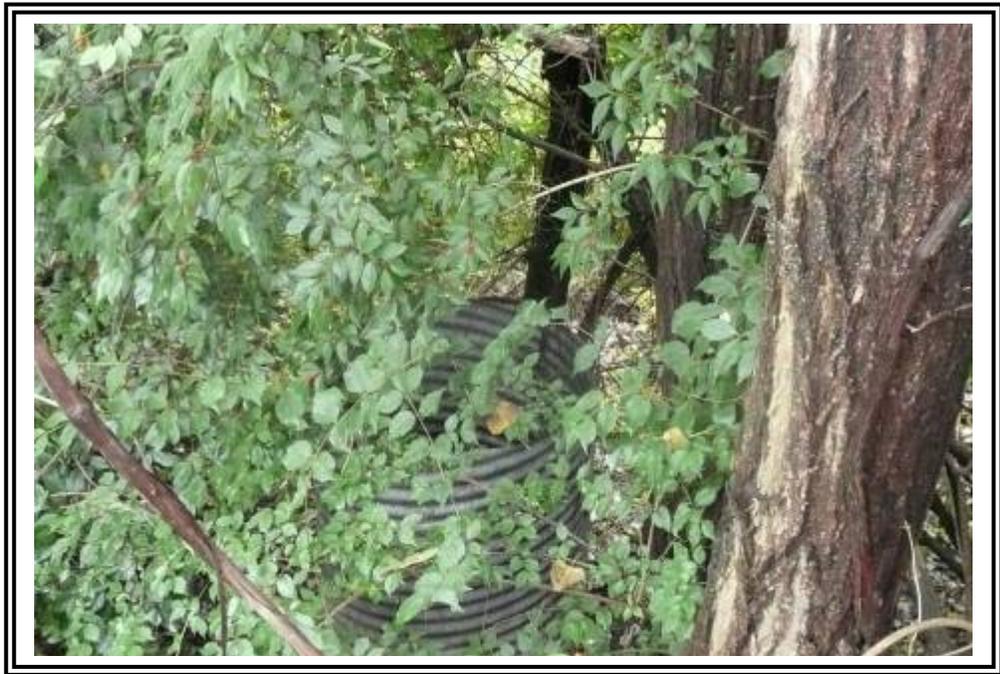
16

Inactive corrugated metal outlet riser/decanting structure in trees and vegetation.

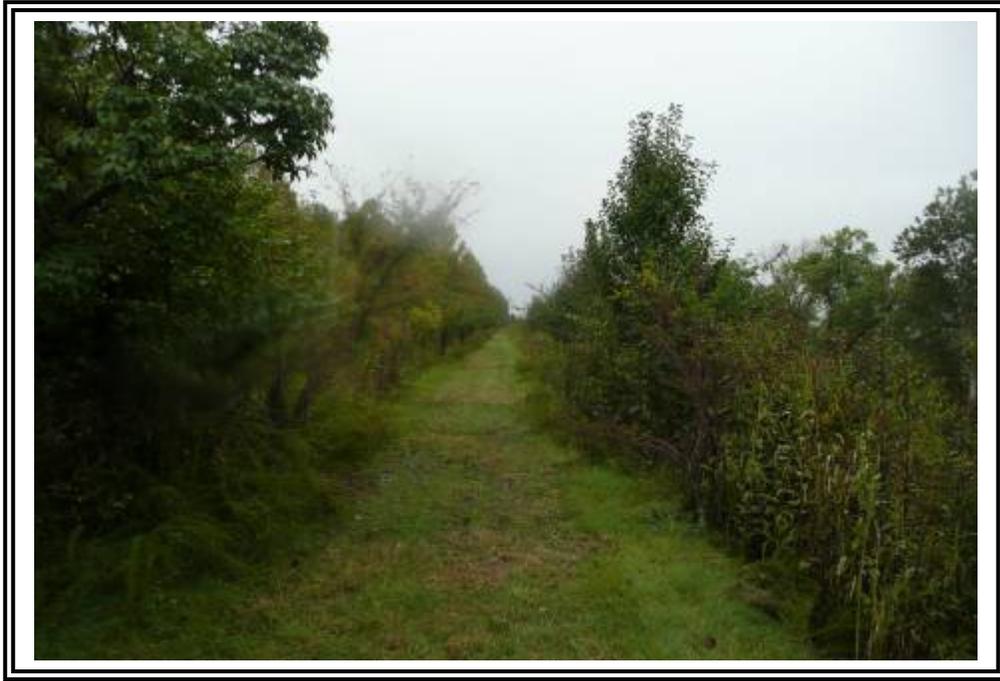
17

West dike crest, looking south. Note very heavy vegetation overgrowth and trees on interior and exterior slopes.

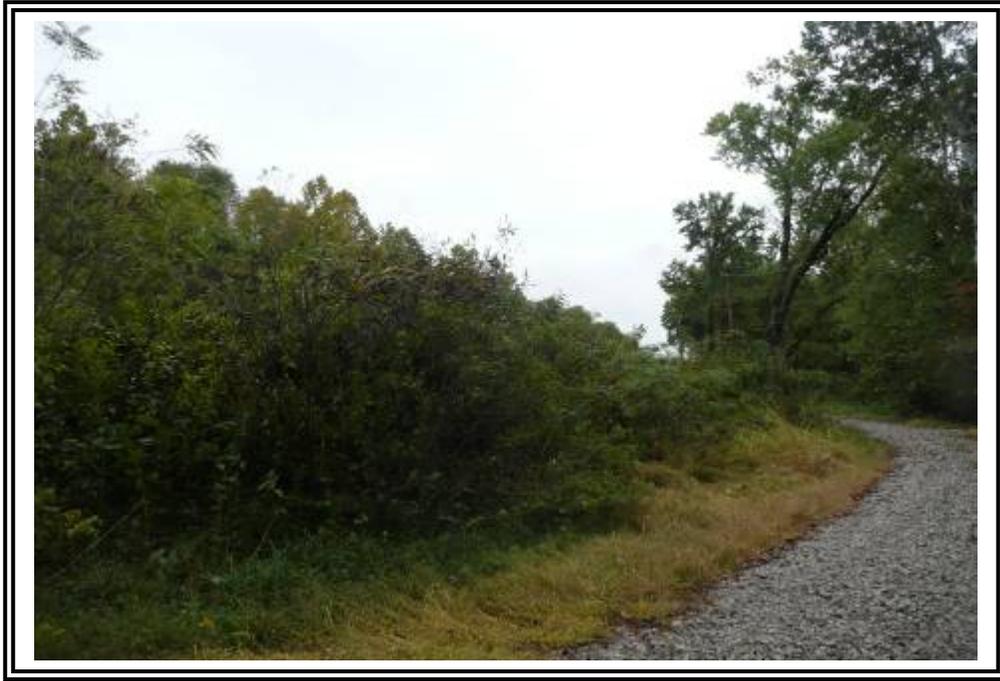
19

Very heavy vegetation and brush growth on west dike exterior slope, looking south.

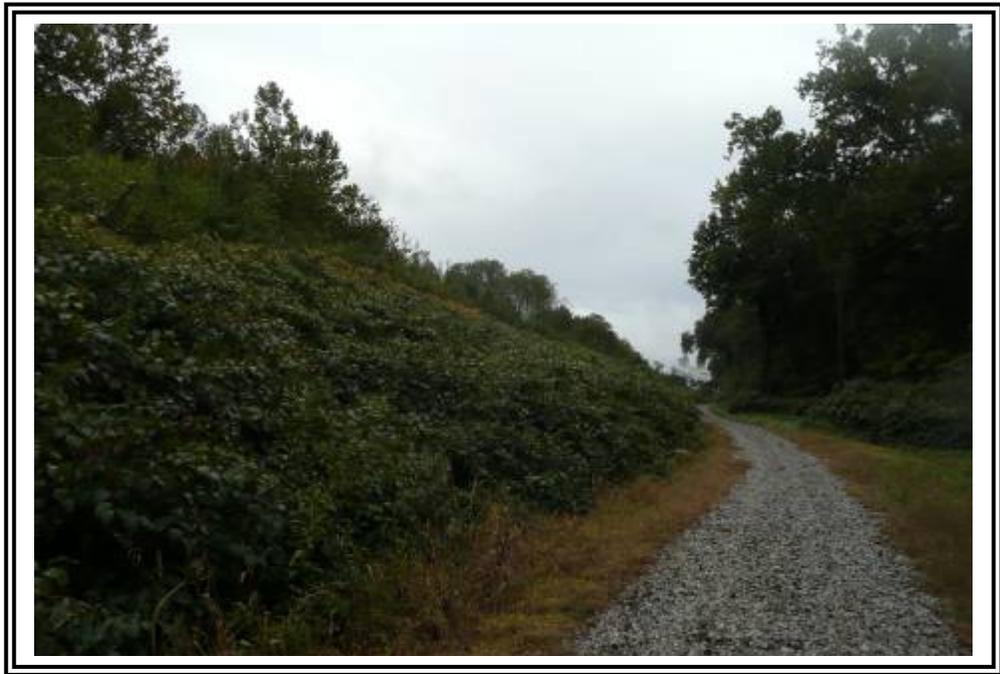
20

West dike exterior slope, looking south. Note heavy, broad, leafy, bush-like vegetation.

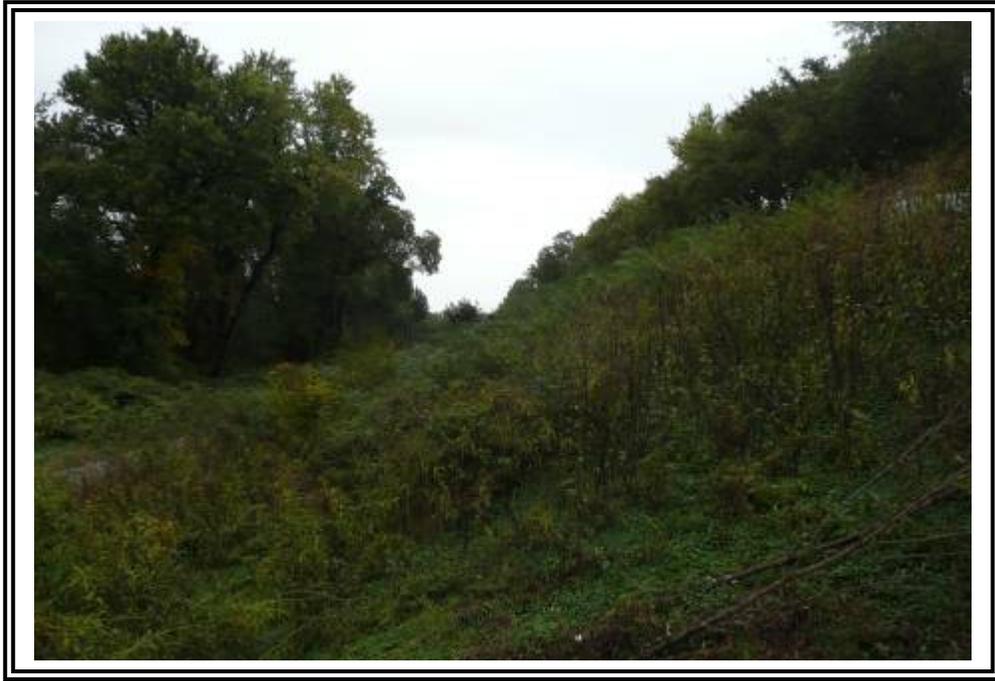
21

Exterior slope of west dike, looking north. Heavy vegetation prevalent with tree growth in basin above slope.

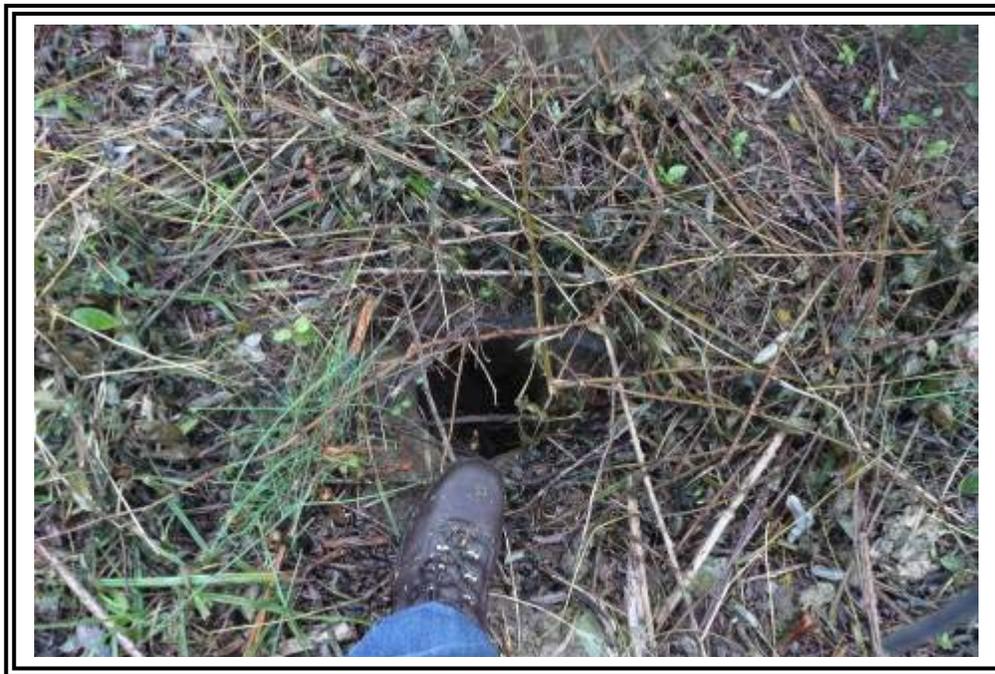
22

On the south dike an animal burrow was observed on the exterior slope (Photo 22).

Possible rodent burrow at western terminus of south dike.

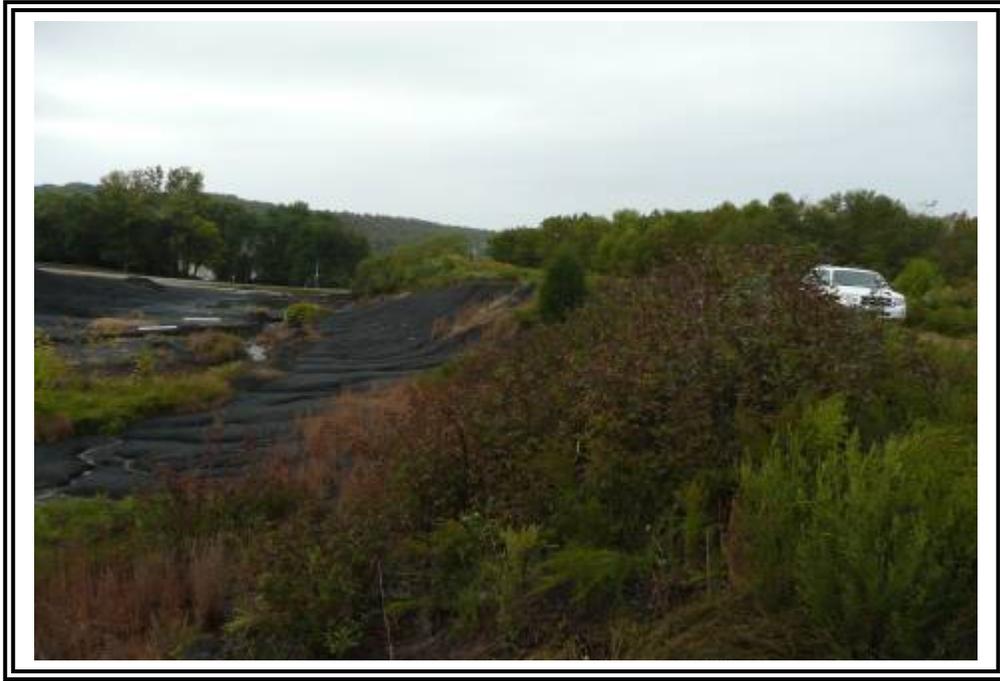
23

Exterior slope of south dike, looking west. Note erosion rills in coal material pushed against dike and areas of moderate to heavy vegetation. Dike in this area abuts the coal pile operations.

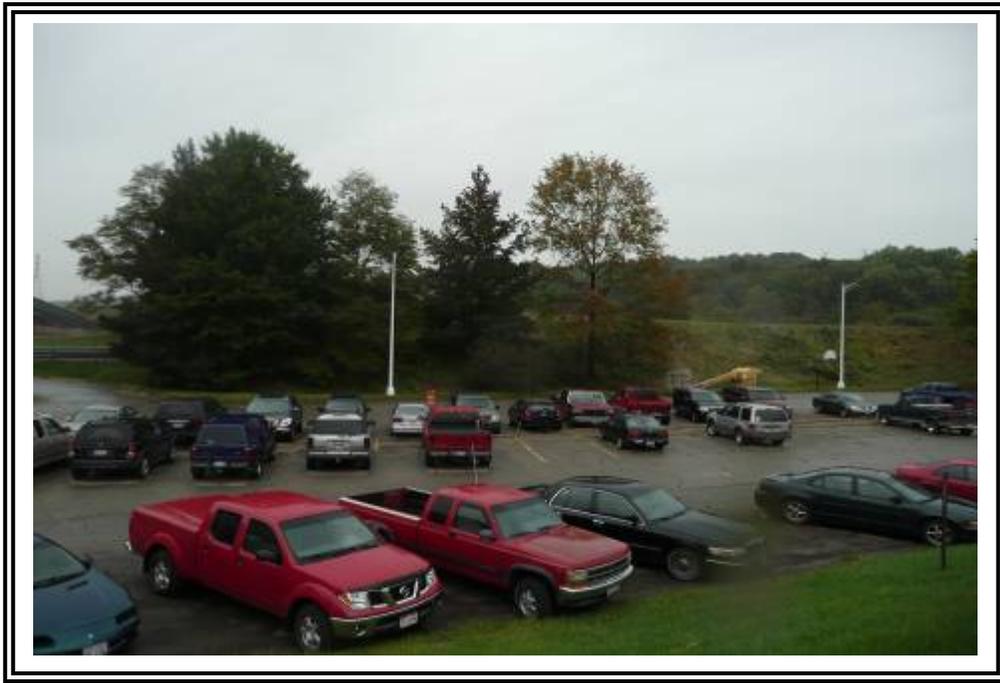
25

Exterior slope of the south dike, looking north. Note large, mature trees at the southwest corner (left) of the dike.

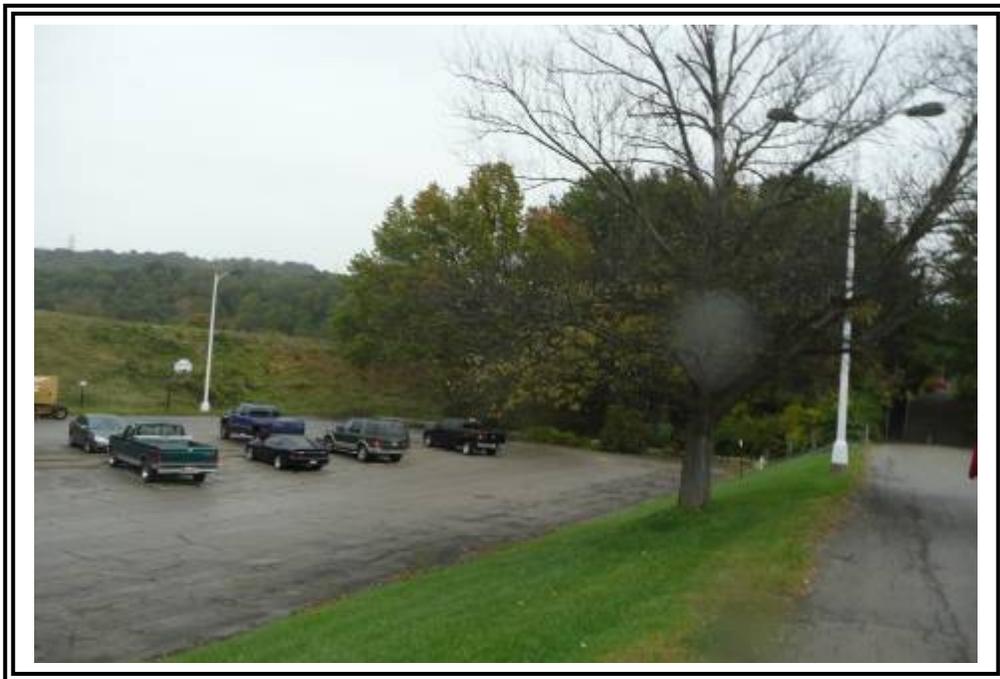
26

Exterior slope of the south dike, looking northeast toward central portion of the dike.
Large trees on dike slope, as well as parking lot embankment, abut the dike.

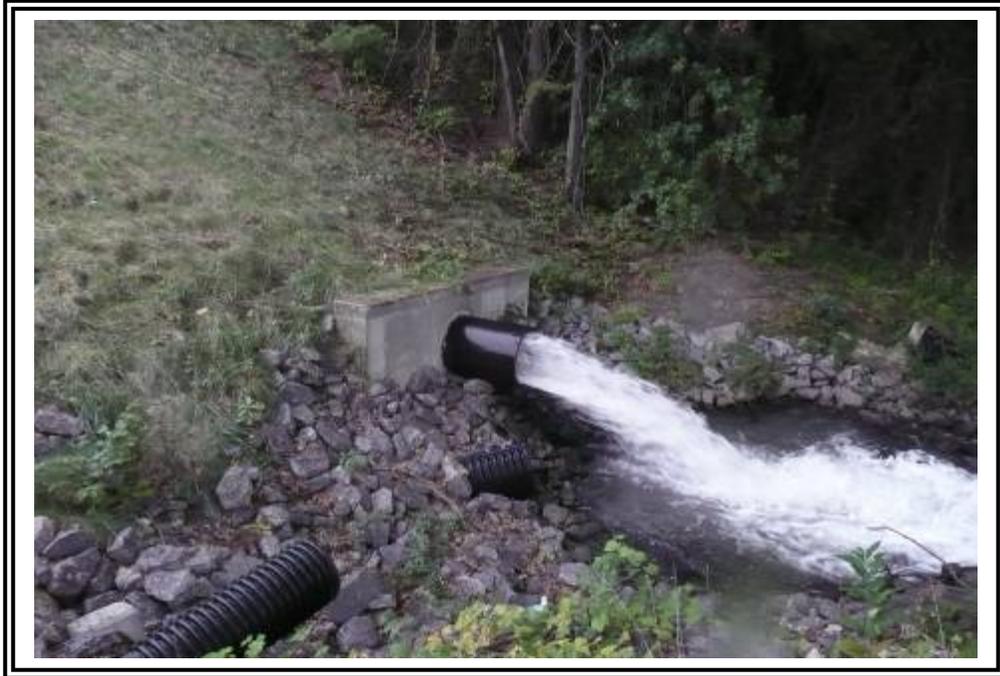
27

Ash Pond B outlet headwall, rock lined outlet channel and site drainage/seepage pipes.

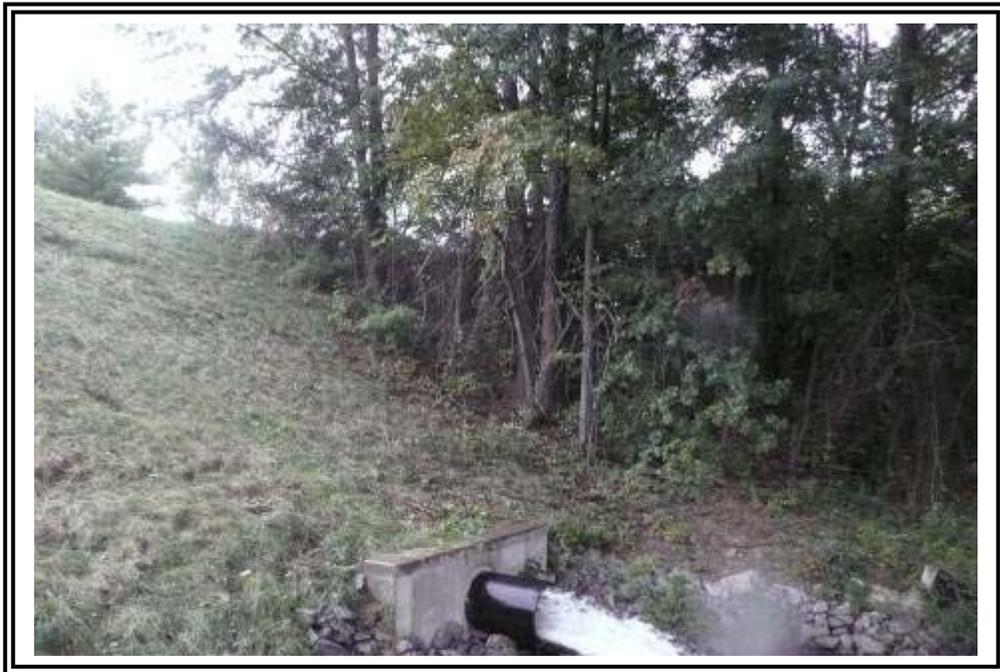
28

Ash Pond B outlet and vegetation and trees on slope face.

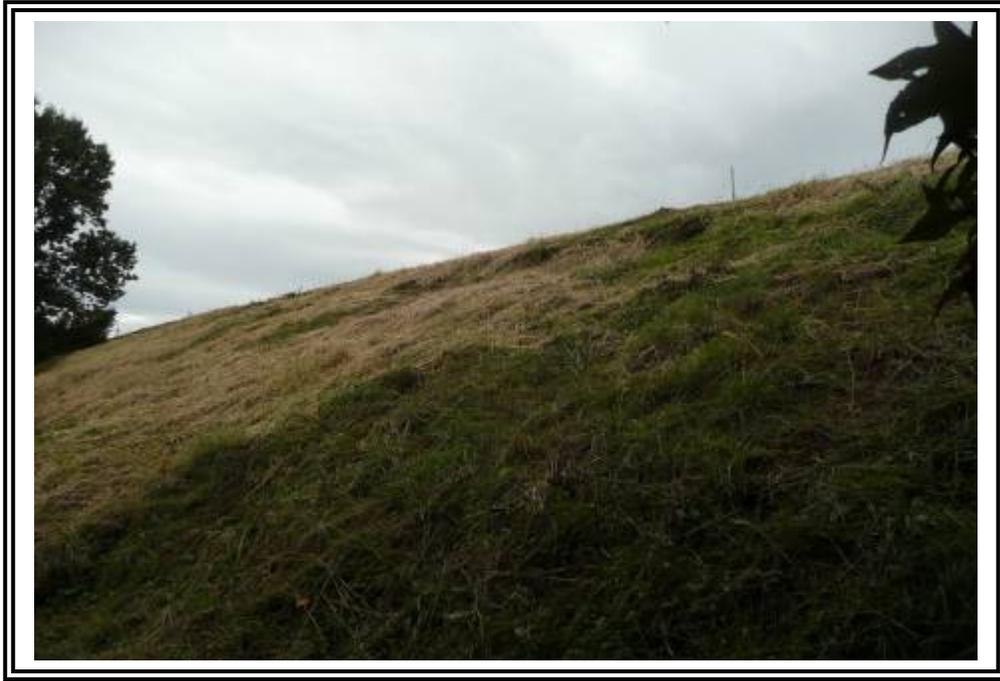
A bulge approximately 21 inches wide (measured along length of the dike) was observed at the toe of the exterior slope of the east dike at approximately one-third the length of the embankment from the north end (Photos 36 and 37). Active scarps were observed in the exterior face of the slope at multiple locations (Photos 34, 35 and 38). About mid-way along the dike an active scarp approximately 25 feet wide was observed. Occasional standing water in the heavily vegetated ditch at slope toe was also observed. Trees up to 24 inches in diameter were noted at the toe of the east dike exterior slope (Photo 39).

Active surface scarp and slough on east dike (different feature from Photo No. 34).

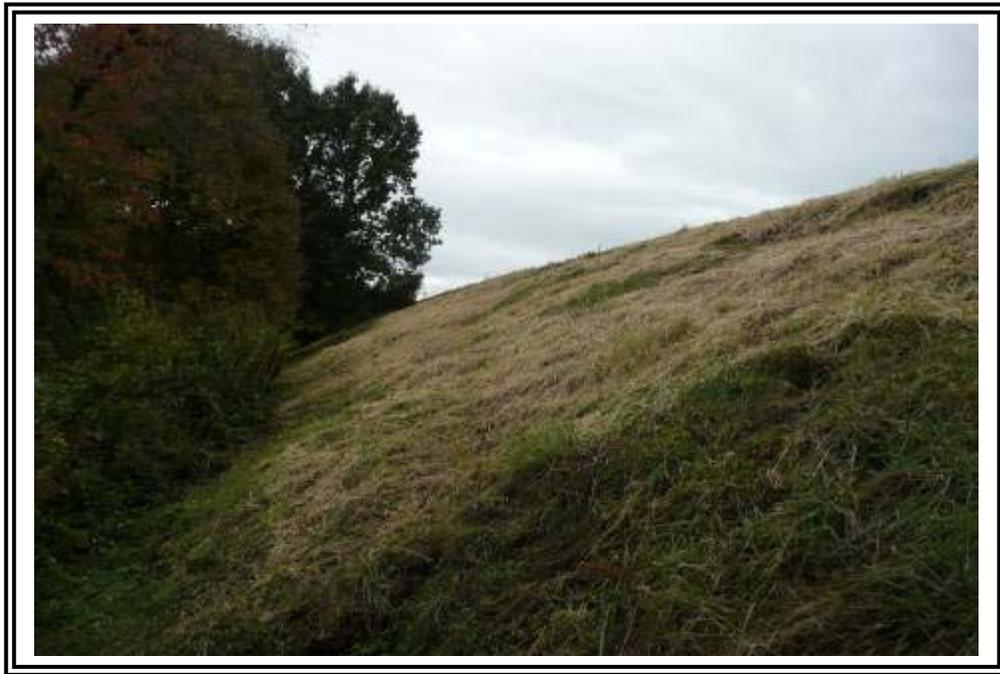
36

Toe bulge expression from active surface scarp and slough in Photo No. 35, looking south.

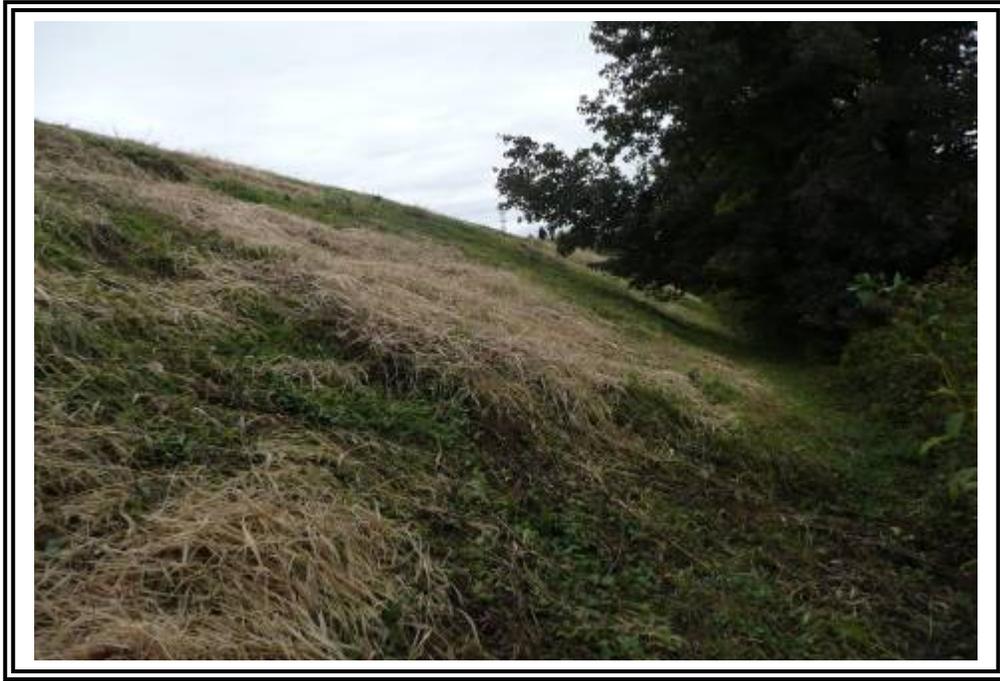
37

Toe bulge expression from active surface scarp and slough in Photo No. 35, looking north.

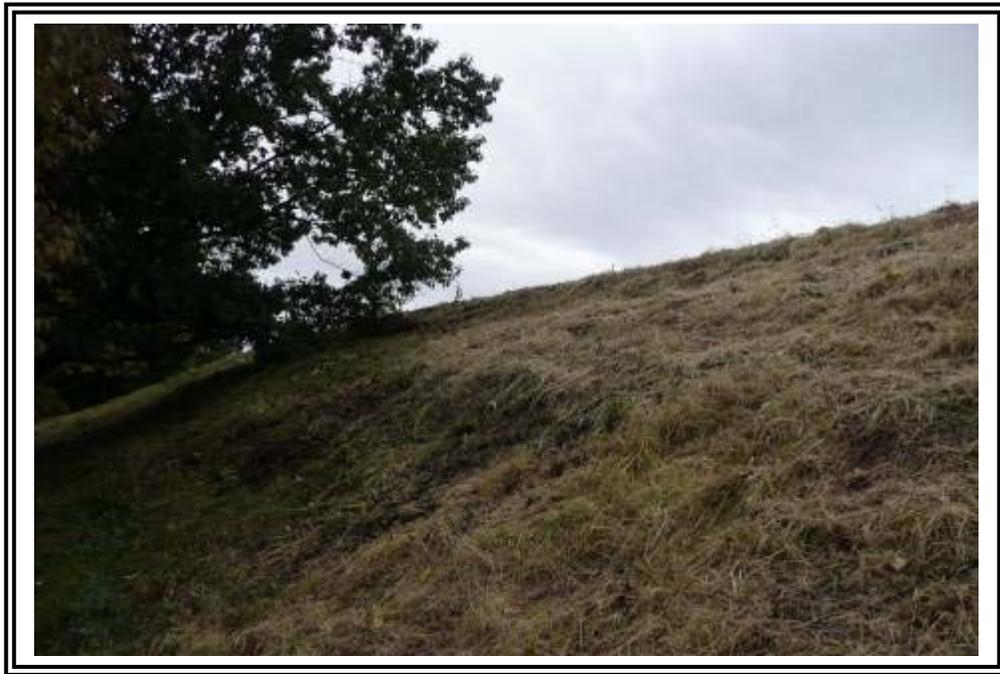
38

Slough on east dike exterior slope adjacent to mature tree at slope toe.

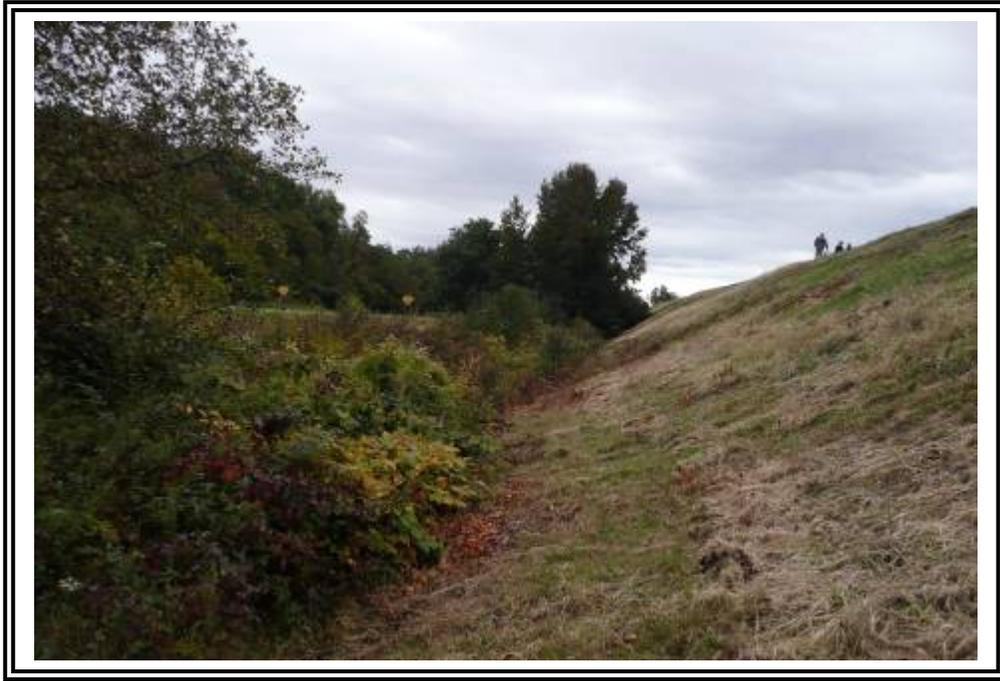
39

General view of east dike exterior slope, looking south from northern terminus. Note vegetation at dike toe. A ditch/drainage swale is located at base of dike toe.

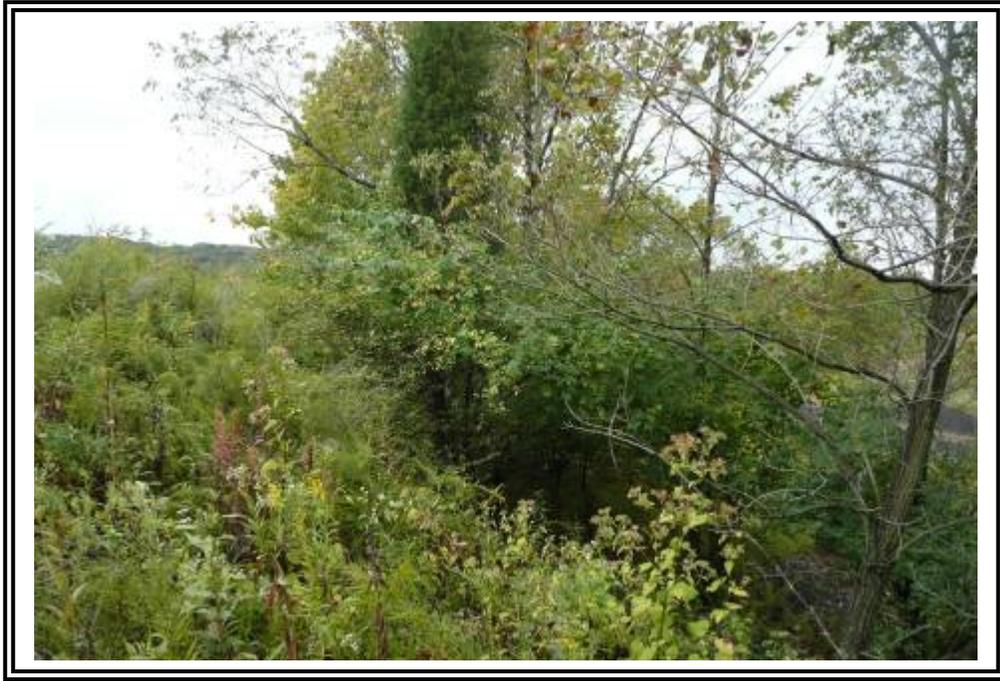
41

Exterior slope of north dike, looking west. This is also the interior slope of the Ash Pond A south dike. Note heavy vegetation and small tree growth.

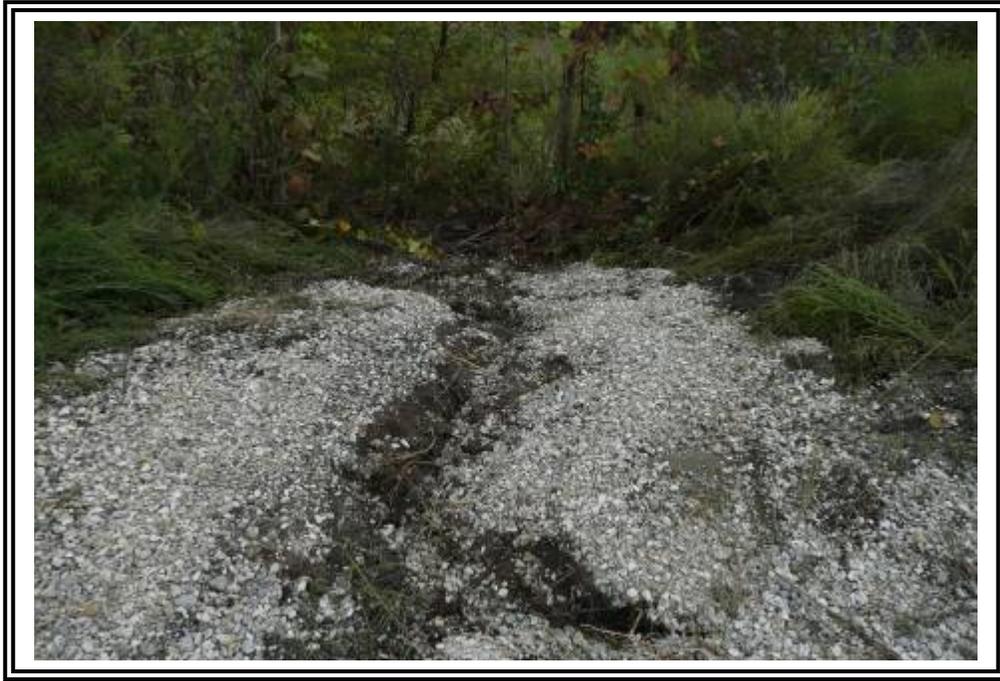
43

Erosion rill on exterior slope of north dike.

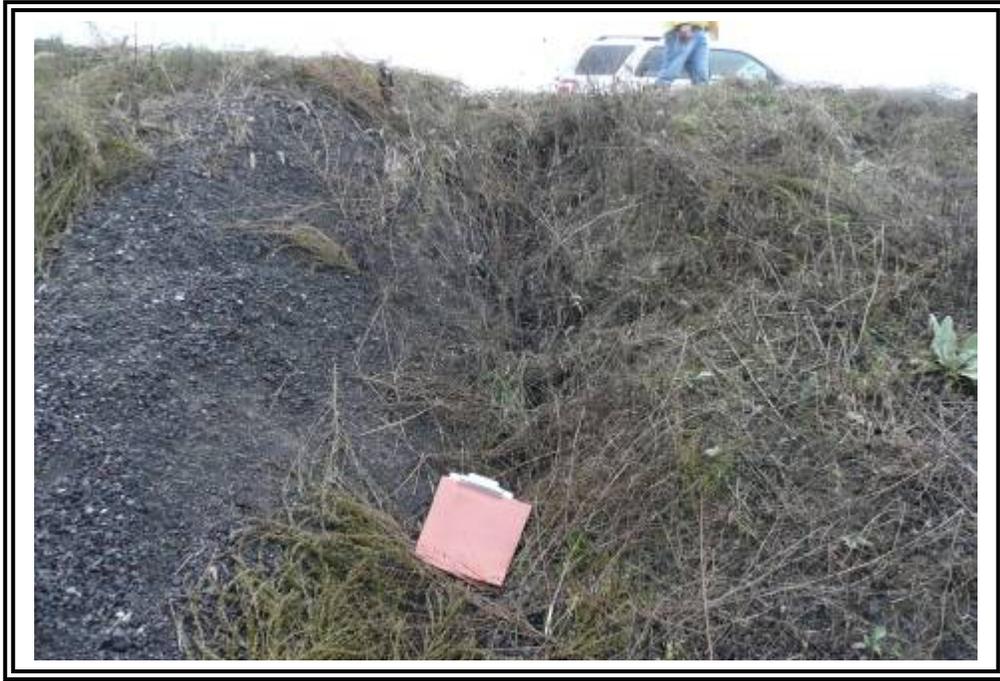
47

Deep erosion gully on west dike, exterior slope.

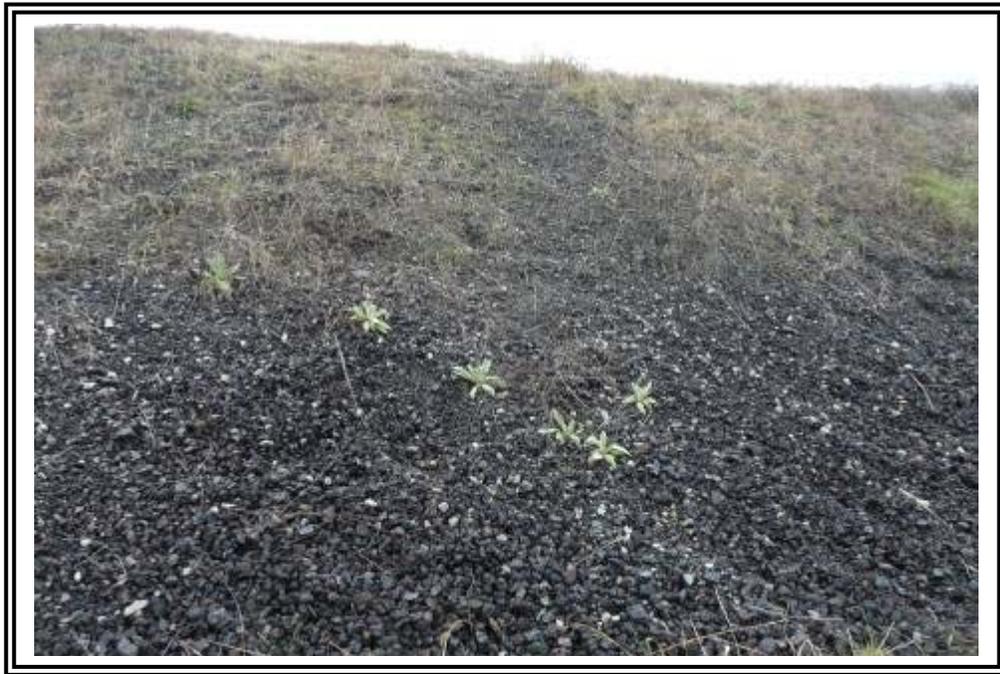
48

Slag surface prevalent in this portion of the west dike where grass/weed cover is sparse.

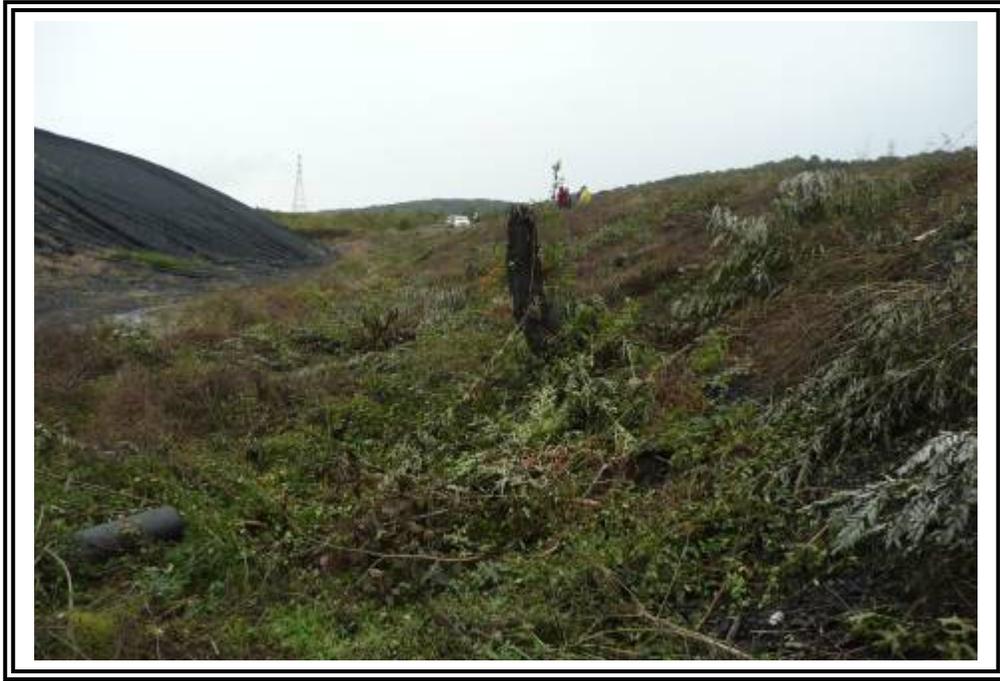
49

Exterior slope of the west dike, looking north. Note vegetation cover and dead/rotten tree trunk.

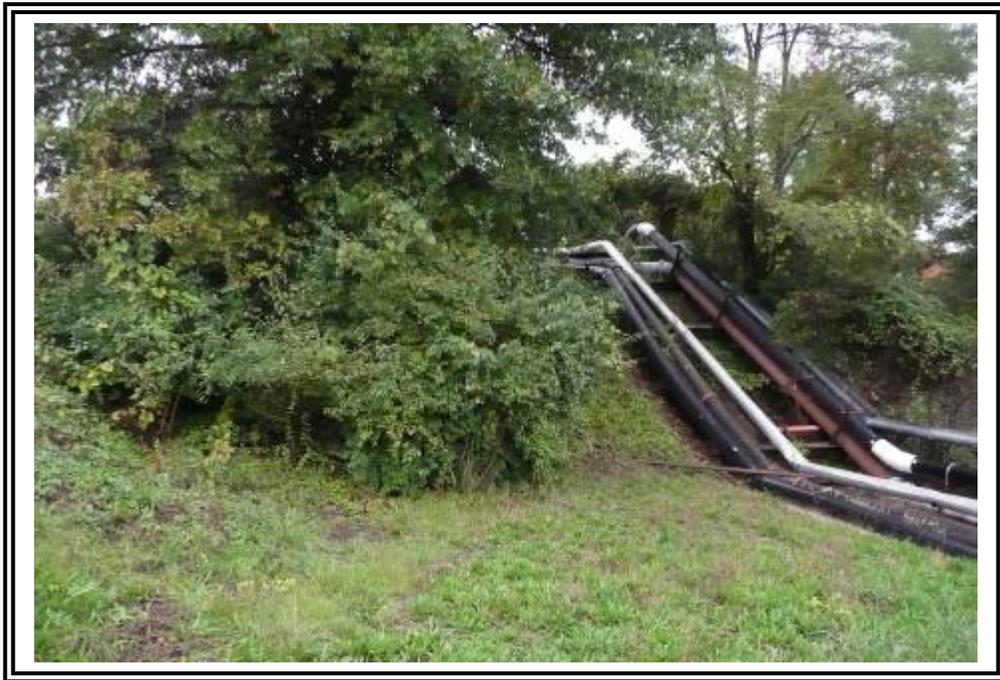
53

Exterior slope where the west dike meets the south dike, looking northeast.
Note heavy vegetation and tree growth.
