Assessment of Dam Safety Coal Combustion Surface Impoundments (Task 3) Final Report

Duke Energy

W.C. Beckjord Station
New Richmond, Ohio

March 22, 2010

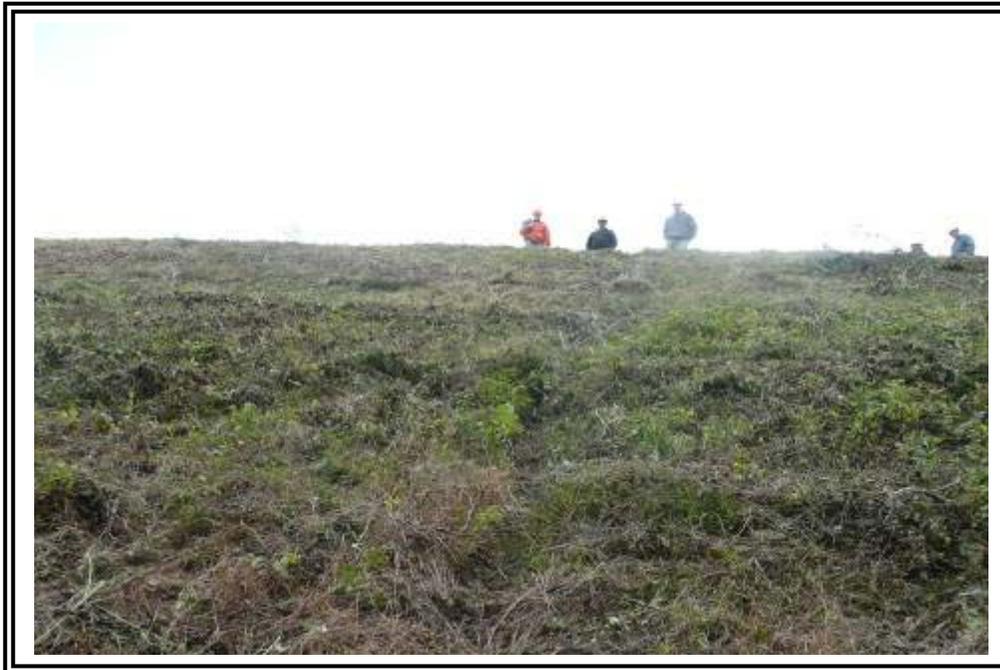
68

Erosion rill or possible animal trail.

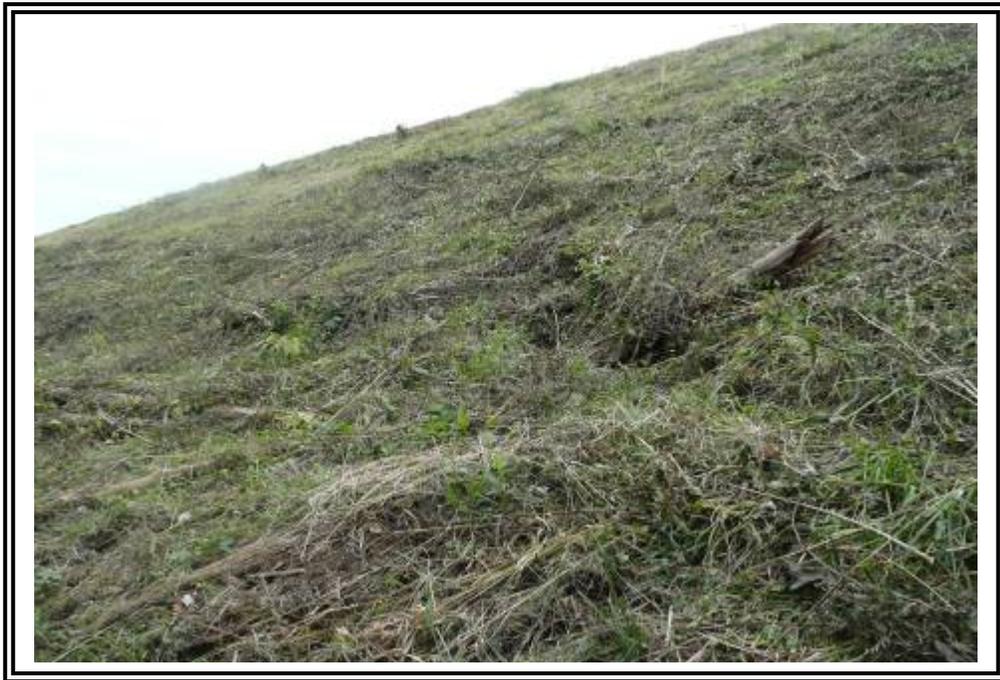
71

Vegetated surface scarp/creep on east dike slope.

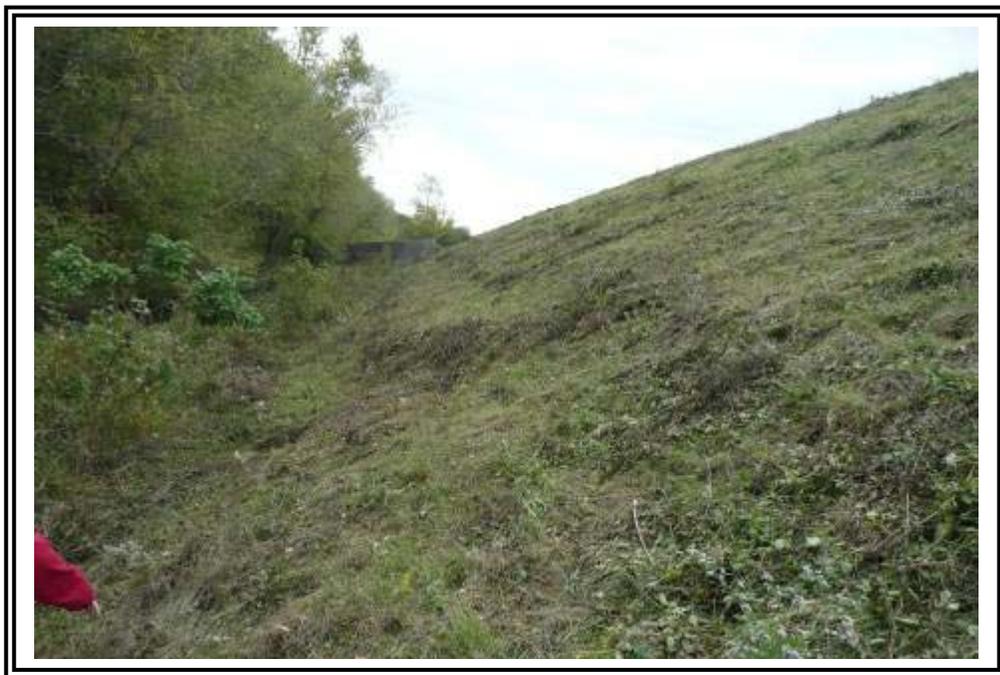
72

Vegetated toe bulge and surface slough on east dike slope, looking south.
Concrete training wall at creek entrance in background.

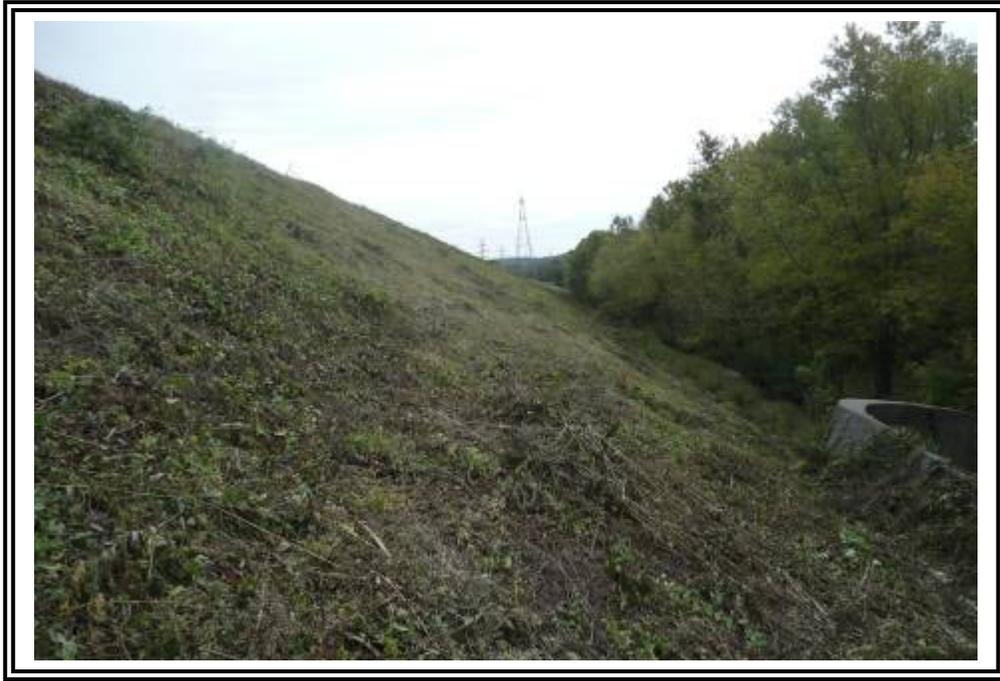
73

Vegetated undulations on east dike exterior slope above concrete training wall, looking north.

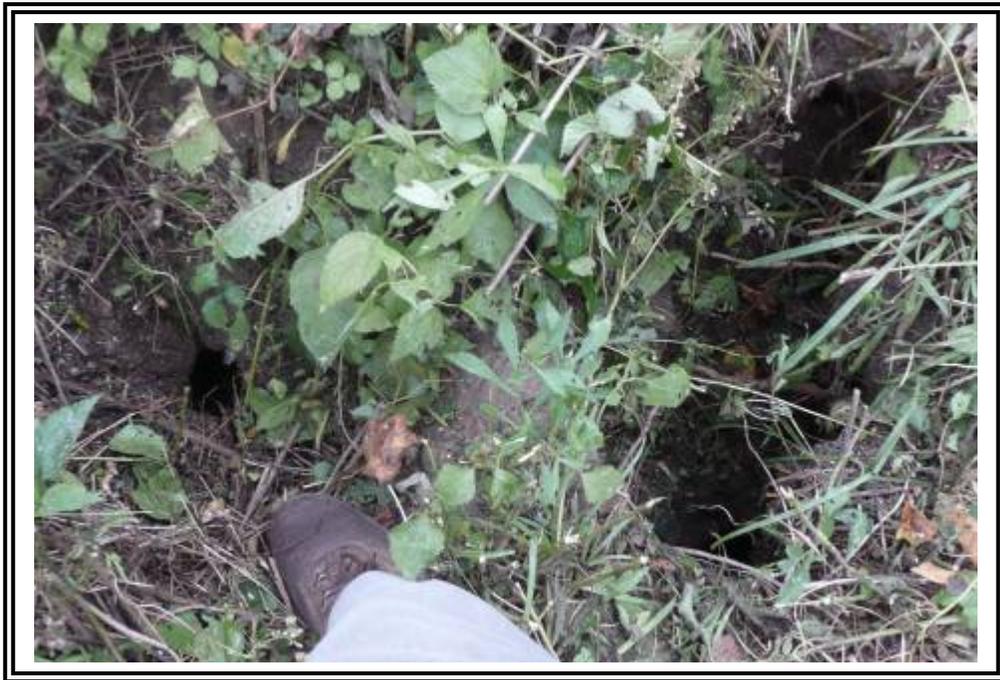
75

Rodent burrow (to left) and possible erosion feature (to right) adjacent to and above concrete training wall.

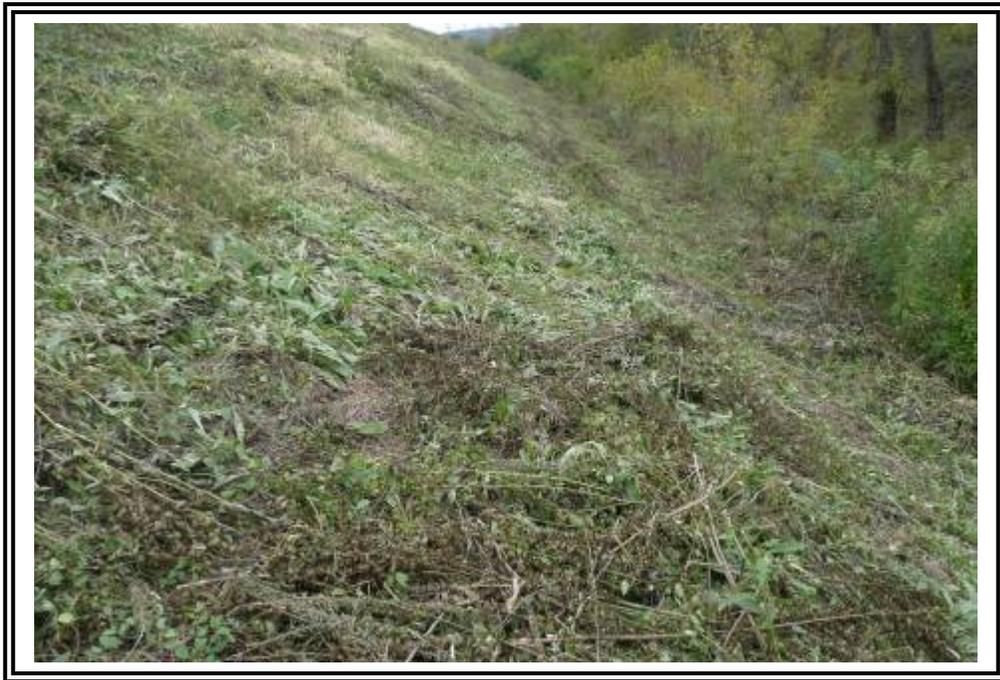
77

Broad leafy vegetation more prevalent in this area of the east dike, looking north.

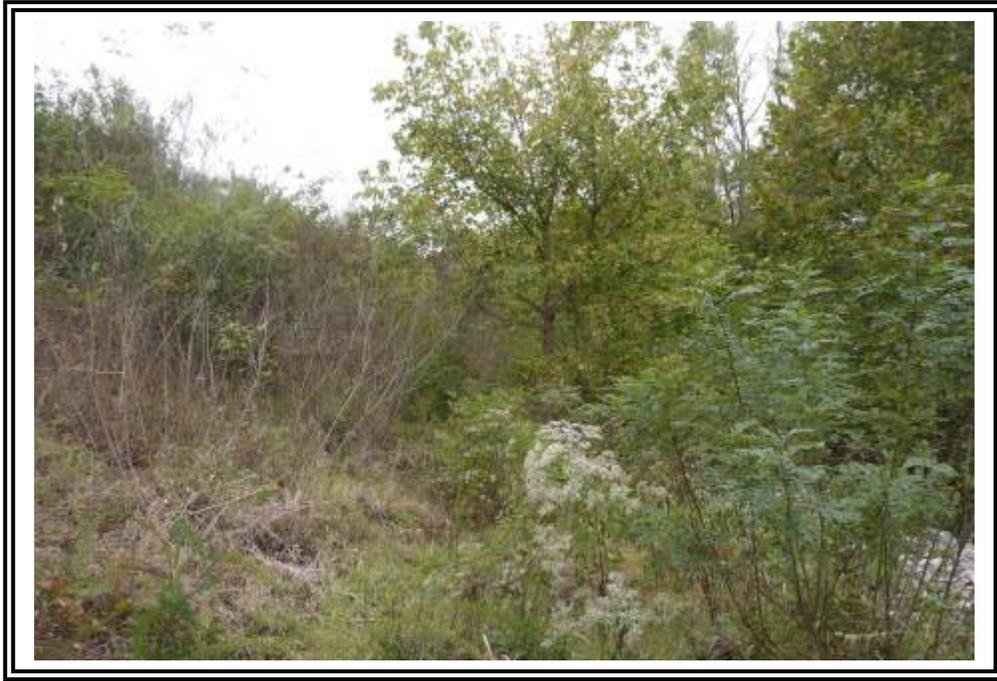
79

Exterior slope toe of east dike at the southeast corner, looking north. Note heavy vegetation and young trees.

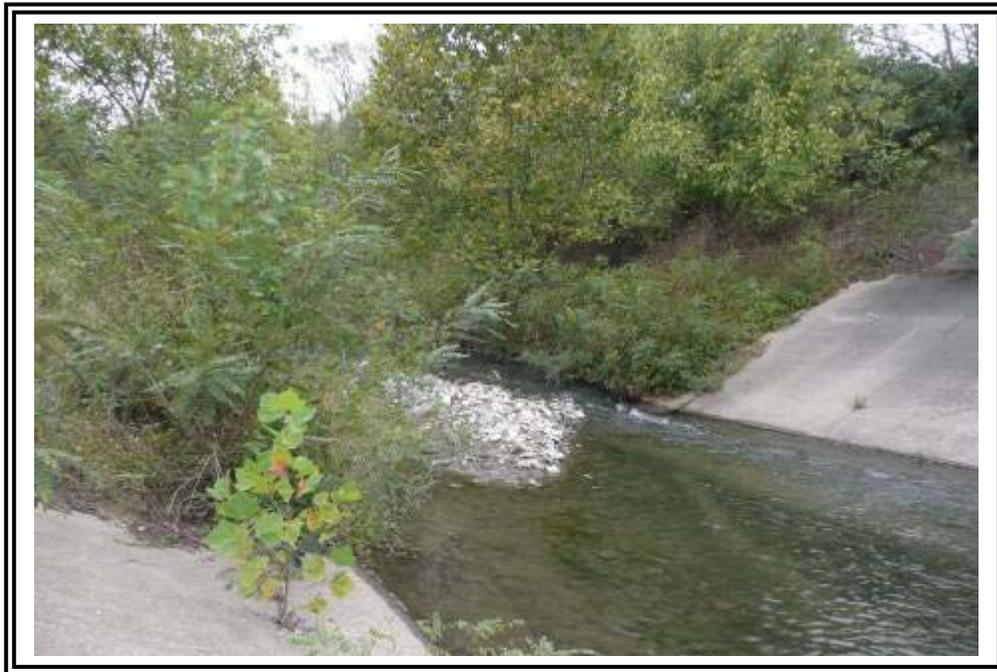
80

Channelized creek adjacent to east dike toe where the creek starts to turn to the west between Ash Pond C and Ash Pond C Extension.

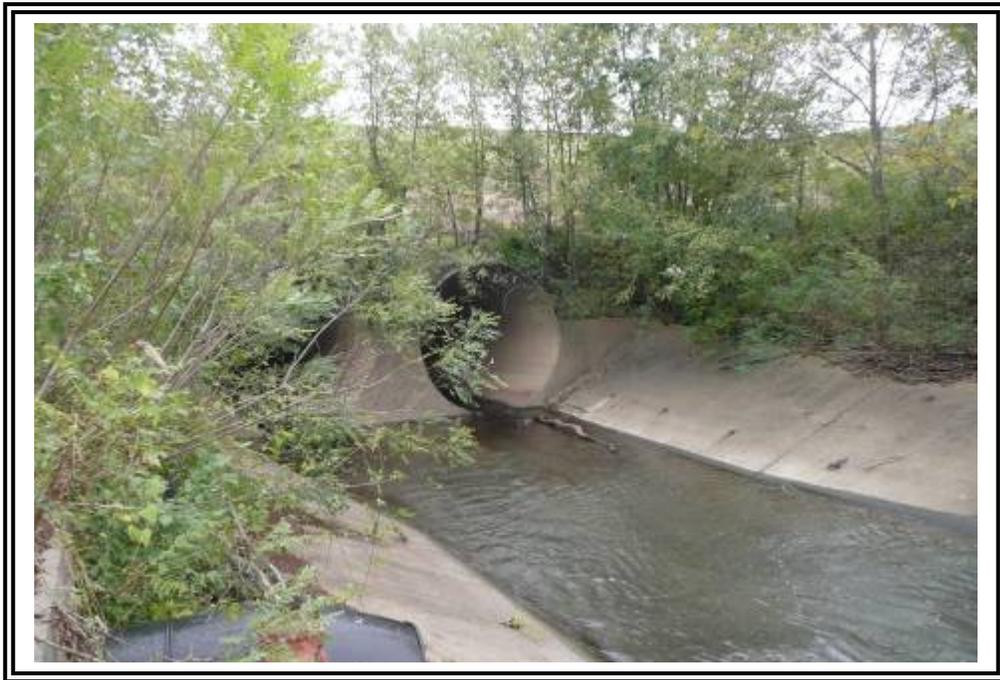
81

Channelized creek between Pond C and Pond C Extension at the Pond C outlet, looking east. Creek traverses beneath a haul road embankment through large diameter culverts.

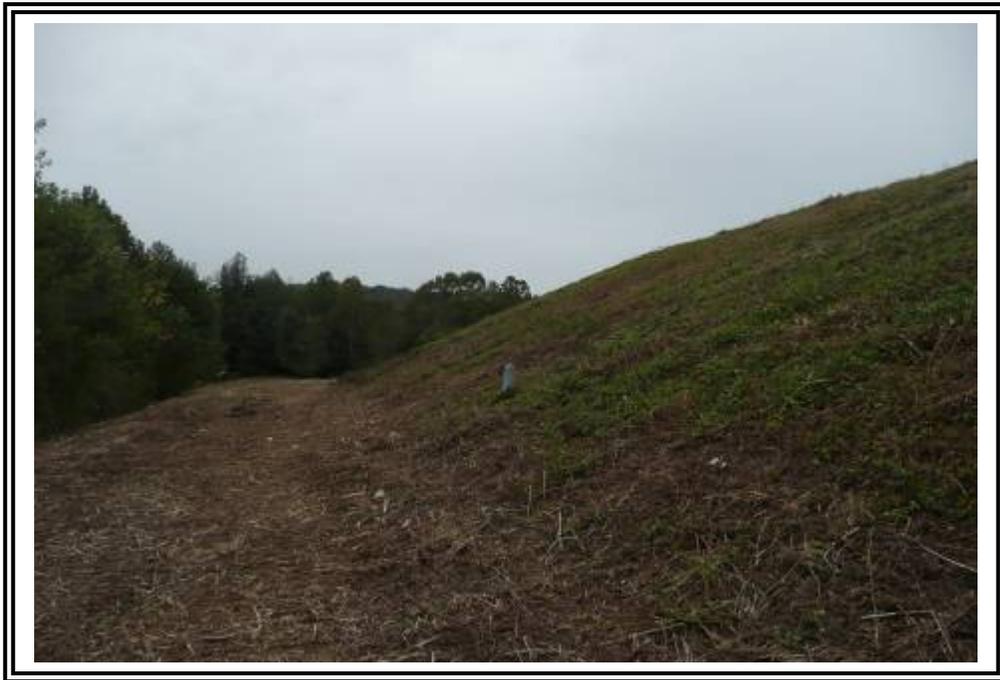
83

Exterior slope of the south dike, looking west. Note slope instrumentation.

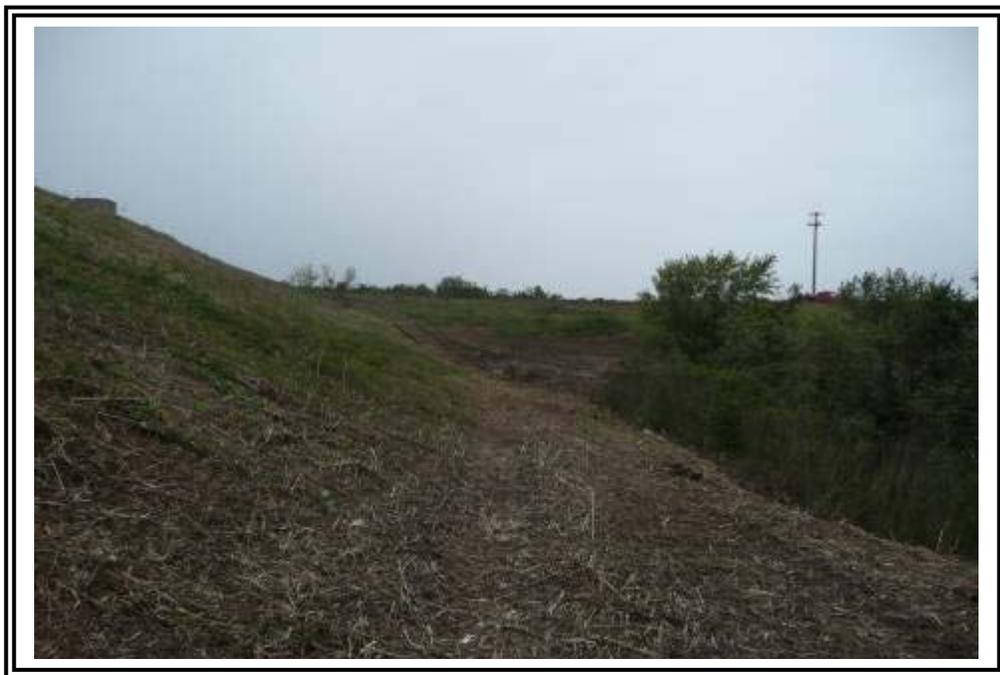
84

Exterior slope of the south dike, looking east.

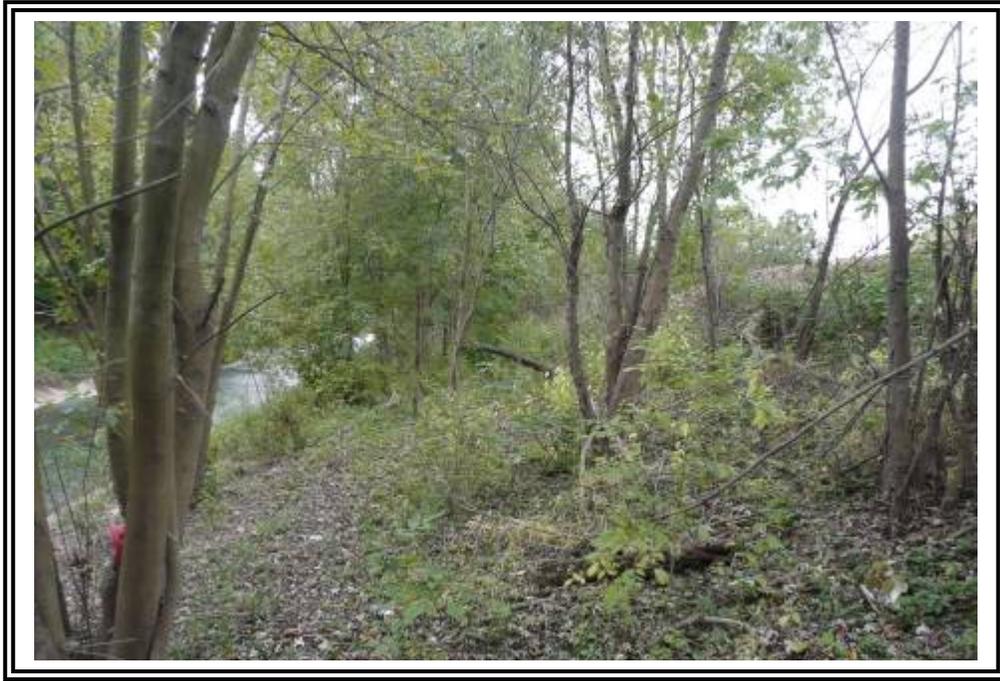
85

Vegetation adjacent to channelized creek, looking west.
This area is below the bench at the south dike and is believed to be on the creek bank.

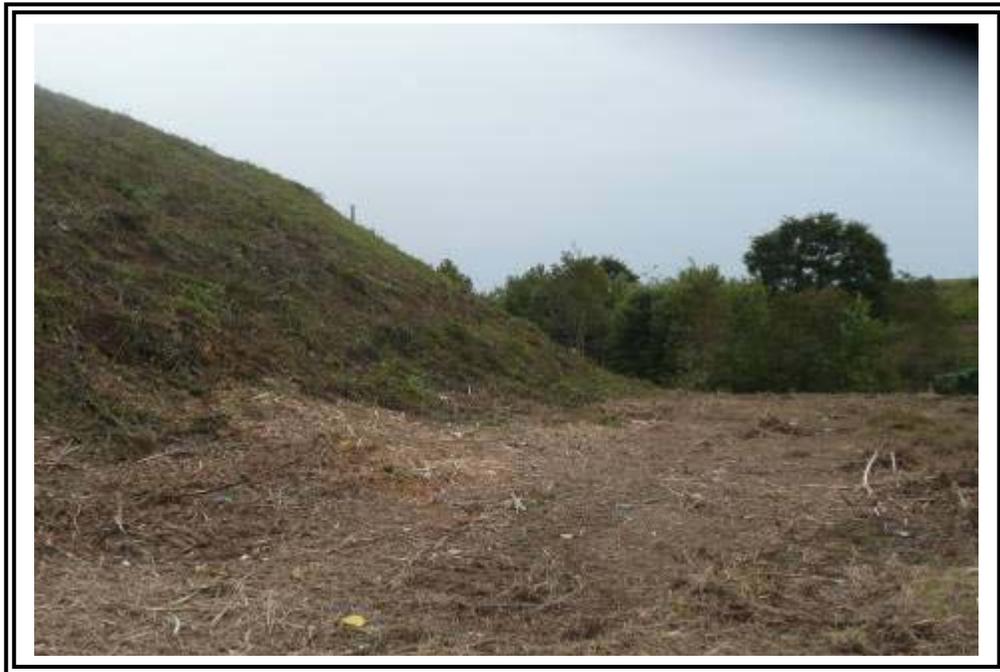
86

Exterior slope at the southwest corner of west dike, looking south. Instrumentation visible near slope crest.

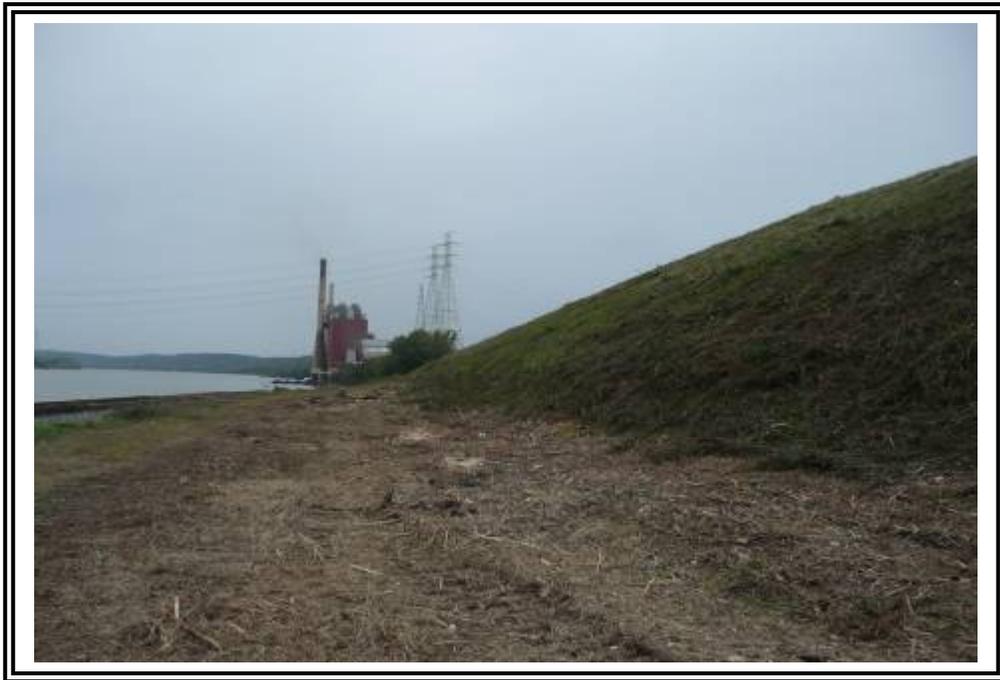
87

West dike exterior slope adjacent to the Ohio River, looking north.

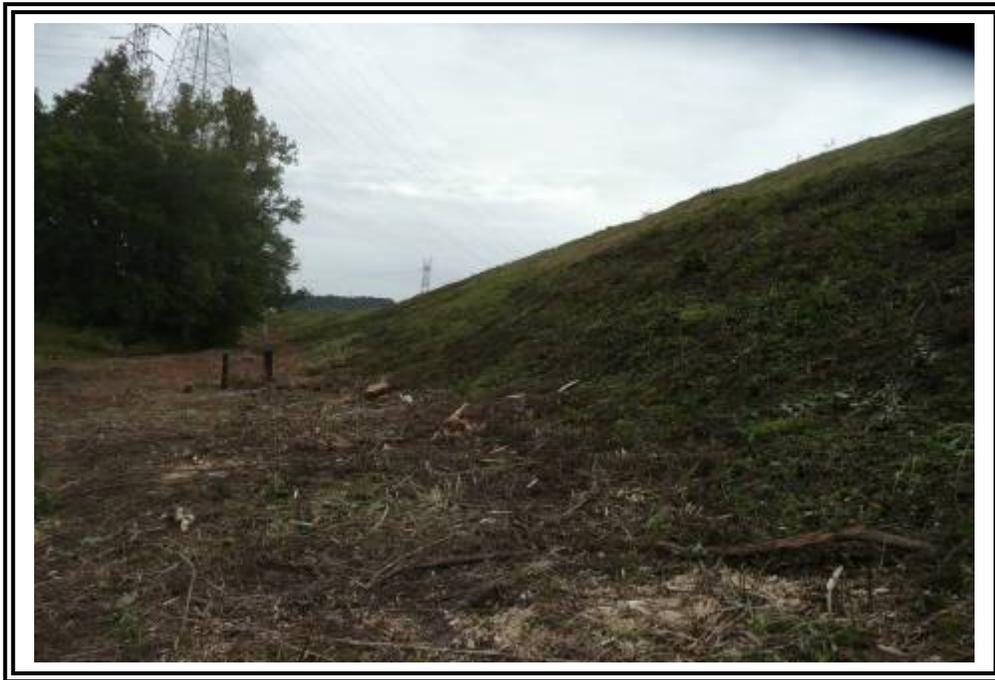
91

West dike slope, looking north. Note groundwater monitoring well at slope toe.

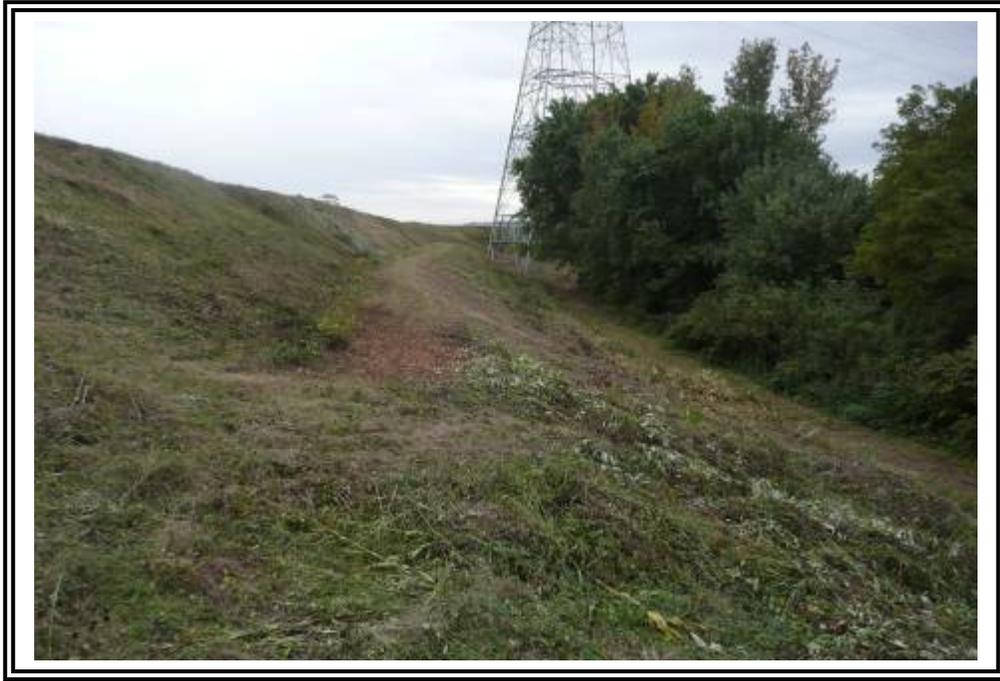
97

Exterior slope of west dike on bench near northwest corner, looking south from mid slope.

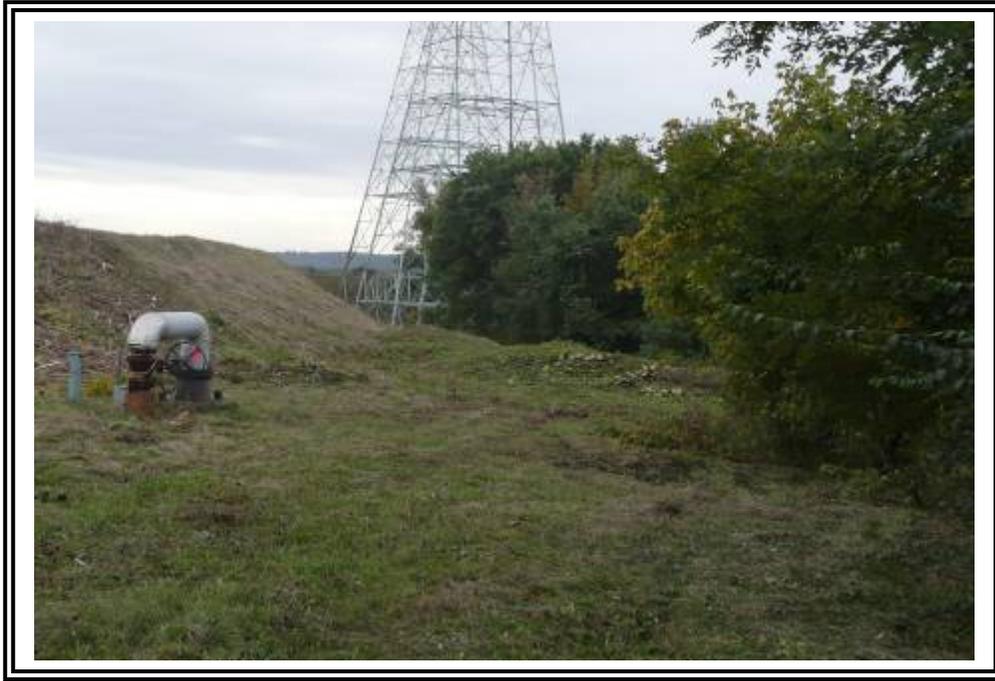
99

West dike outboard slope showing spoil piles that restrict drainage at the slope toe, looking south.

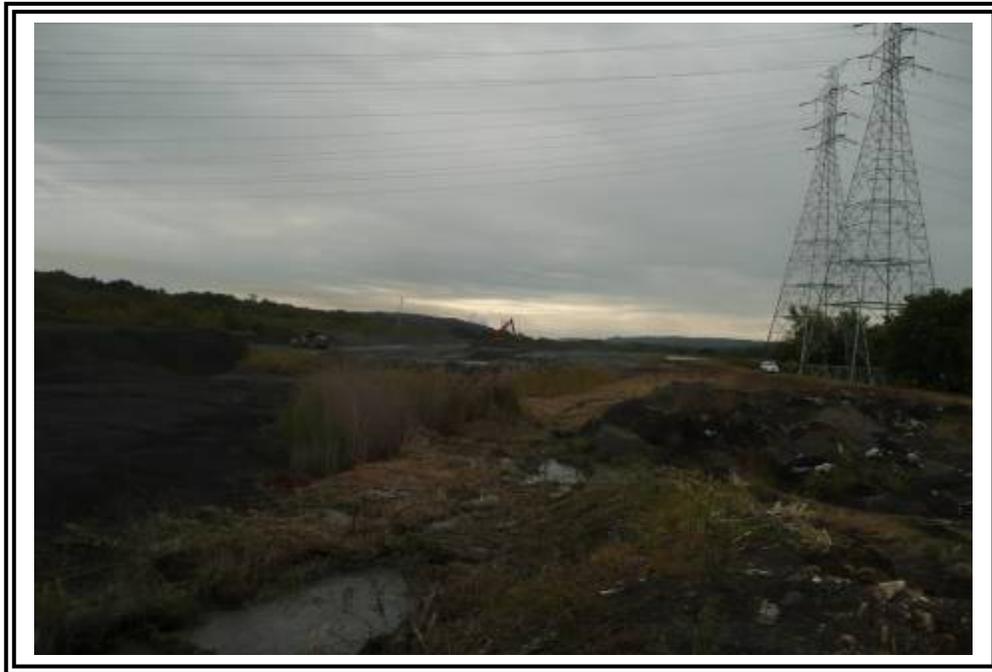
100

Looking south from northwest corner of west dike across pond area. Note there is no open water in this area.

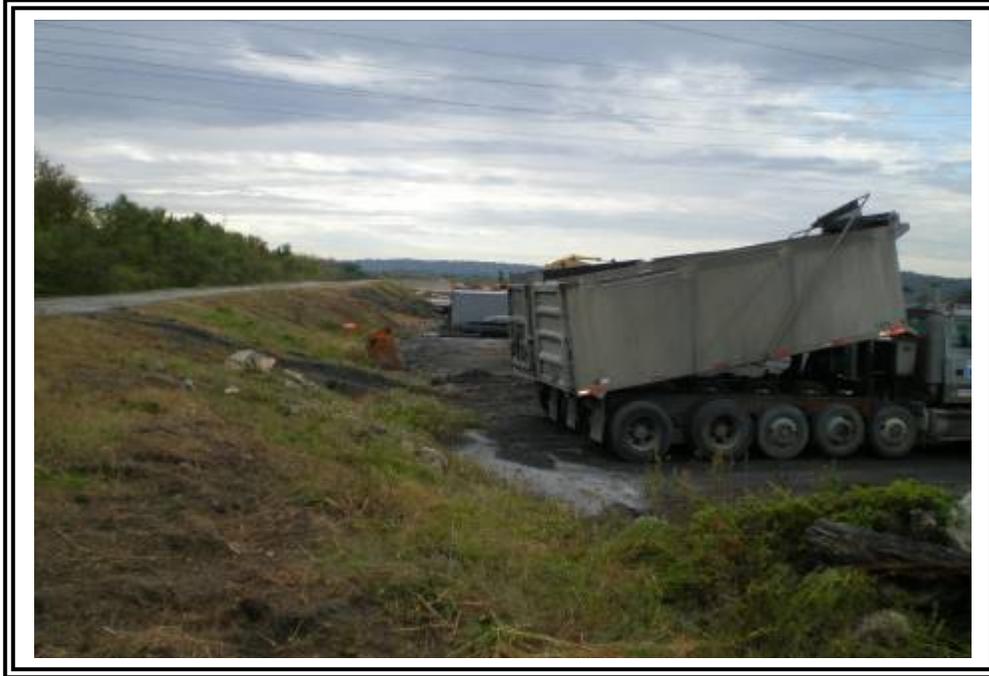
101

East dike interior slope, looking south.

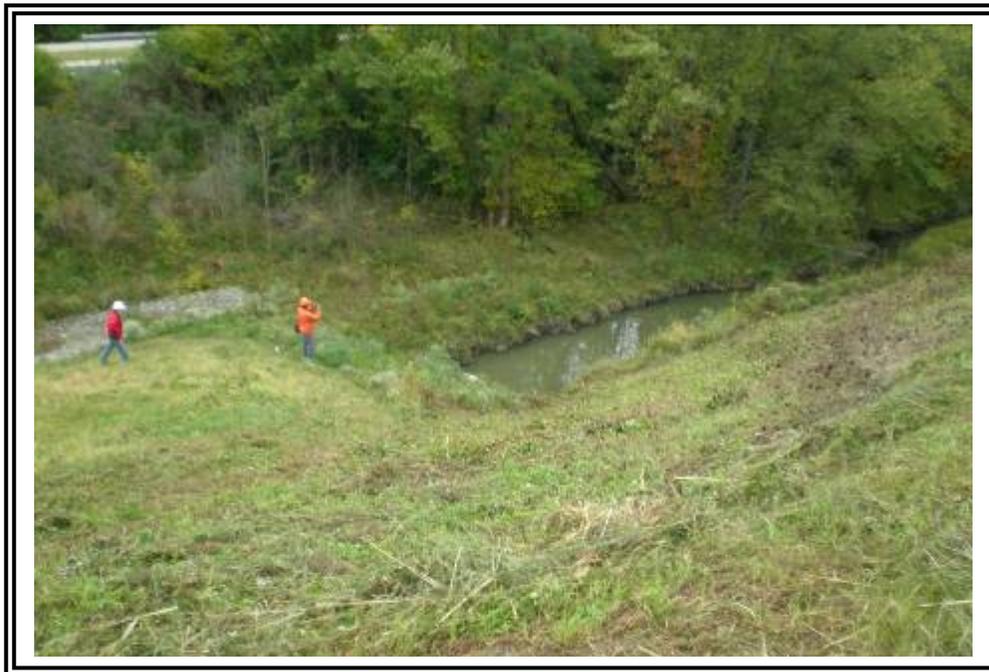
102

Change in slope, becomes much steeper, end of rock lined ditch, start of creek, looking southeast.

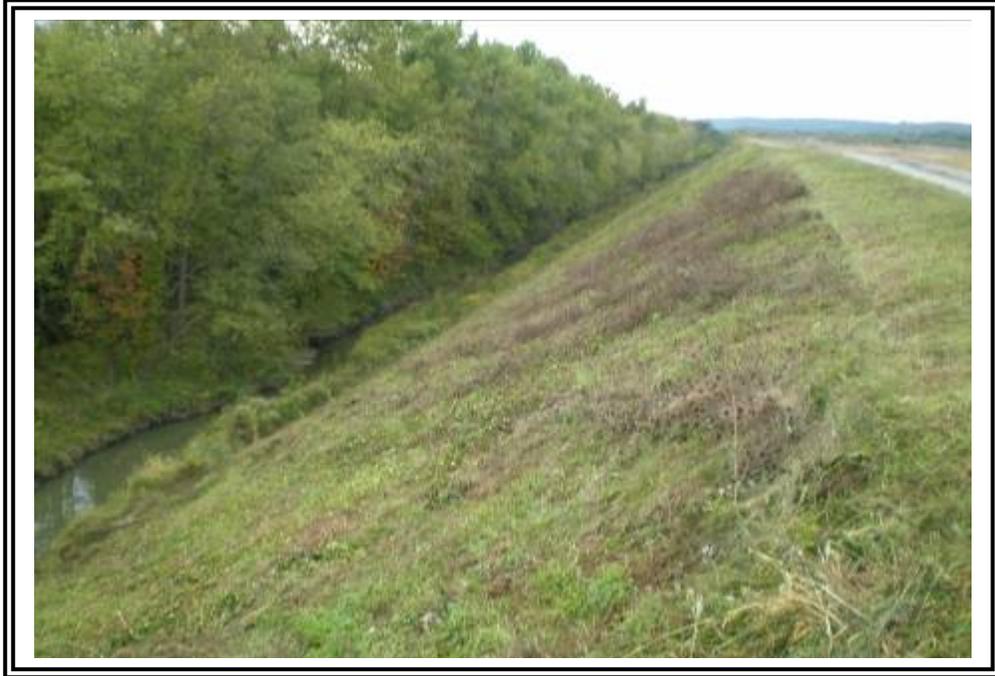
103

Steeper portion of east exterior slope, looking south.

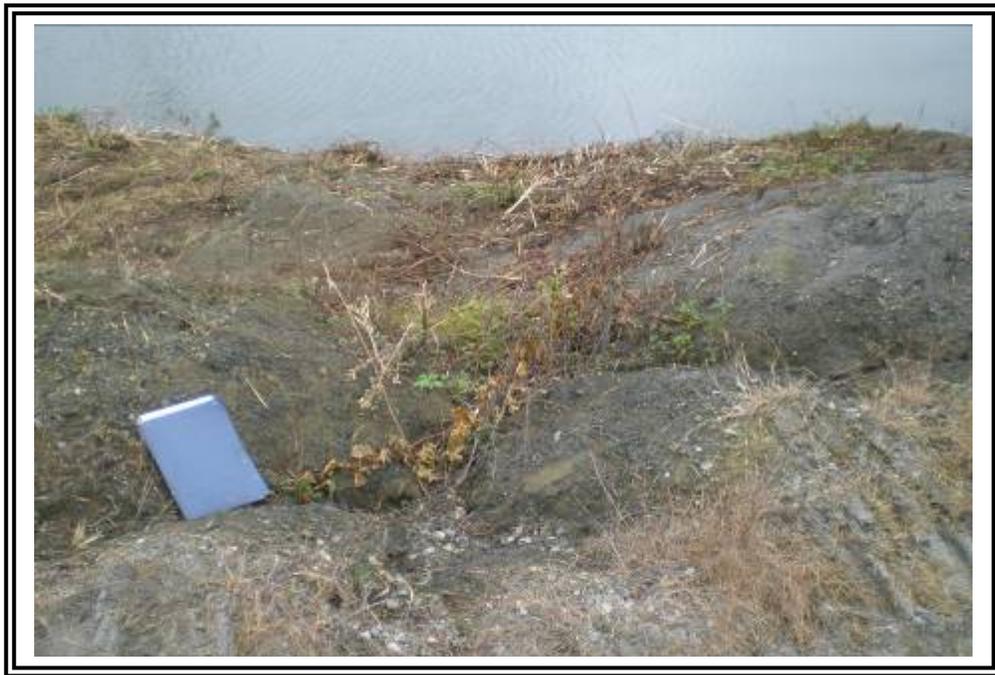
104

Erosion on upstream slope, looking west.

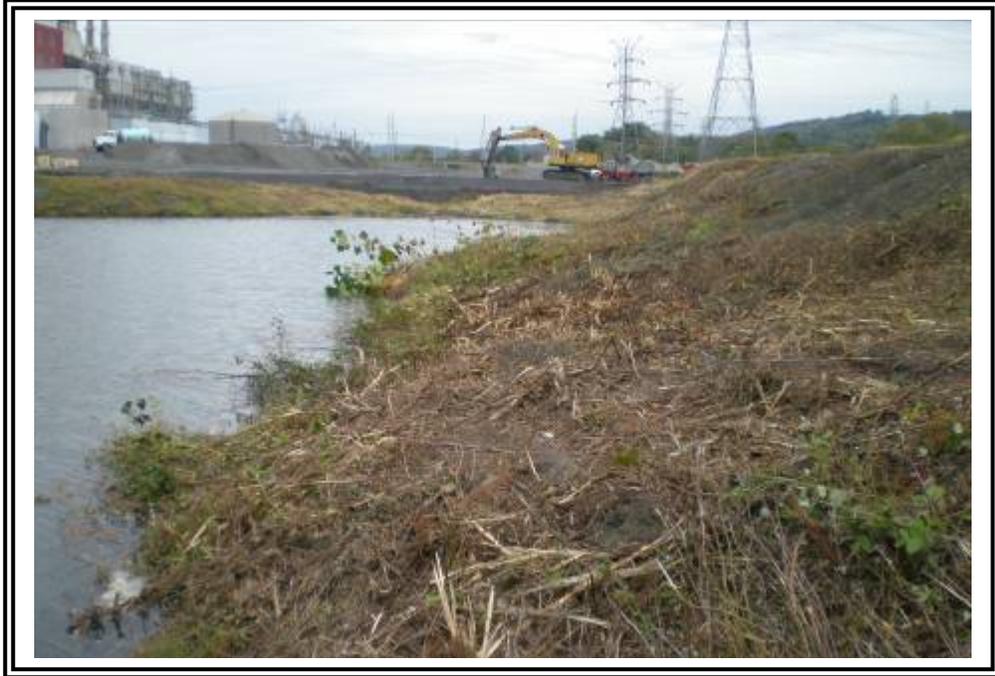
105

East dike interior slope, looking north.

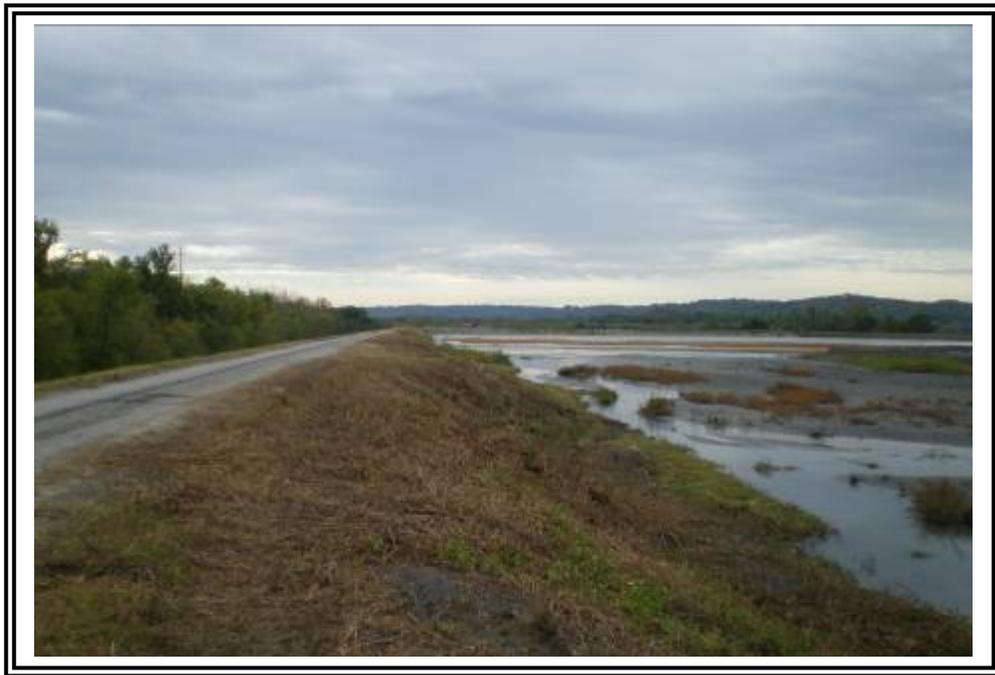
106

Crest and interior slope of west dike, looking south.

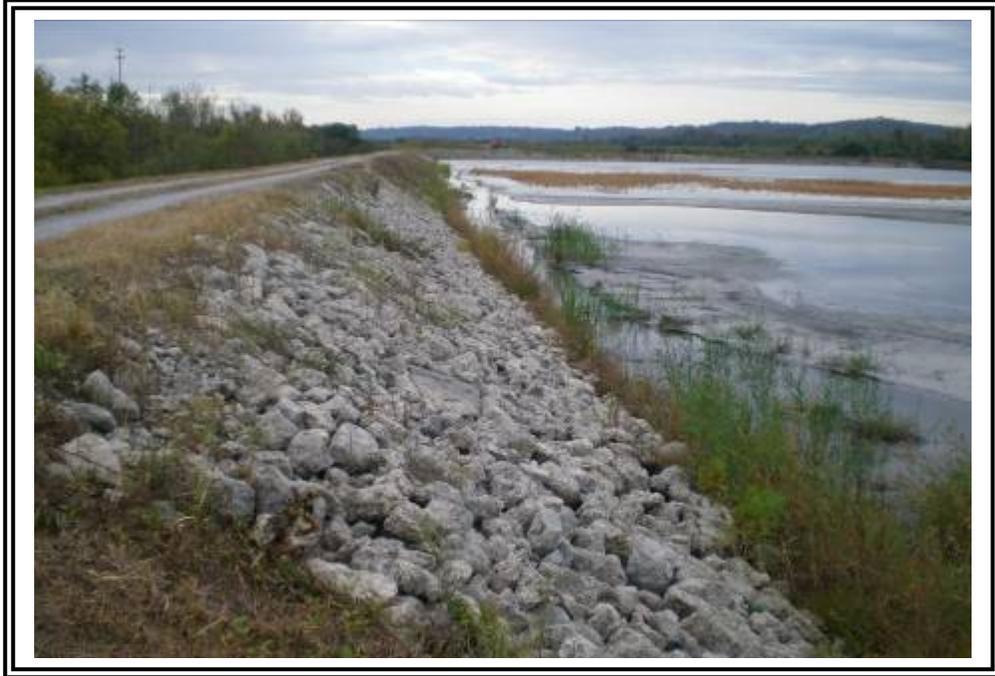
107

Crest and interior slope at start of rip rap, looking south.

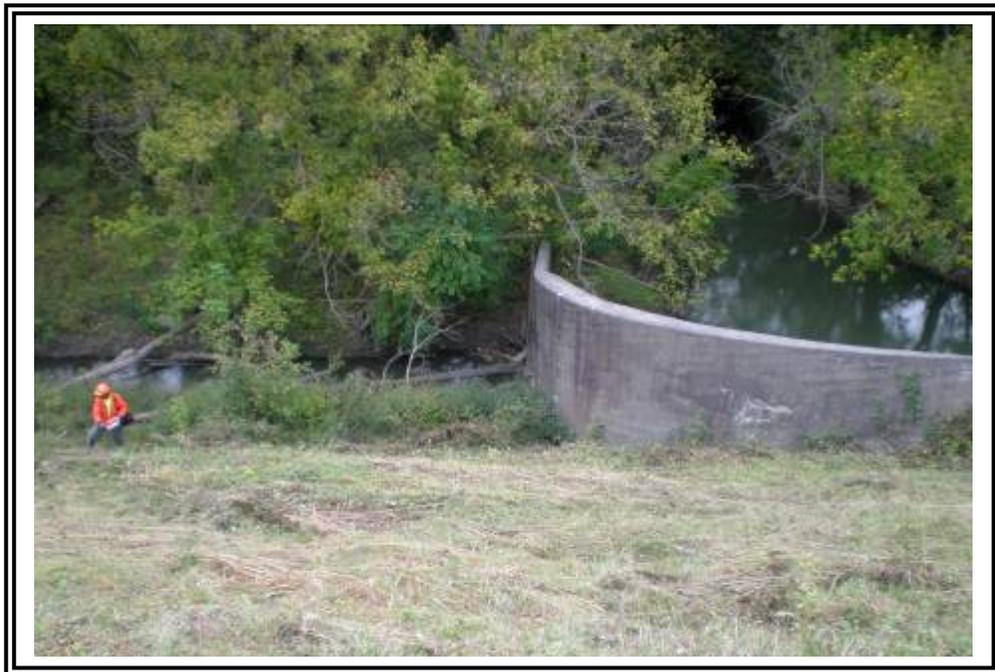
108

Exterior slope at concrete wall where creeks meet, looking east.

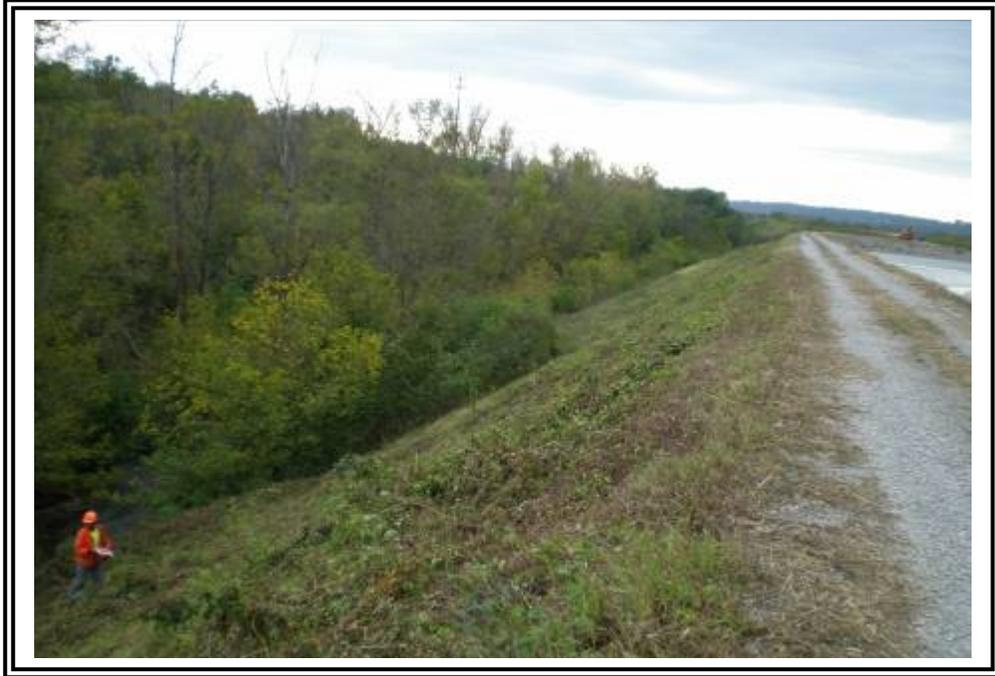
109

Exterior slope and crest after wall, looking south-southwest.

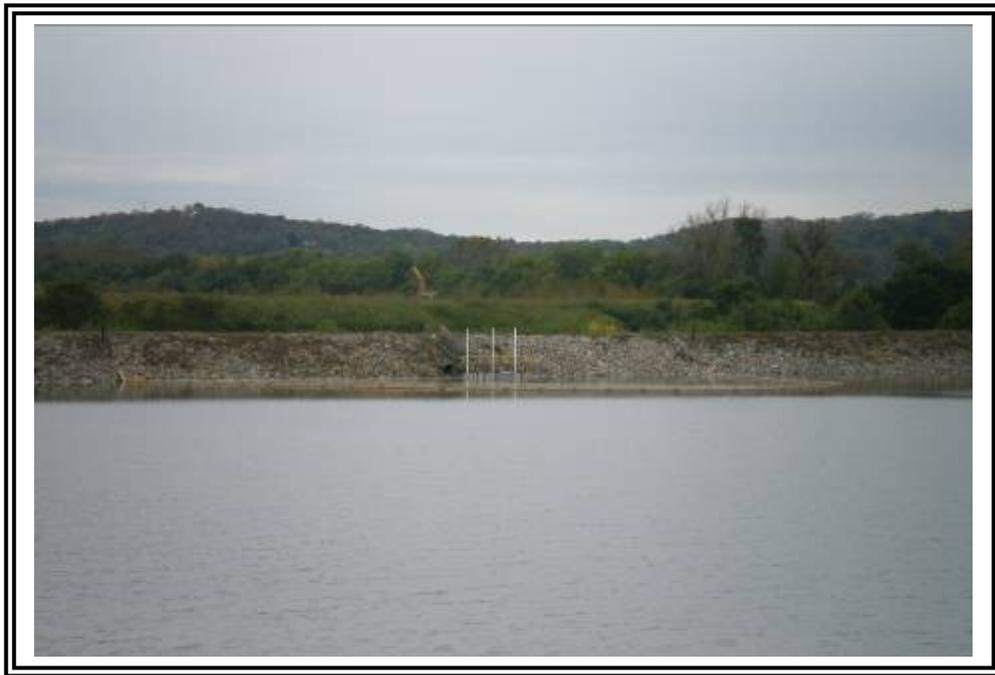
110

Outflow structure, looking south.

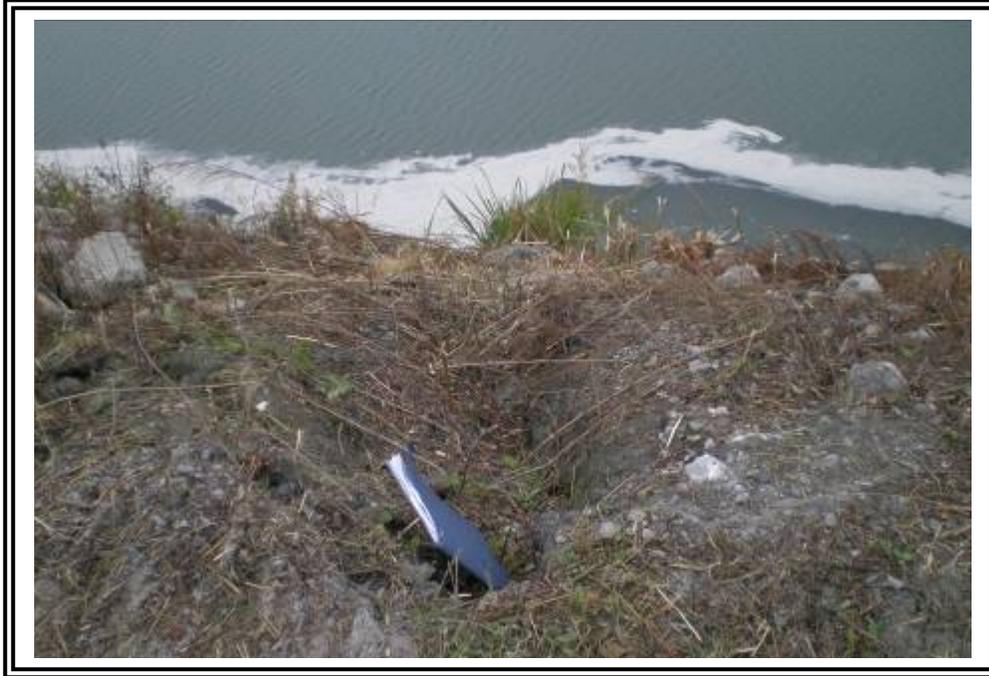
111

Deep rill on interior slope and gap in rip rap, looking west.

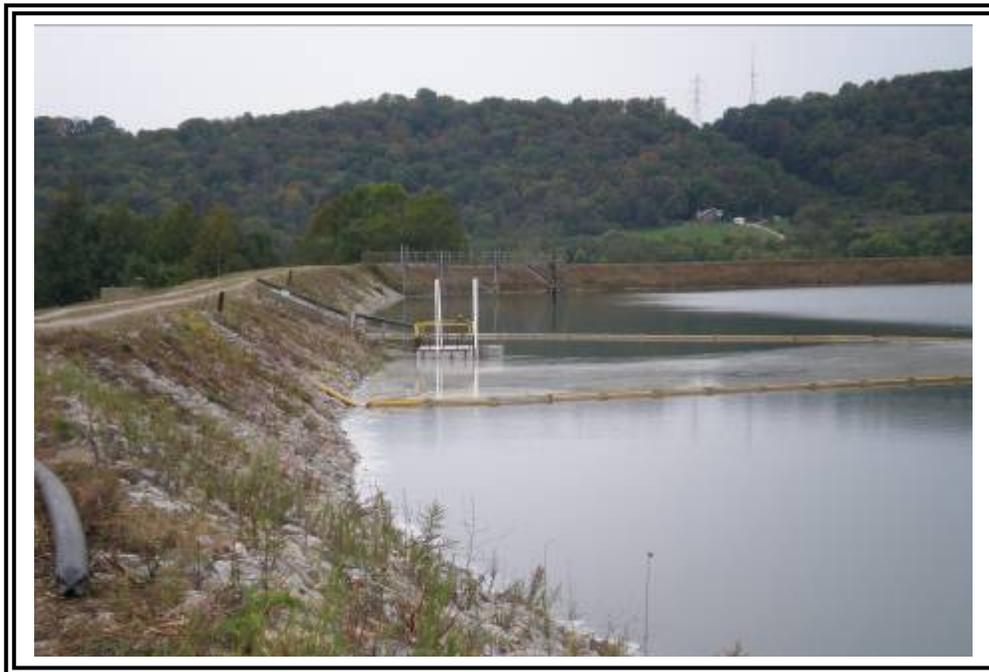
112

South dike interior slope and outfall structures, looking west.

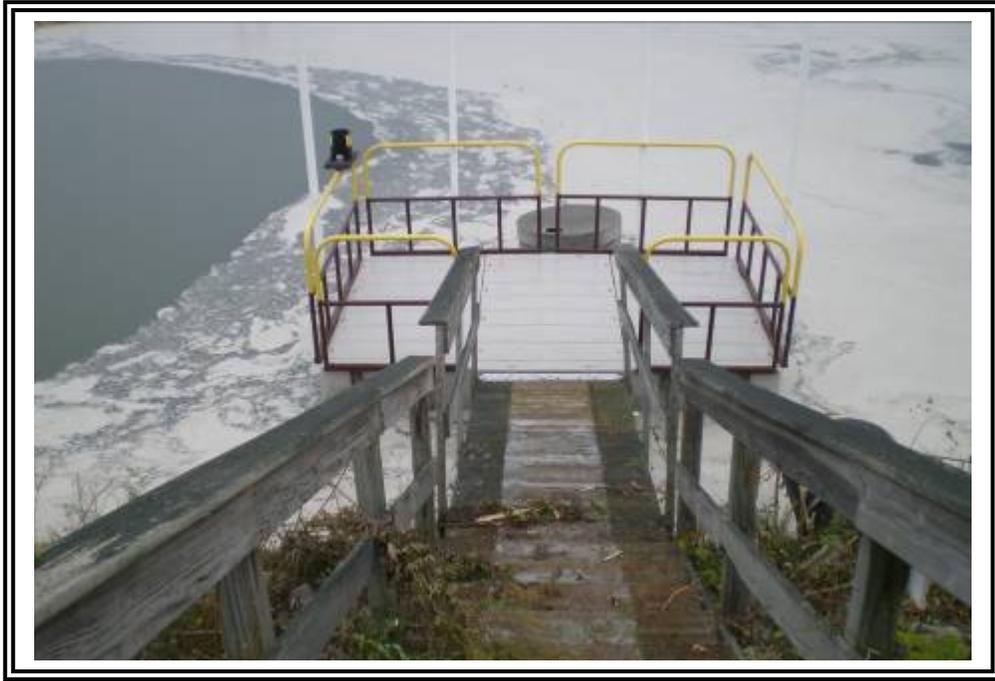
113

Outfall, looking north.

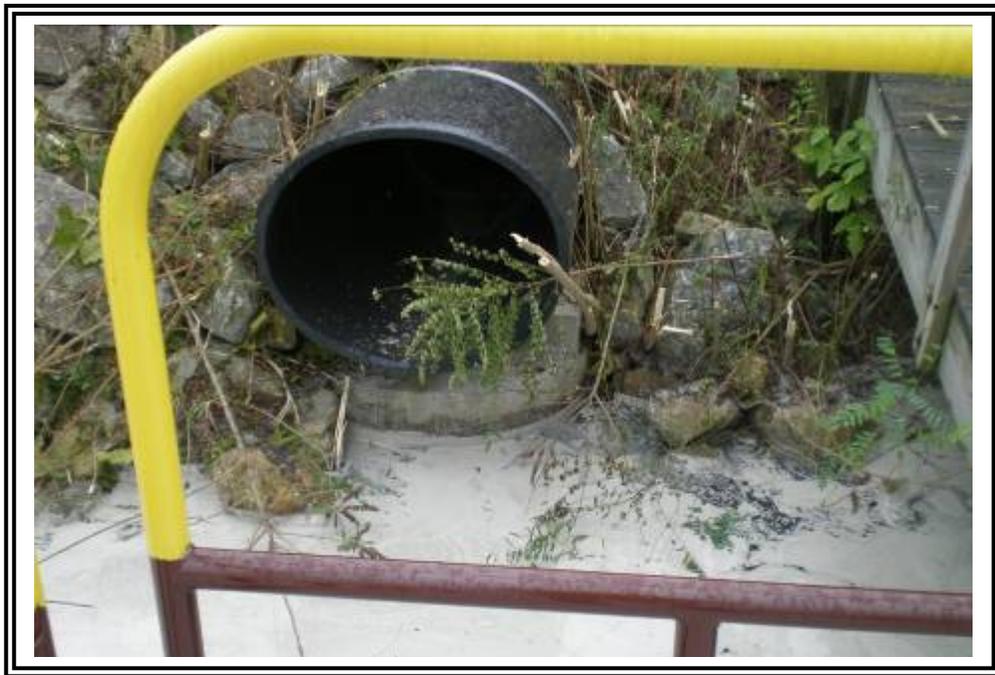
114

Pipe coming in pond next to outfall.

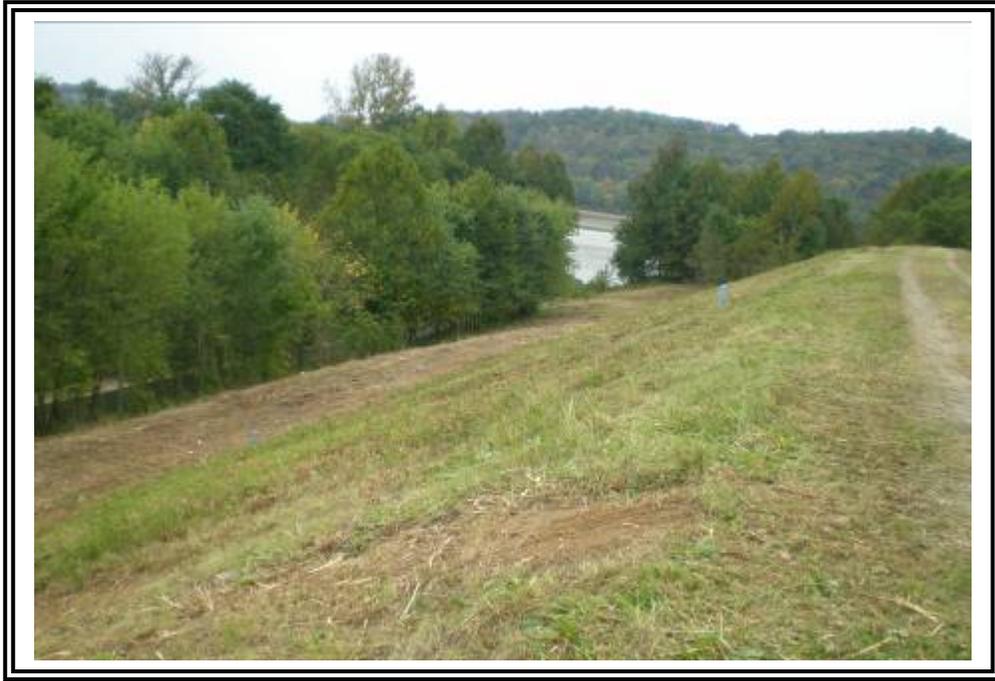
115

South dike crest and exterior slope, looking west.
