Assessment of Dam Safety Coal Combustion Surface Impoundments (Task 3) Final Report

Duke Energy

W.C. Beckjord Station
New Richmond, Ohio

March 22, 2010

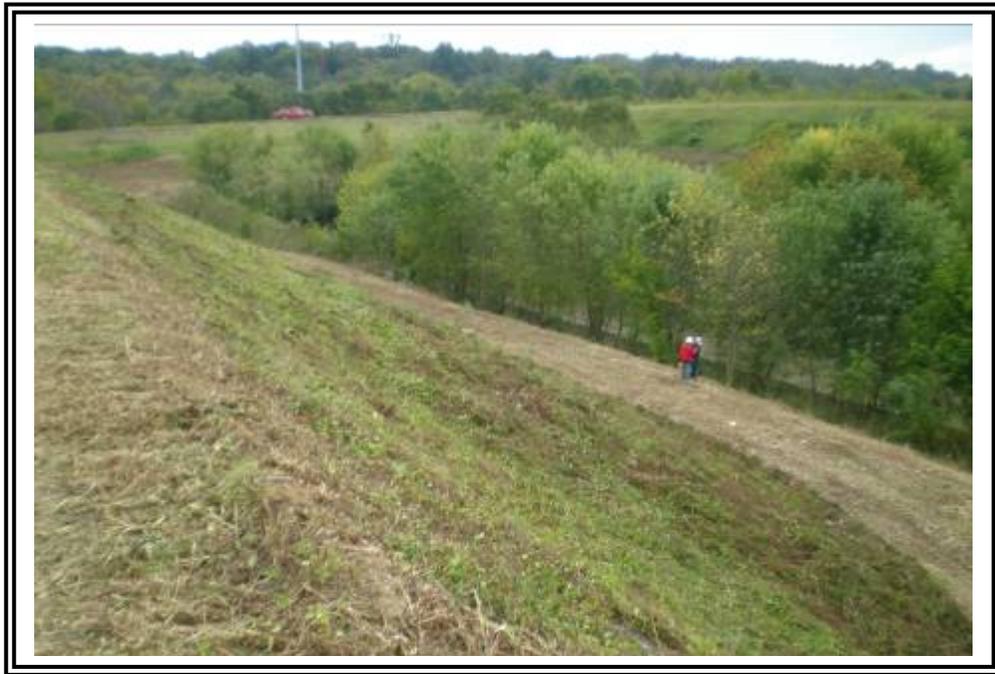
116

Exterior slope of south dike, looking southeast.

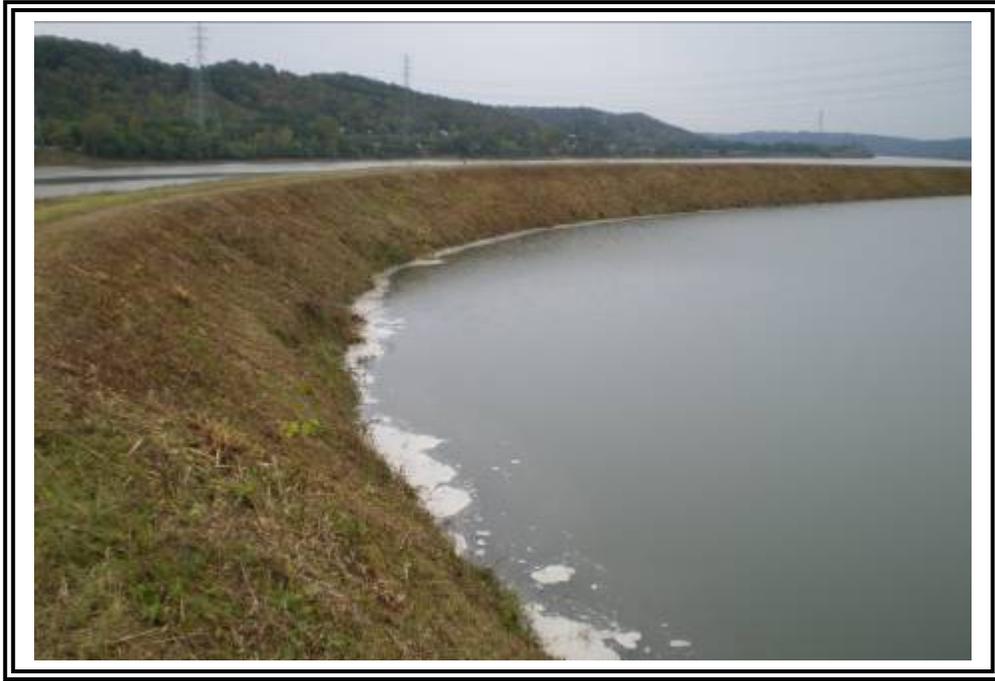
117

West dike interior slope corner, looking west-northwest.

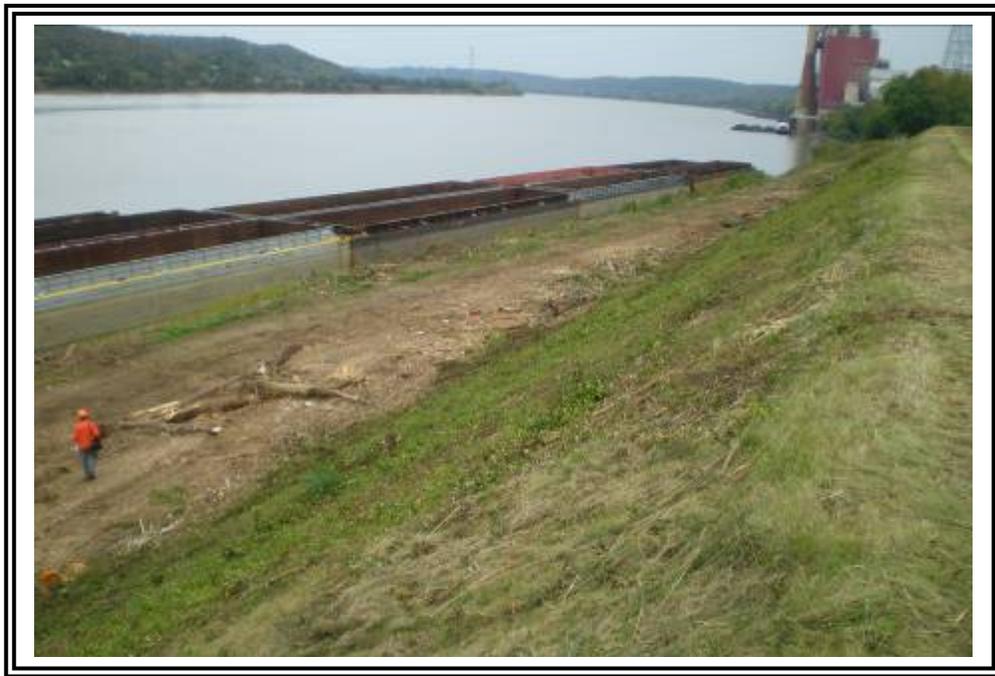
118

Exterior slope of west dike, looking north.

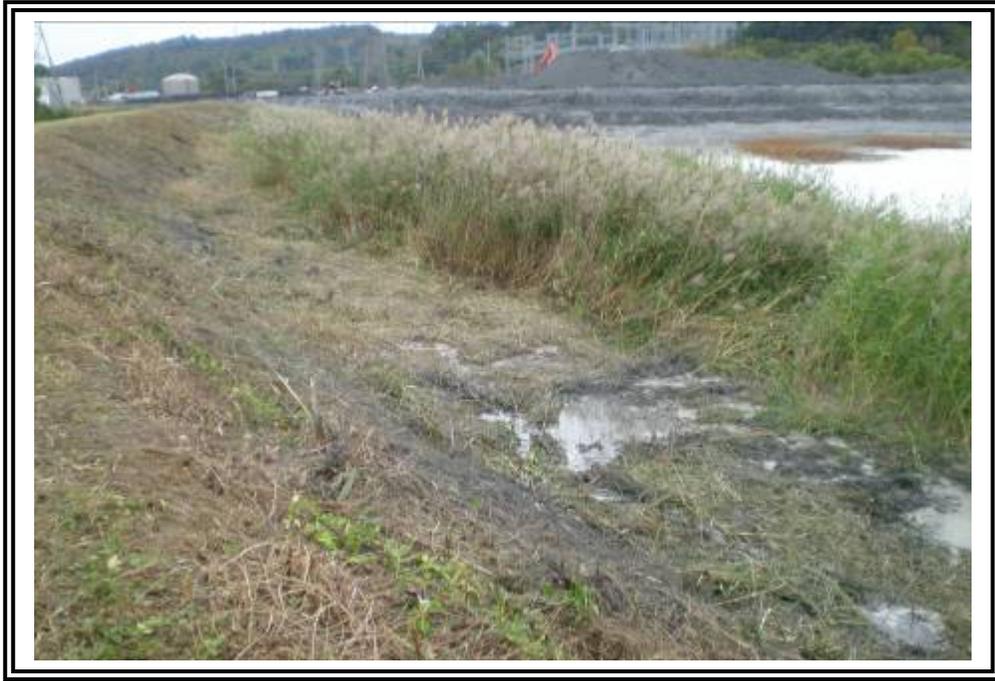
119

West dike interior slope, looking north.

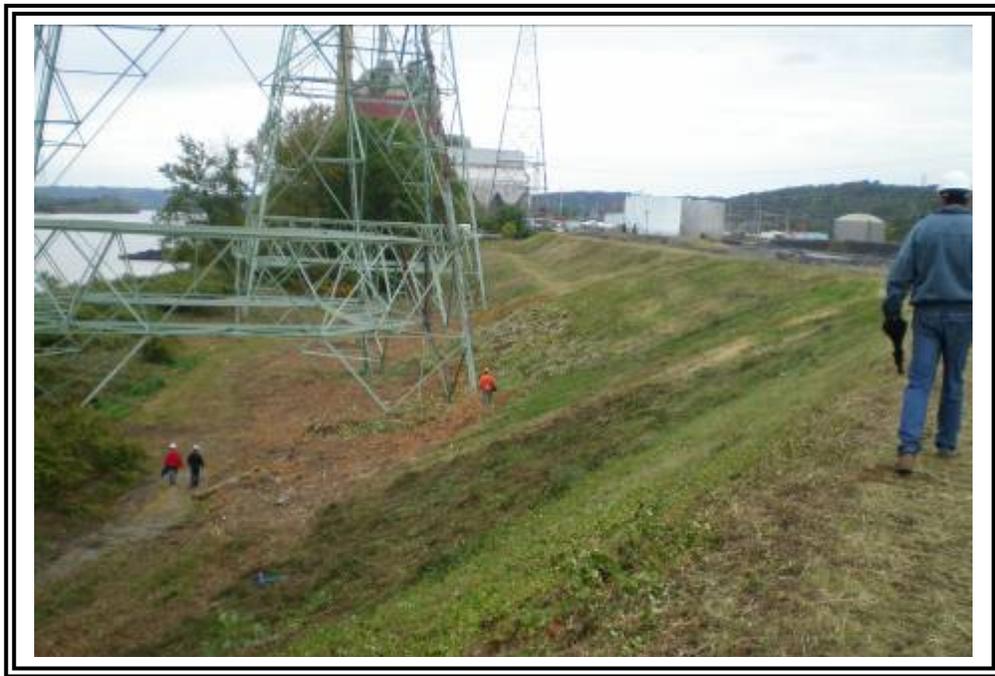
120

West dike exterior slope, note change in slope, looking north.

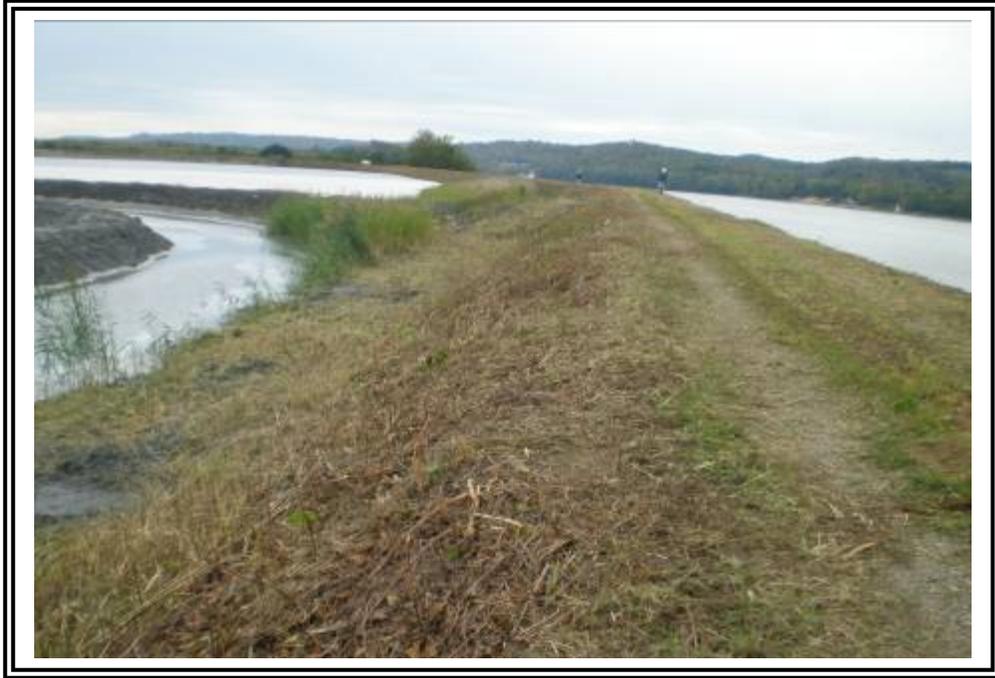
121

West dike crest and interior slope, looking south.

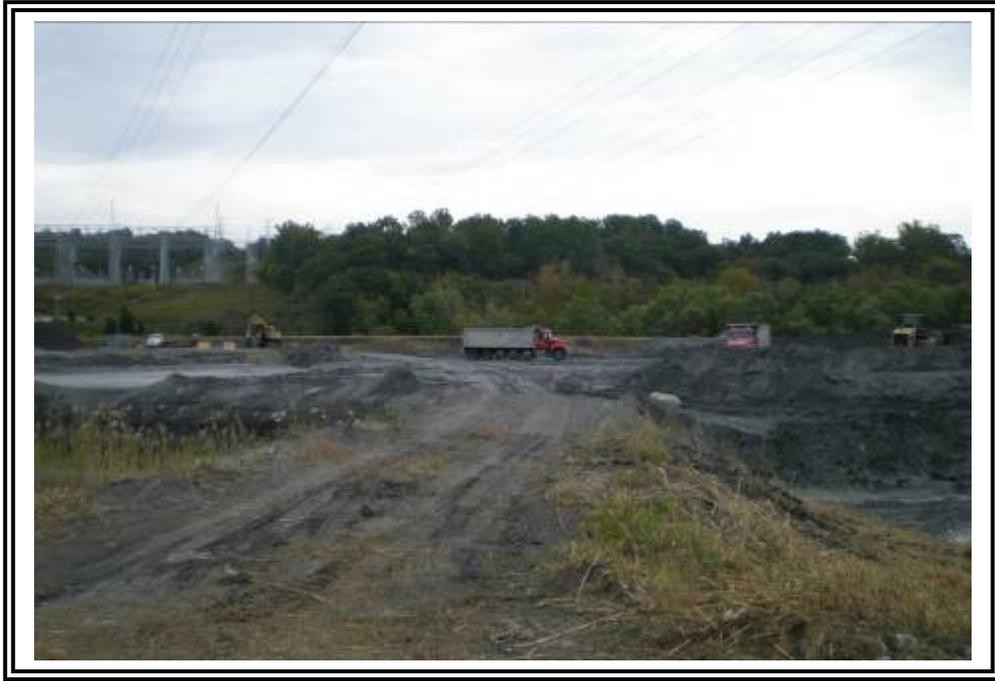
123

Looking east across pond at truck entrance for piling and moving ash.

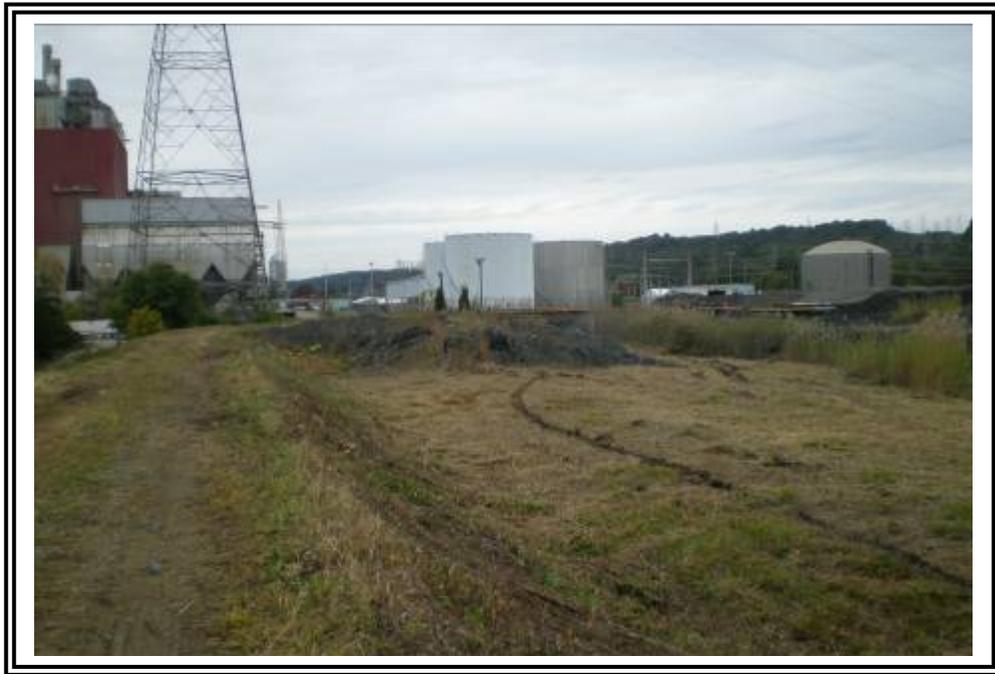
124

West dike crest and interior, looking north.

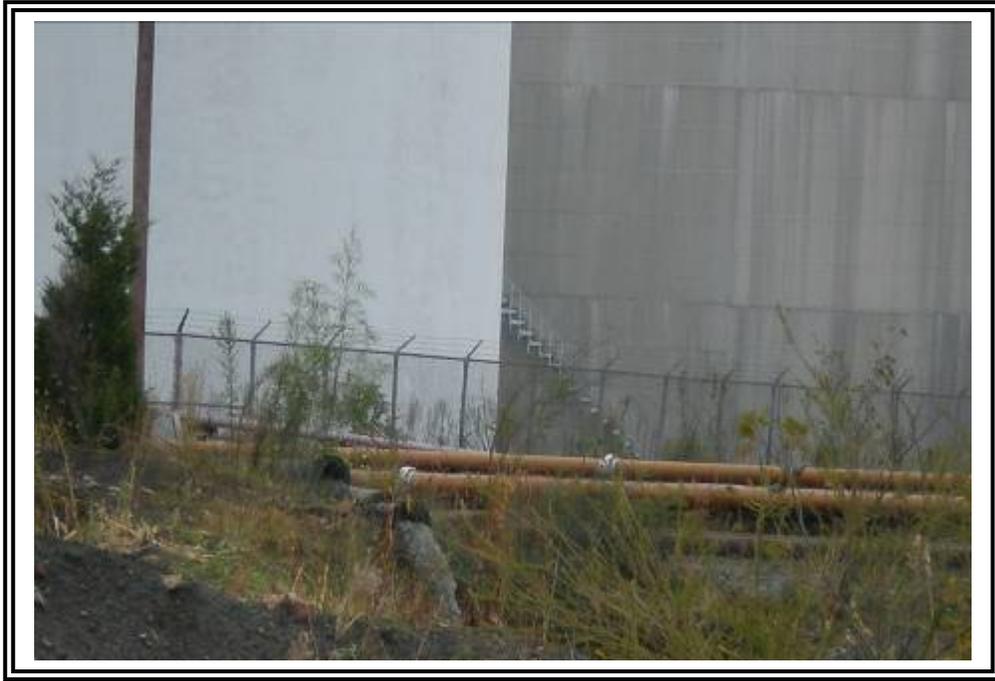
125

Inflow pipes.

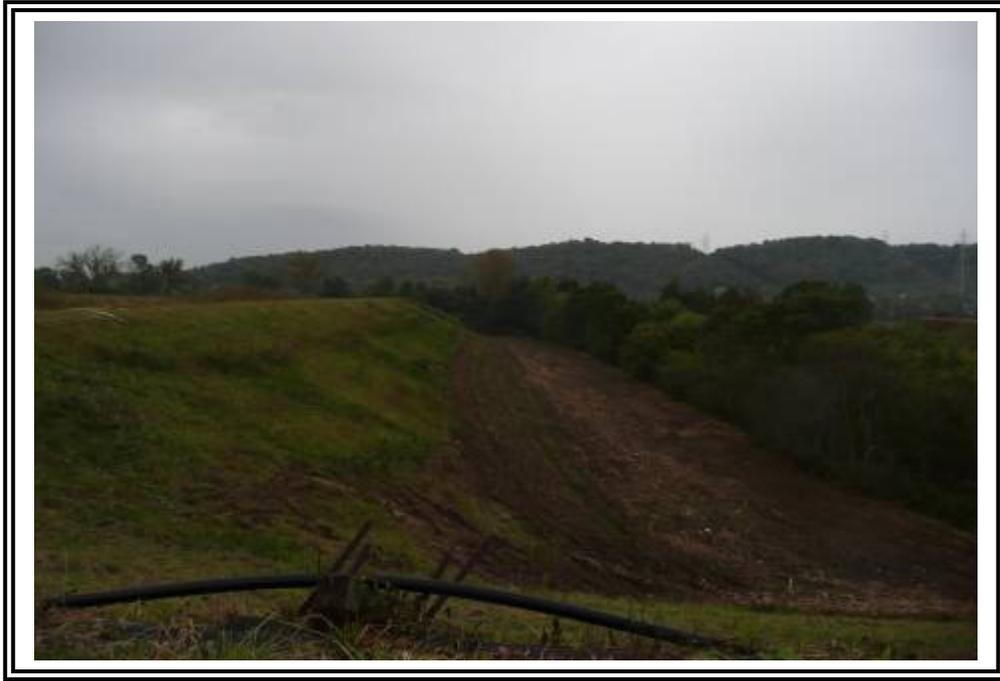
126

Exterior slope of north dike, looking west.

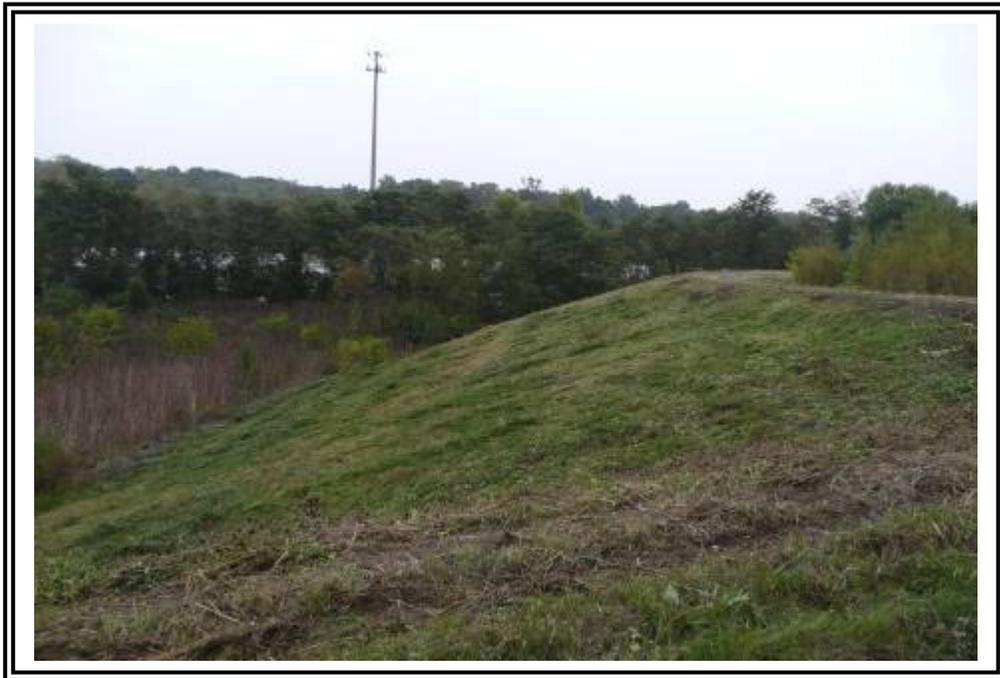
127

Exterior slope of north dike, looking east. Vegetation and rock toe drain is visible at base of slope.

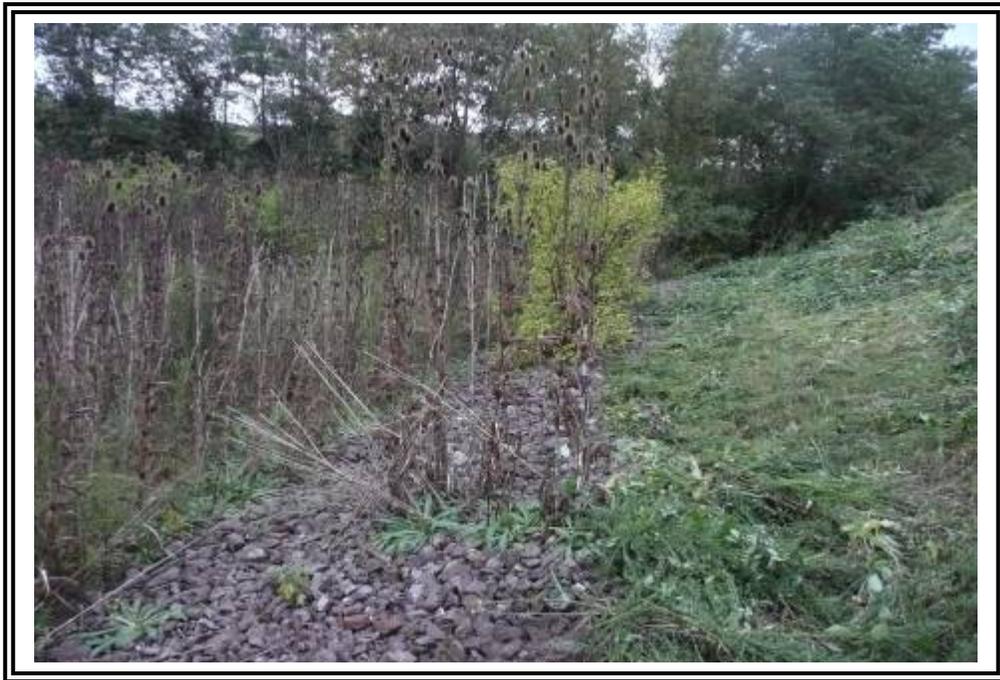
128

Rock toe drain and vegetation beginning to establish itself.

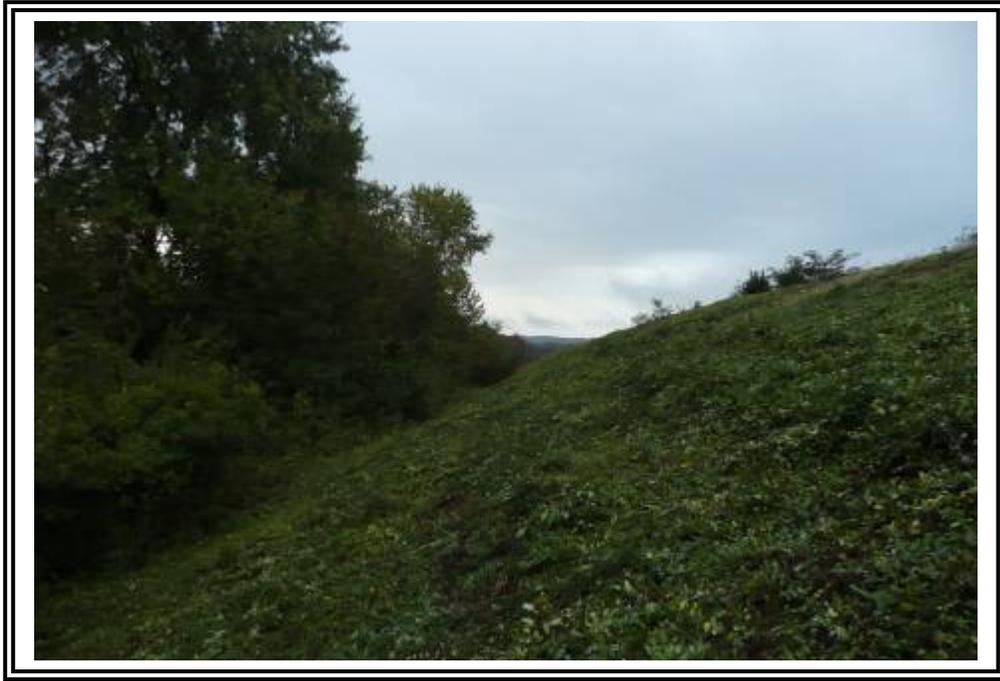
130

Exterior slope of east dike, looking south. Trees and heavy vegetation established adjacent to and on slope toe.

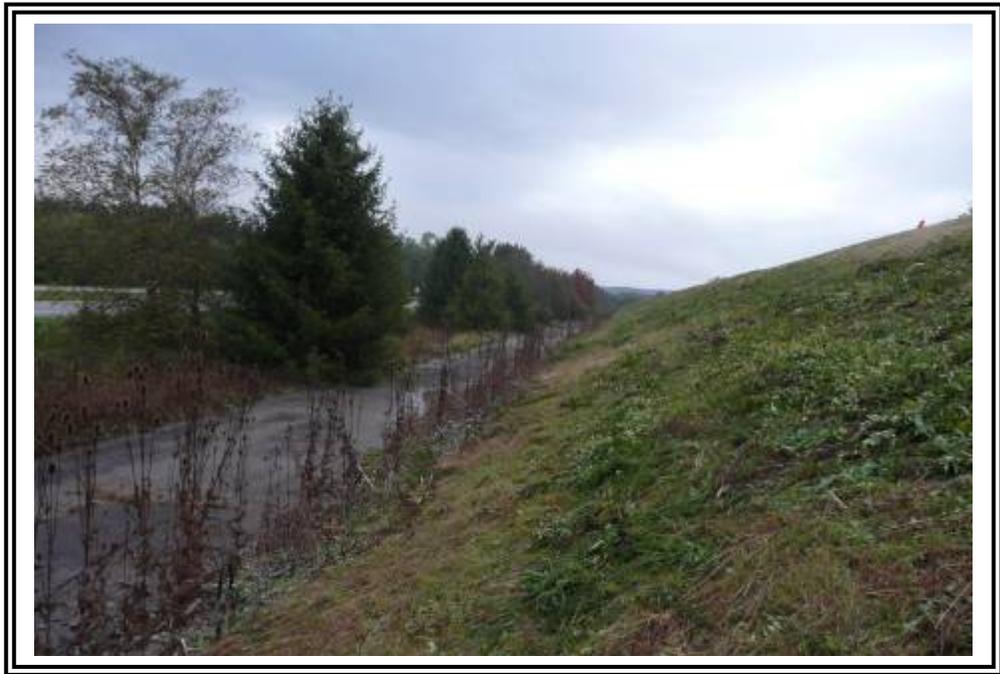
131

Exterior slope of east dike in area where old access road is located at base of slope.
Note dying vegetation in rock toe drain.

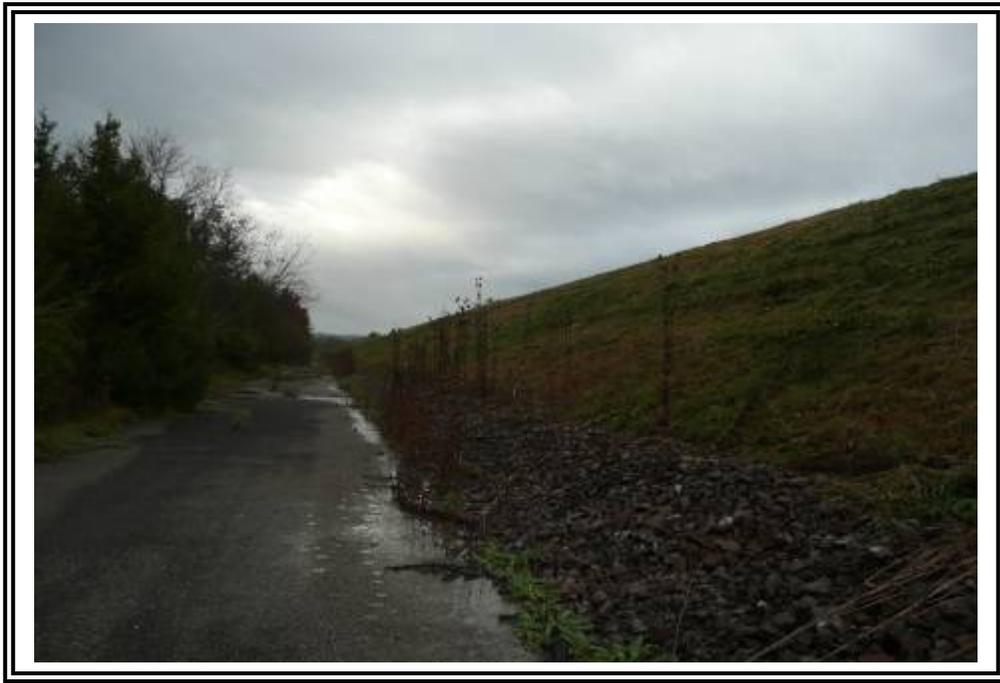
132

East dike exterior slope, looking south from old roadway.

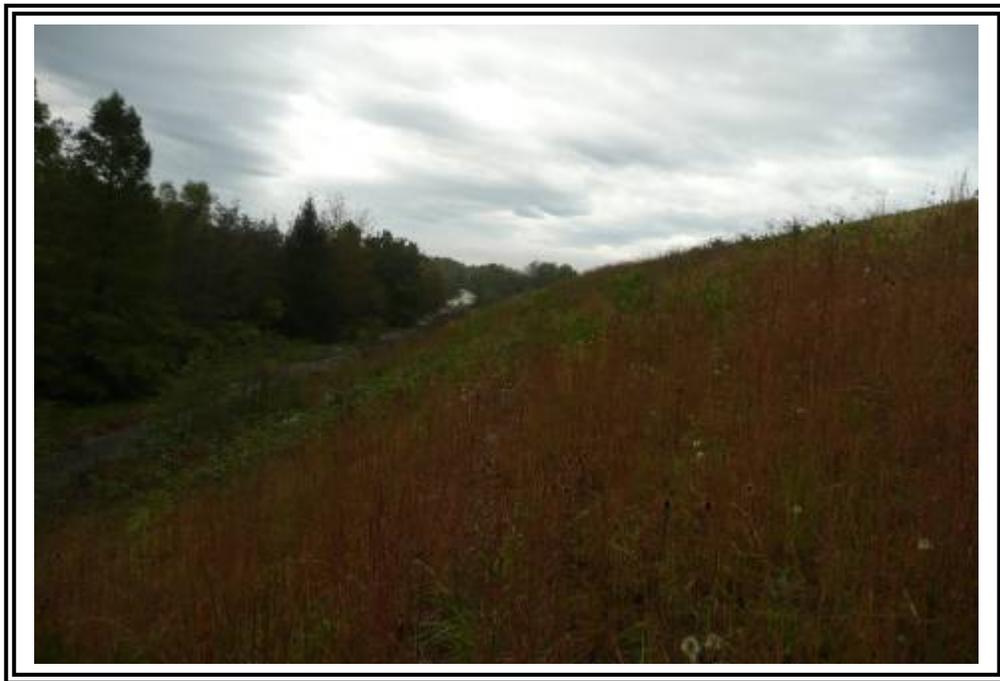
133

East dike, exterior slope, looking south from mid-slope in area of vegetation change.

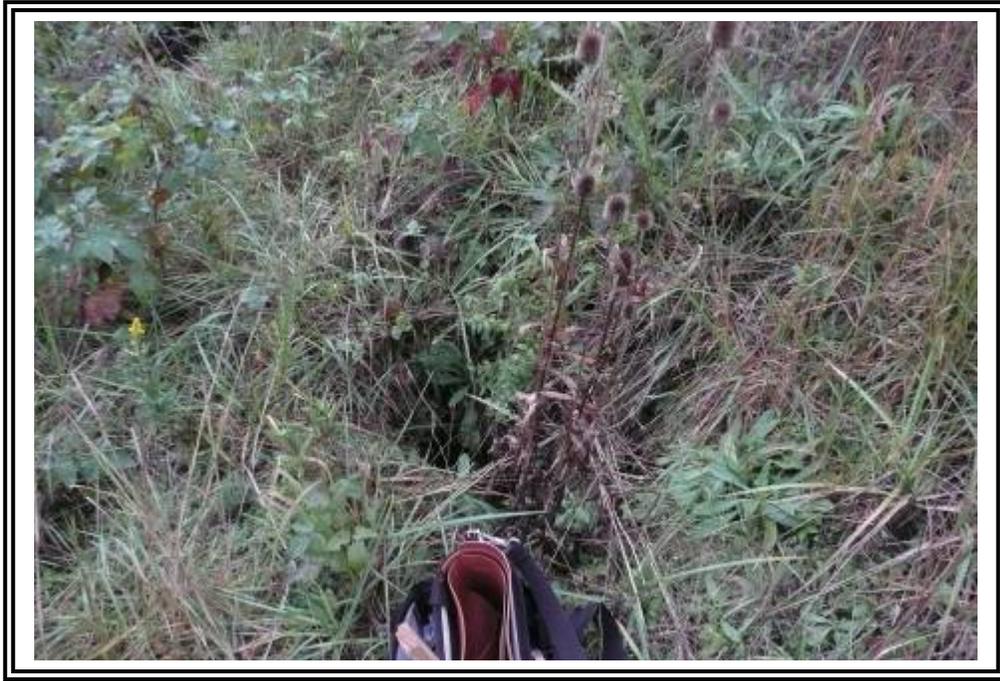
134

Grassy surface hole/depression likely the result of shallow creep/sloughing that became prevalent below mid-slope along the southern 240 feet of the east dike. These were typically obscured by vegetation.

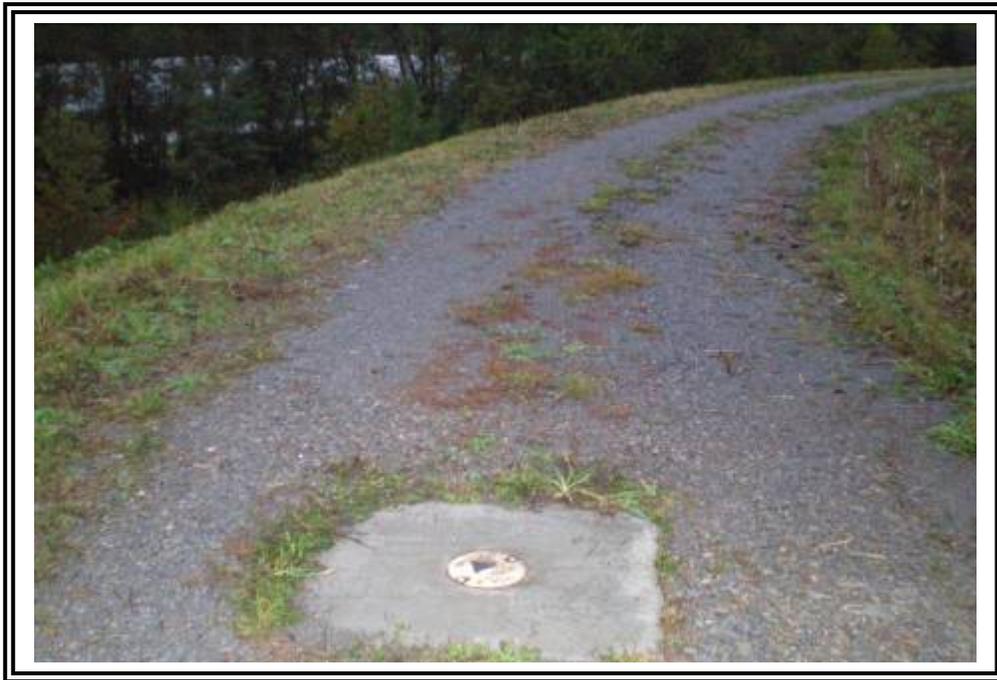
136

Looking south, monument on crest of east dike to monitor for movement.

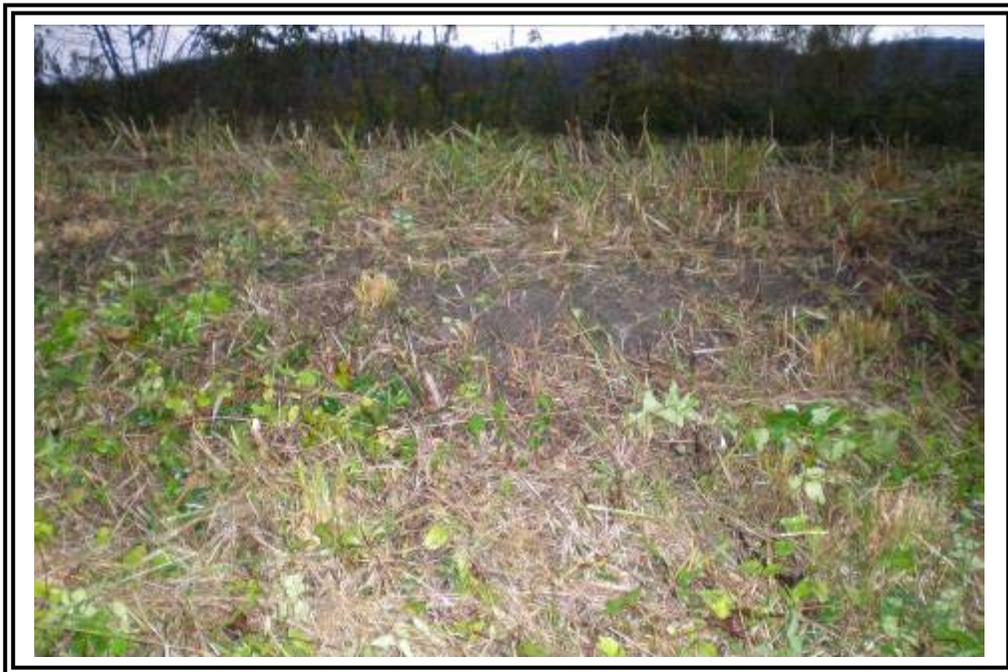
137

Looking west at erosion rill at crest on upstream side of east dike.

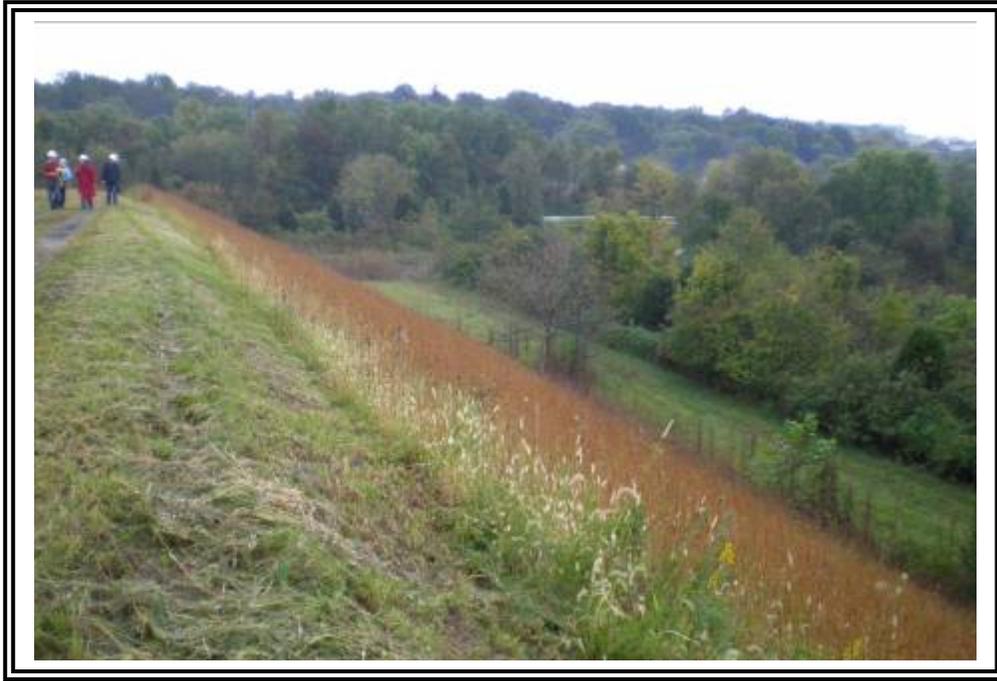
138

Looking east along downstream slope of south dike.

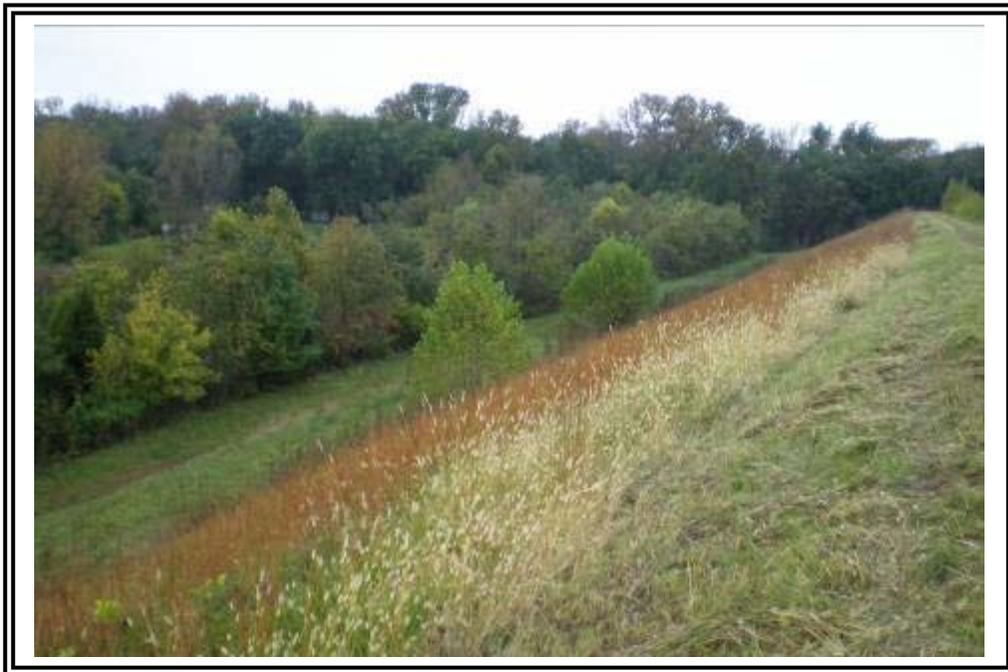
139

Looking west along downstream slope of south dike.

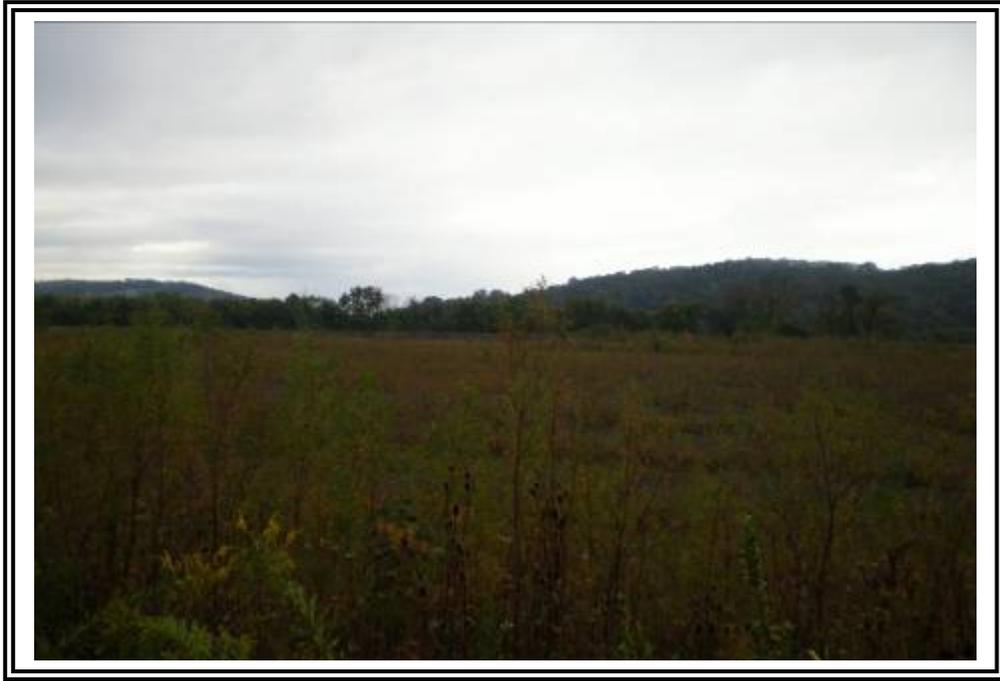
140

Looking west across pond.

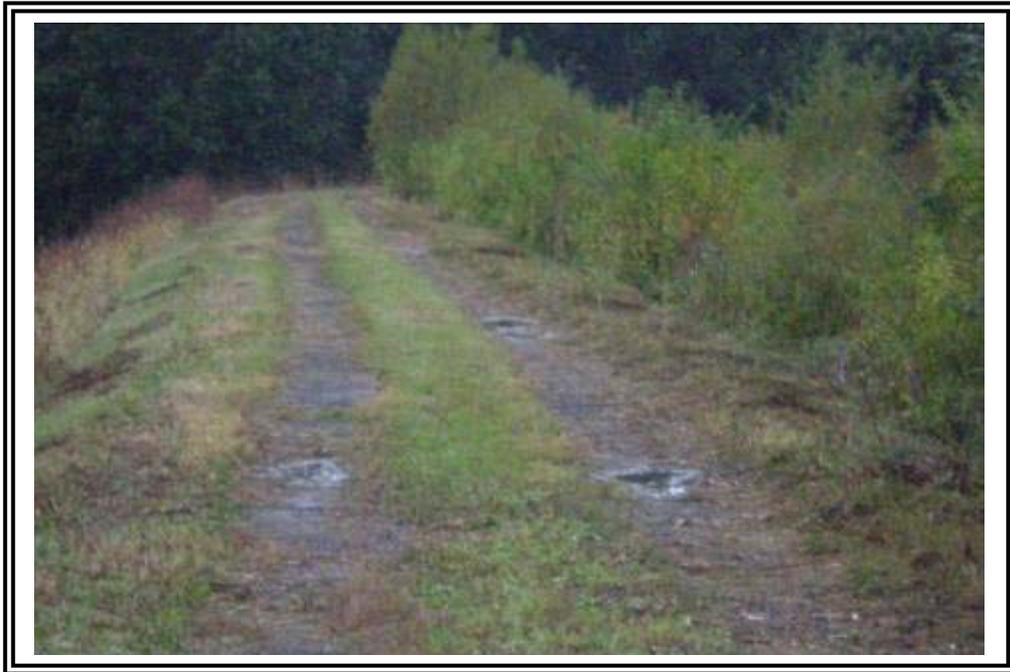
141

Looking west along crest of south dike.

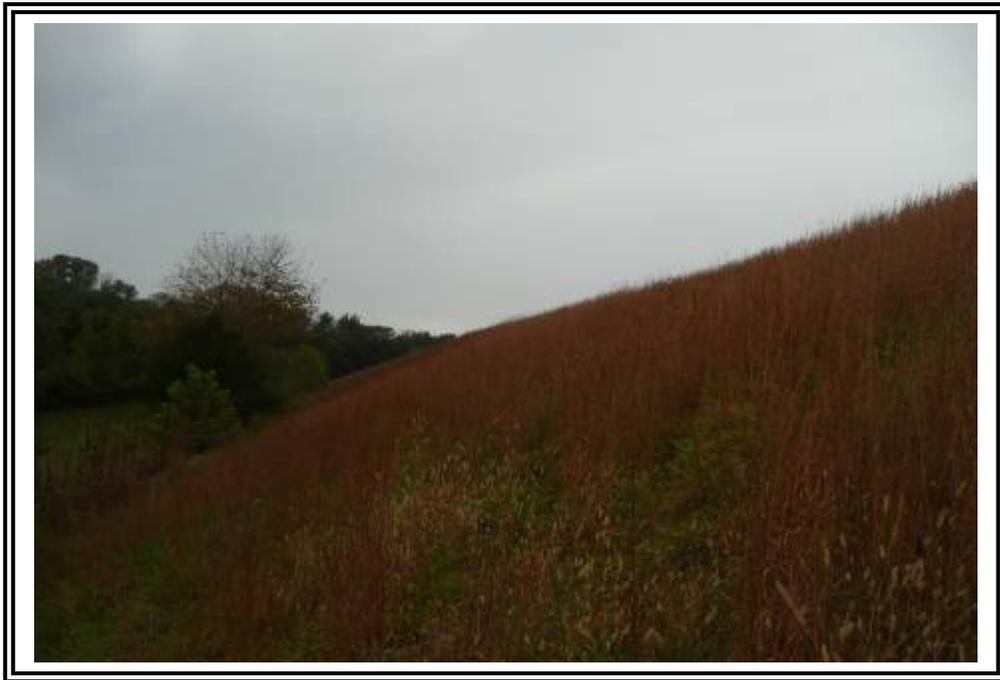
142

Looking west along the exterior slope face of the south dike.

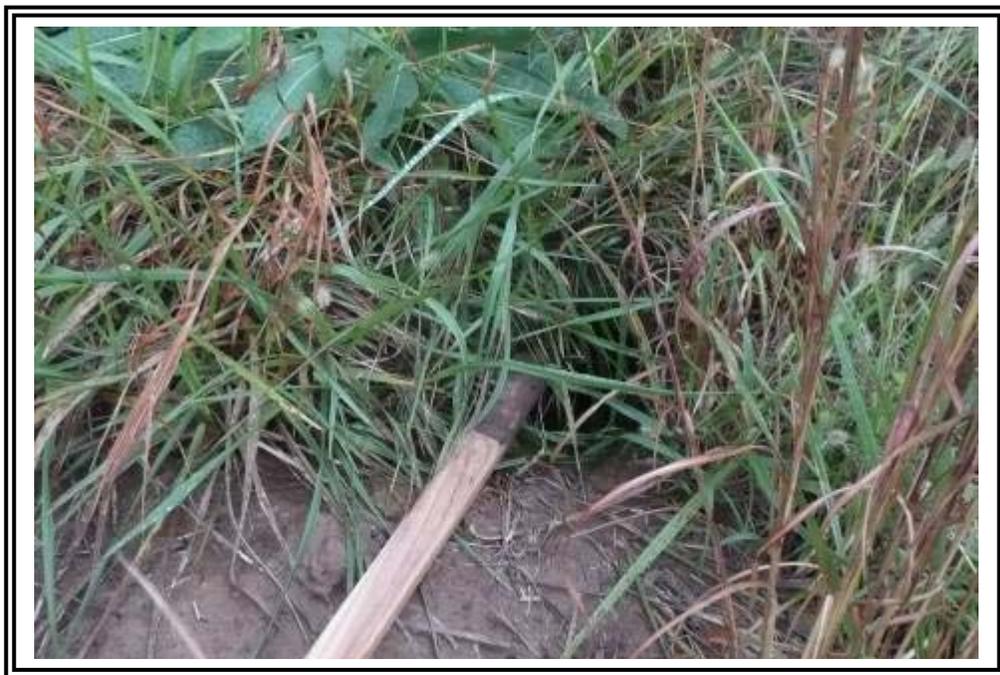
143

Small rodent burrow on south dike.

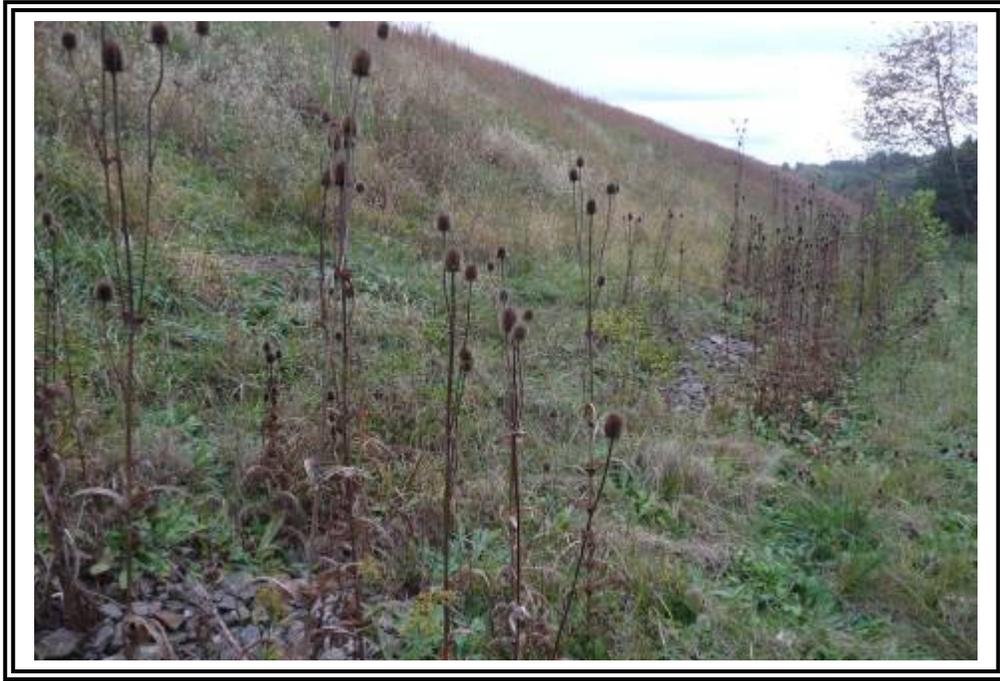
144

Small vegetated slough and erosion transporting soil over the rock toe drain on south dike.

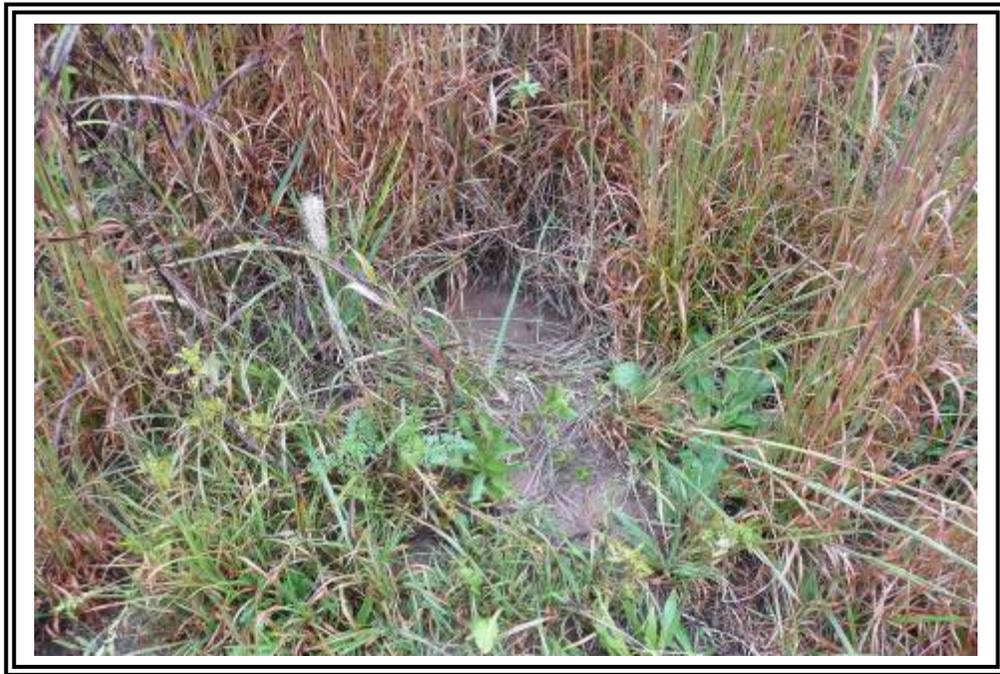
145

Depression//hole on south dike exterior slope holding standing water from recent rainfall.

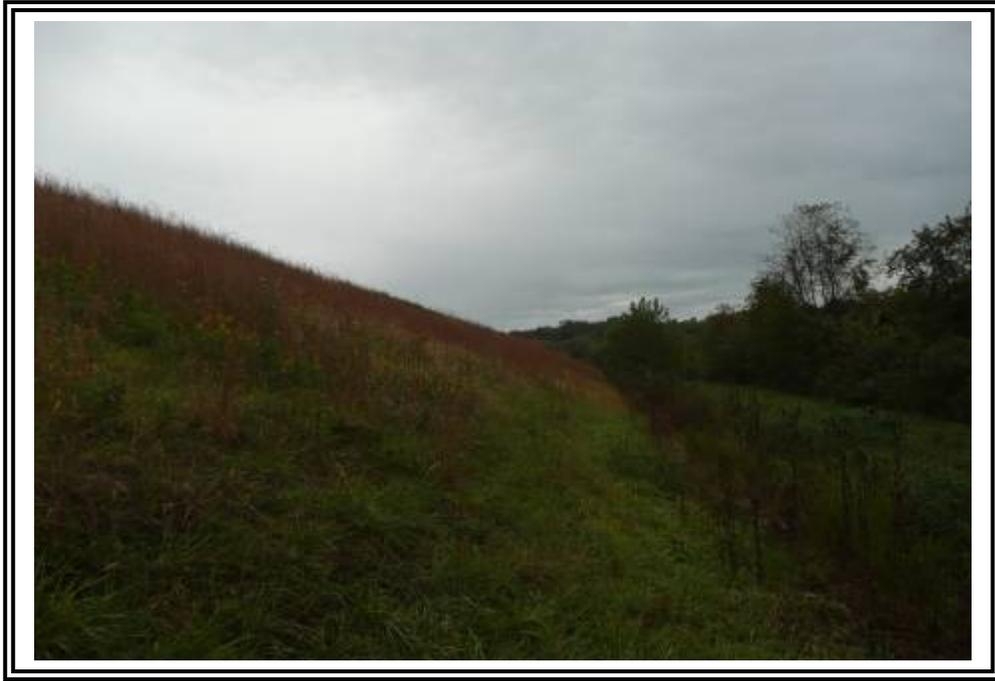
146

South dike exterior slope, looking east.

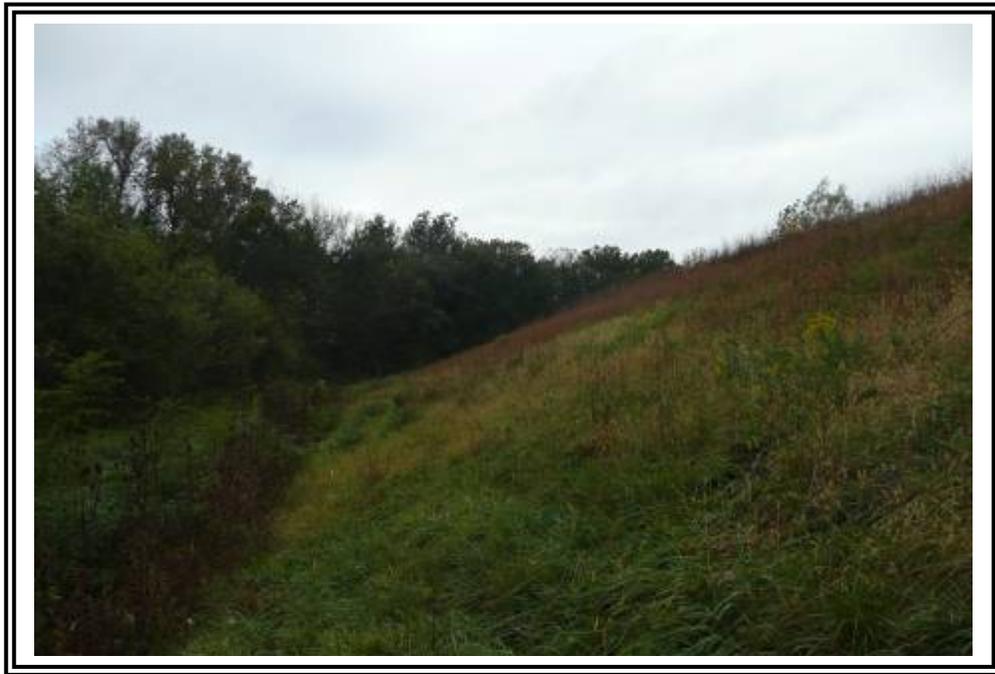
147

Exterior slope of south dike, looking west toward western end of dike.

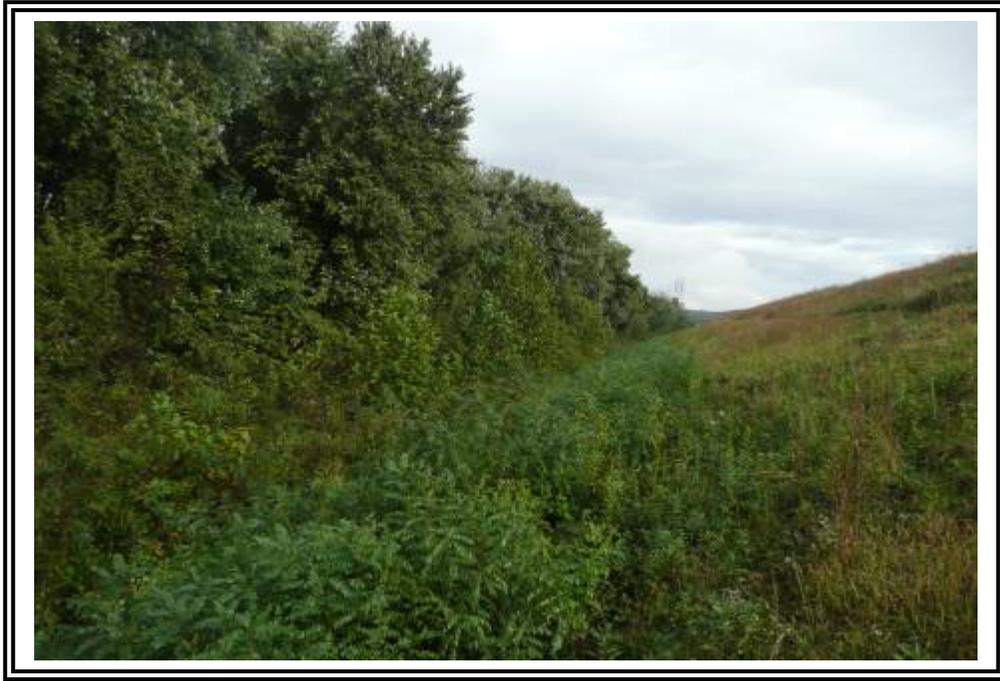
148

West dike, exterior slope, looking north. Note very heavy vegetation on bottom 1/3 of slope near dike toe.

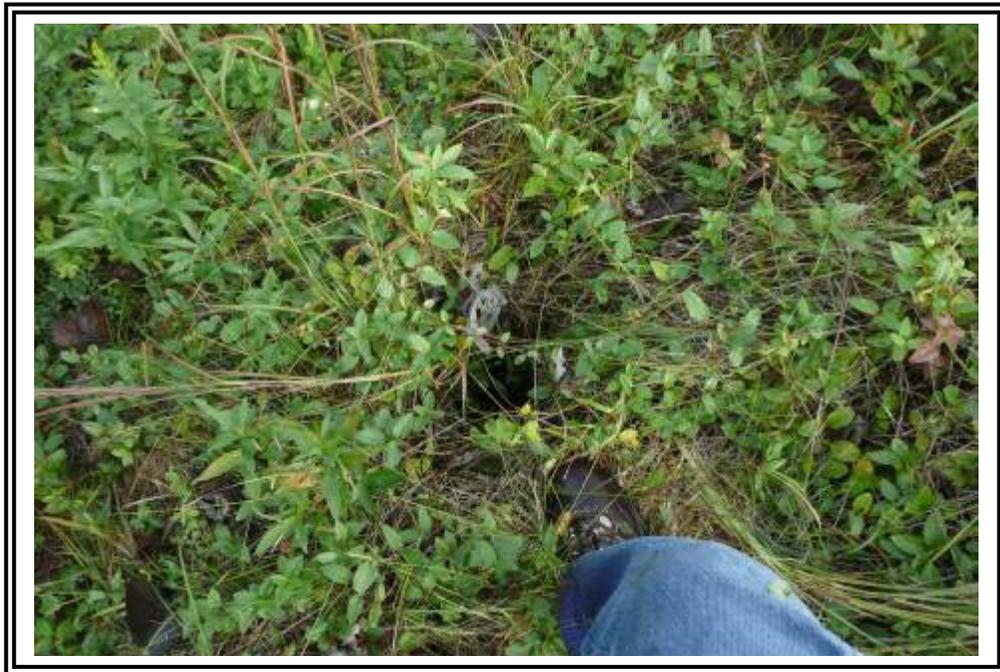
149

Old rodent burrow obscured in vegetation on west dike.

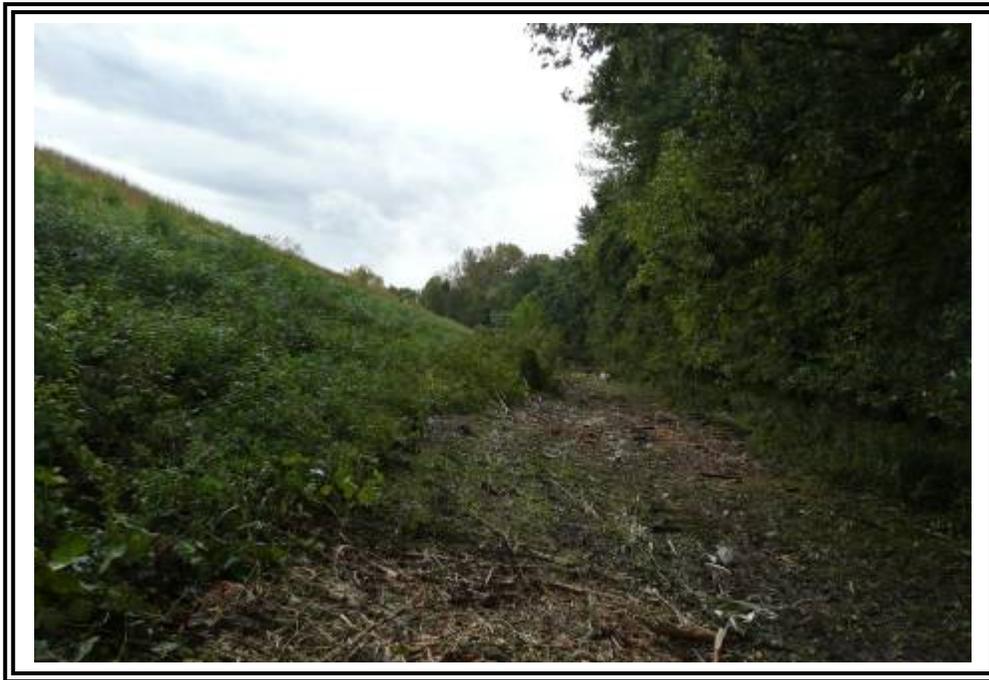
152

Exterior toe of the west dike, looking south showing effect of recent clearing activities.

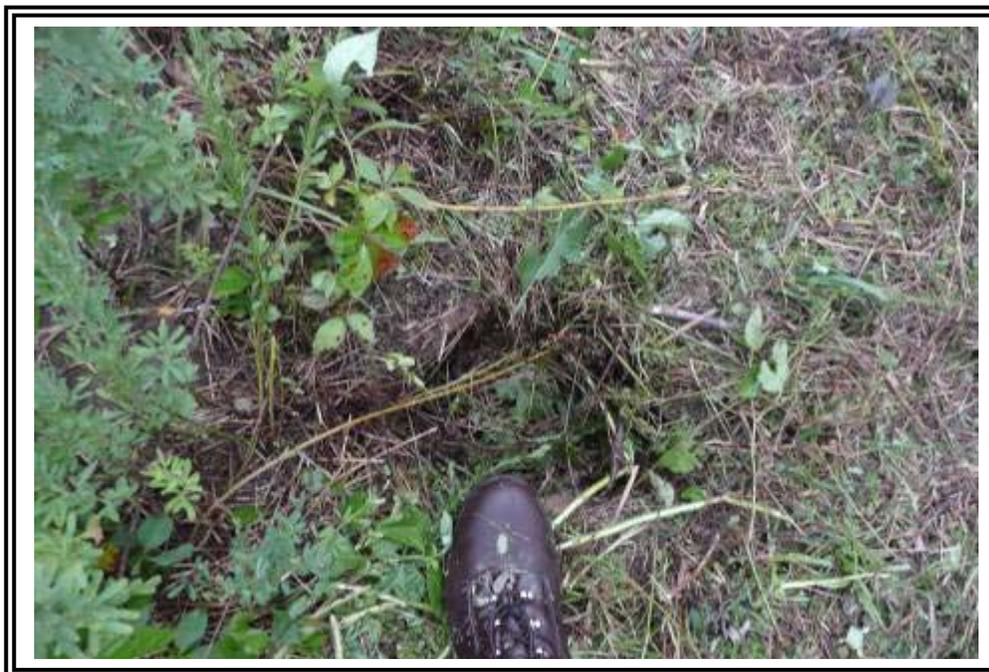
153

Grassed pocket/depression on exterior slope of west dike. Likely the result of shallow creep/sloughing.
