Assessment of Dam Safety Coal Combustion Surface Impoundments (Task 3) Final Report

Duke Energy

W.C. Beckjord Station
New Richmond, Ohio

March 22, 2010

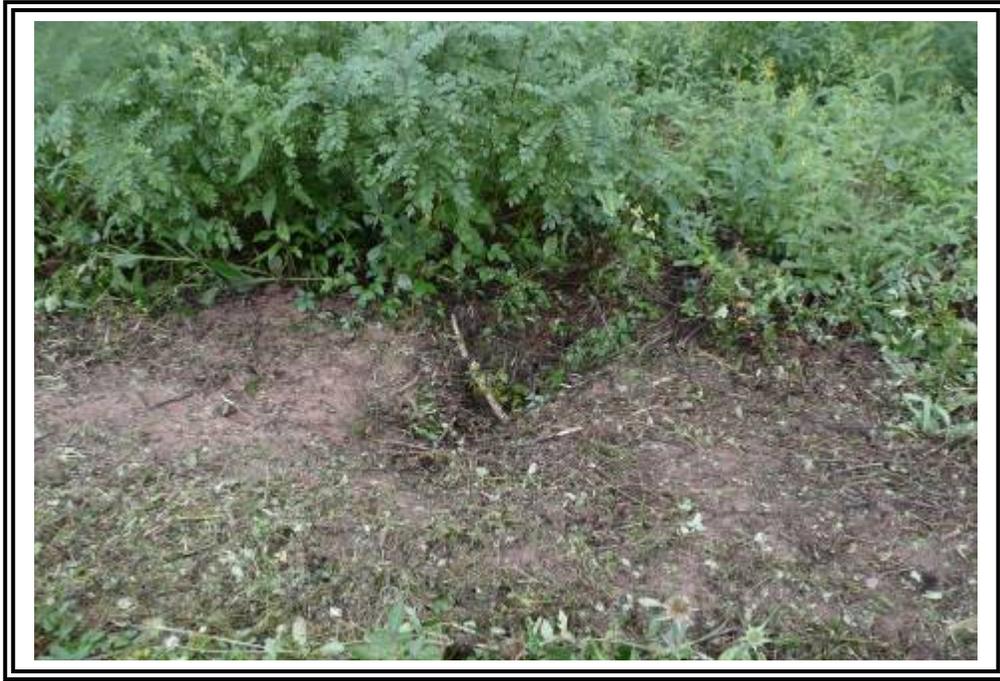
154

Looking down slope at erosion rill mowing exposed above bottom $\frac{1}{4}$ to $\frac{1}{3}$ of exterior slope of the west dike where the slope steepens in area of heavy vegetation.

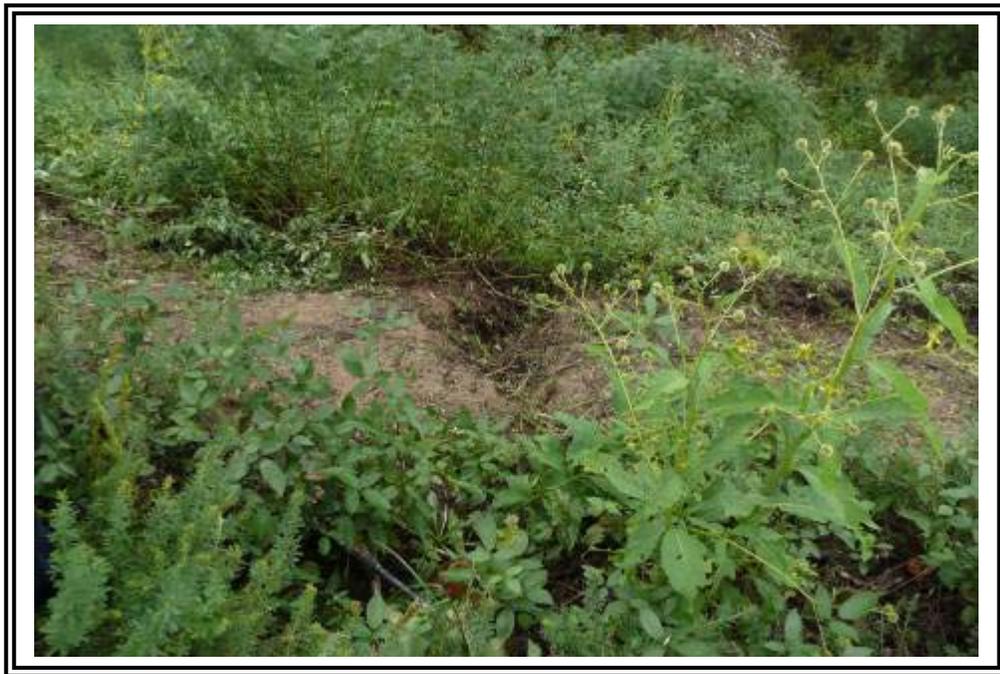
155

Another grassed erosion rill mowing has exposed on exterior slope of west dike.

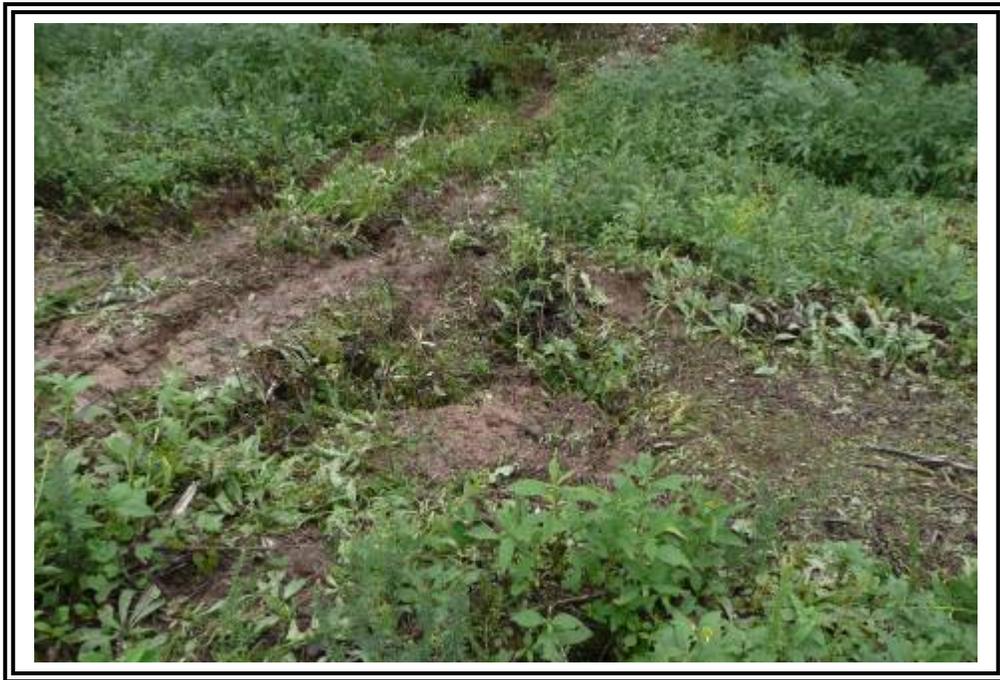
156

Example of an erosion rill on the west dike face normally obscured by vegetation.

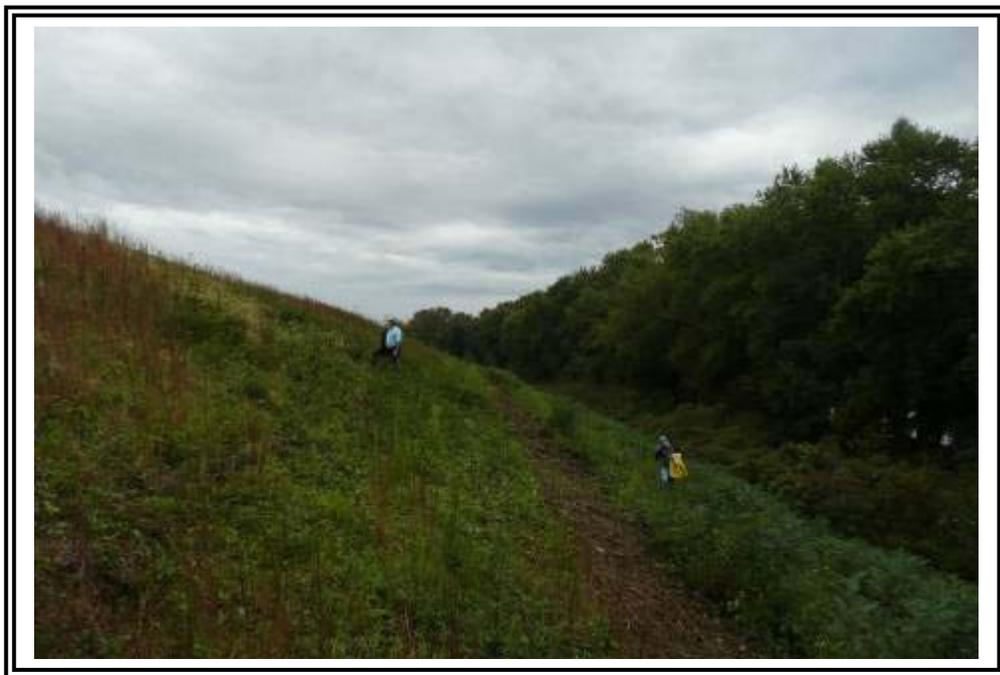
157

Exterior slope of the south dike, facing south.
Note heavy brush vegetation at toe of slope where rock toe drain is located.

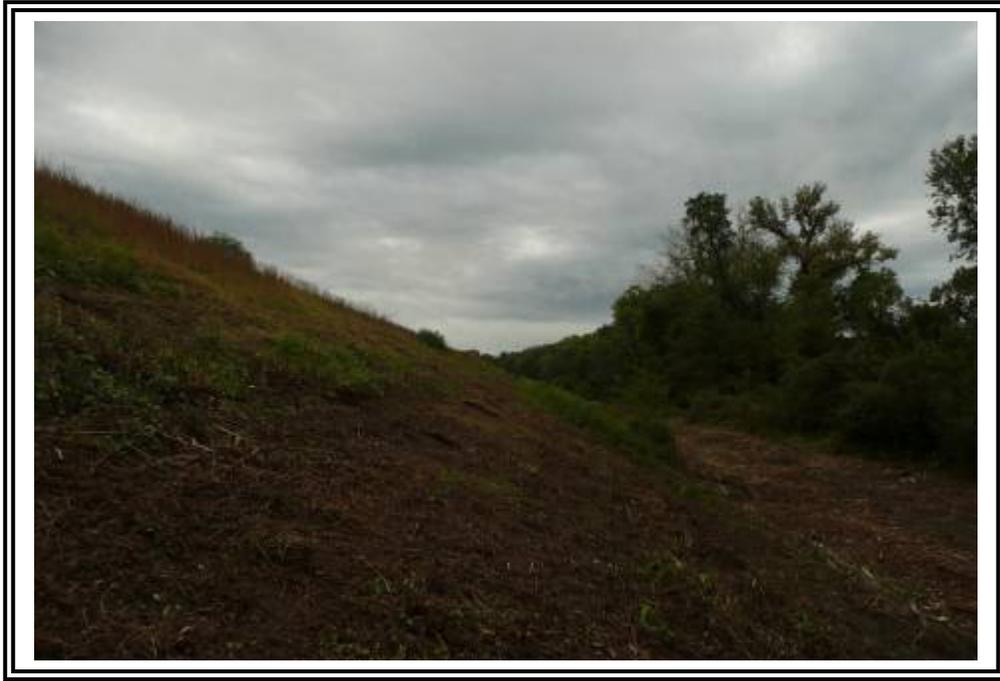
158

Looking south along the exterior slope of west dike. Heavy vegetation was recently mowed.

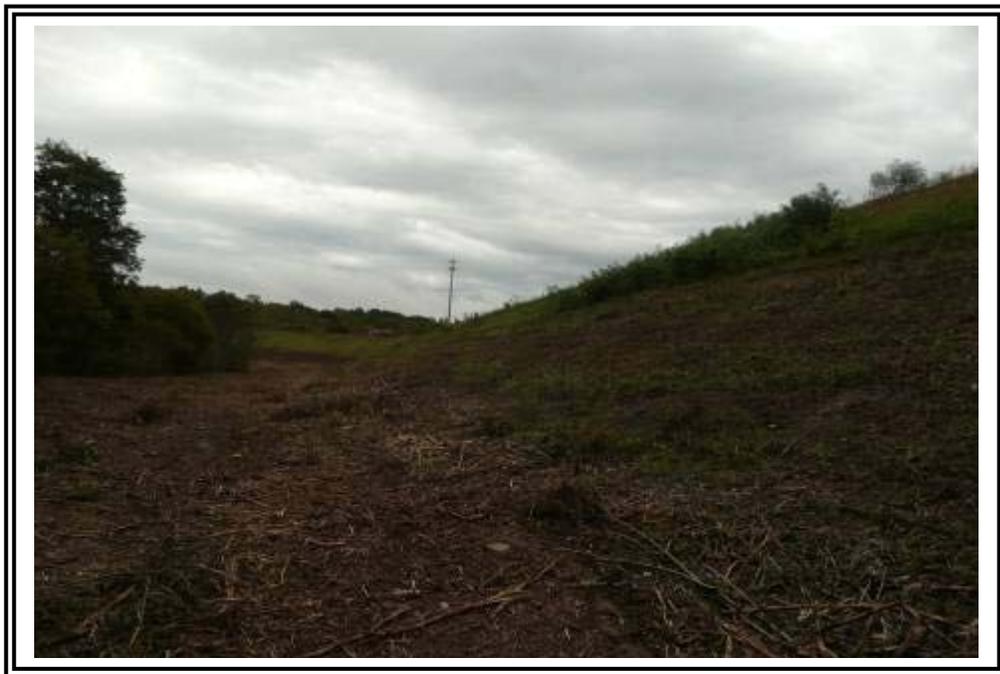
159

Looking east along the exterior slope of the north dike from the north end of the west dike. Access drive embankment from Pond C to Pond C Extension can be seen in background.

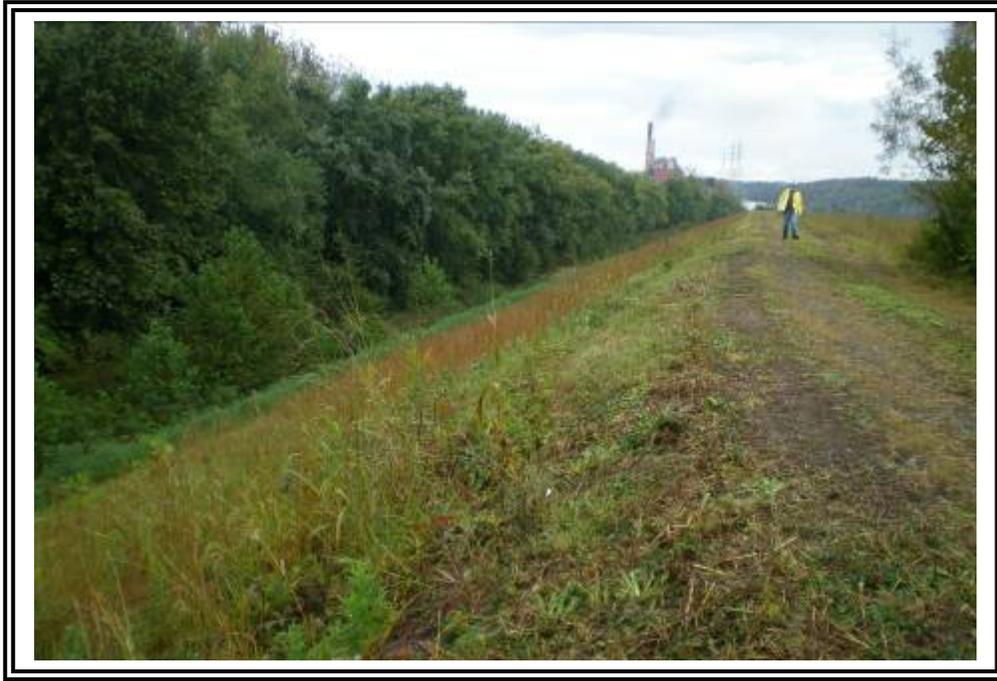
160

Crest of west dike, looking north.

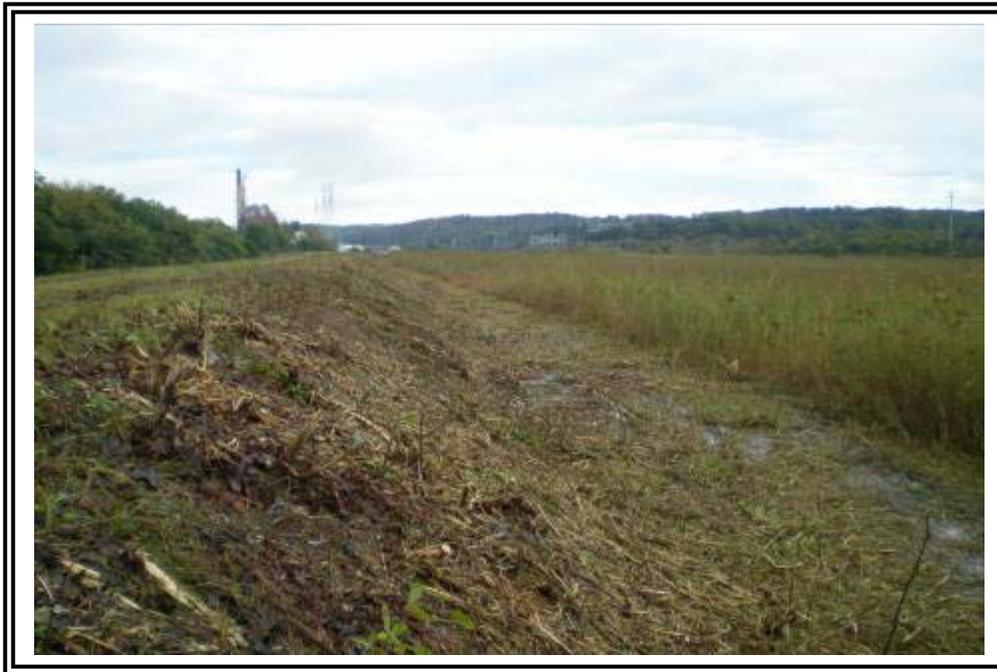
161

Interior slope of west dike, looking north.

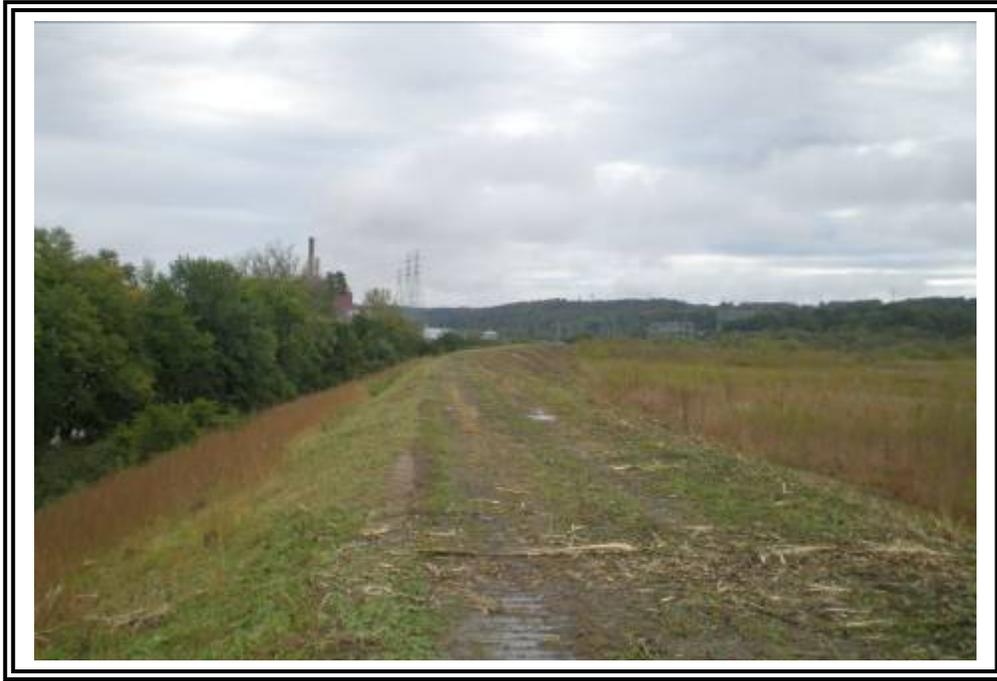
162

Crest of west dike, looking north.

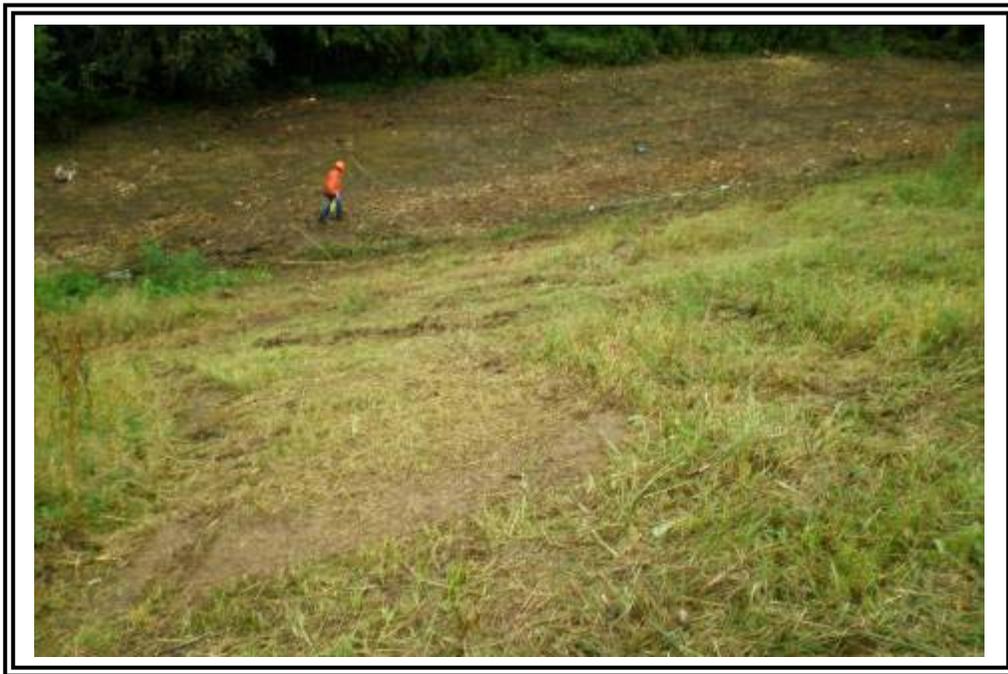
163

Exterior slope of west dike, looking west.

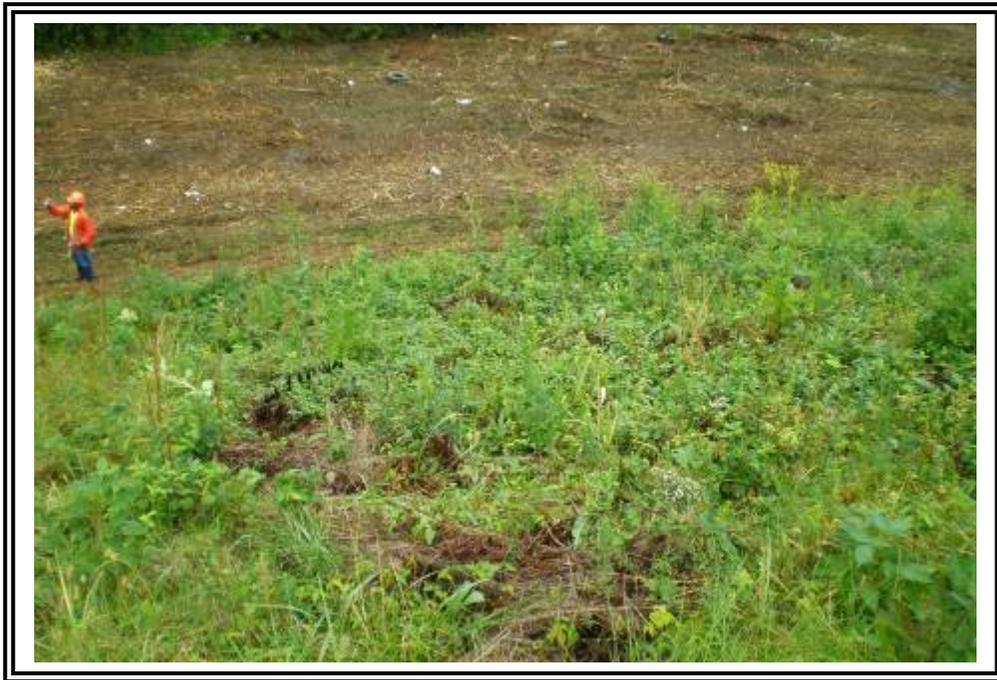
164

Erosion rill on exterior slope of west dike, looking west.

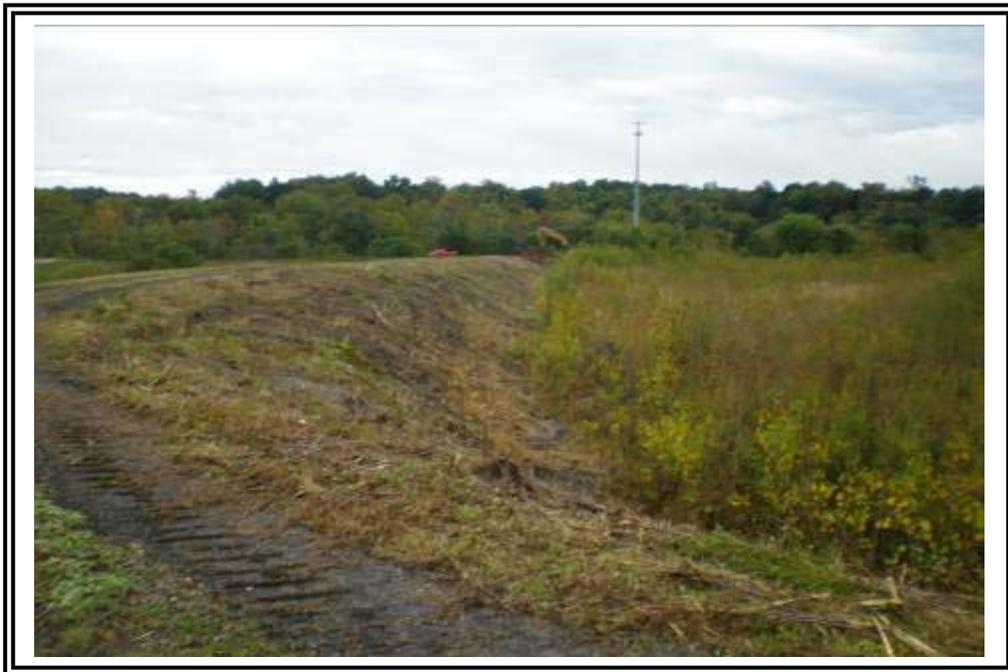
165

Interior slope of west dike, looking east.

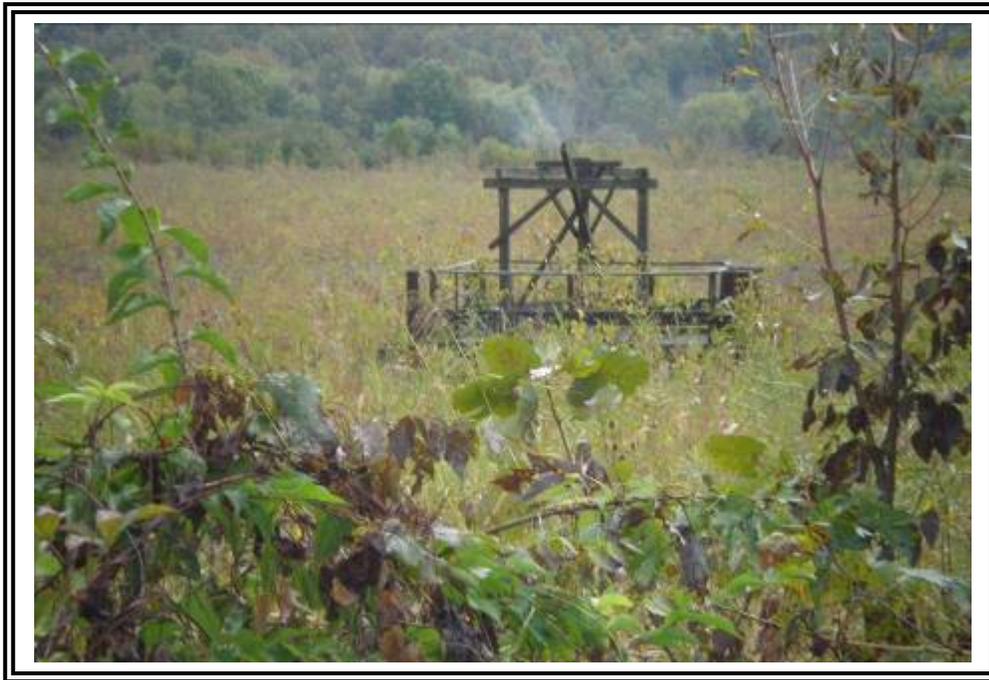
166

Abandoned overflow pipe structure, looking northeast/east.

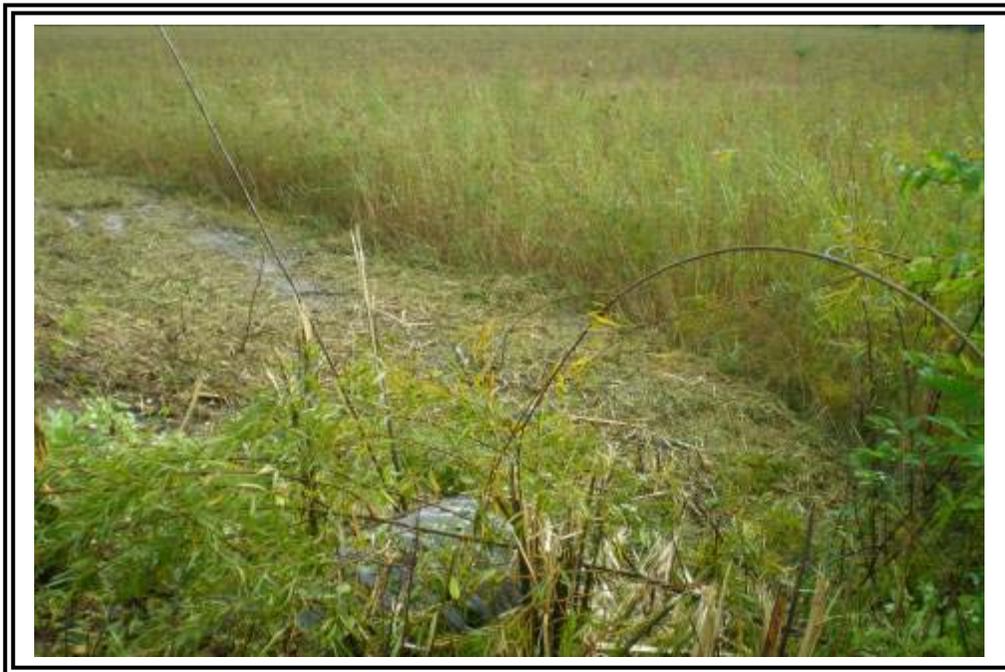
167

Abandoned 24-inch diameter emergency overflow pipe.
