# Assessment of Dam Safety Coal Combustion Surface Impoundments (Task 3) Final Report

Georgia Power  
Company

Plant Branch

CHA Project No. 20085.2060.1510

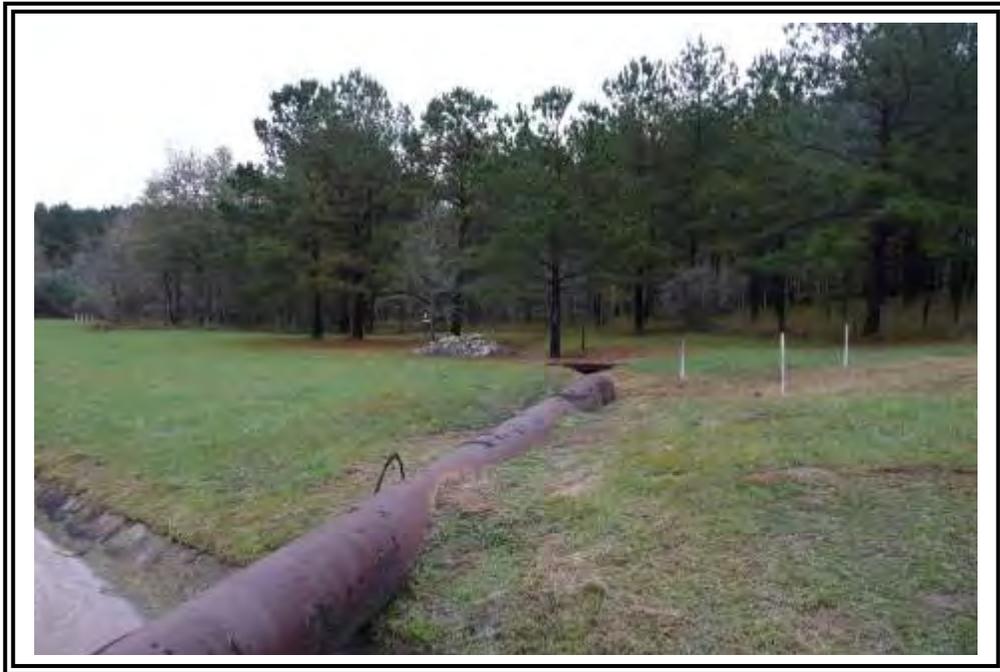
2

Ash Pond E abandoned overflow drain located along southern portion of the dike.  
The drain pipe is constructed of welded steel.

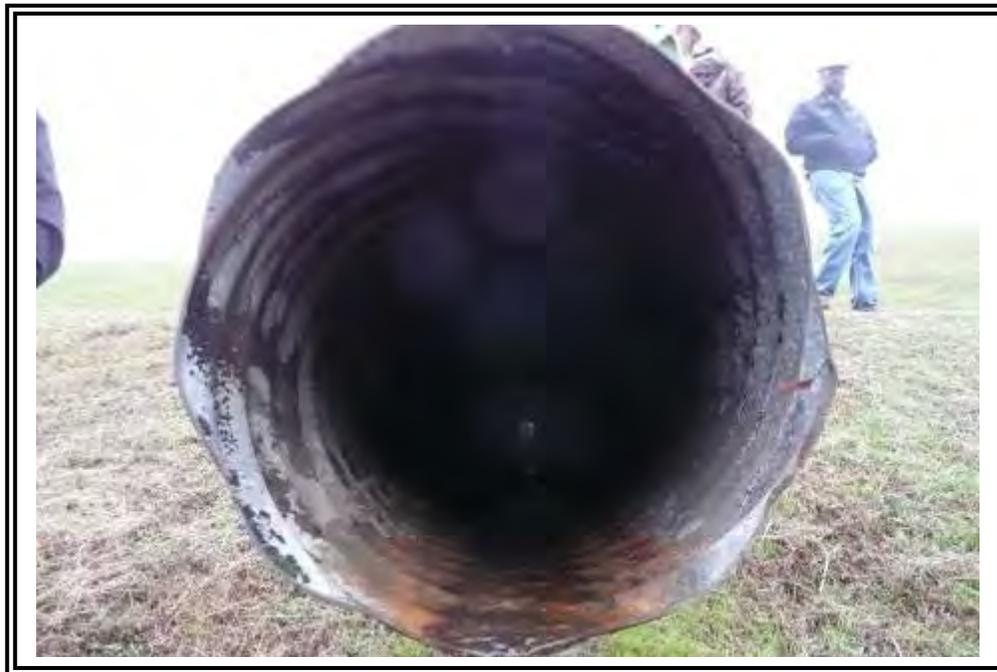
4

Corrugated metal drain pipe located north of Ash Pond E finger drain #11. Light can be seen at the western most end of the drain pipe, indicating a clear drainage channel from upper channel drain to lower channel drain.

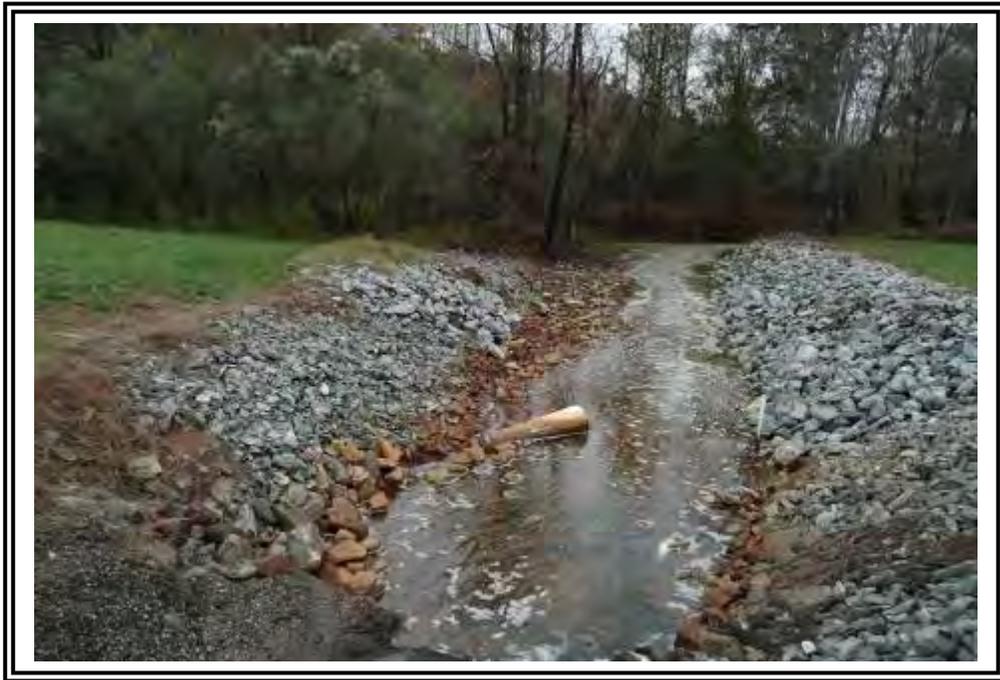
7

Ash Pond E, receiving stream for drainage from the blanket drain system.

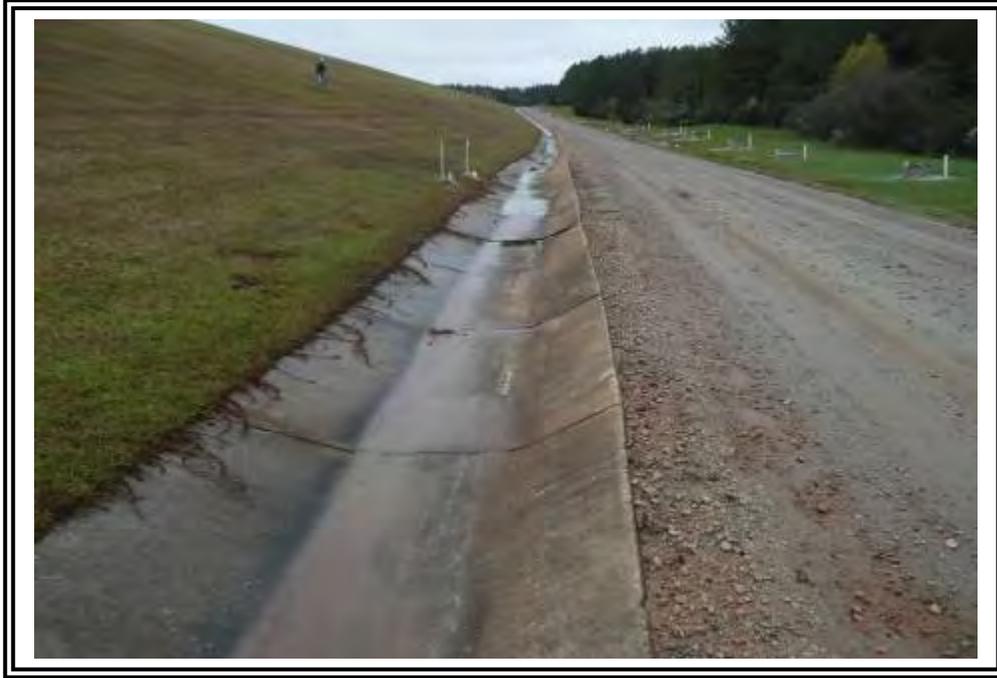
9

Ash Pond E, concrete lined channel drain at the base of the dike (upper channel).

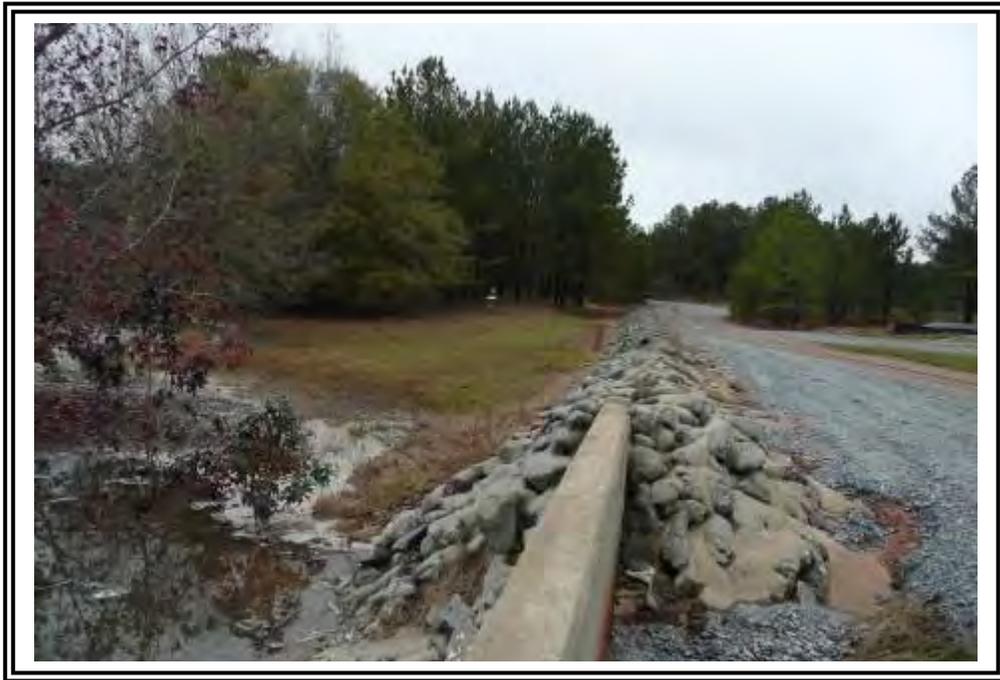
11

Ash Pond E, north end of dike, facing north.

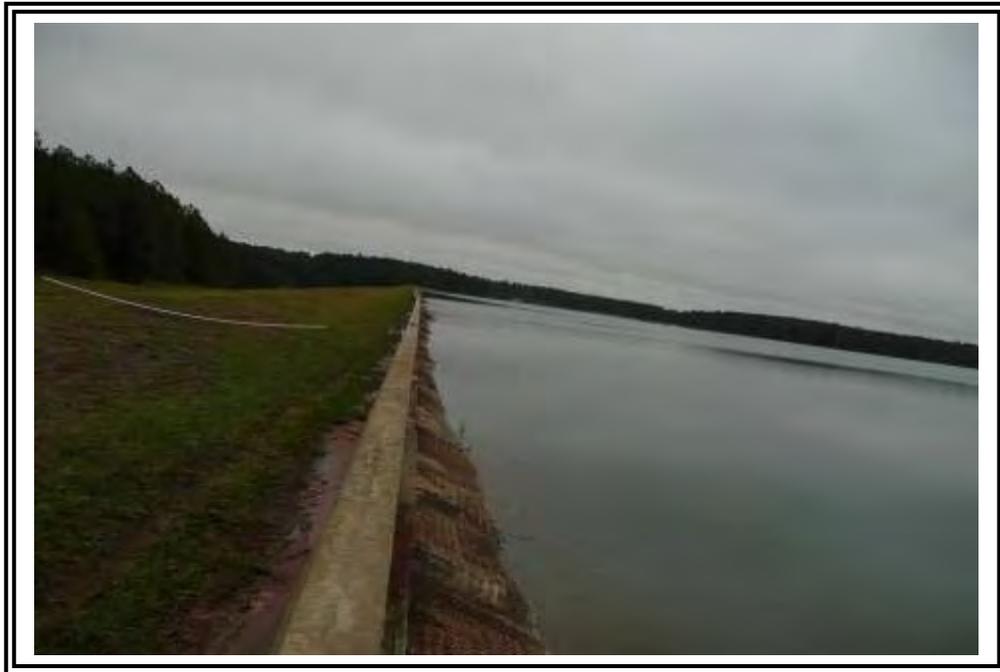
12

Ash Pond E, north end of dike, facing south.  
Shown above, wave wall and rip-rap placement along upstream edge of pond.

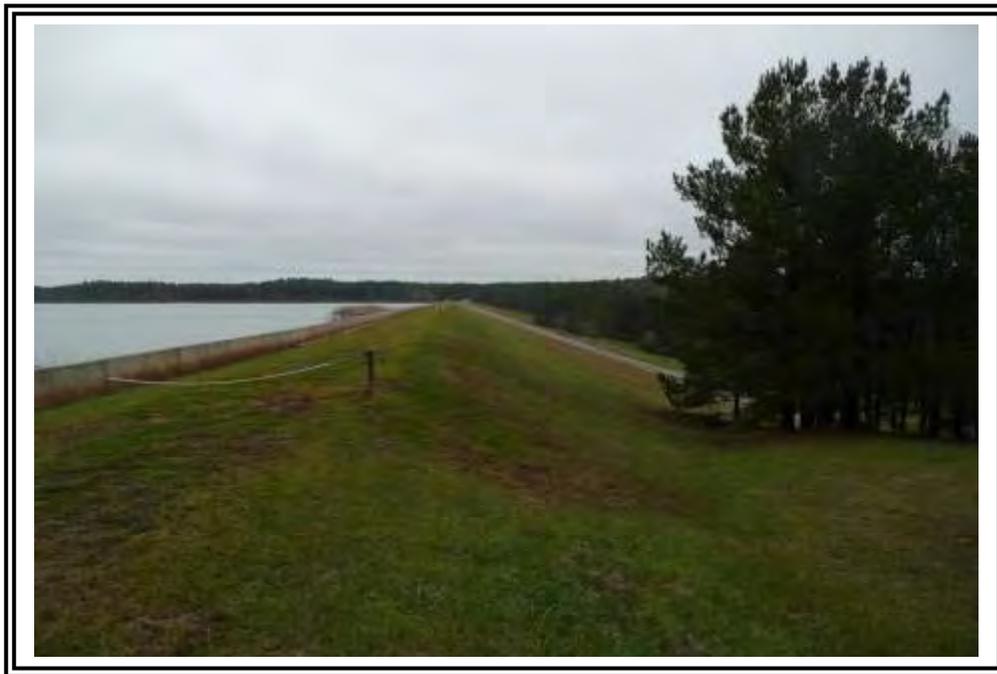
14

Ash Pond E, south end of dike, facing north.

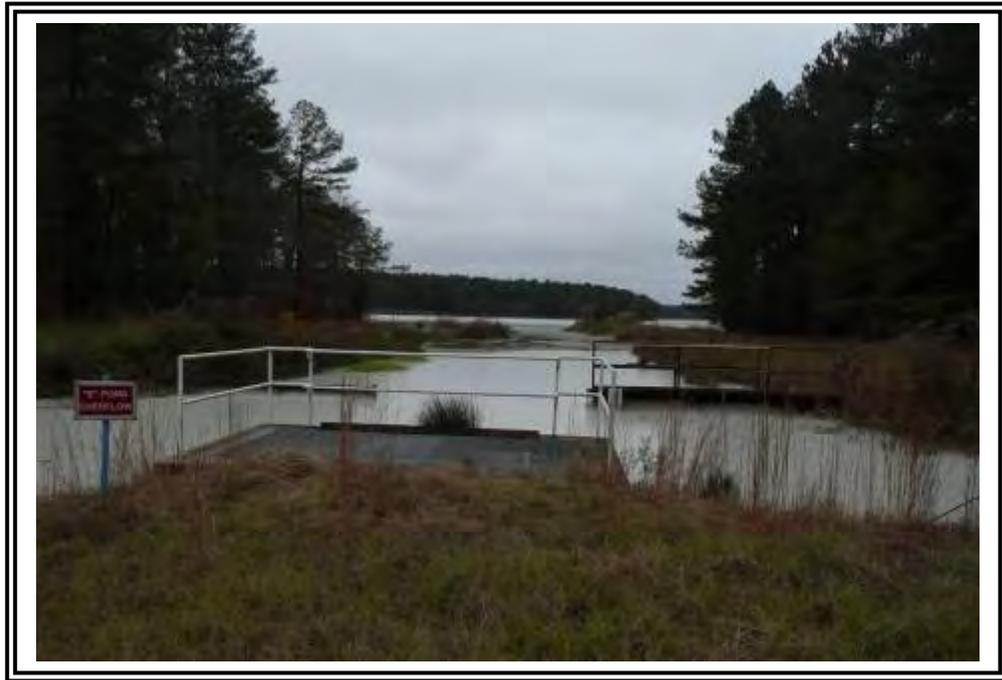
15

Ash Pond E decant spillway structure.

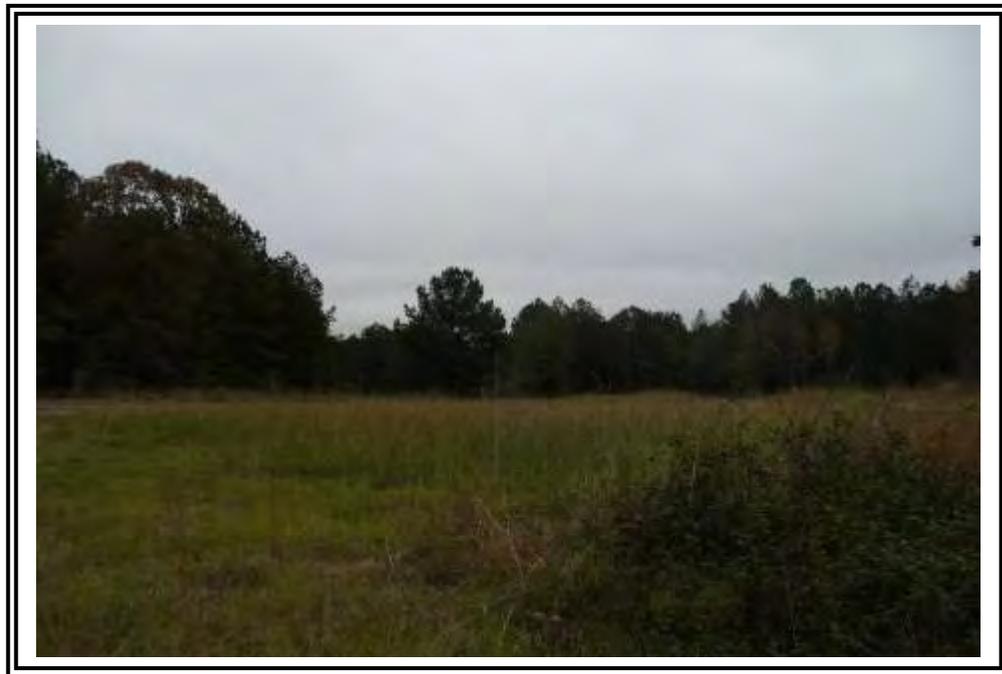
16

Ash Pond E emergency spillway.

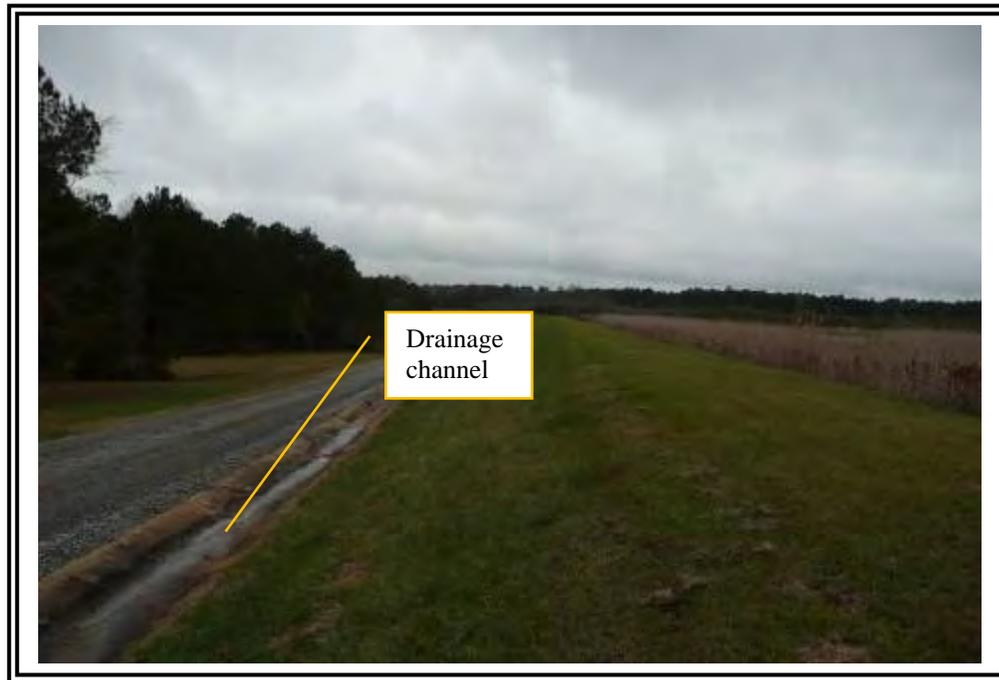
17

Ash Pond D, south edge of dike facing north. Concrete lined drainage channel shown frame left.

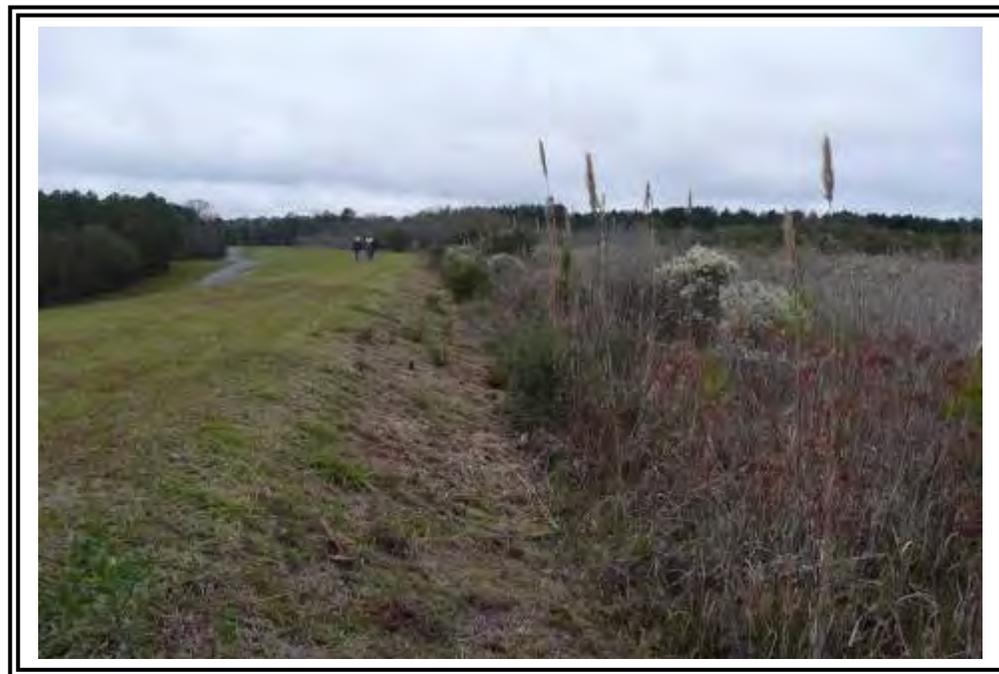
18

Ash Pond D, south end of dike facing north. Upstream slope and vegetation in the pond shown frame right.

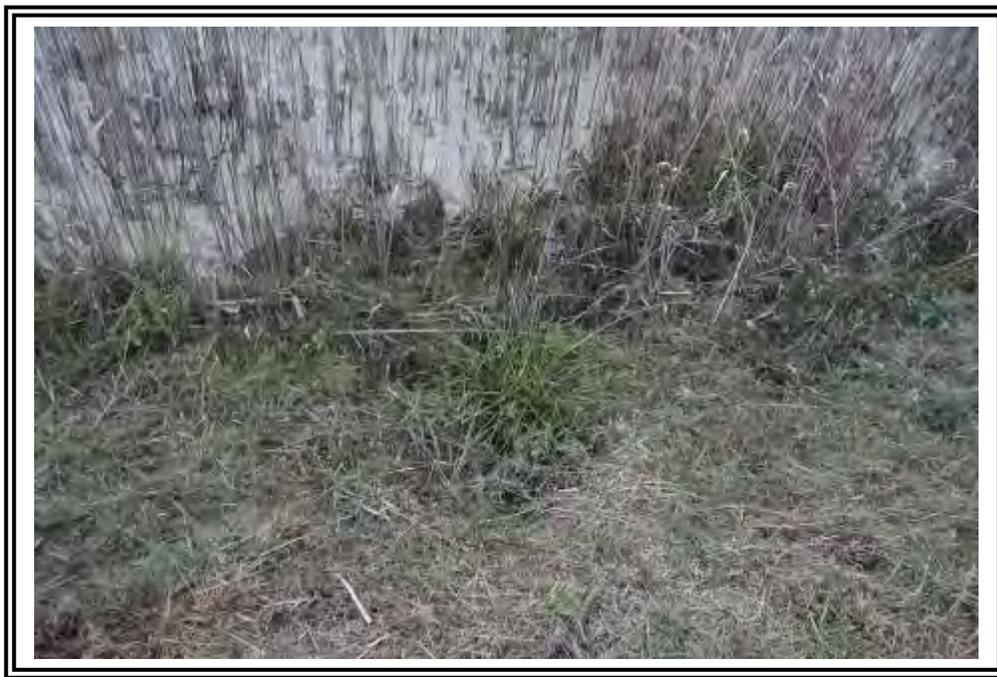
20

Ash Pond D, central portion of the dike facing east.  
Interior edge of the dike (pond side).

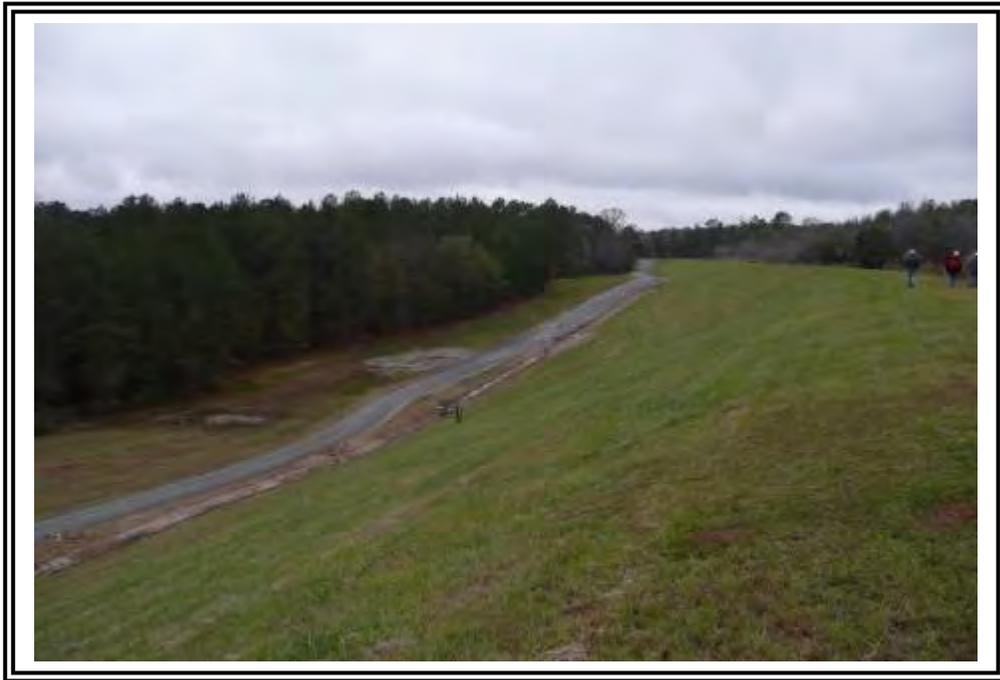
21

Ash Pond D, central portion facing north east.

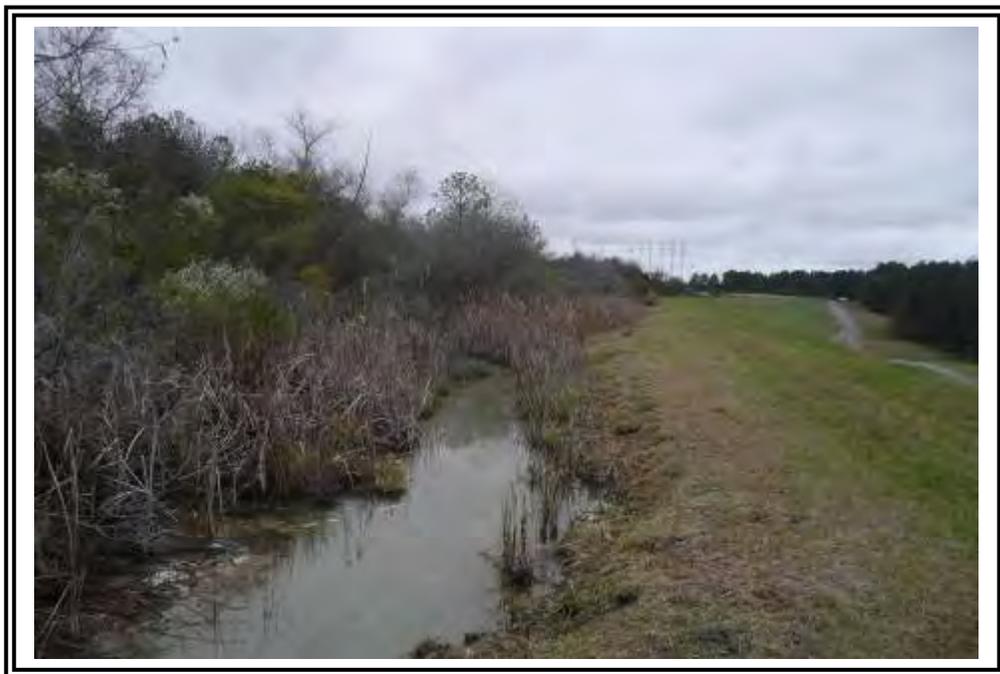
22

Ash Pond D, north edge of dike facing south east. Note widened crest of dike.

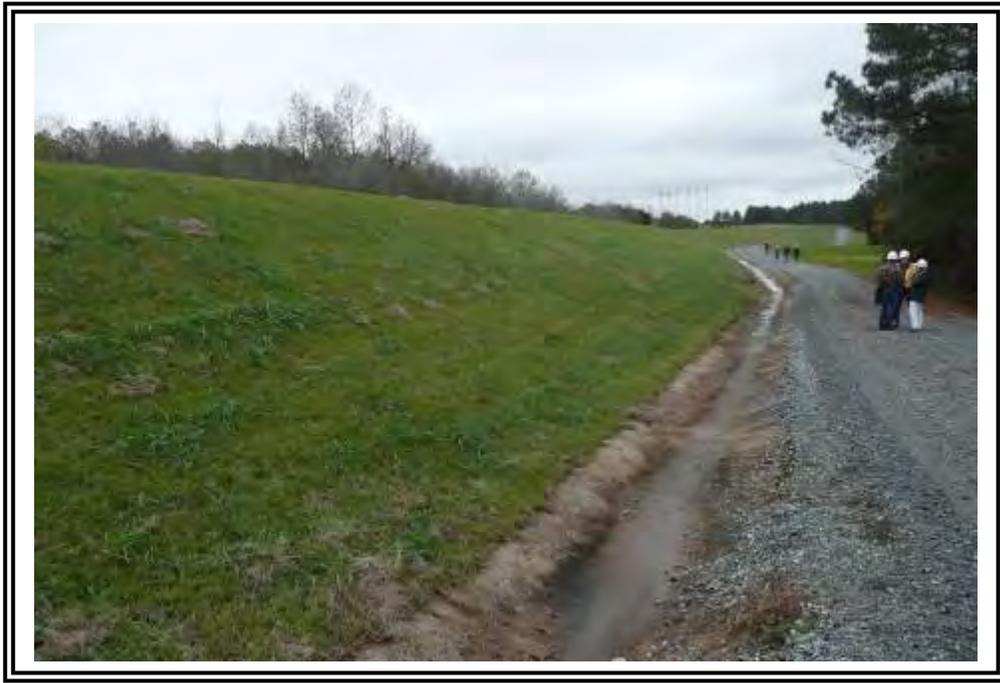
23

Ash Pond D, north end of dike at edge of toe facing southeast showing concrete lined drainage channel along toe of dike.

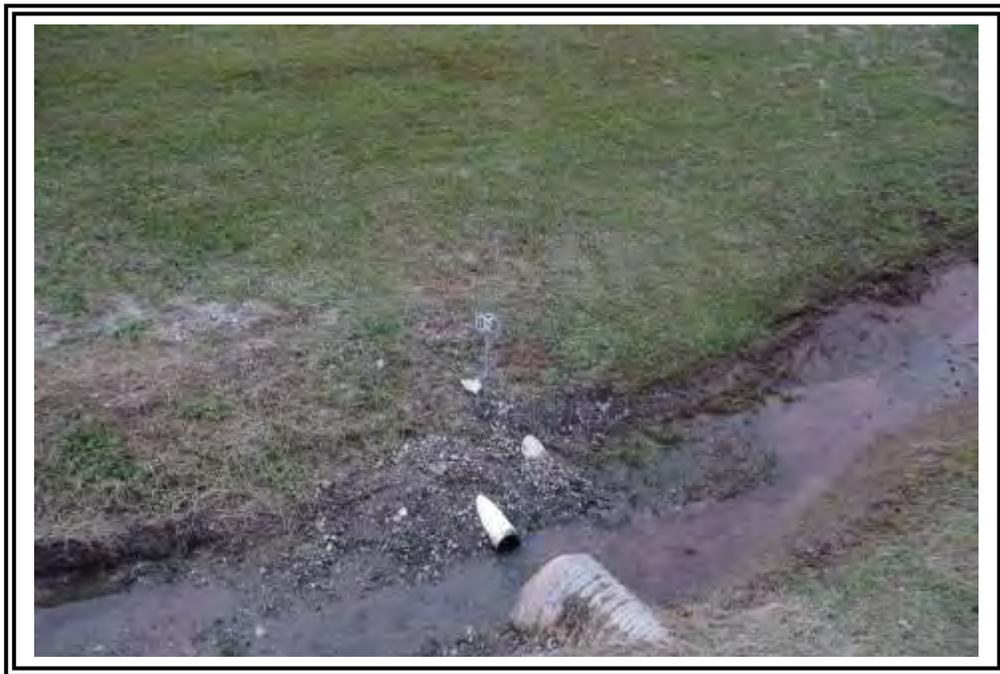
26

Ash Pond D finger drain D-3. .

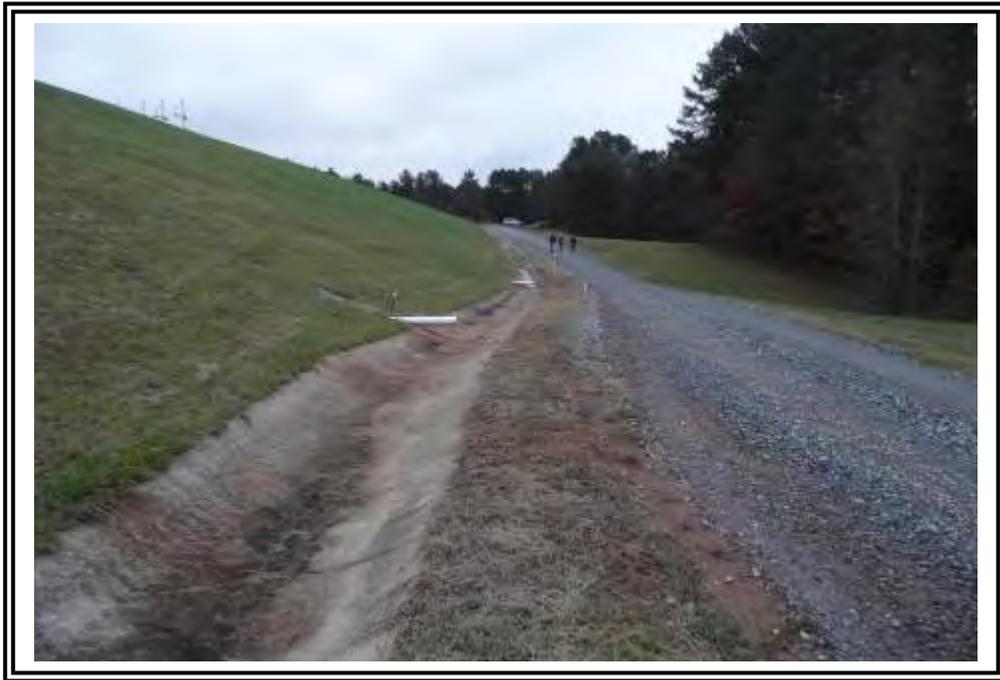
29

Ash Pond D, central portion of dike along toe facing south east.  
Concrete lined channel drain along toe and finger drains shown frame left.

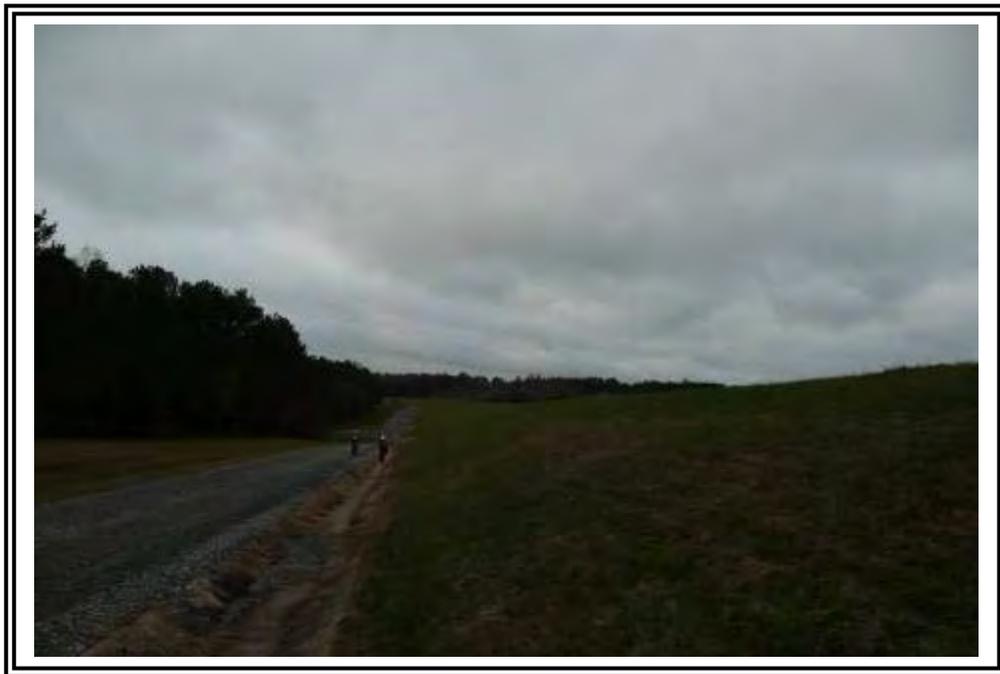
30

Ash Pond D, south end along toe of dike, facing northwest.

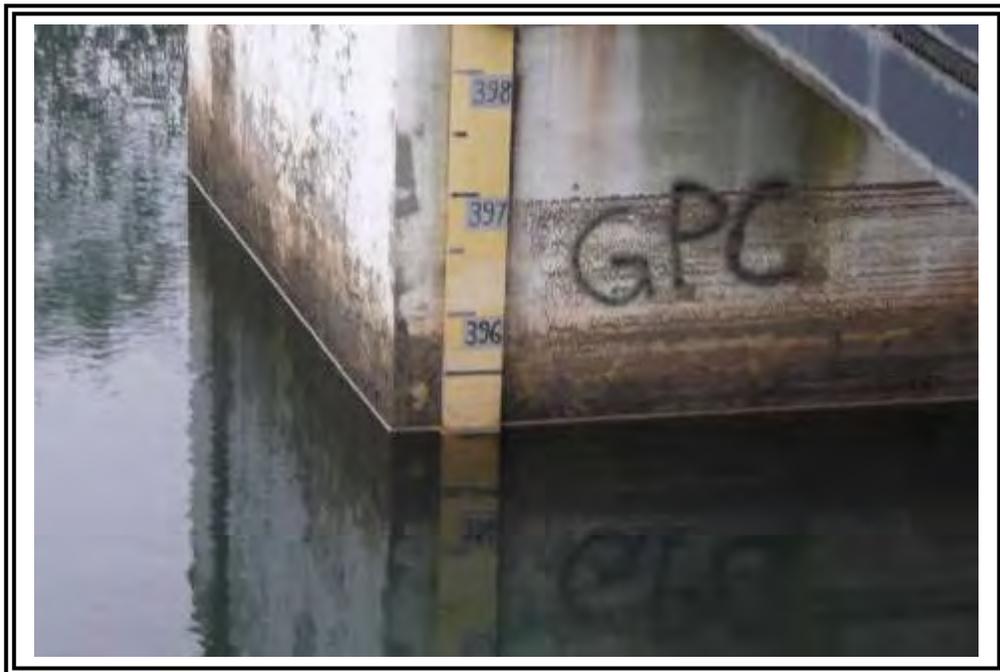
32

Ash Pond C water level indicated by the gauge at the historic discharge facility (395.0').

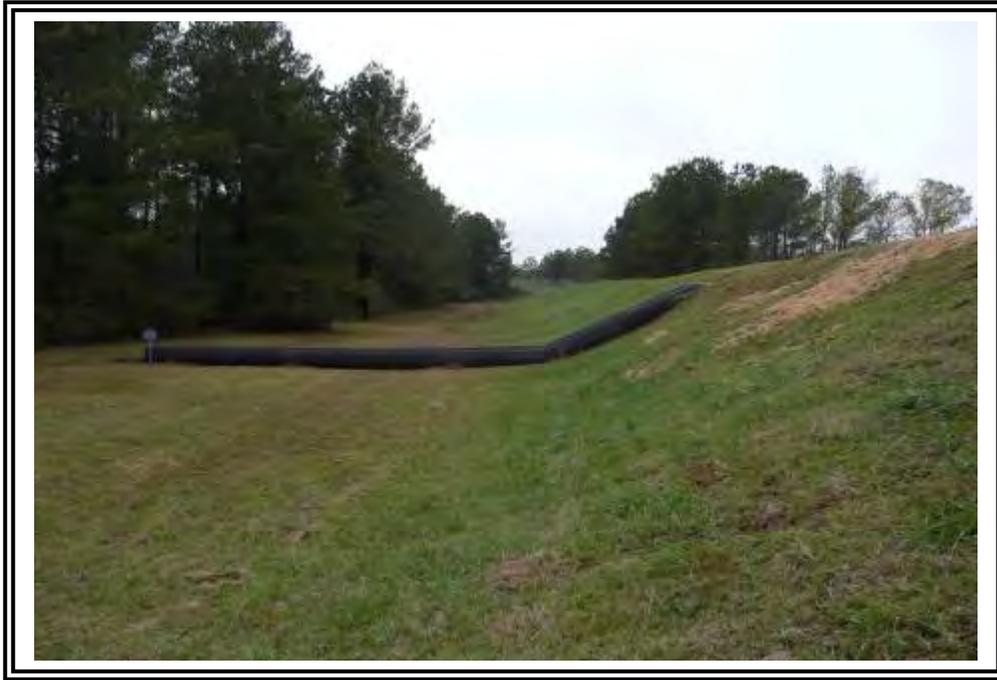
33

Ash Pond C emergency overflow located on southern portion of west dike north of historic discharge facility.

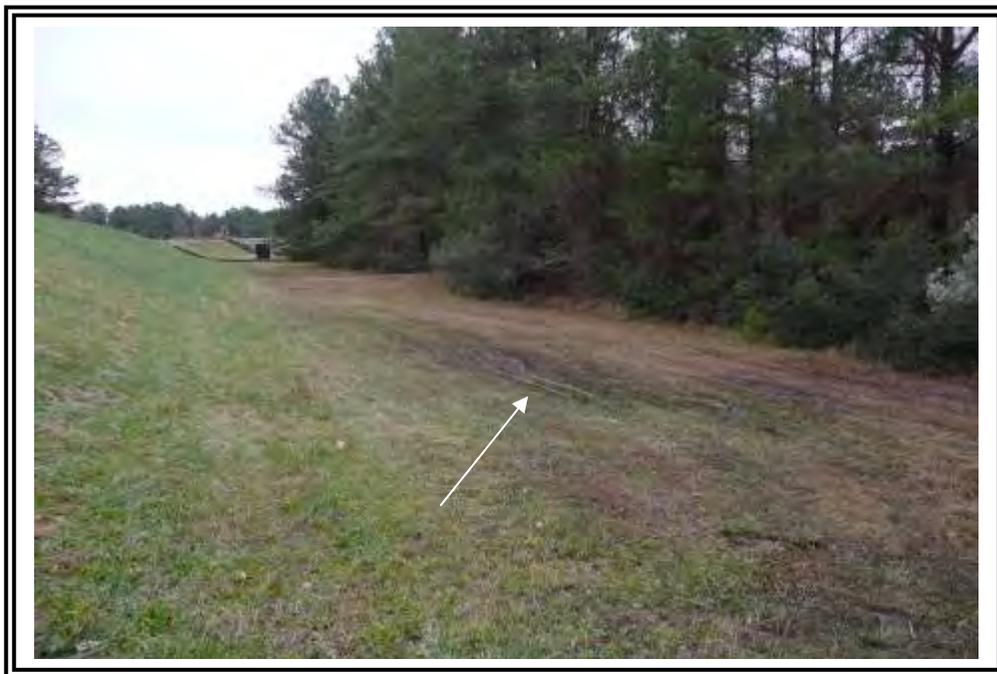
34

Central portion of Ash Pond C west dike toe facing south.  
One of two "soft spots" indicated by the arrow.

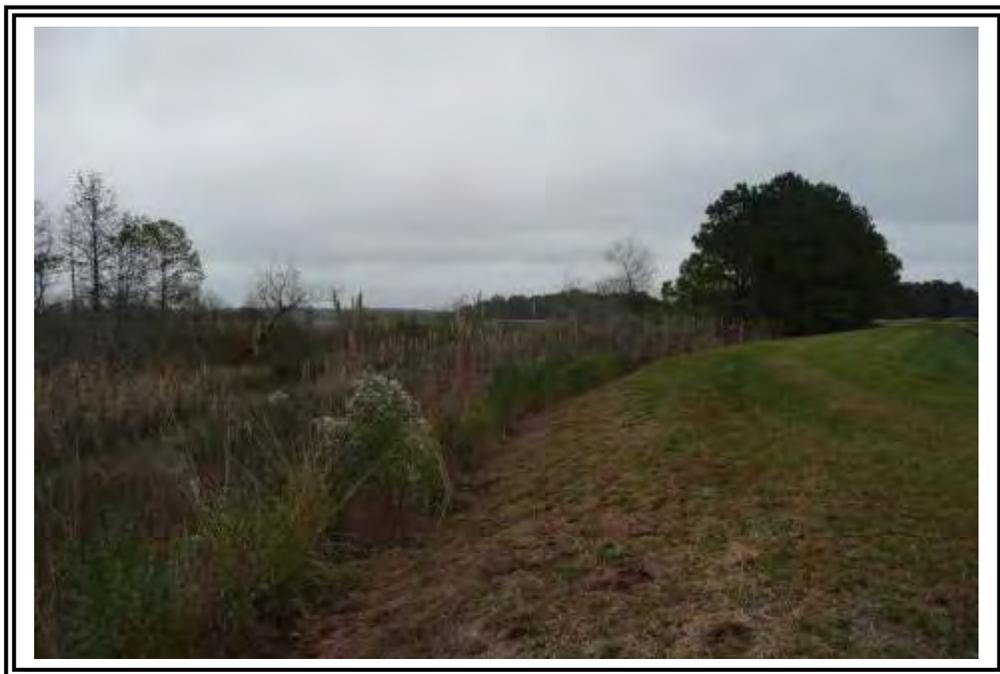
36

Ash Pond C, upstream dike edge shown at north portion of the west dike, facing south.

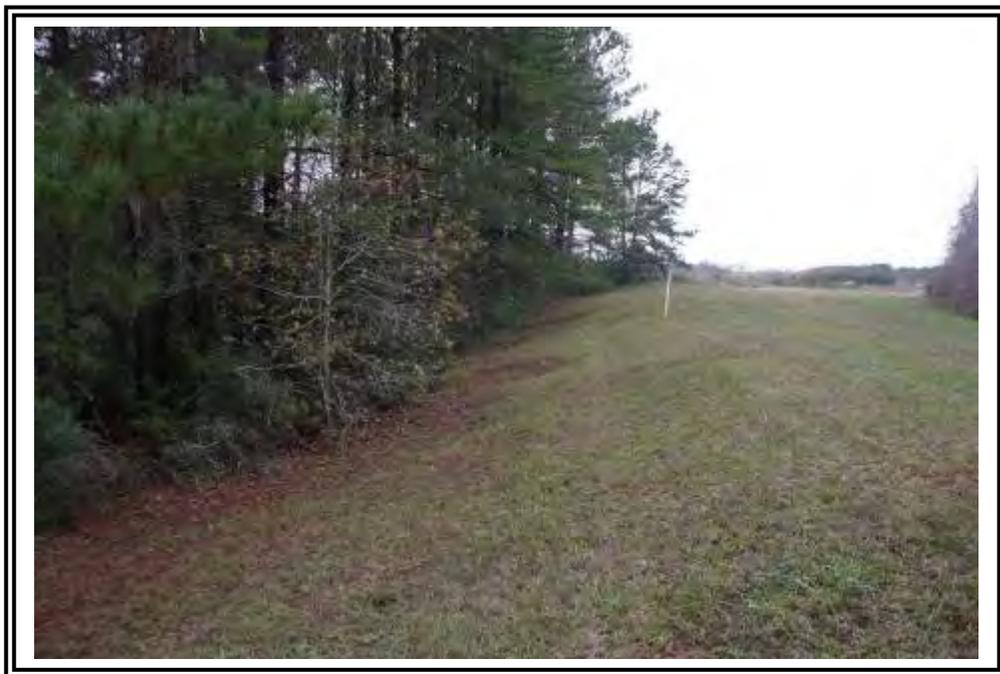
38

Ash Pond C, downstream edge of west dike at north end of dike, facing north.

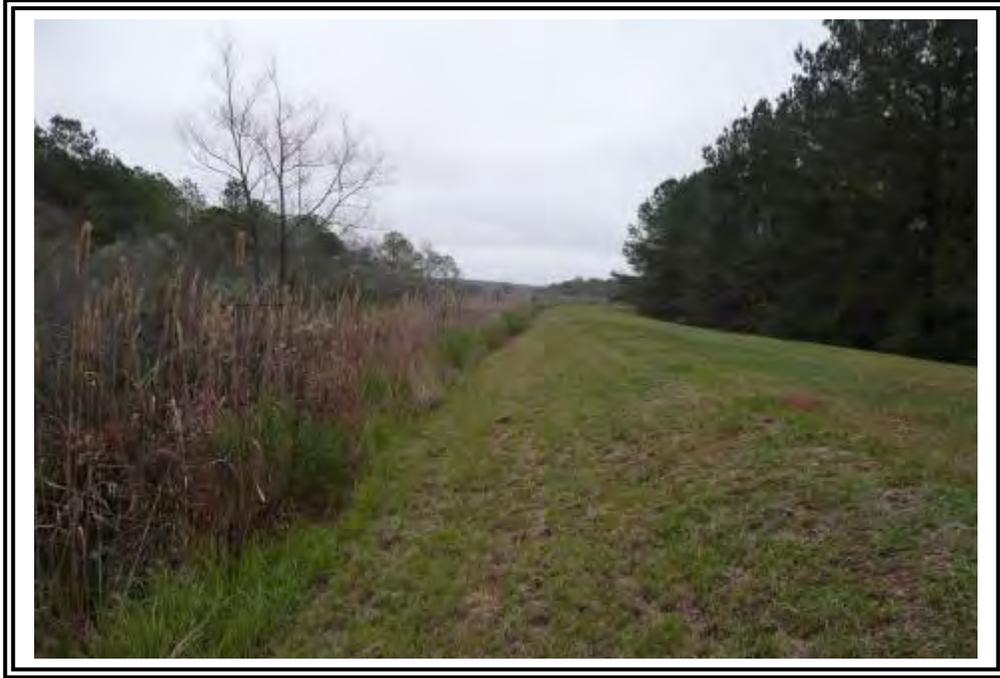
39

Ash Pond C, north end of west dike interior, facing south. Interior edge of dike shown frame left with vegetation present. Exterior edge of dike shown frame right with heavy vegetative cover present past dike toe.

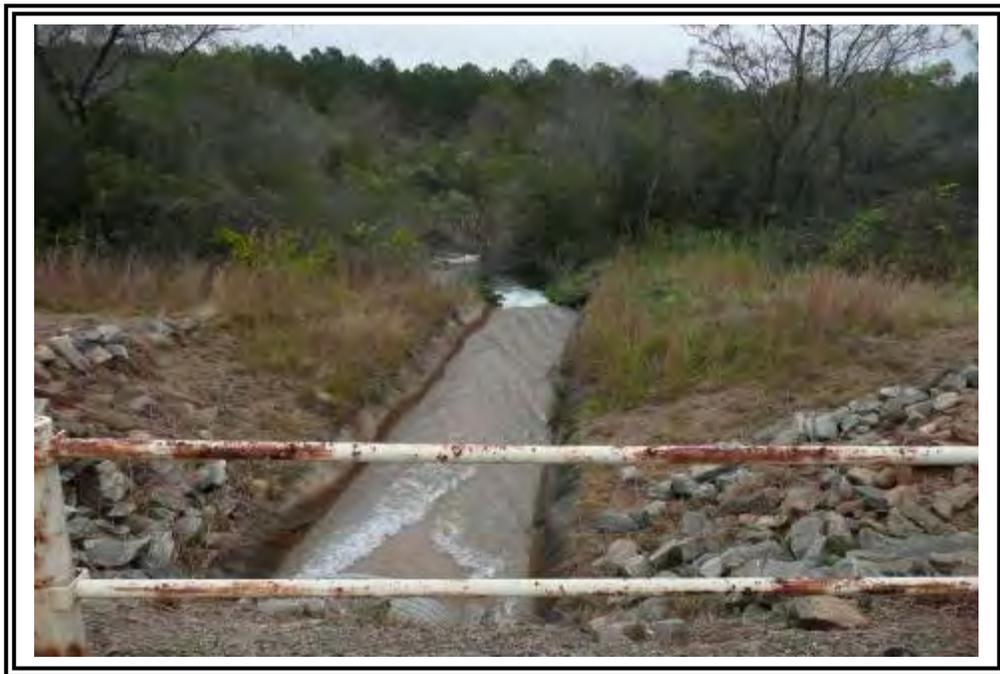
40

Overflow into Ash Pond C from atop the bridge facing southeast.

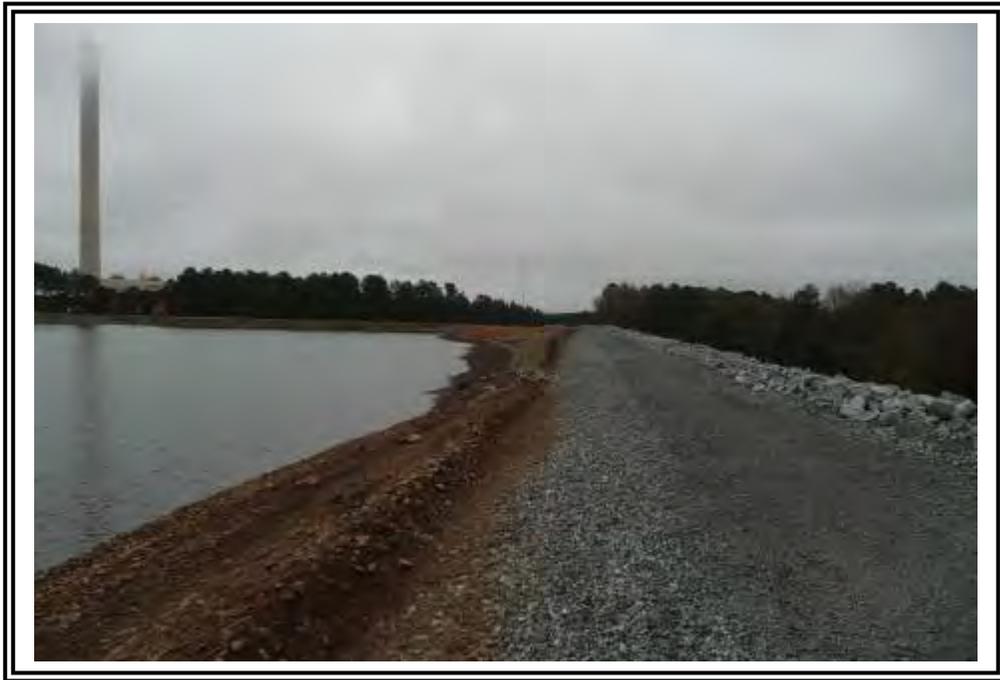
41

Ash Pond C, west end of south dike facing east.

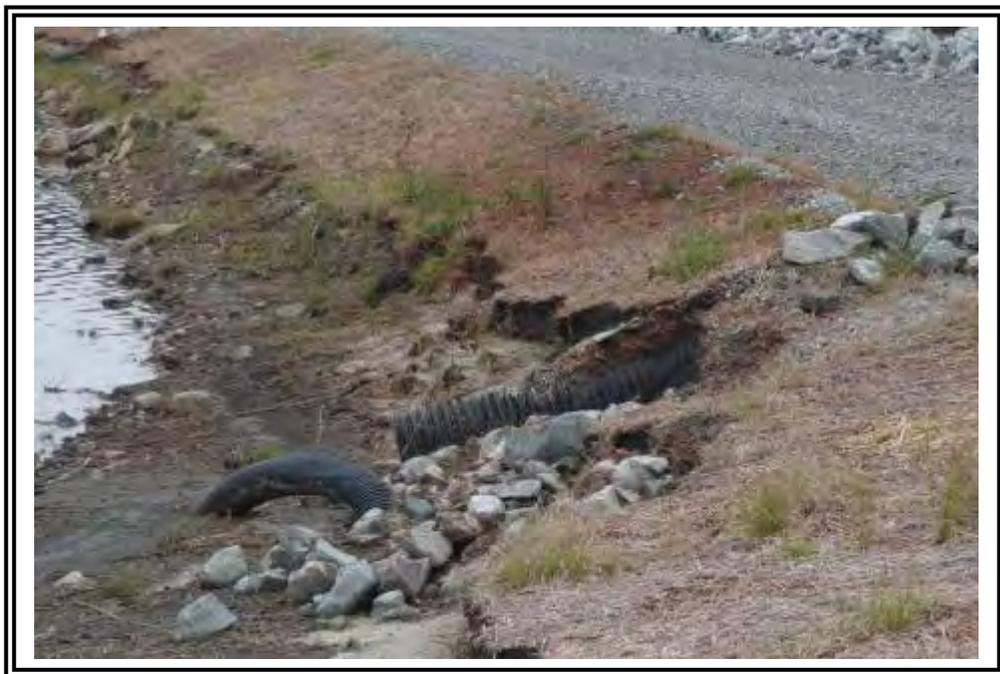
42

Upstream side of Ash Pond C west end of south dike facing east. Crest run-off drain shown.

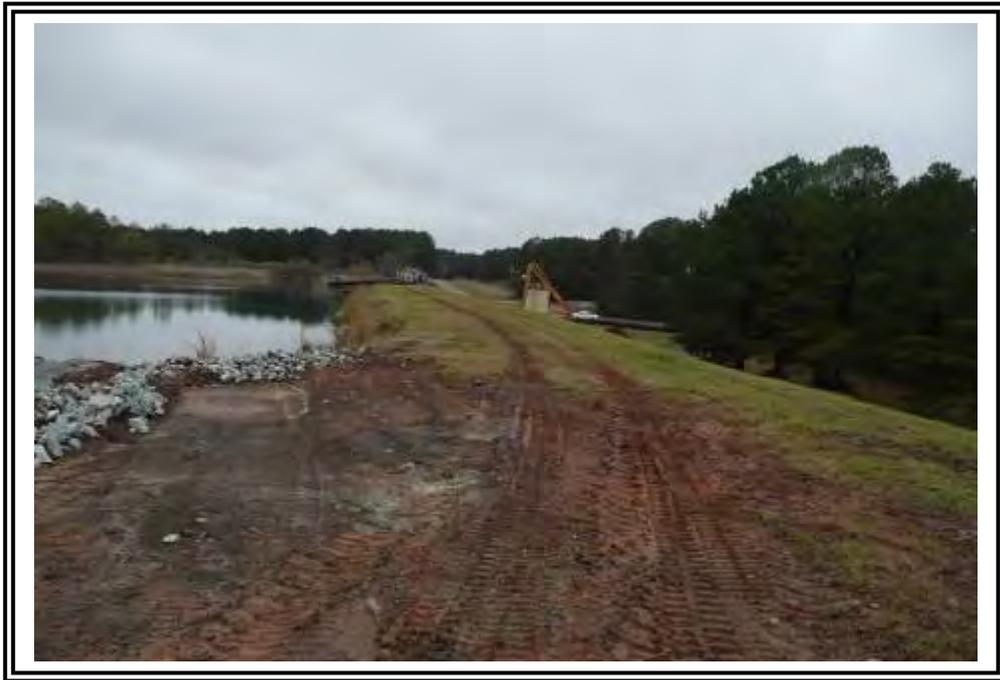
43

Ash Pond C, south end of east dike facing north.

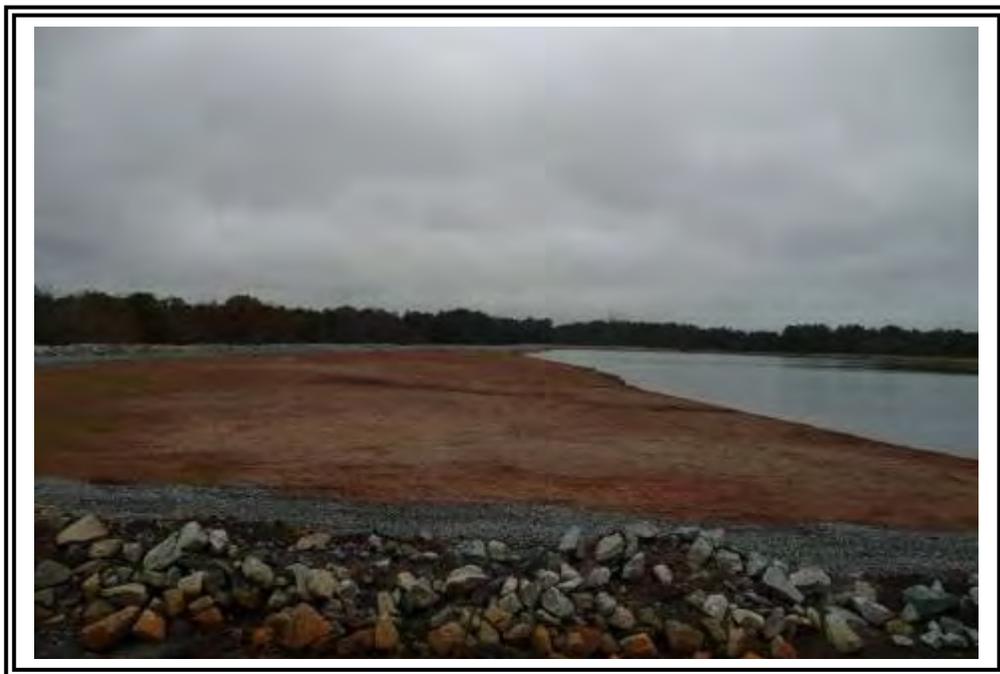
44

Ash Pond C, south end of east dike facing west. Southeast corner of Ash Pond C shown.

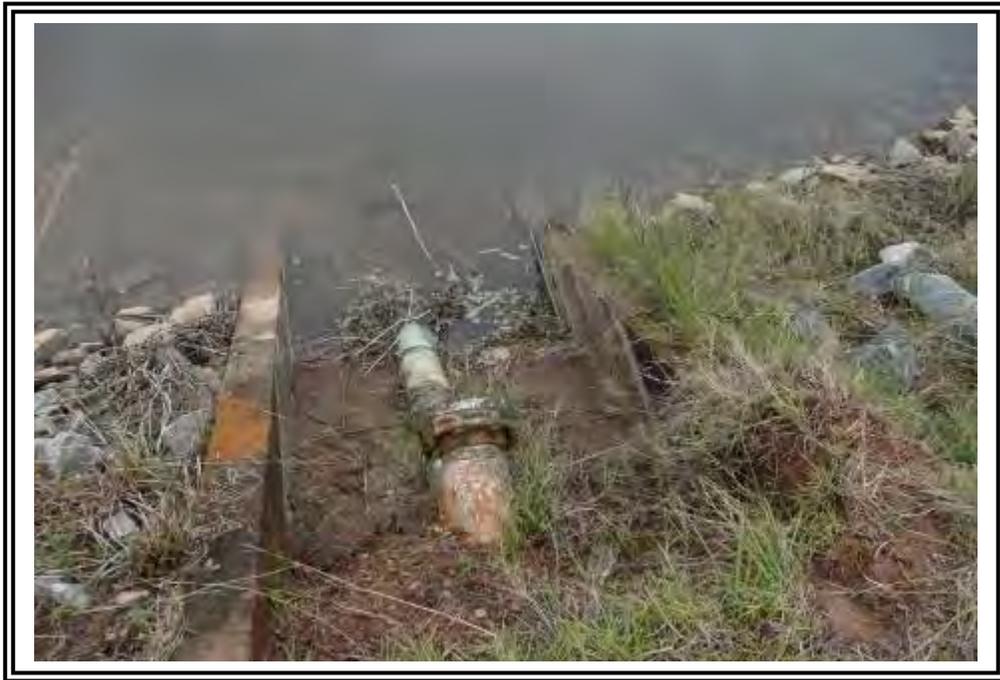
45

Ash Pond C, south end of east dike. Historic drain shown.

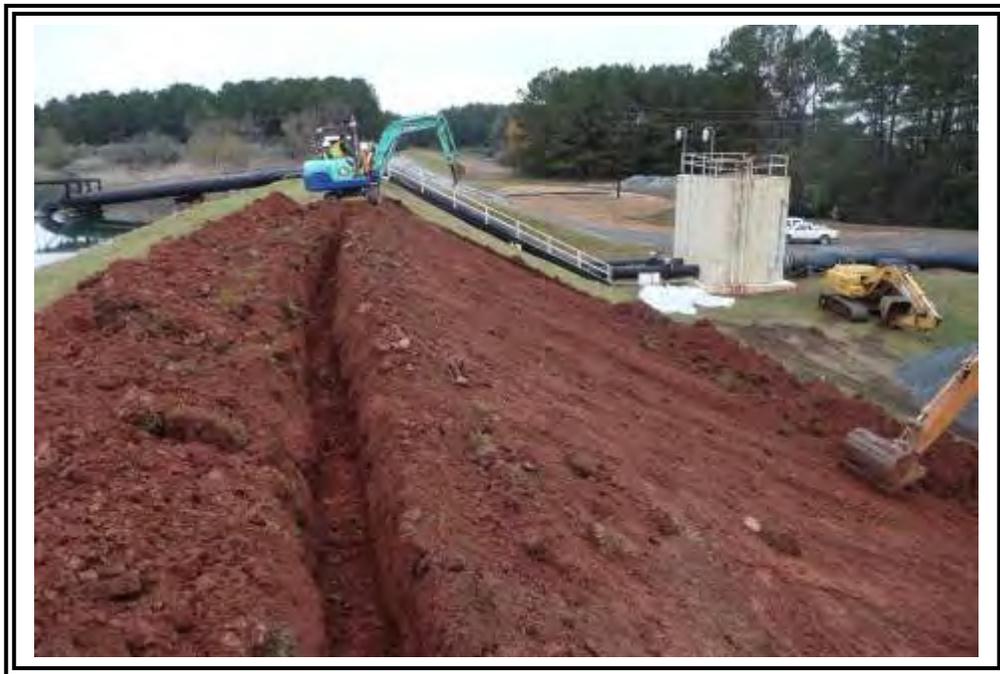
46

Ash Pond C, south central portion of east dike.  
Downstream dike re-facing with rip-rap under construction.

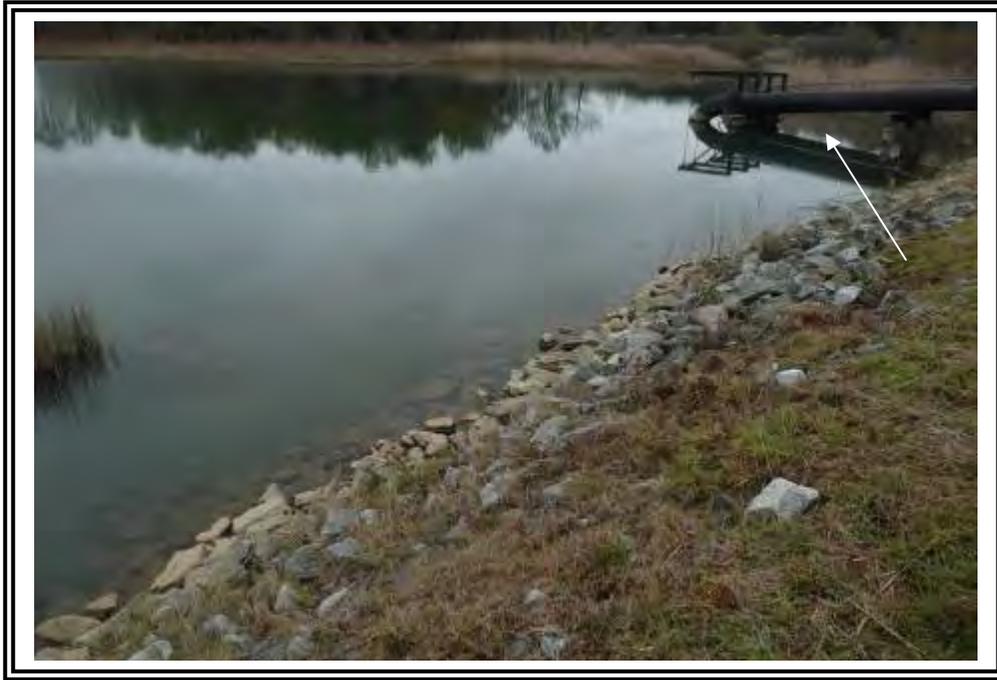
47

South central portion of Ash Pond C east dike, upstream slope shown with rip-rap.  
Re-cycle water system intake shown frame right.

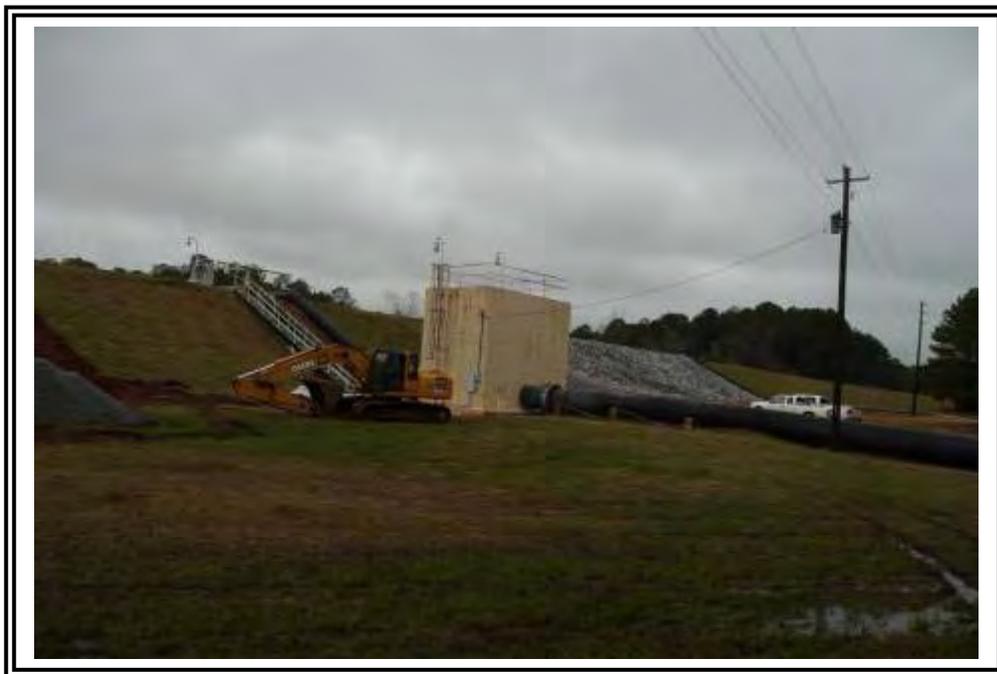
48

Ash Pond C, south central portion of east dike.  
Recycle water system shown. This system discharges recycle water to the plant.
