# Assessment of Dam Safety Coal Combustion Surface Impoundments (Task 3) Final Report

Georgia Power  
Company

Plant Branch

CHA Project No. 20085.2060.1510

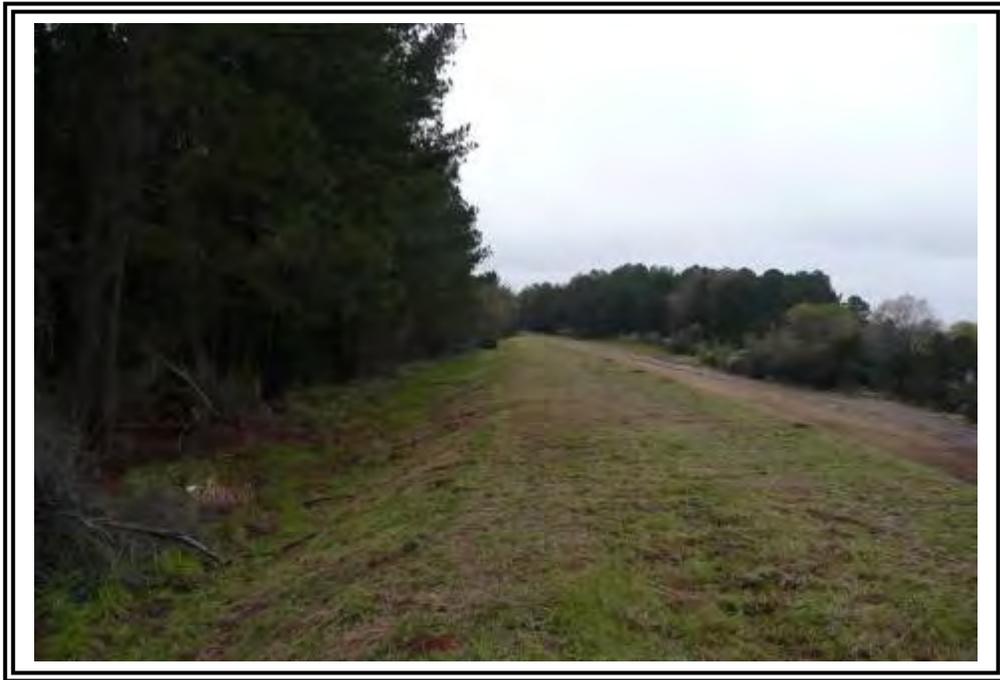
51

Ash Pond C, north portion of east dike facing north.

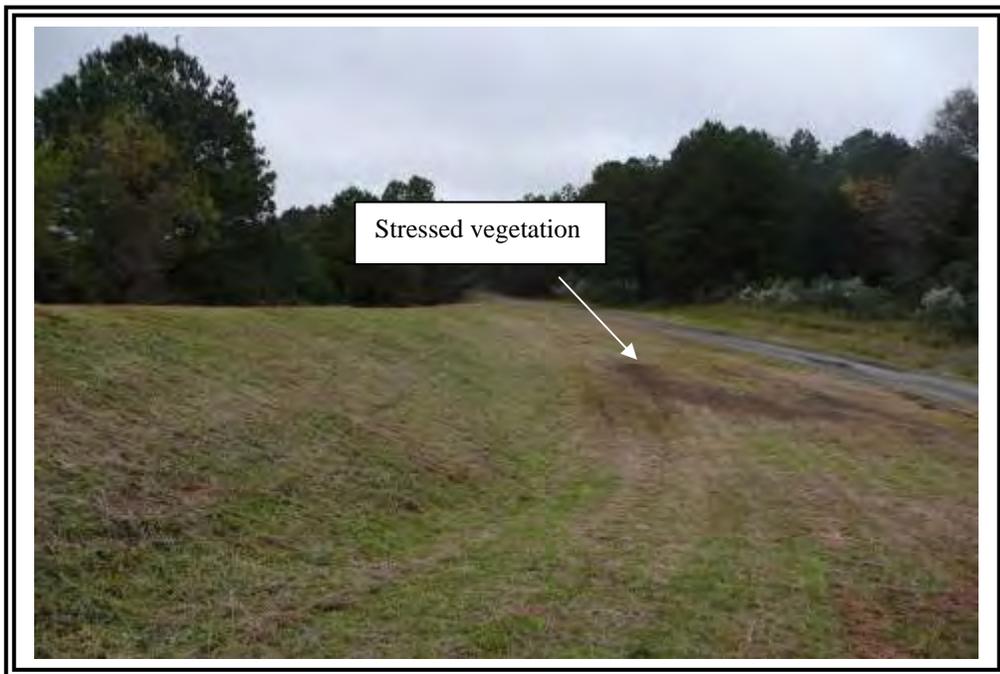
52

Ash Pond C, downstream slope at north end of east dike, facing north.  
Stressed vegetation shown frame right.

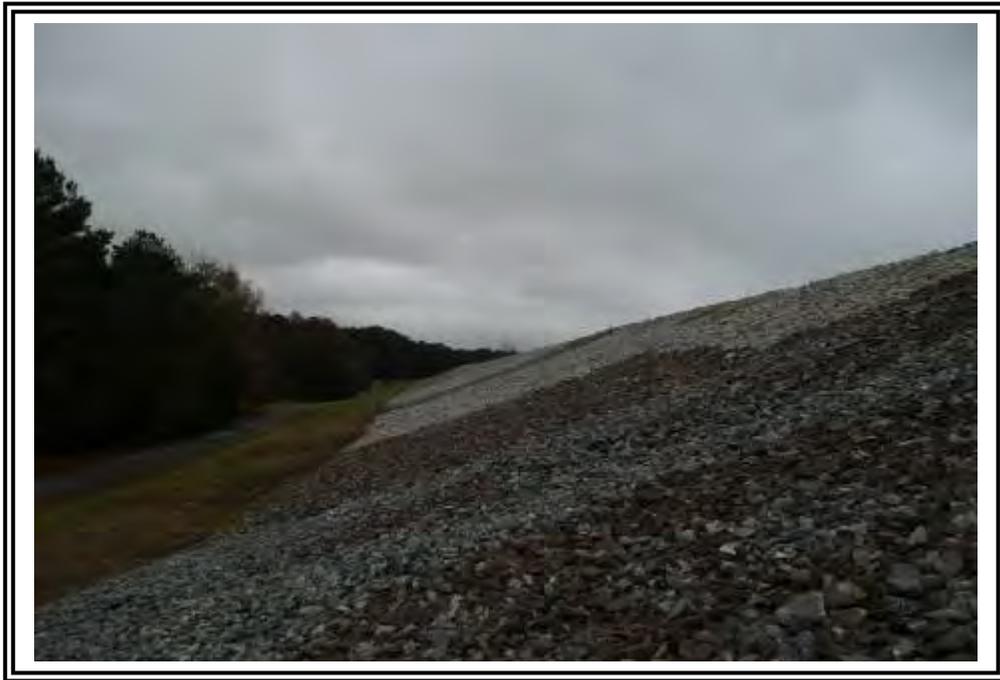
55

Ash Pond C, east end of south dike facing west.  
Downstream slope shown with rip-rap facing.

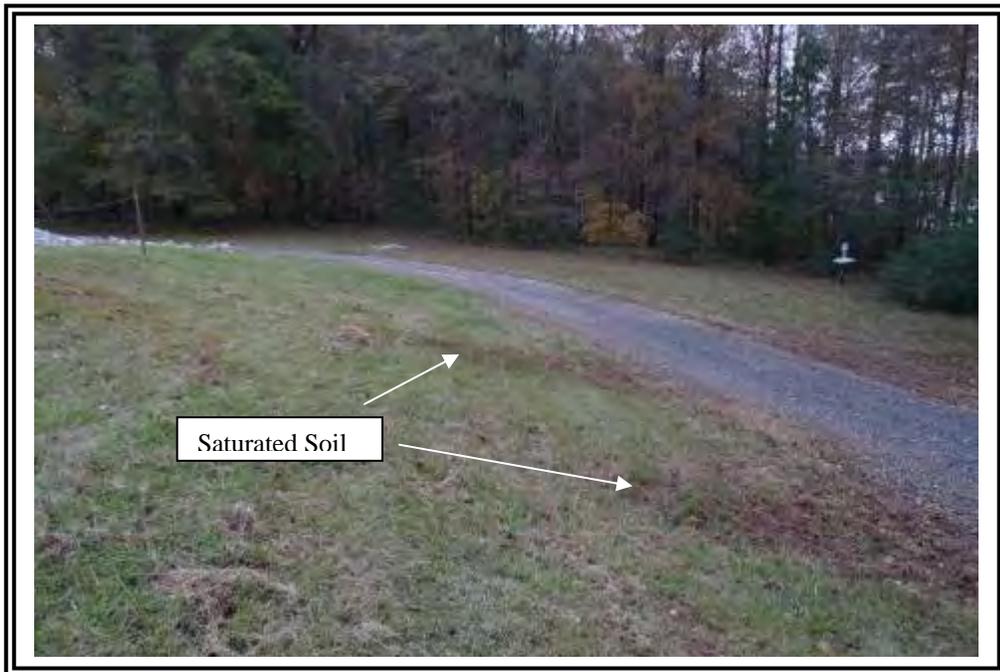
56

Ash Pond C, east end of south dike at the toe, facing east. Two saturated areas shown  
(several located in this area).

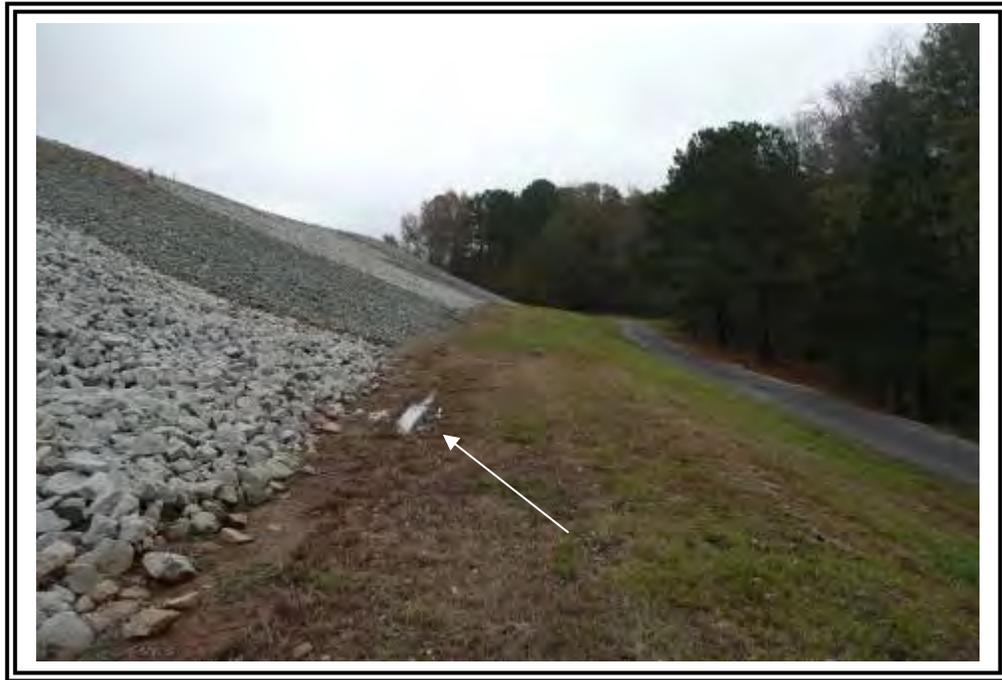
57

Ash Pond C, central portion of south dike along toe facing east.  
Water due to rainfall shown frame left.

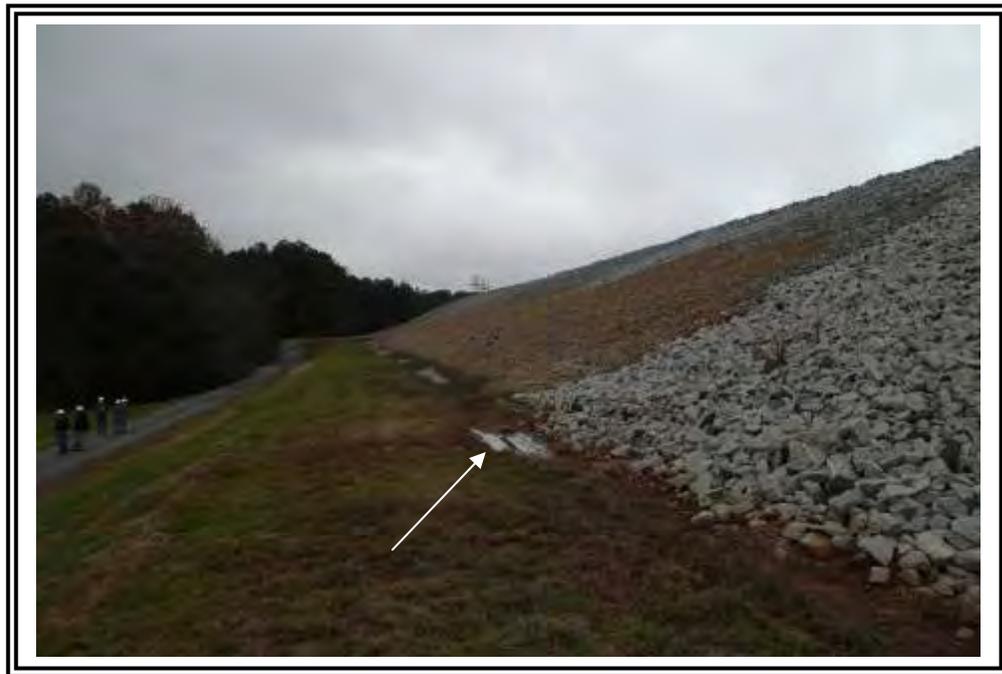
58

Ash Pond C, central portion of south side facing west. Water due to rainfall shown frame right.

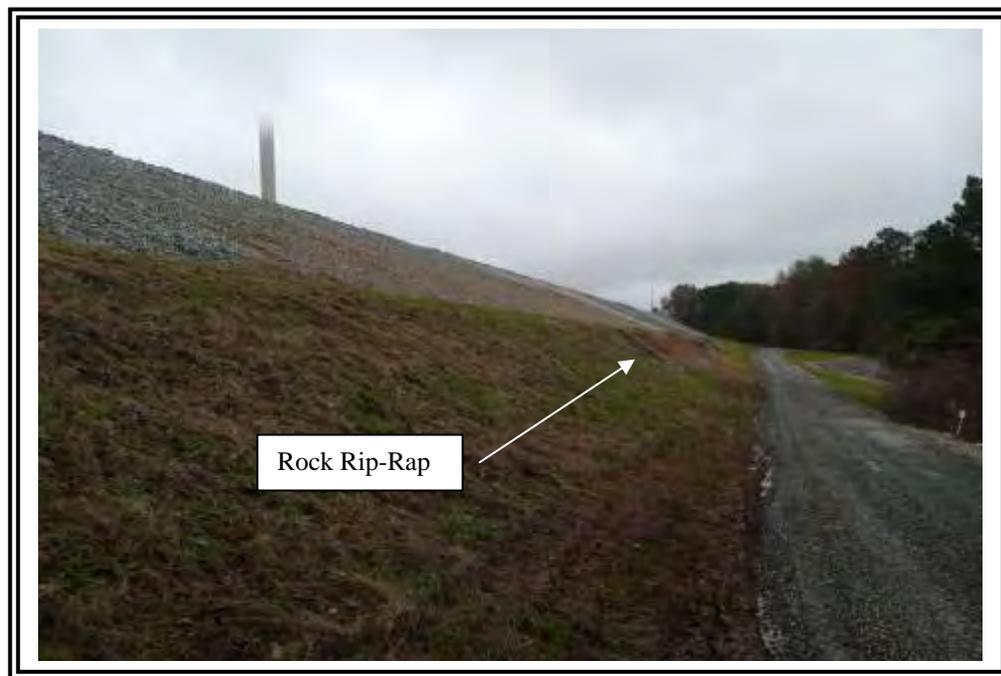
60

Ash Pond C, western central portion of south dike facing east. Toe re-faced utilizing rock rip-rap.

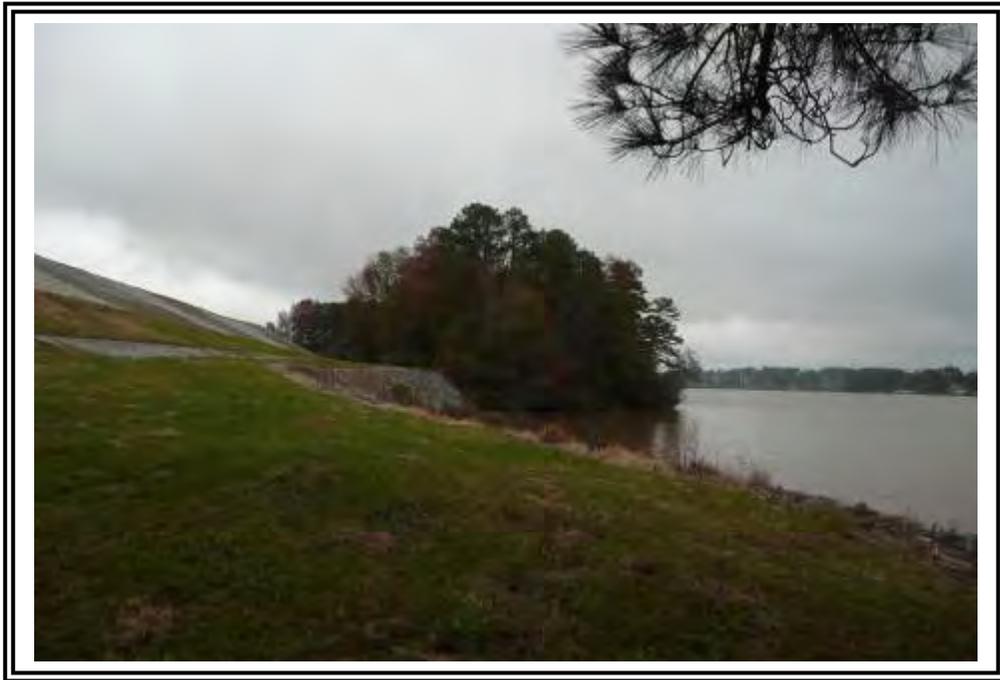
61

Ash Pond C, western central portion of south dike, facing east, adjacent south of toe.

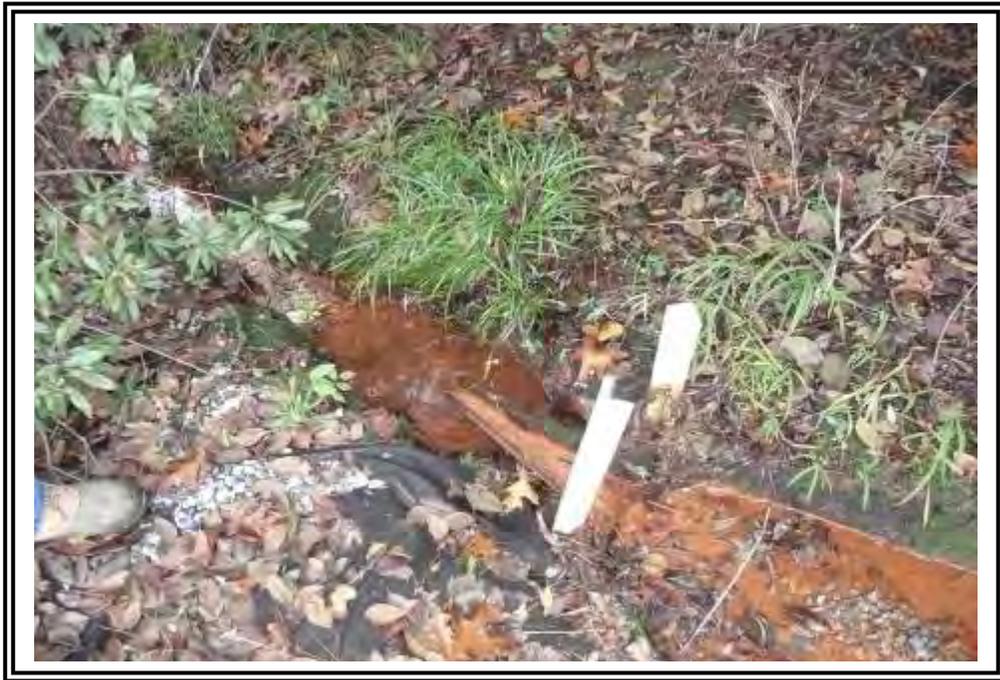
63

Ash Pond C, west end of south dike. Seepage weir shown.

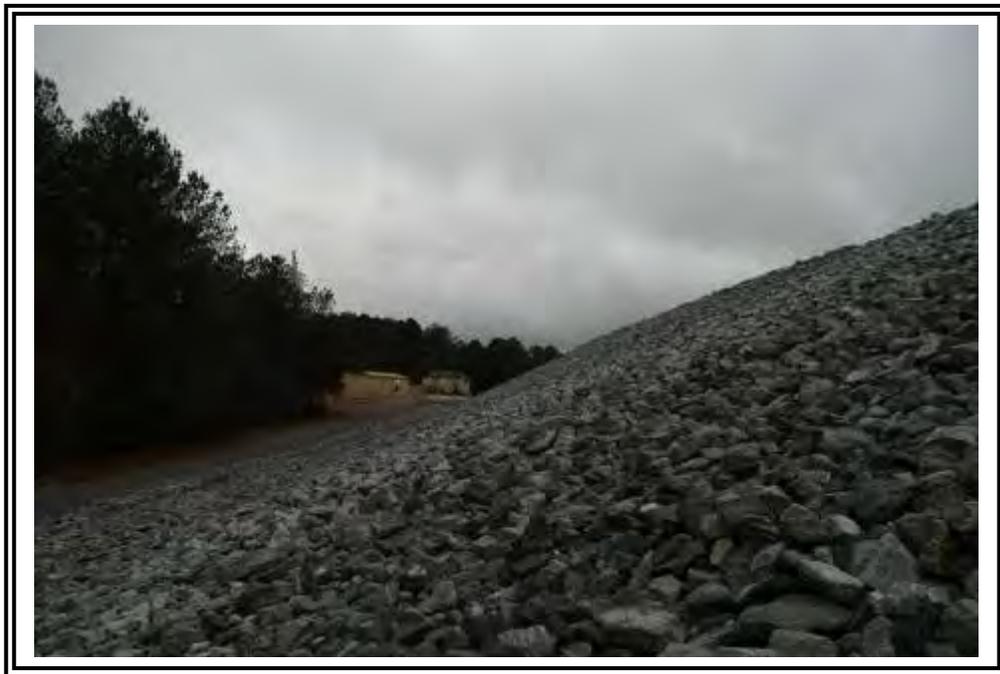
64

Ash Pond C, west end of south dike facing west. Rock rip-rap facing on dike exterior shown.

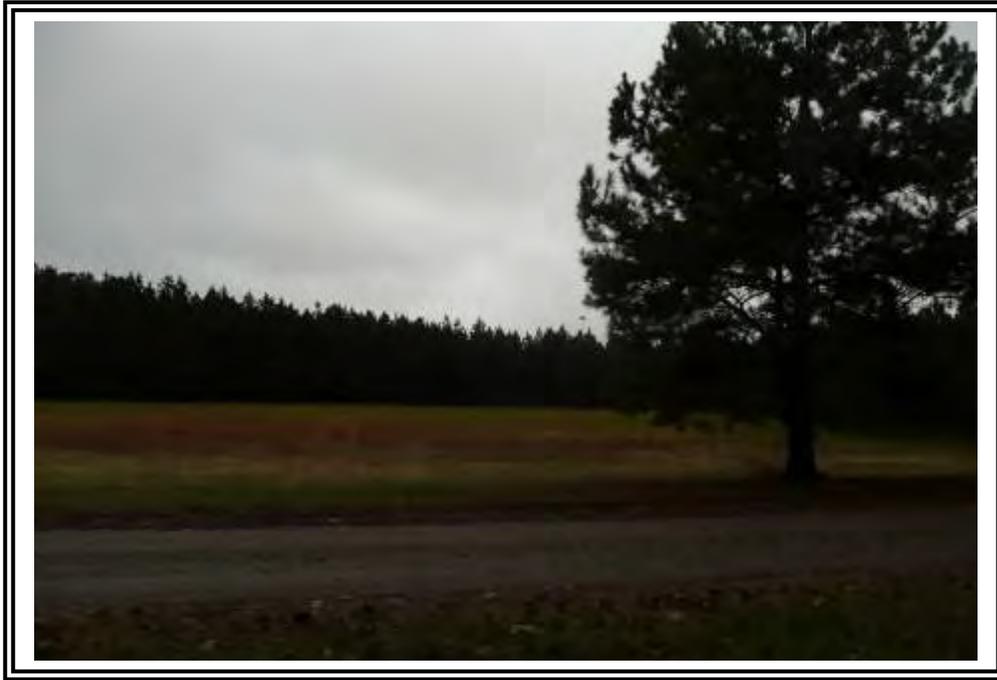
65

Ash Pond B, central portion of dike crest, facing north into area of pond filled with bottom ash and covered with topsoil.

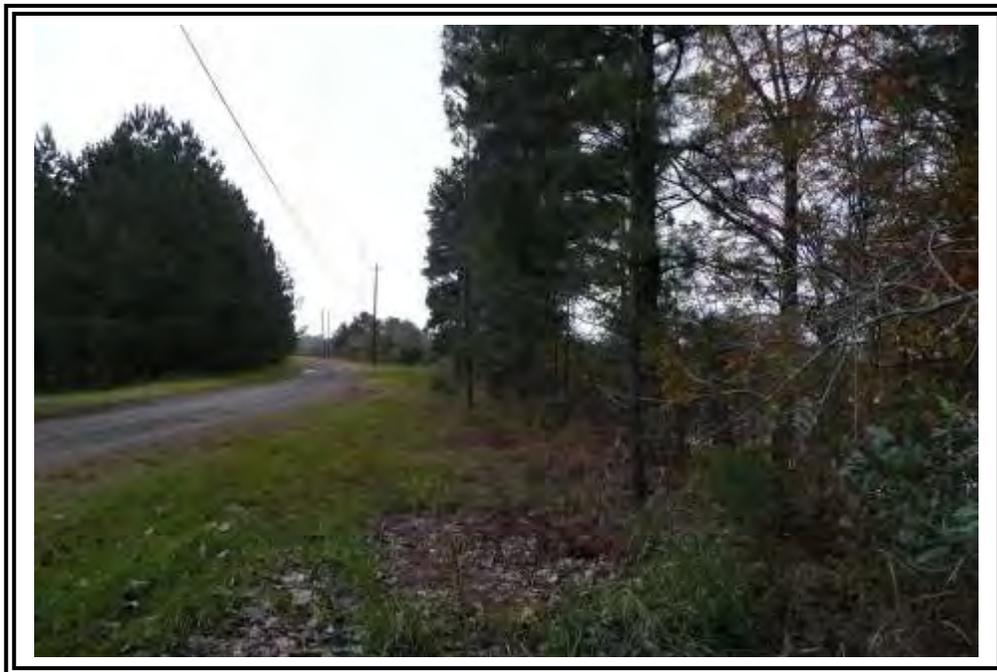
66

Ash Pond B, central portion of dike facing east. Downstream slope of dike shown frame right with vegetation present. Interior edge of dike shown frame left with vegetation (tree cover) present along eastern end of the pond.

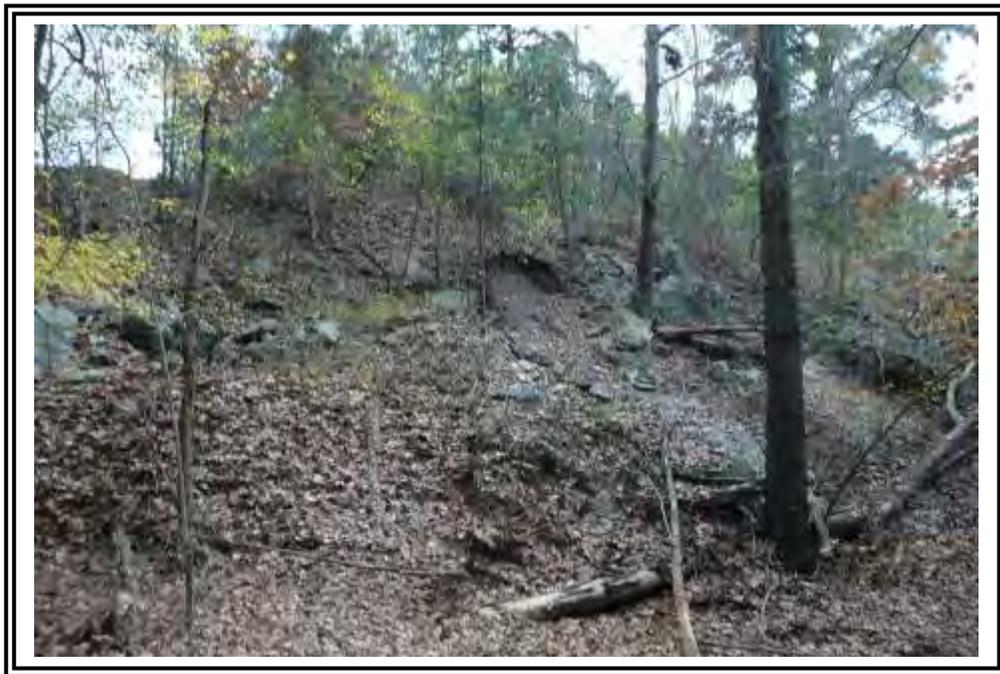
68

Ash Pond B, central portion of dike facing north, along the toe. Exterior of dike shown with large boulders and vegetative growth.

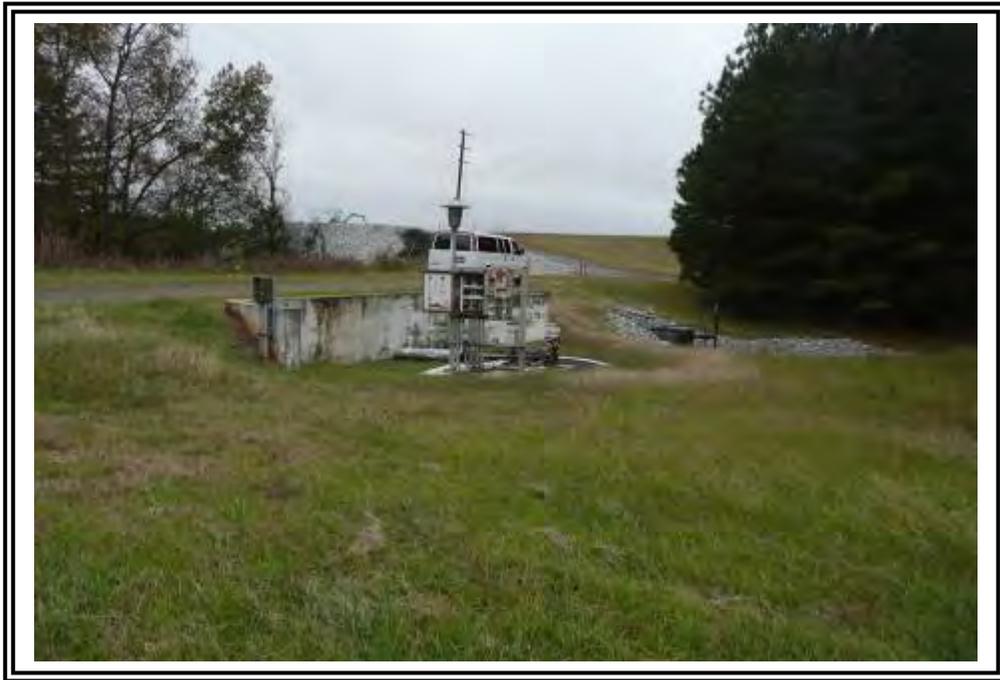
69

Ash Pond B, west end of dike. Emergency spillway (black pipe in background) and abandoned primary discharge facility shown.

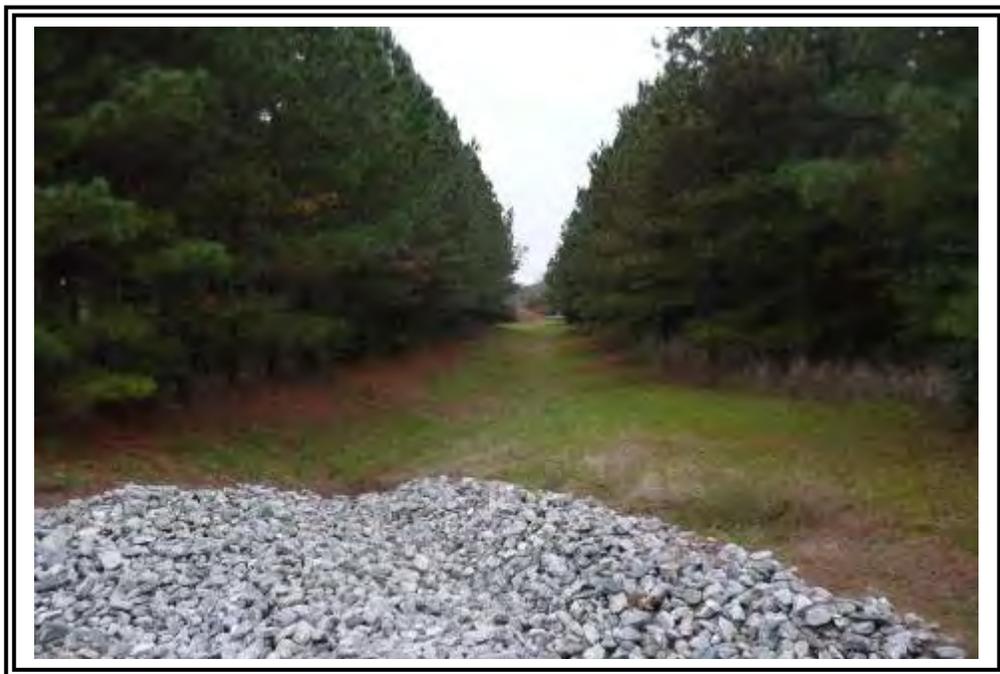
70

Ash Pond B, west end of dike facing north, at emergency spillway and site drainage open channel. Inlet protection for emergency spillway into discharge facility shown.

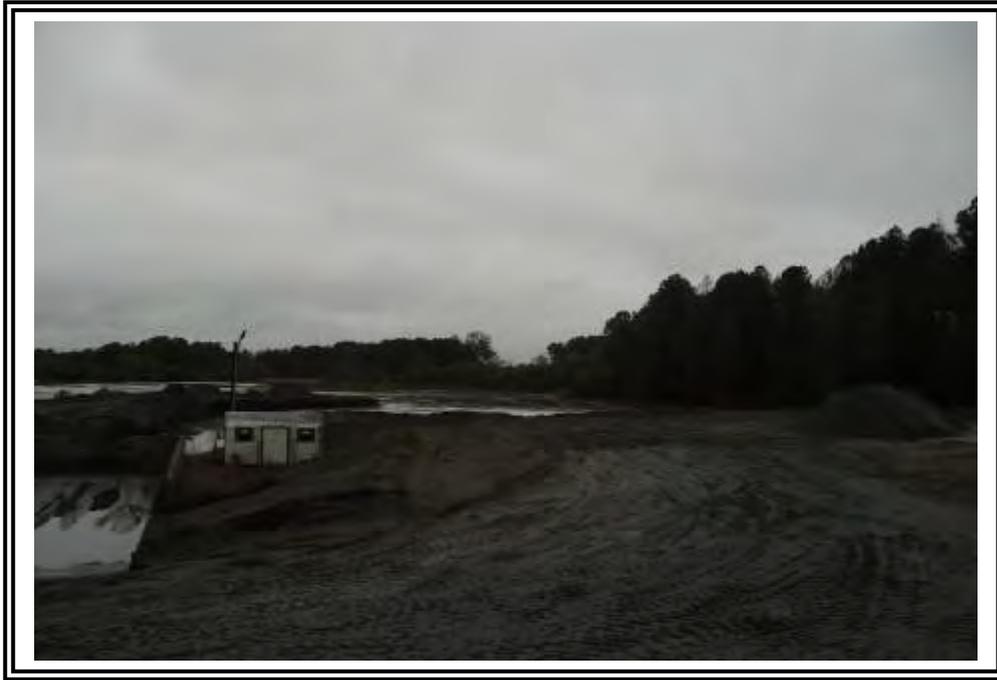
71

Ash Pond B, north end of pond along eastern edge facing west. Shown is the portion of Ash Pond B unfilled with bottom ash. Ash processing facility shown frame left.

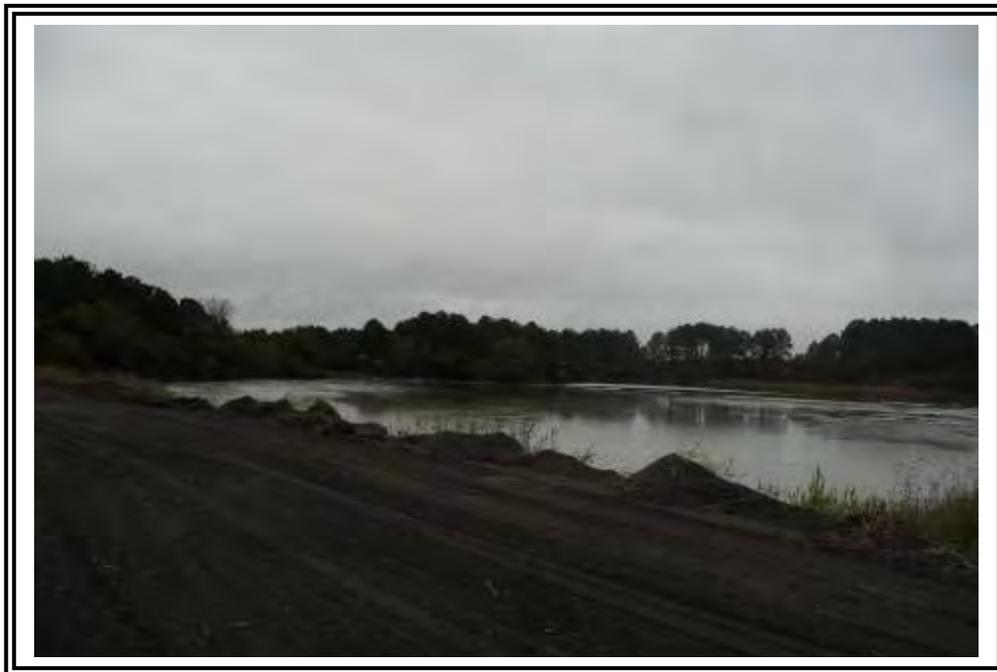
72

Ash Pond B, north end of pond along eastern edge facing south west. Shown is portion of the pond remaining unfilled with bottom ash. Frame left and furthest shows the area of Ash Pond B filled with bottom ash, covered with topsoil, and vegetative cover.
