# **Assessment of Dam Safety of Coal Combustion Surface Impoundments**

**PowerSouth Energy Cooperative**

**Charles R. Lowman Power Plant**

**August 6, 2010**

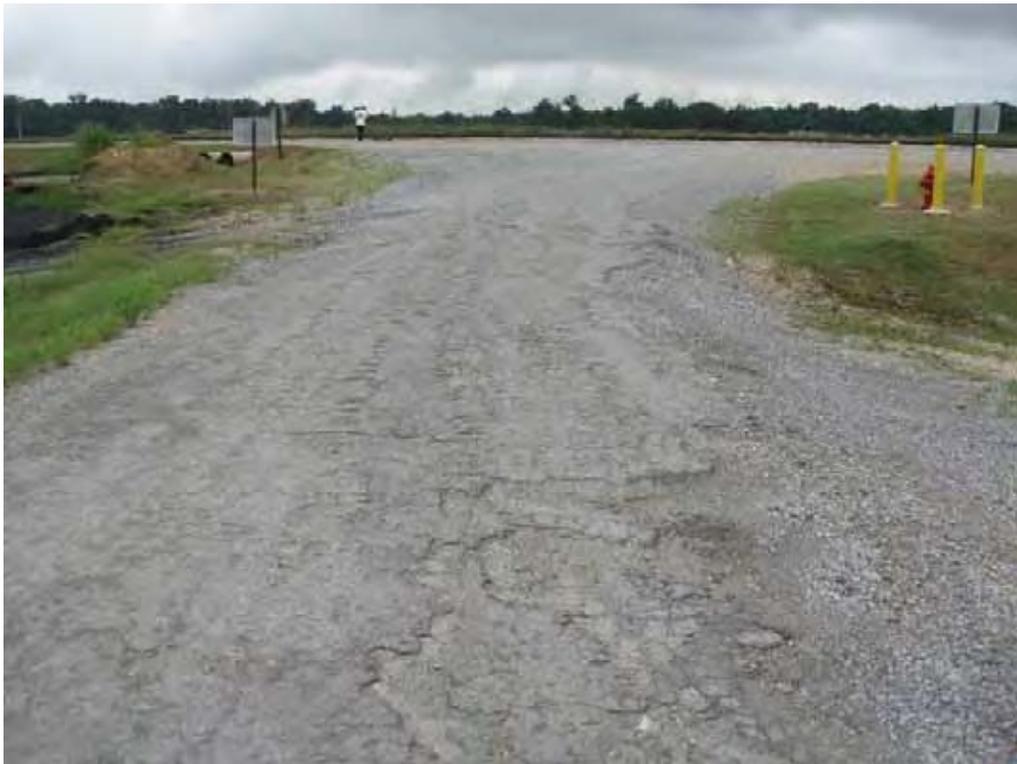
**Photo No. 1: #1 Bottom Ash Pond – North embankment crest looking west.**

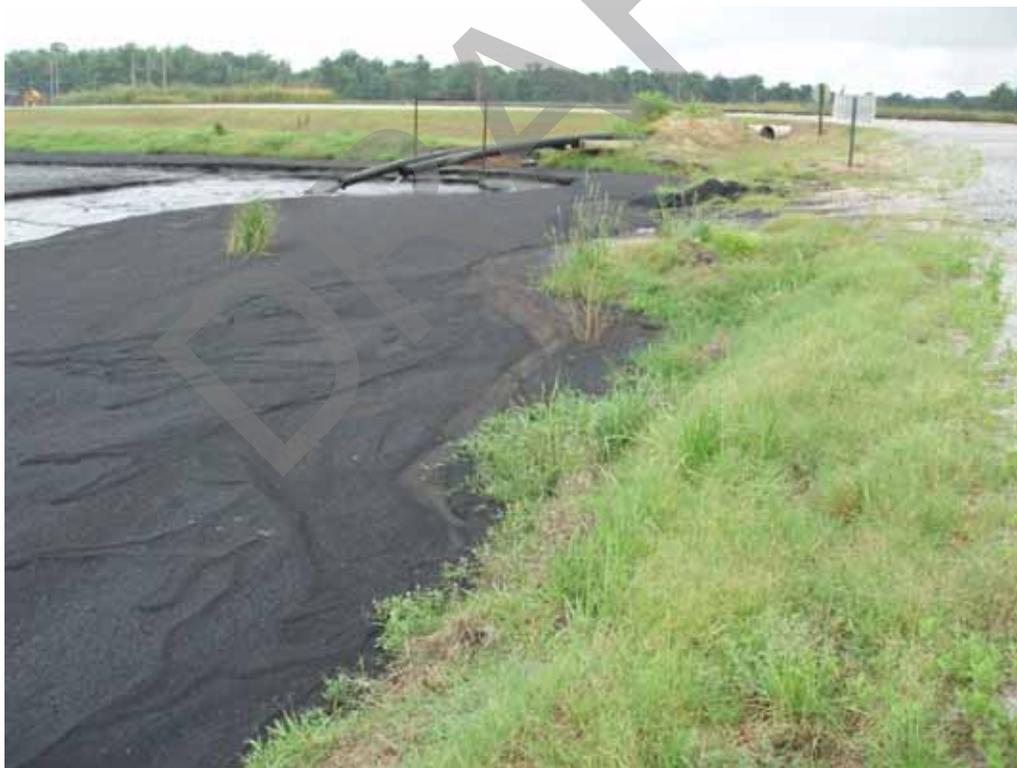
**Photo No. 2: #1 Bottom Ash Pond – North embankment interior slope, looking west. Looking at sluce line discharge from Units 2 & 3.**

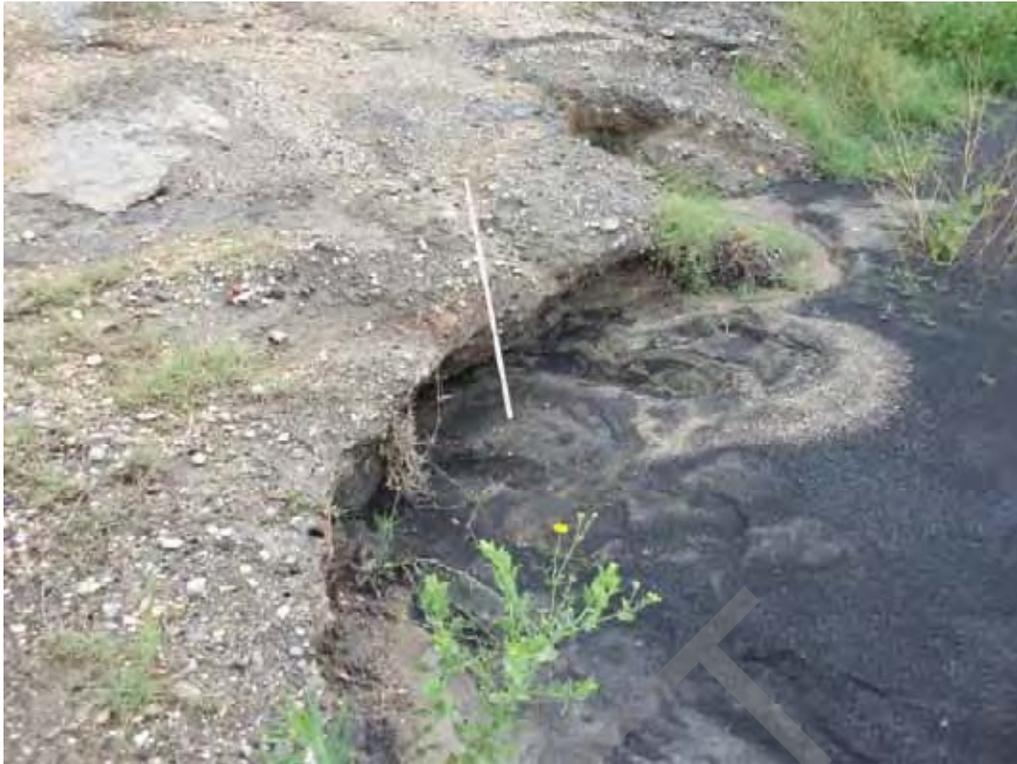
of the slope (Photograph 6). Light vegetation less than 6 inches tall covers the interior embankments to the high water line, where the surface is void of protective cover and embankment fill materials are subject to erosion (Photographs 3, 4, 15, and 25). No armoring of the interior slope is present, and approximately half of the pond's interior surface consists of exposed ash product.

**Photo No. 3: #1 Bottom Ash Pond – North embankment interior slope, looking east. Ash product covering slope.**

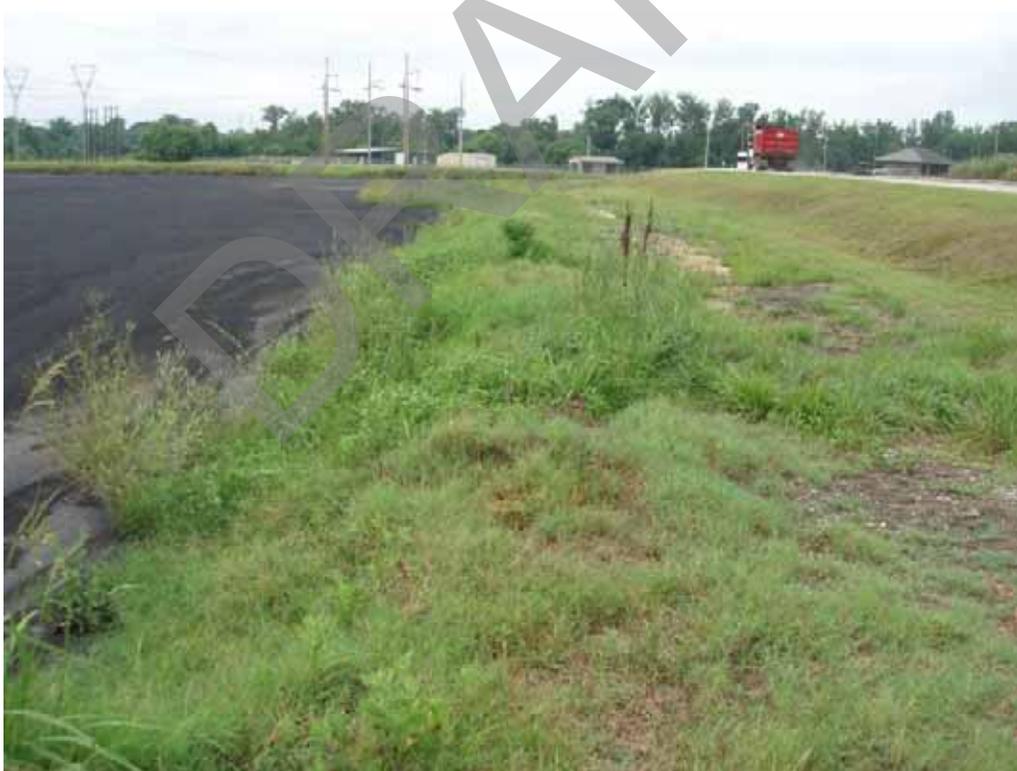
**Photo No. 4: #1 Bottom Ash Pond – West embankment interior slope, looking south.**

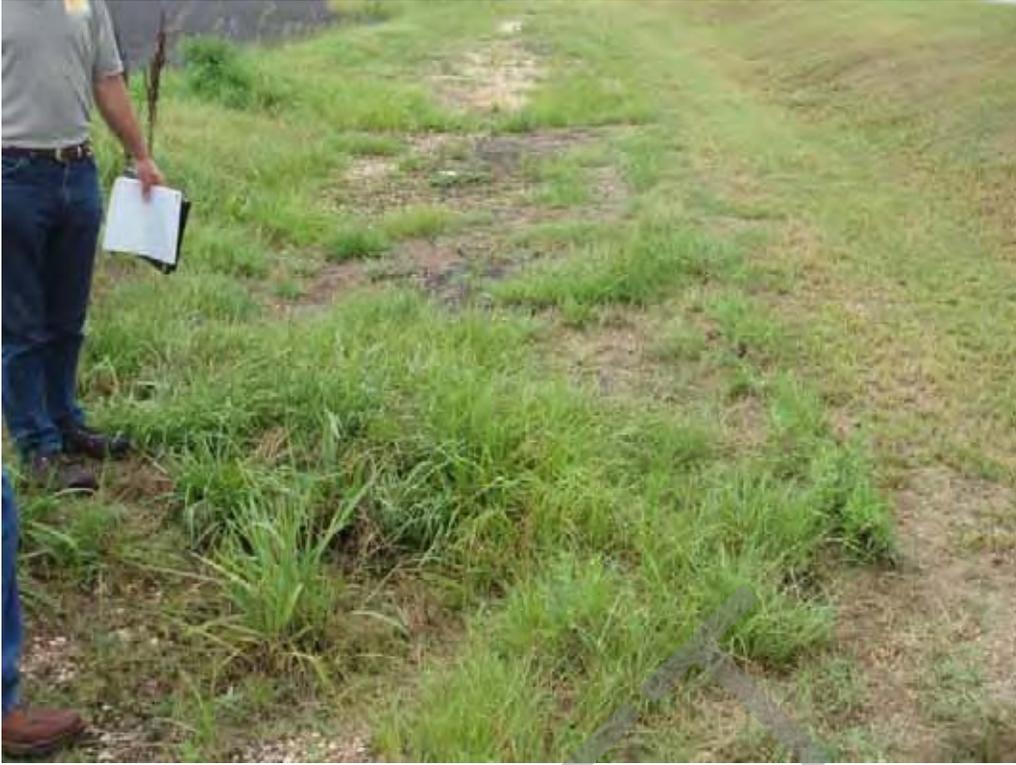
**Photo No. 5: #1 Bottom Ash Pond – West embankment interior slope, looking south, typical vegetation.**

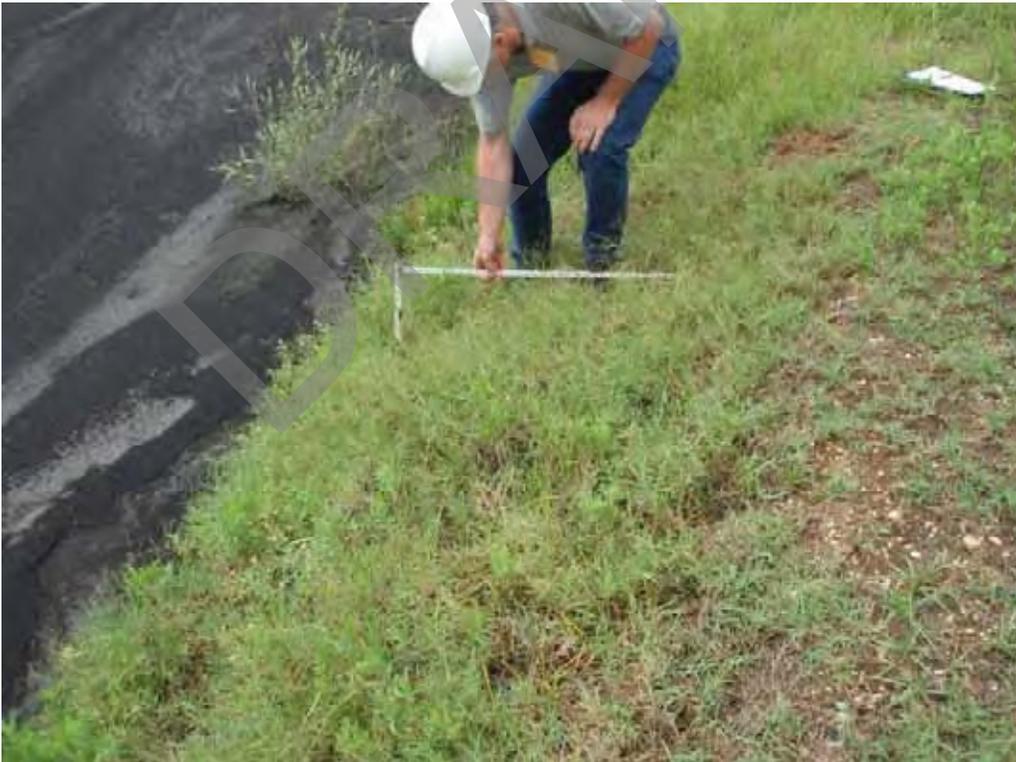
The interior slopes appear to be in poor condition. The upper 8 to 10 feet of the embankment interior slopes are approximately 2H:1V and 3H:1V towards the bottom

**Photo No. 6: #1 Bottom Ash Pond – West embankment interior slope. 3H:1V slope measured toward bottom of slope, 2H:1V measured on upper 8 to 10 feet.**

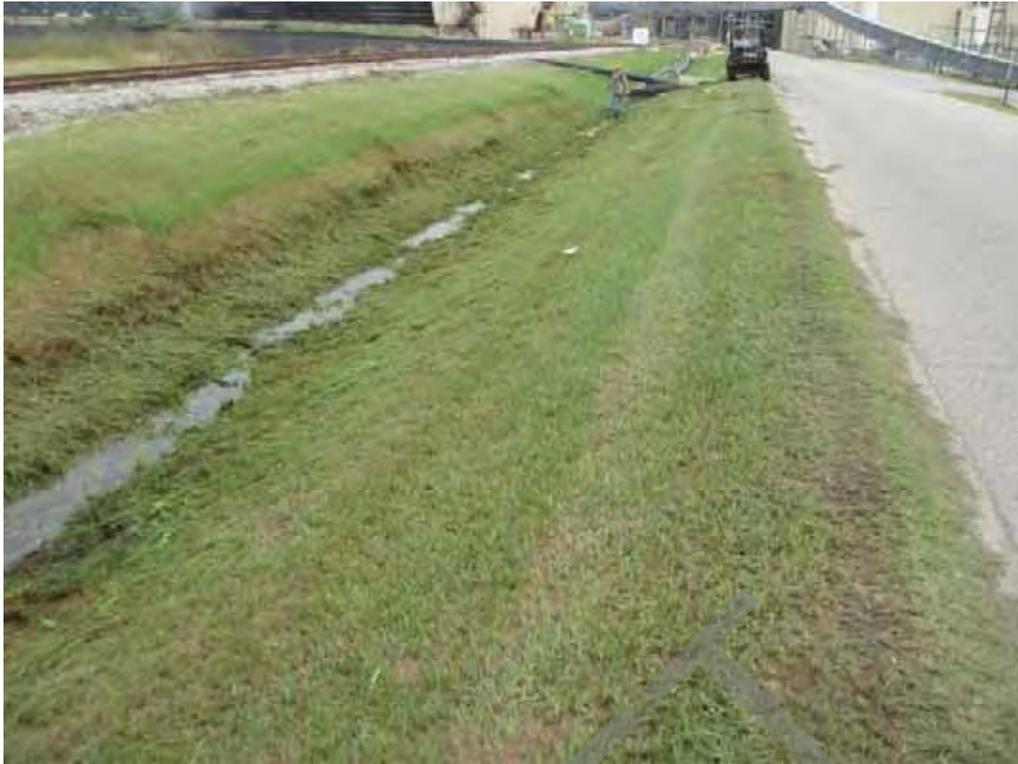
**Photo No. 7: #1 Bottom Ash Pond – West embankment exterior slope, looking north. Note standing water in drainage ditch at toe.**

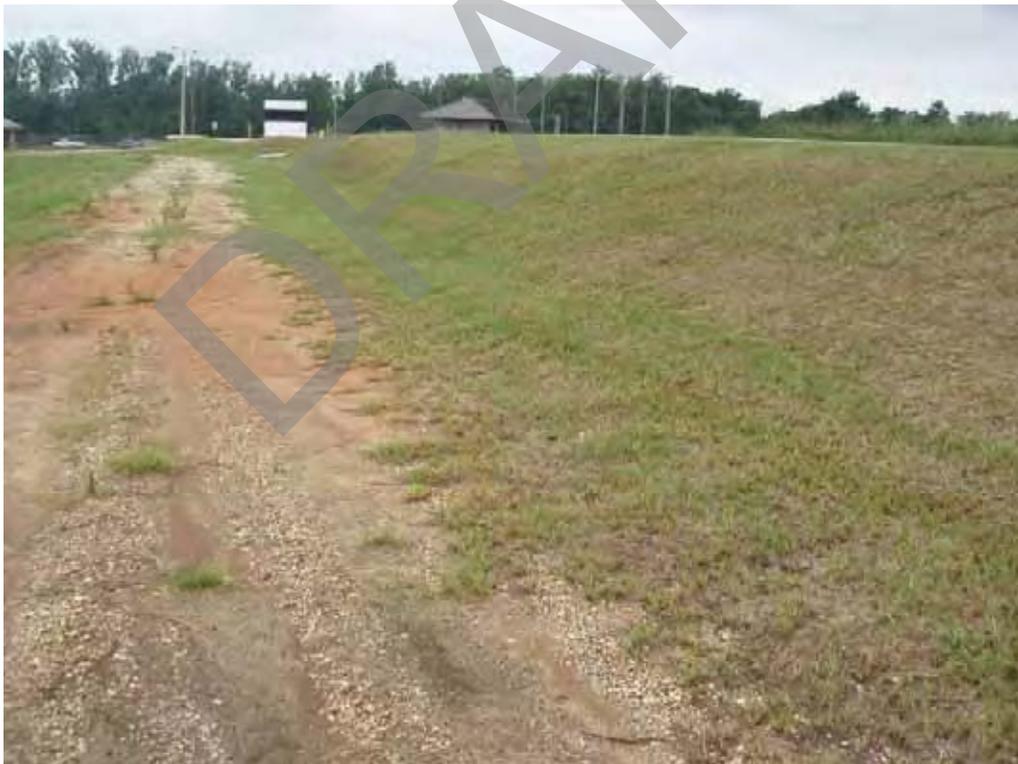
The crest of the #1 Bottom Ash Pond appeared to be in good condition (Photographs 40, 8, 13, and 30). The crest was approximately 20 feet wide with the exception of the west embankment that was approximately 35 feet wide. The north, west, and east crests are exposed to vehicle traffic. The surface of the crests, exposed to traffic, consists of compacted granular soils on the north and east embankments, and asphalt paving on the west embankment.

**Photo No. 8: #1 Bottom Ash Pond – West embankment crest, looking south. Plant access road embankment on right.**

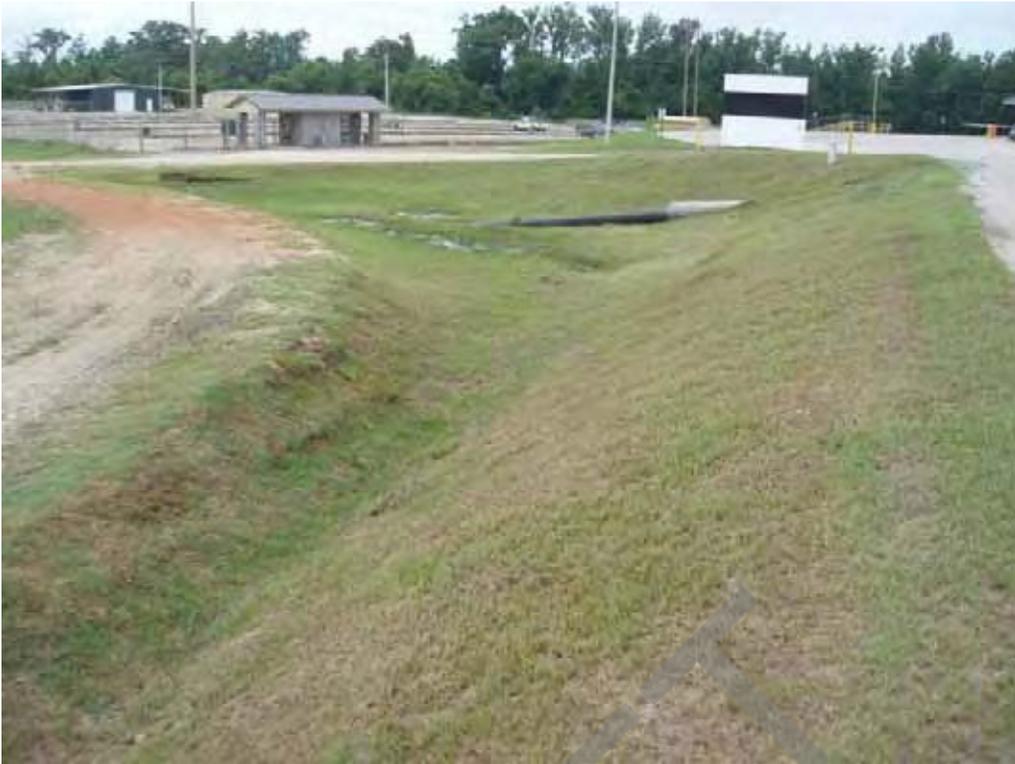
**Photo No. 9: #1 Bottom Ash Pond – West embankment crest, looking south.**

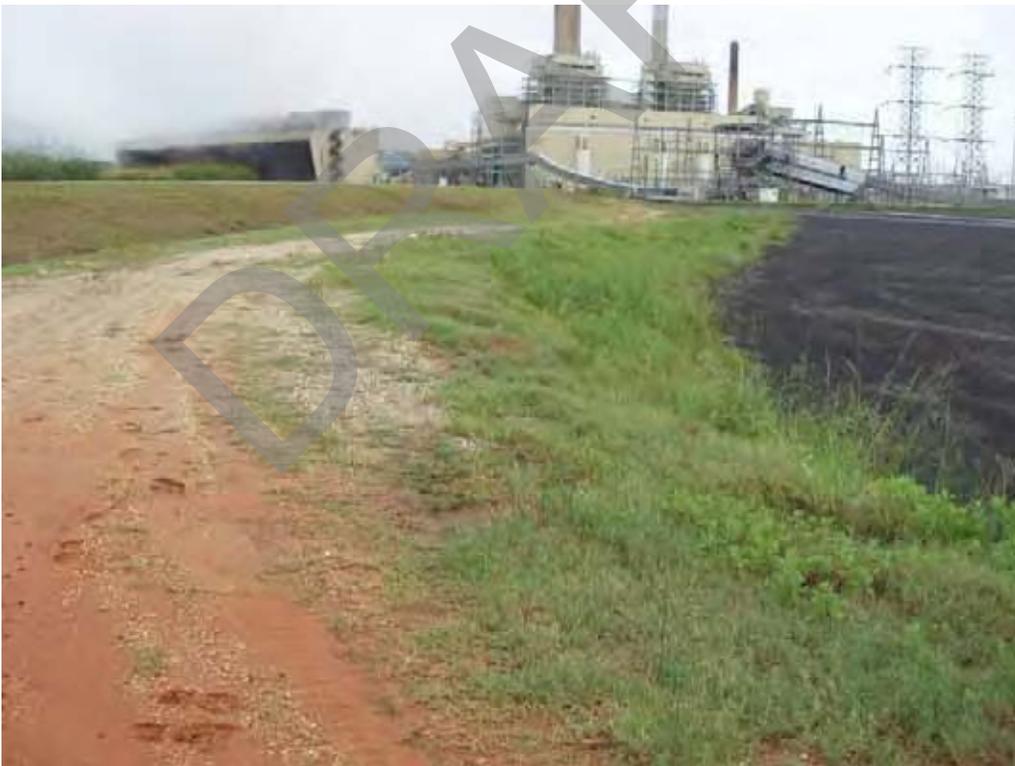
**Photo No. 10: #1 Bottom Ash Pond – West embankment interior slope, looking north.**

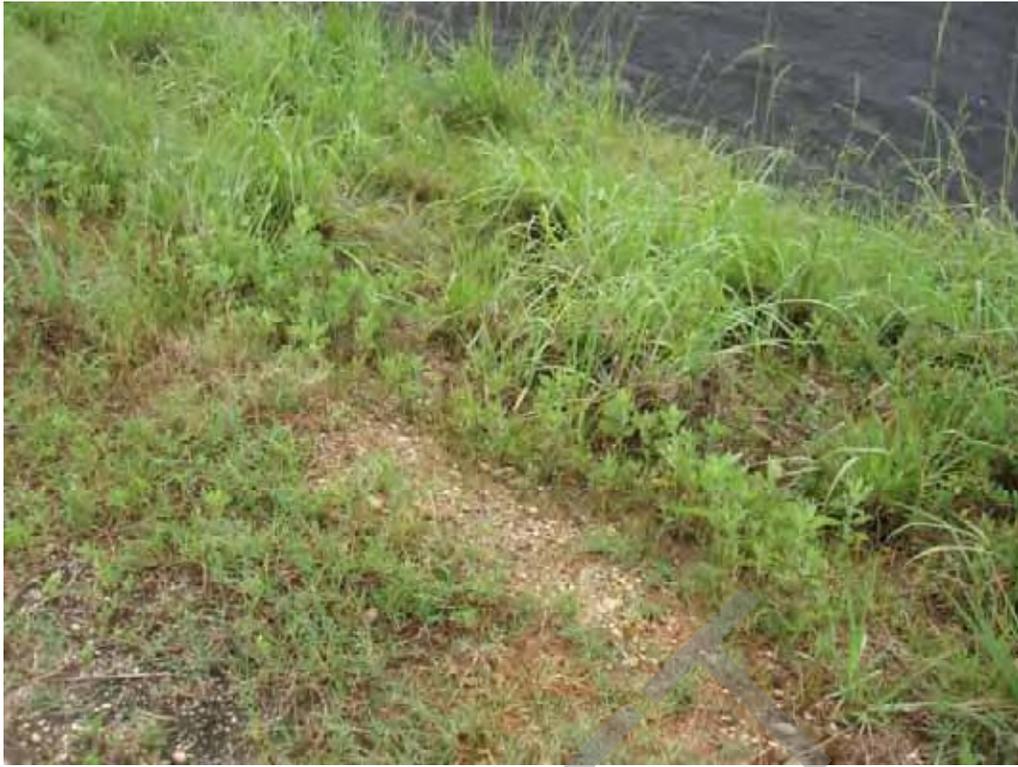
**Photo No. 11: #1 Bottom Ash Pond – South embankment crest. Looking at granular road.**

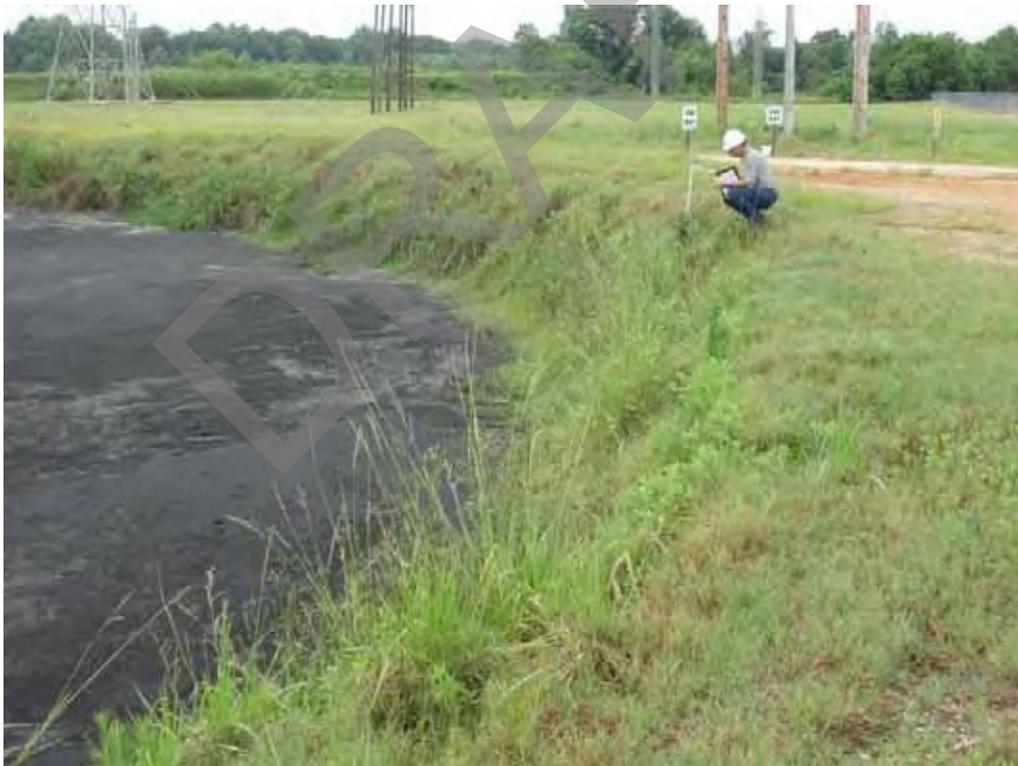
**Photo No. 12: #1 Bottom Ash Pond – Southwest corner interior slope, looking south.**

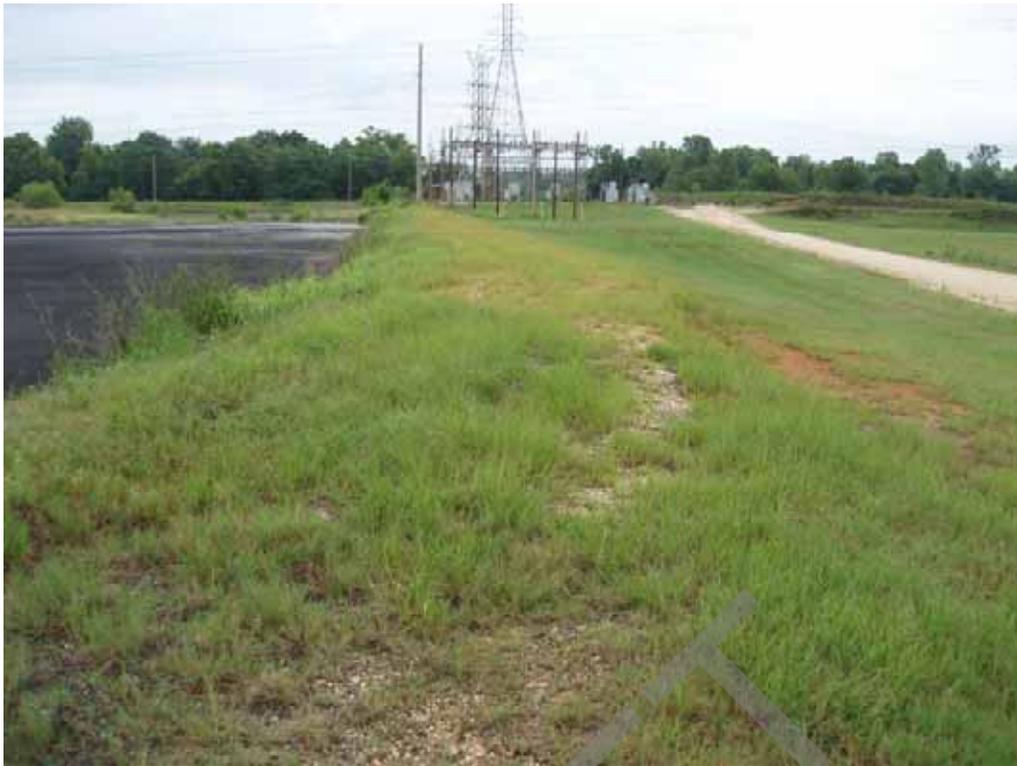
**Photo No. 13: #1 Bottom Ash Pond – South embankment crest, looking east.**

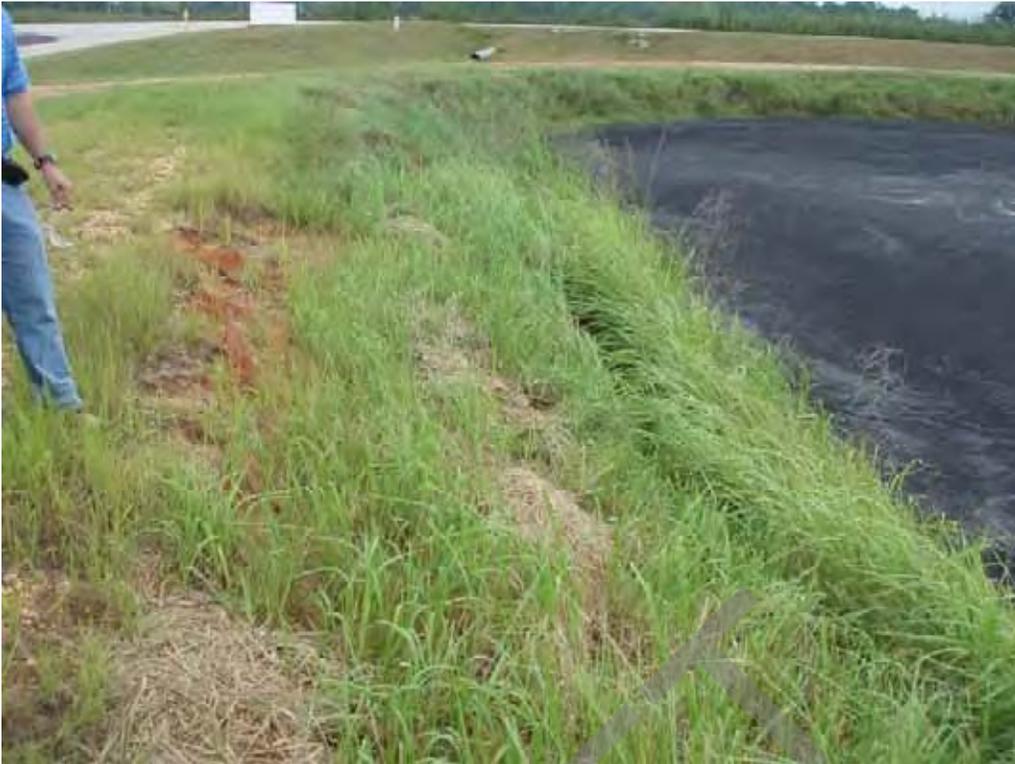
**Photo No. 15: #1 Bottom Ash Pond – South embankment interior slope, looking west. Note minor surface erosion.**

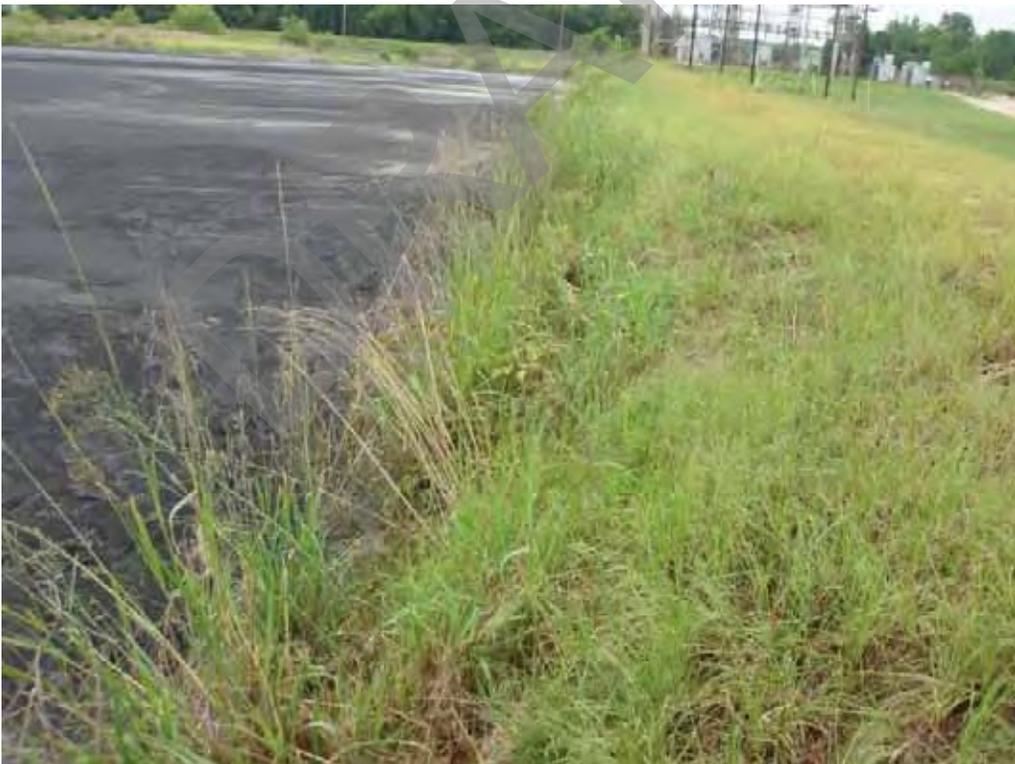
**Photo No. 16: #1 Bottom Ash Pond – South embankment interior slope, looking east.**

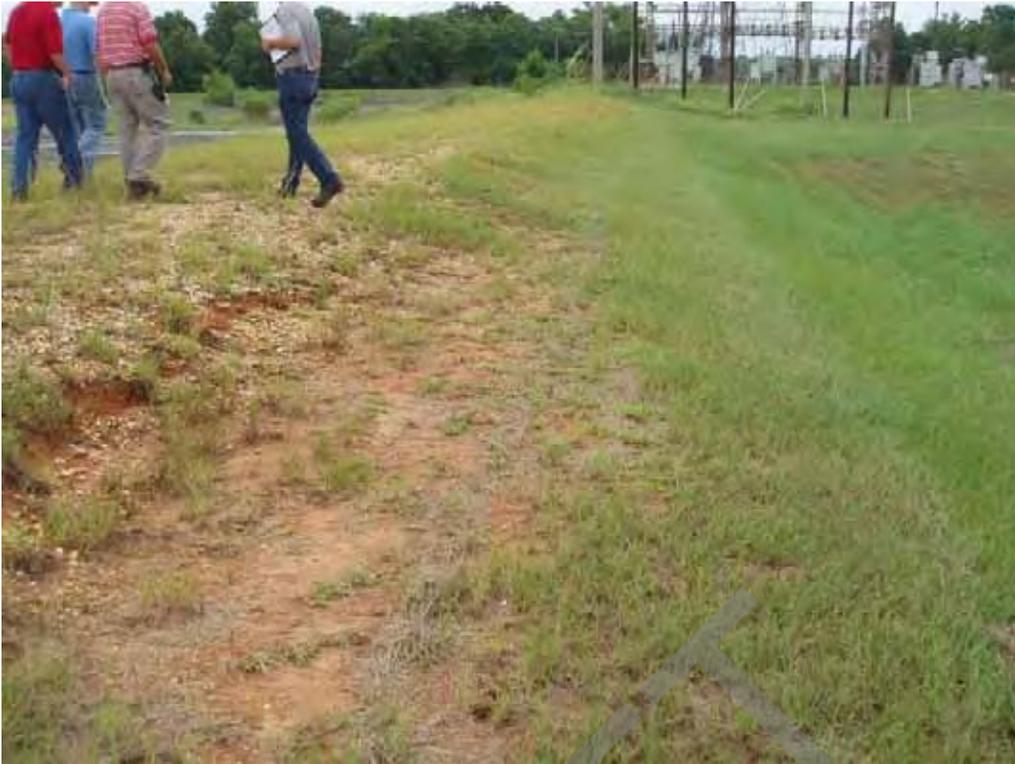
**Photo No. 17: #1 Bottom Ash Pond – South embankment exterior slope, looking east. Note surface erosion.**

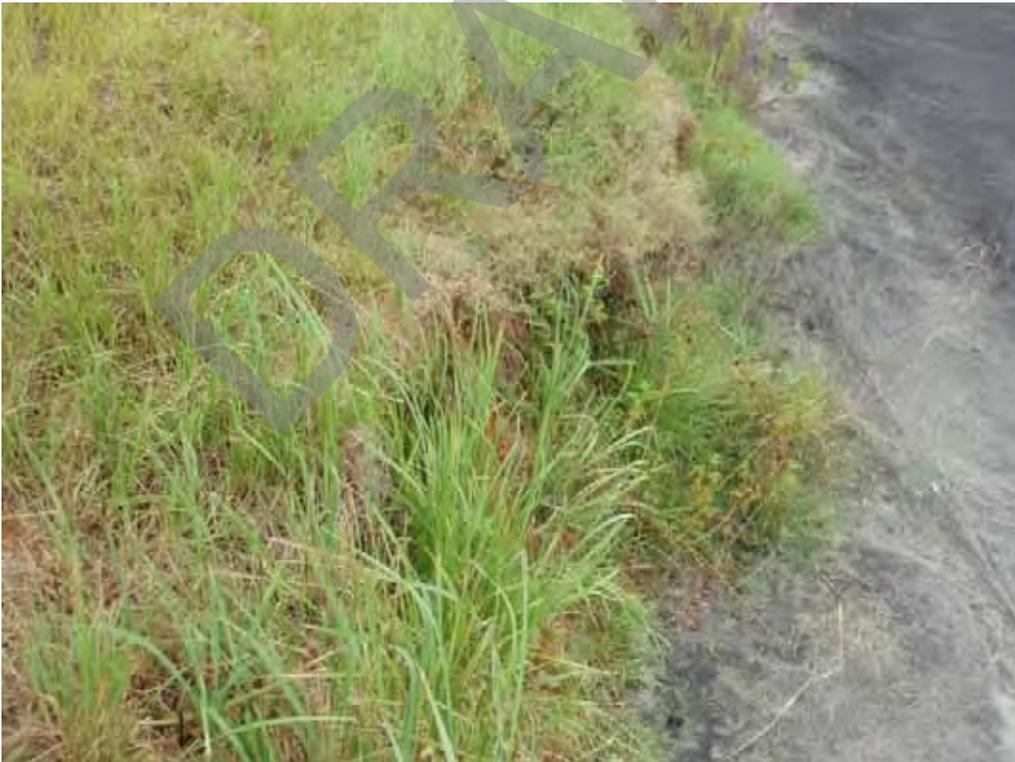
**Photo No. 18: #1 Bottom Ash Pond – South embankment interior slope, looking west. Note erosion and undercut of slope.**

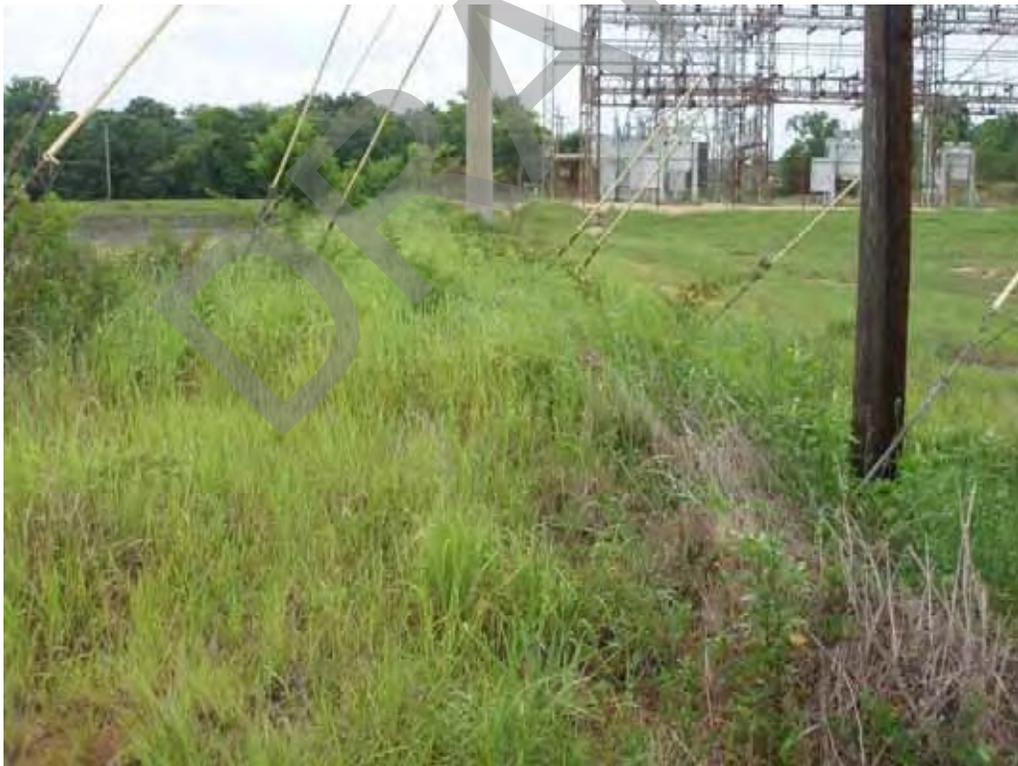
**Photo No. 20: #1 Bottom Ash Pond – South embankment crest, looking east. Note substation in background.**

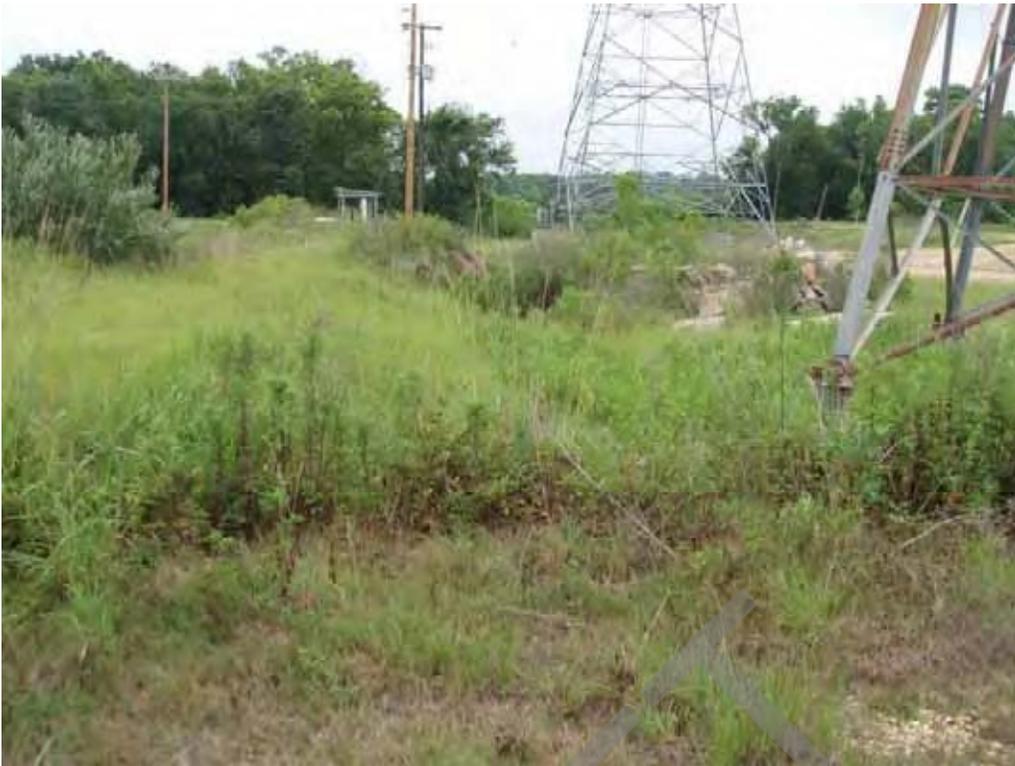
**Photo No. 21: #1 Bottom Ash Pond – South embankment exterior slope, looking east. Looking at vegetation around transmission towers.**

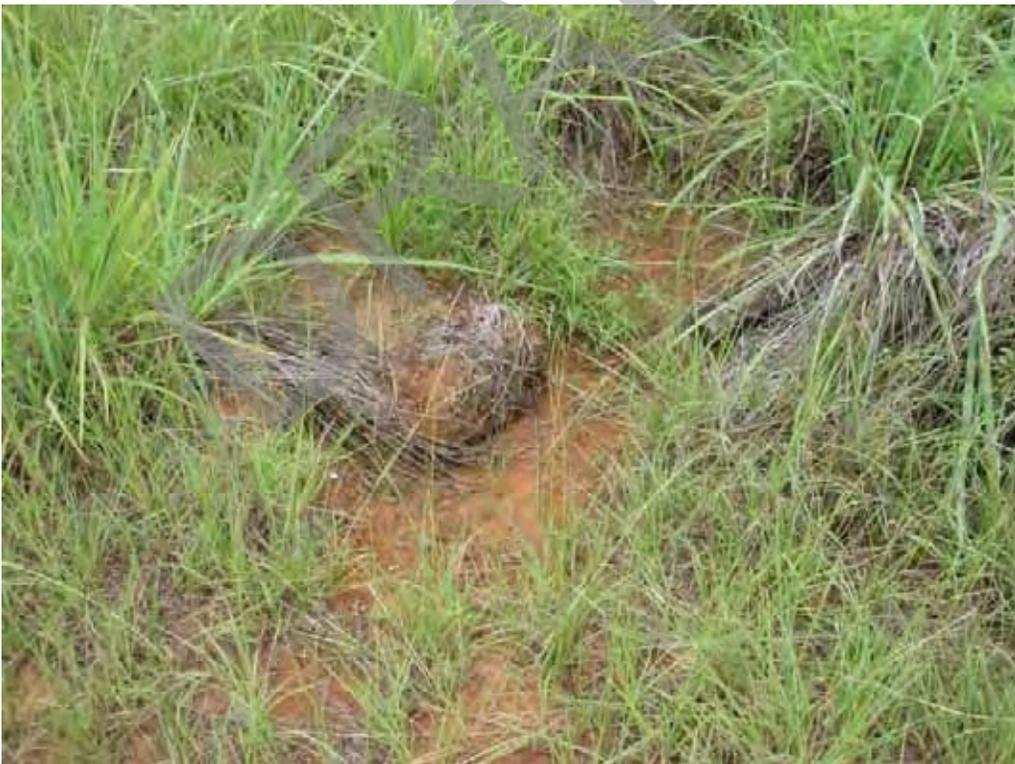
Minor surface erosion was observed along portions of the exterior slope of the north and east embankments (Photographs 22 and 43).

A section of the interior slope of the south embankment has been excavated and remains open, apparently to facilitate the repair of the discharge pipe (Photograph 19). Erosion features, including minor sloughing and erosion rills, were observed on portions of the interior slopes (Photographs 22, 24, 25, 28, 31, 47, and 48).

**Photo No. 22: #1 Bottom Ash Pond – South embankment exterior slope. Looking at minor erosion rill.**

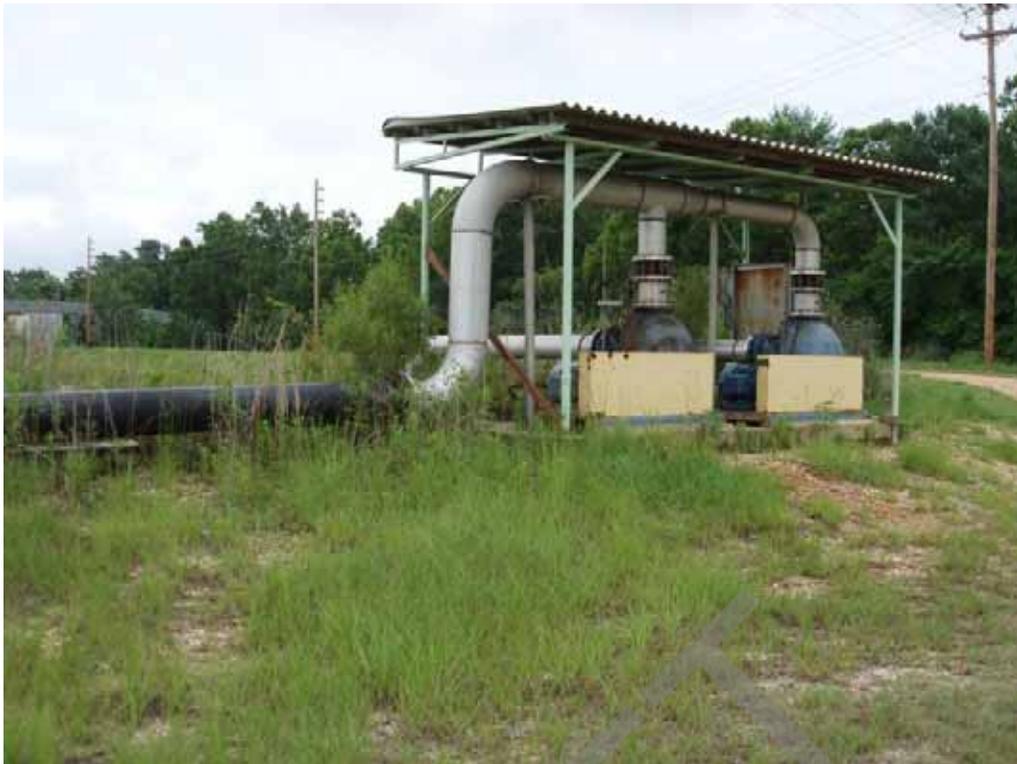
The outlet pipes in the #1 Bottom Ash Pond appear to be in good condition. Two, 10-inch-diameter pipes, located at the southwestern end of the pond, intake water that is pumped to the #2/#3 Bottom Ash Pond through one 14-inch-diameter HDPE pipe (Photographs 23 and 24). No unusual movement was observed around the pumps or piping.

**Photo No. 23: #1 Bottom Ash Pond – South embankment exterior slope, looking north.  
Looking at outlet pumps.**

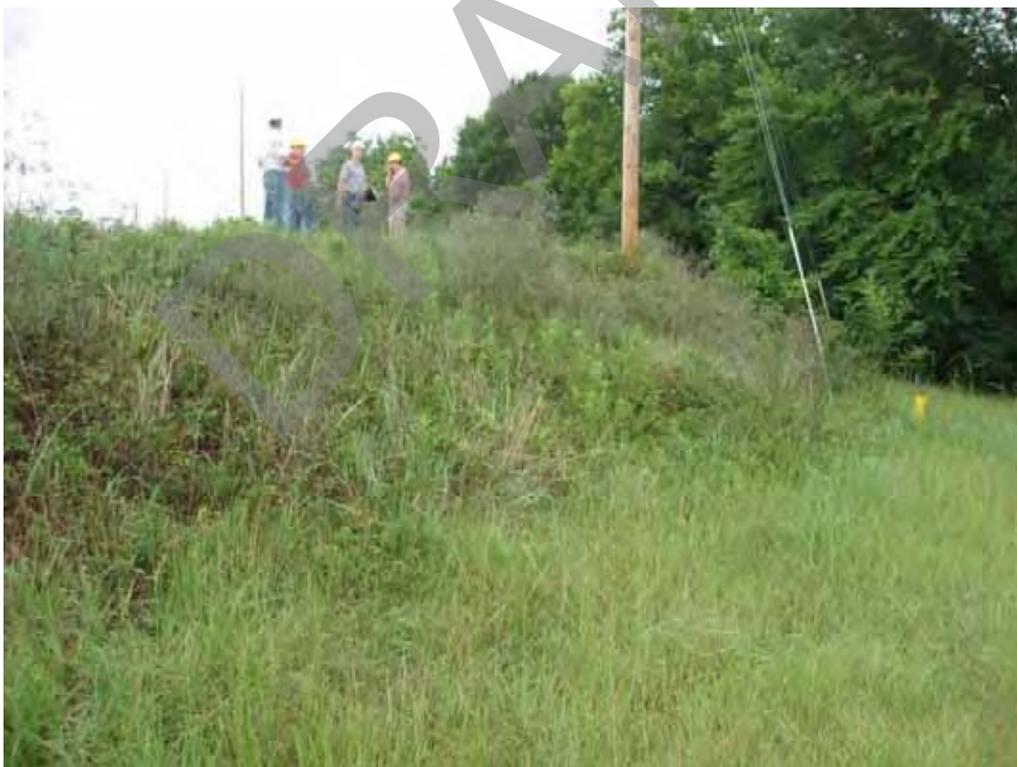
**Photo No. 26: #1 Bottom Ash Pond – South embankment exterior slope, looking north.**

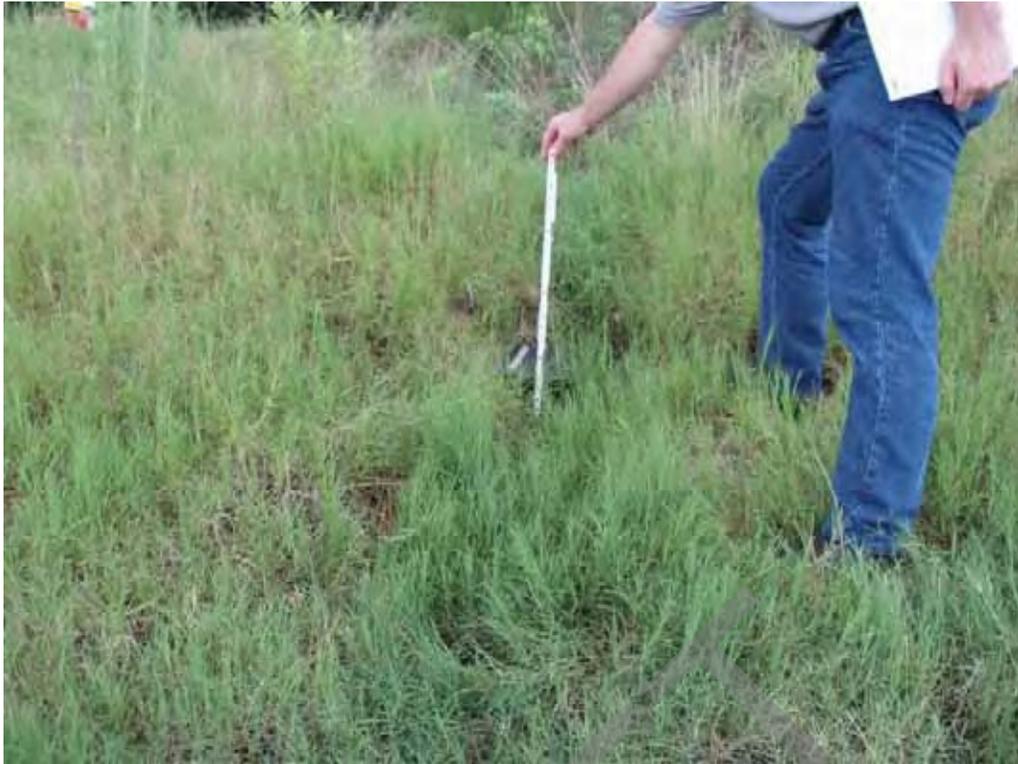
**Photo No. 27: #1 Bottom Ash Pond – East embankment interior slope. Looking at minor erosion rills.**

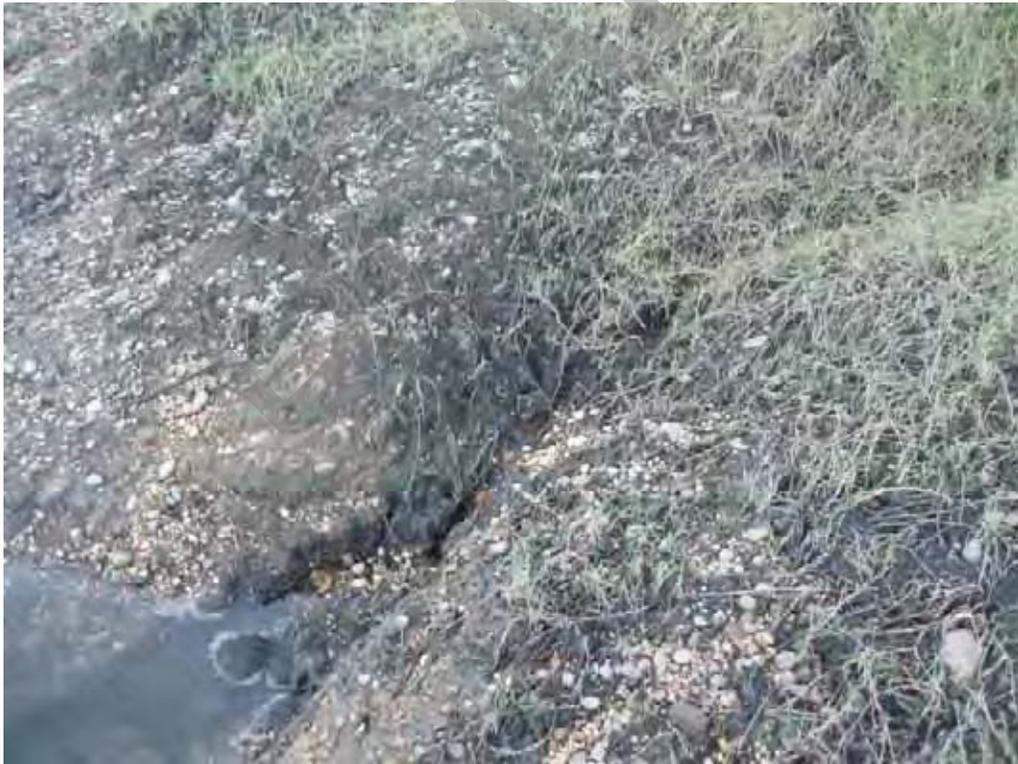
**Photo No. 28: #1 Bottom Ash Pond – East embankment interior slope. Looking at erosion rills.**

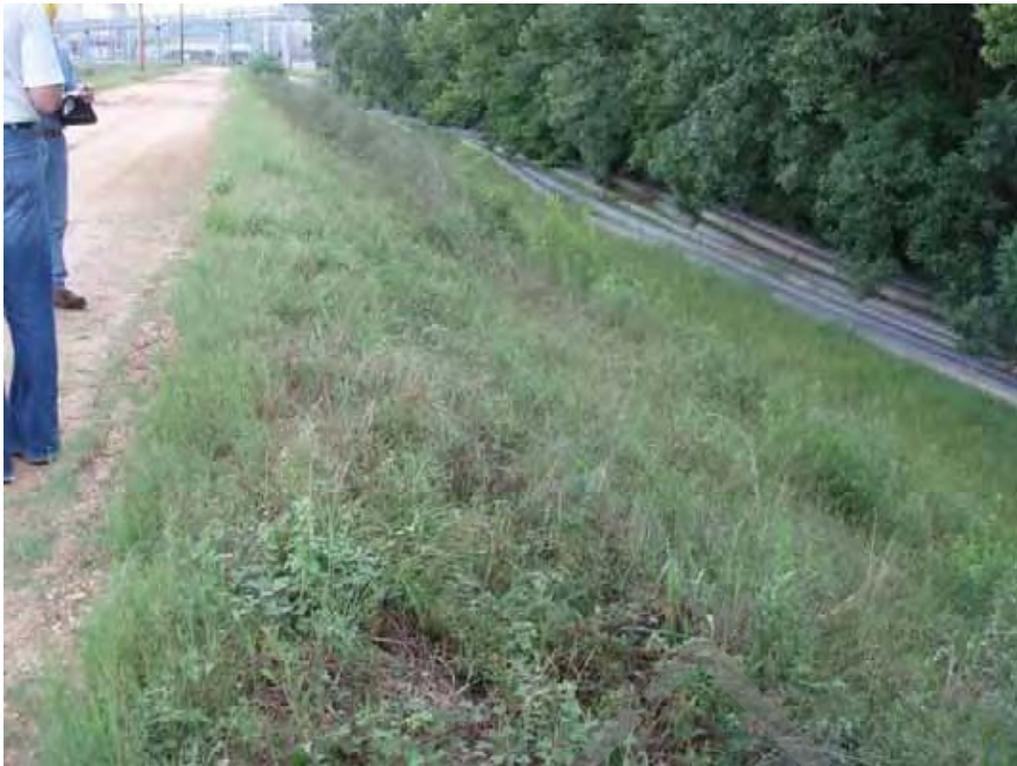
**Photo No. 29: #1 Bottom Ash Pond – East embankment exterior slope, looking north.**

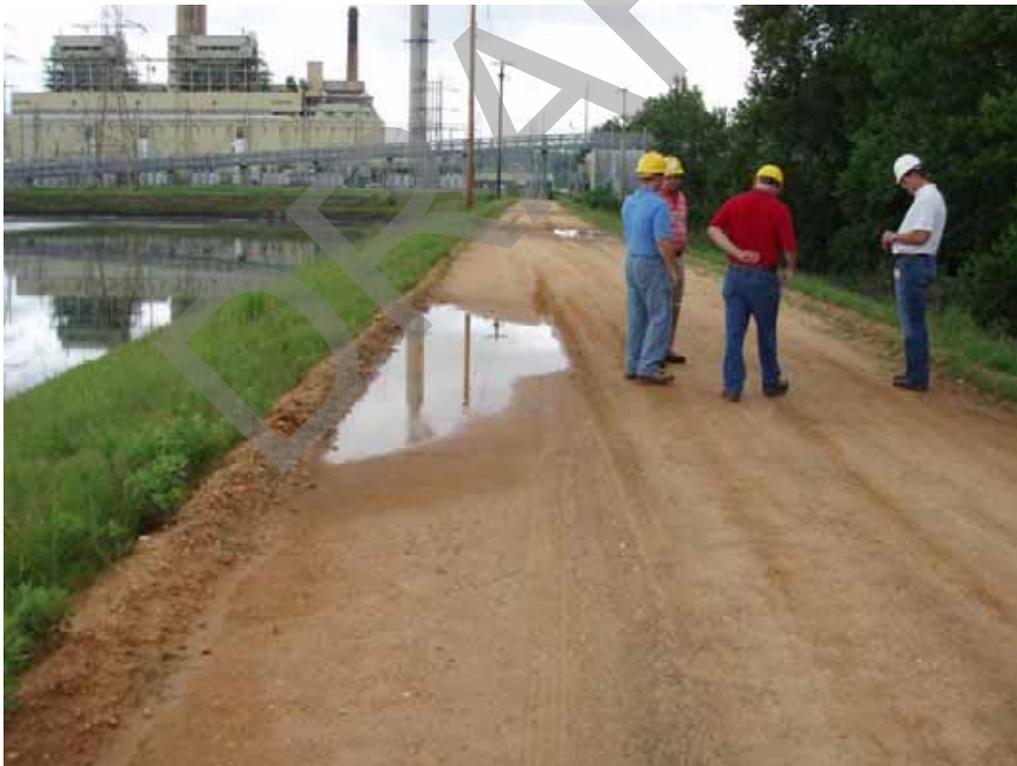
**Photo No. 30: #1 Bottom Ash Pond – East embankment crest, looking north.**

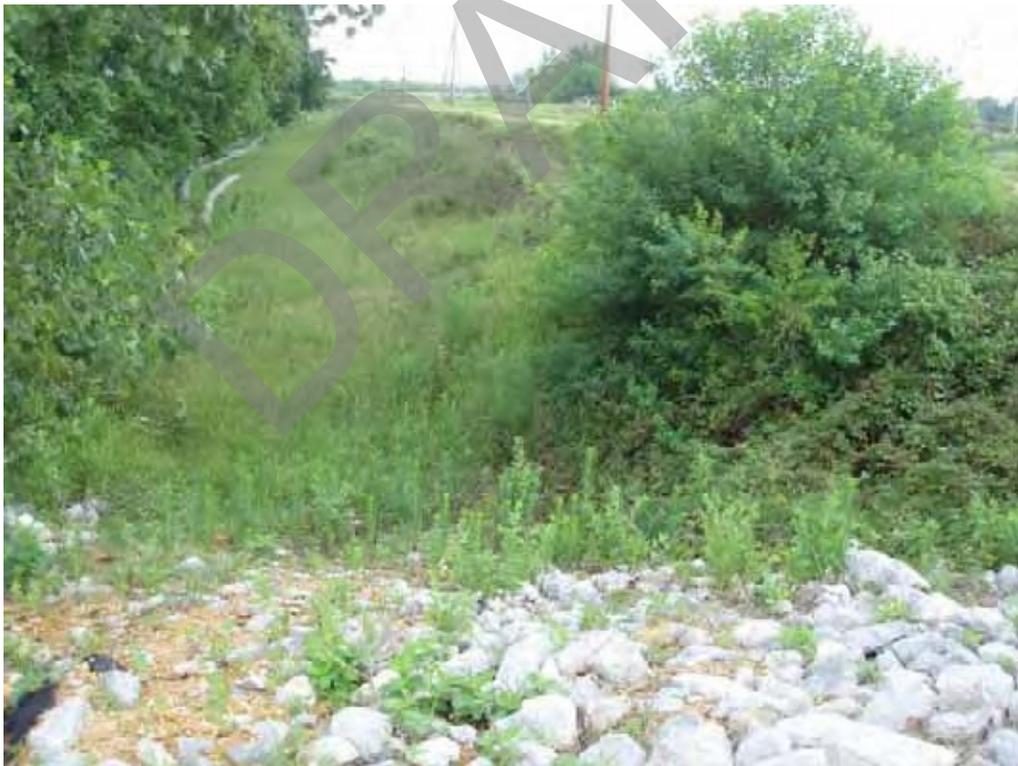
**Photo No. 32: #1 Bottom Ash Pond – East embankment exterior slope, looking south.**

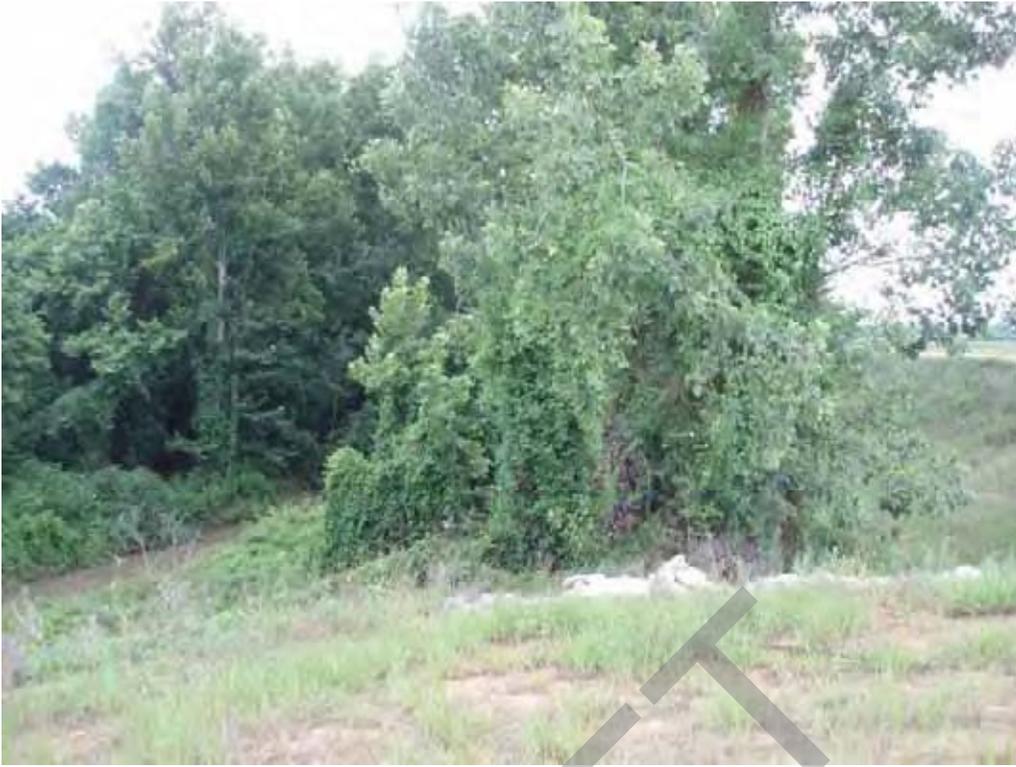
**Photo No. 33: #1 Bottom Ash Pond – Drainage ditch running along east embankment, looking south.**
