# **Assessment of Dam Safety of Coal Combustion Surface Impoundments**

**PowerSouth Energy Cooperative**

**Charles R. Lowman Power Plant**

**August 6, 2010**

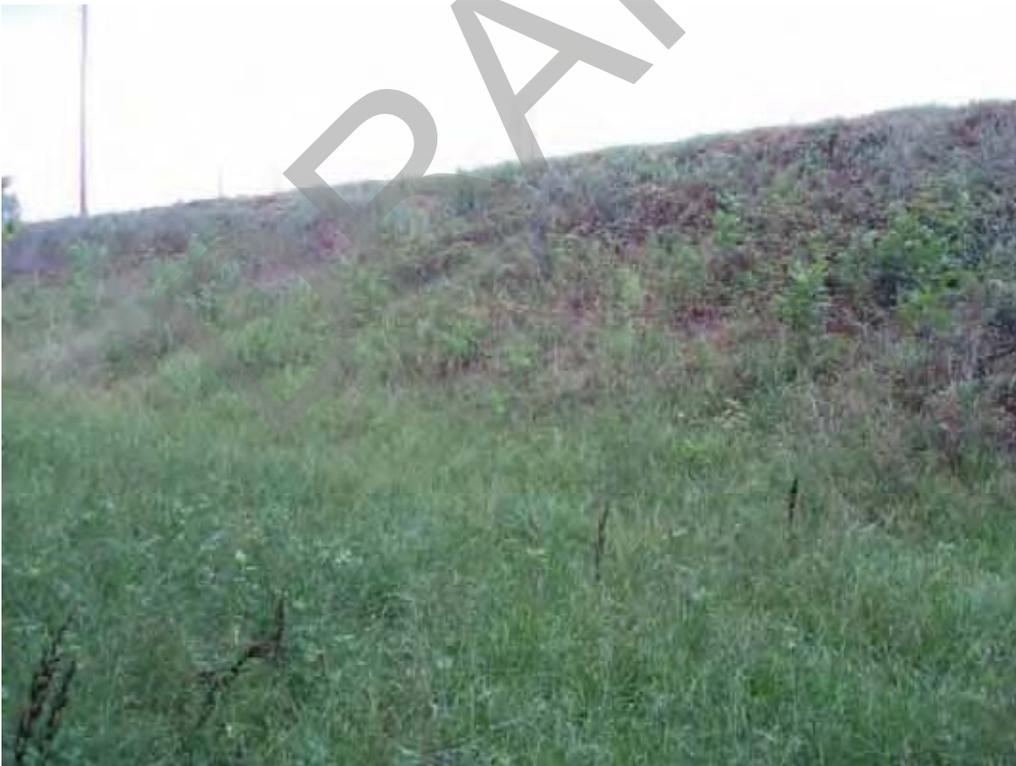
**Photo No. 34: #1 Bottom Ash Pond – East embankment exterior slope, looking southwest.**

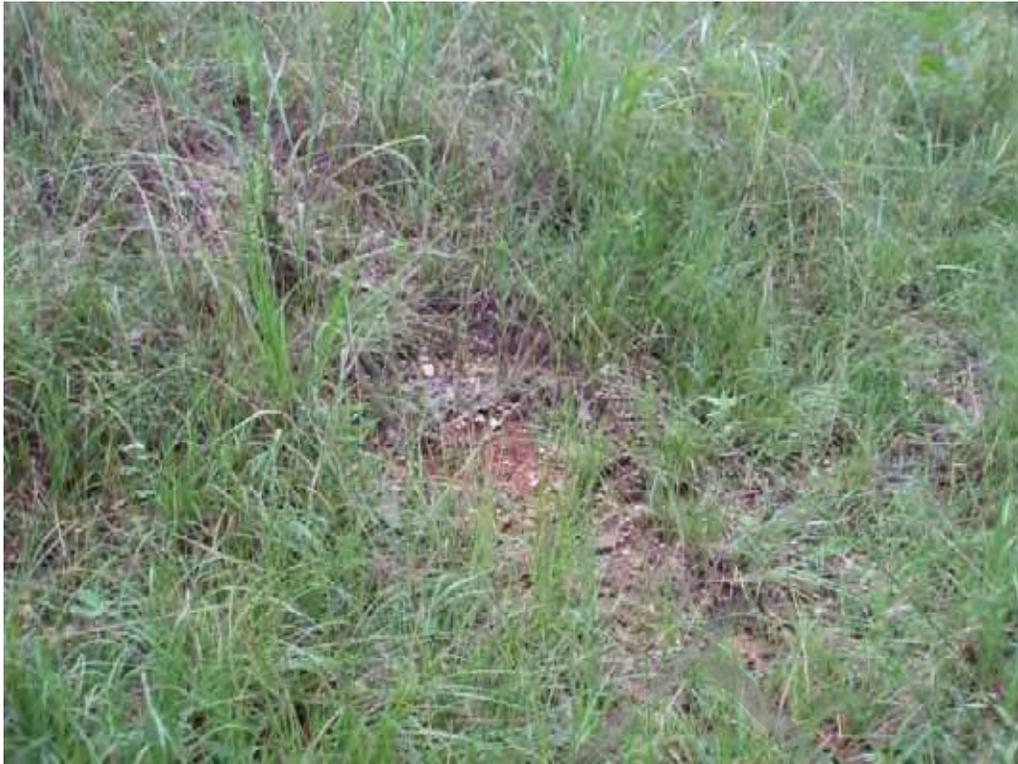
**Photo No. 35: #1 Bottom Ash Pond – East embankment exterior slope. Looking at minor surface erosion.**

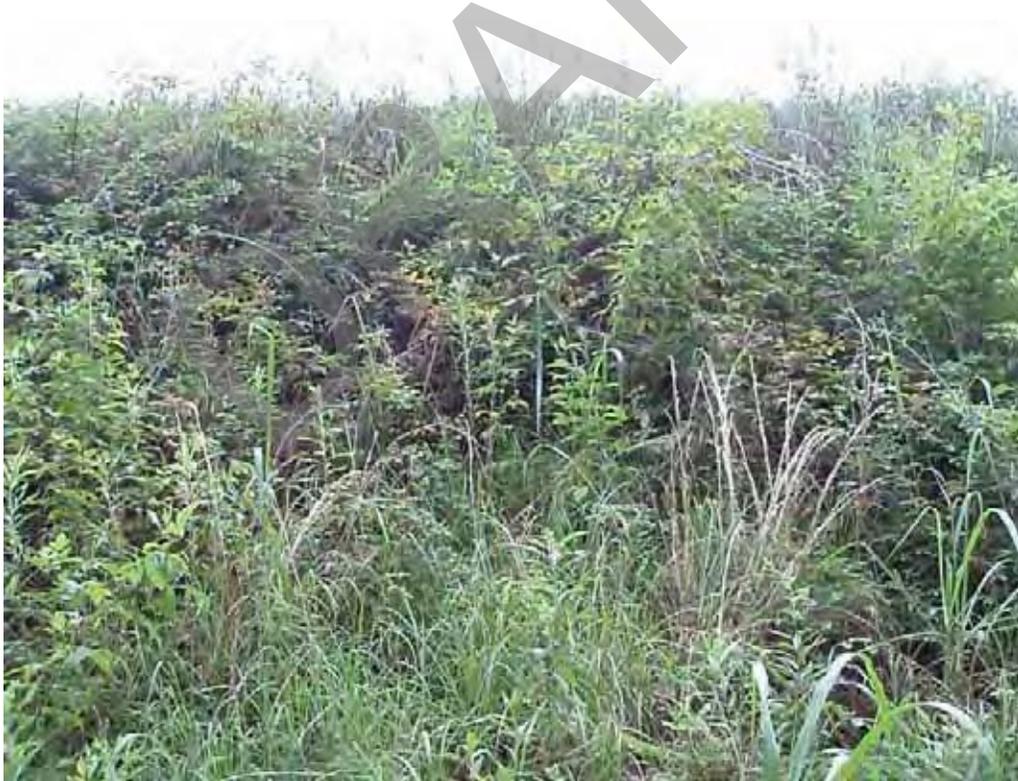
**Photo No. 36: #1 Bottom Ash Pond – East embankment exterior slope. Looking at typical vegetation.**

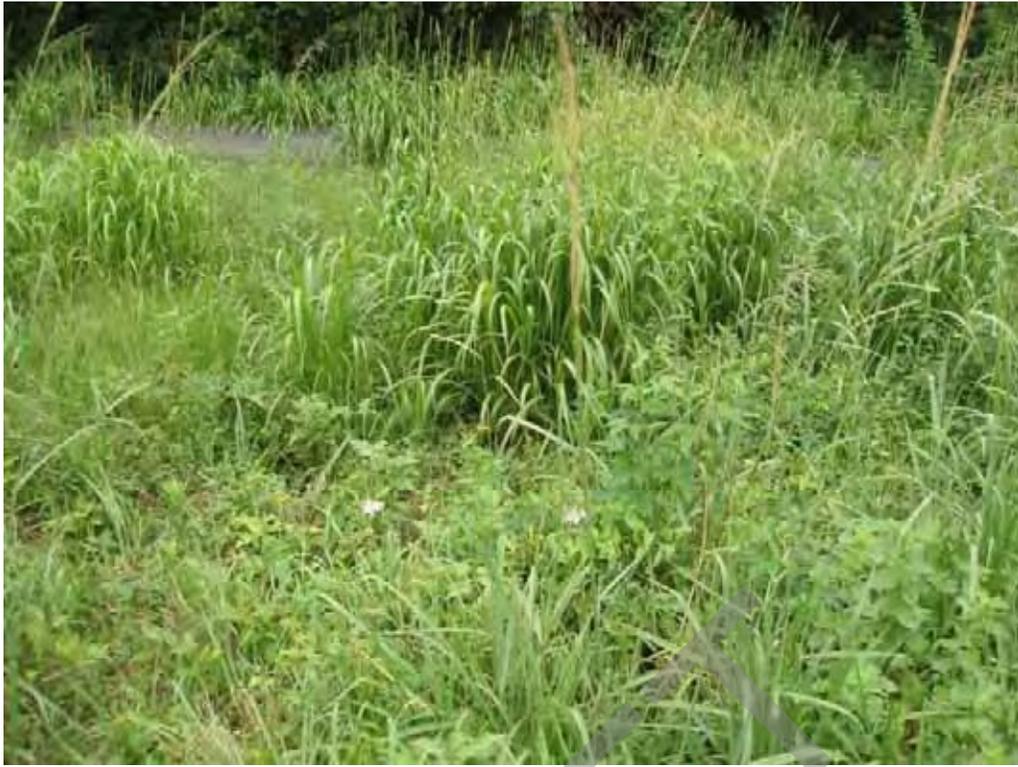
**Photo No. 37: #1 Bottom Ash Pond – East embankment exterior slope, looking east.**

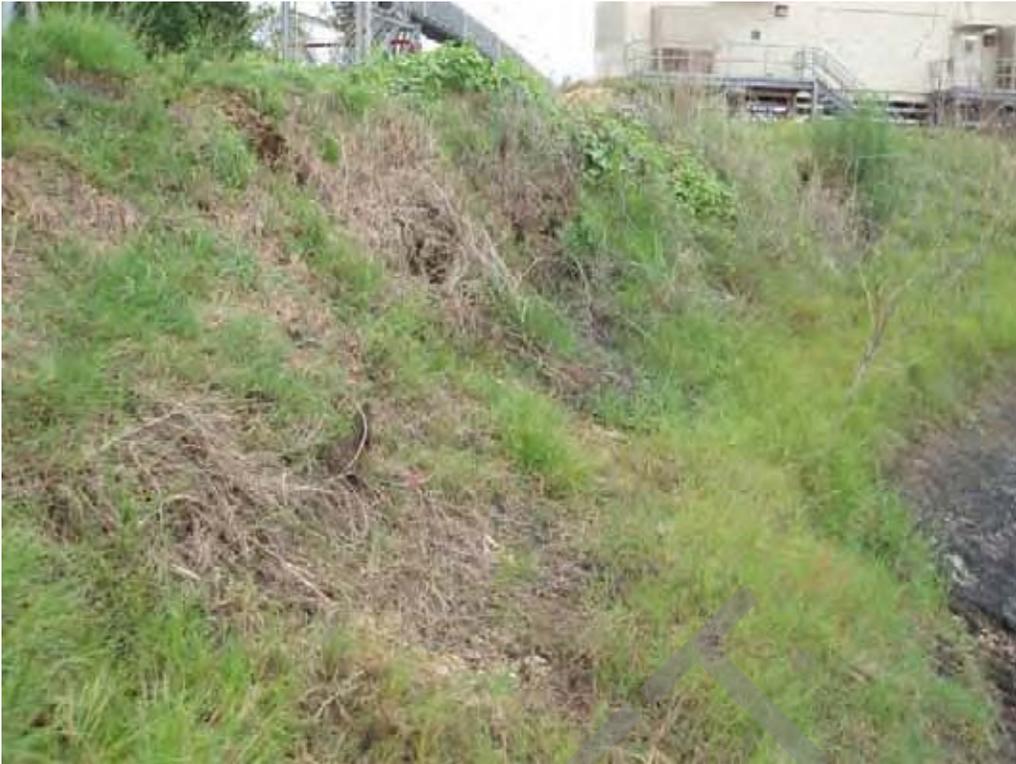
**Photo No. 39: #1 Bottom Ash Pond – North embankment interior slope, looking east.**

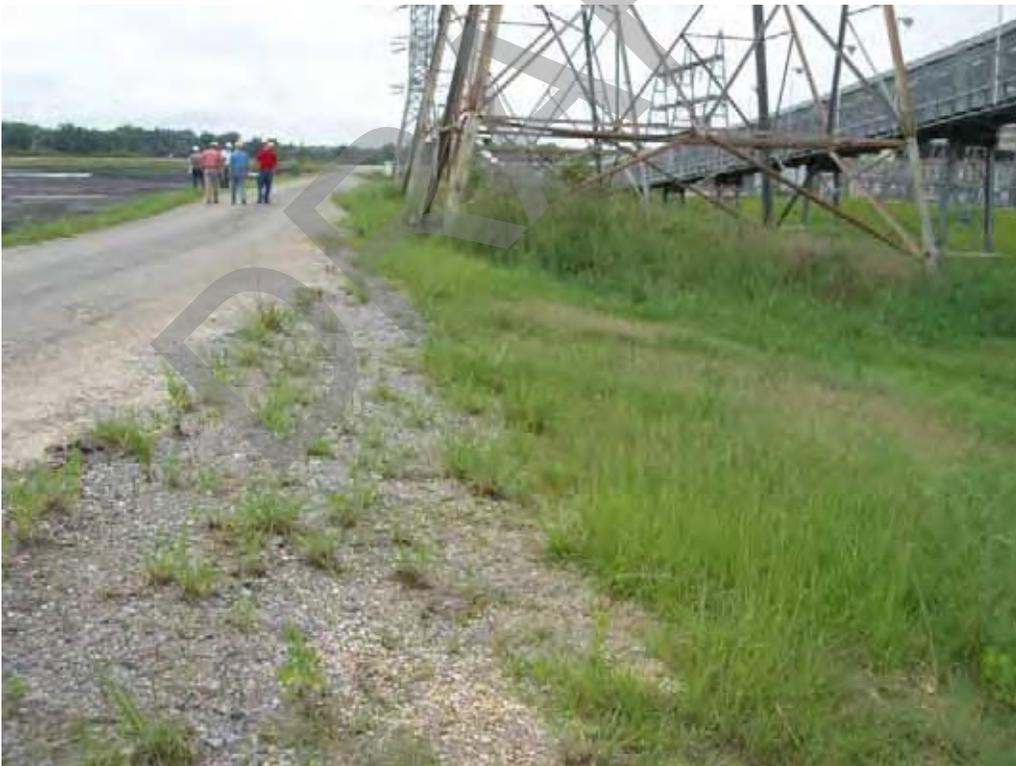
The crest of the #1 Bottom Ash Pond appeared to be in good condition (Photographs 40, 8, 13, and 30). The crest was approximately 20 feet wide with the exception of the west embankment that was approximately 35 feet wide. The north, west, and east crests are exposed to vehicle traffic. The surface of the crests, exposed to traffic, consists of compacted granular soils on the north and east embankments, and asphalt paving on the west embankment.

**Photo No. 40: #1 Bottom Ash Pond – North embankment crest and exterior slope, looking west. Note transmission towers on slope.**

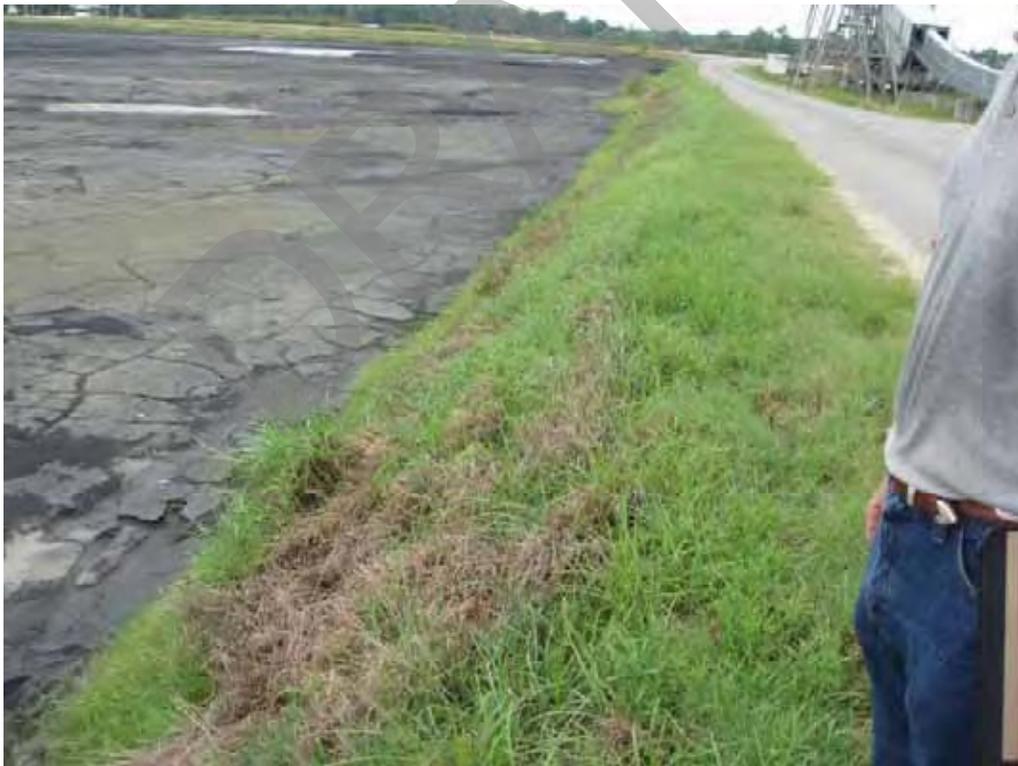
**Photo No. 42: #1 Bottom Ash Pond – North embankment interior slope, looking west.**

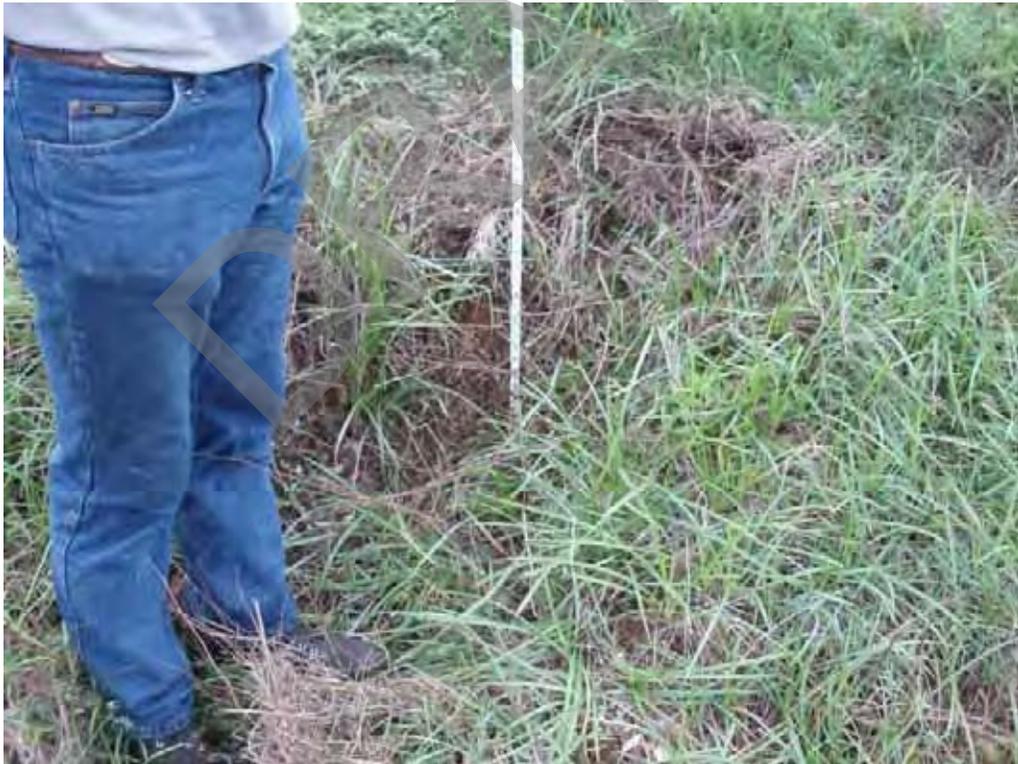
**Photo No. 44: #1 Bottom Ash Pond – North embankment interior slope. Looking at surface erosion/erosion rill.**

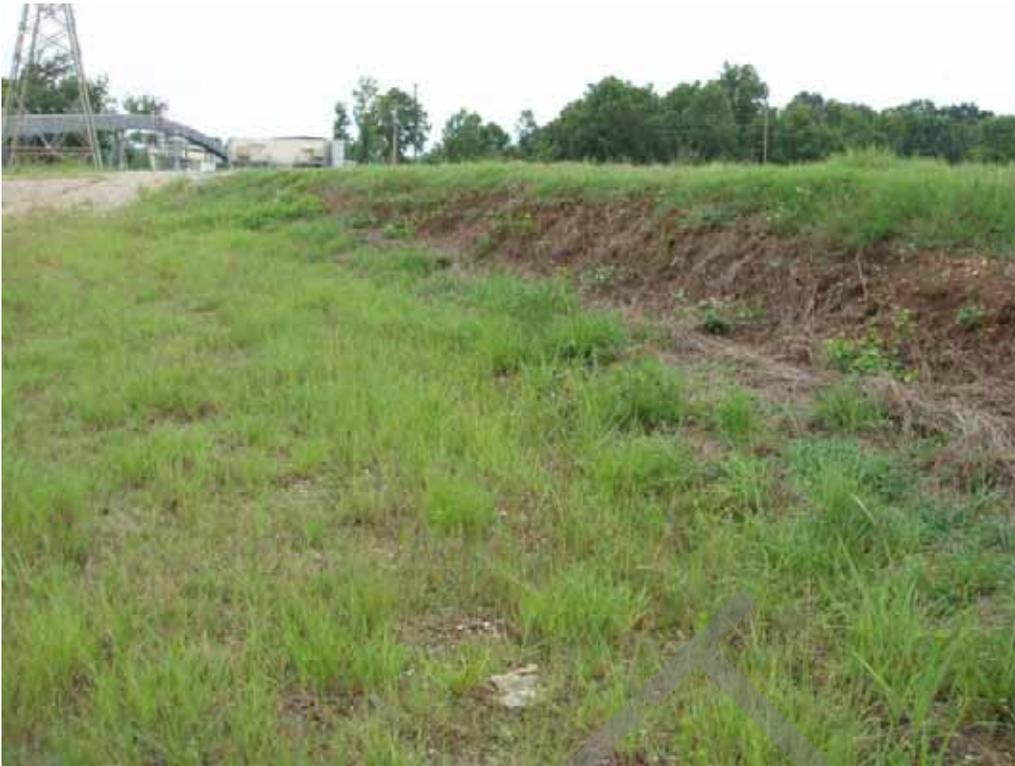
**Photo No. 45: #1 Bottom Ash Pond – North embankment exterior slope, looking east. Note surface erosion on upper slope.**

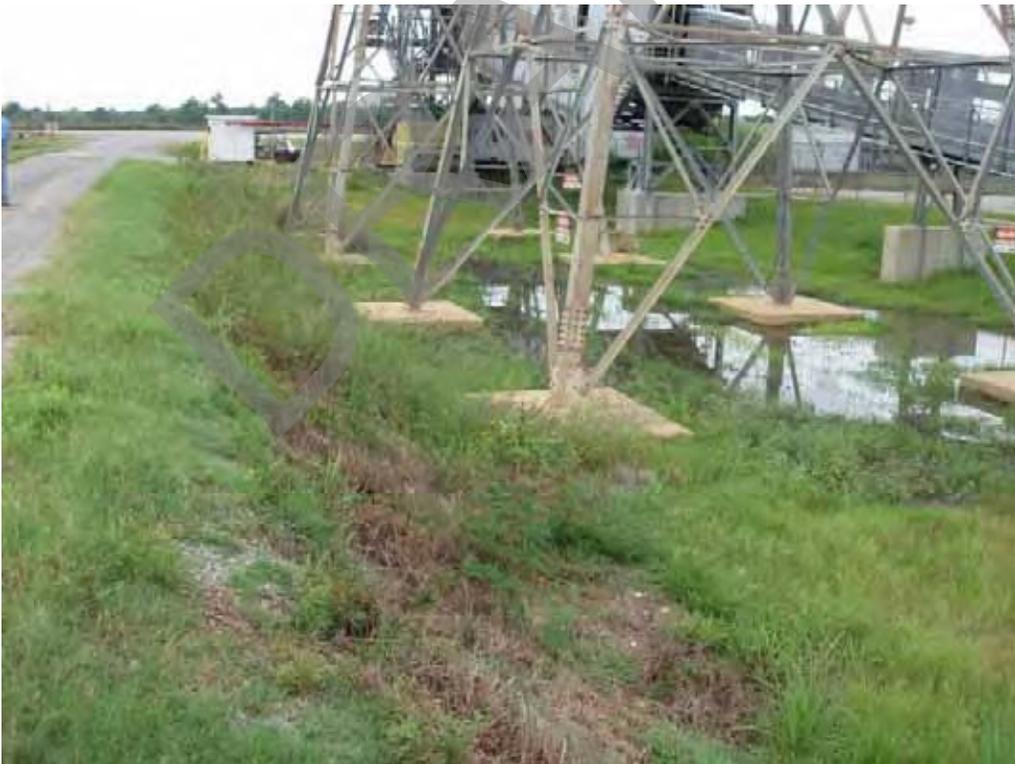
An electric substation was located approximately 85 feet north of the exterior slope of the south embankment, and square-base transmission towers were located near the toe of the exterior slope of the north and south embankments. The north embankment exterior slope, in the vicinity of the towers, was approximately 1.5H:1V. Standing water was observed within the base area of two of the towers located at the north embankment, and grassy vegetation 24 to 36 inches in height was observed at the base of the south embankment towers (Photographs 46 and 21). Due to the significant recent rainfall, the observed standing water could not be clearly identified as seepage.

**Photo No. 46: #1 Bottom Ash Pond – North embankment exterior slope, looking west. Note standing water near transmission tower base.**

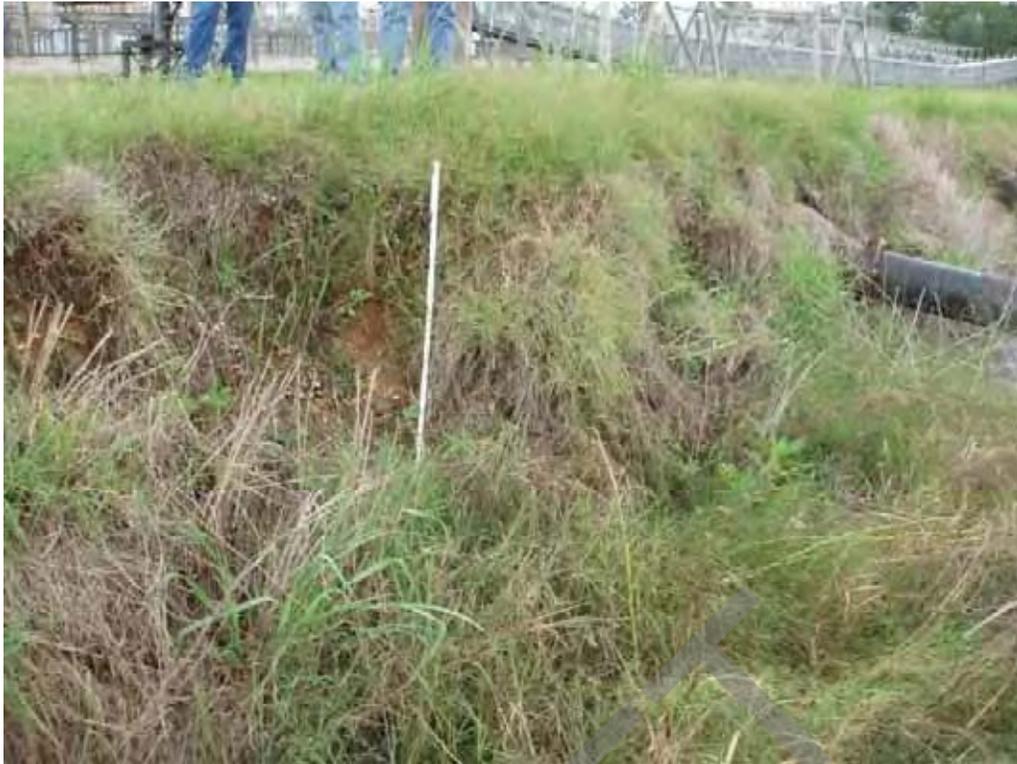
A section of the interior slope of the south embankment has been excavated and remains open, apparently to facilitate the repair of the discharge pipe (Photograph 19). Erosion features, including minor sloughing and erosion rills, were observed on portions of the interior slopes (Photographs 22, 24, 25, 28, 31, 47, and 48).

**Photo No. 47: North embankment interior slope, looking northeast. Looking at erosion rill. Sluice line from Unit 1 to the right.**

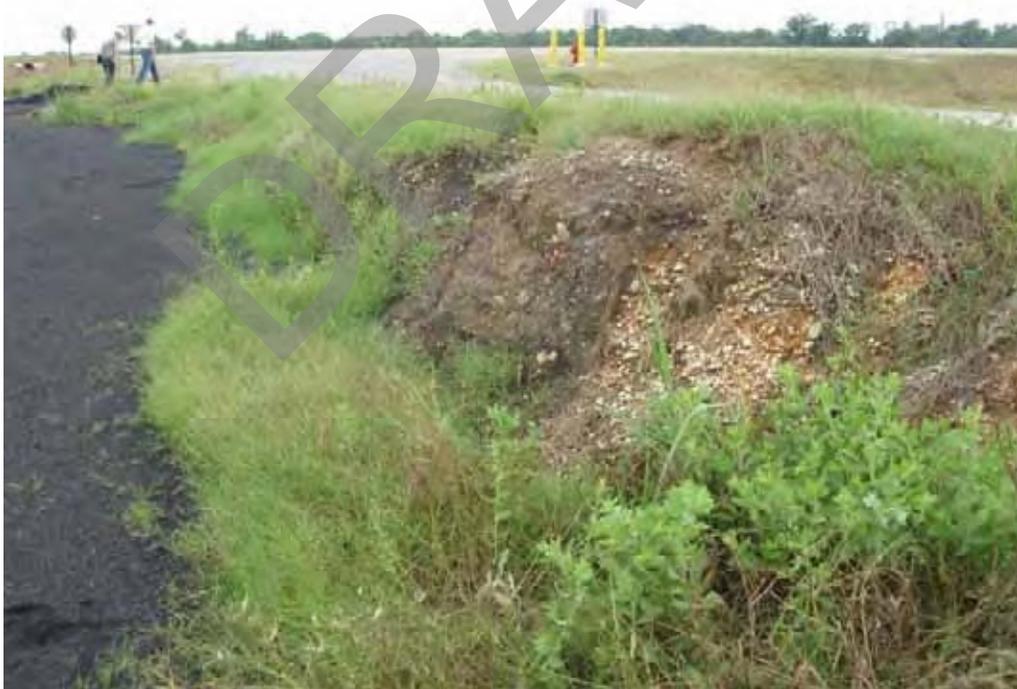
**Photo No. 48: #1 Bottom Ash Pond – North embankment interior slope, looking northwest. Looking at surface erosion.**

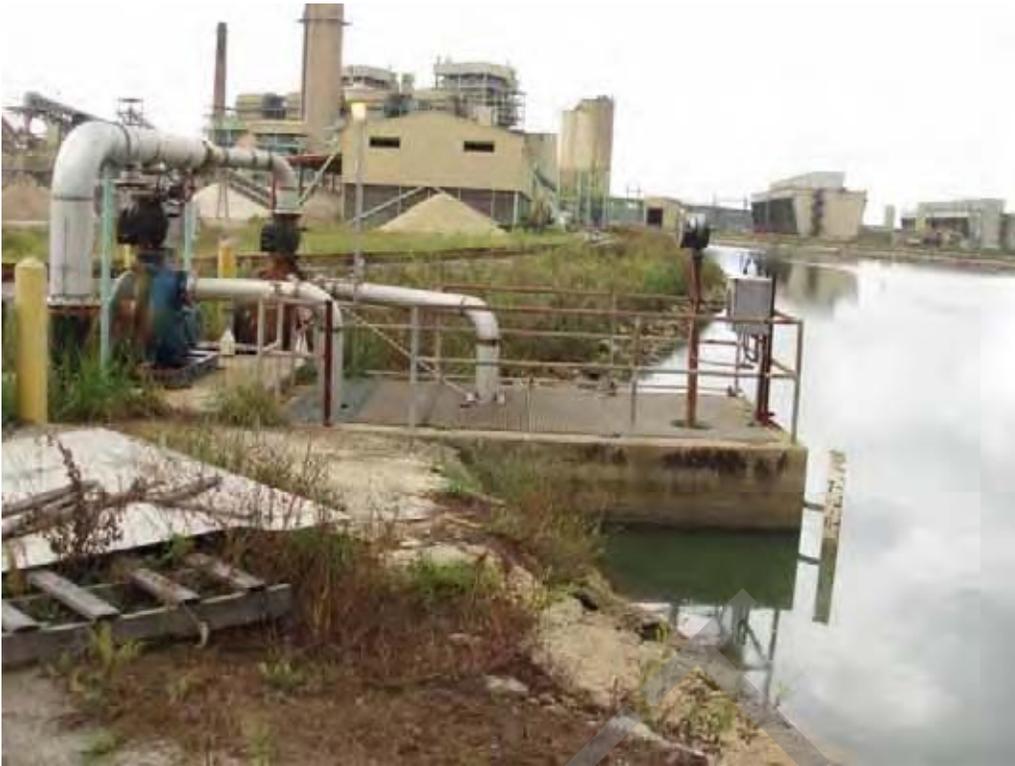
A staff gauge is located within each pond to measure the impoundment water level (Photographs 49 and 75). Based on information provided by PSEC personnel, the pond water levels are monitored and recorded daily.

**Photo No. 49: Process Waste Pond – North embankment interior slope. Looking at intake pumps.**

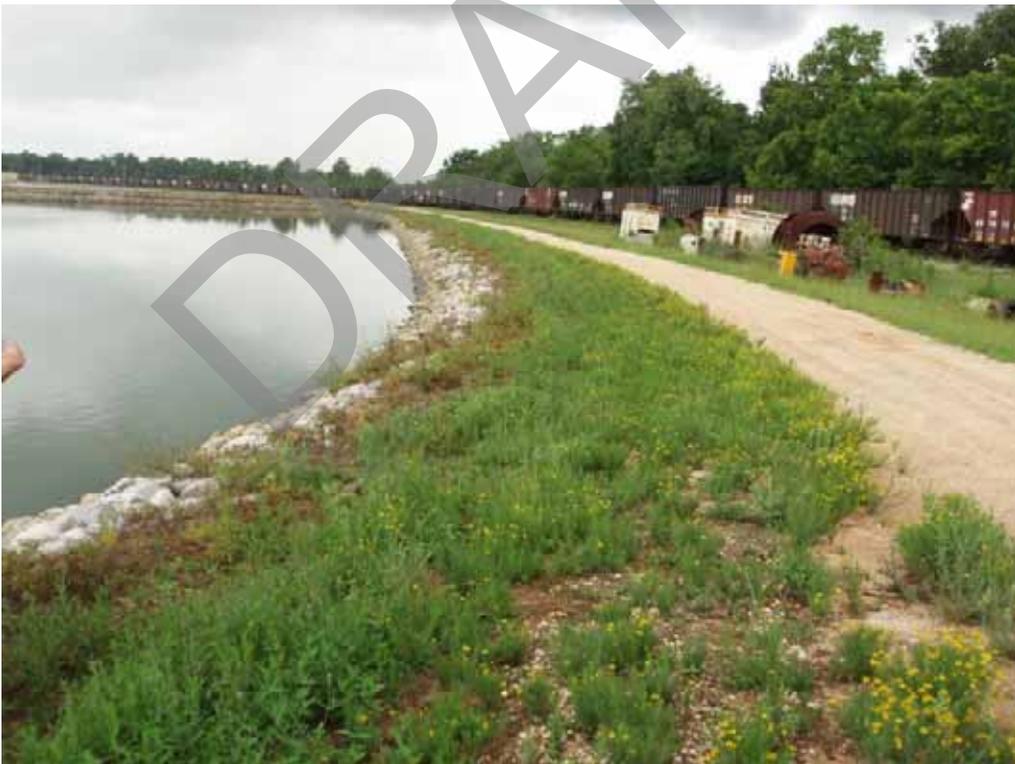
**Photo No. 50: Process Waste Pond – West embankment interior slope, looking south.**

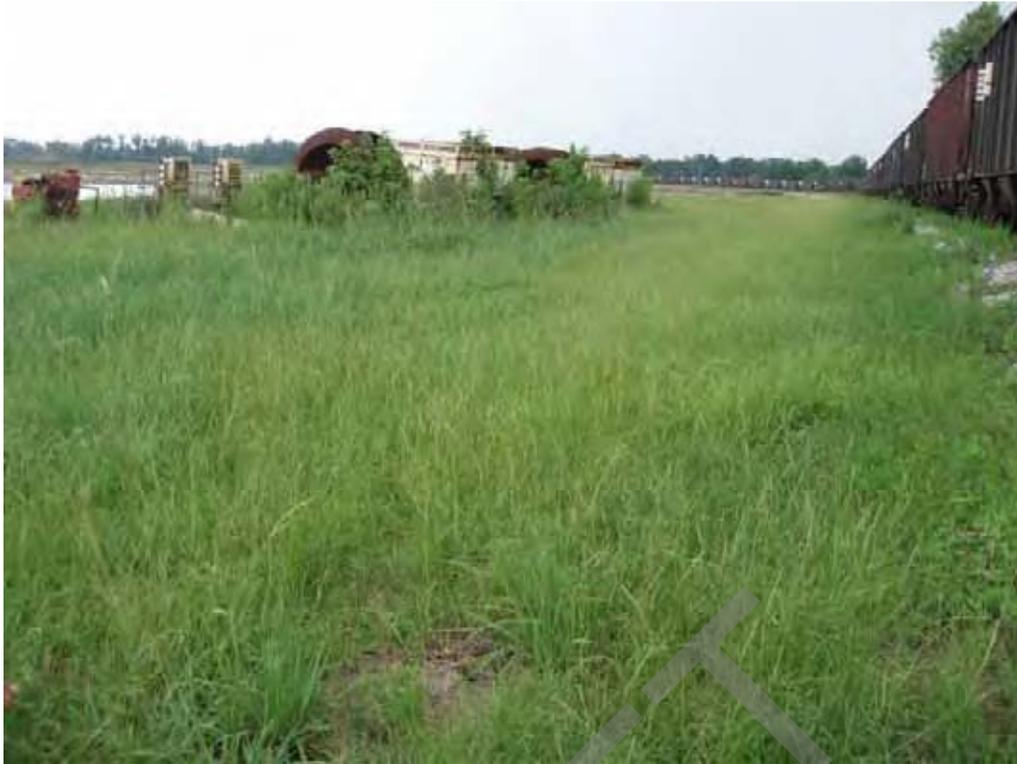
**Photo No. 51: Process Waste Pond – West embankment crest, looking south.**

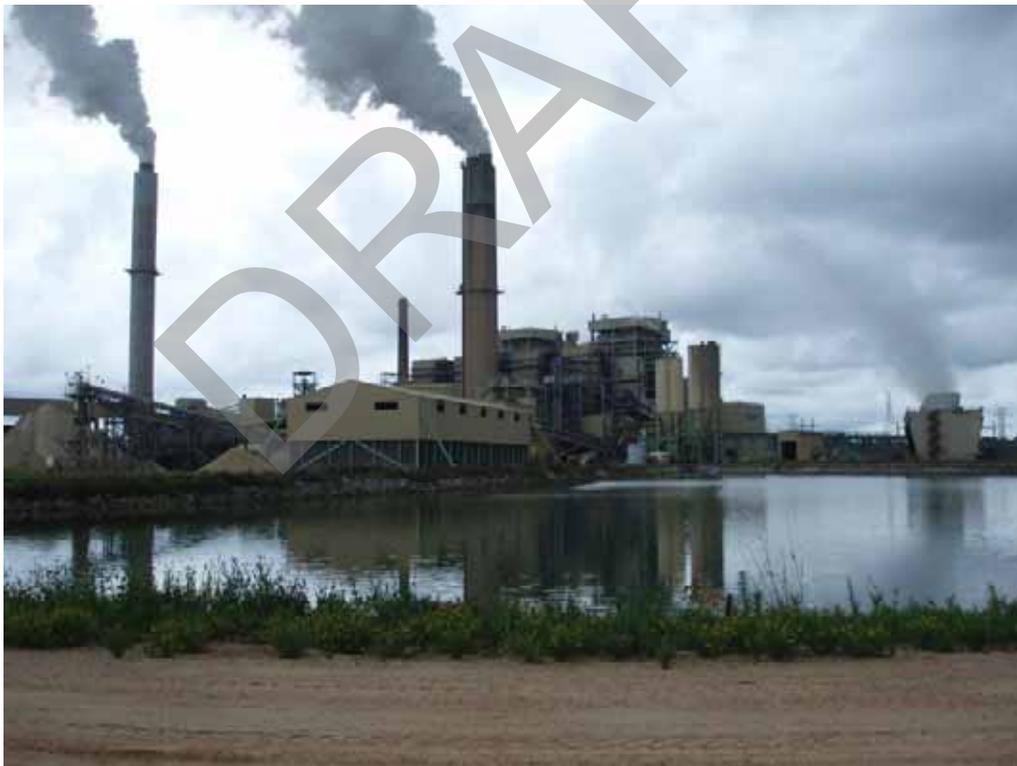
**Photo No. 52: Process Waste Pond – West embankment crest, looking east.**

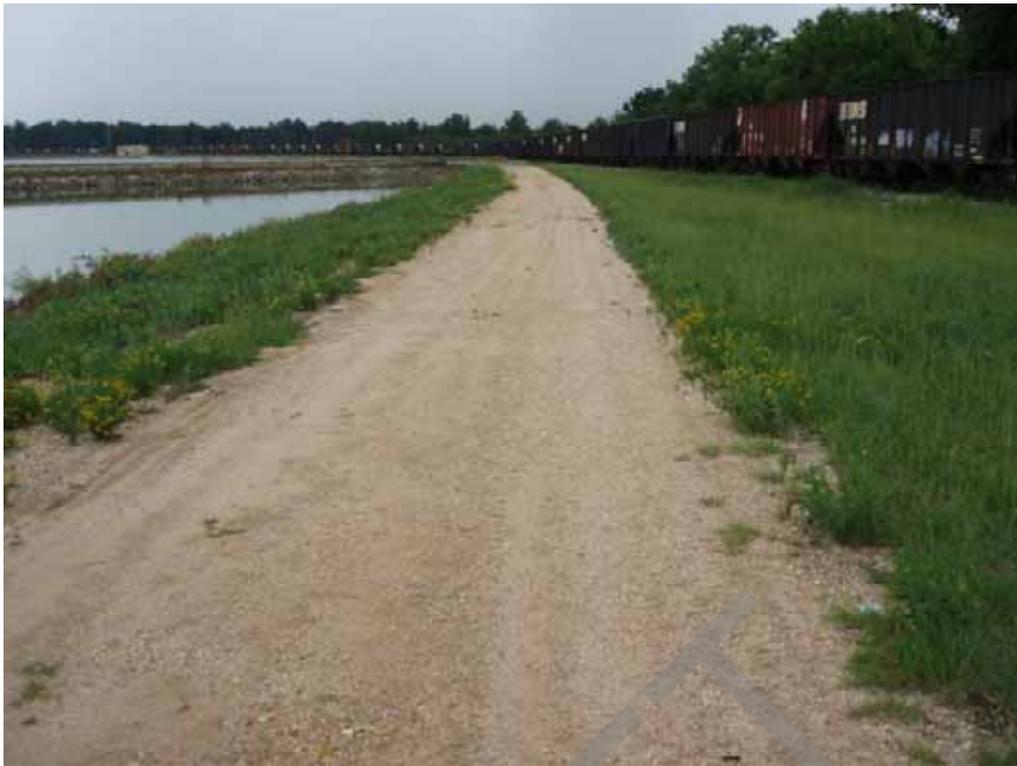
The crest appeared to be in good condition (Photographs 53, 60, and 64). All three of the embankment crests include a Norfolk Southern railroad spur on crushed stone railroad ballast. The north embankment extends nearly horizontal to the plant. The west embankment crest is approximately 100 feet wide. The south embankment crest is approximately 15 feet wide. No depressions, ruts, or evidence of settlement were observed on the crests.

**Photo No. 53: Process Waste Pond – West embankment crest, looking south.**

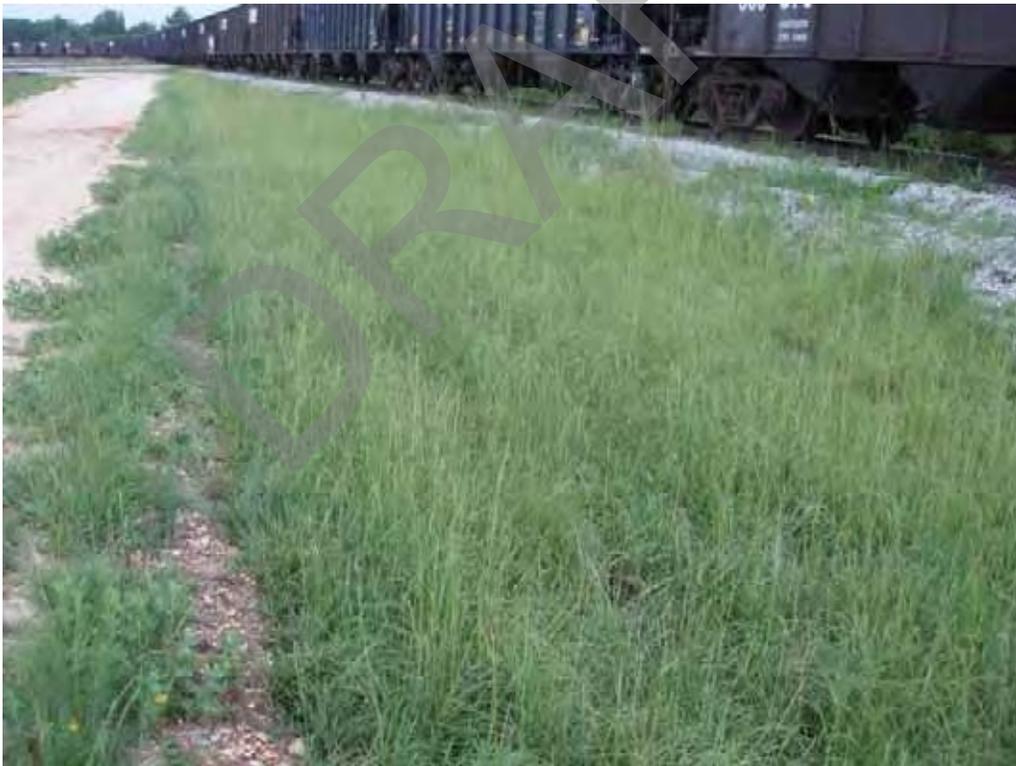
**Photo No. 54: Process Waste Pond – West embankment crest, looking south.**

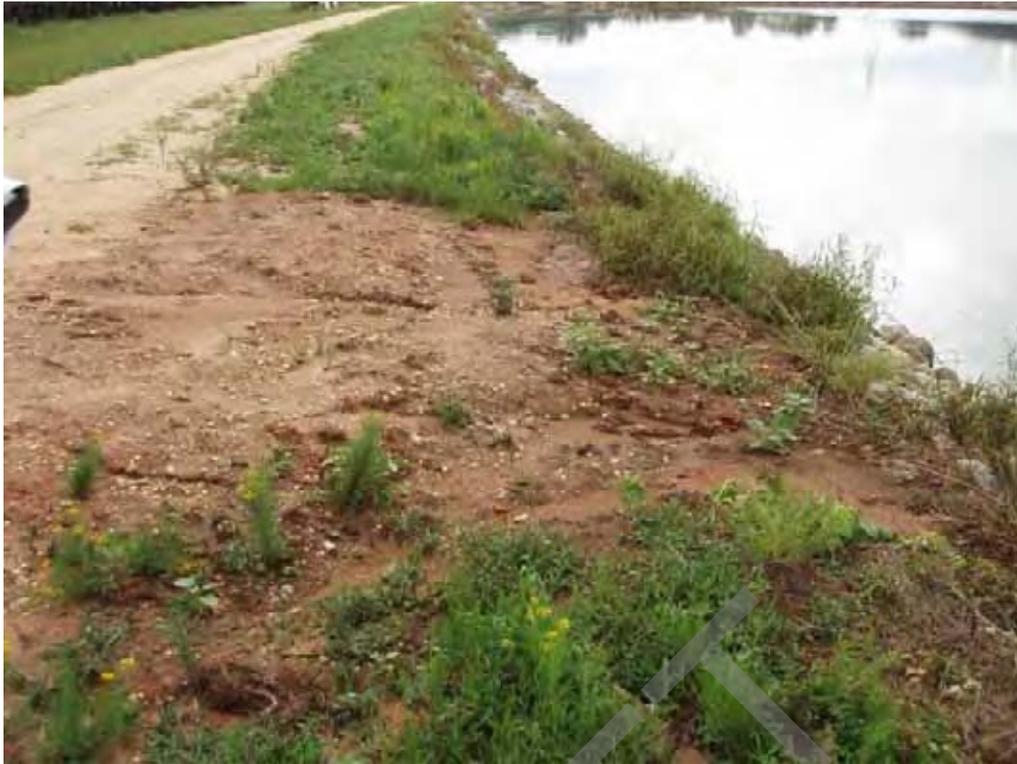
Minor surface erosion was observed on the interior slope of the west embankment (Photograph 55).

**Photo No. 55: Process Waste Pond – West embankment interior slope, looking north. Note surface erosion.**

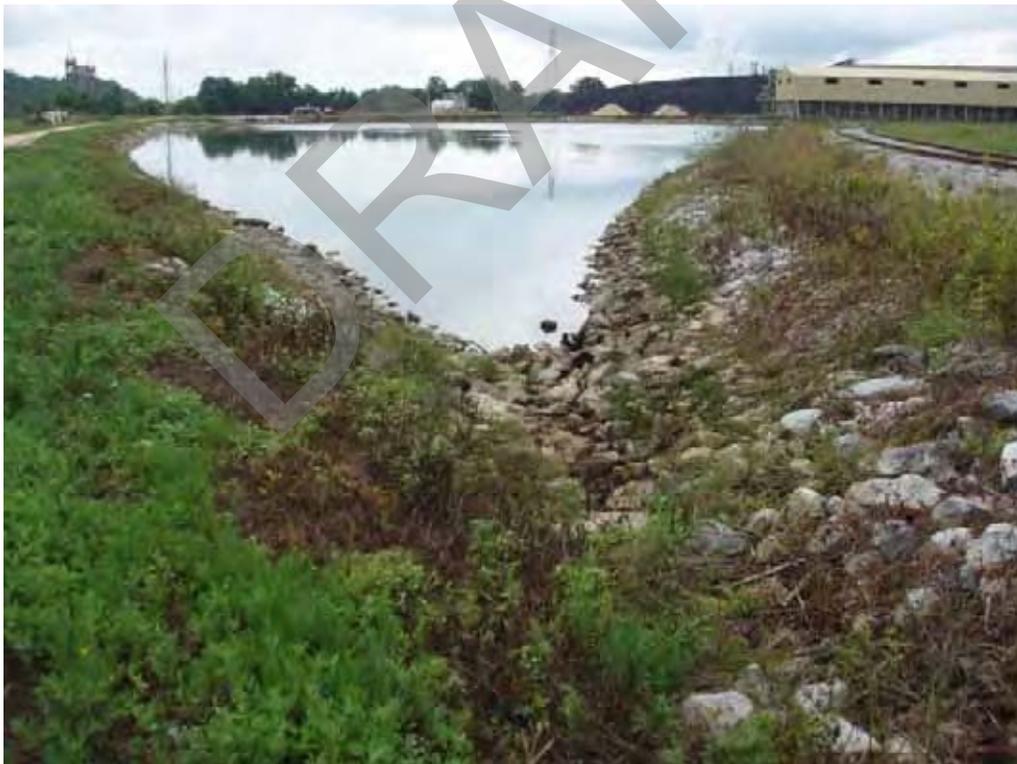
**Photo No. 56: Process Waste Pond – West embankment interior slope, looking northeast.**

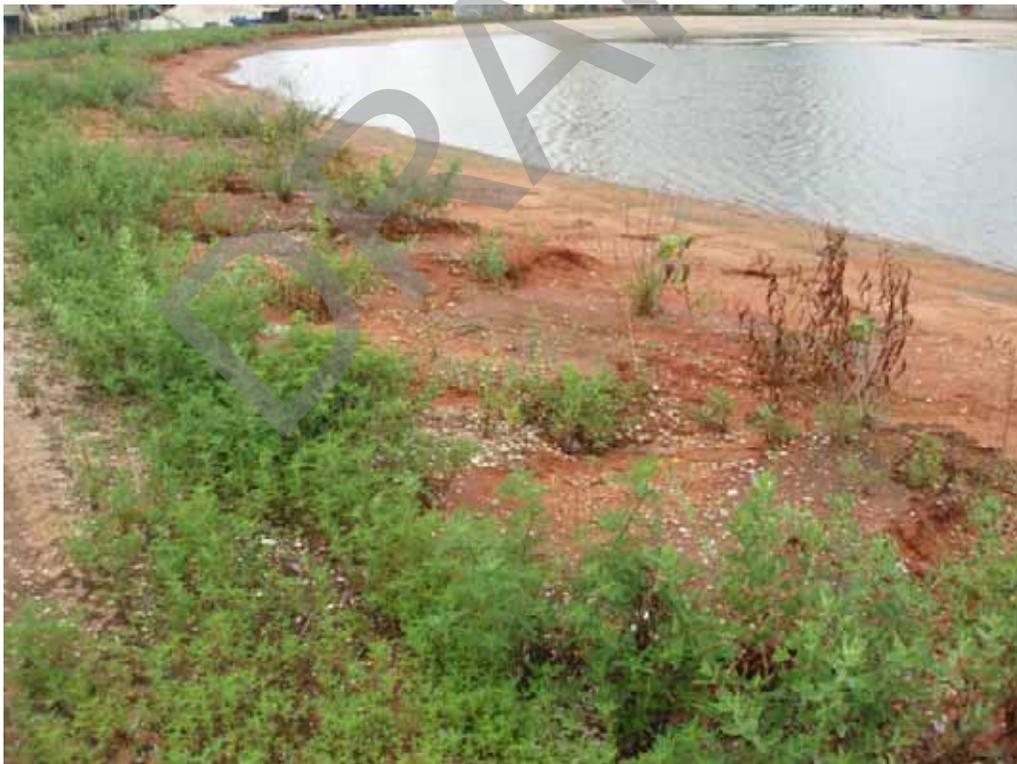
**Photo No. 58: Process Waste Pond – South (divider) embankment exterior slope, looking southeast. Looking at erosion rills in fill material.**

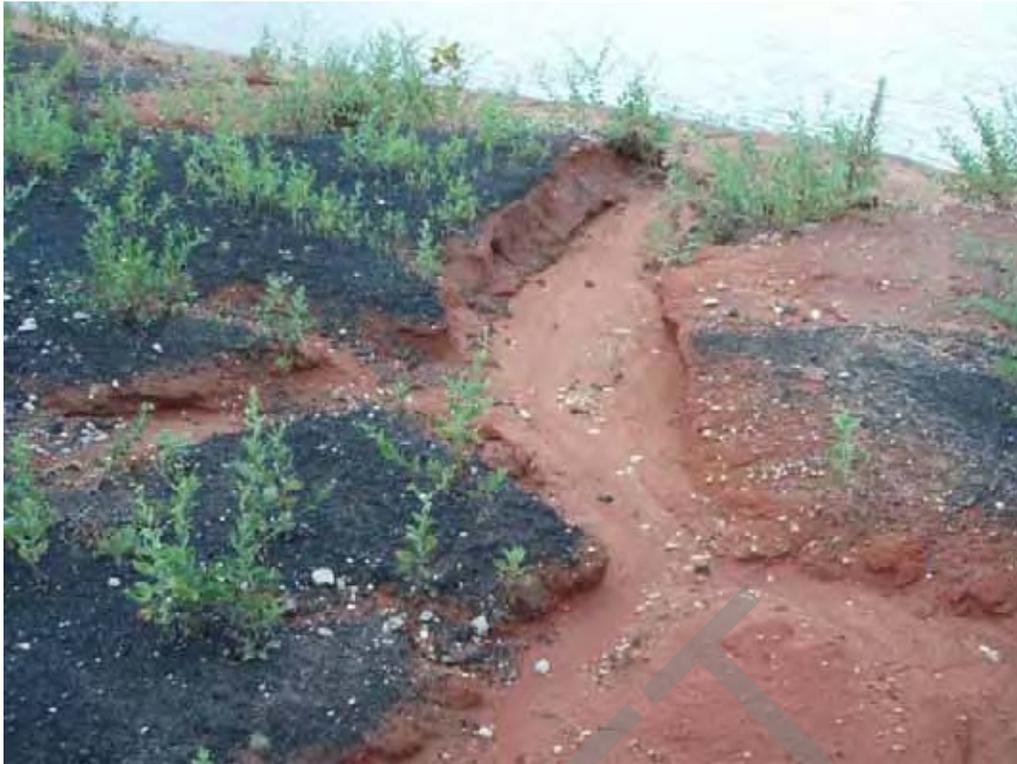
**Photo No. 59: Process Waste Pond – South (divider) embankment exterior slope. Looking at erosion rills in fill material.**

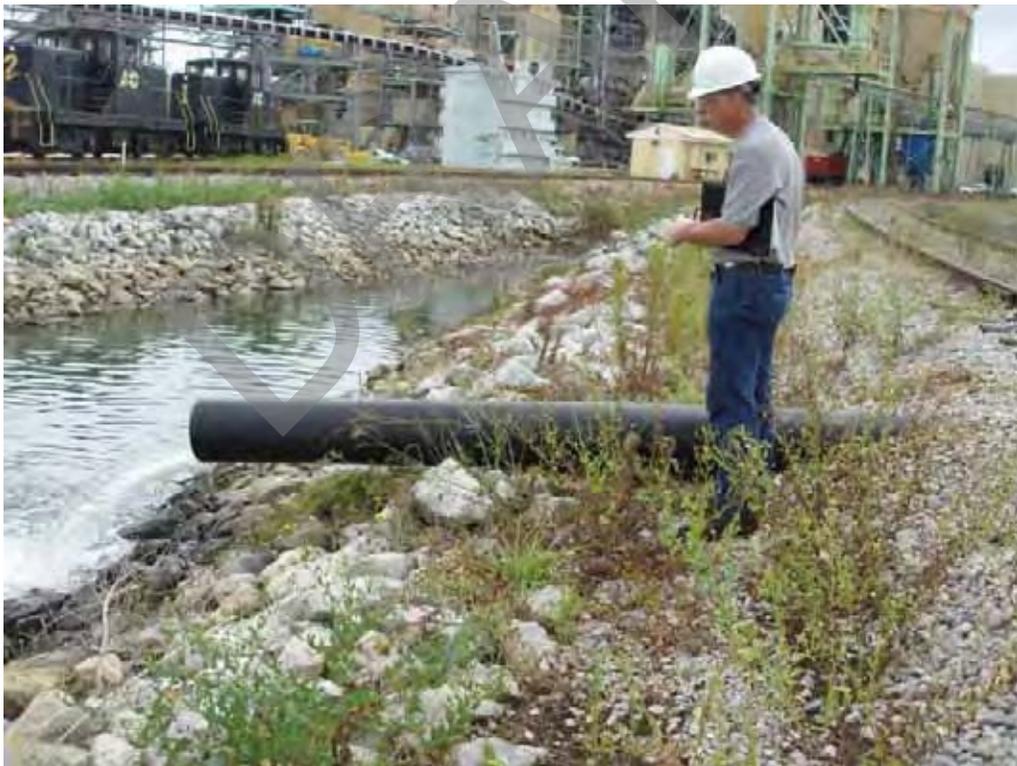
**Photo No. 62: Process Waste Pond – South embankment interior slope, looking east. Looking at discharge outfall from pump station.**

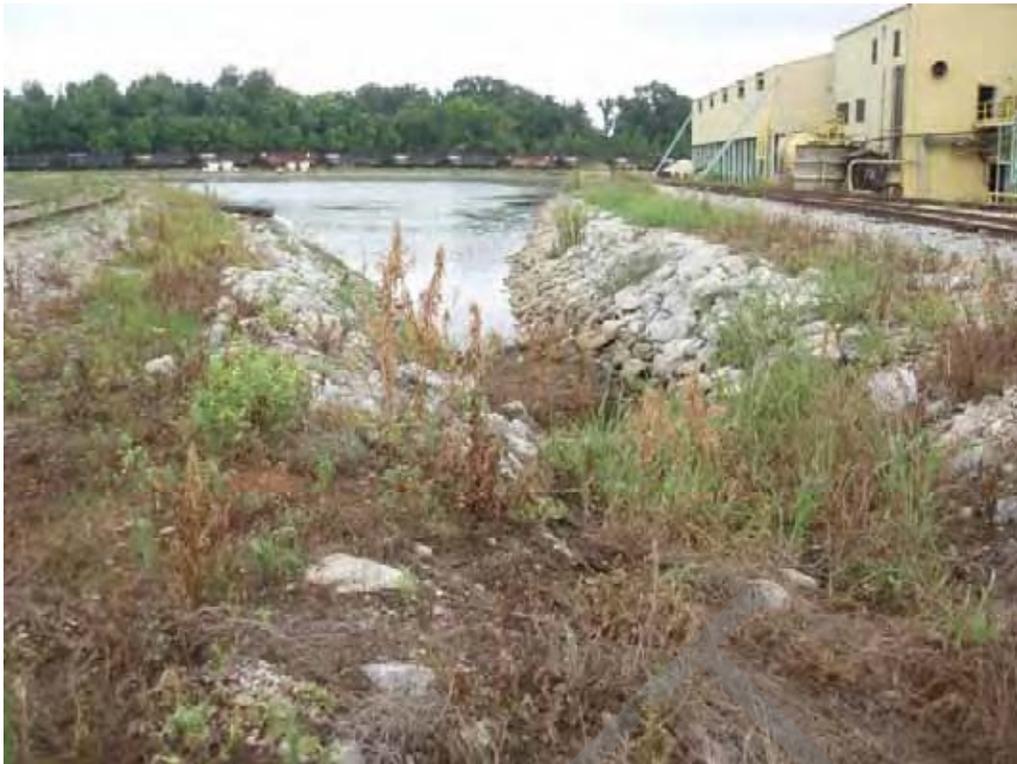
**Photo No. 63: Process Waste Pond – South and north embankment interior slopes, looking northwest. Note vegetation growing within riprap.**

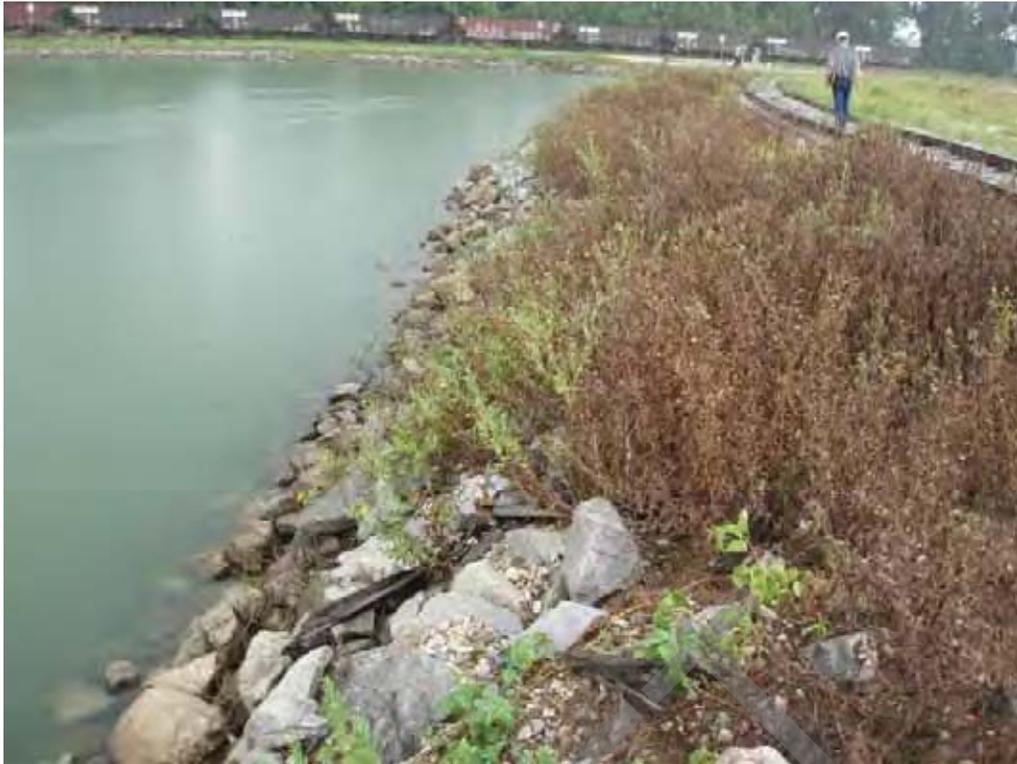
Vegetation, consisting primarily of brush less than 24 inches tall, was observed on the interior slopes of the north and south embankments (Photographs 61 and 67).

**Photo No. 67: Process Waste Pond – North embankment interior slope, looking north. Note vegetation growing in riprap.**

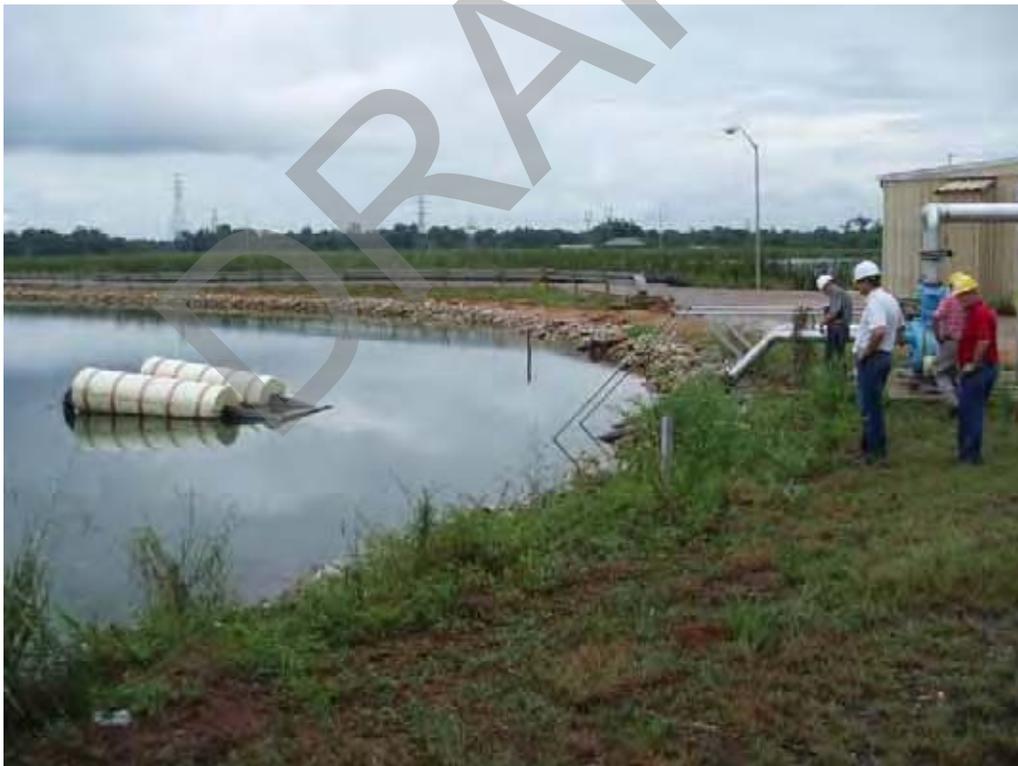
**Photo No. 74: Scrubber Waste Pond – West embankment interior slope, looking southeast. Looking at intake piping and pump station.**

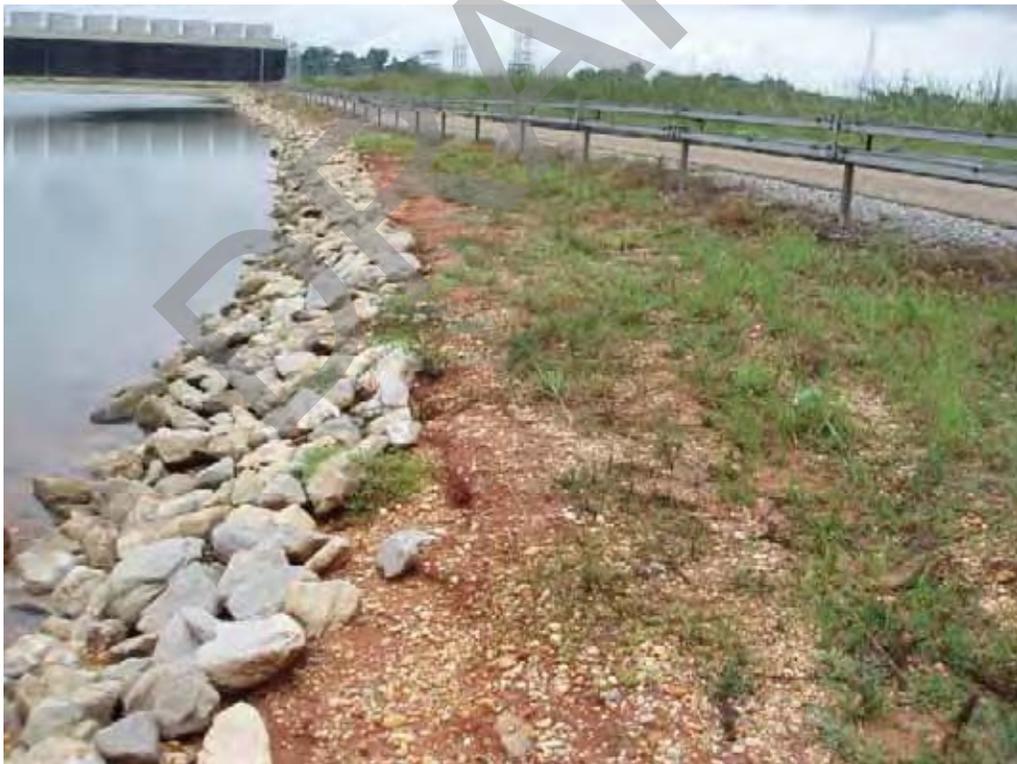
**Photo No. 76: Scrubber Waste Pond – South (divider) embankment interior slope, looking east. Note surface erosion and settlement above riprap.**
