# **Assessment of Dam Safety of Coal Combustion Surface Impoundments**

**PowerSouth Energy Cooperative**

**Charles R. Lowman Power Plant**

**August 6, 2010**

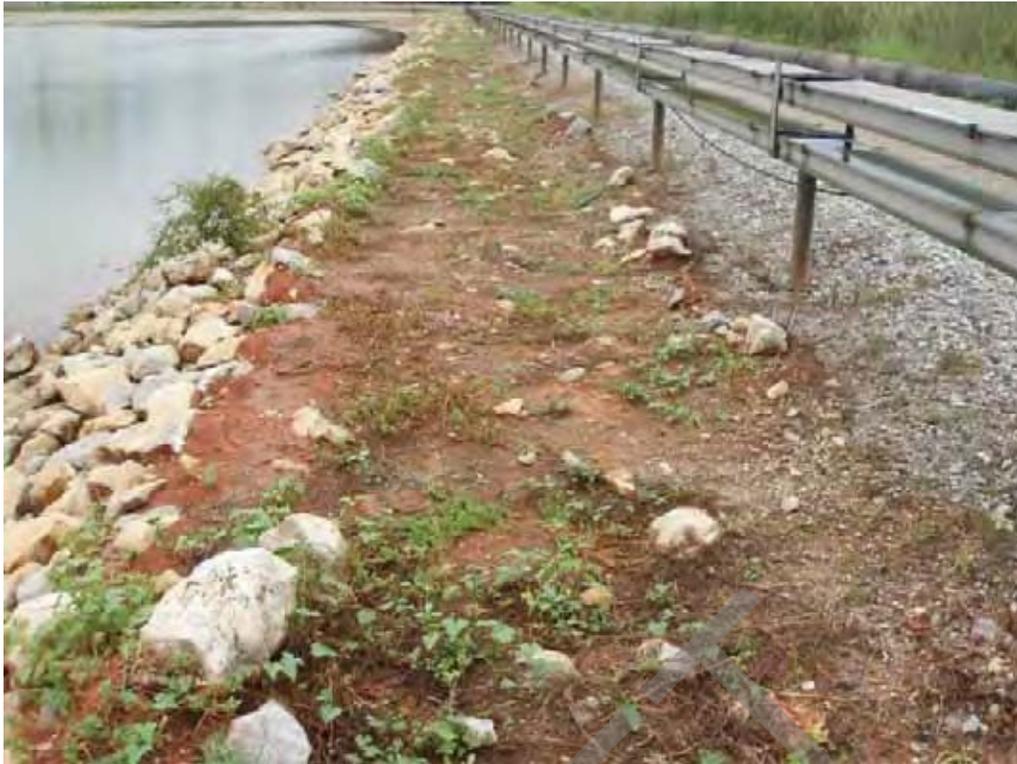
Surface erosion features were observed on the interior slopes of the south and east embankments (Photograph 82 and 84). Spongy soils, sloughing, and voids were observed along the length of the south embankment in the location of a buried pipeline (Photograph 77).

**Photo No. 77: Scrubber Waste Pond – South embankment interior slope, looking east. Looking at location of spongy soils in area of buried pipeline.**

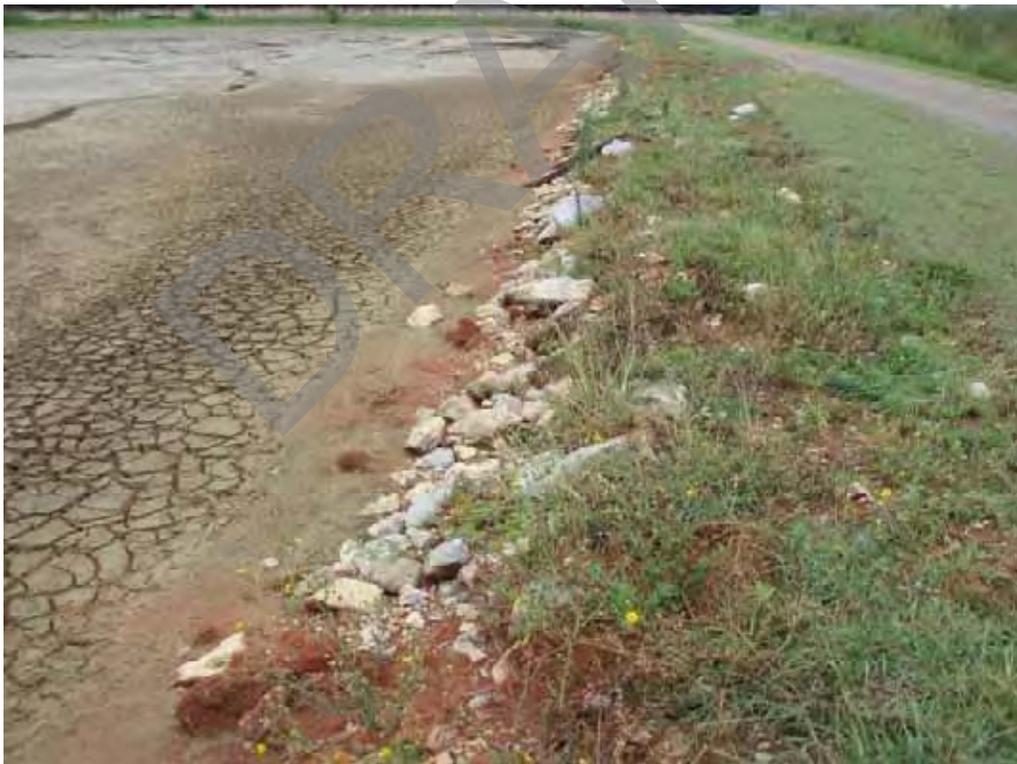
**Photo No. 78: Scrubber Waste Pond – South embankment interior slope, looking east. Note surface erosion and sparse riprap.**

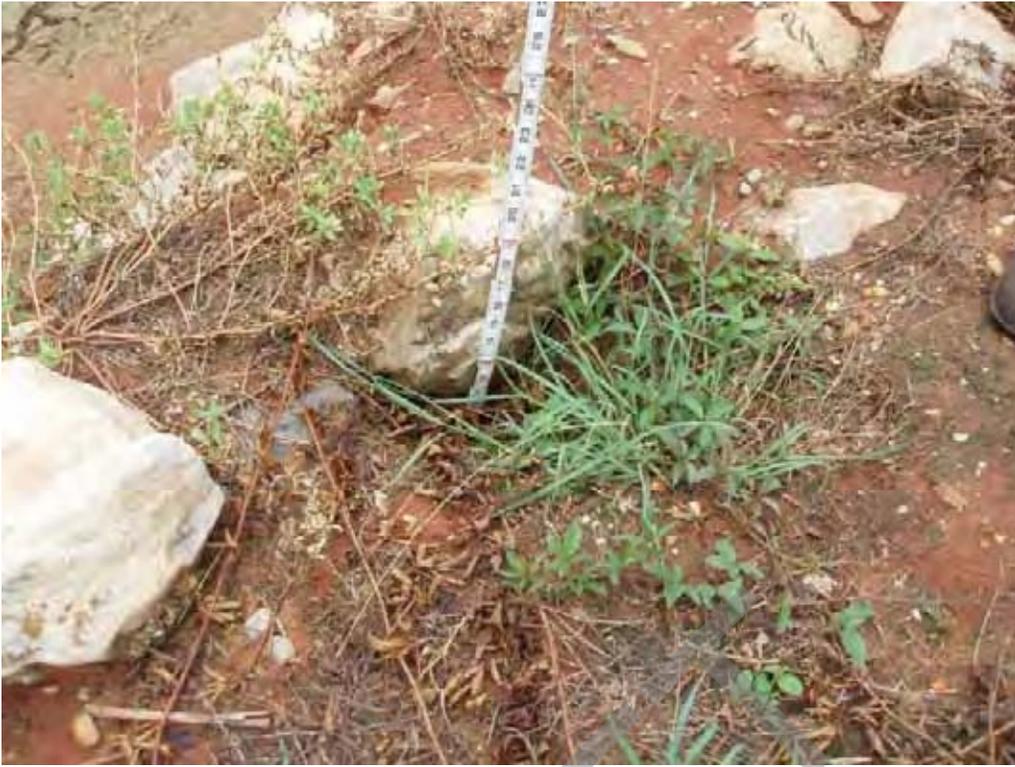
**Photo No. 79: Scrubber Waste Pond – South embankment exterior slope. Looking at 10-inch-deep void beneath riprap.**

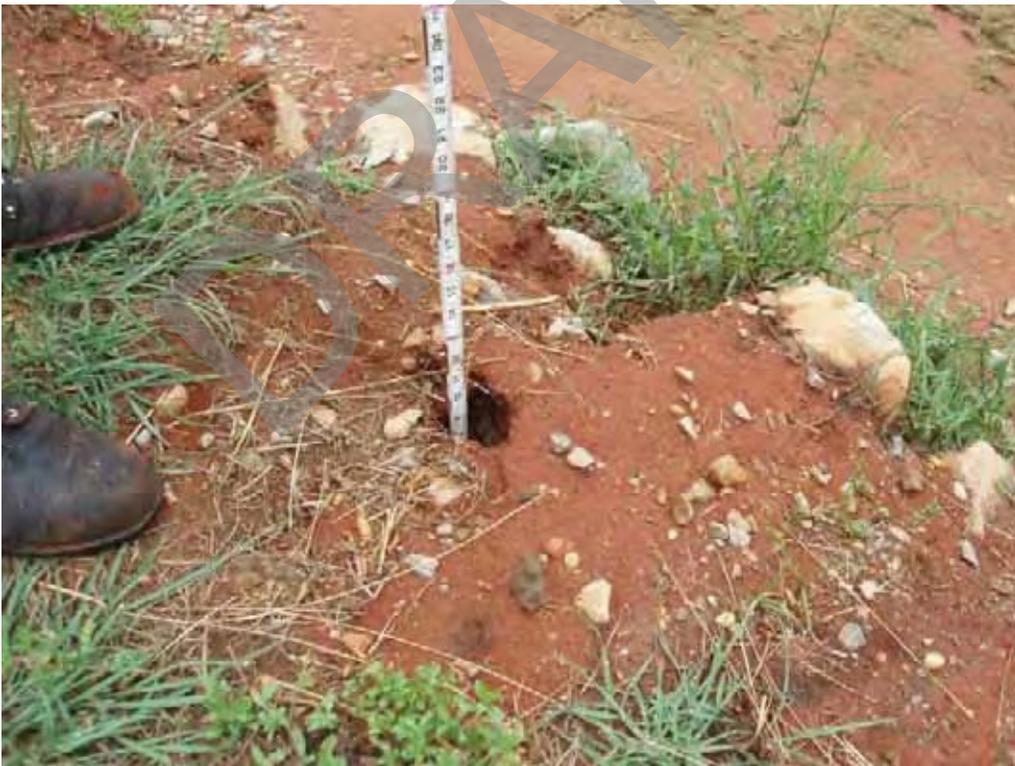
**Photo No. 80: Scrubber Waste Pond – South embankment exterior slope. Looking at 10-inch-deep void in soils.**

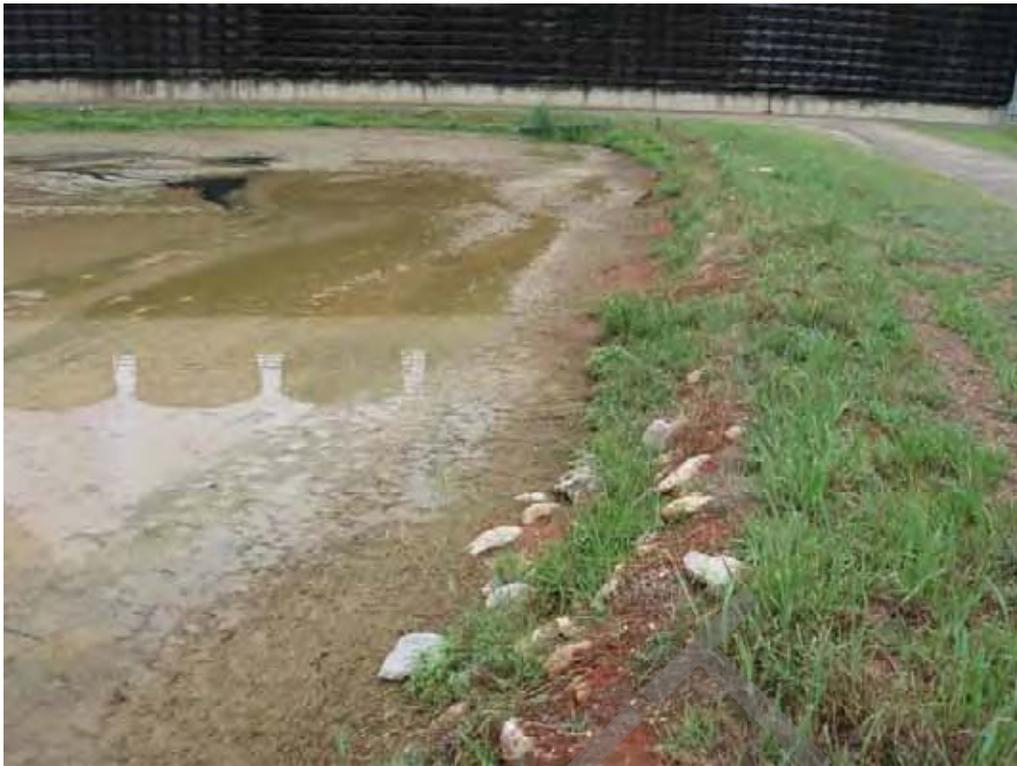
Also observed on the south and east embankments were areas where riprap coverage was less than 50 percent, voids within the riprap, and vegetation growing within the riprap (Photographs 80, 81, 84, and 89).

**Photo No. 81: Scrubber Waste Pond – South embankment interior slope, looking east. Note sparse riprap and surface erosion.**

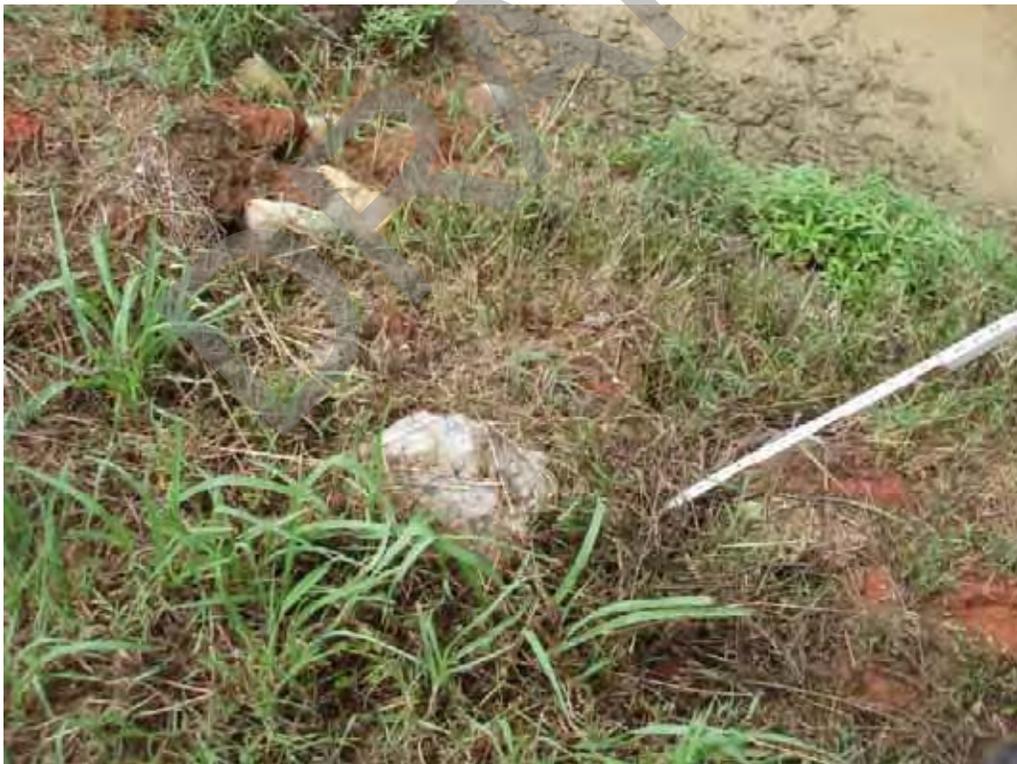
**Photo No. 82: Scrubber Waste Pond – South embankment interior slope. Looking at 8-inch-deep void.**

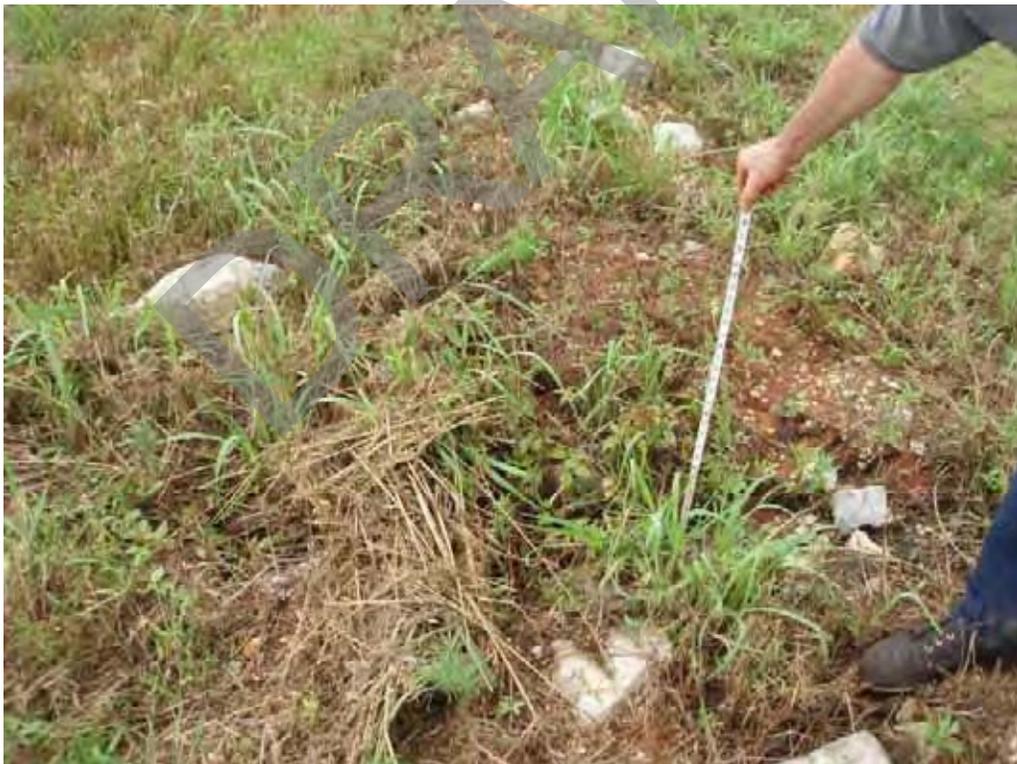
**Photo No. 84: Scrubber Waste Pond – East embankment interior slope. Looking at surface erosion and sparse riprap.**

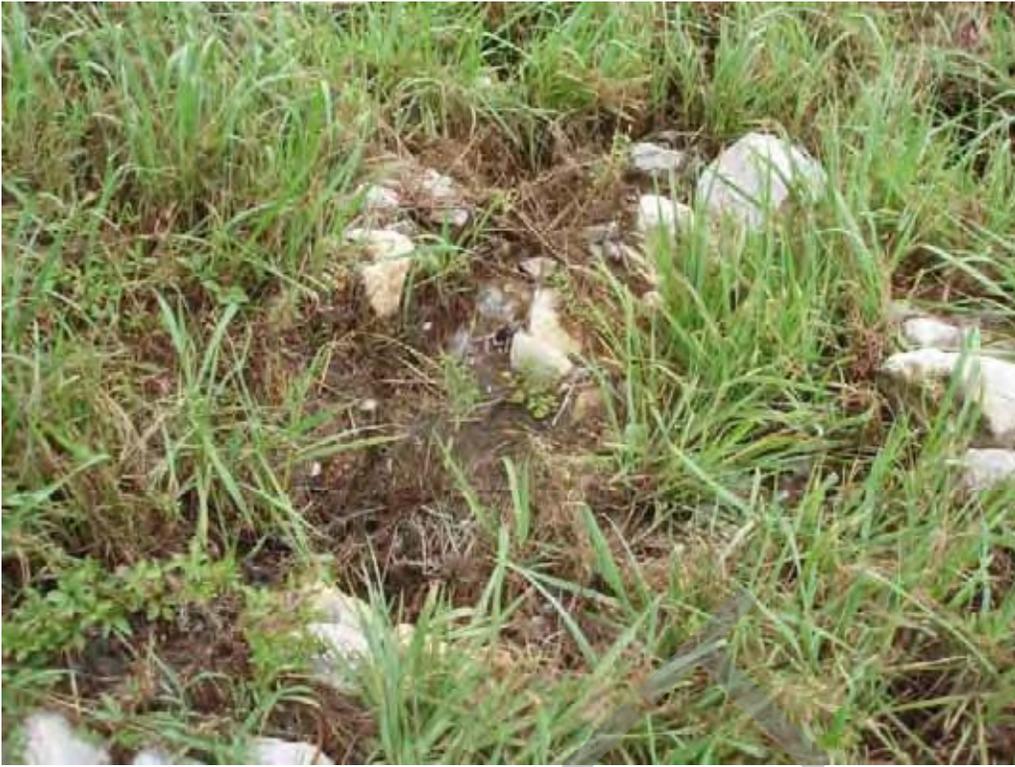
**Photo No. 87: Scrubber Waste Pond – East embankment interior slope. Looking at surface erosion, sparse riprap and vegetation within riprap.**

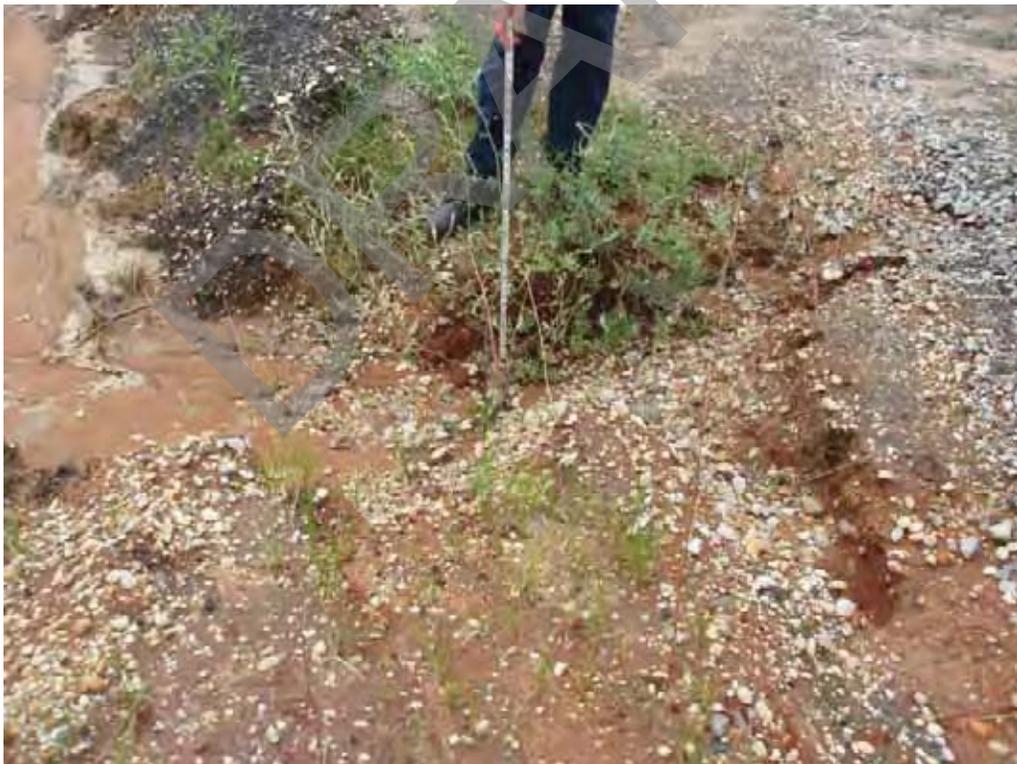
**Photo No. 96: Scrubber Waste Pond – North (divider) embankment interior slope. Looking at erosion rills in fill material.**

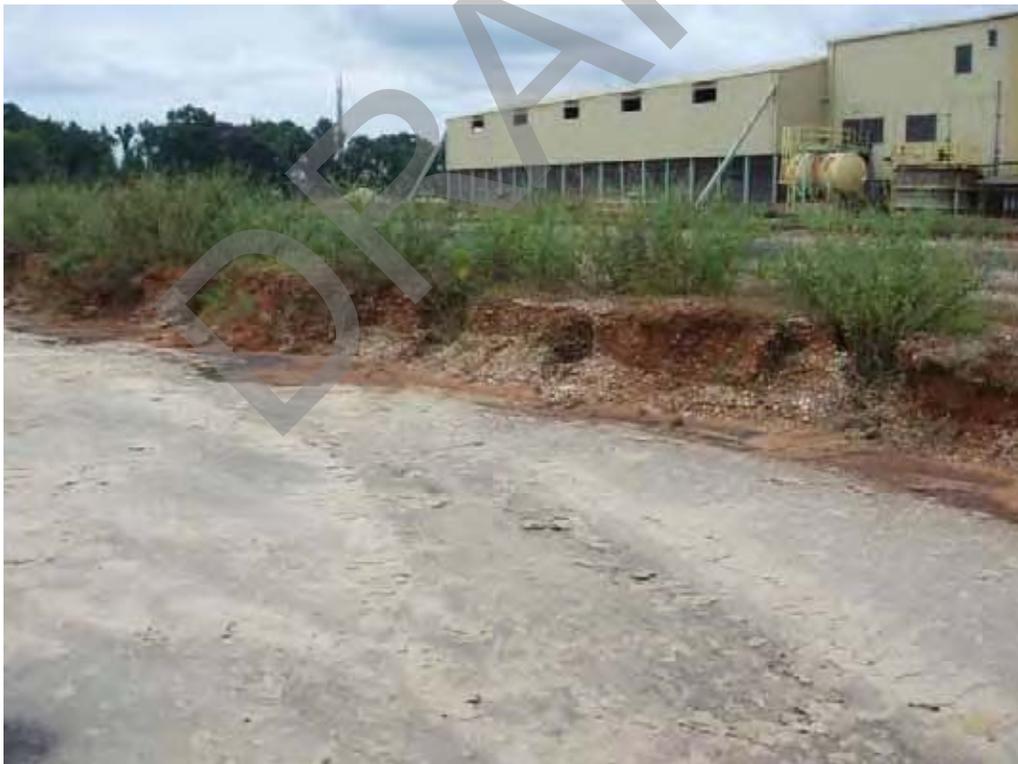
**Photo No. 98: Scrubber Waste Pond – North embankment interior slope, looking northwest. Looking at erosion rills in fill material.**

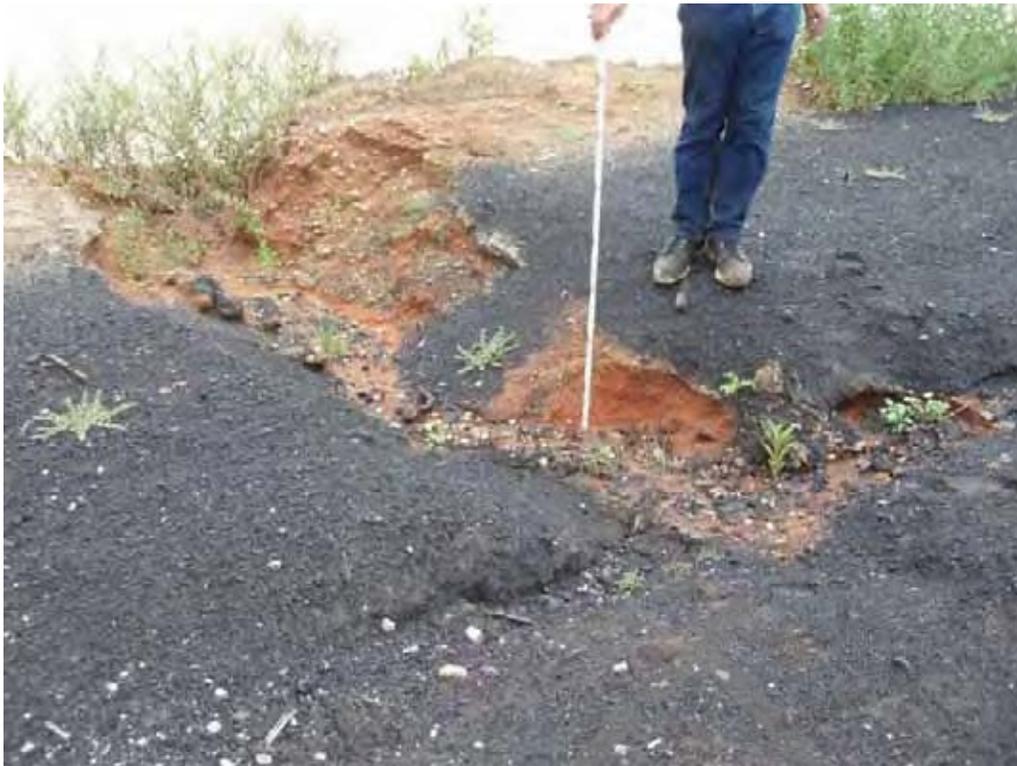
**Photo No. 99: Scrubber Waste Pond – North embankment interior slope. Looking at erosion rill in fill material.**

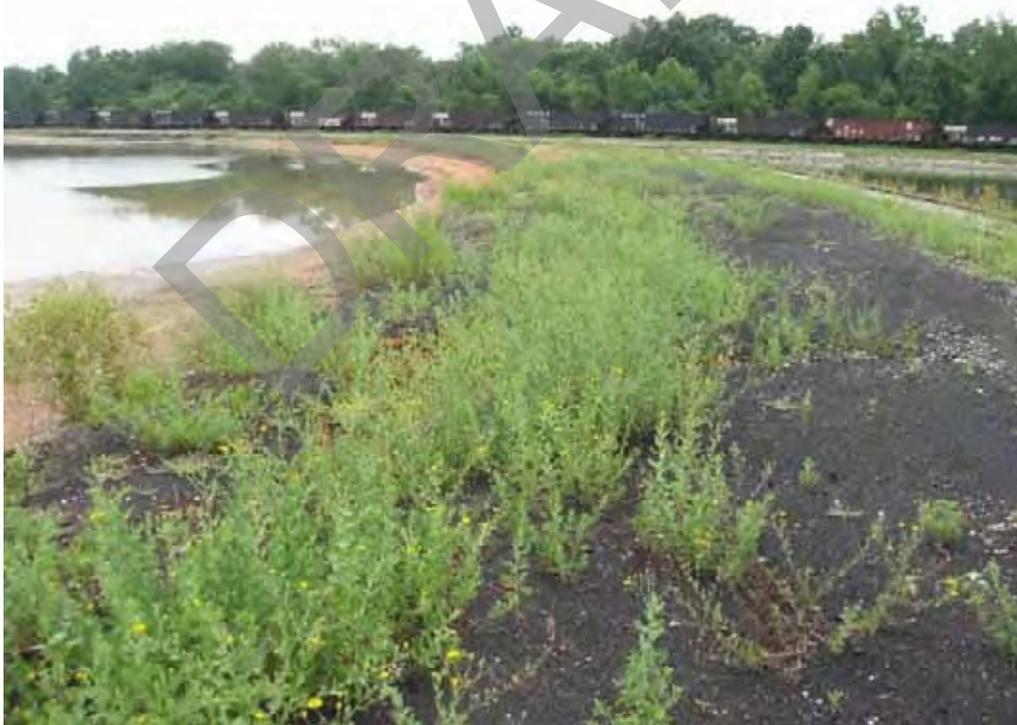
The embankment interior slopes appear to be in poor condition. The interior slopes generally appear to be approximately 3H:1V; except at areas on the south embankment that are approximately 2H:1V. The west and south interior slopes are armored with riprap (Photographs 73 and 78). The east embankment interior slope is sparsely vegetated with grass and vegetation generally less than 8 inches tall and some small saplings up to one inch in diameter. The east embankment did not have armoring (Photograph 89). Bare fill material placed to create a haul road is covering the north embankment interior slope (Photograph 100).

**Photo No. 100: Scrubber Waste Pond – North (divider) embankment interior slope, looking west. Looking at haul road fill material.**

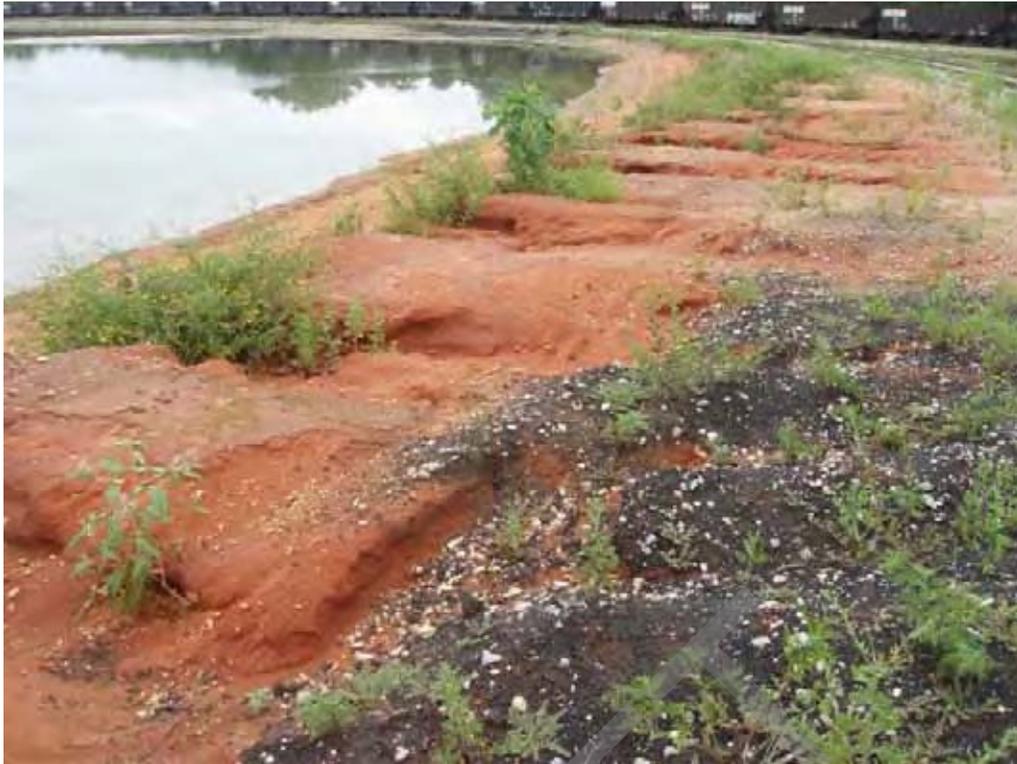
Erosion rills observed along the north embankment interior slope appeared to only extend into the haul road fill materials (Photograph 101).

Erosion rills were observed along the exterior slope of the south embankment, but the rills appeared to only extend into the fill material (Photograph 101).

**Photo No. 101: Scrubber Waste Pond – North embankment interior slope. Looking at erosion rills in fill material.**

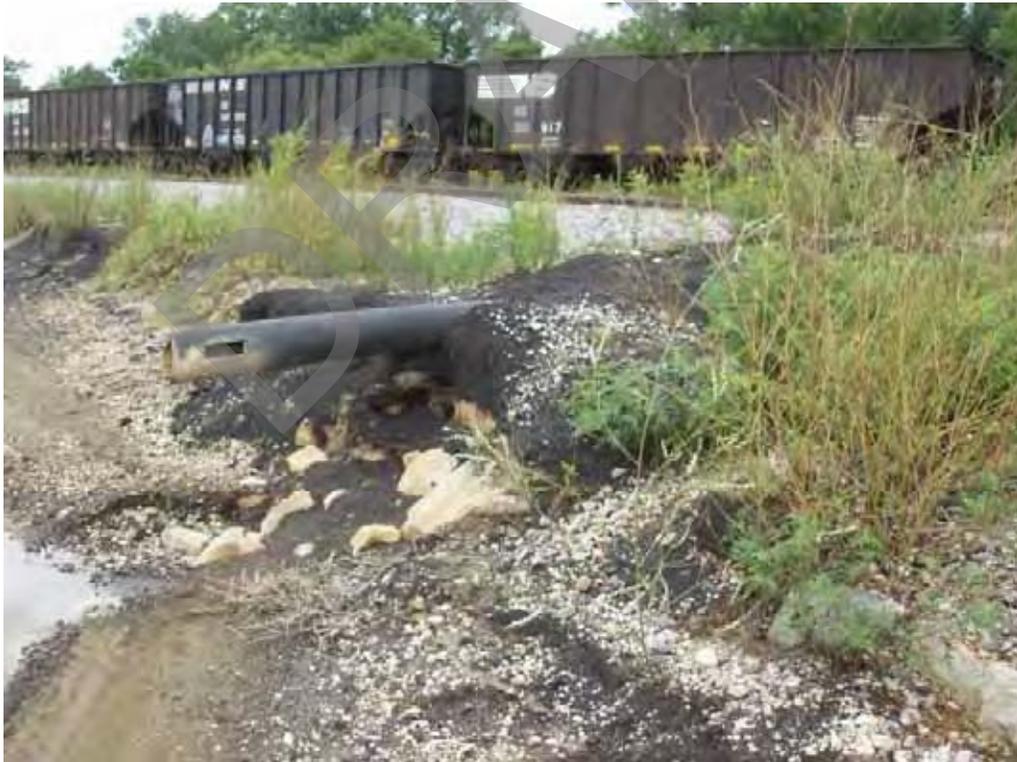
**Photo No. 102: Scrubber Waste Pond – North embankment interior slope, looking southwest. Looking at unknown pipe.**

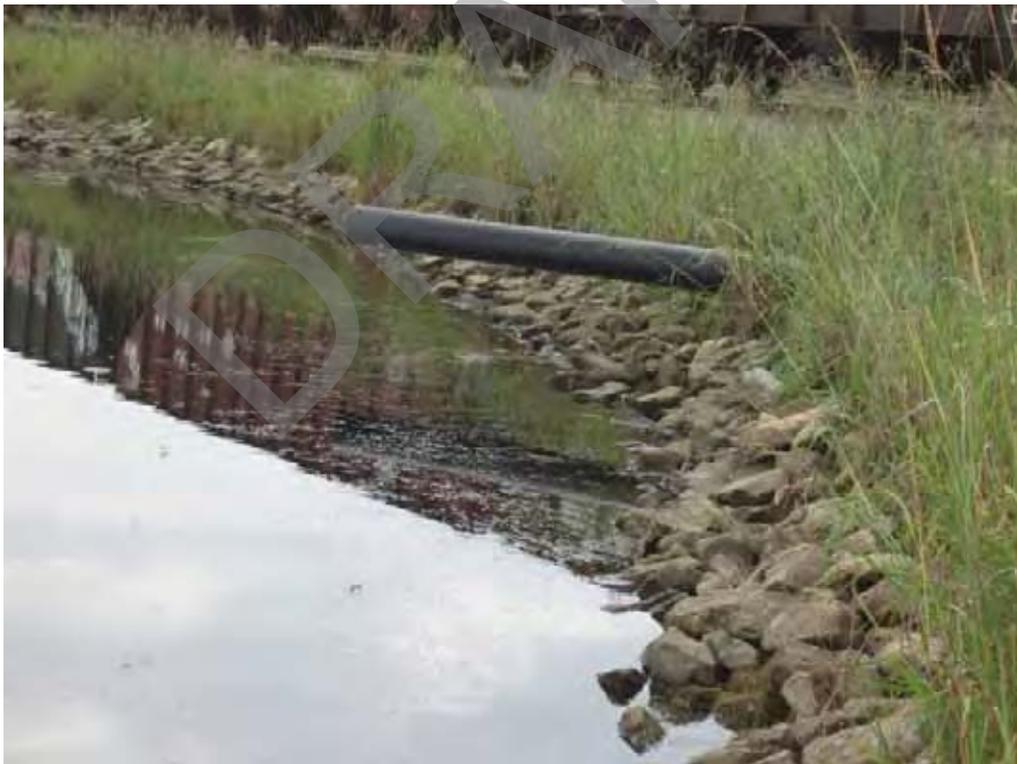
**Photo No. 104: #2/#3 Bottom Ash Pond – West embankment interior slope, looking southwest. Looking at discharge pipe from pump station.**

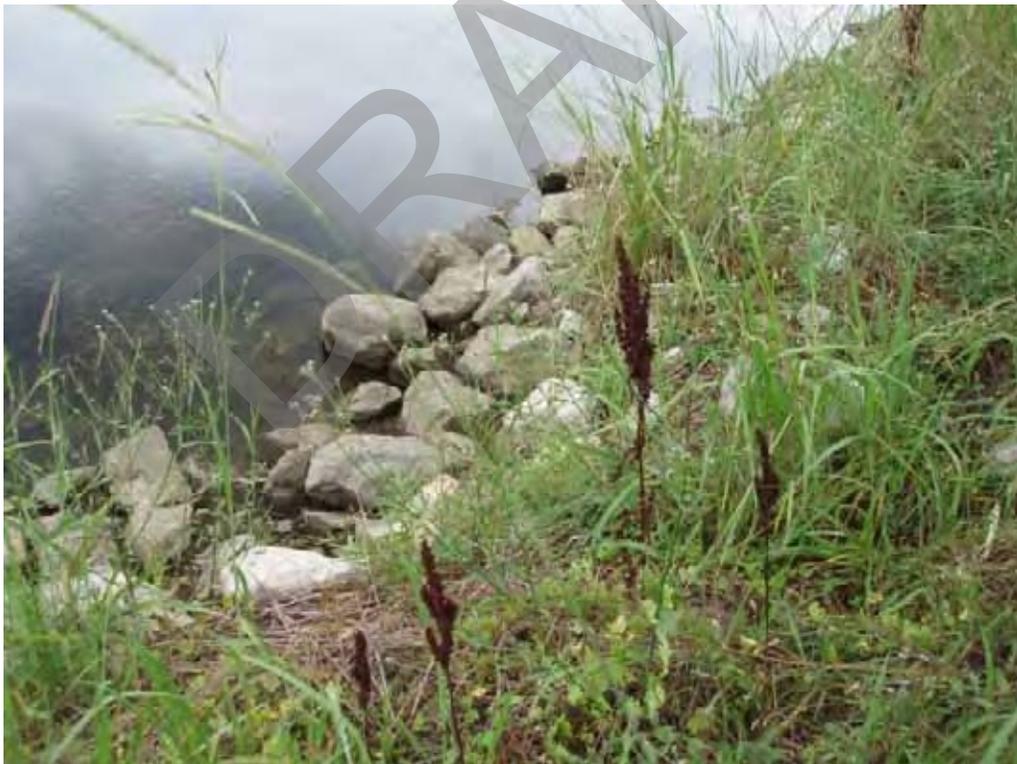
**Photo No. 106: #2/#3 Bottom Ash Pond – West embankment interior slope. Looking at erosion of riprap.**

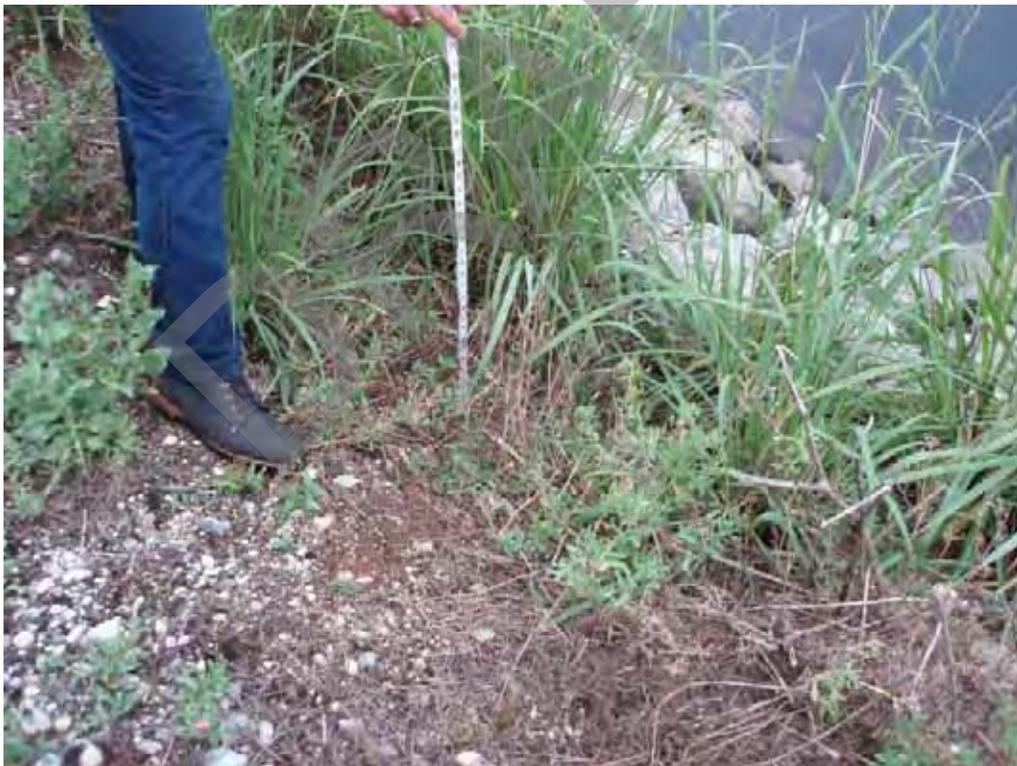
Locations of erosion due to missing riprap, vegetation growing within riprap, and possible localized settlement were observed at various locations on the interior slopes (Photographs 108, 114, 129 and 132).

**Photo No. 108: #2/#3 Bottom Ash Pond – West embankment interior slope. Looking at surface erosion and possible localized settlement.**

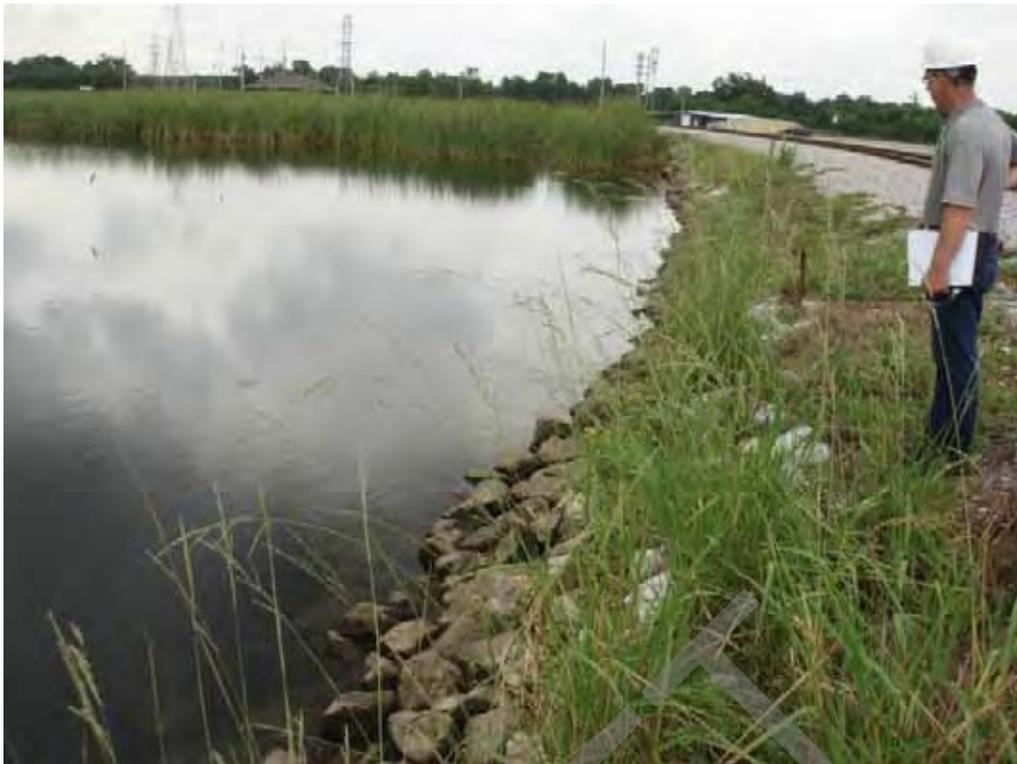
**Photo No. 109: #2/#3 Bottom Ash Pond – South embankment interior slope, looking southeast. Note cattails growing within impoundment in background.**

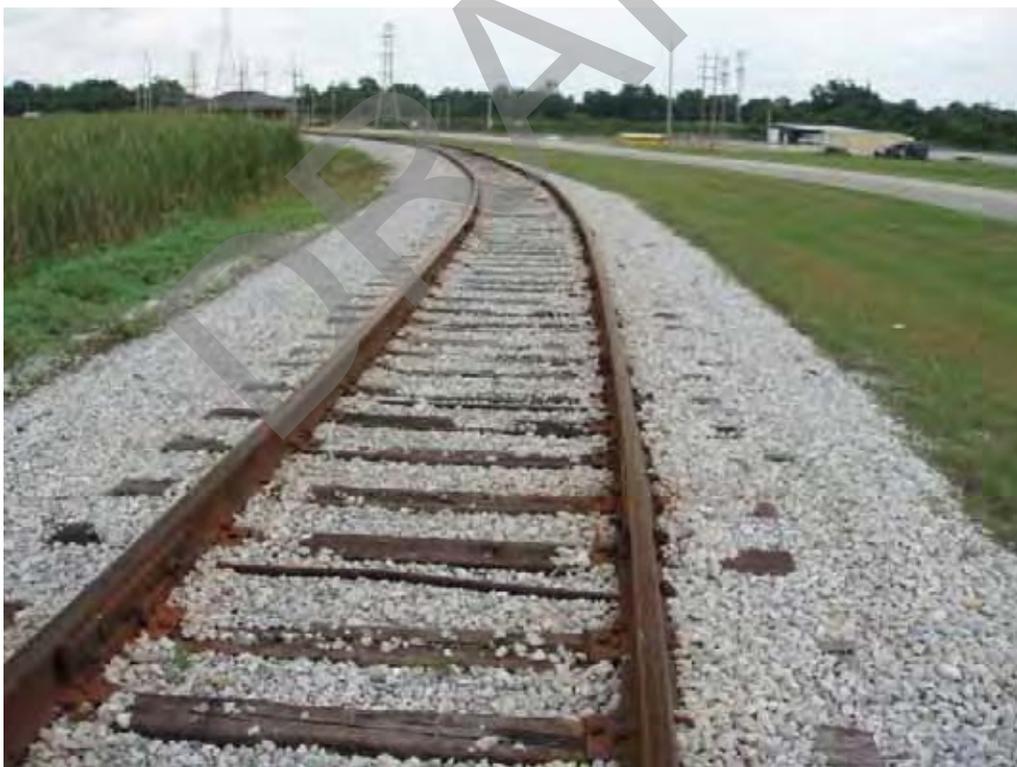
The crest appears to be in good condition (Photographs 110 and 130). The average crest width is approximately 20 feet, except at the east embankment, where the crest is approximately 30 feet wide. A Norfolk Southern railroad spur is located on the west, south, and east embankment crests that are covered with crushed stone railroad ballast (Photographs 110 and 118). The north embankment crest is covered with asphalt paving and subject to vehicle traffic (Photograph 133). No depressions, ruts, or evidence of settlement were observed on the crests (Photographs 110, 118, and 130).

**Photo No. 110: #2/#3 Bottom Ash Pond – South embankment crest, looking east.**

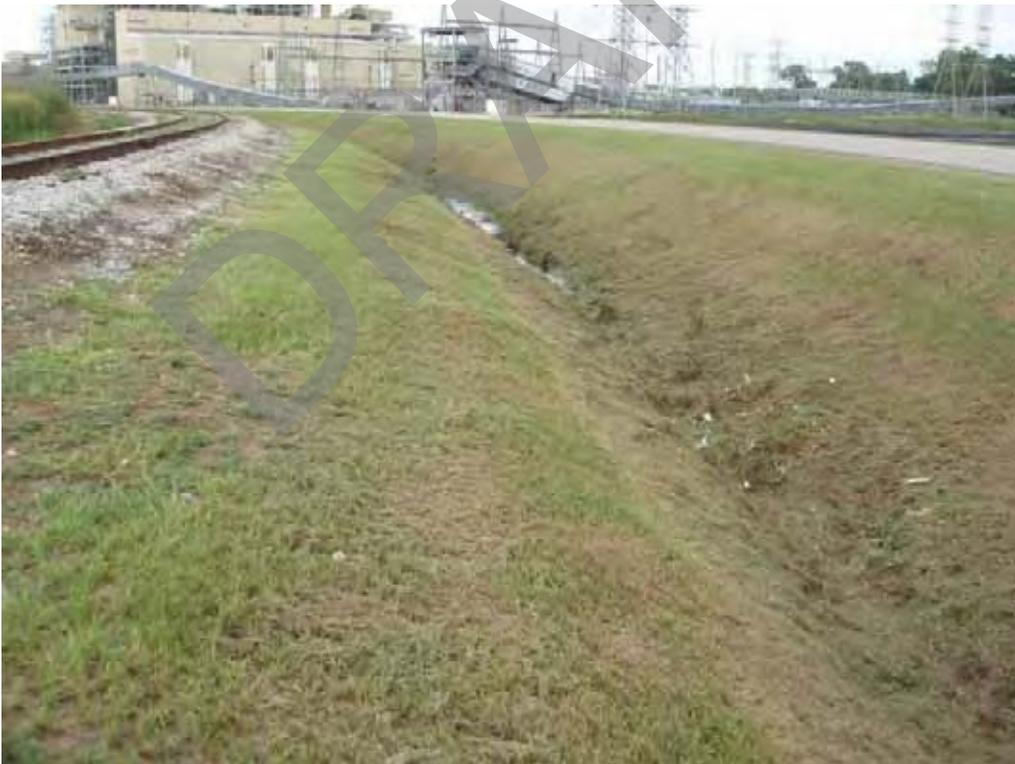
The embankment exterior slopes appear to be in fair condition. The exterior slopes are approximately 2H:1V. Grass, ranging from 3 to 6 inches tall covers the south and east embankment exterior slopes (Photographs 144 and 116). The majority of the west embankment exterior slope is covered in dense, vegetation including trees up to 8 inches in diameter (Photograph 139). The exterior slope of the north (divider) embankment is sparsely covered with riprap (Photograph 78).

**Photo No. 116: #2/#3 Bottom Ash Pond – East embankment exterior slope, looking north.**

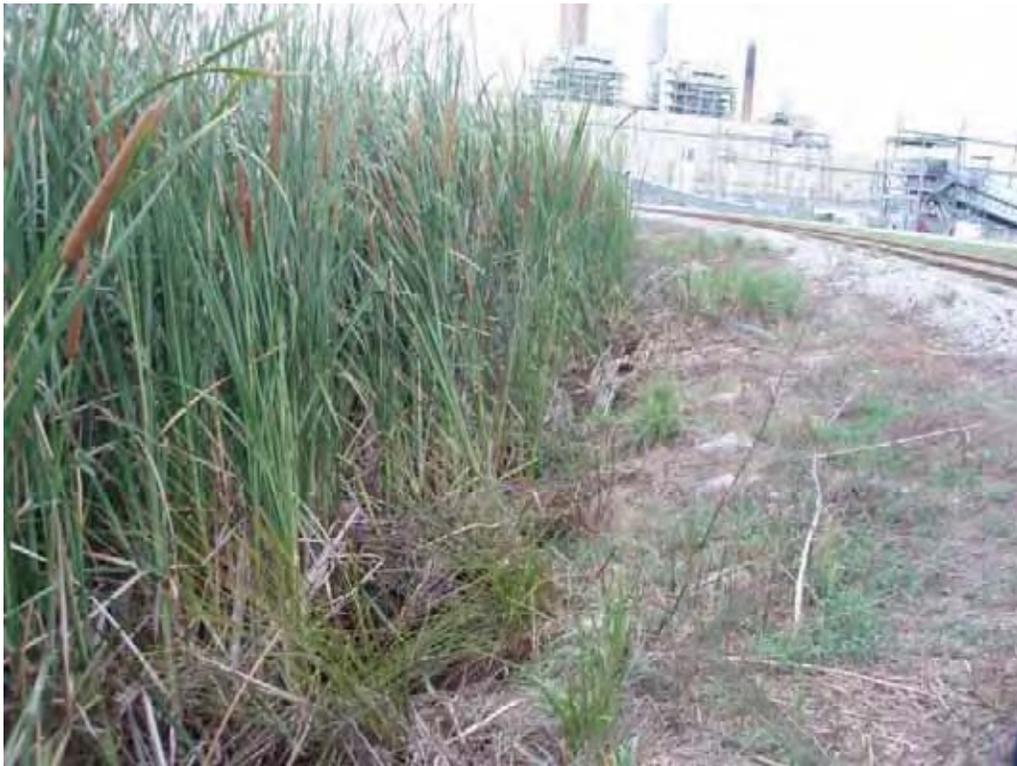
**Photo No. 117: #2/#3 Bottom Ash Pond - East embankment interior slope, looking north.  
Note sparse riprap and cattails growing on slope.**

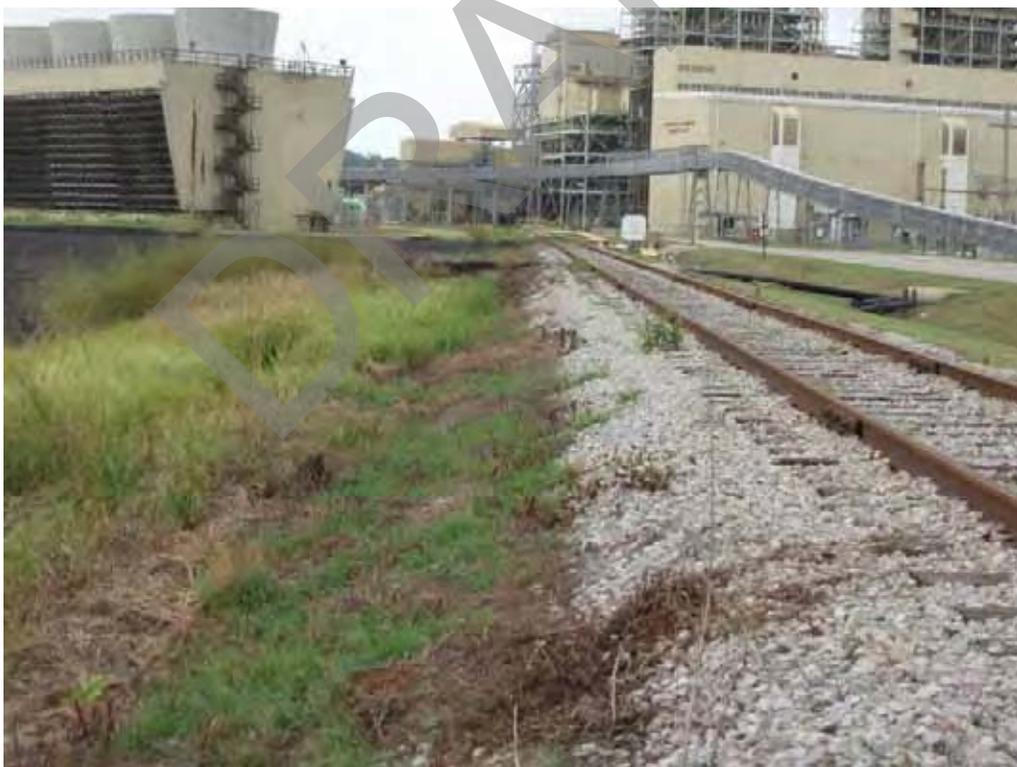
**Photo No. 118: #2/#3 Bottom Ash Pond - East embankment crest, looking north.**

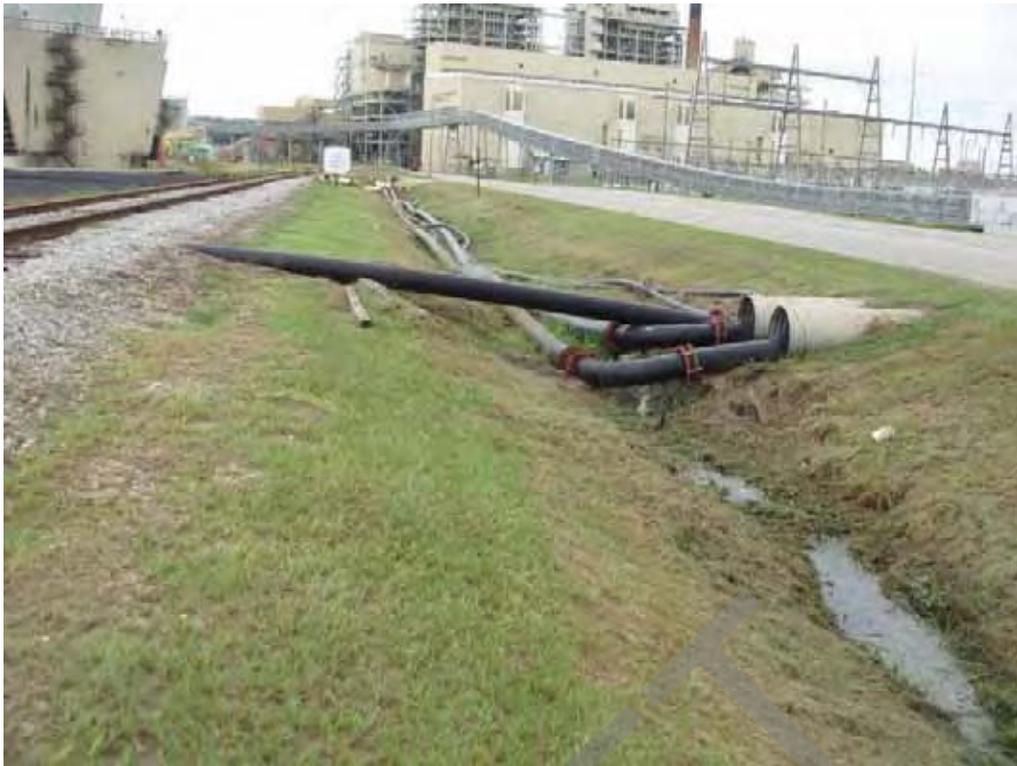
The #2/#3 Bottom Ash Pond has piping configured to allow receiving CCW from Units 1, 2, and 3, through two 10-inch-diameter HDPE pipes; though this pipe was not connected during the assessment (Photograph 119, 120, and 121). The pond receives water from the #1 Bottom Ash Pond through a 14-inch-diameter HDPE pipe. The pump station located on the northwest corner of the pond can pump water to and from the #2/#3 Bottom Ash Pond. Water may be pumped into the pond from the Scrubber Waste Pond, discharged through a 10-inch-diameter HDPE pipe. A 36-inch-diameter iron pipe intakes water from the #2/#3 Bottom Ash Pond to the pump house where it can be pumped to the Scrubber Waste Pond, the Process Waste Pond, or to the Plant for use as process water.

**Photo No. 119: #2/#3 Bottom Ash Pond – East embankment exterior slope, looking north.  
Looking at piping from Units 1, 2, & 3.**

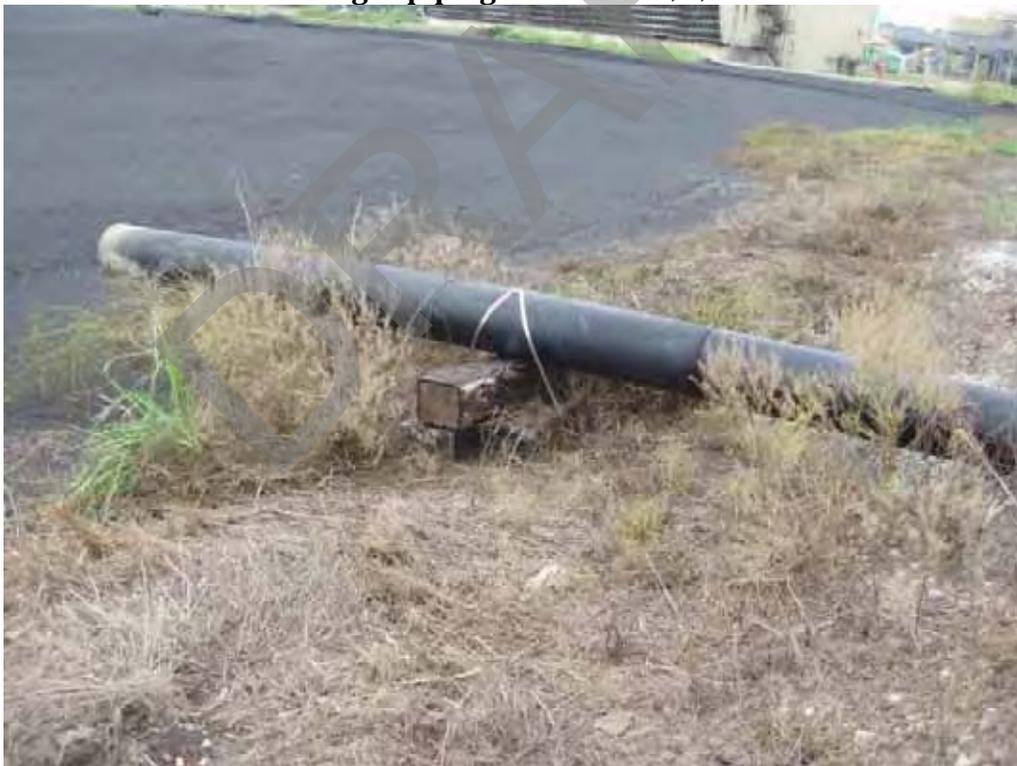
**Photo No. 120: #2/#3 Bottom Ash Pond – East embankment interior slope. Looking at inactive discharge pipe from Units 1, 2, & 3. Note sluice lines were configured for discharge of Units 1, 2 & 3 CCW to #1 Bottom Ash Pond.**

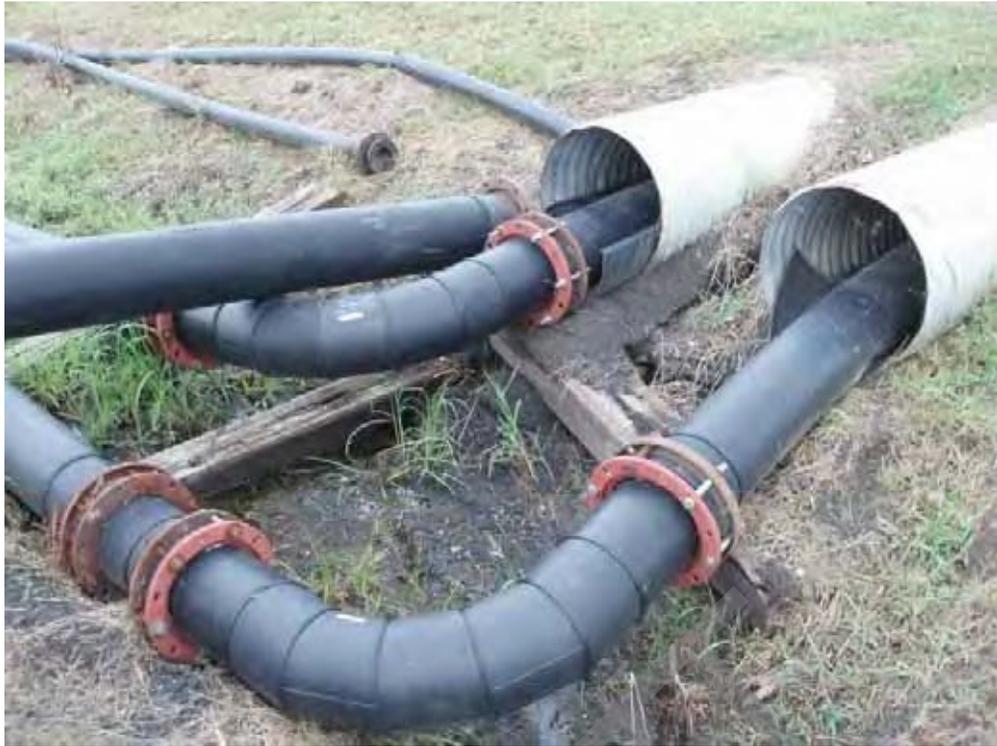
**Photo No. 121: #2/#3 Bottom Ash Pond – East embankment exterior slope. Looking at piping used to divert Units 1, 2, & 3 CCW from the #1 Bottom Ash Pond into the #2/#3 Bottom Ash Pond.**

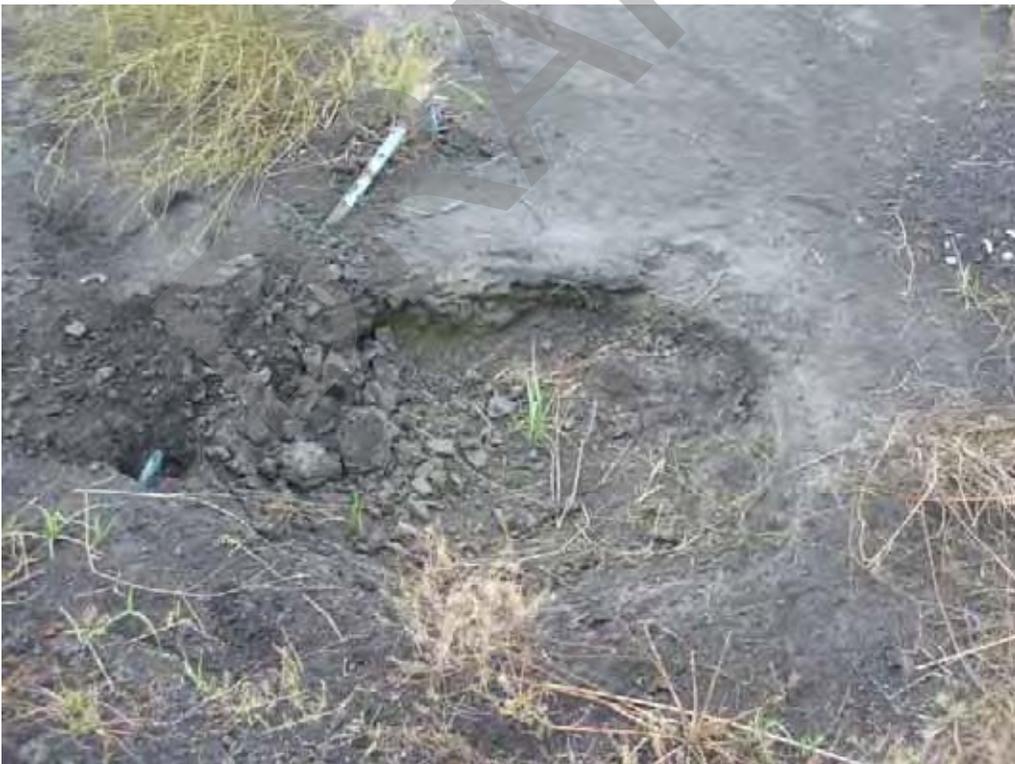
**Photo No. 124: #2/#3 Bottom Ash Pond – East embankment interior slope. Looking at abandoned electrical line.**

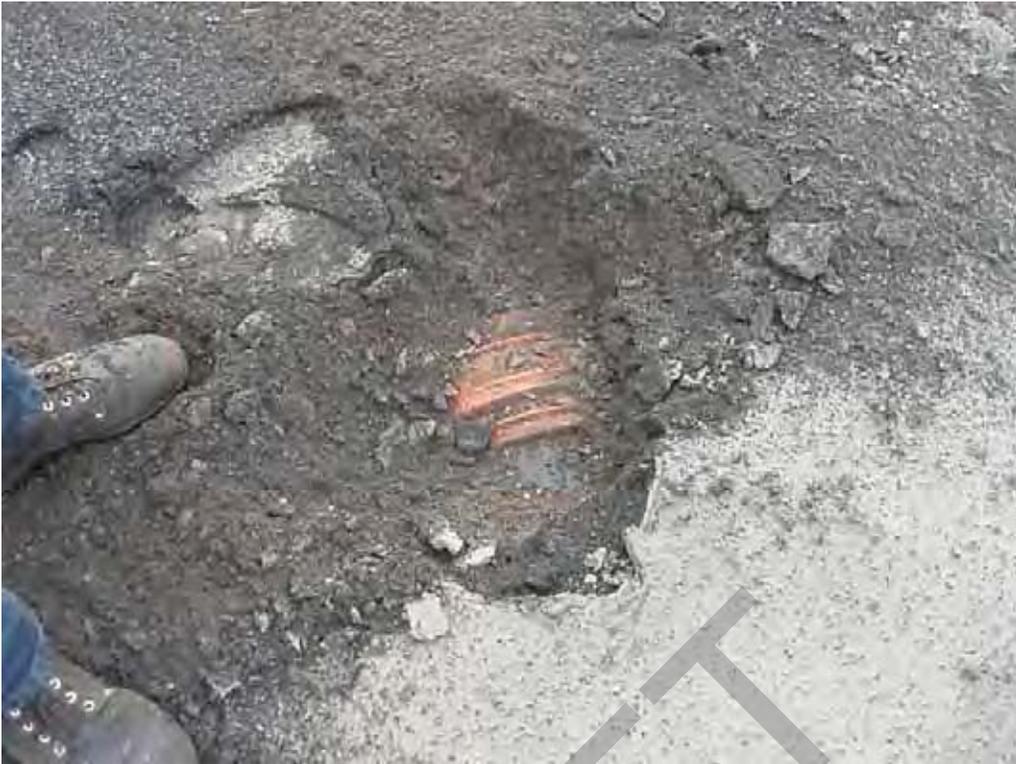
**Photo No. 125: #2/#3 Bottom Ash Pond – East embankment interior slope. Looking at buried piping within ash product.**
