# **Assessment of Dam Safety of Coal Combustion Surface Impoundments**

**PowerSouth Energy Cooperative**

**Charles R. Lowman Power Plant**

**August 6, 2010**

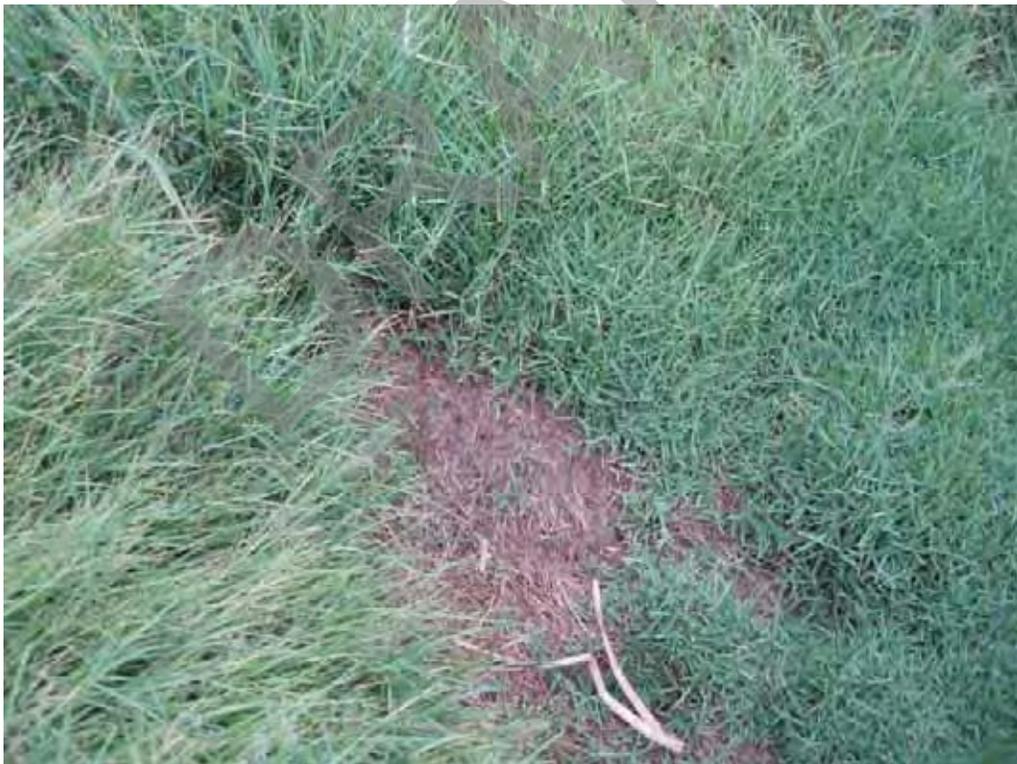
**Photo No. 128: #2/#3 Bottom Ash Pond – North embankment interior slope. Looking at rut or inactive erosion rill.**

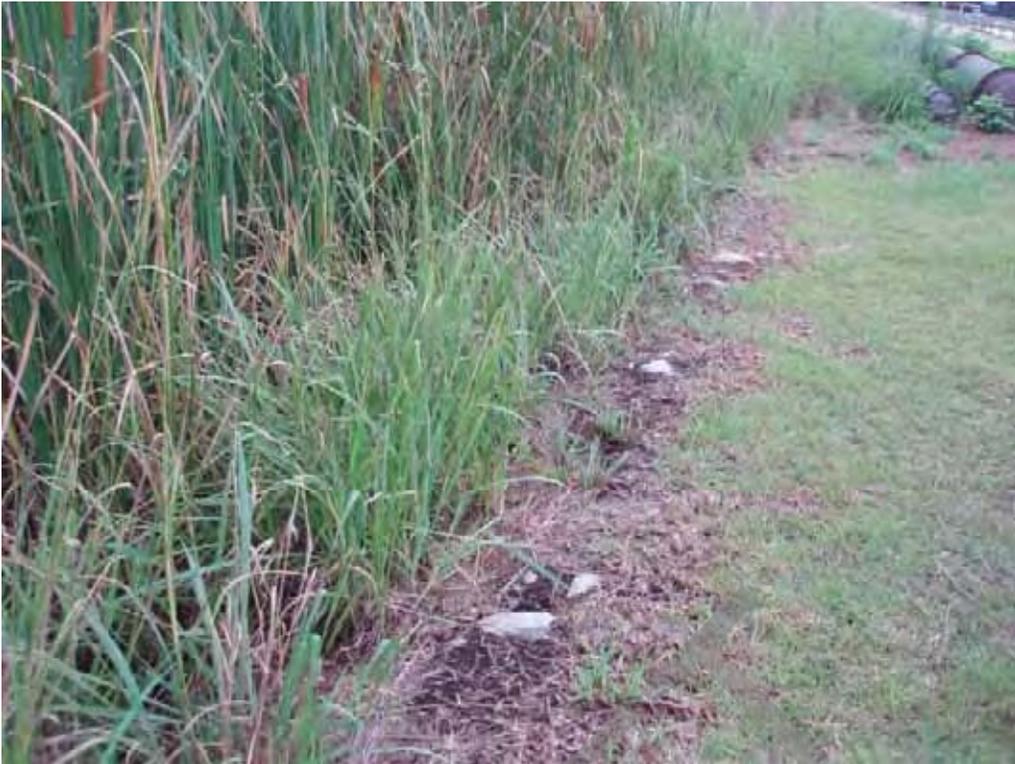
The interior slopes appear to be in satisfactory condition. The embankment interior slopes are approximately 2H:1V. Riprap armor was observed on each of the interior slopes, with the exception of the north embankment. The north embankment interior slope is heavily vegetated with grass and brush starting at a point approximately 350 feet east of the edge of the pond and continuing to the west embankment. The vegetation, ranging in height from 24 to 48 inches, was growing within riprap armoring (Photographs 129 and 132). Clearing and cutting of vegetation in this area appears to be adversely impacted by three above-grade sluice lines running along the edge of the embankment. The 350-foot-long section of the south exterior embankment (between the east embankment and the beginning of the sluice lines) is obscured from view by an accumulation of sediment and vegetation. Some partially exposed (riprap) stones were observed on the surface of the embankment (Photograph 129).

Locations of erosion due to missing riprap, vegetation growing within riprap, and possible localized settlement were observed at various locations on the interior slopes (Photographs 108, 114, 129 and 132).

The south embankment (divider) exterior slope is heavily vegetated with grass and brush starting at a point approximately 350 feet east of the edge of the pond and continuing to the west embankment. The vegetation, ranging in height from 24 to 48 inches, was growing within riprap armoring (Photographs 129 and 132). Clearing and cutting of vegetation in this area appears to be adversely impacted by three above-grade sluice lines running along the edge of the embankment. The 350-foot-long section of the south exterior embankment (between the east embankment and the beginning of the sluice lines) is obscured from view by an accumulation of sediment and vegetation. Some partially exposed (riprap) stones were observed on the surface of the embankment (Photograph 129).

**Photo No. 129: #2/#3 Bottom Ash Pond – North embankment interior slope. Looking at vegetation and sparse riprap.**

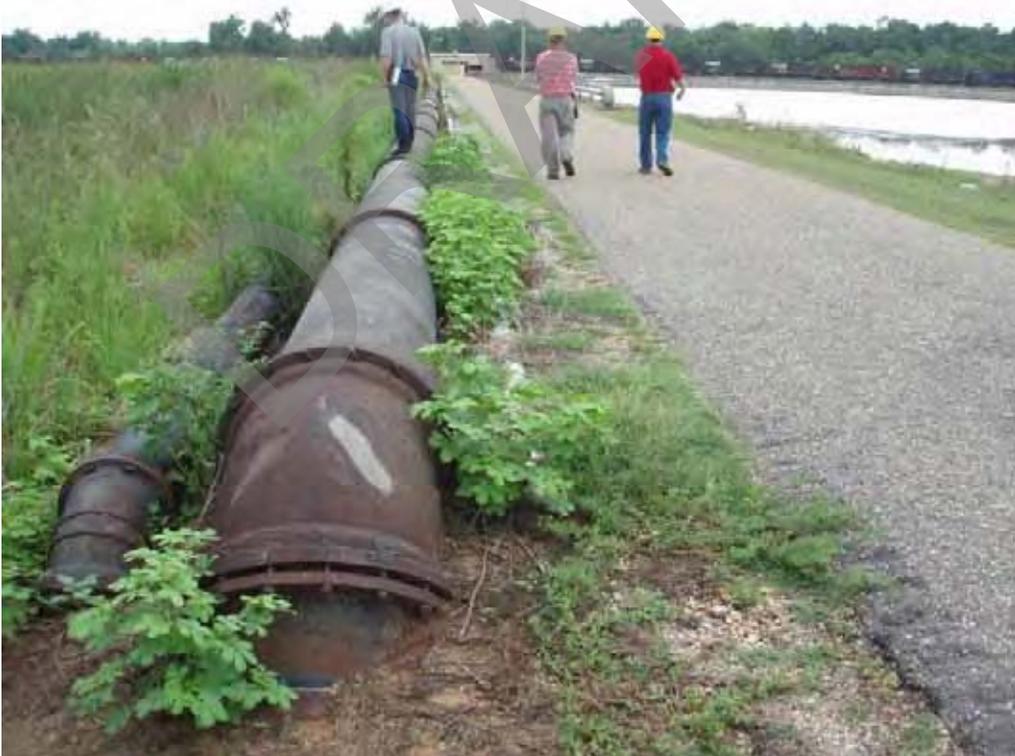
The crest appears to be in good condition (Photographs 110 and 130). The average crest width is approximately 20 feet, except at the east embankment, where the crest is approximately 30 feet wide. A Norfolk Southern railroad spur is located on the west, south, and east embankment crests that are covered with crushed stone railroad ballast (Photographs 110 and 118). The north embankment crest is covered with asphalt paving and subject to vehicle traffic (Photograph 133). No depressions, ruts, or evidence of settlement were observed on the crests (Photographs 110, 118, and 130).

**Photo No. 130: #2/#3 Bottom Ash Pond – North (divider) embankment interior slope and crest, looking west. Note vegetation around sluice lines.**

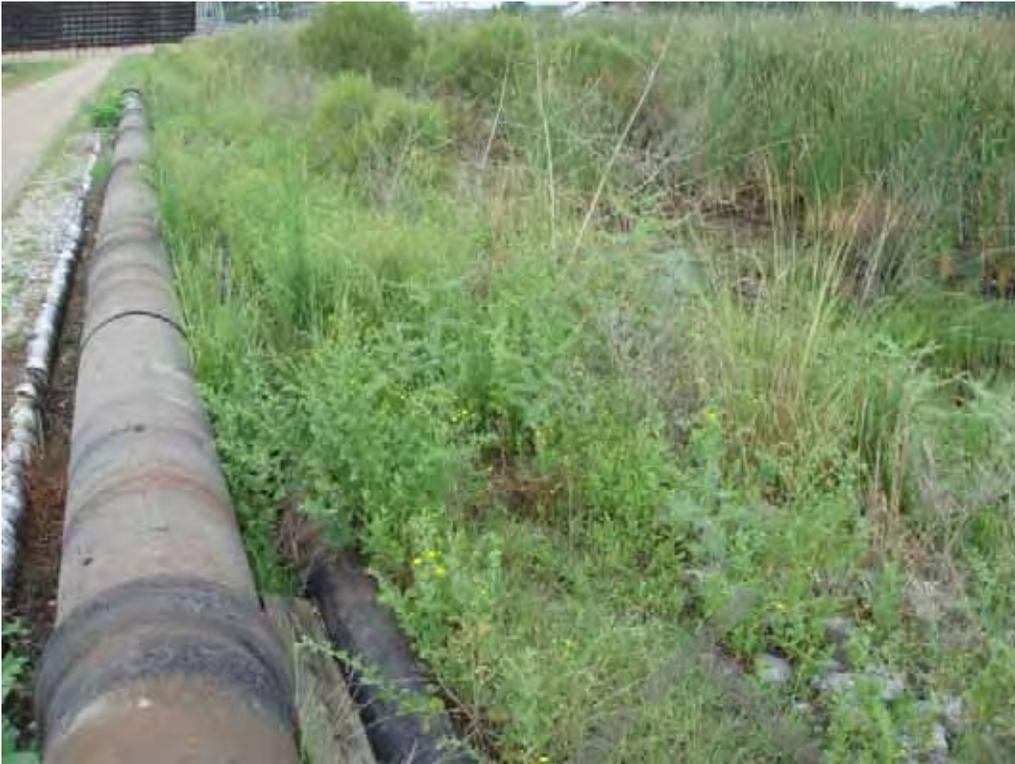
**Photo No. 131: #2/#3 Bottom Ash Pond – North embankment interior slope, looking east.  
Note vegetation growing on slope and cattails within pond.**

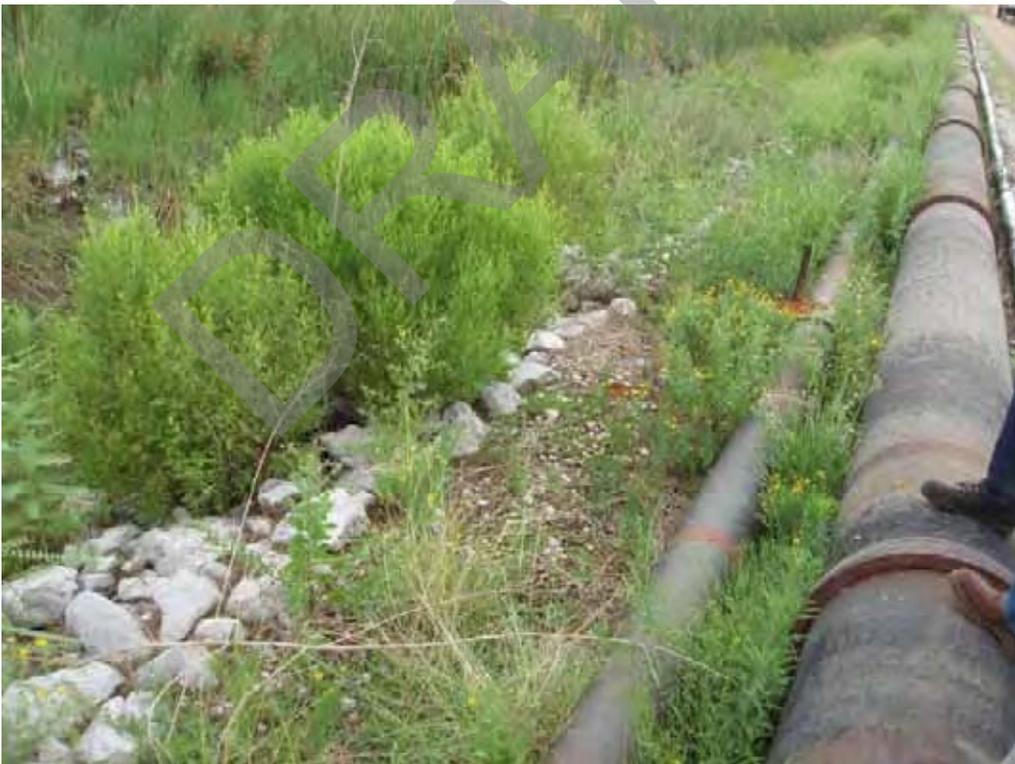
**Photo No. 132: #2/#3 Bottom Ash Pond – North embankment interior slope, looking west.  
Note vegetation growing within riprap.**

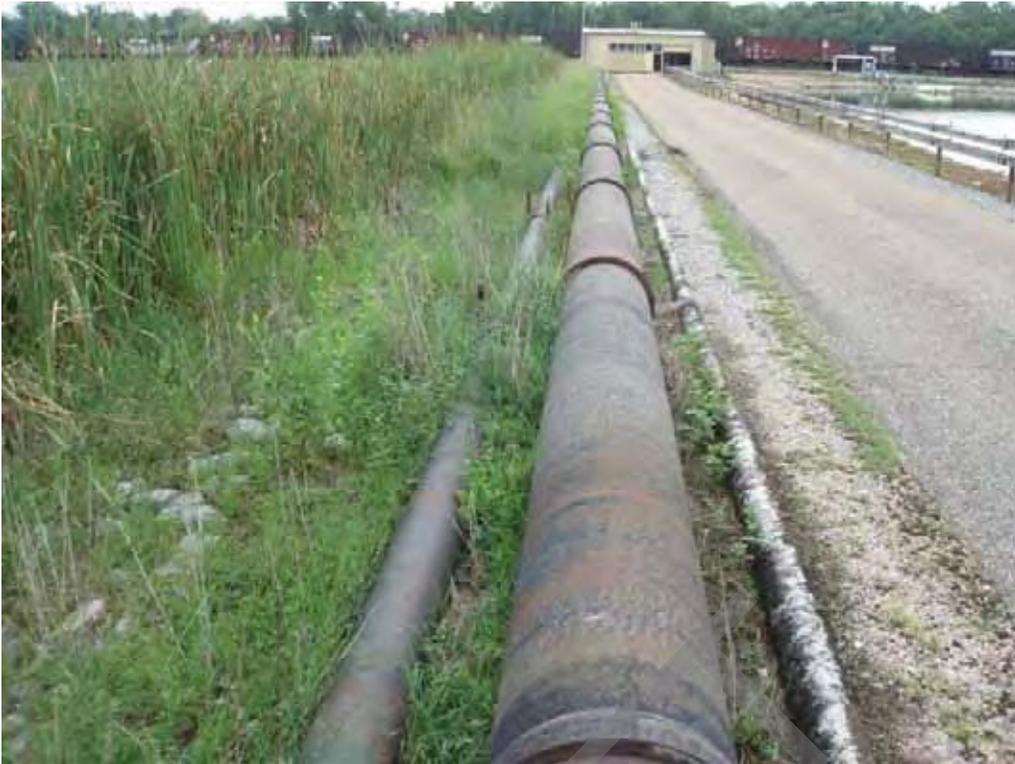
**Photo No. 133: #2/#3 Bottom Ash Pond – North (divider) embankment interior slope and crest, looking west. Note dense vegetation covering slope.**

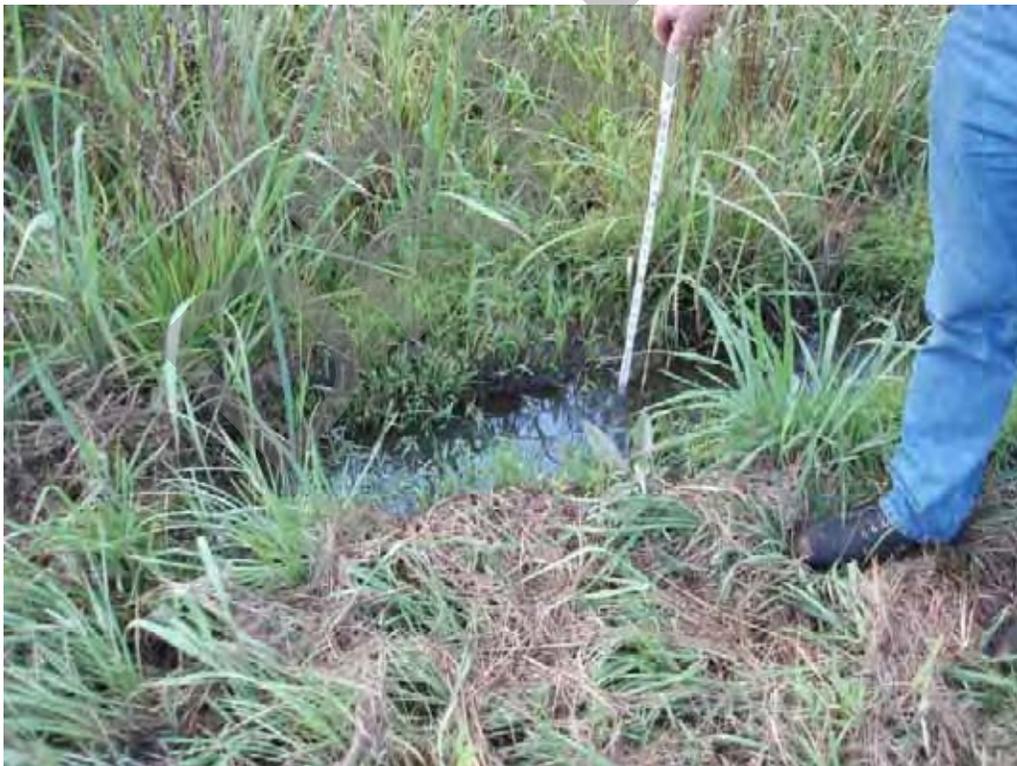
**Photo No. 138: #2/#3 Bottom Ash Pond – West embankment exterior slope. Looking at area of possible seepage.**

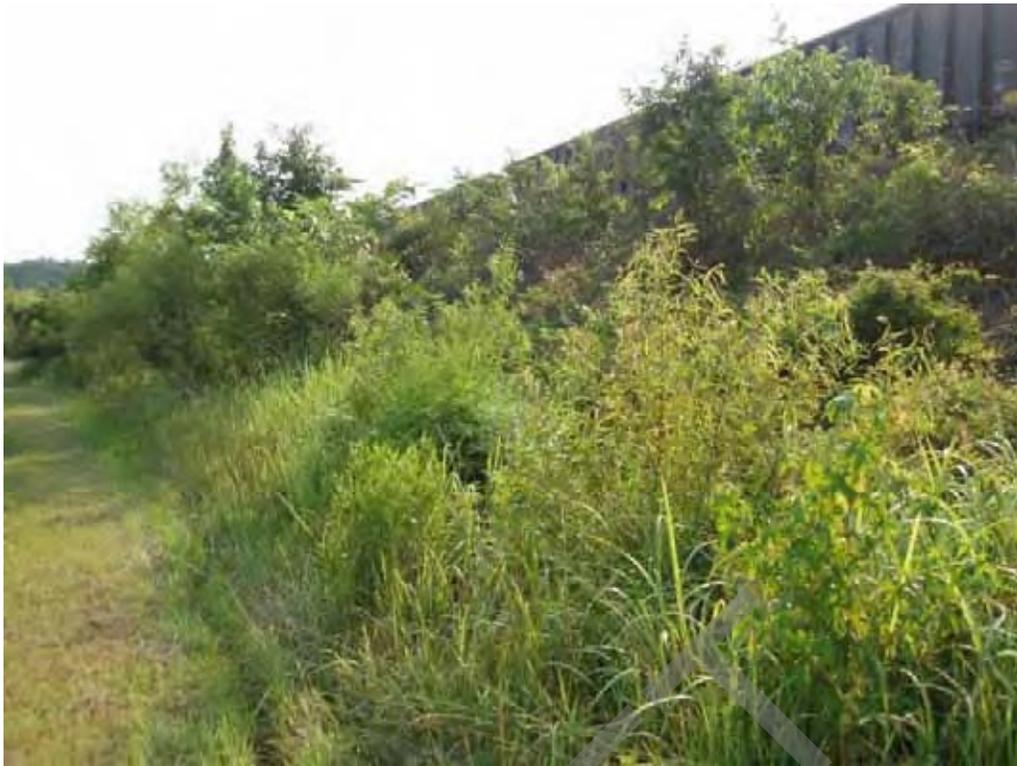
**Photo No. 139: #2/#3 Bottom Ash Pond – West embankment exterior slope, looking north.  
Note dense vegetation on slope.**

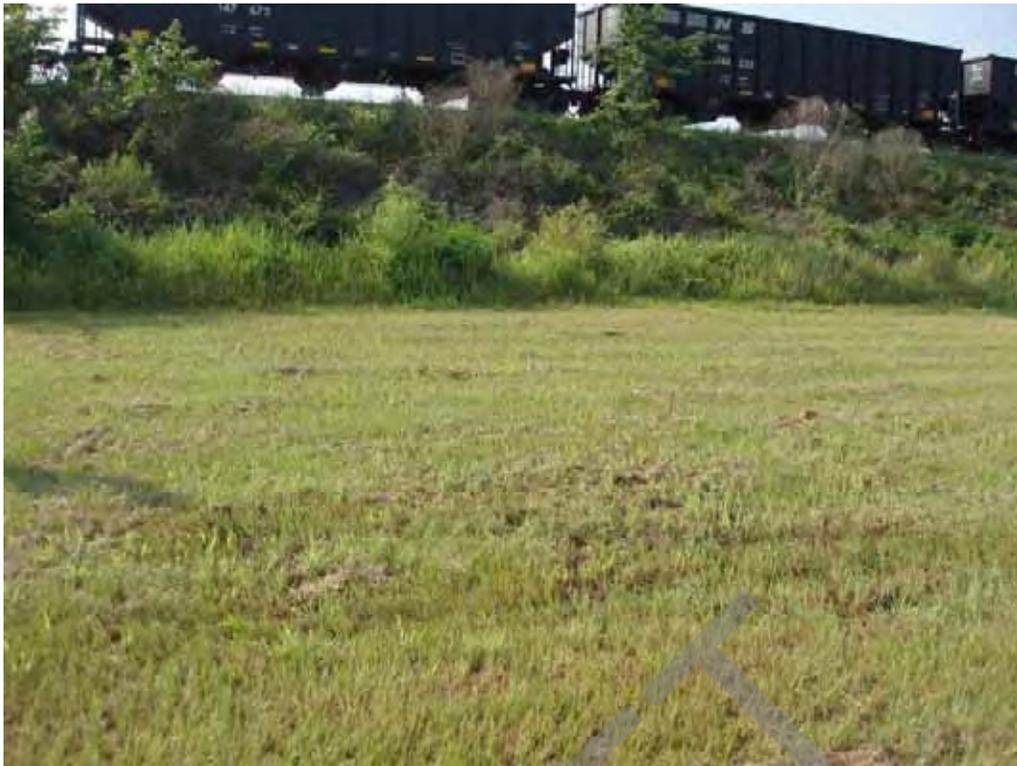
An area of possible seepage was observed near the toe of the west embankment, near the southwest corner (Photograph 141). The area consisted of damp, spongy ground that extended about 55 feet out from the toe. CDG reported that active water seepage was observed in this area during a site visit conducted on March 25 and 26, 2009.

**Photo No. 141: #2/#3 Bottom Ash Pond – West embankment exterior slope, looking east. Looking at extent of spongy material in area of possible seepage.**

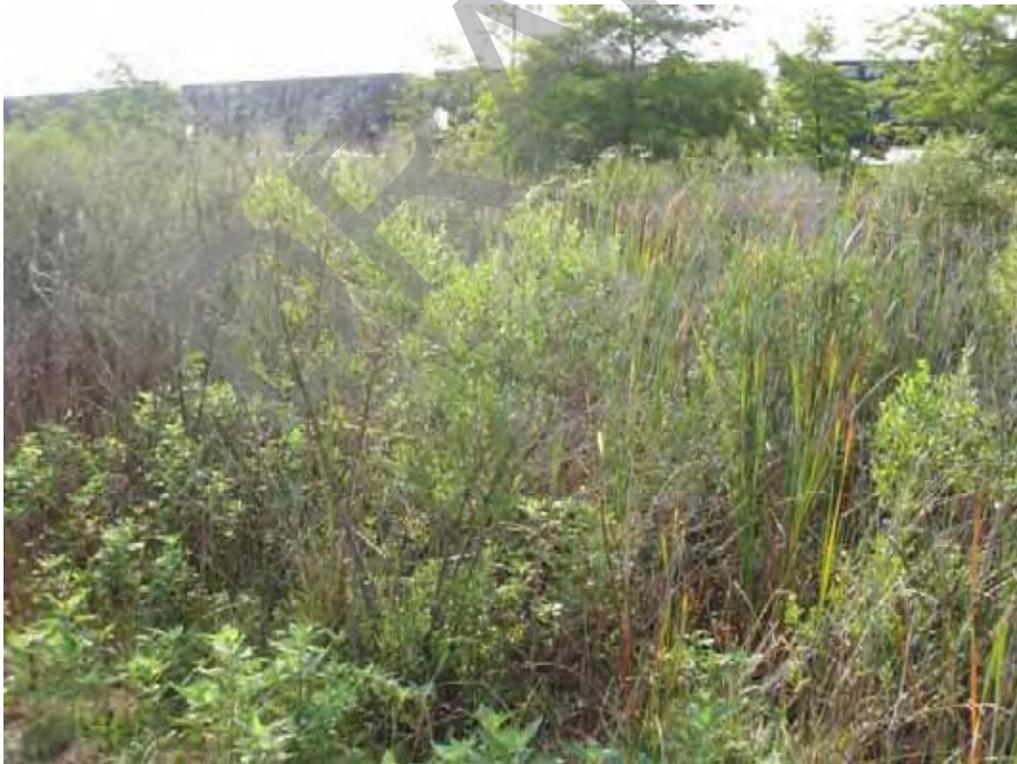
**Photo No. 142: Scrubber Waste Pond – West embankment exterior slope. Note dense vegetation on slope.**

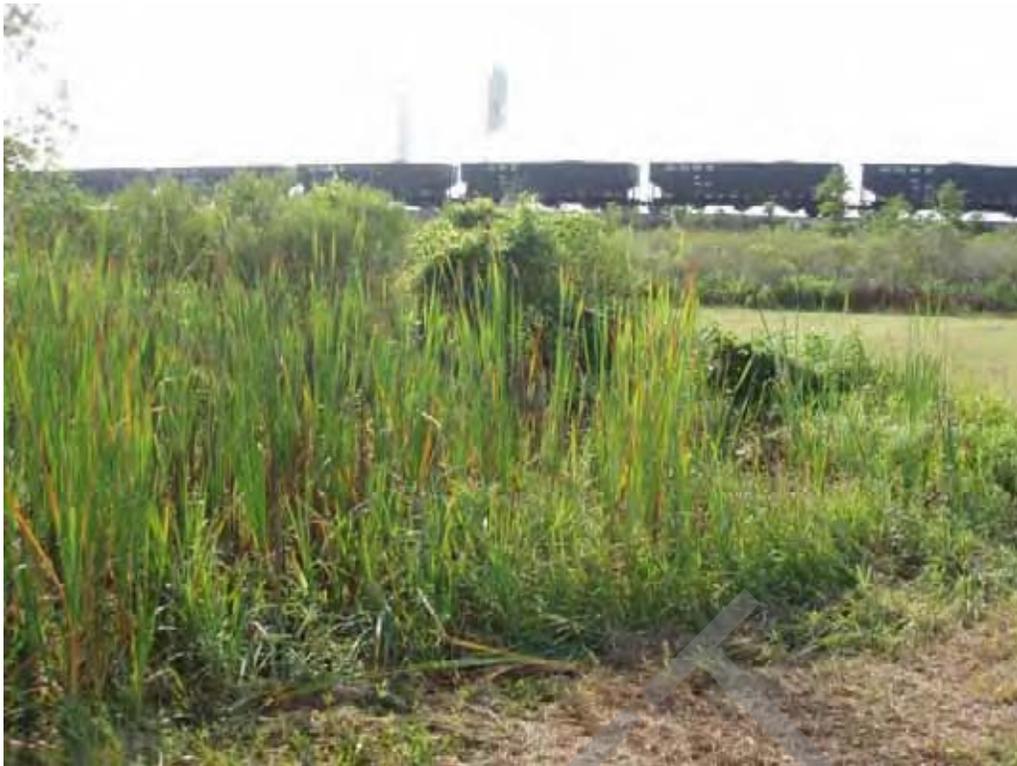
**Photo No. 143: Scrubber Waste Pond – Outside west embankment toe. Looking at cattails in area of possible seepage.**

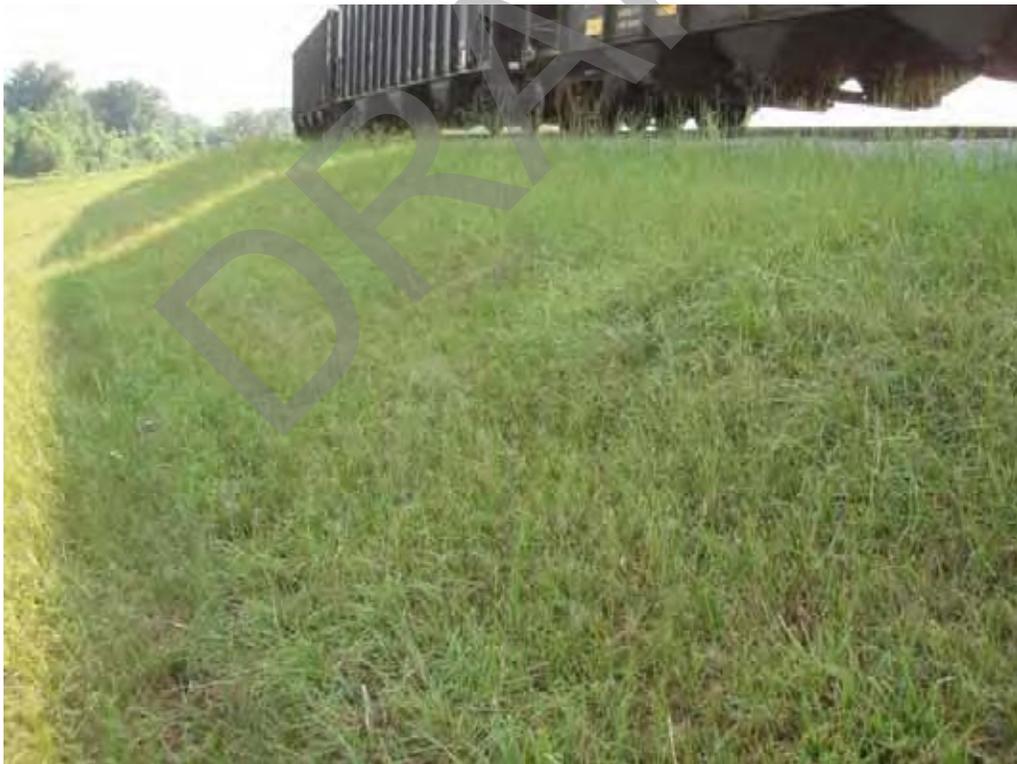
**Photo No. 144: #2/#3 Bottom Ash Pond – West embankment exterior slope, looking north.**

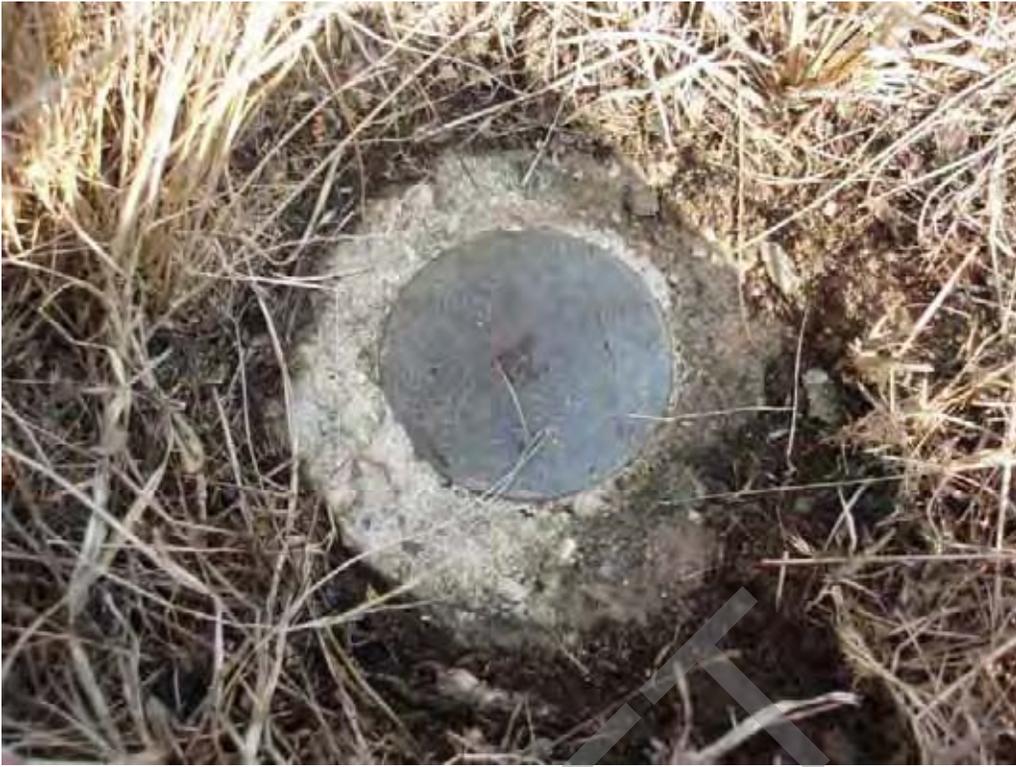
**Photo No. 145: #2/#3 Bottom Ash Pond – South embankment exterior slope. Looking at plant survey monument.**

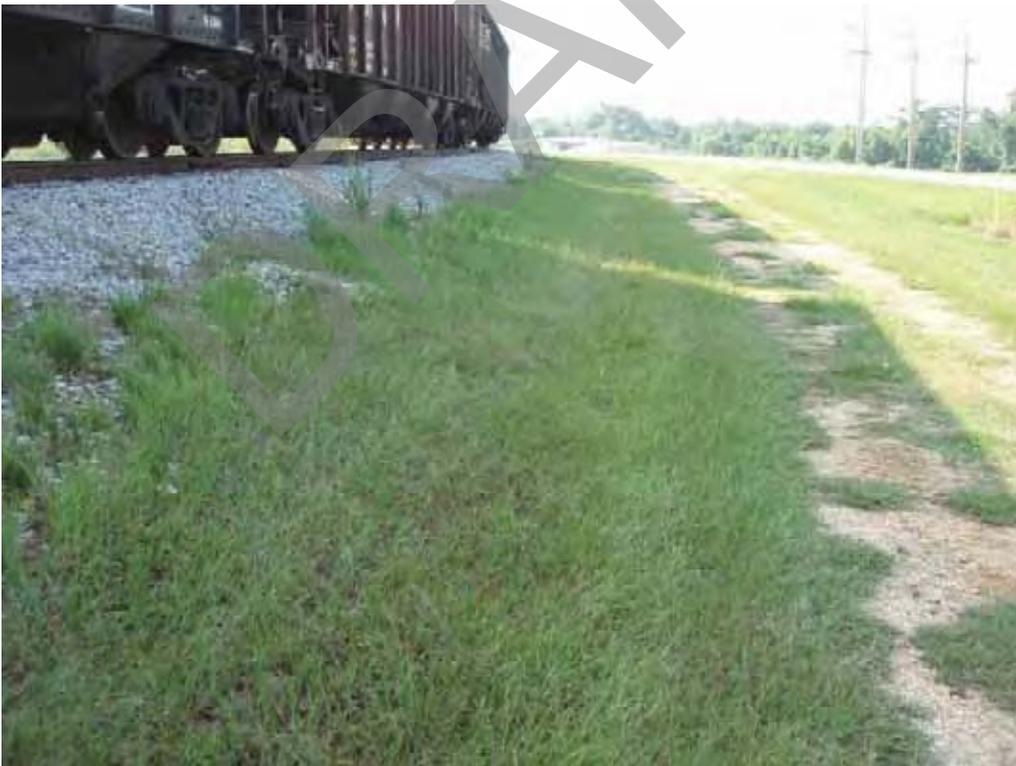
**Photo No. 146: #2/#3 Bottom Ash Pond – South embankment exterior slope, looking east.**

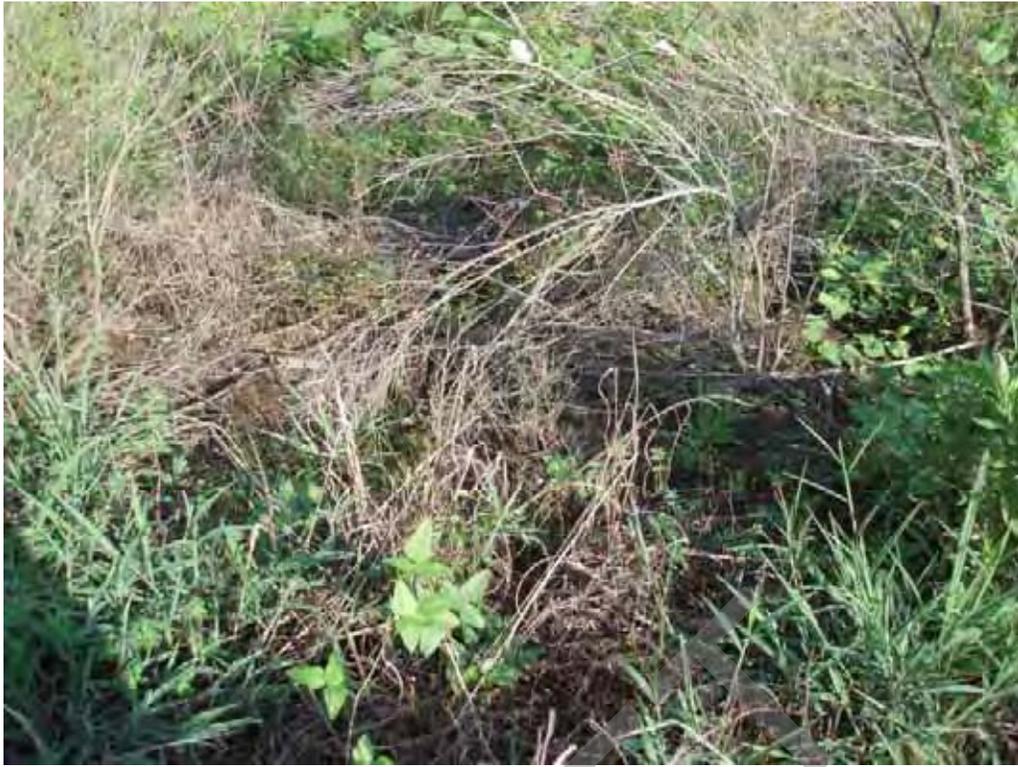
**Photo No. 147: #2/#3 Bottom Ash Pond – West embankment exterior slope, looking north.**

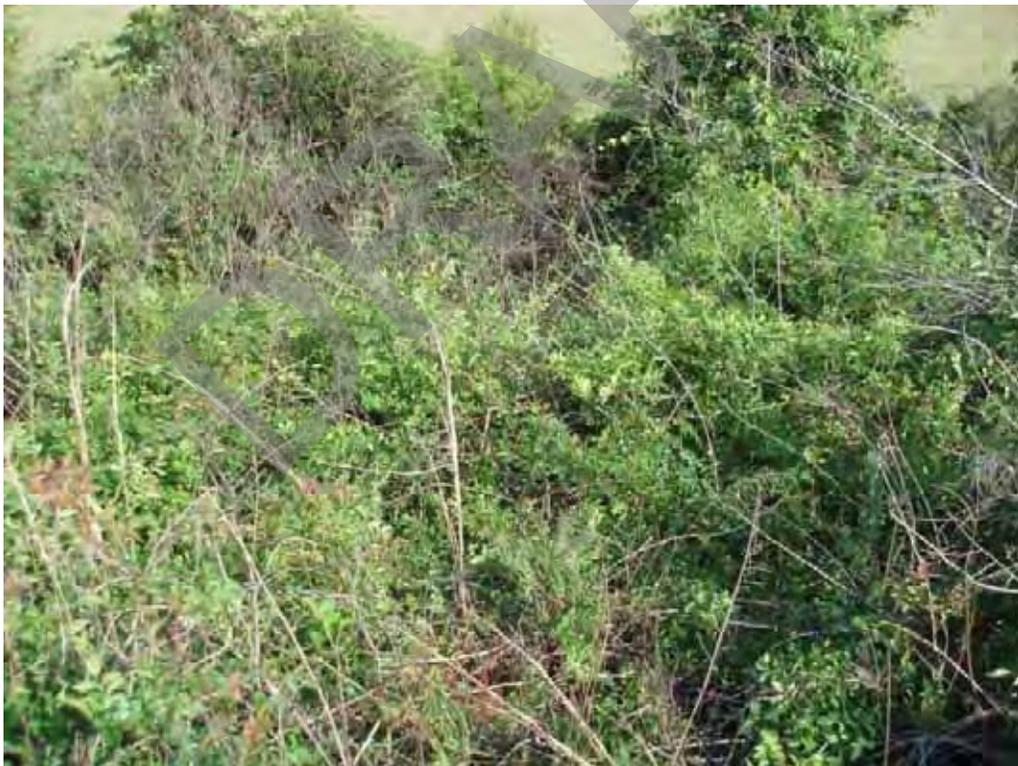
**Photo No. 148: Scrubber Waste Pond – West embankment exterior slope, looking west.  
Looking at typical vegetation on slope.**

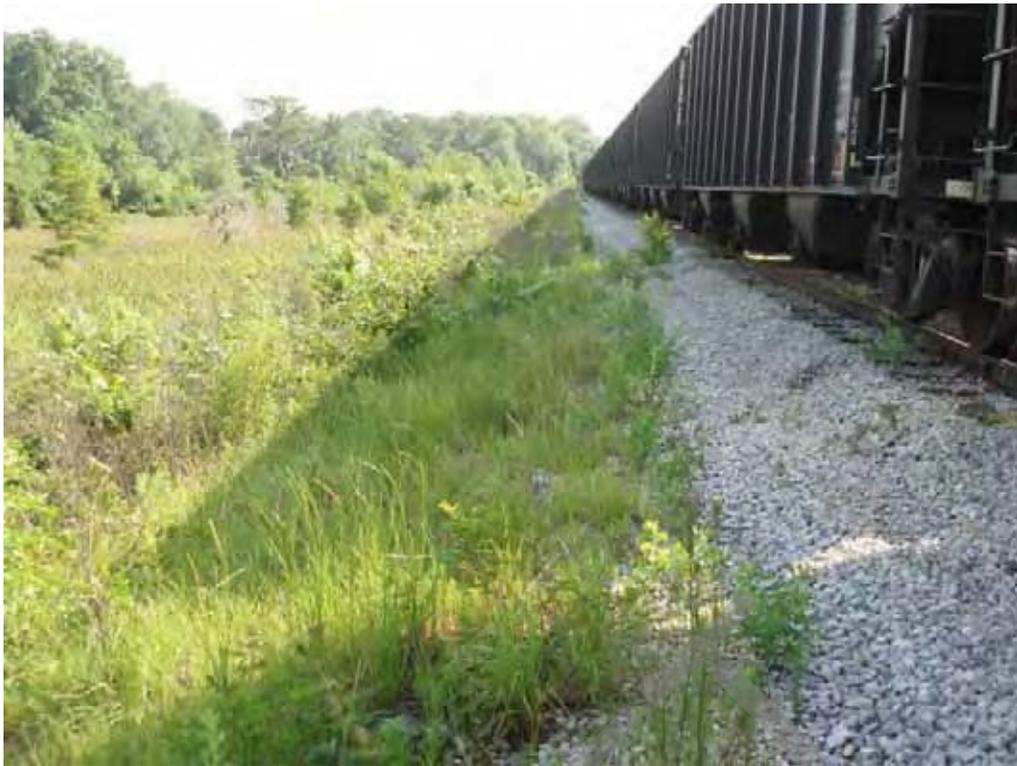
**Photo No. 151: Scrubber Waste Pond – West embankment exterior slope and crest, looking north.**

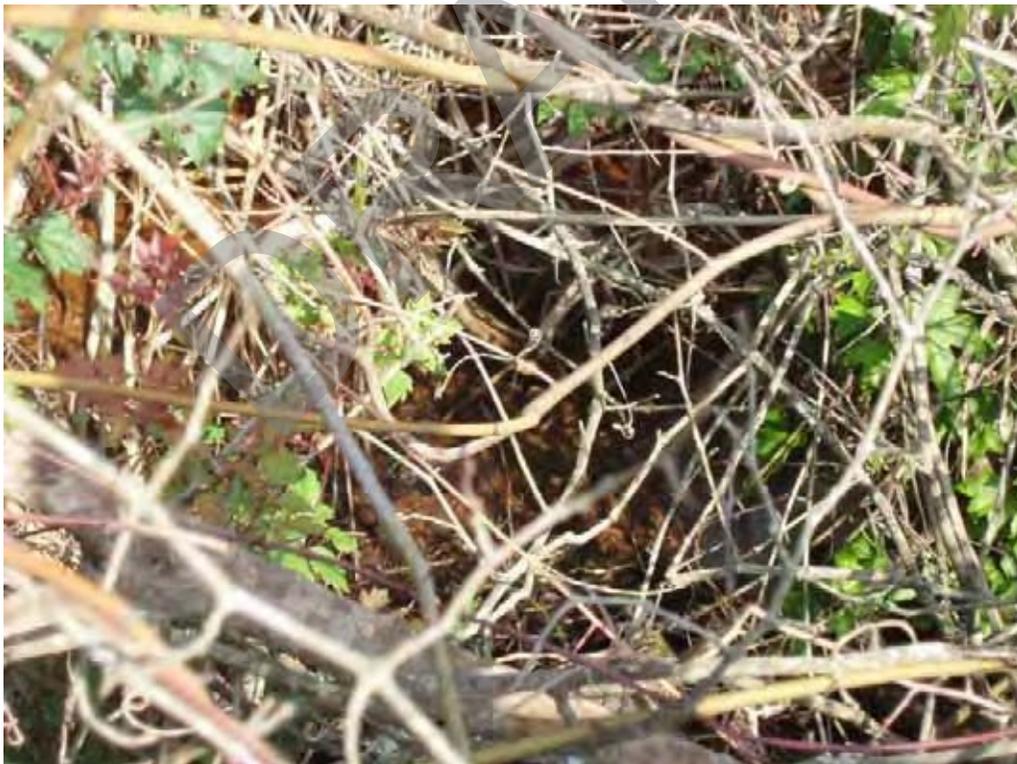
**Photo No. 152: Scrubber Waste Pond – West embankment exterior slope. Looking at possible seepage/standing water near toe.**

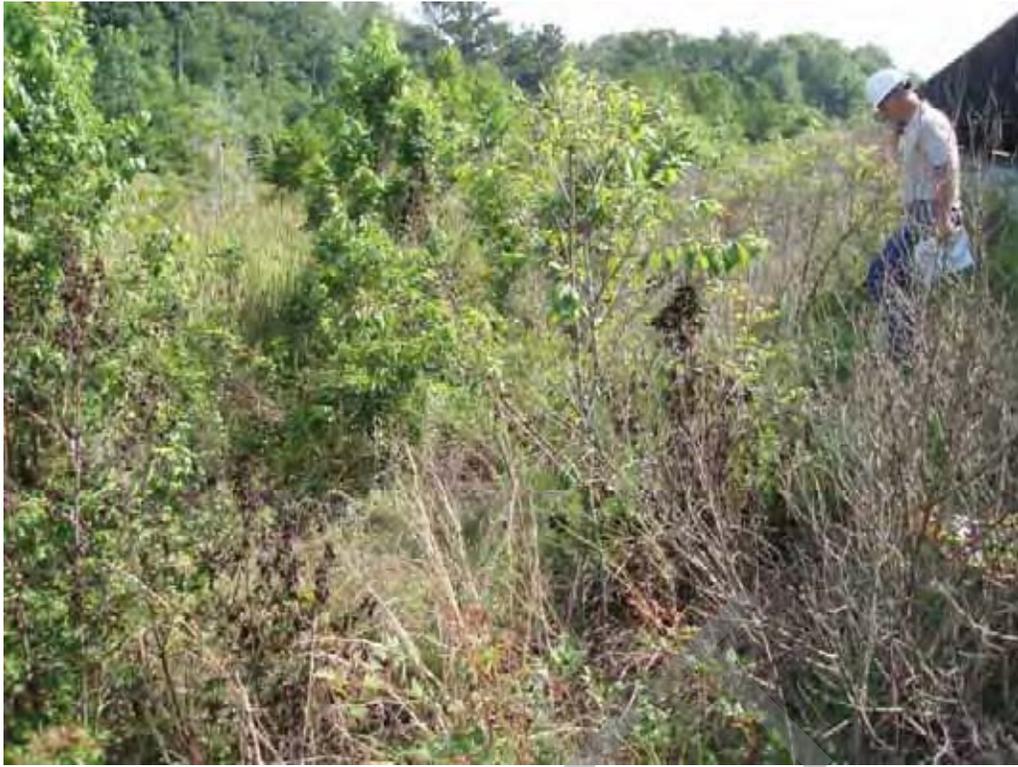
**Photo No. 155: Scrubber Waste Pond – West embankment exterior slope, looking north.**

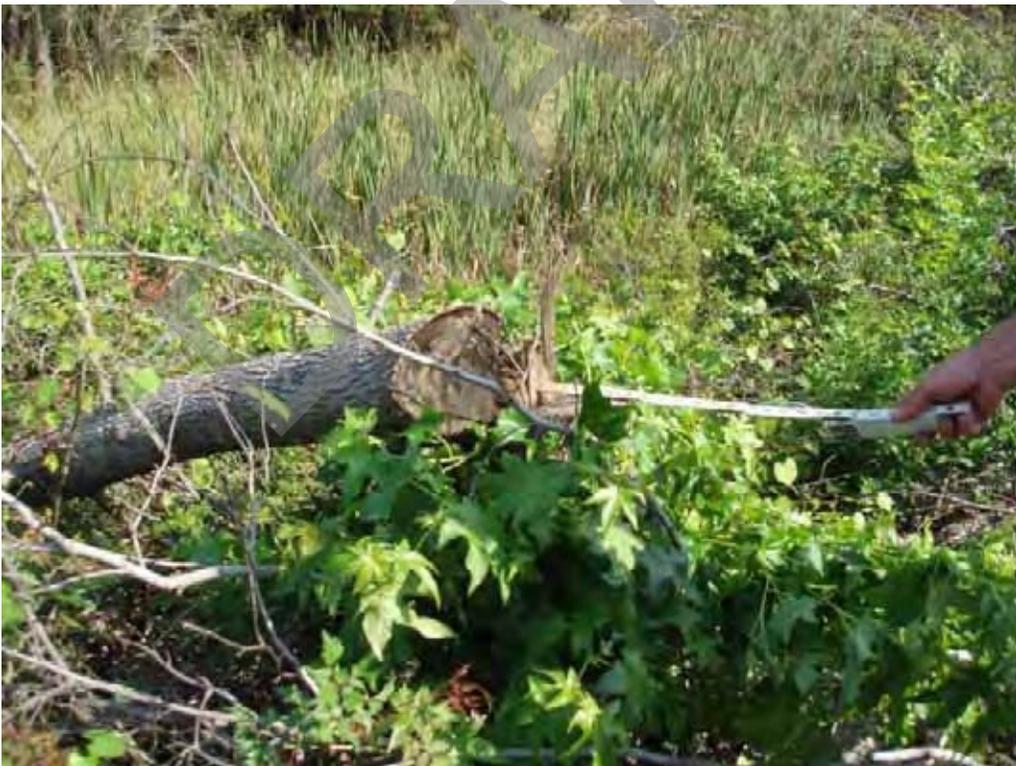
**Photo No. 158: Scrubber Waste Pond – West embankment exterior slope. Looking at 6-inch-diameter tree recently cut down.**

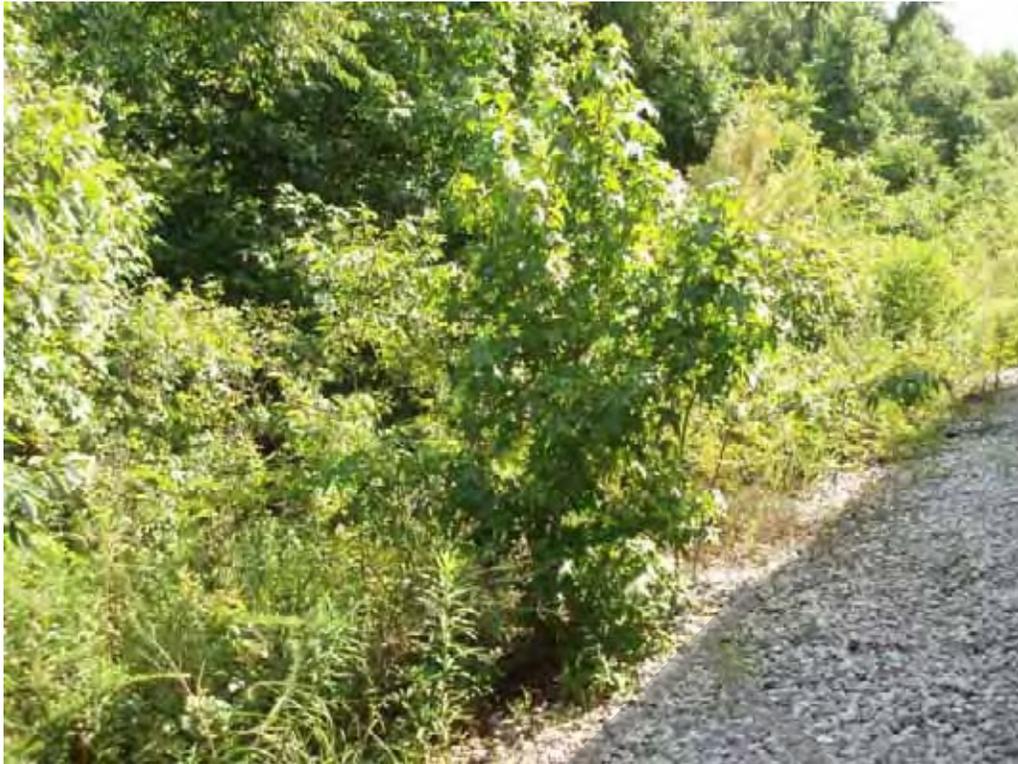
**Photo No. 161: Scrubber Waste Pond – West embankment exterior slope, looking north. Note dense vegetation on slope.**

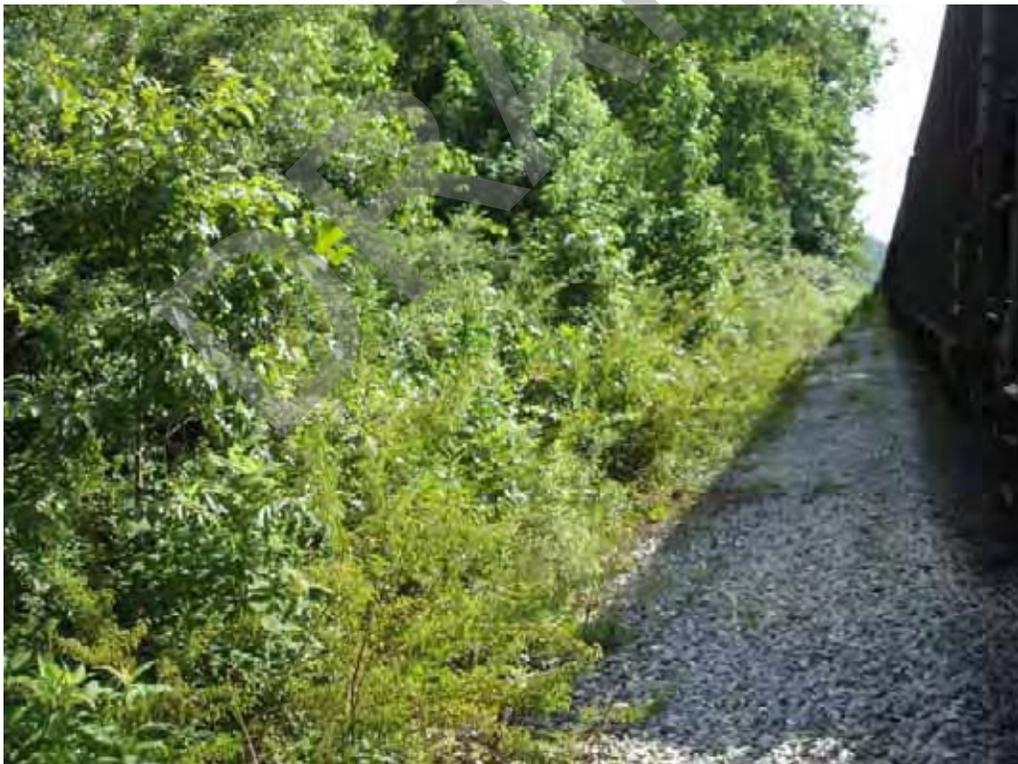
**Photo No. 162: Process Waste Pond – West embankment exterior slope, looking north. Note dense vegetation on slope.**
