DRAFT TECHNICAL MEMORANDUM

TO: [REDACTED] EPA Region 8, On-Scene Coordinator
FROM: [REDACTED], Superfund Technical Assessment and Response Team (START)
DATE: August 12, 2015
SUBJECT: Gold King Mine Investigation and Blowout Event

PHOTOGRAPH LOG

| Project Name: Gold King Mine | Site Location: Silverton, San Juan County, Colorado | Project No.: 0001/1408-01 |

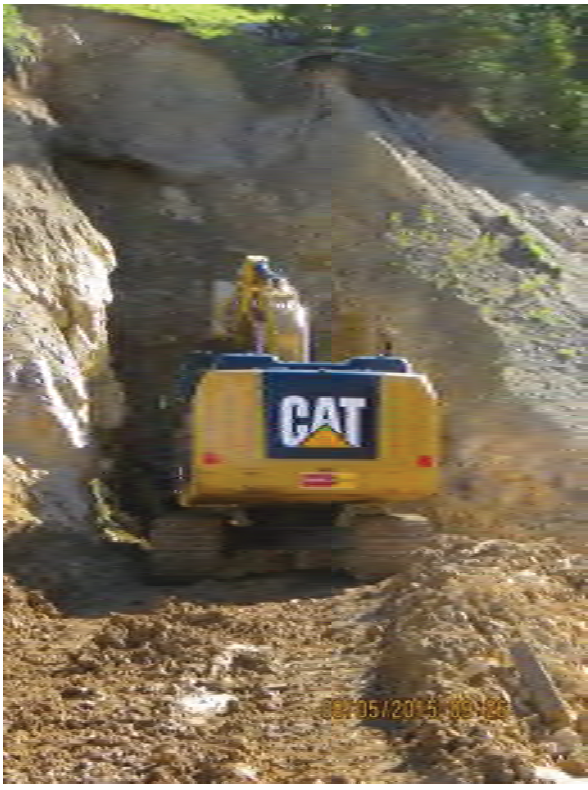
| Photo No.: 15 | Date: 08/05/2015 |

| Description: Bedrock found above the anticipated adit. | |

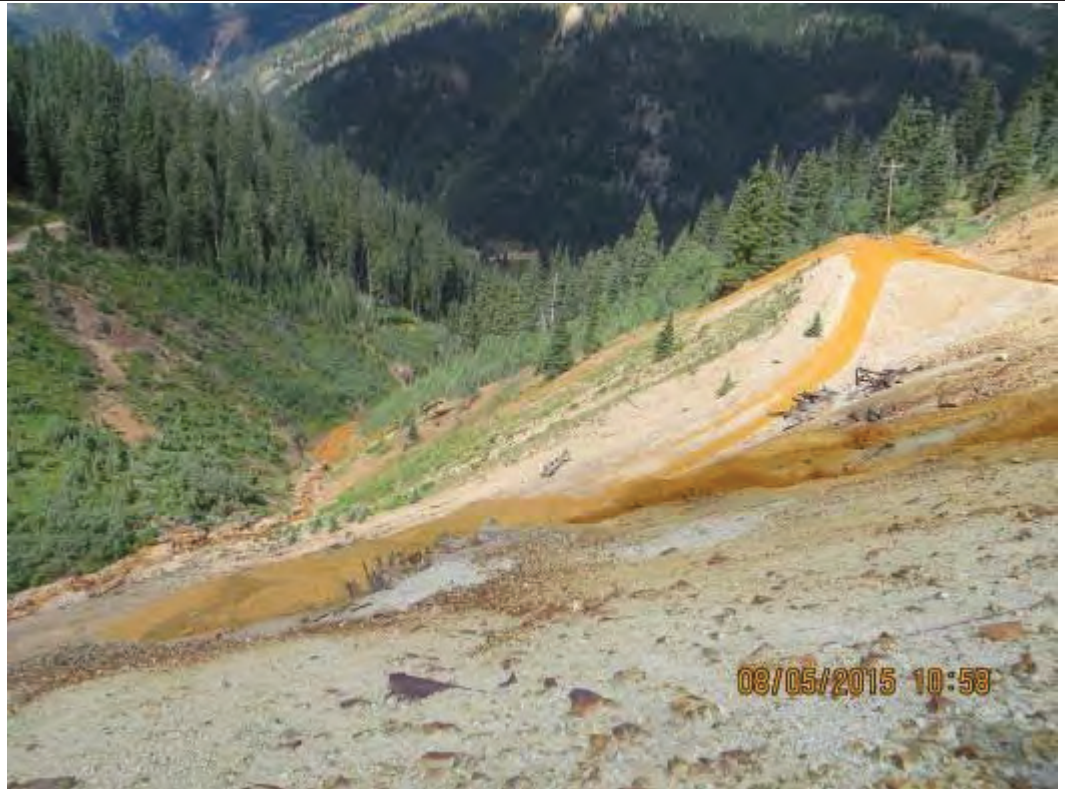
Photo No.
22

Description:
Water flowing over the edge of the waste dump and collapsing the edge.

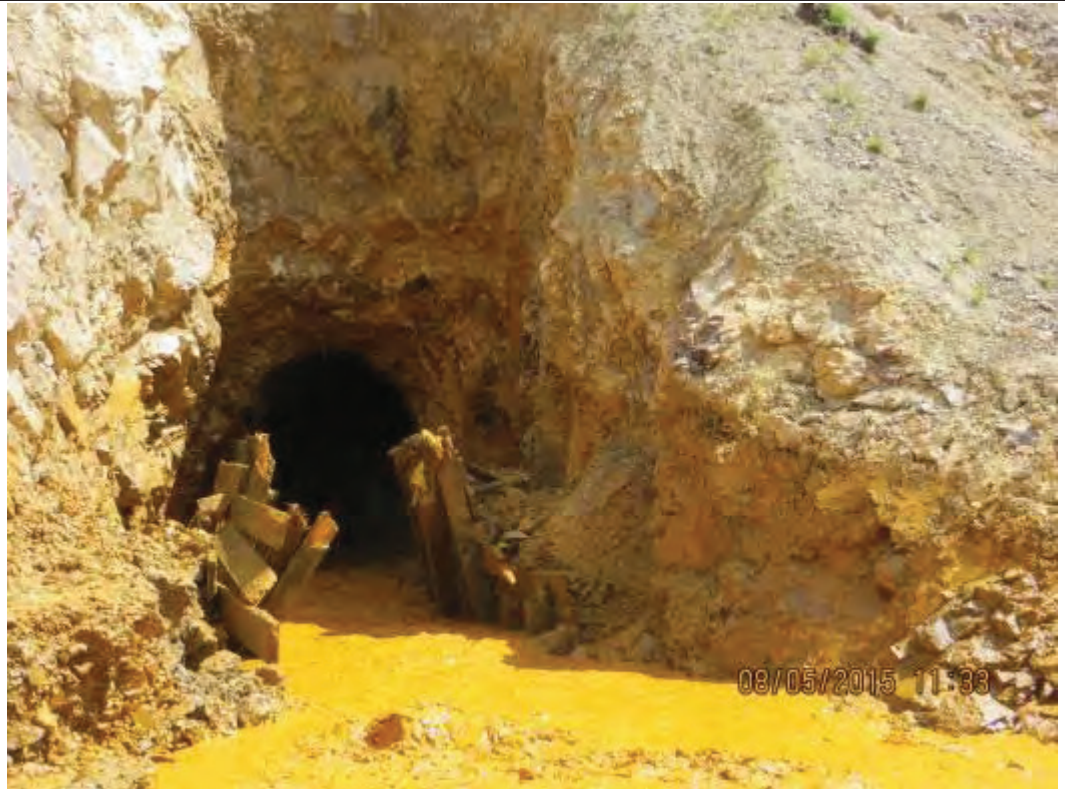
Photo No.
28

Description:
pH of discharge water is approximately 4 to 4.5.

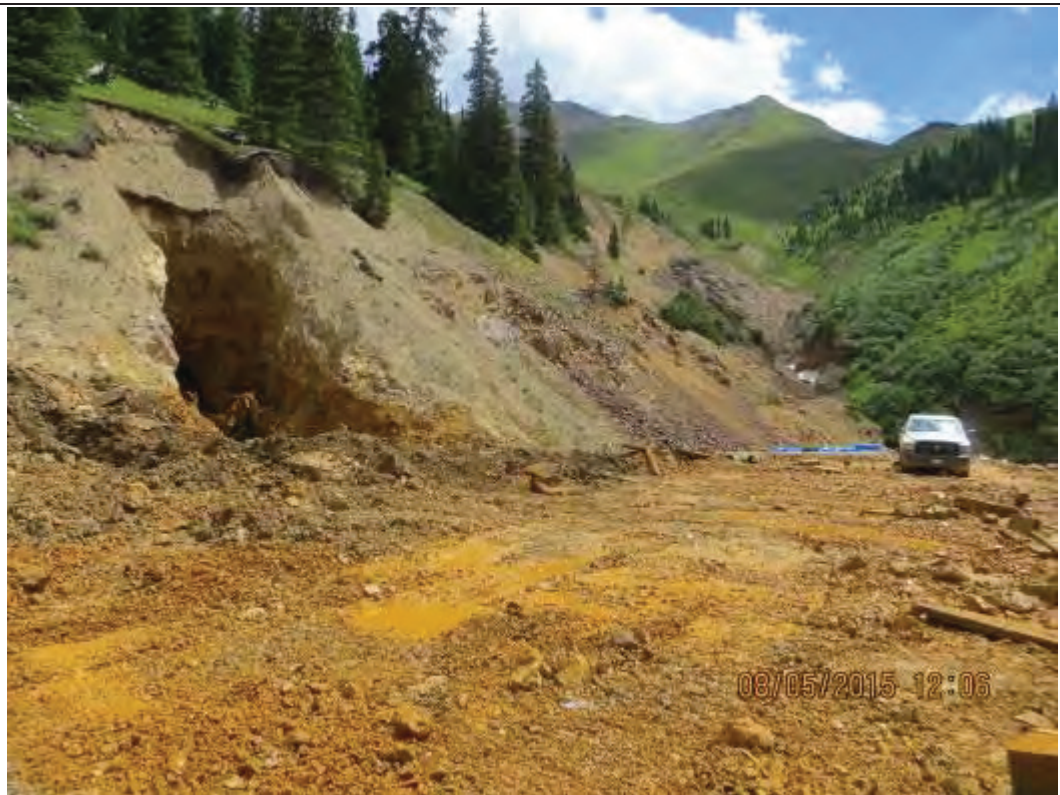
| Photo No.: 32 | Date: 08/05/2015 |

| Description: Exposed adit and redirected flow, flow is beginning to subside. | |

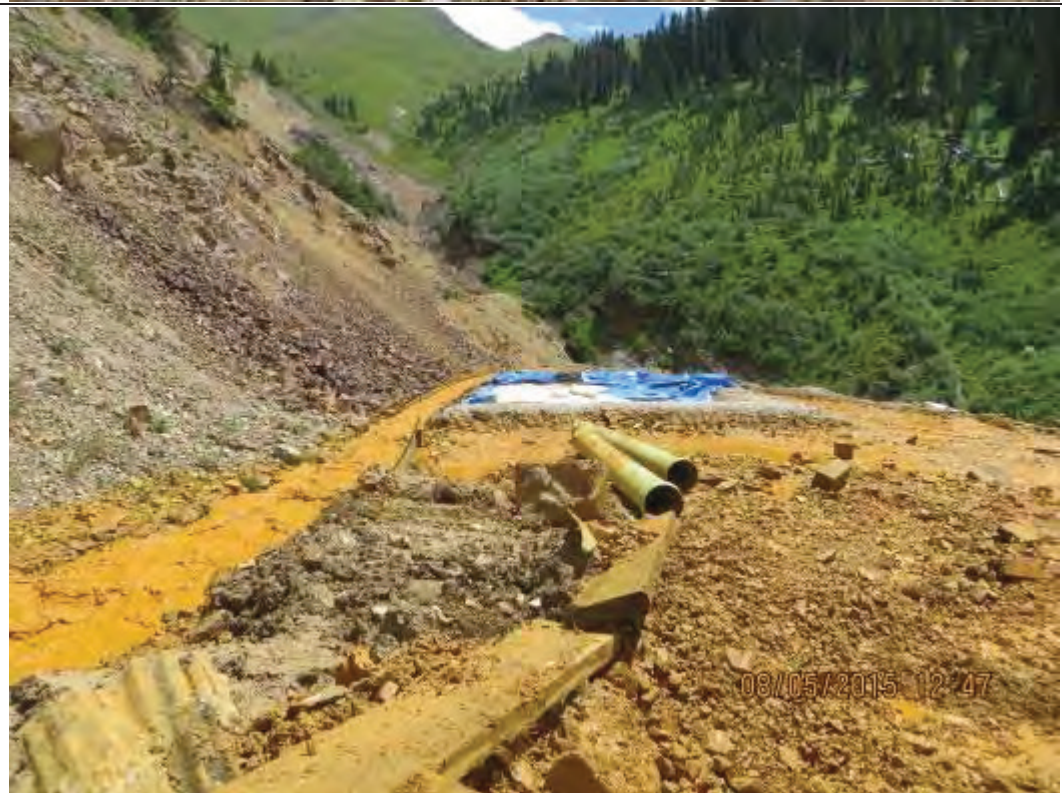
Description:
Existing culvert flows subsiding minimally.

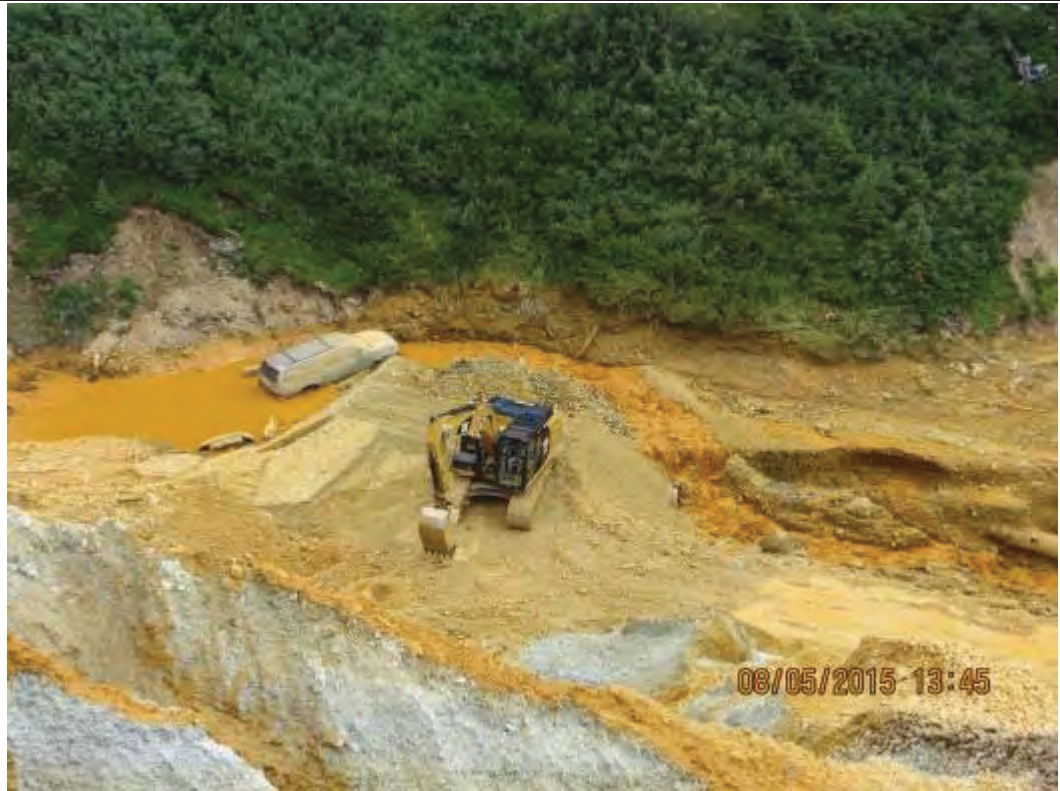
| Description: Excavator continues to fix access road. Continued high flow is slowing progress. | |

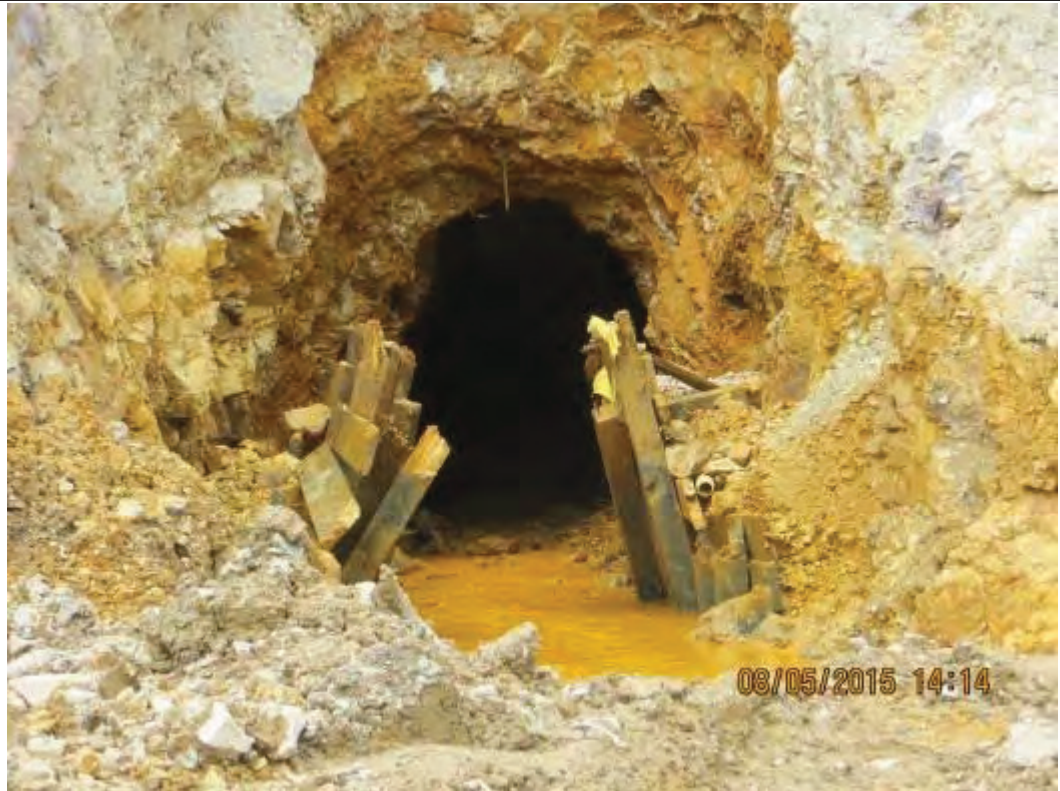
| Description: Water levels lowering at adit entrance, no visible changes to structure. | |

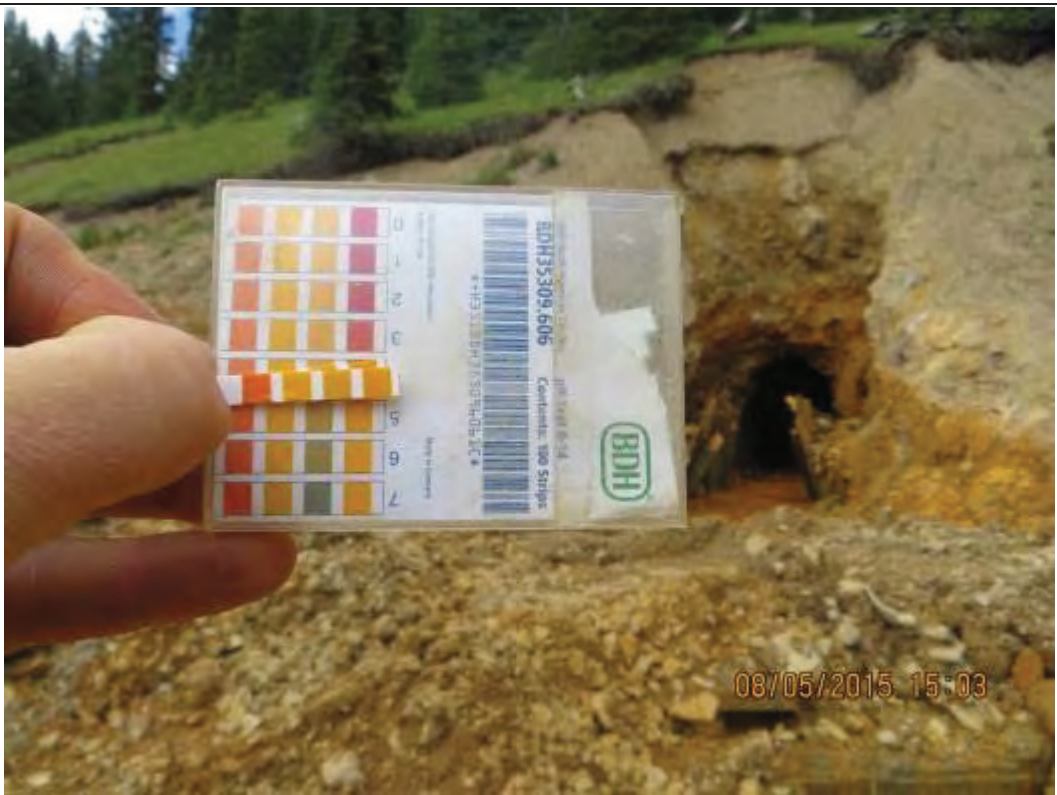
| Description: pH measured at approximately 4.5. | |

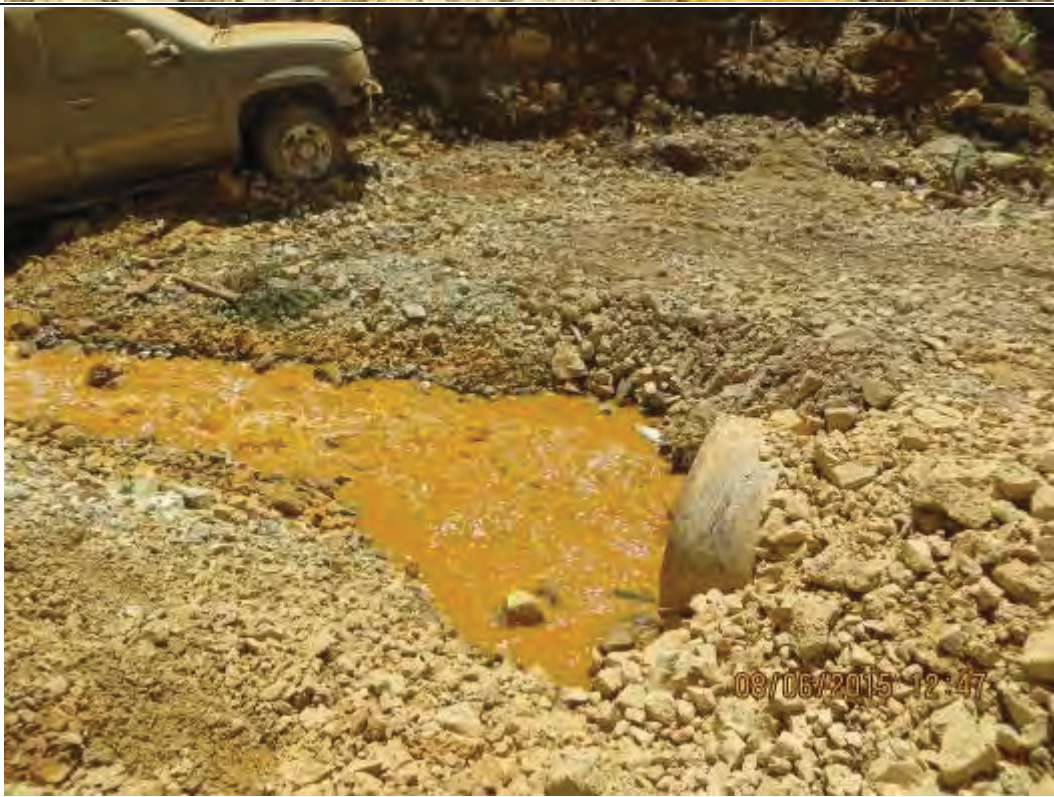
| Description: Temporary culvert for North Fork Cement Creek at road at base of Gold King mine dump. | |

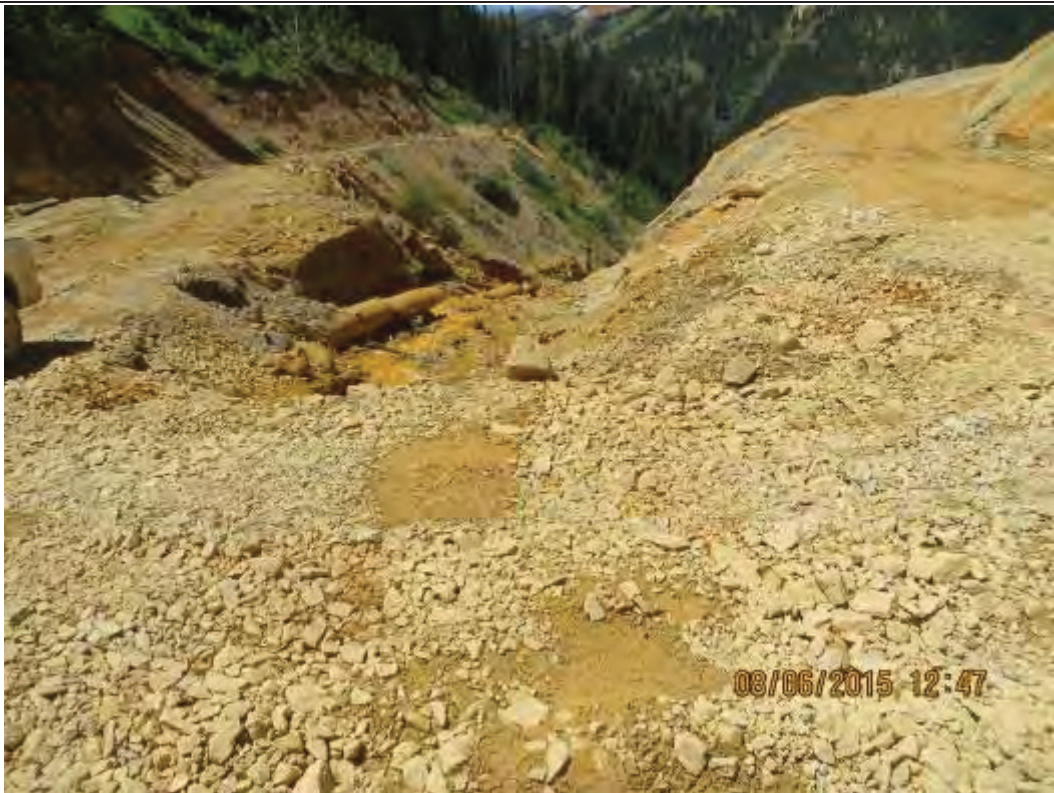
| Photo No. 13 | Date: 08/06/2015 | |

| Description: Temporary road crossing at base of Gold King mine dump. | | |

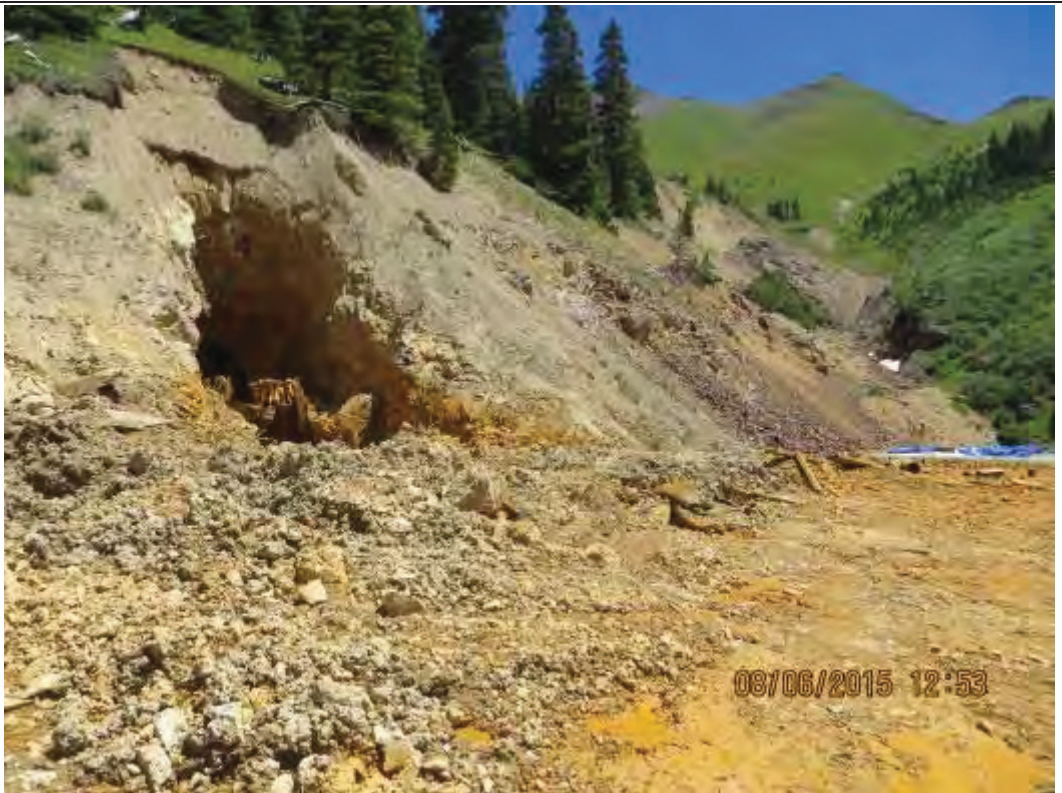
| Photo No. 25 | Date: 08/06/2015 |

| Description: Gold King adit post discharge. | |

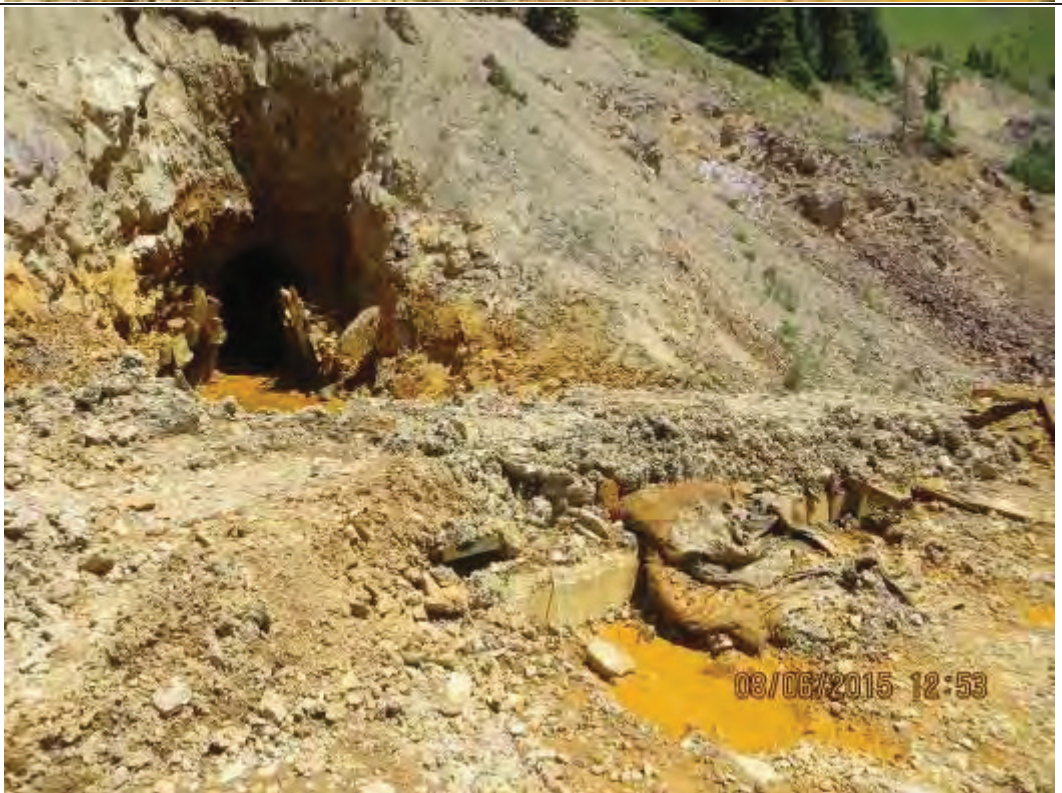
| Photo No. 26 | Date: 08/06/2015 |

| Description: Gold King adit post discharge. | |

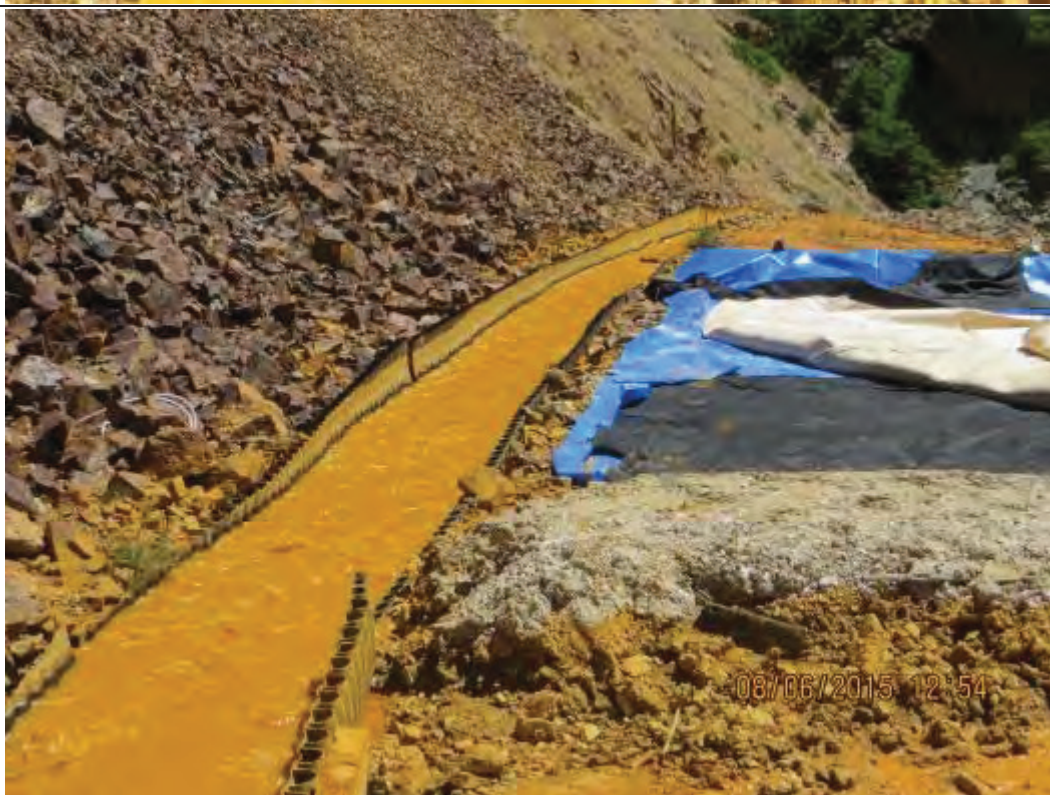
Photo No.
29

Horiba Readings stabilizing in adit discharge. pH 3.41

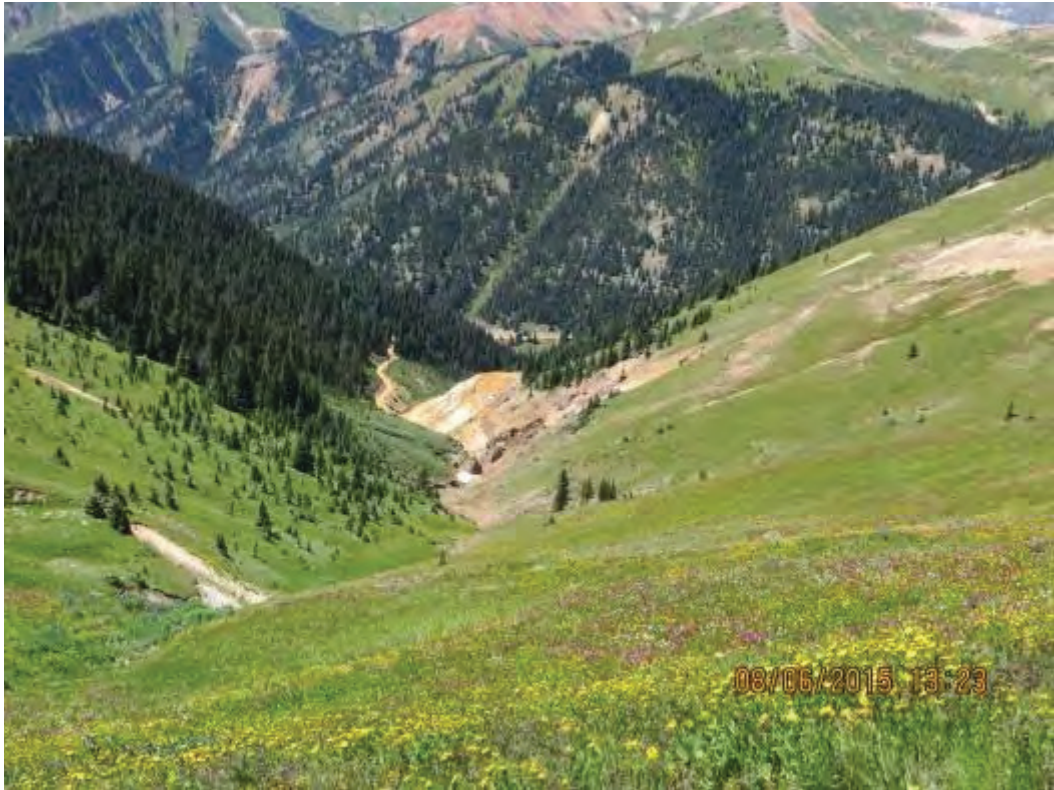
Photo No.
35

Overview of the Gold King mine dump after mine discharge.

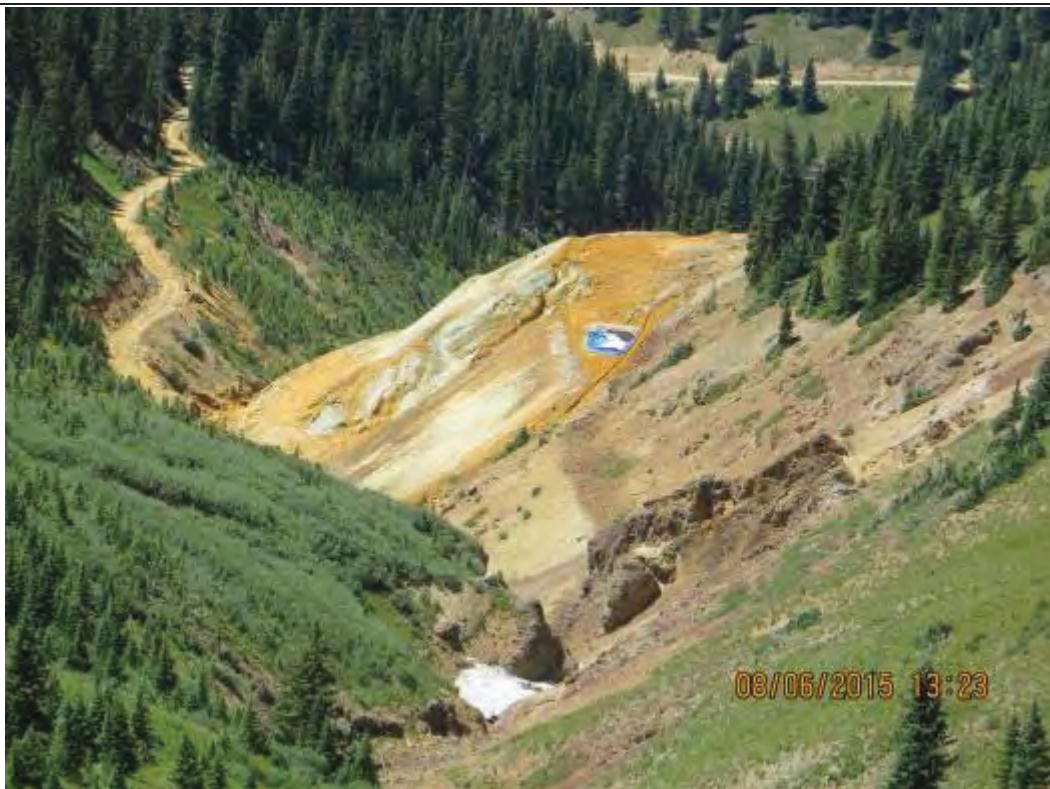
Photo No.
36

Horiba reading of Cement Creek upstream of North Fork confluence. Bad DO reading. pH = 5.04

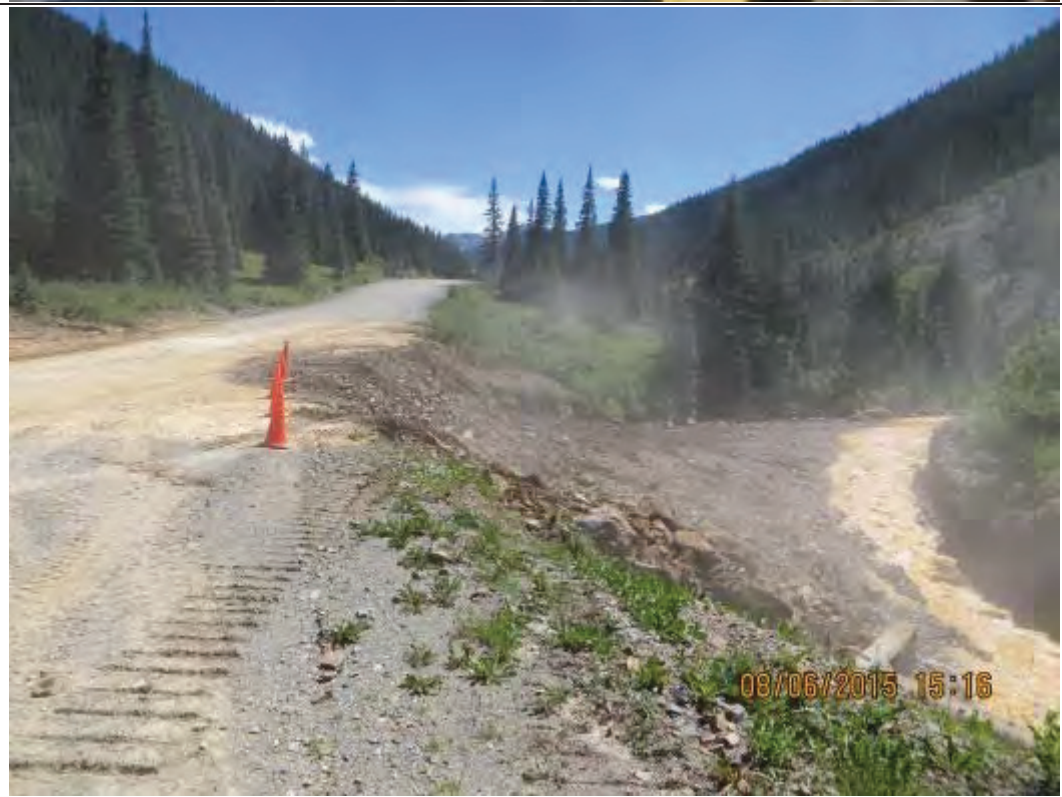
| Photo No. 1 | Date: 08/07/2015 | |

| Description: Animas River morning of 8/7/15 | | |

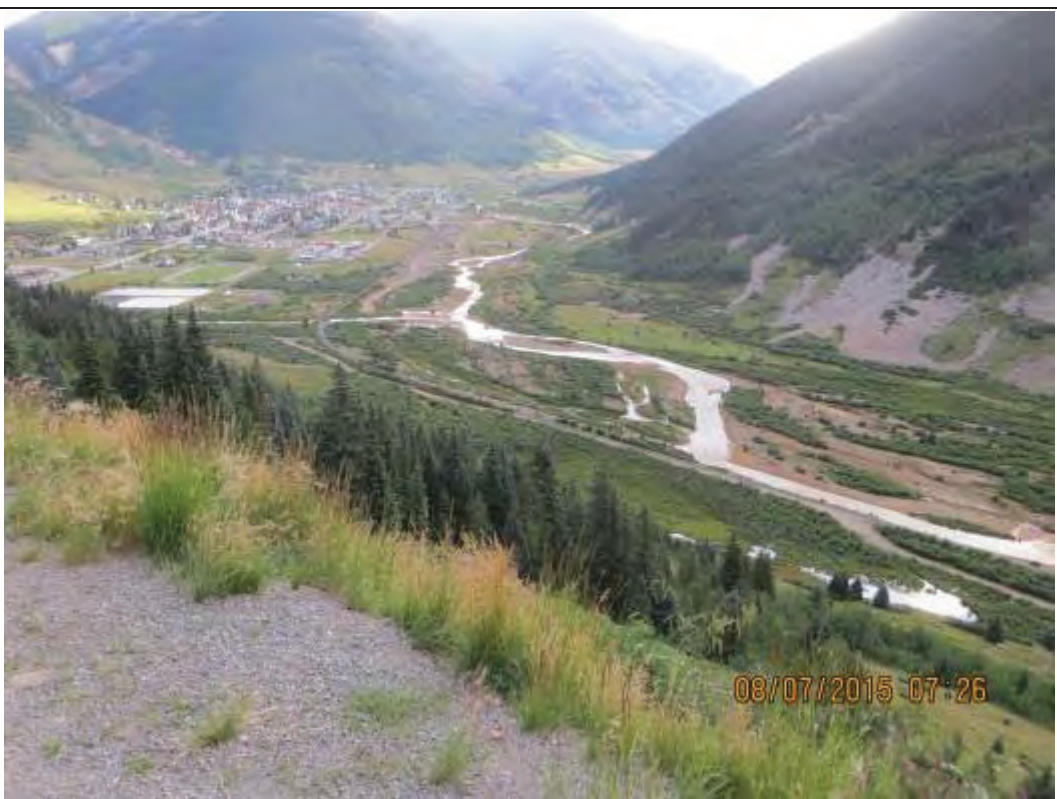
| Photo No.: 4 | Date: 08/07/2015 |

| Description: Road repairs between Silverton and Gladstone. | |

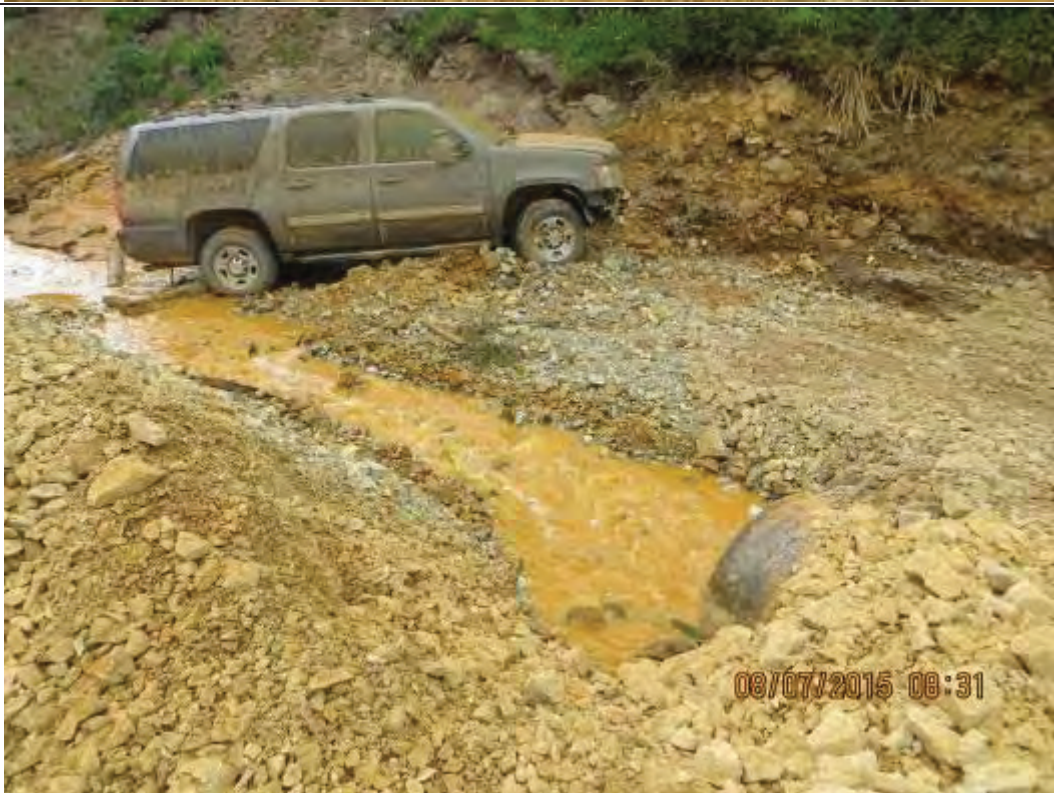
Photo No.
7

Gold king Mine Portal the morning of 8/7

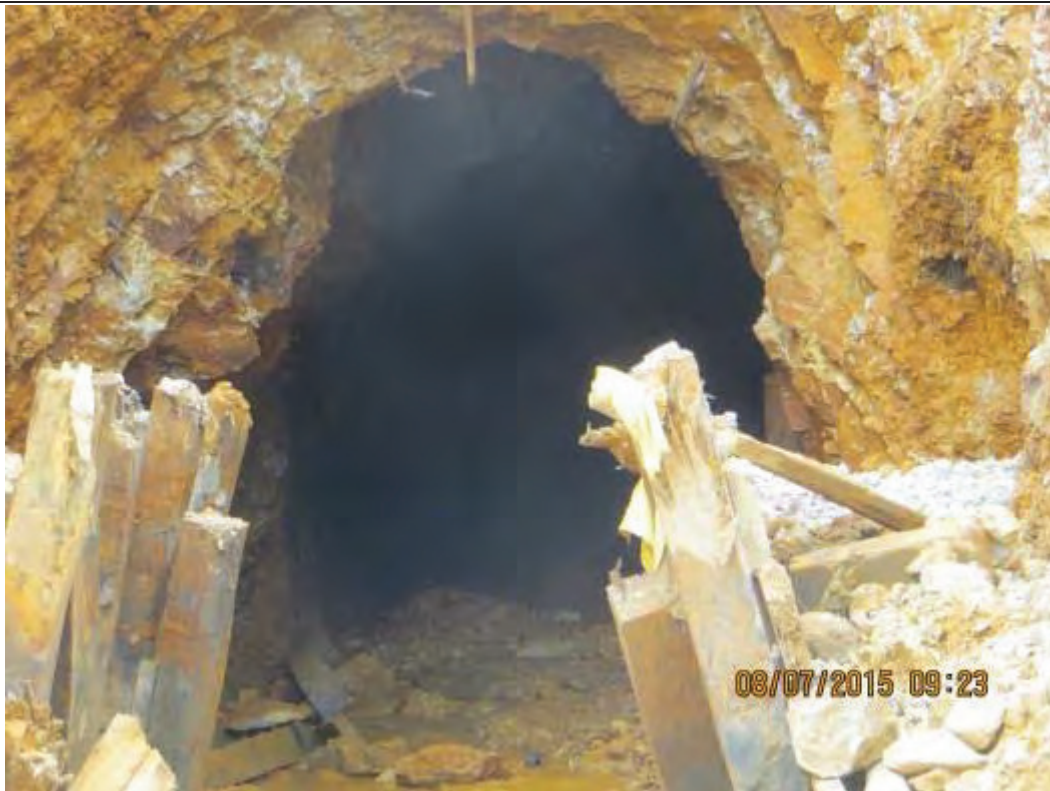
Photo No.
13

Gold King Adit pH = 2.97.

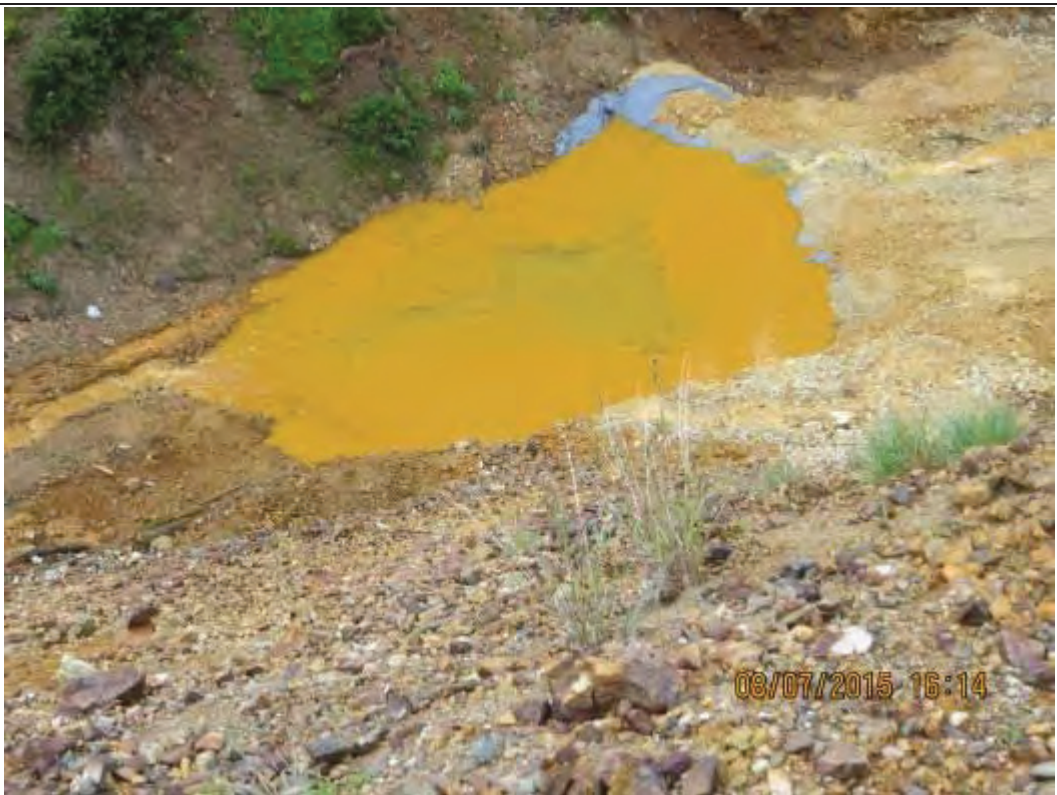
| Photo No. 24 | Date: 08/07/2015 |

| Description: Building ponds at Cement Creek and the North Fork. | |

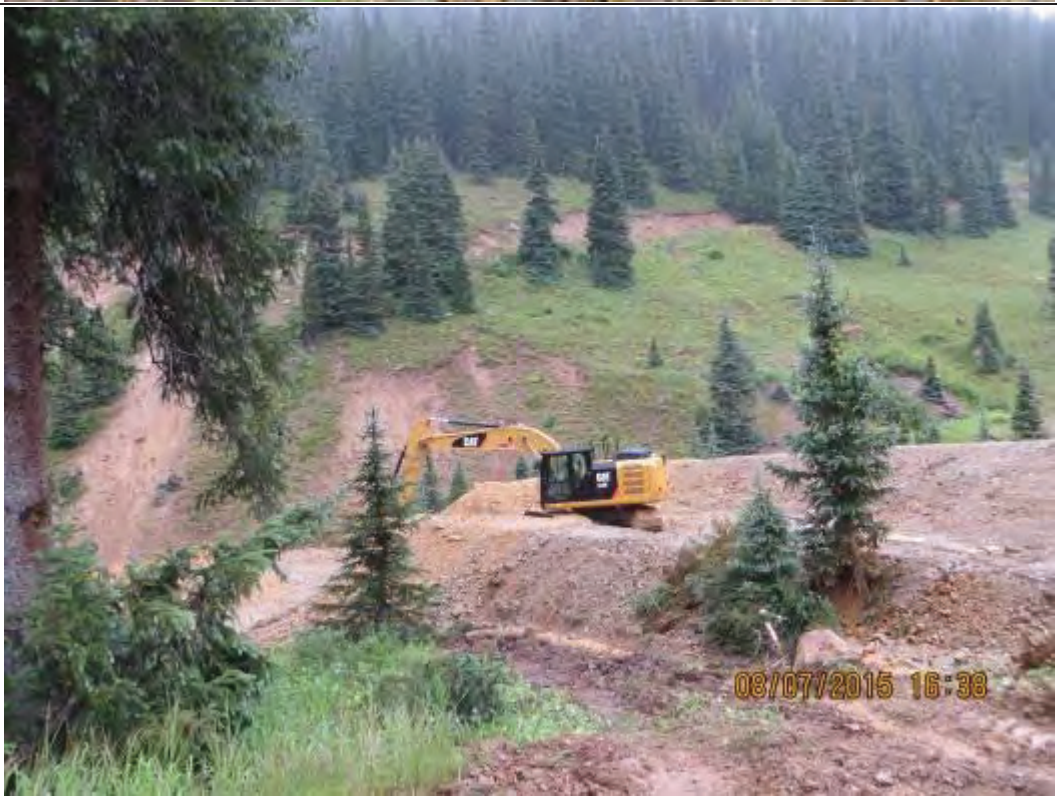
Photo No.
25

Description:
County Road 53 where North Fork crosses.

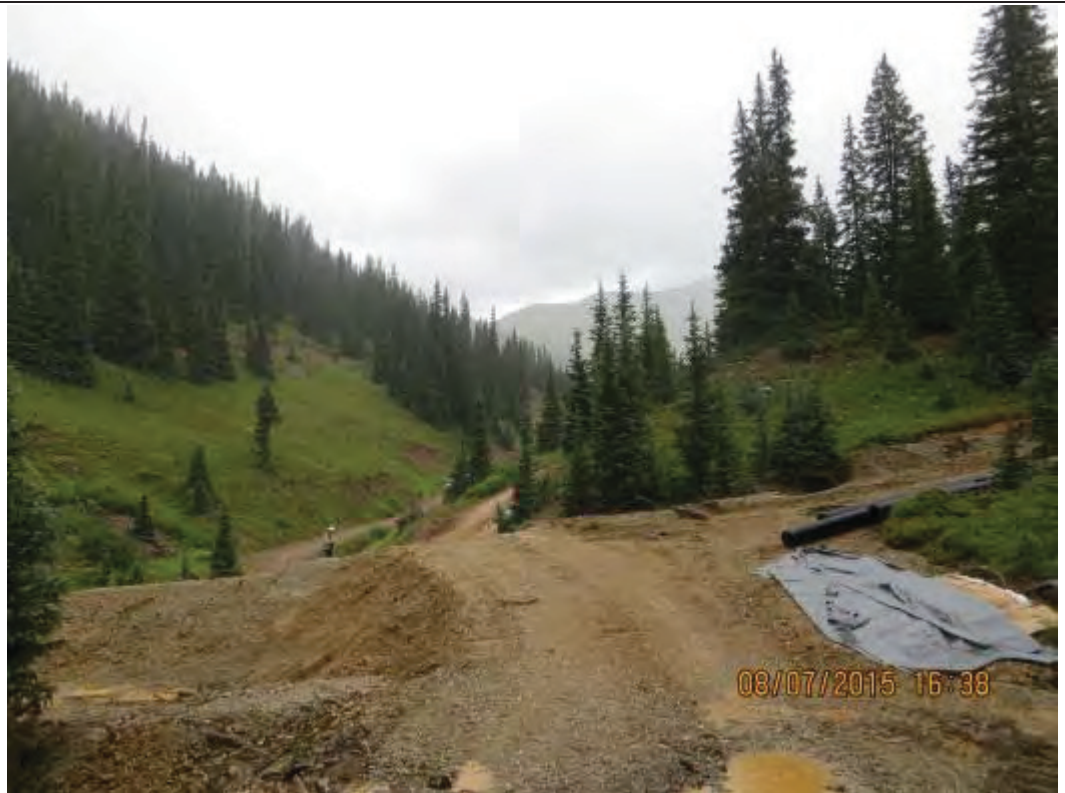
Photo No.
26

Description:
North Fork flow from Gold King.
